# FINAL REPORT RIVER RESTORATION PROJECT 2009 BLANCO RIVER NEAR PAGOSA SPRINGS, CO

# Submitted To: Colorado Water Conservation Board July 7, 2010

Submitted By:
LOWER BLANCO PROPERTY OWNERS ASSOCIATION

# Lower Blanco River Restoration Project Summary 2009 Phase V

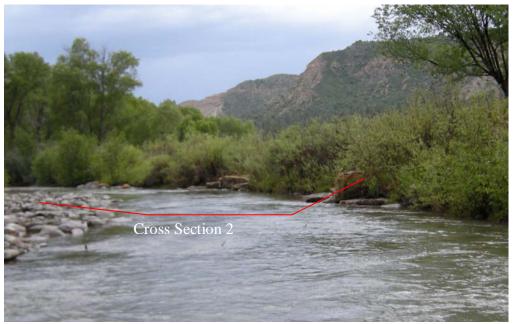
Cross Section #2 After construction looking downstream. Newly constructed point bar river left and rock habitat clusters river right.
