December 29, 2010

**Re: 2010 Monitoring Report for the Phase 1 Edwards Eagle River Restoration Project in Eagle County, Colorado, Corps File No. SPK-2008-00608-CW**

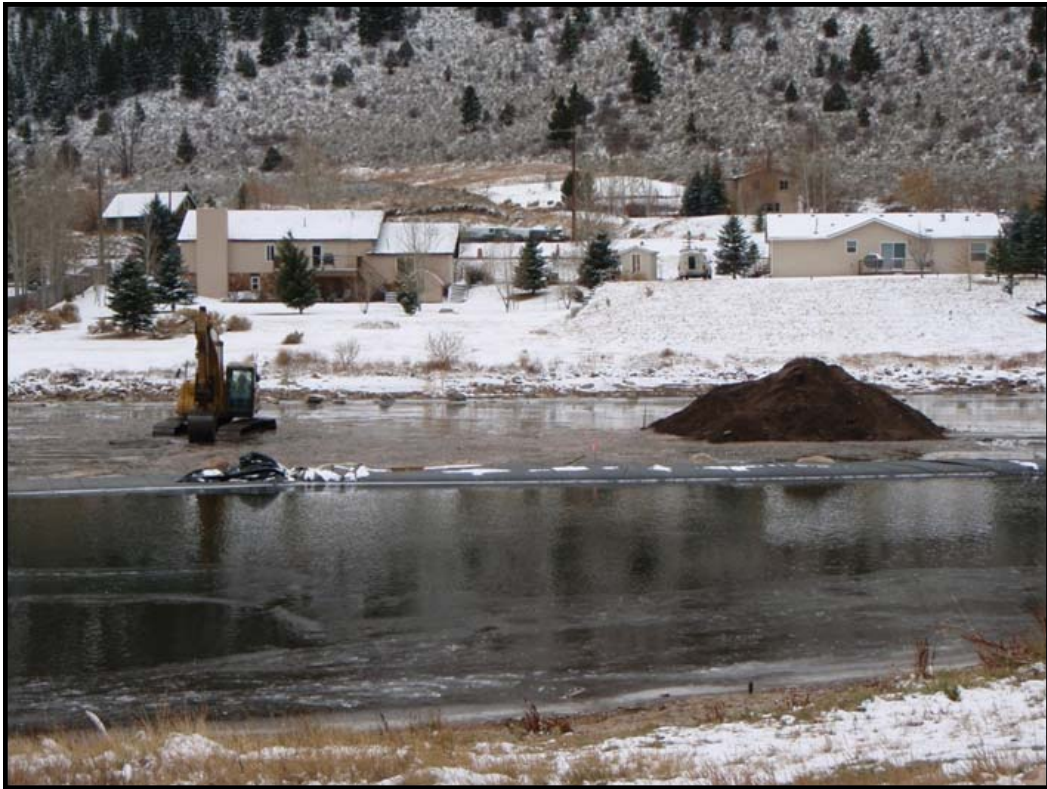
**Point 1S2L:** November 2008 during construction, looking across the river at Bar 1-17 from right bank.

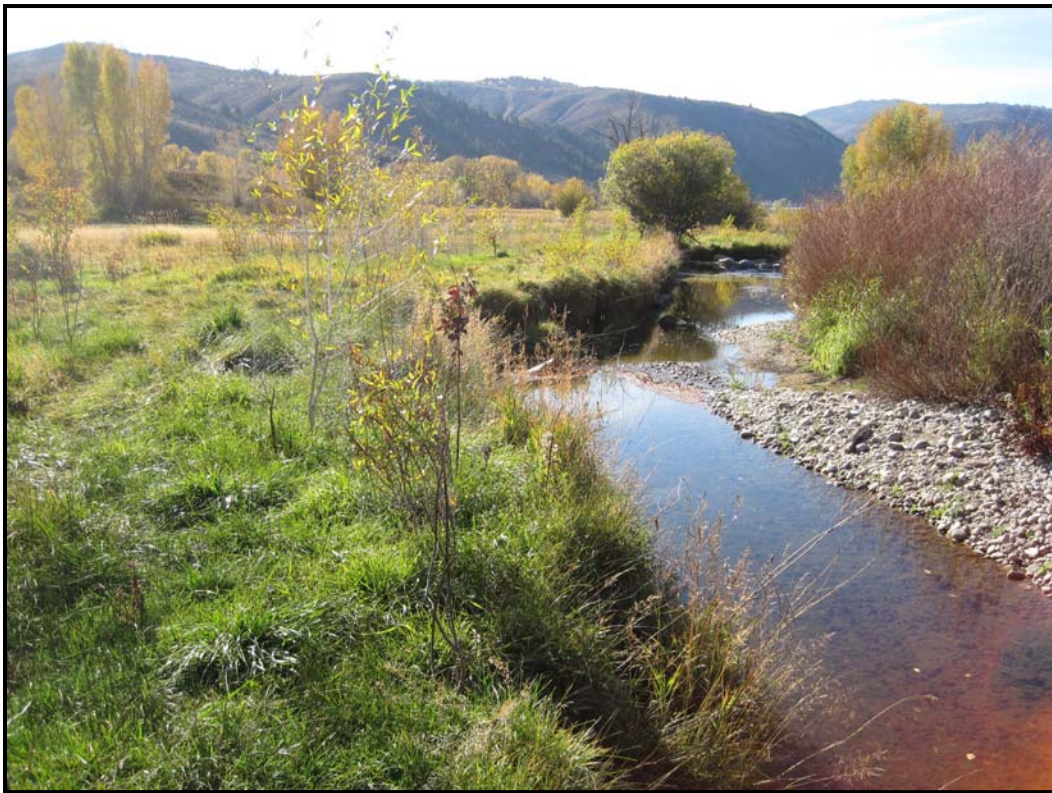
**Point 1S7L:** 10-13-10 Reach 5, side channel along left bank, looking downstream at side channel.

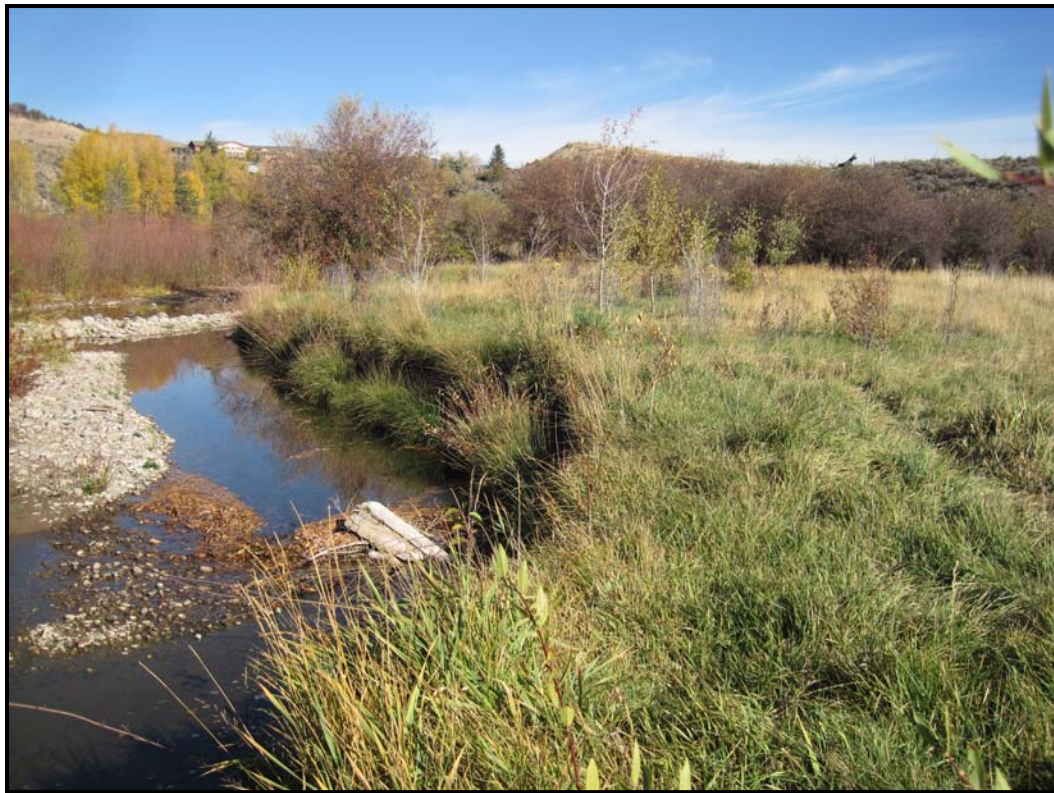
**Point 1S8L:** 10-13-10 Reach 5, side channel along left bank, looking upstream at side channel.

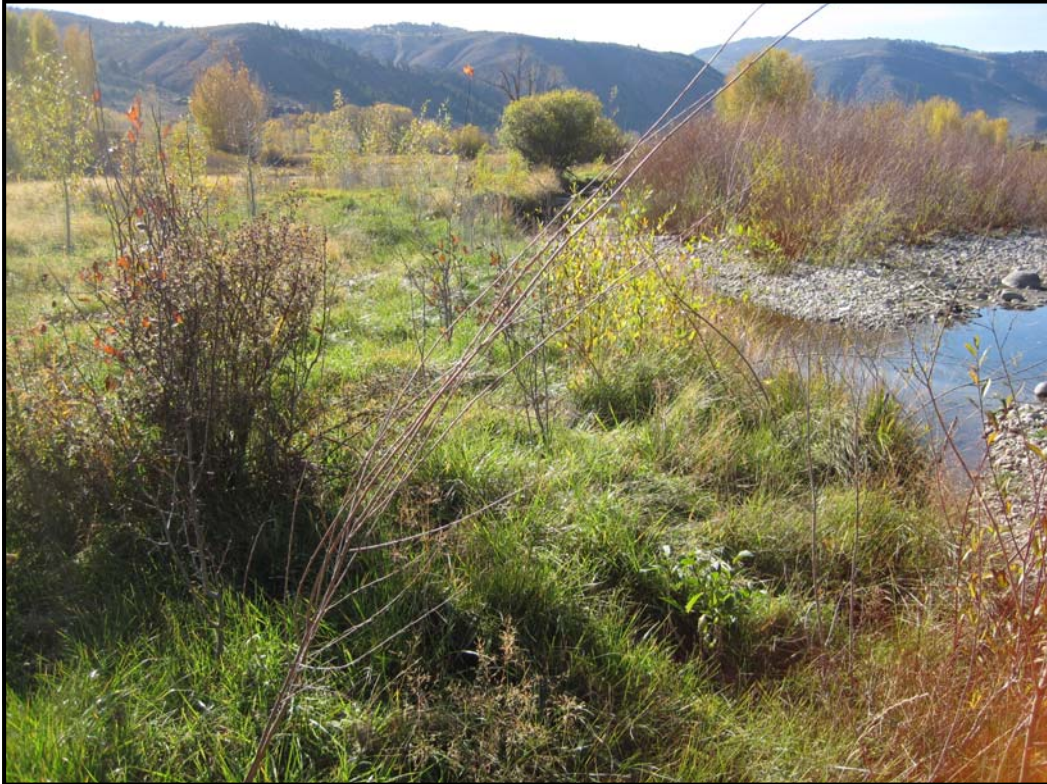
**Point 1S9L:** 10-13-10 Reach 5, left bank, looking downstream to Bar 1-5.

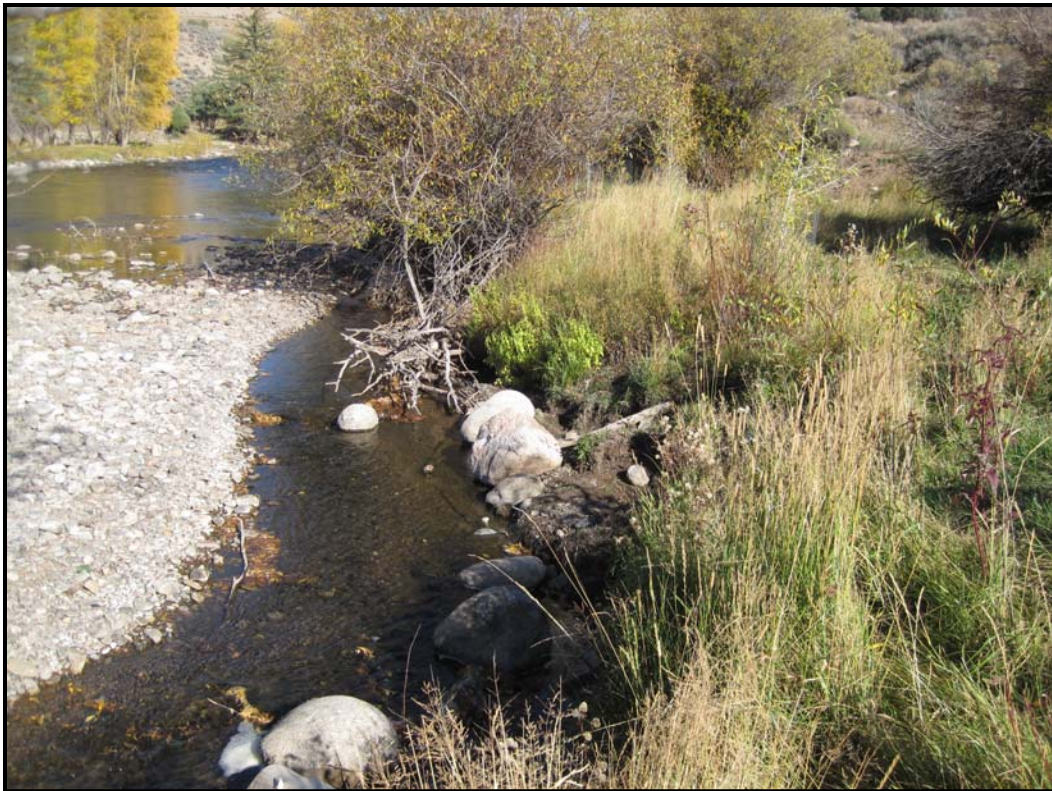
**Point 1S10L:** 10-13-10 Reach 5, left bank, standing on bank near 1-9 looking upstream.

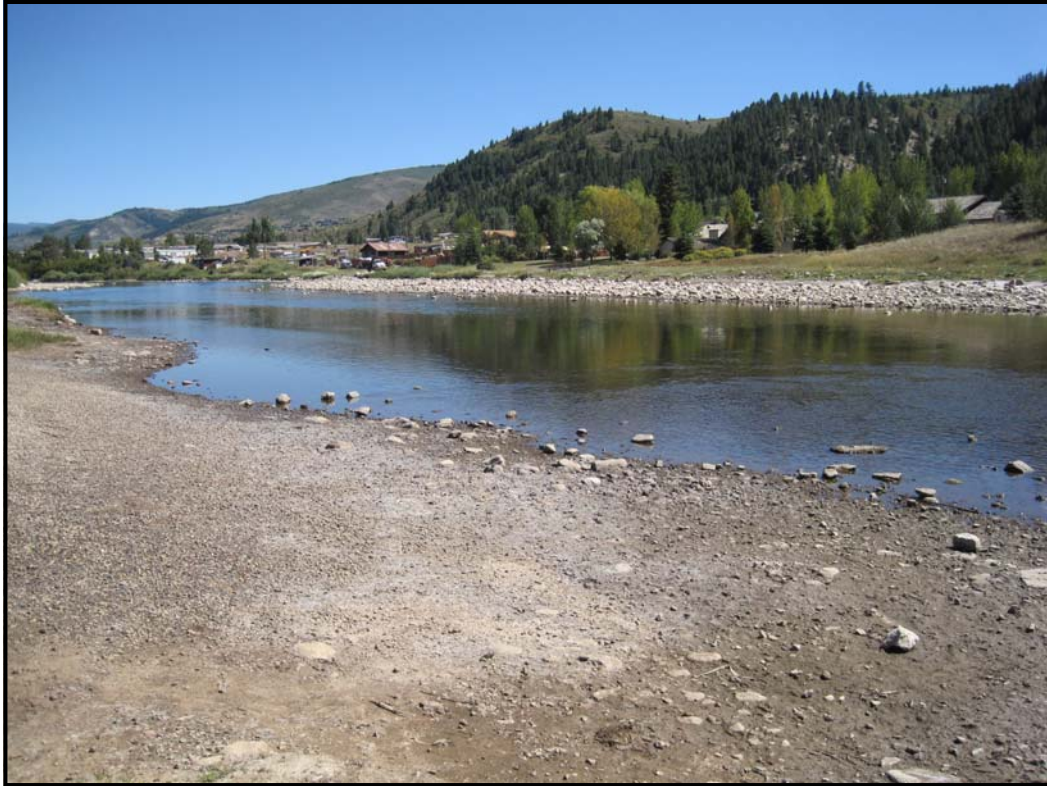
**Point 1S3R:** 9-3-10 From the boat launch, looking across/up river toward Bar 1-17 (in background).

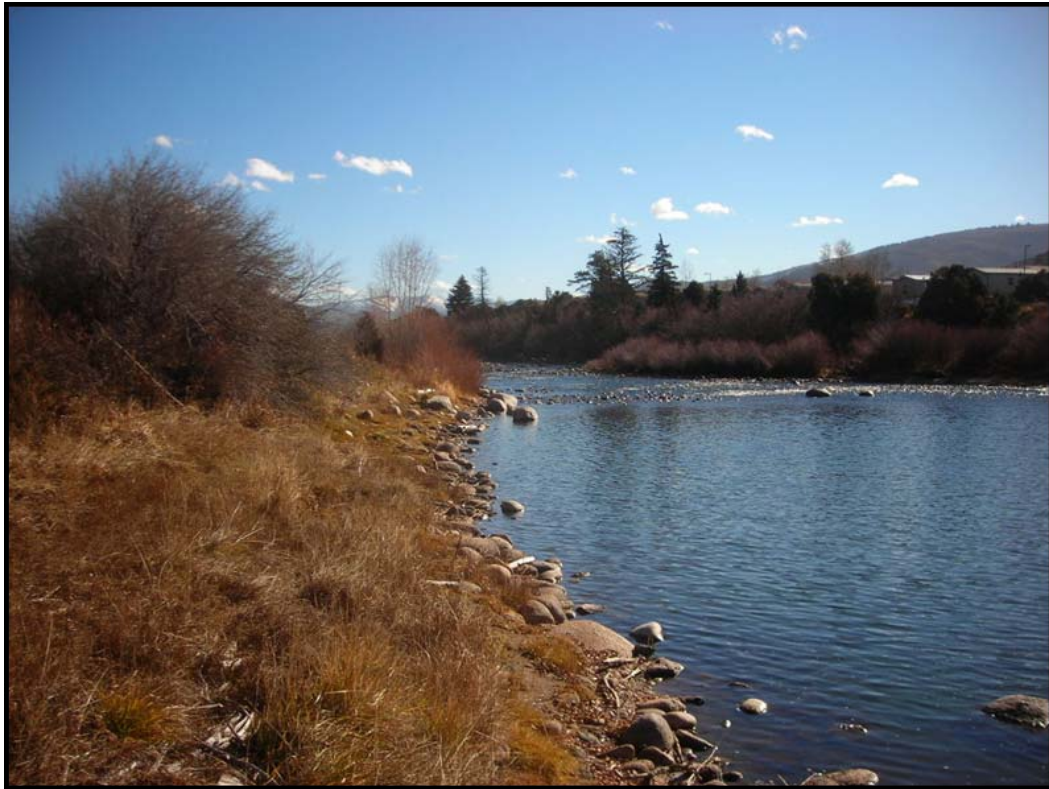
**Point 1S4R:** November 2006 Reach 2, right bank, looking upstream at Bar 1-15a.

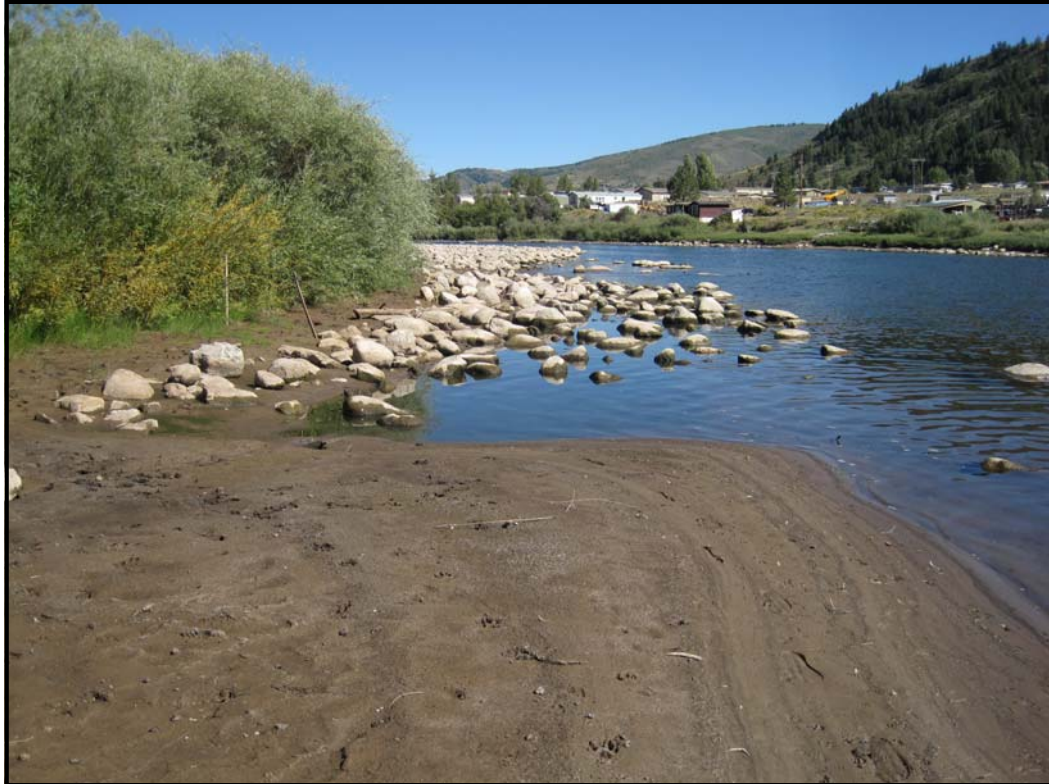
**Point 1S4R:** 9-3-10 Reach 2, right bank, looking upstream at Bar 1-15a, with Bar 1-15 in the background.

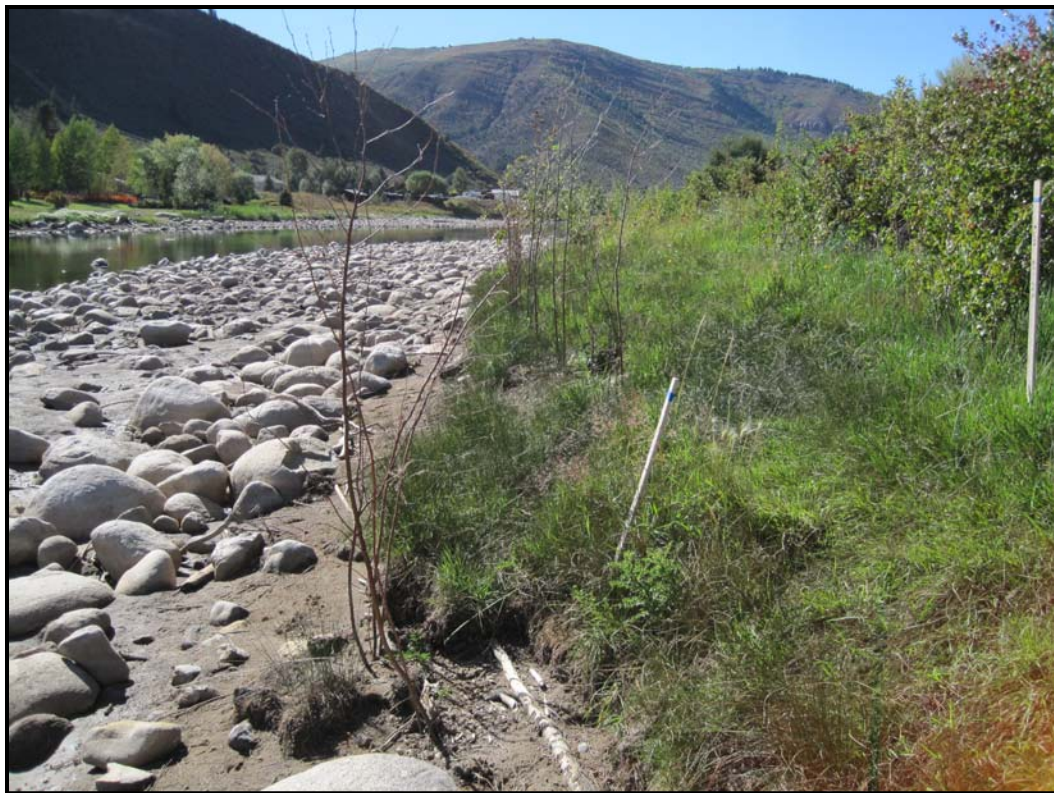
**Point 1S5R:** November 2009 Reach 2, right bank, looking downstream to Bar 1-15b.

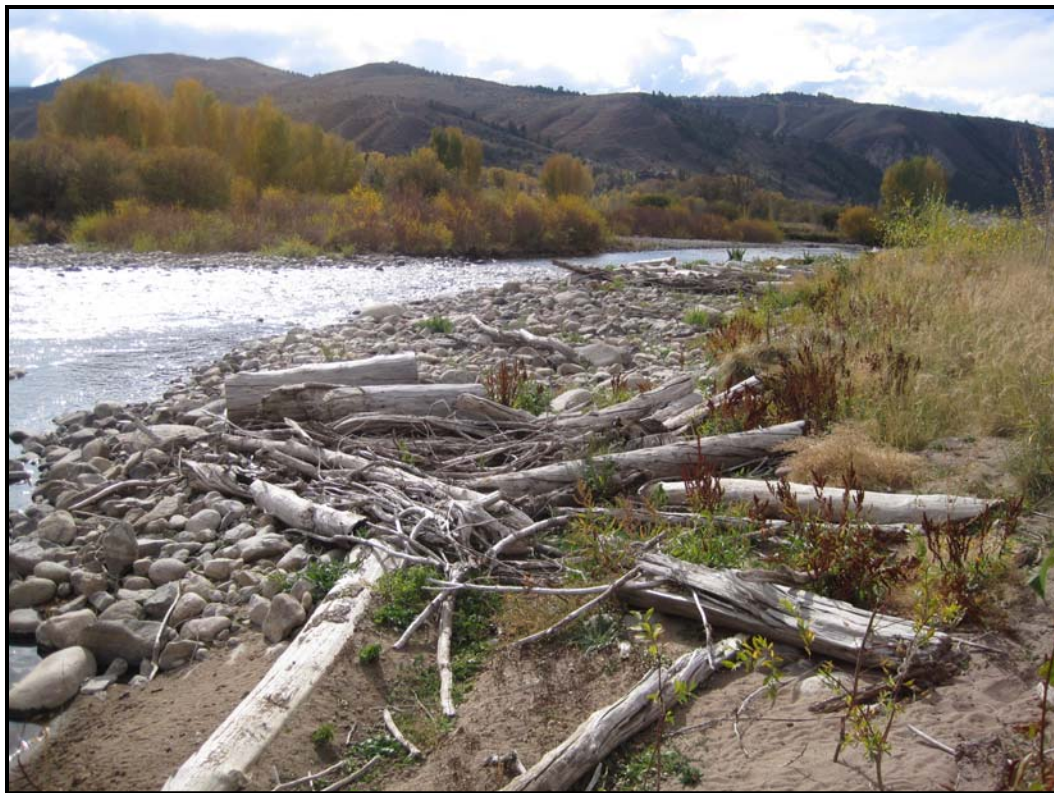
**Point 1S8R:** 10-5-10 Reach 5, right bank, looking downstream ) to Bar 1-4.

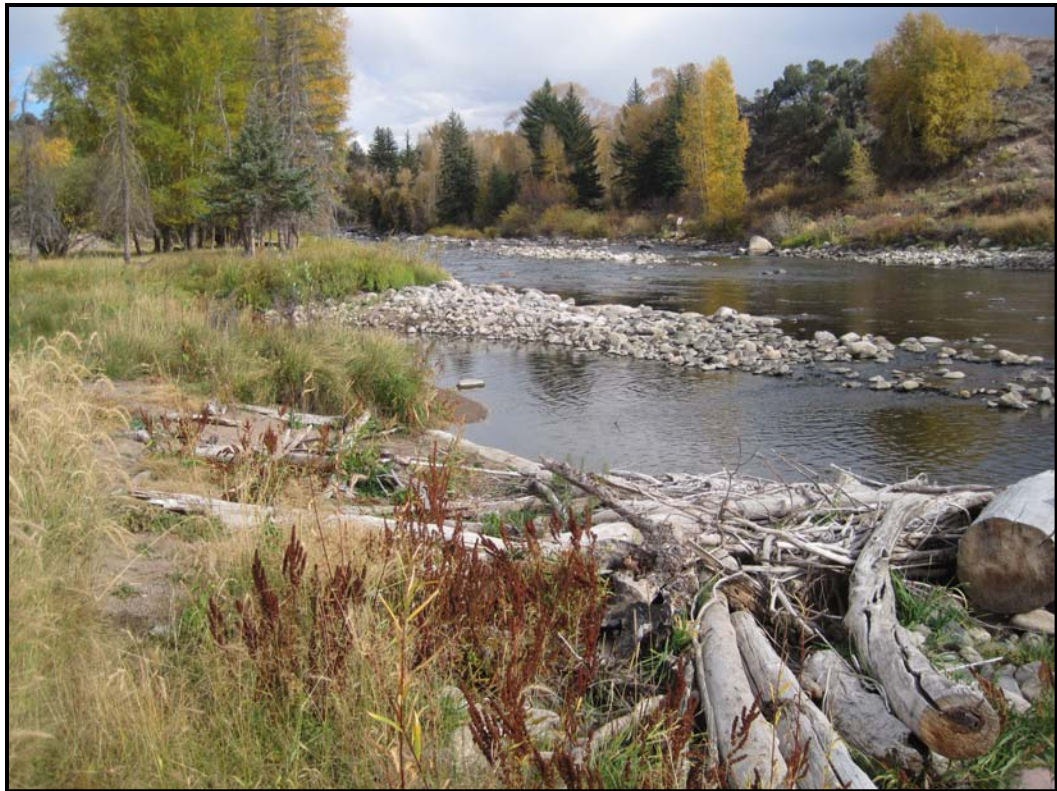
**Point 1S9R:** 10-5-10 Reach 5, right bank, looking upstream to oxbow confluence and Bar 1-1.

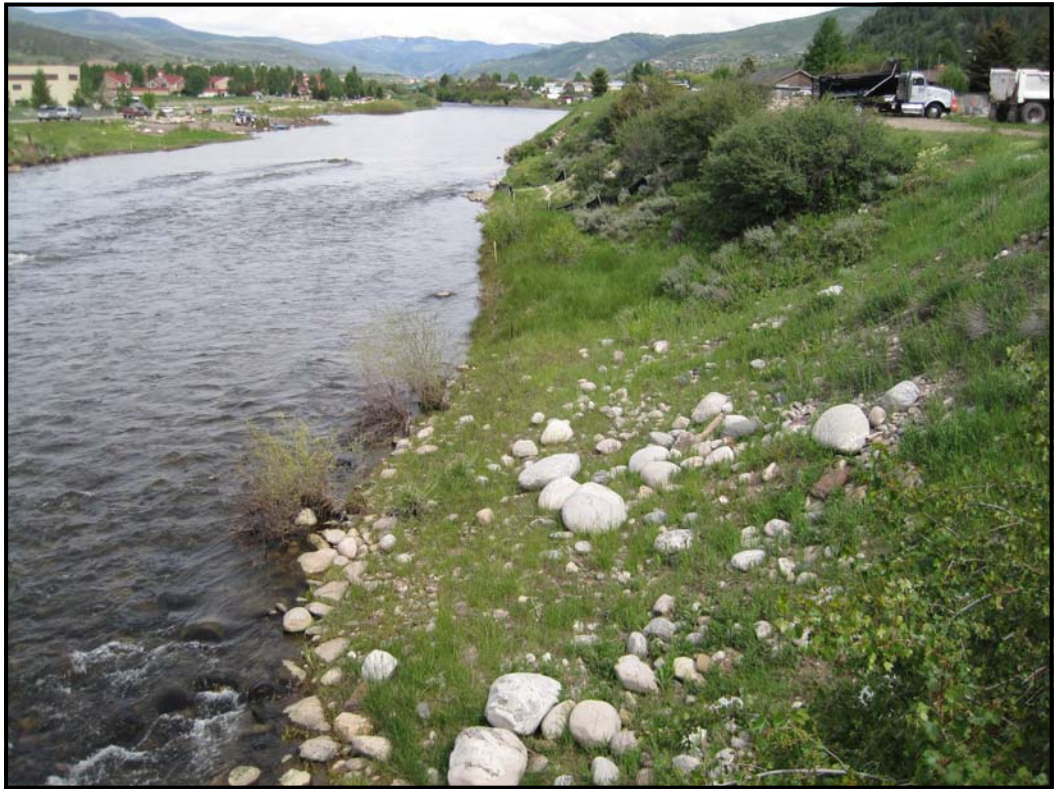
**Point 1V1L:** 6-12-09 Pre-planting, from Hillcrest Bridge looking upstream at cobble bar 1-22.

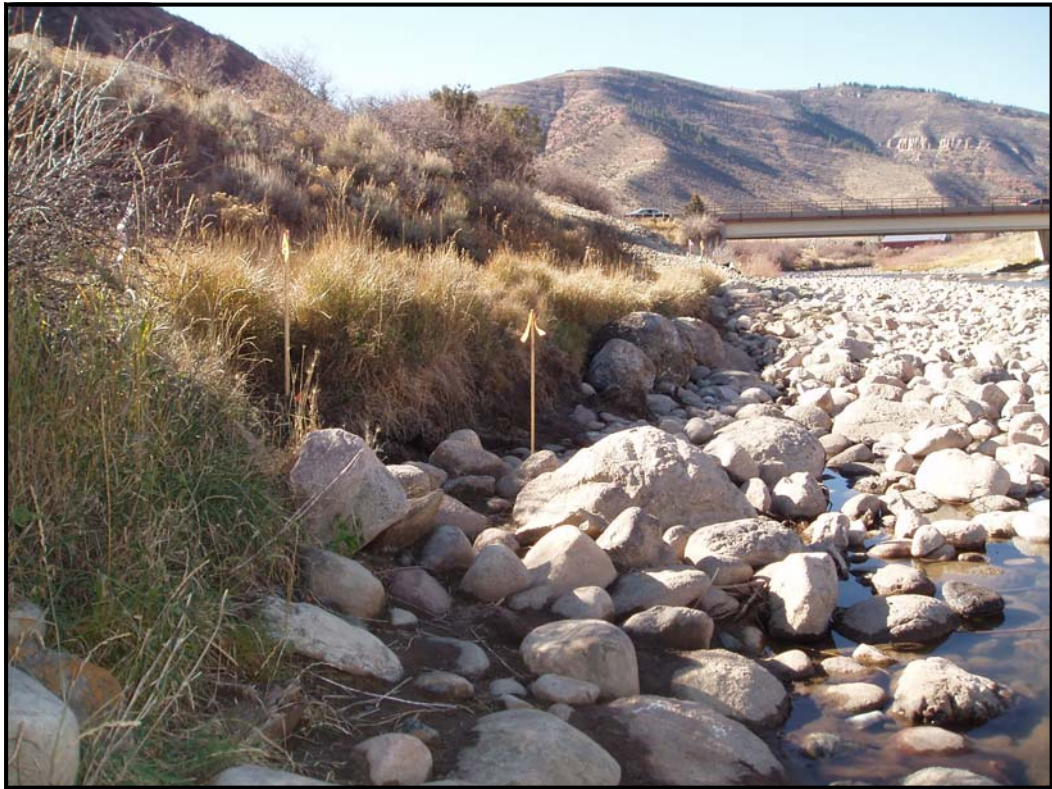
**Point 1V2L:** 10-30-08 Pre-planting, from Cobble Bar 1-22 looking downstream at riparian terrace.

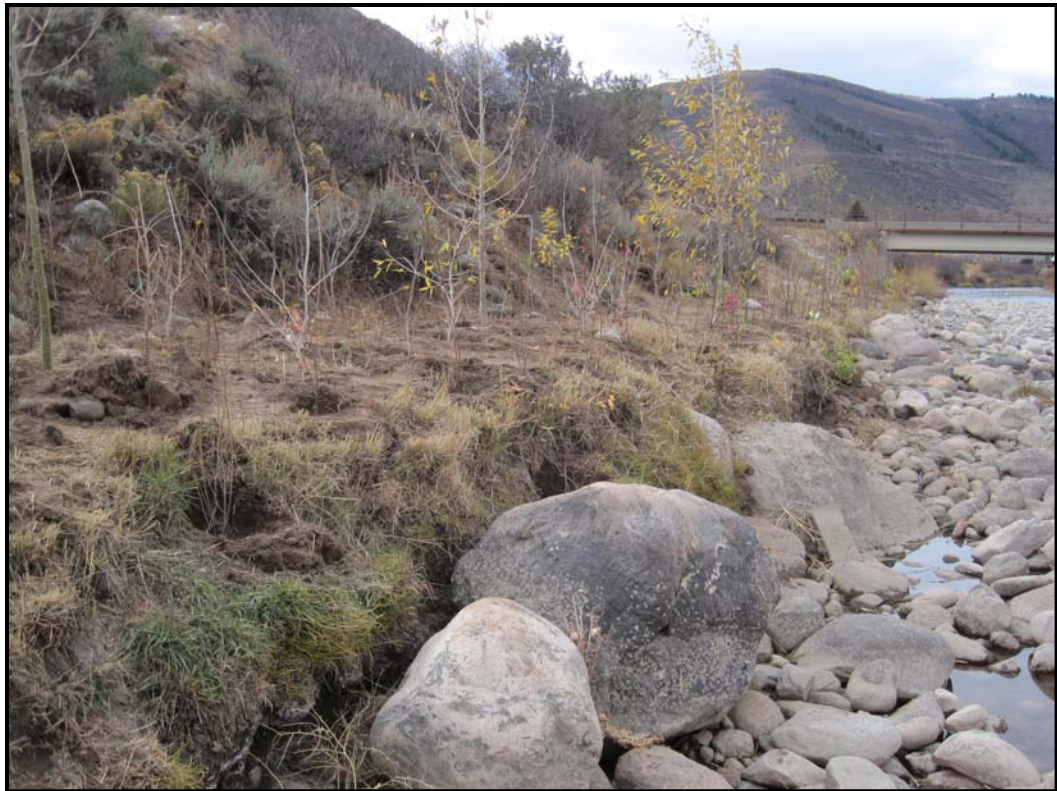
**Point 1V2L:** 10-20-09 Willows planted on the bank; cottonwoods and shrubs on the terrace, and transitional shrubs, spruce, and juniper interplanted into existing shrubs on the slope. (2010 photo not available)

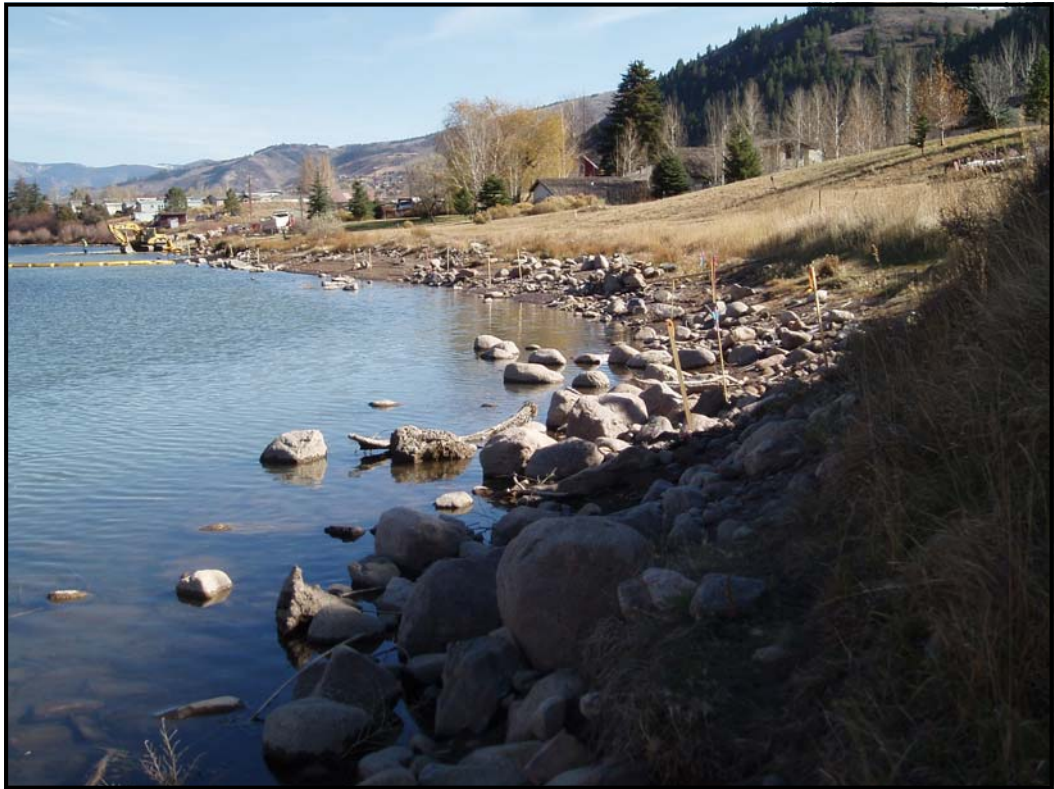
**Point 1V3L:** 10-30-08 Pre-planting, from Cobble Bar 1-22, looking upstream.

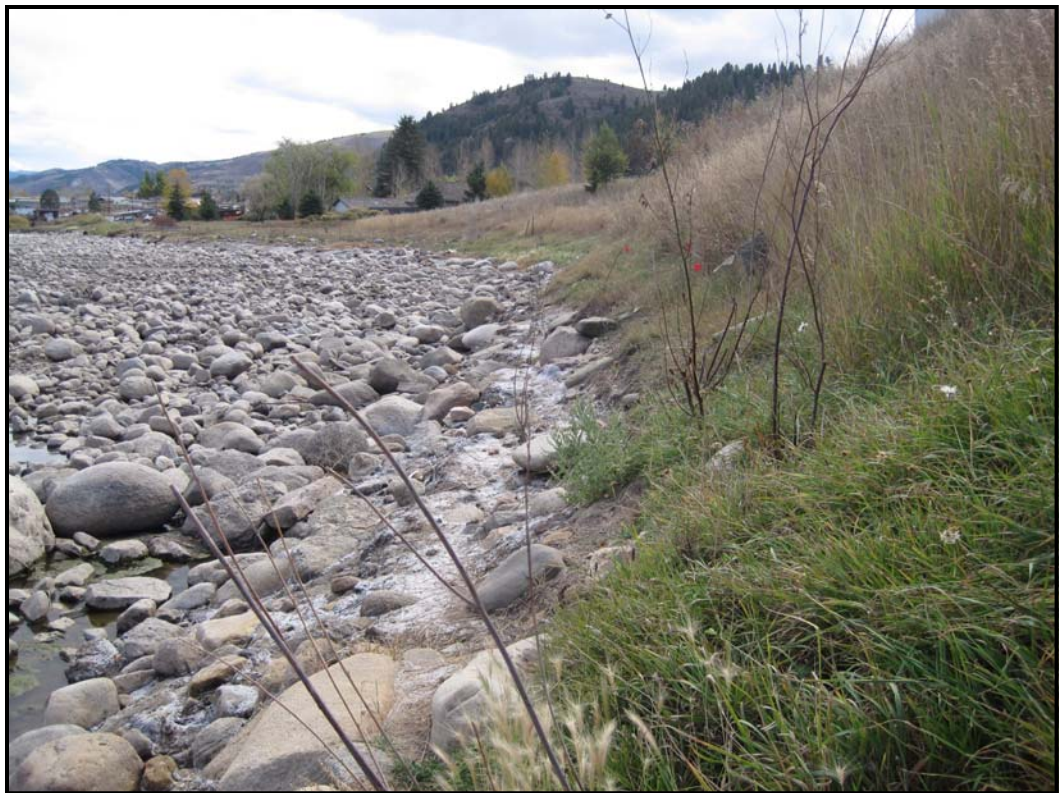
**Point 1V3L:** 10-5-10 Willows planted on the bank; with cottonwoods, alder, and birch on slope.

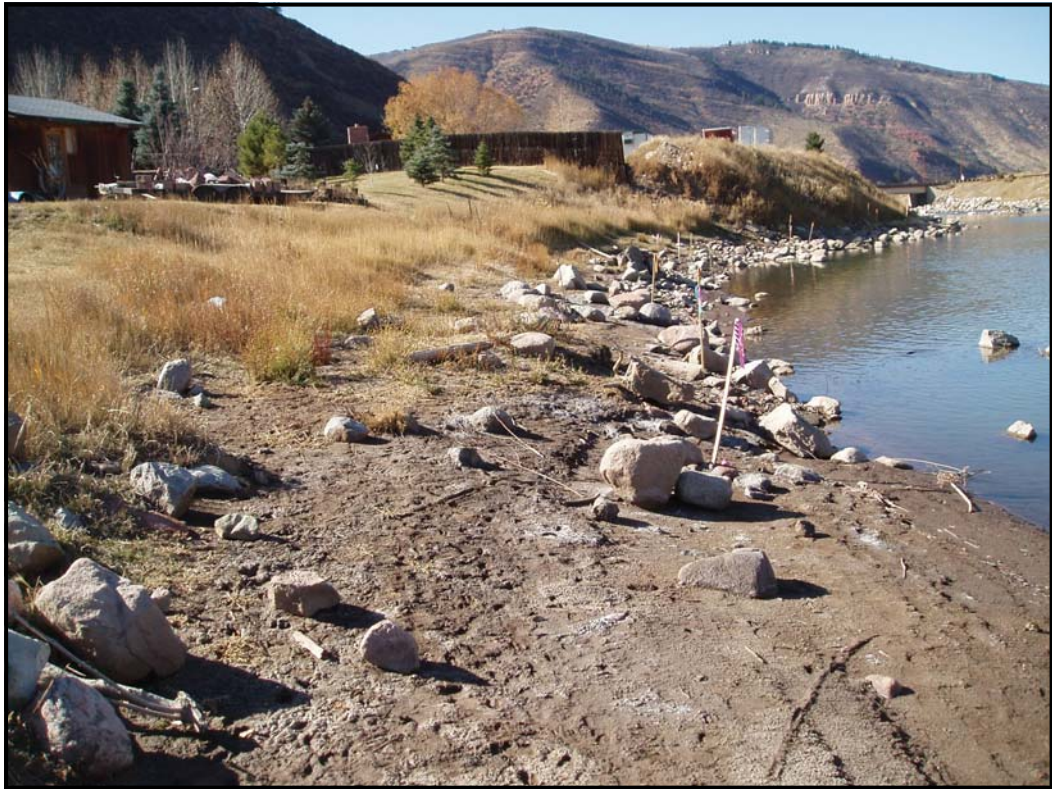
**Point 1V4L:** 10-30-08 Pre-planting, from Cobble Bar 1-17, looking downstream.

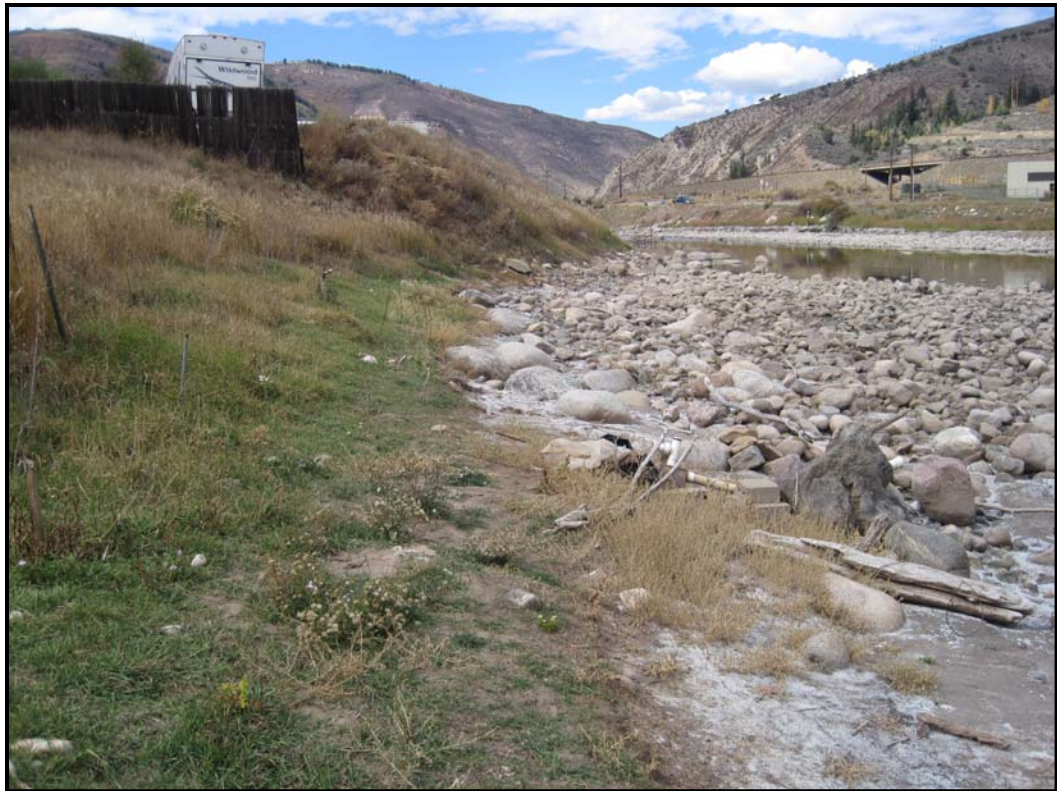
**Point 1V4L:** 10-5-10 Willows planted at the river edge; with cottonwoods and mixed shrubs behind.

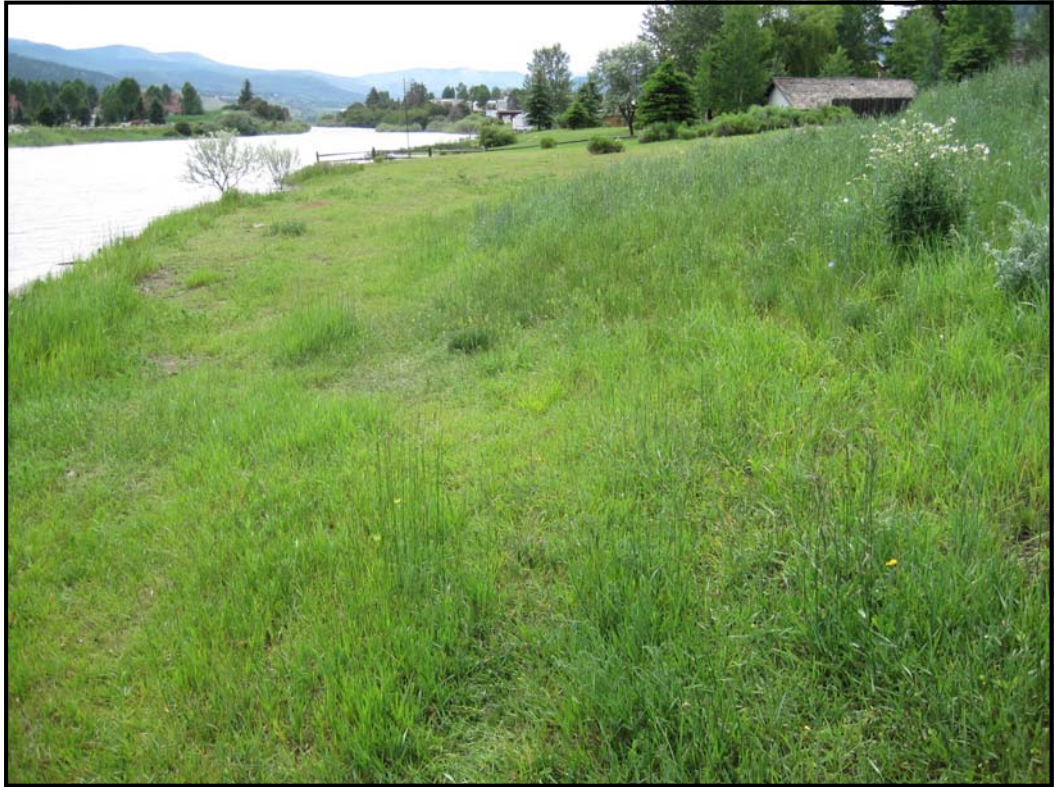
**Point 1V5L:** 6-26-09 Pre-planting, adjacent to Cobble Bar 1-17, looking upstream.

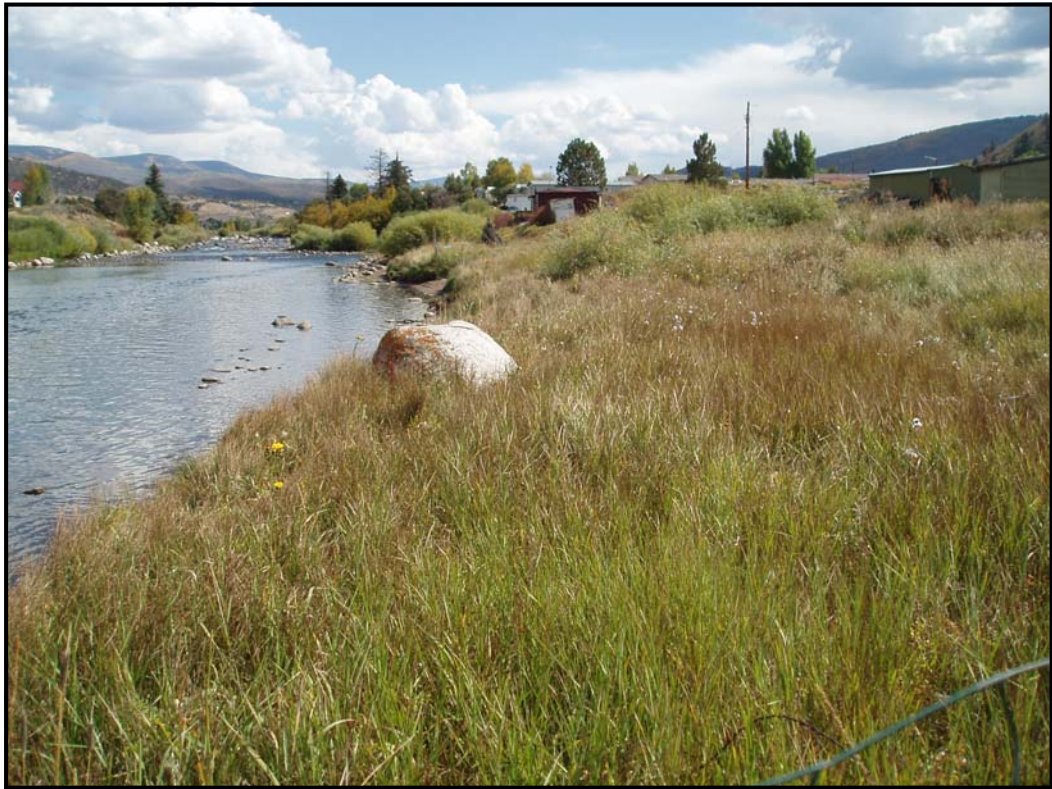
**Point 1V5L:** 10-5-10 Willows planted at the river edge; with cottonwoods, mixed shrubs, and spruce behind.

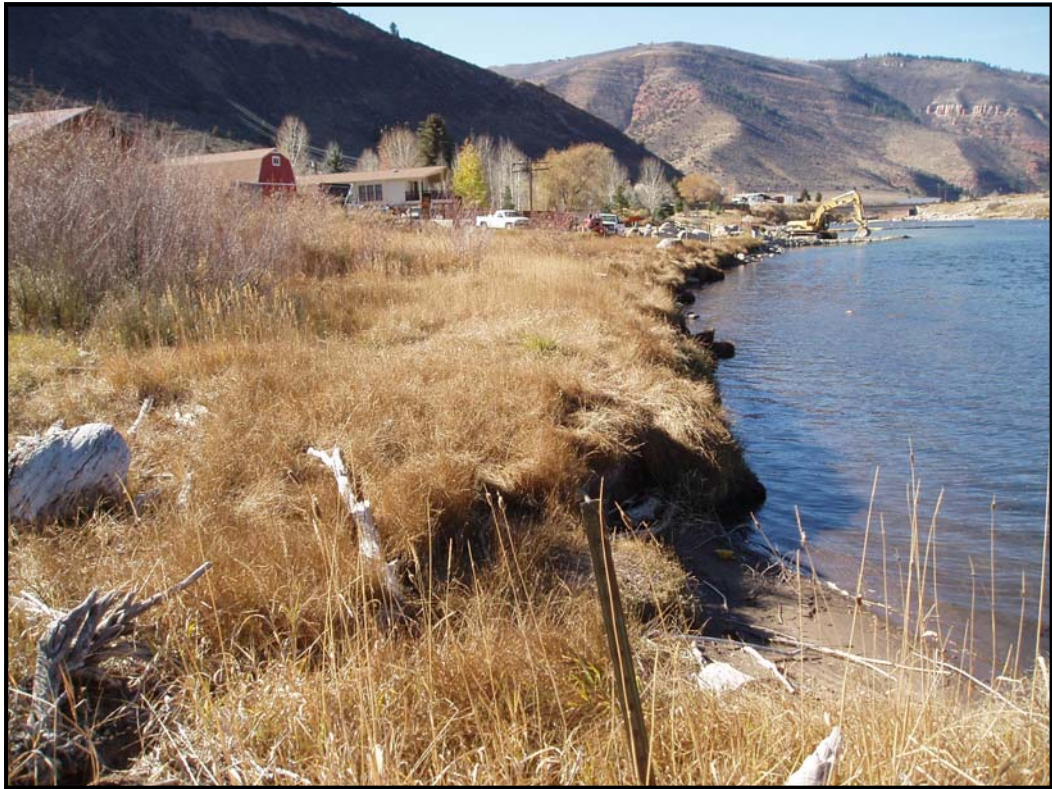
**Point 1V6L:** 10-5-10 Bank planted densely with willows; cottonwoods and mixed shrubs on riparian terrace, and upland shrubs on slope.

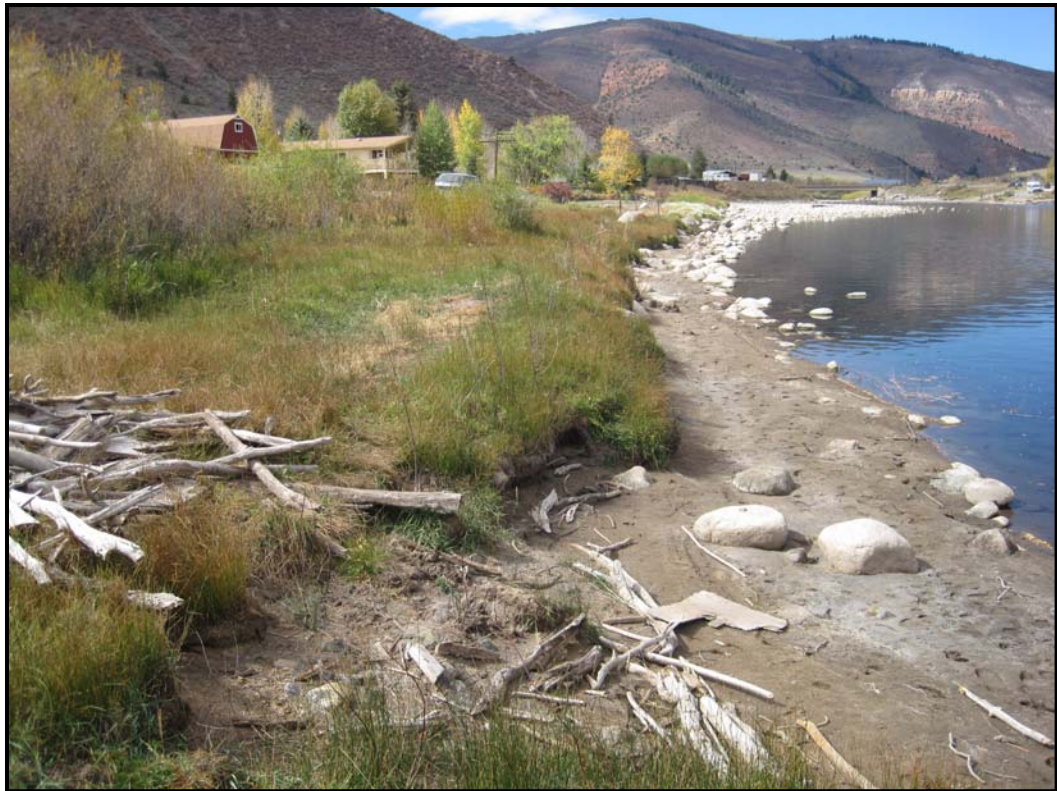
**Point 1V7L:** 10-30-08 Pre-planting, looking downstream toward Treatment Area 1-17.

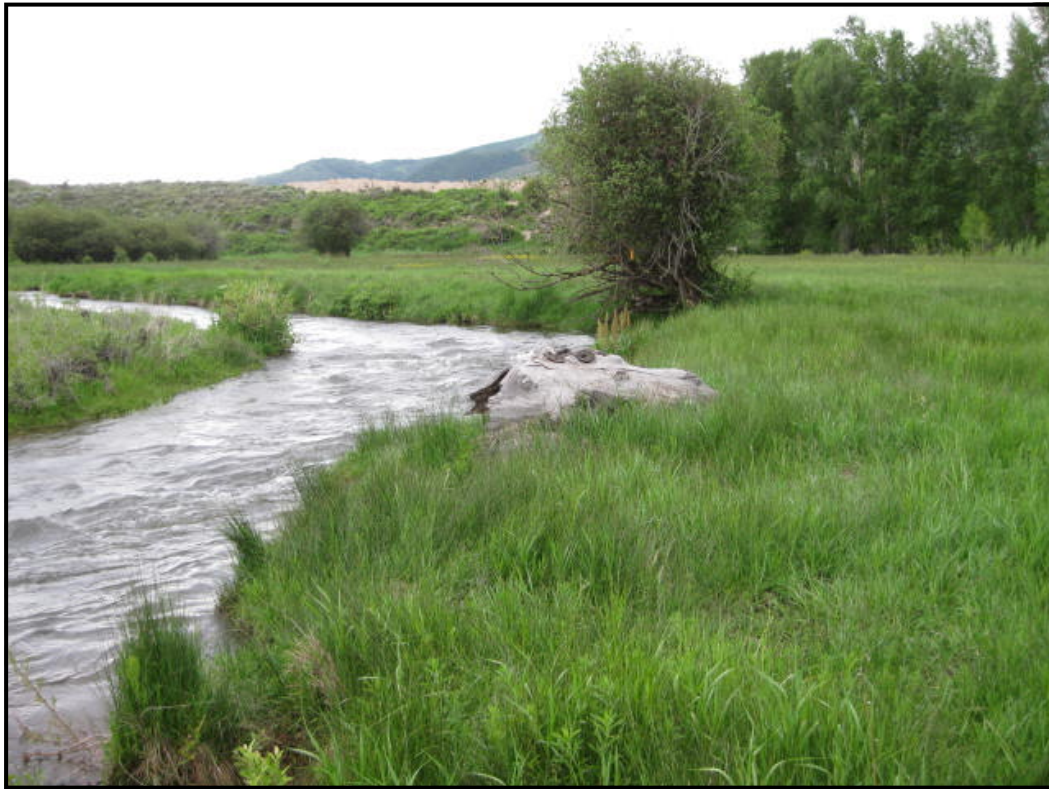
**Point 1V7L:** 10-5-10 Bank planted with willows..

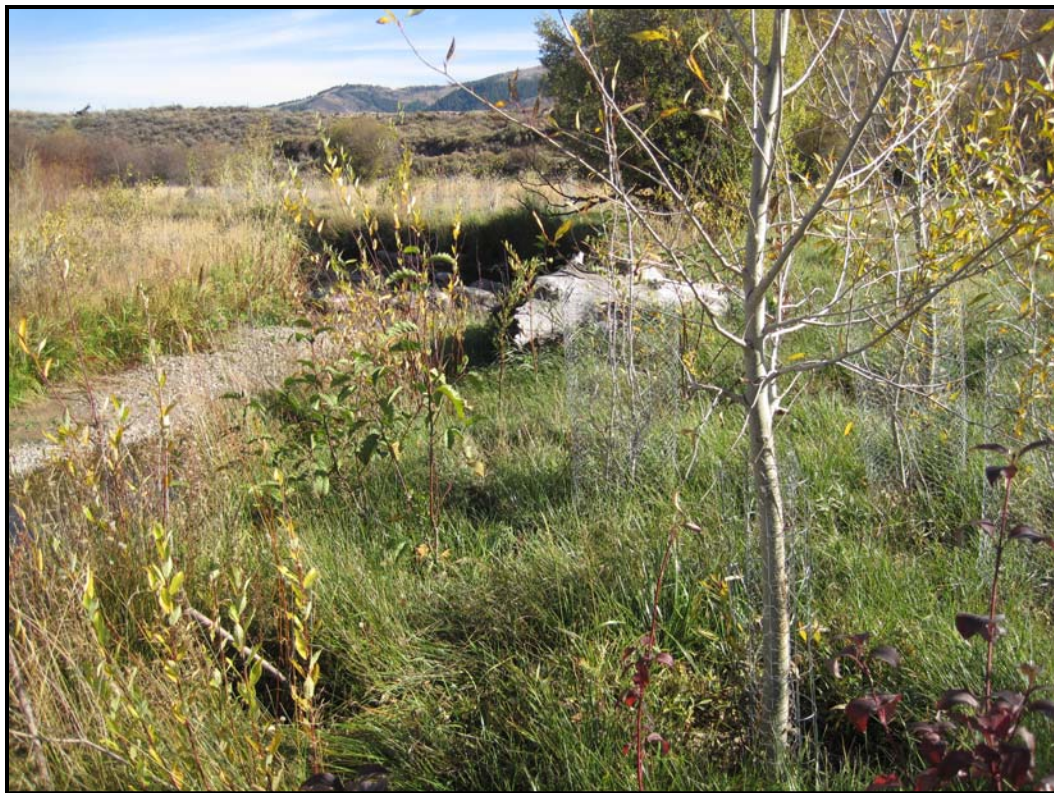
**Point 1V8L:** 6-25-09 Pre-planting, looking upstream at side channel.

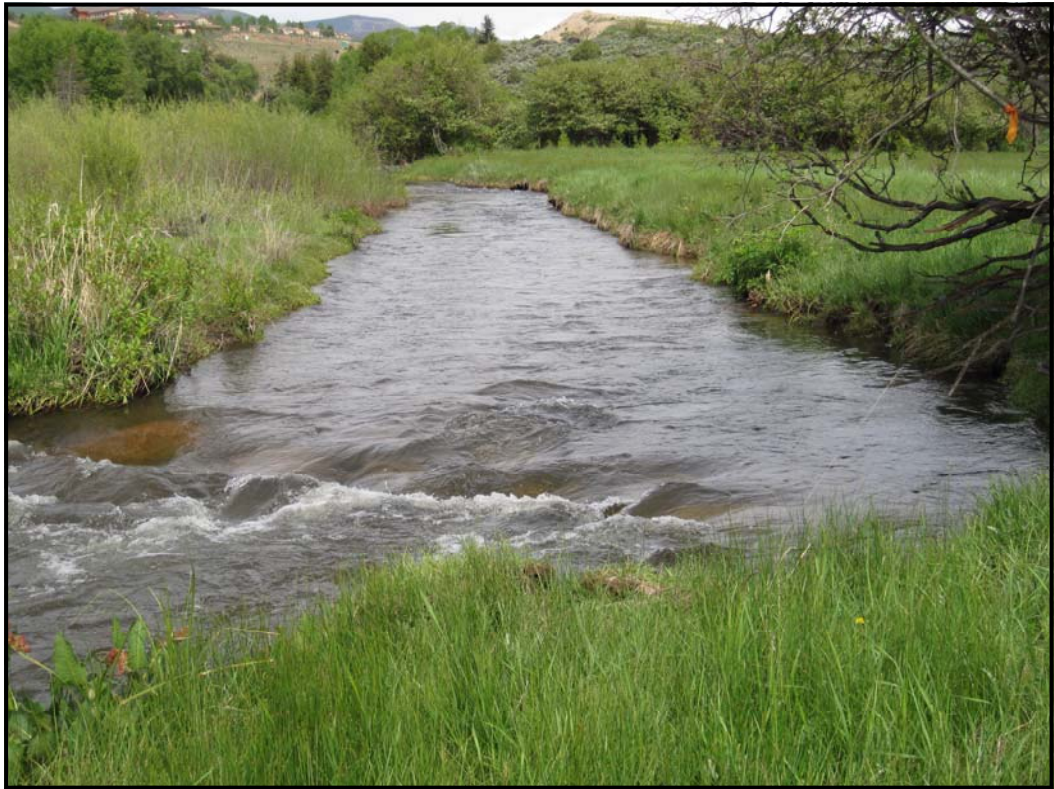
**Point 1V8L:** 10-13-10 Willows on bank; narrowleaf cottonwood, hawthorn, and mixed shrubs behind.

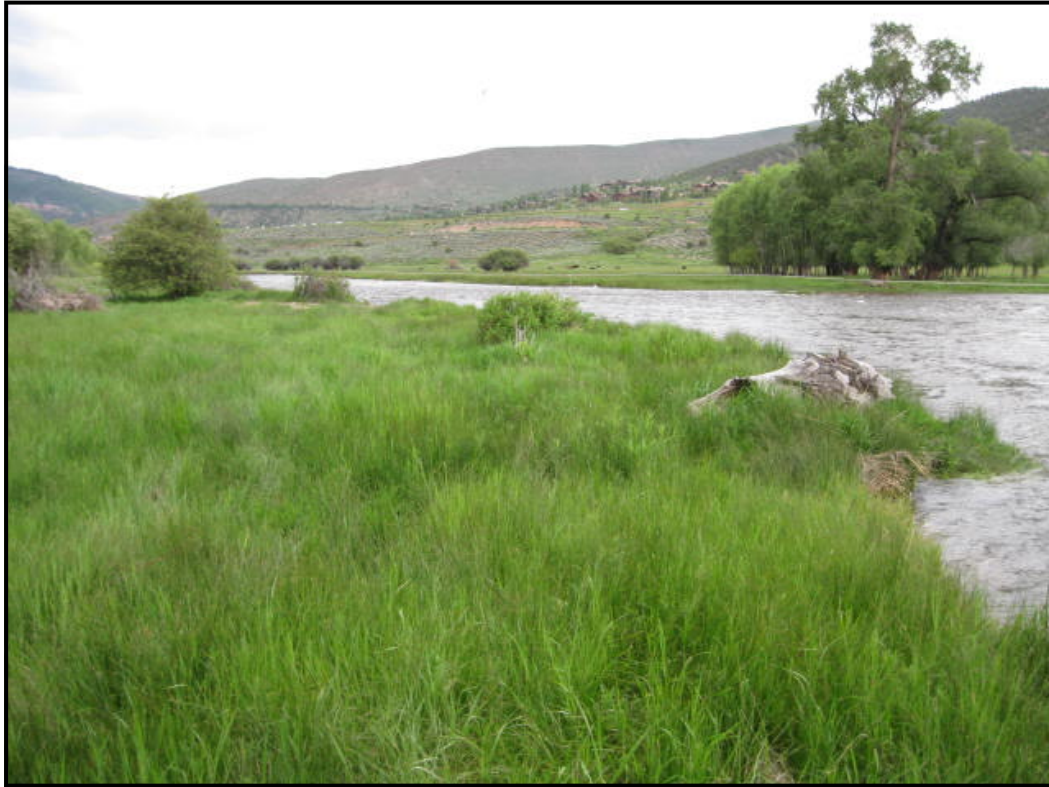
**Point 1V9L:** 10-13-10 Willows, dogwood, honeysuckle, and currant on bank; cottonwoods and mixed shrubs behind.

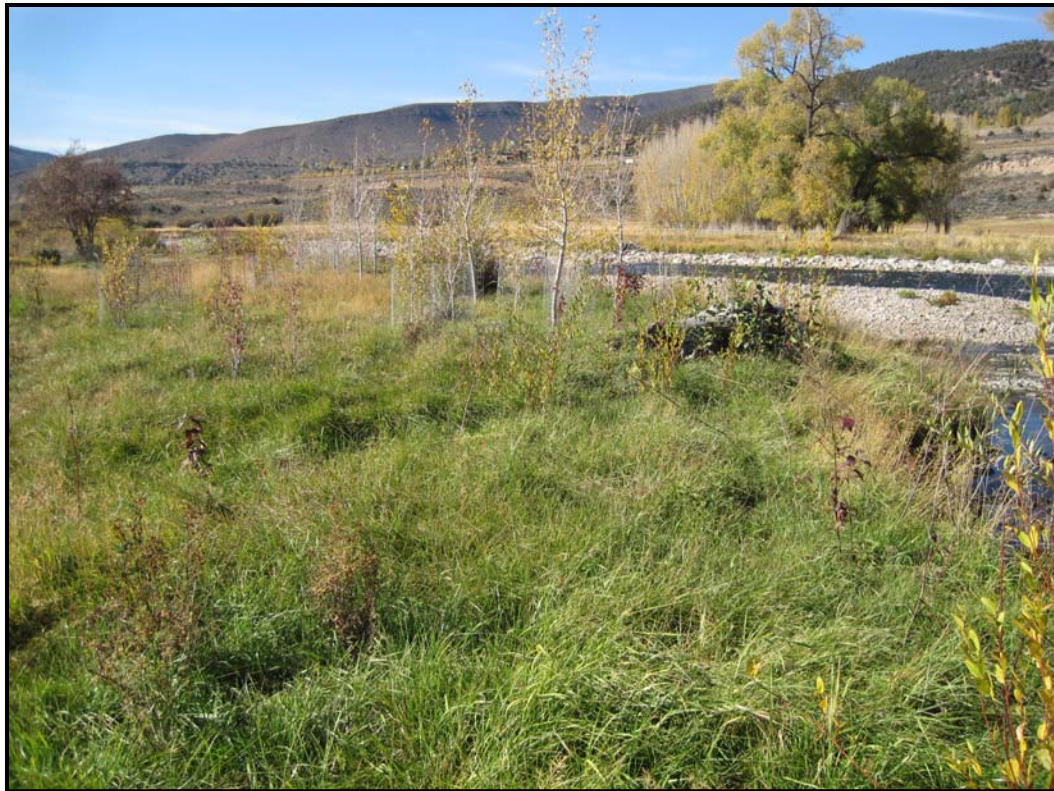
**Point 1V10L:** 6-25-09 Pre-planting, where side channel joins river, looking downstream toward Cobble Bar 1-9.
