December 29, 2010

**Re: 2010 Monitoring Report for the Phase 1 Edwards Eagle River Restoration Project in Eagle County, Colorado, Corps File No. SPK-2008-00608-CW**

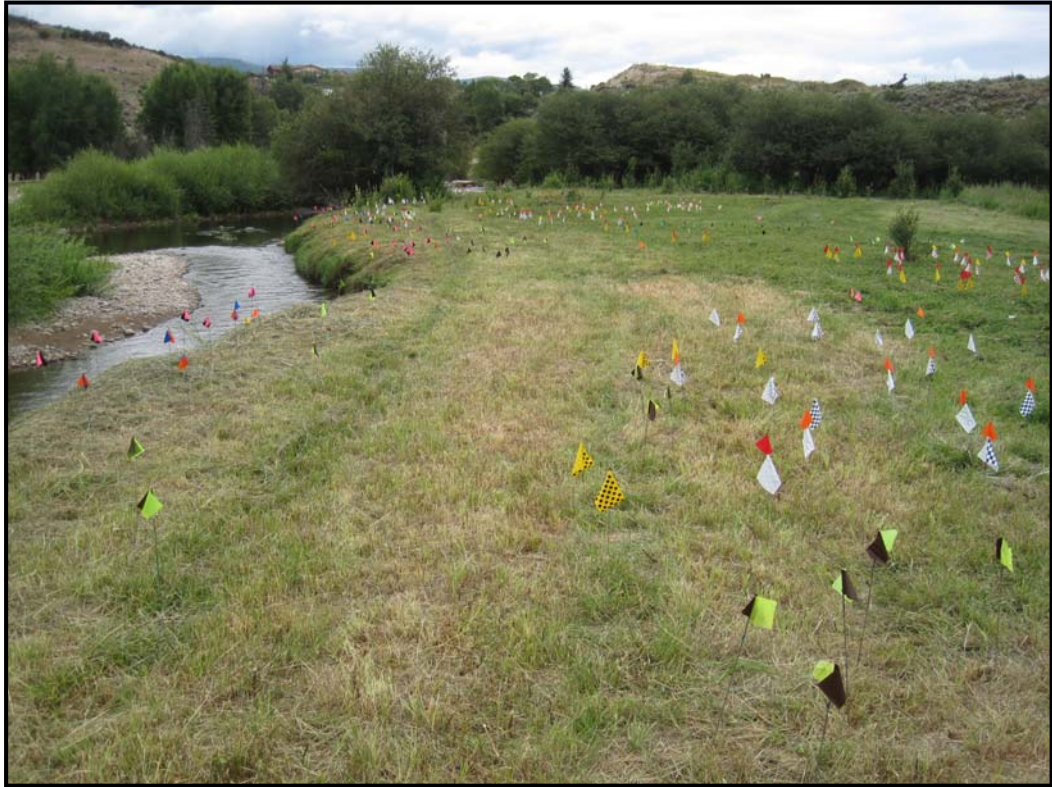
**Point 1V10L:** 10-13-10 Willows on bank; cottonwoods and mixed shrubs behind.

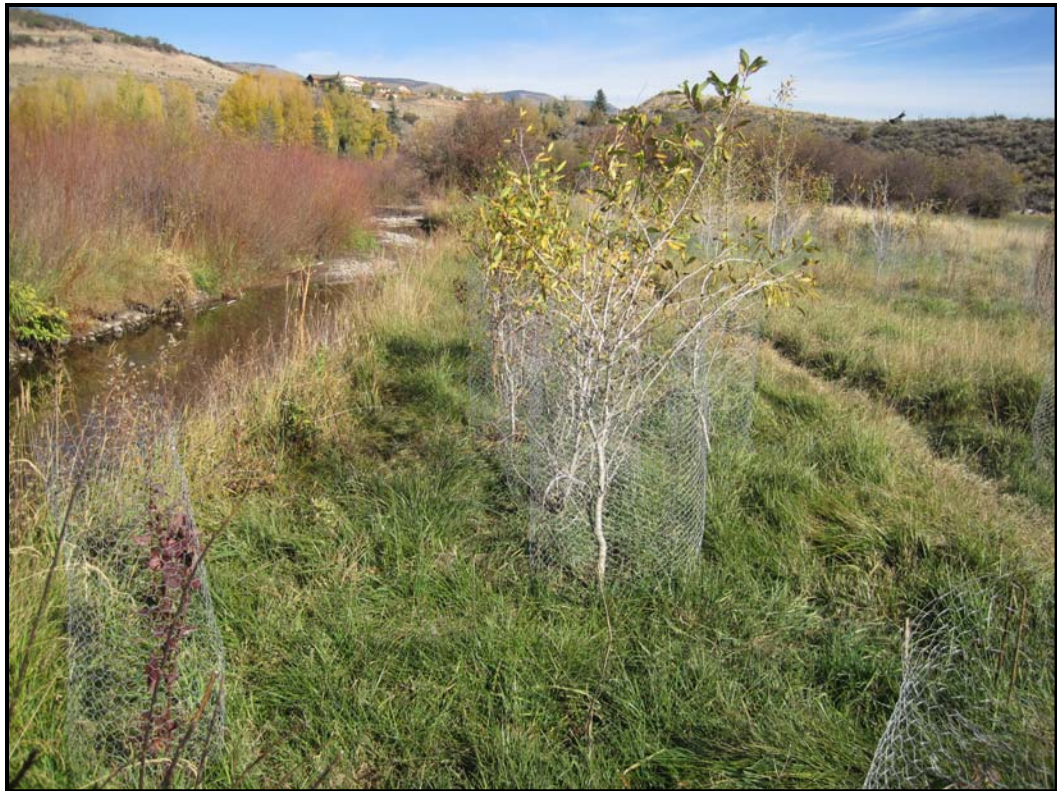
**Point 1V11L:** 8-14-09 Pre-planting, at upstream end of side channel.

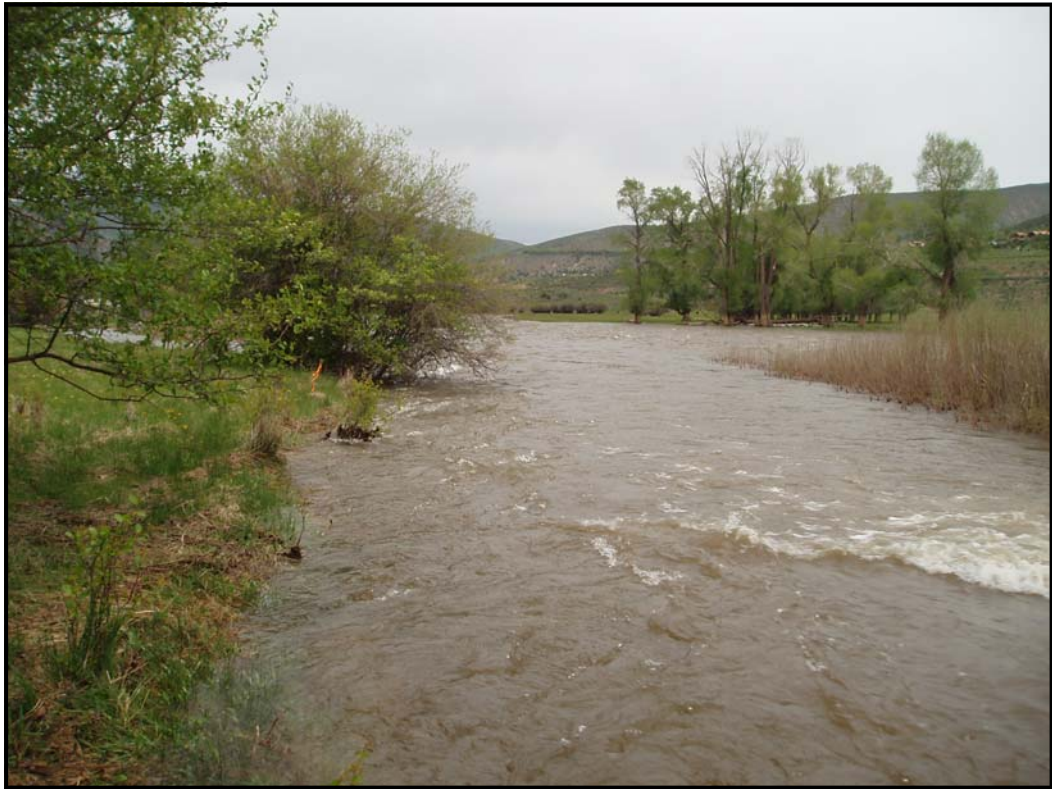
**Point 1V11L:** 10-13-10 Willows, dogwood, and currant on bank; cottonwoods, hawthorns, and mixed shrubs behind.

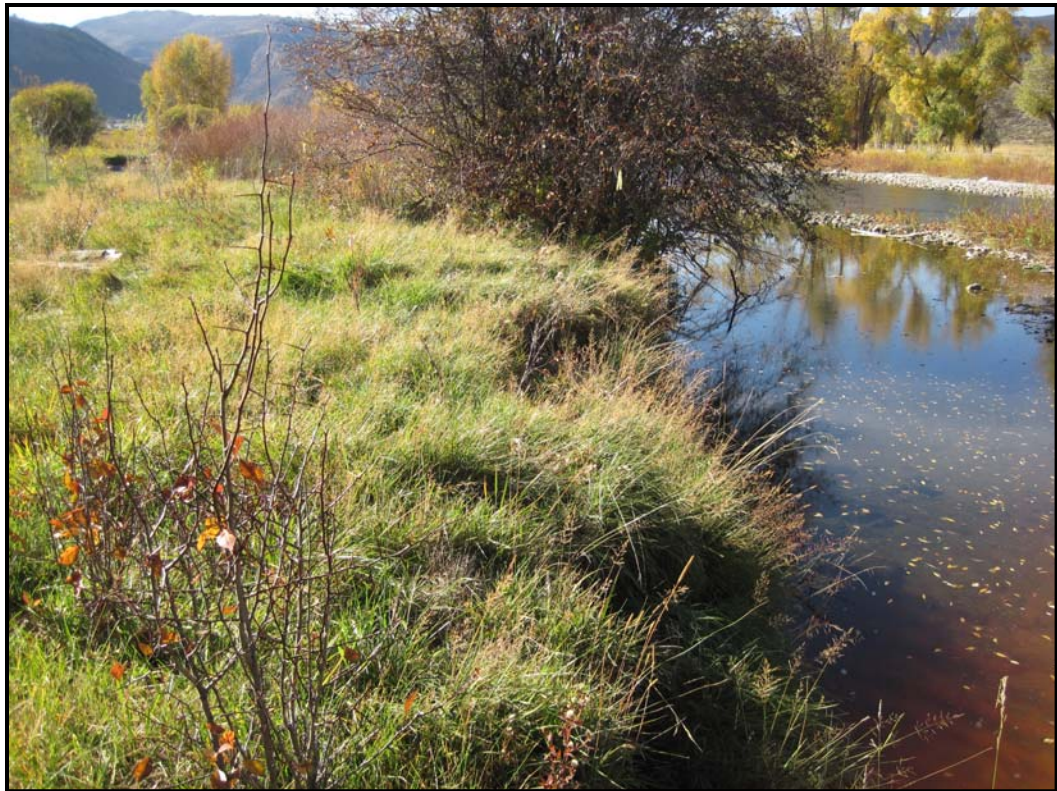
**Point 1V12L:** 6-3-08 Pre-planting, looking downstream.

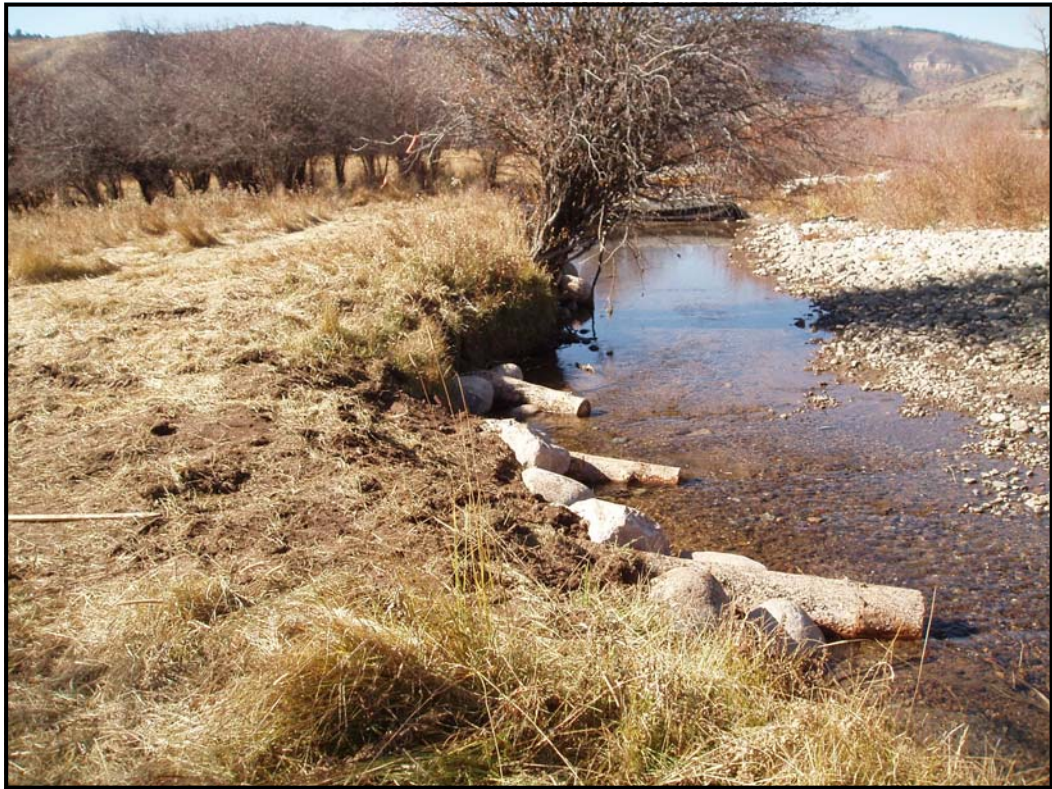
**Point 1V12L:** 10-13-10 Willows, dogwood, honeysuckle, and currant on bank; hawthorns, and mixed shrubs behind.

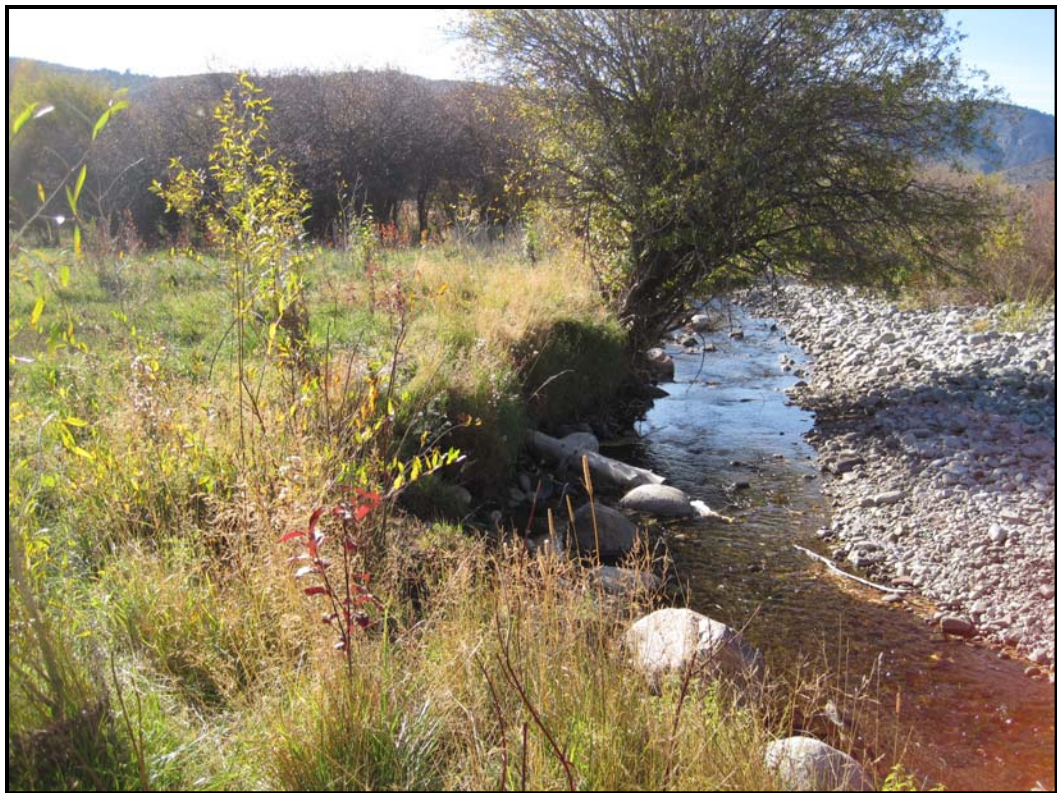
**Point 1V13L:** 10-30-08 Pre-planting, looking downstream at recently-installed log-rock deflectors.

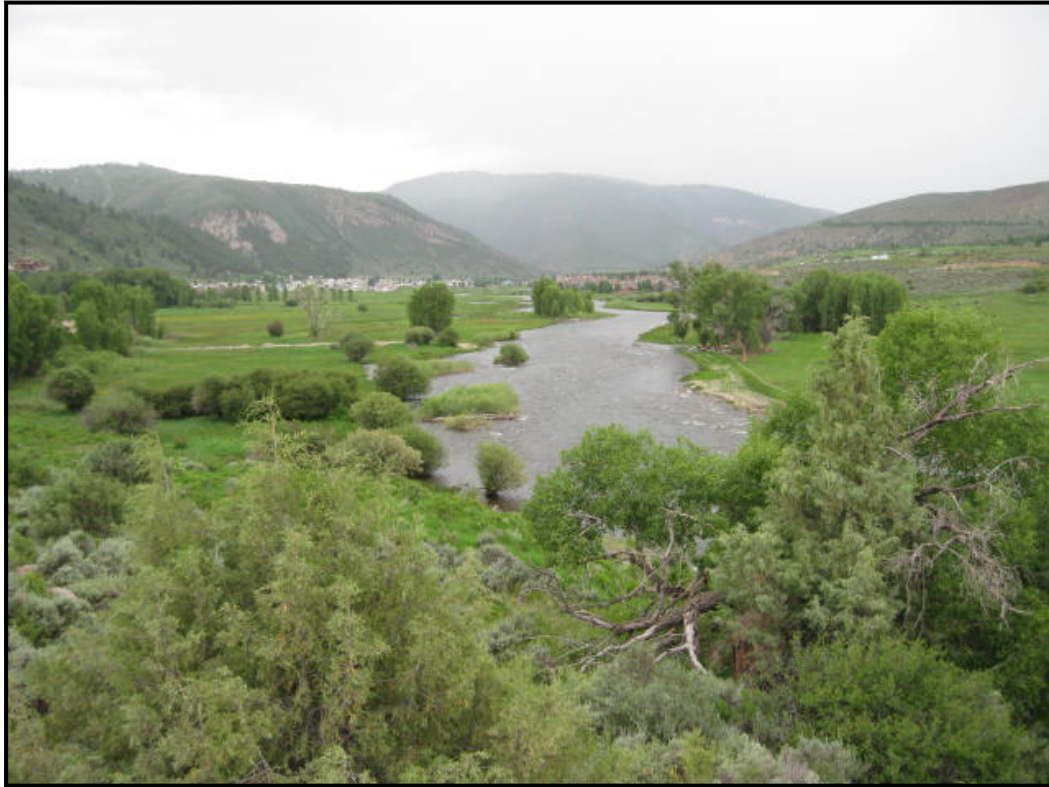
**Point 1V13L:** 8-21-09 Willows, dogwood, honeysuckle, and currant on bank; hawthorns, and mixed shrubs behind.

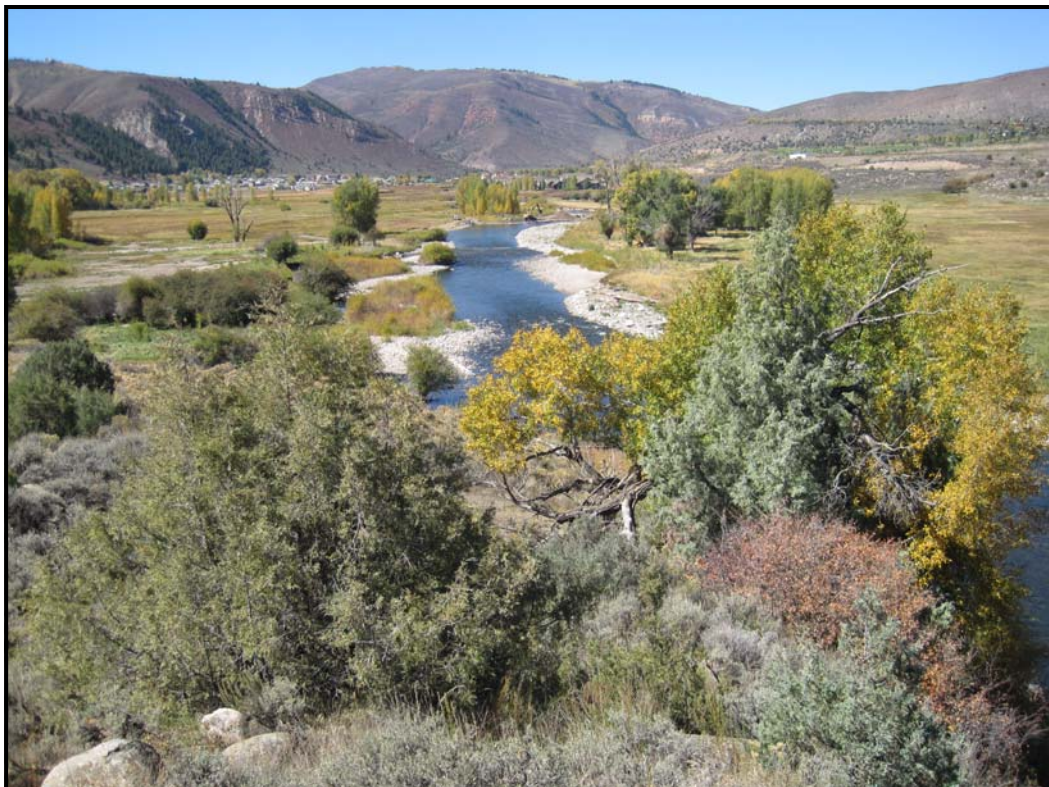
**VR+3 Overview:** 6-25-08 Pre-planting, looking downstream from upstream end of project area.

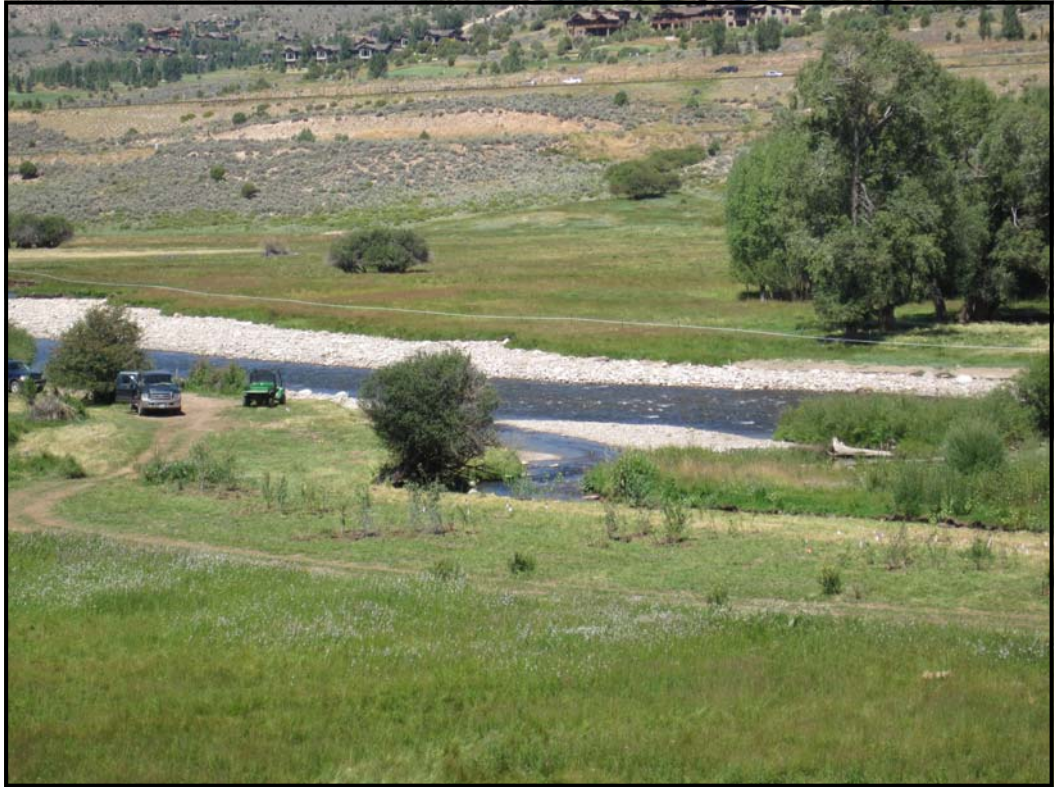
**VR+3 Overview:** 9-28-10 Looking downstream from upstream end of project area.

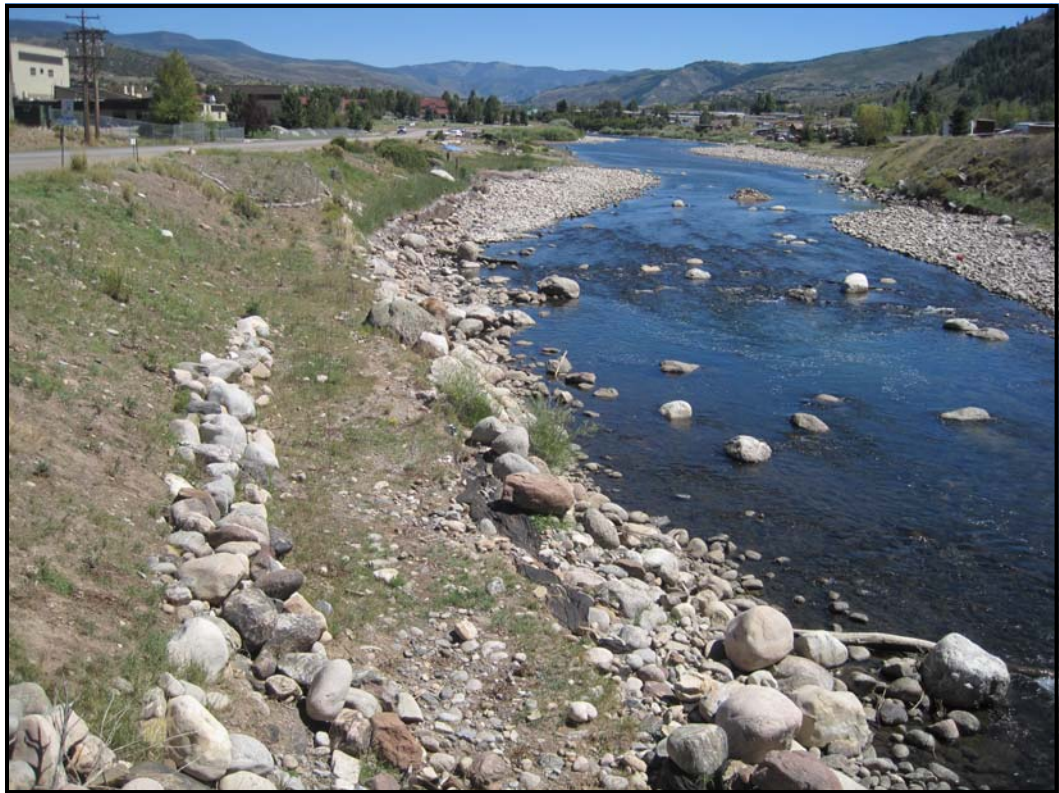
**Point 1V1R:** 8-7-09 Pre-planting, looking upstream from the Hillcrest Bridge toward Cobble Bar 1-20.

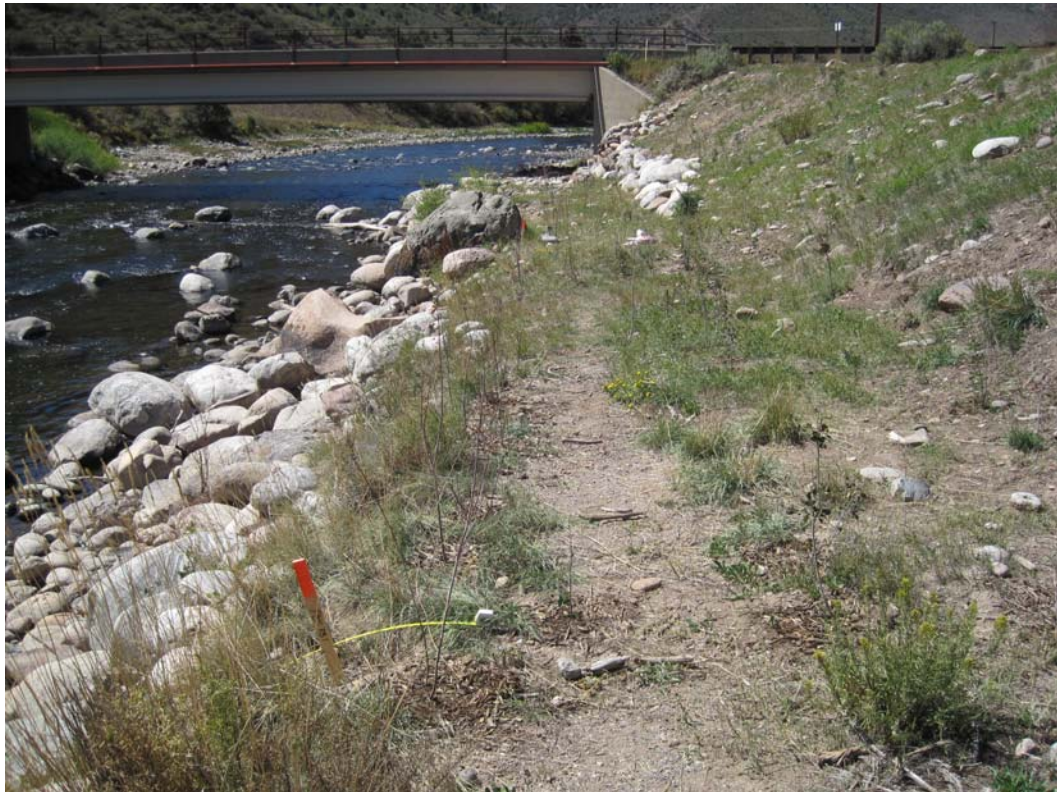
**Point 1V2R:** 7-14-09 Pre-planting, looking downstream from Cobble Bar 1-20 toward the Hillcrest Bridge.

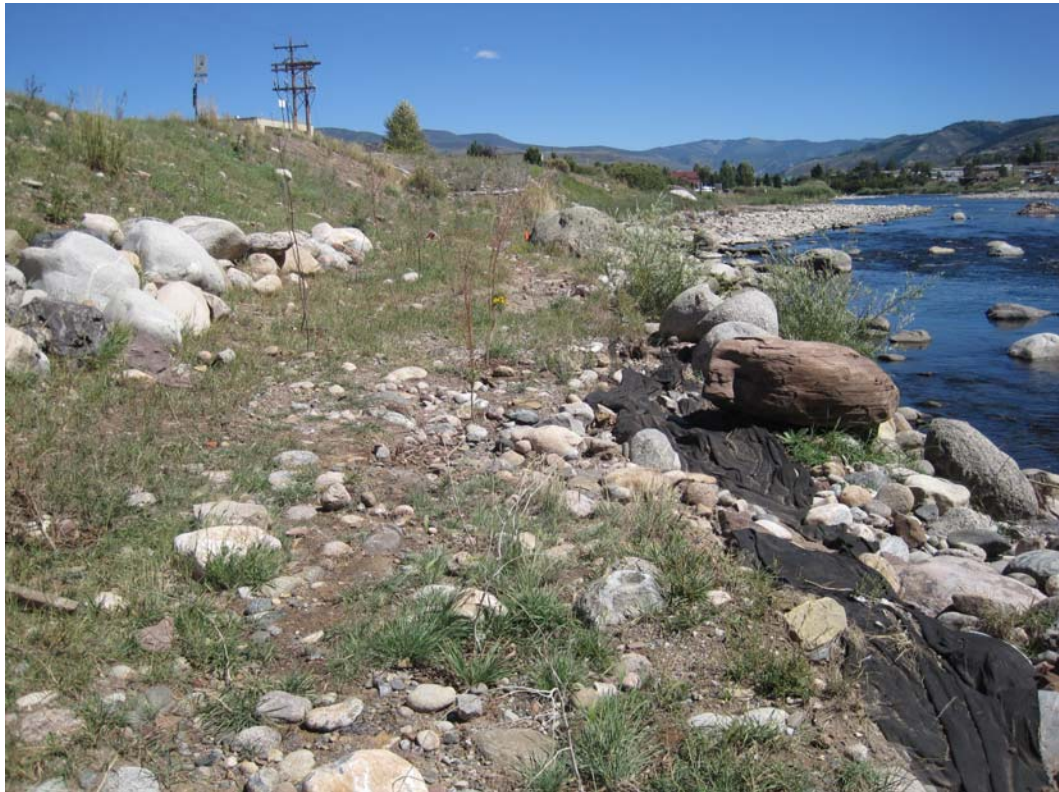
**Point 1V3R:** 7-14-09 Pre-planting, looking upstream from Cobble Bar 1-20 toward the boat launch.

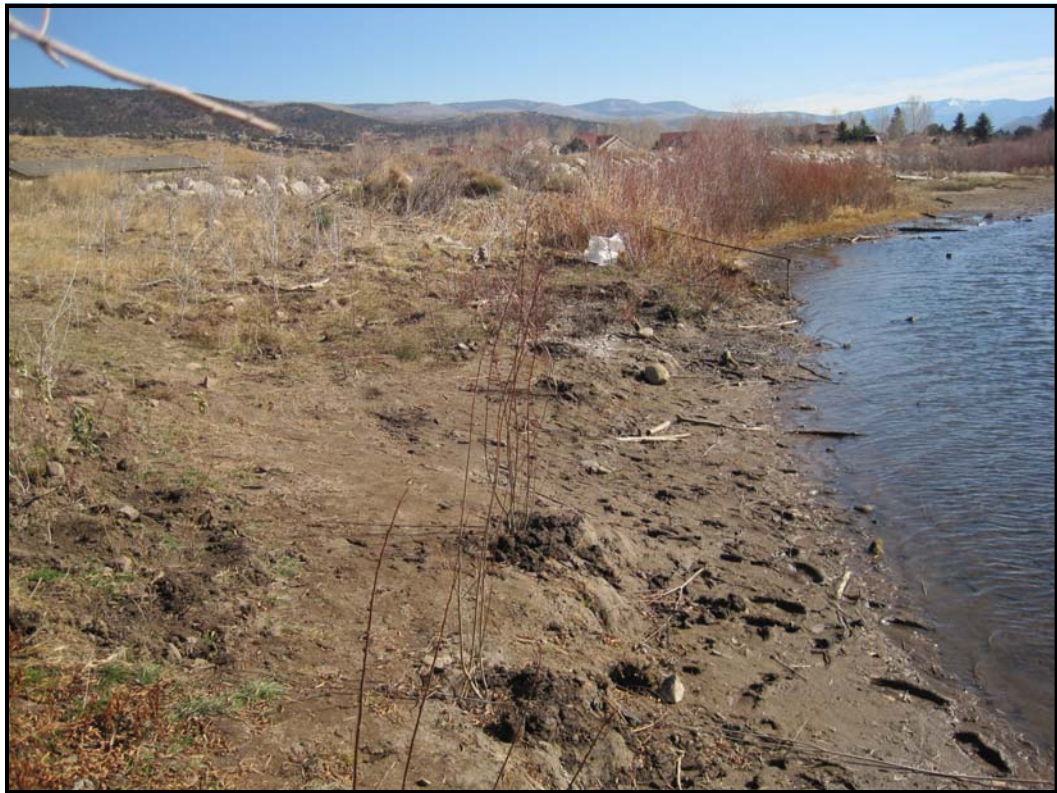
**Point 1V4R:** 8-7-09 Pre-planting, looking upstream from the boat launch.

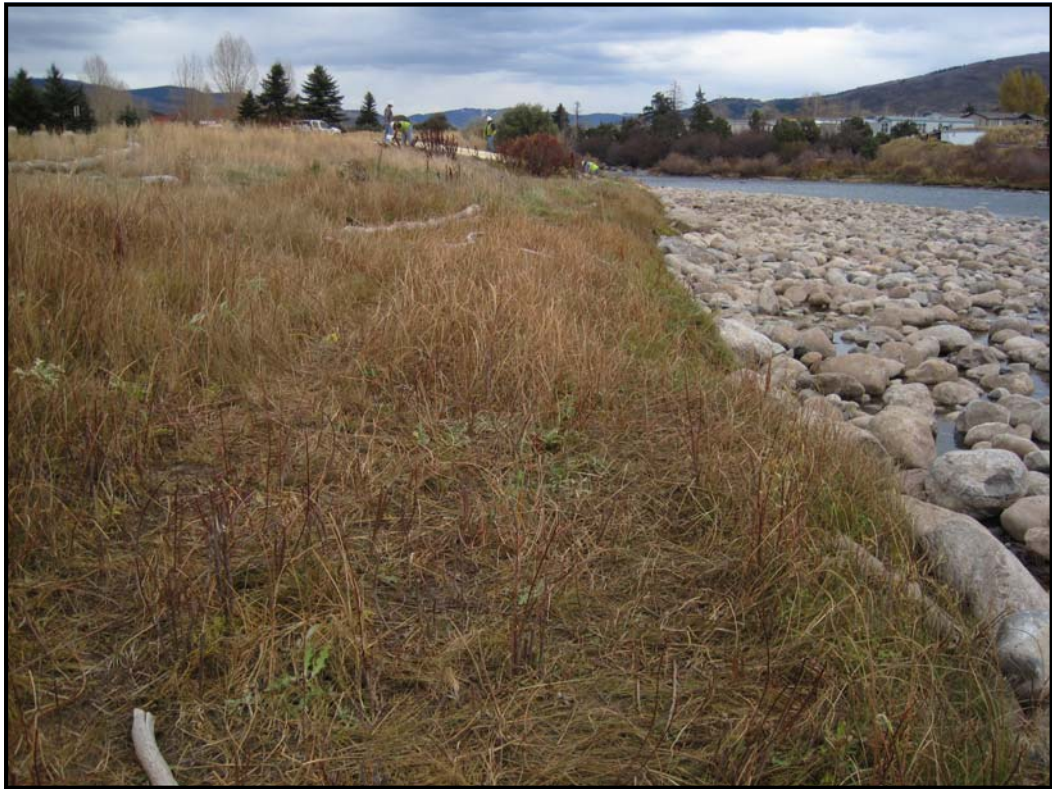
**Point 1V4R:** 11-6-09 Willows, birch, alder, dogwood, honeysuckle, and currant near bank, with cottonwoods and mixed shrubs behind. (2010 Photo not available)

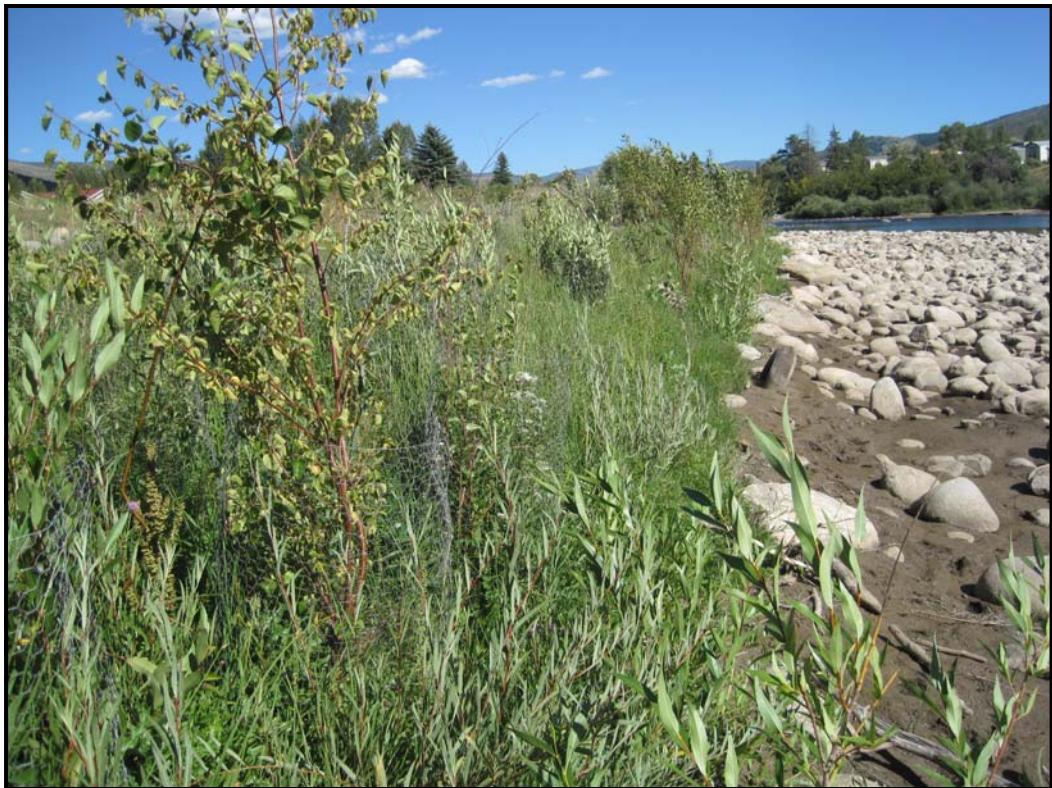
**Point 1V5R:** 11-09 Pre-planting, looking upstream from Cobble Bar 1-15.

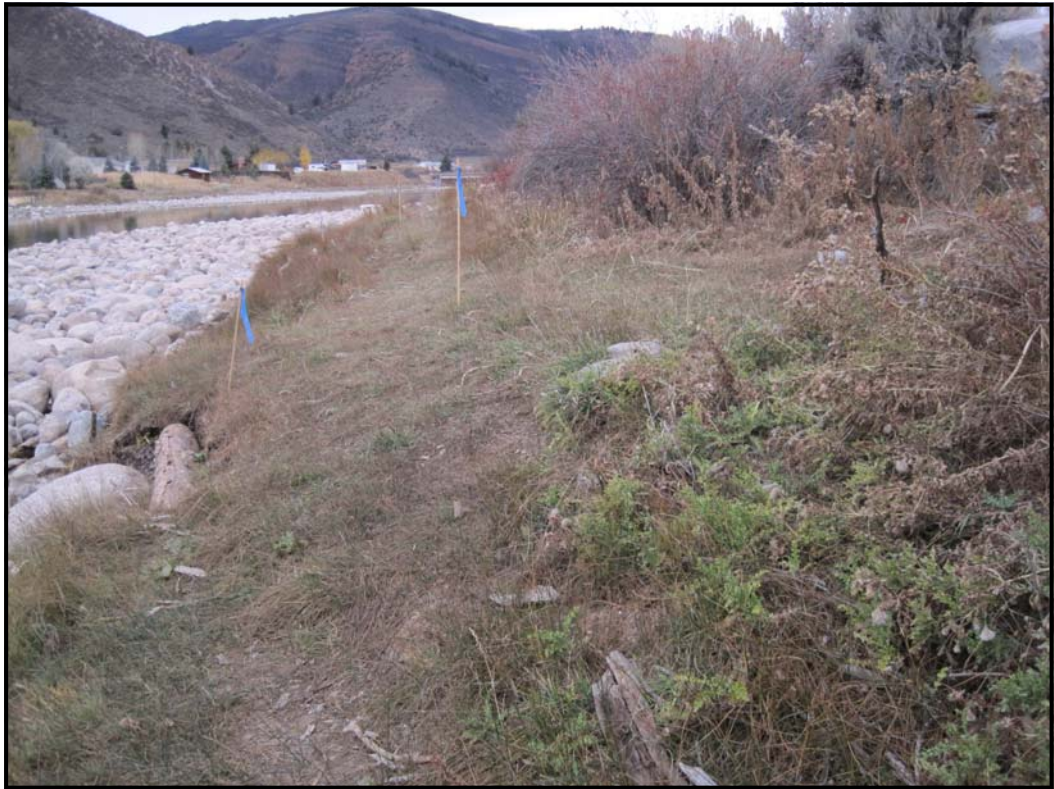
**Point 1V5R:** 9-3-10 Looking upstream from Cobble Bar 1-15; willow and birch plantings in foreground.

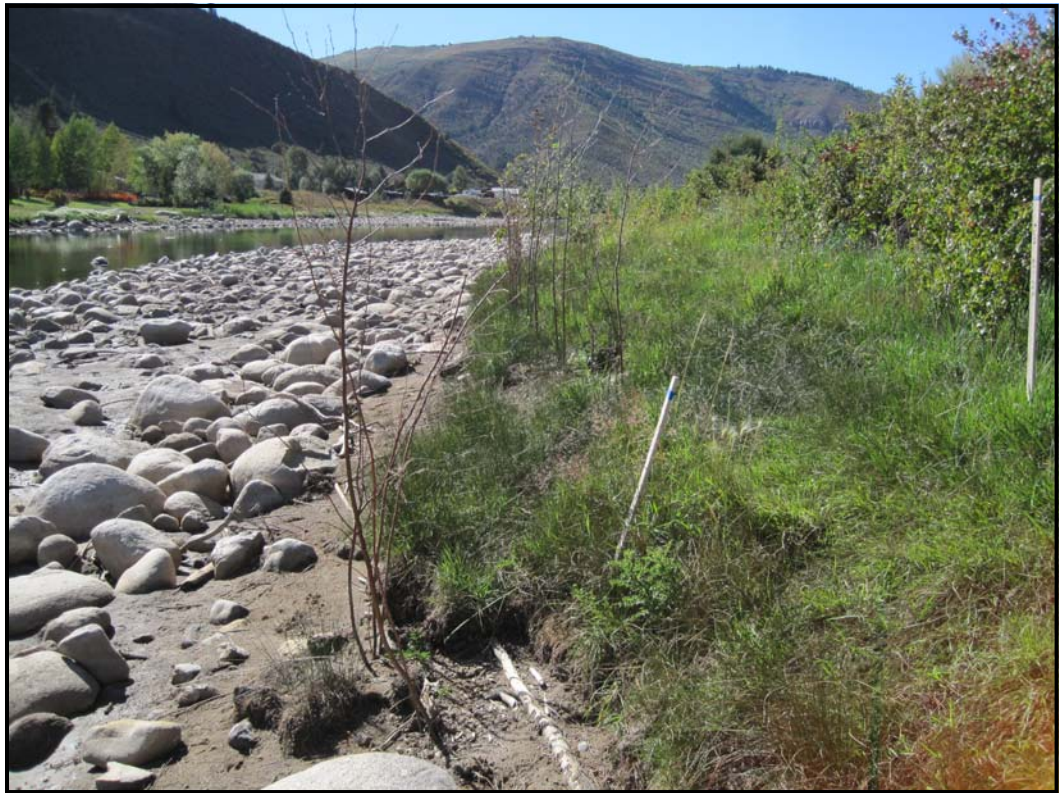
**Point 1V6R:** 10-20-09 Pre-planting, looking downstream from Cobble Bar 1-15.

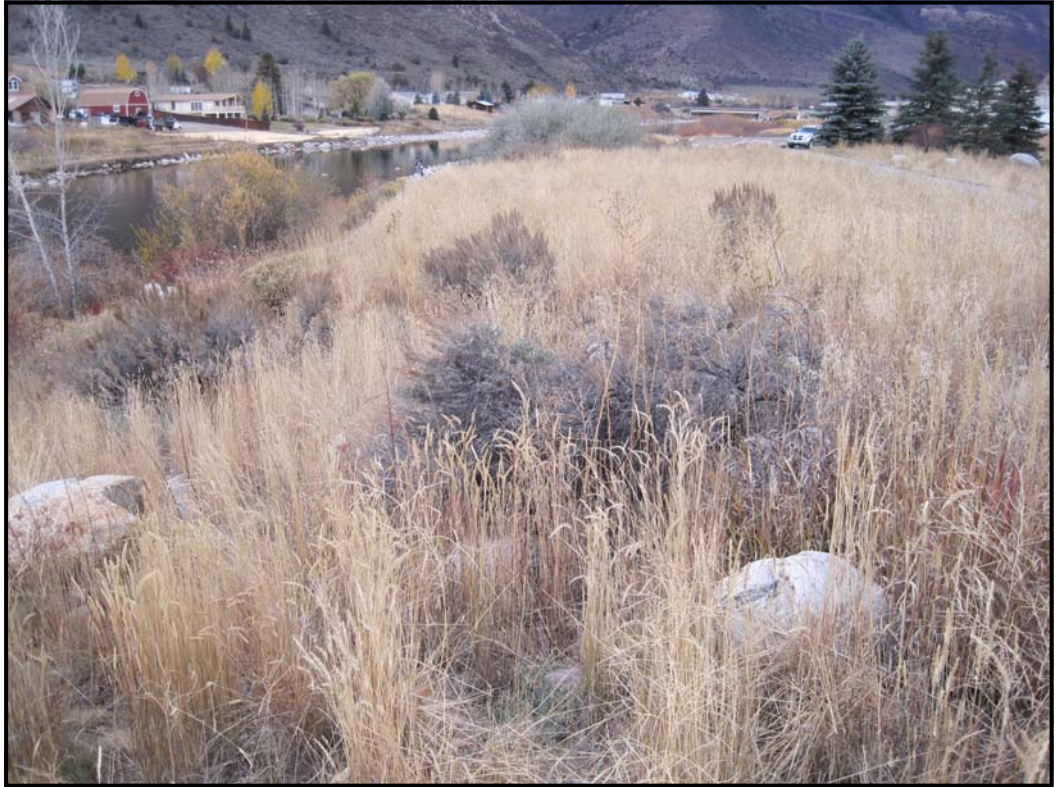
**Point 1V6R:** 9-3-10 Willows, birch, alder, dogwood, honeysuckle, and currant near bank, with cottonwoods and mixed shrubs behind. Silver buffaloberry, three-leaf sumac, wax currant, and big sage interplanted with existing shrubs on upper bank.

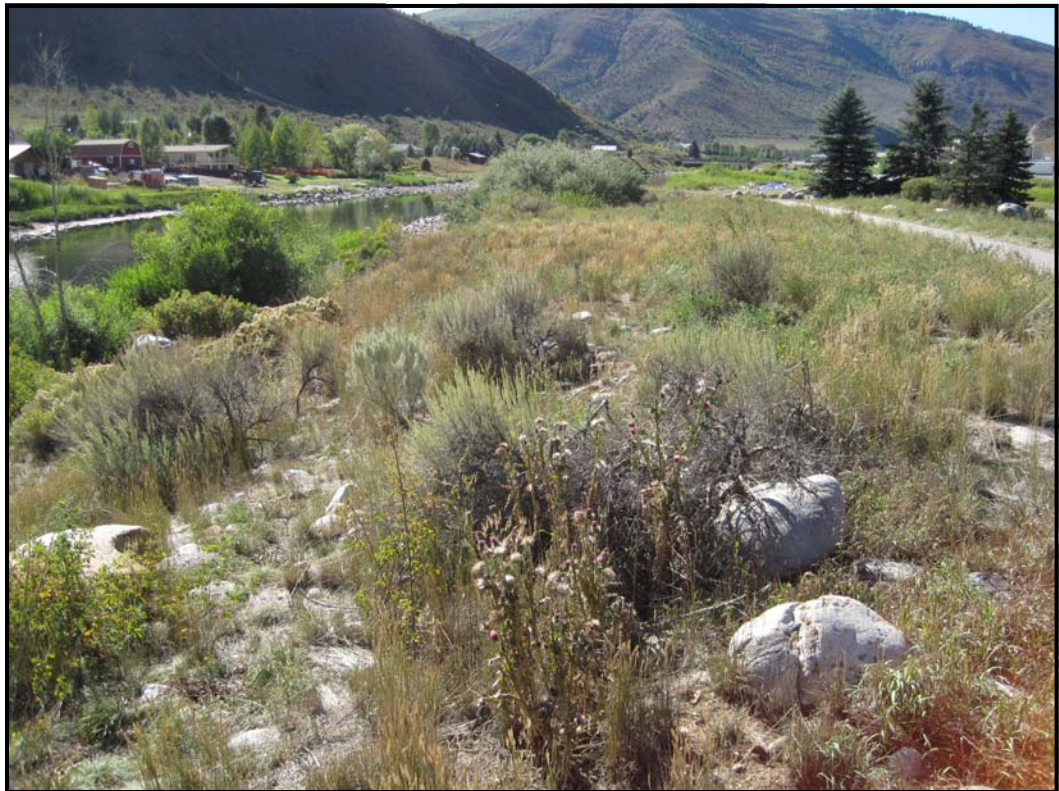
**Point 1V7R:** 10-20-09 Pre-planting, upland area above Cobble Bar 1-15.

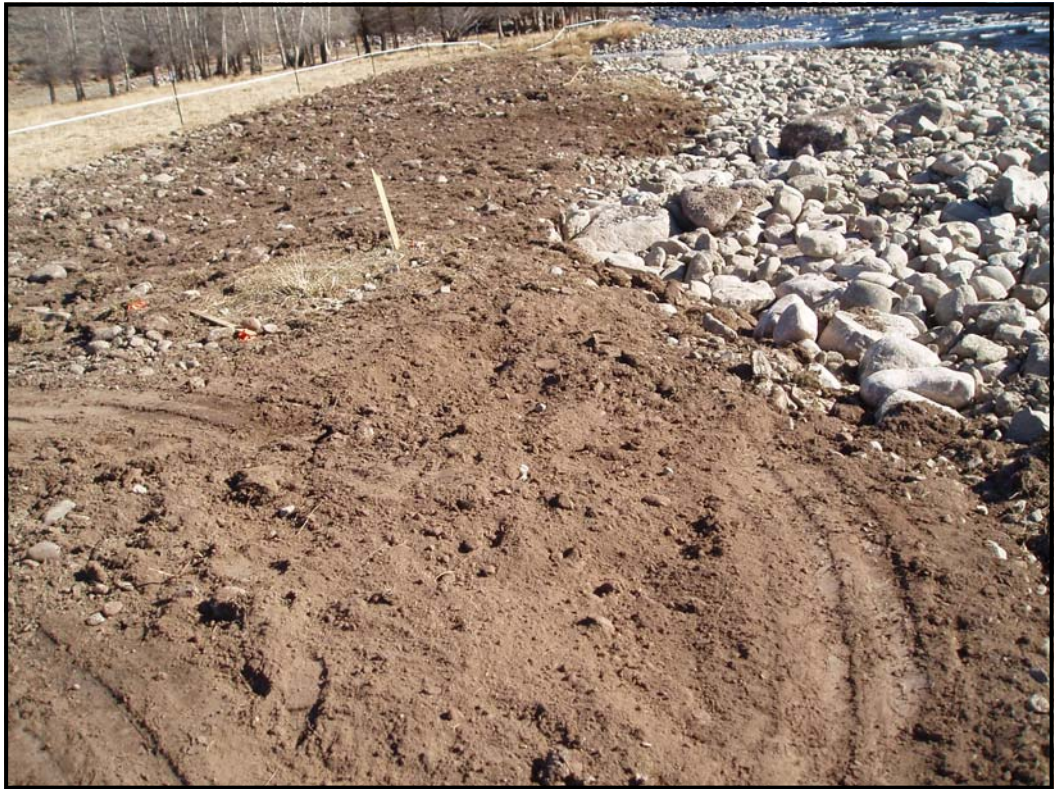
**Point 1V7R:** 9-3-10 Silver buffaloberry, three-leaf sumac, wax currant, big sage, western serviceberry, Wood's rose, and Rocky Mountain juniper planted into existing crested wheatgrass.

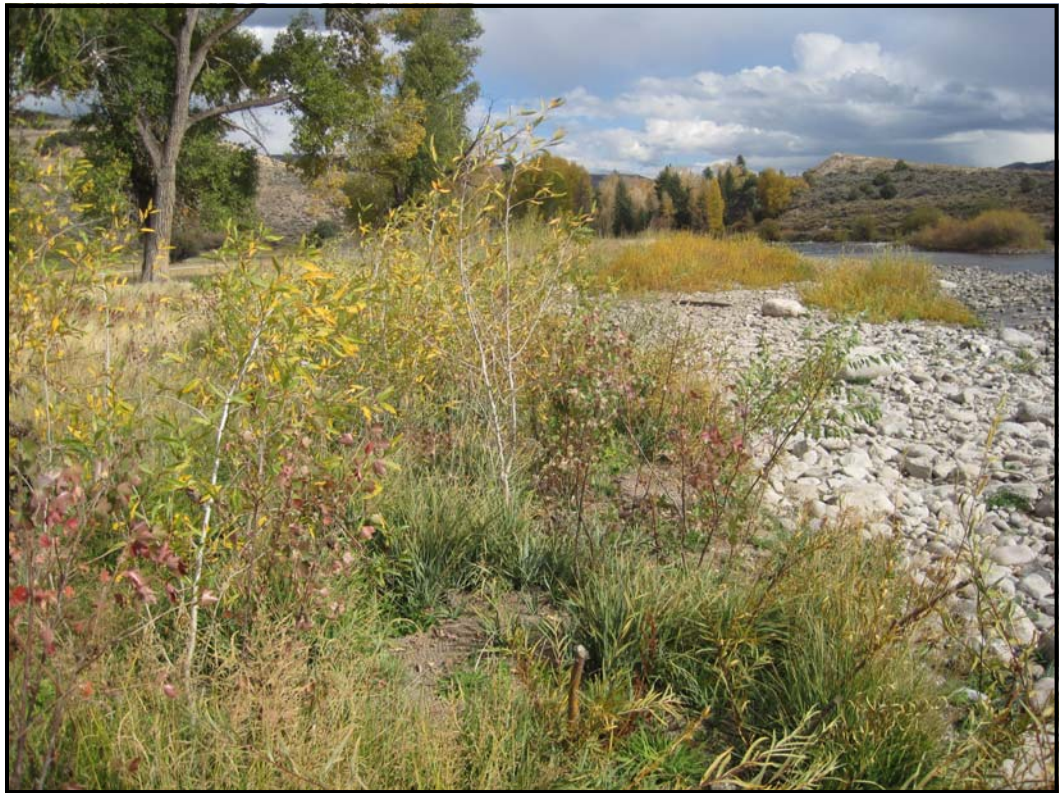
**Point 1V8R:** 11-24-08 Pre-planting, looking upstream from Cobble Bar 1-8.

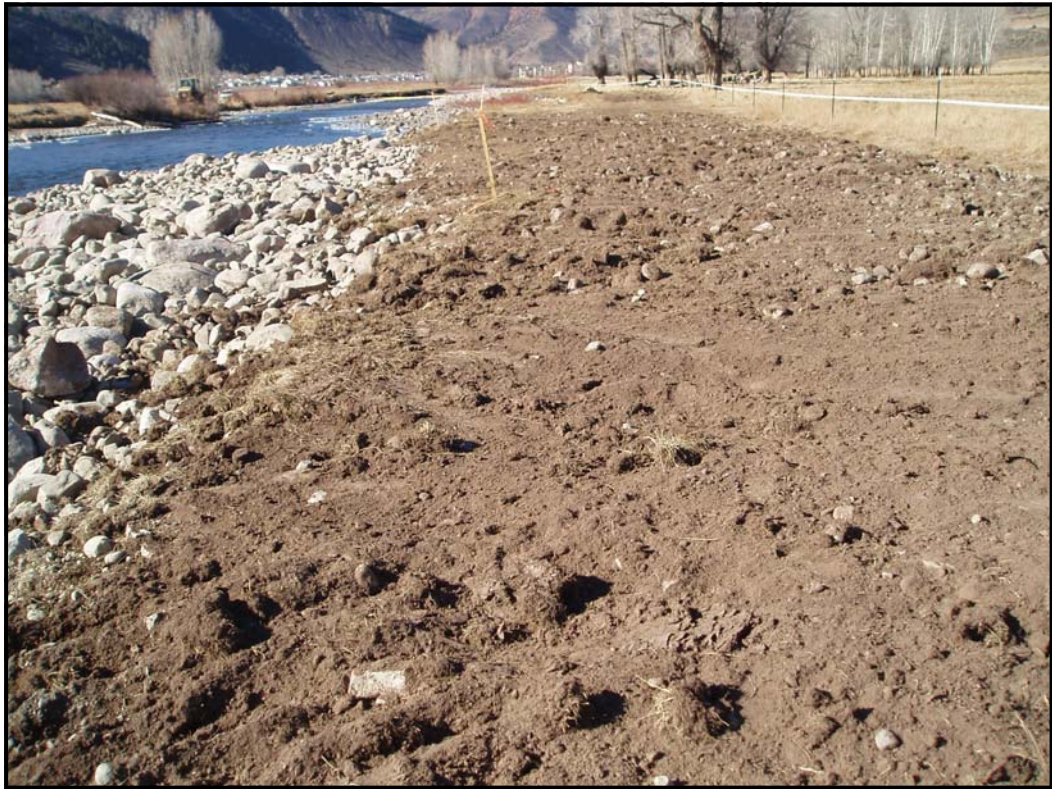
**Point 1V8R:** 10-5-10 Willows, dogwood, honeysuckle, and currant near bank, with cottonwoods, blue spruce, and mixed shrubs behind.

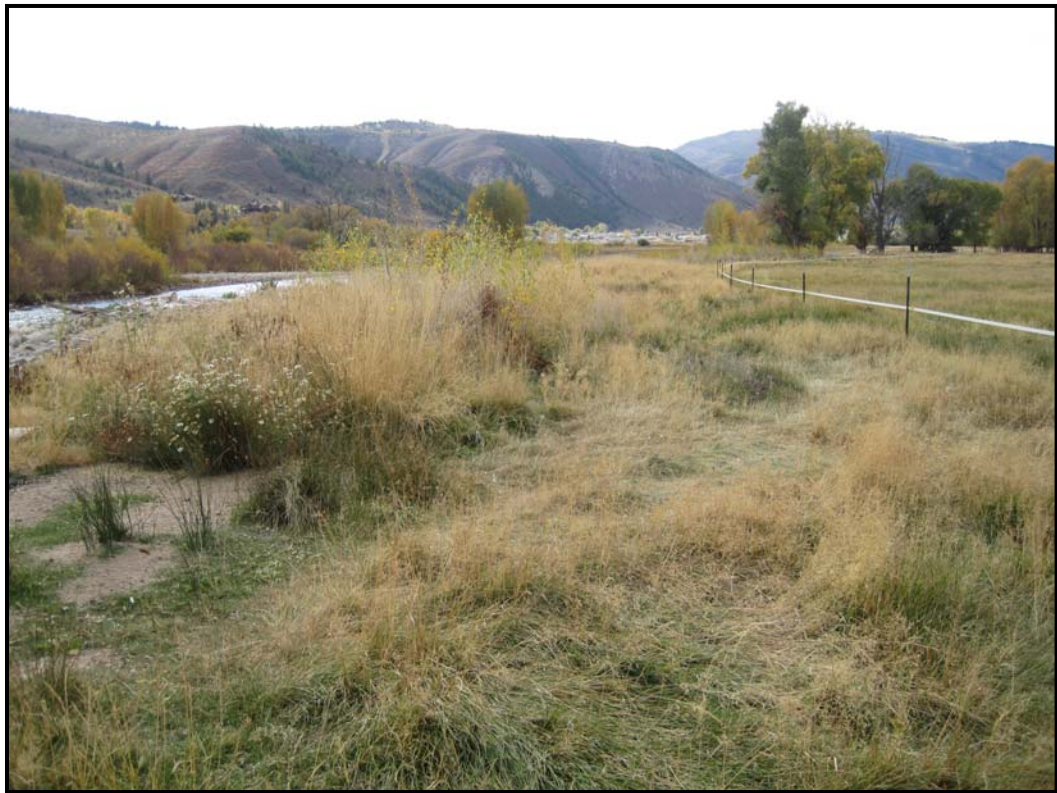
**Point 1V9R:** 11-24-08 Pre-planting, looking downstream from Cobble Bar 1-4.

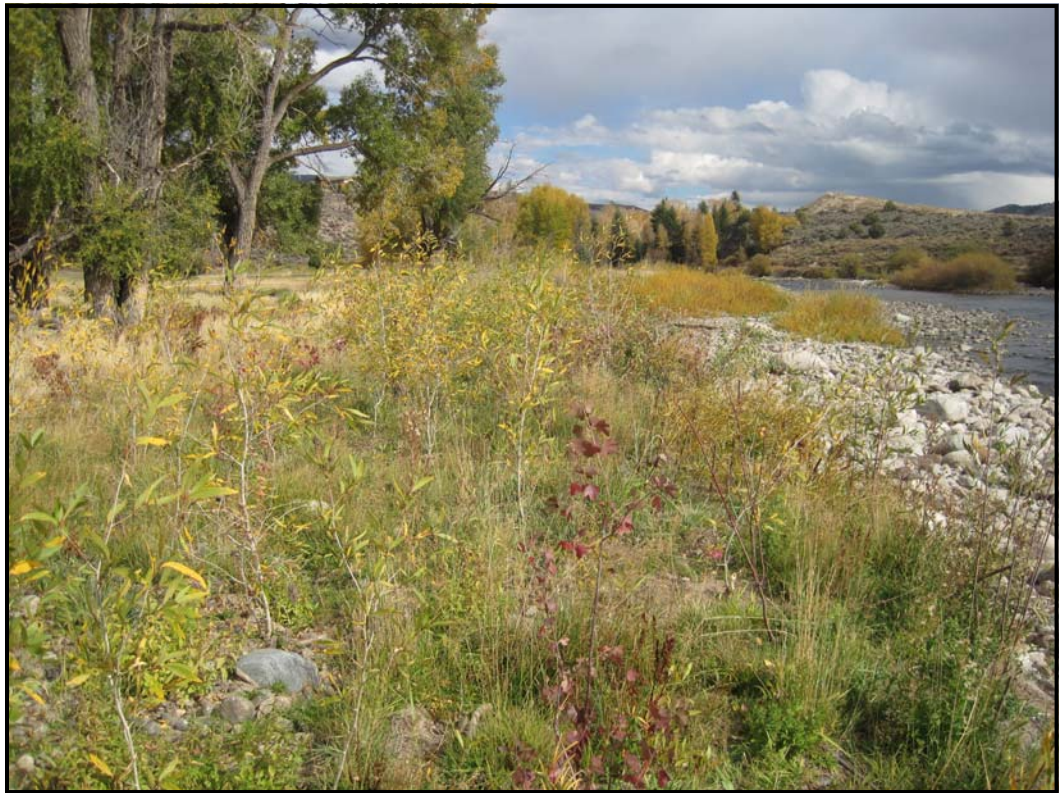
**Point 1V10R:** 11-24-08 Pre-planting, looking upstream from Cobble Bar 1-4.

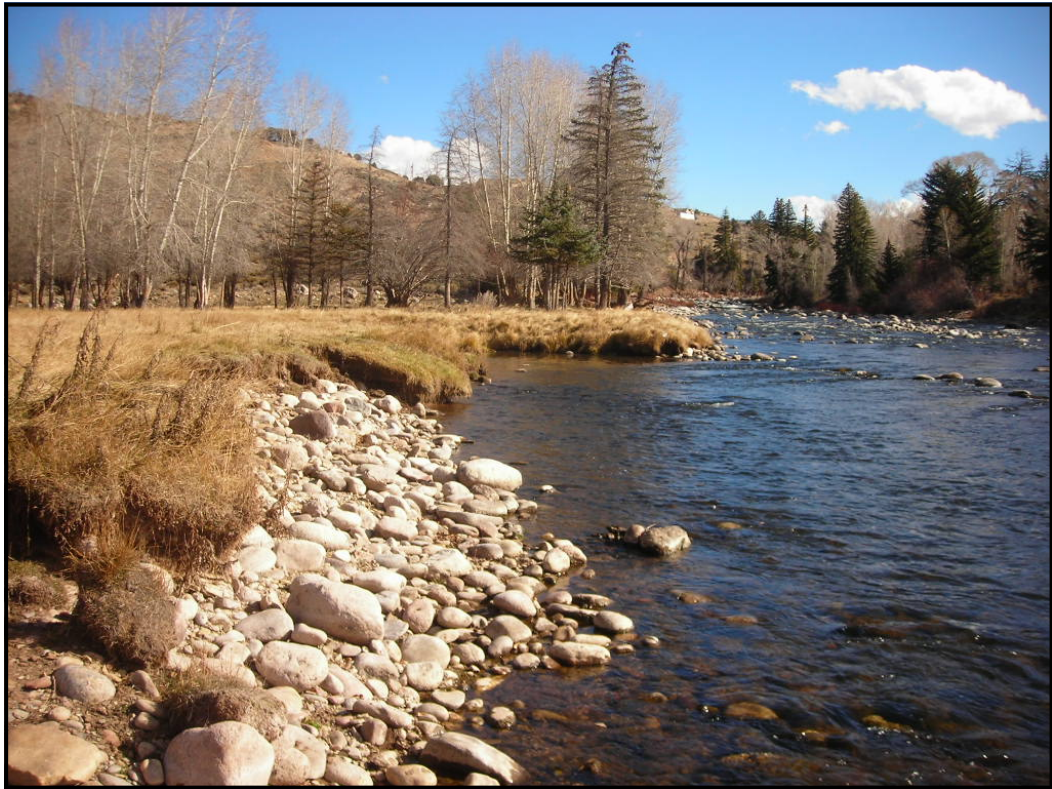
**Point 1V10R:** 10-5-10 Willows, dogwood, honeysuckle, and currant near bank, with cottonwoods, blue spruce, and mixed shrubs behind.

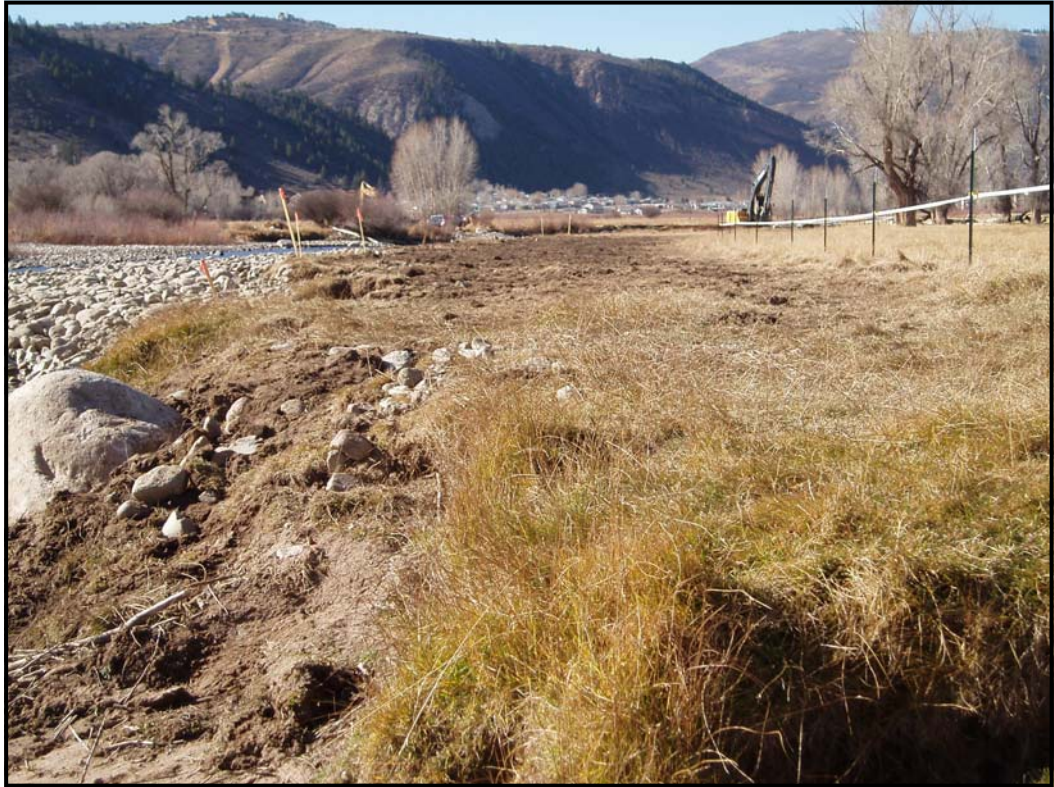
**Point 1V11R:** 10-5-10 Debris from unusually high spring runoff impacted some plantings in this area.

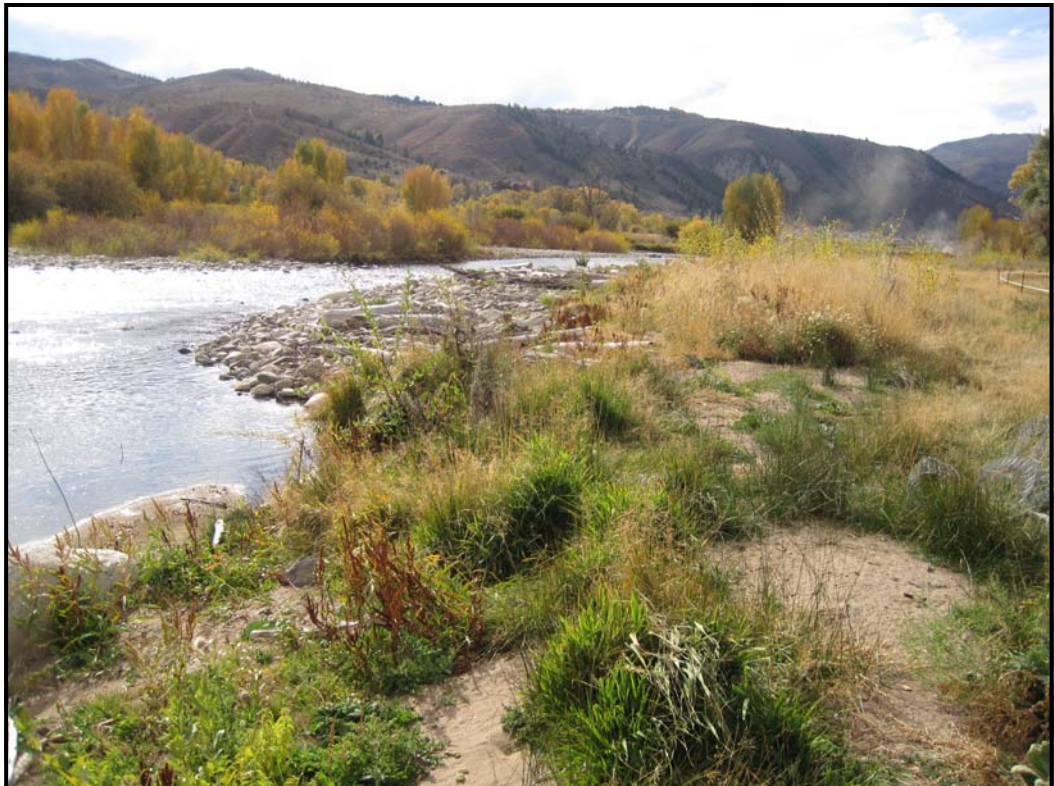
**Point 1V12R:** 11-18-08 Pre-planting, at Treatment 1-3 looking downstream.
