December 29, 2010

**Re: 2010 Monitoring Report for the Phase 1 Edwards Eagle River Restoration Project in Eagle County, Colorado, Corps File No. SPK-2008-00608-CW**

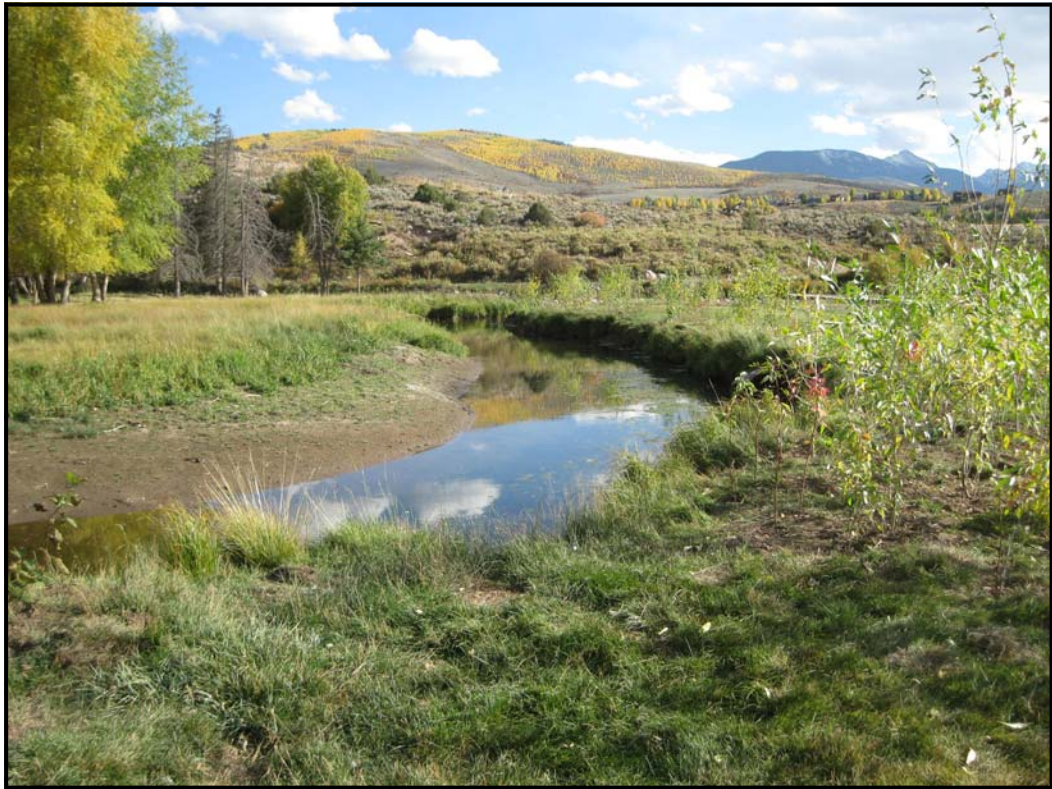
**Point 1V12R:** 10-5-10 Sand and debris from unusually high spring runoff impacted some plantings in this area.

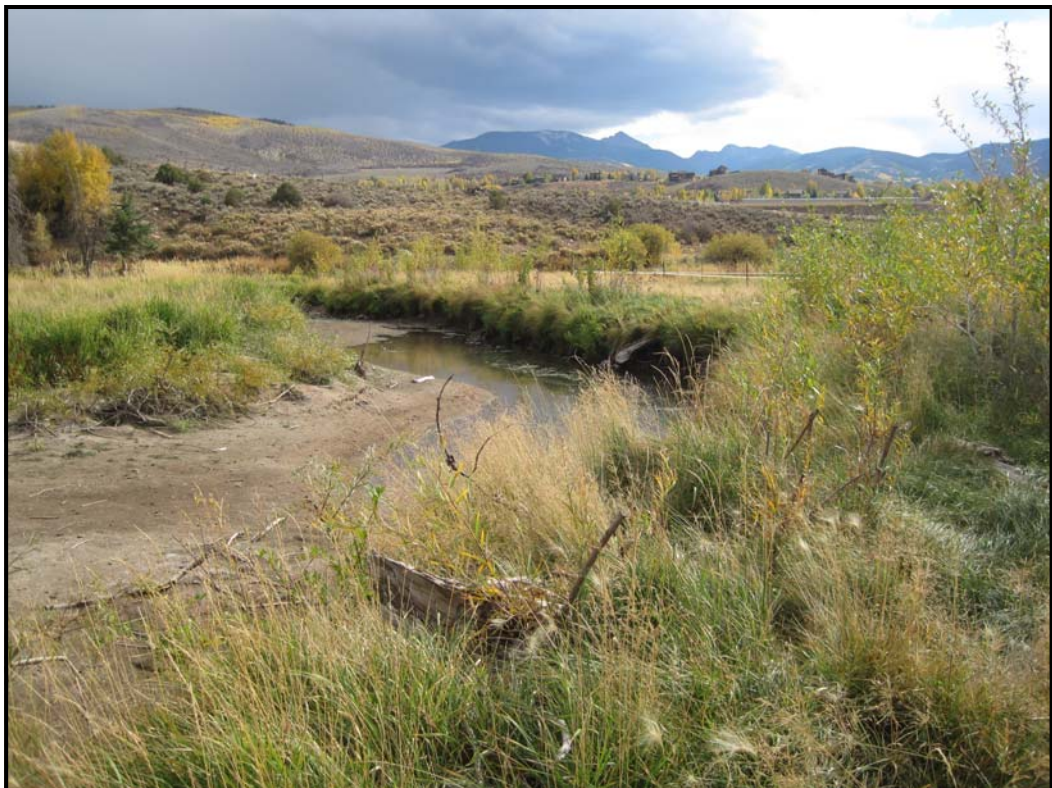
**Point 1V13R:** 9-29-09 Immediately post-planting, at apex of oxbow, looking south.
