# Union Creek Stream Stabilization Project Final Report

Submitted to: Colorado Water Conservation Board

Submitted by: Colorado Mountain College Natural Resource Management Program

March 7, 2014

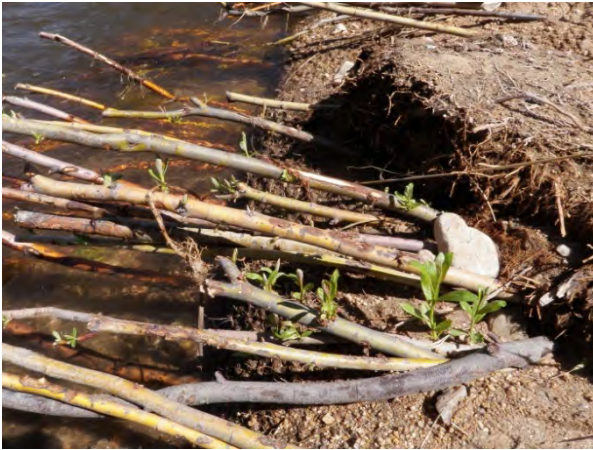
Figure 10. Soil lift willows after 8 weeks of growth.

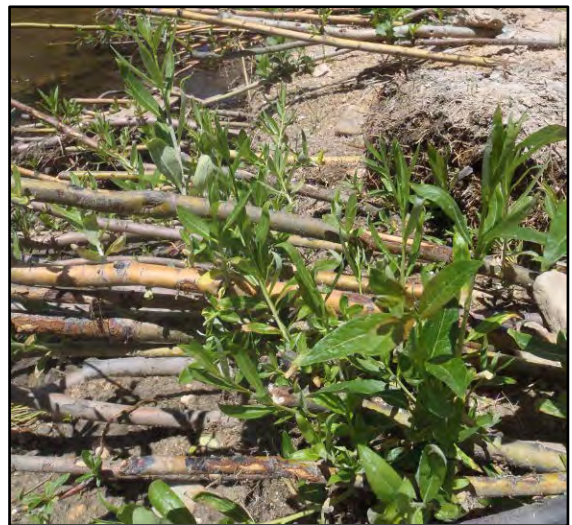
Figure 11. Same willows after 11 weeks.

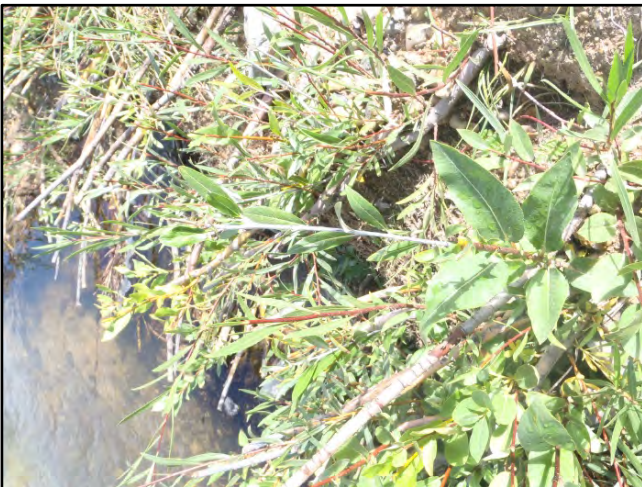
Figure 12. Same willows after 21 weeks.
