Campbell Valley Restoration 2011 Final Report

Wildlands Restoration Volunteers, in partnership with The Nature Conservancy, US Fish and Wildlife Service, and the Robert's Ranch.

July 1, 2010 – August 31, 2011

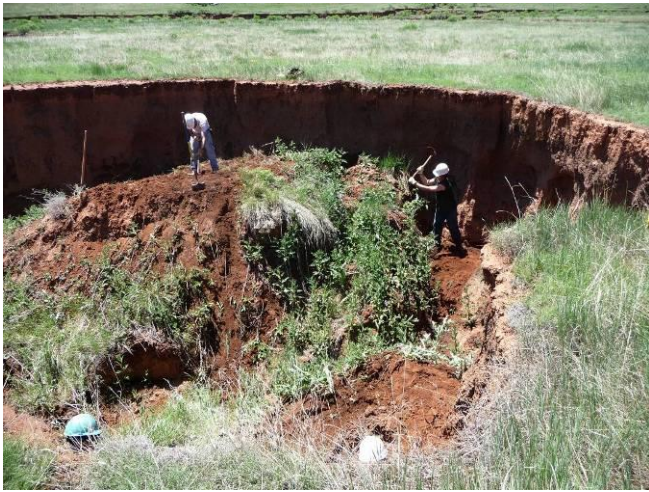
Regrading soil pillars by hand to reduce snow-based saturation points near headcuts and the base of valley walls. Additional grading was completed by excavator.

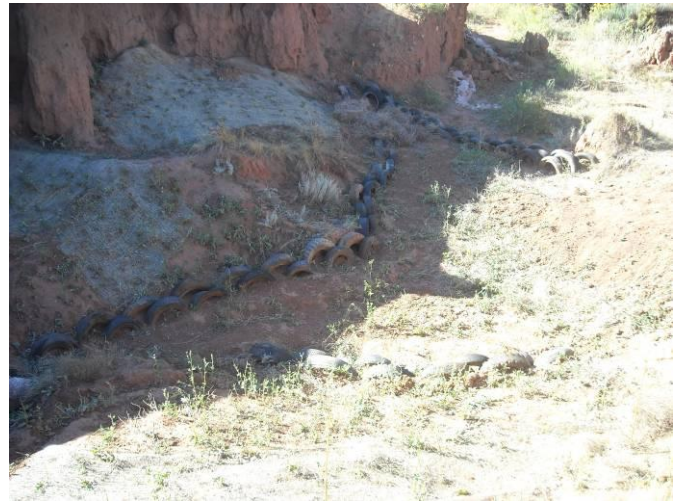
Tire toe wall

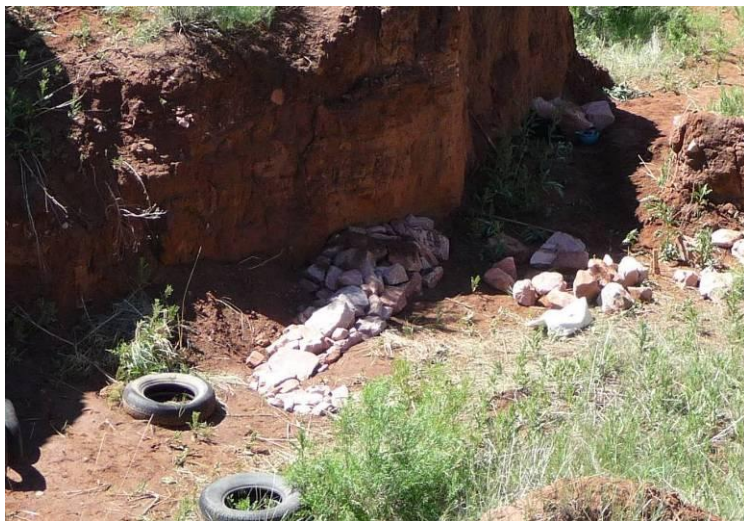
Rock Vane

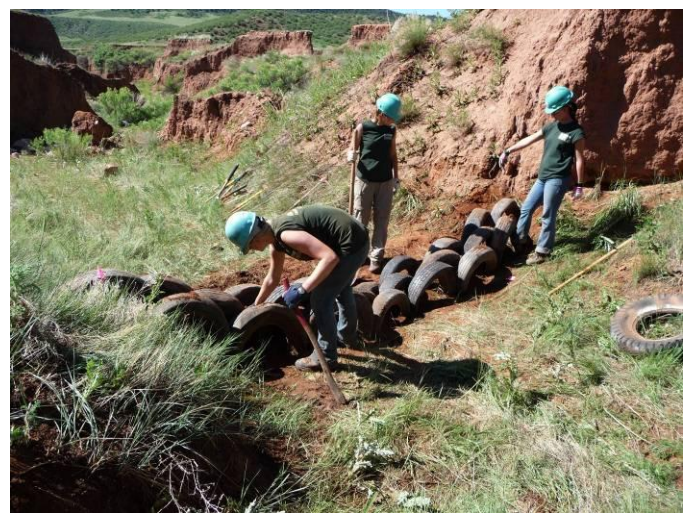
Vertical Tire Check Dam.

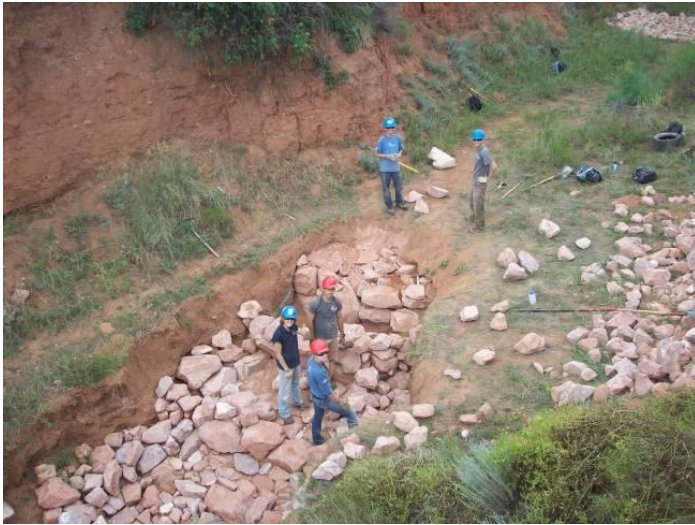
Construction of 4-step step pool with
6-foot headcut.

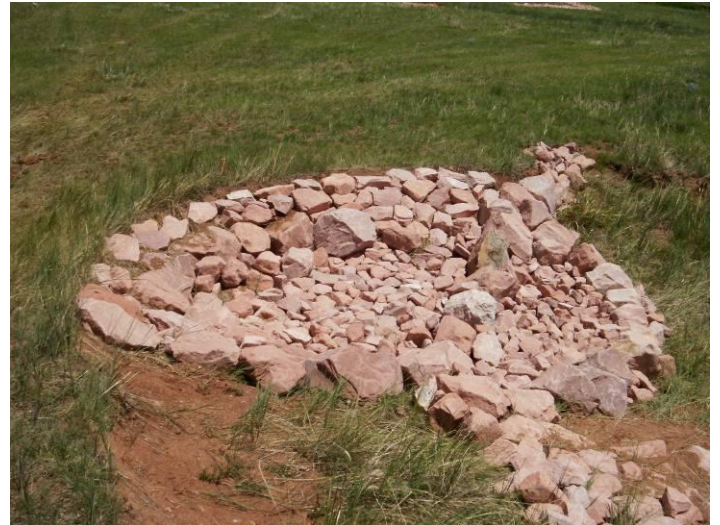
Medium-sized Zuni Bowl

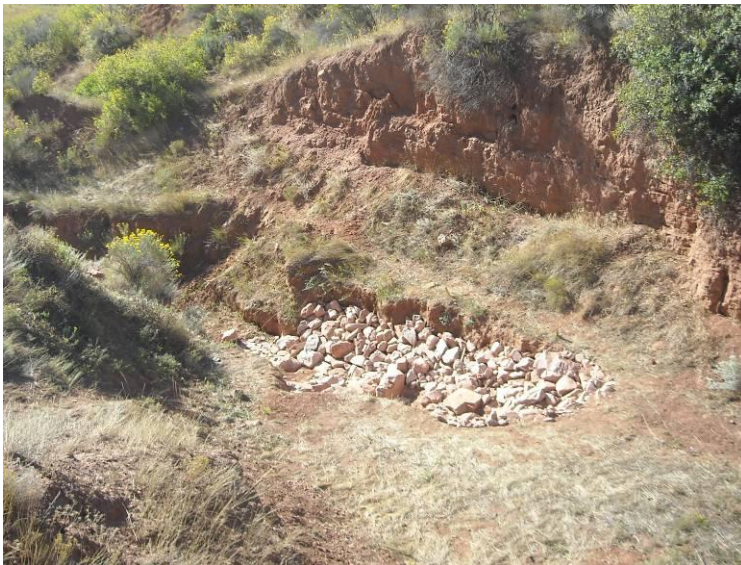
Completion of 4-step step-pool.

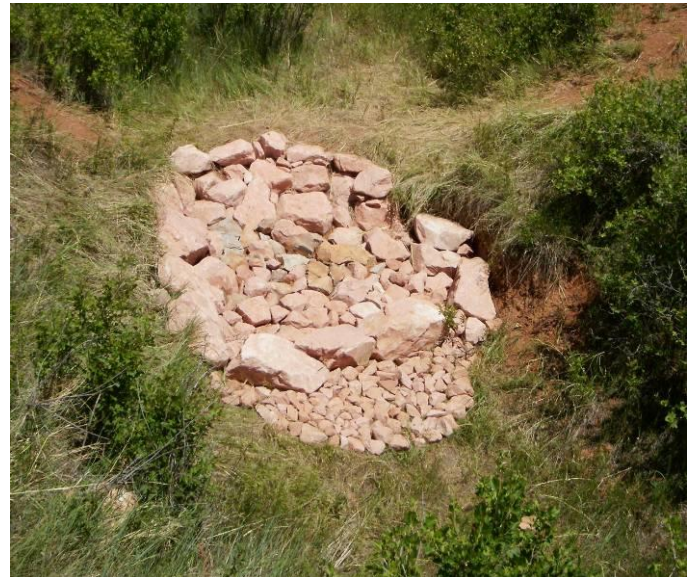
Small Zuni Bowl.

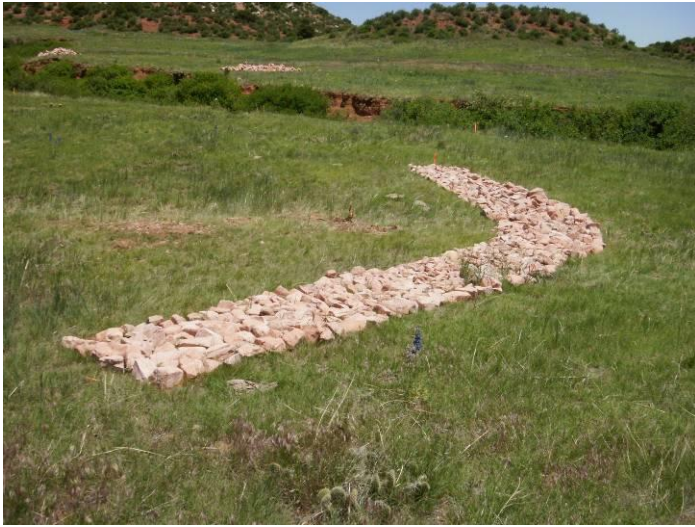
Media Luna

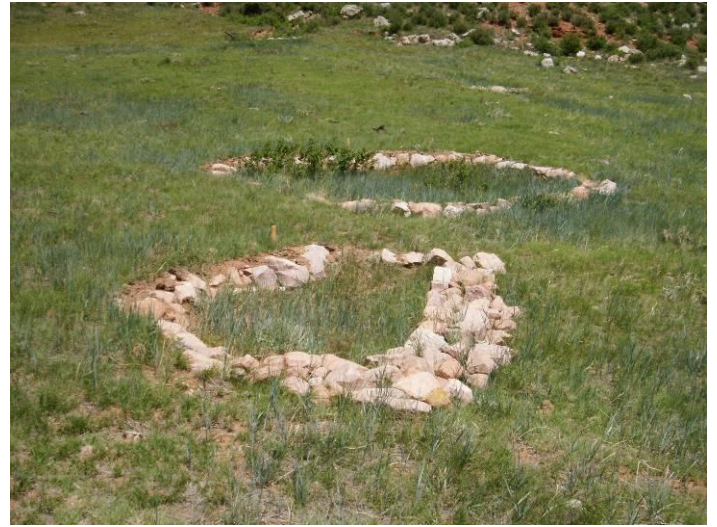
Scarp Walls

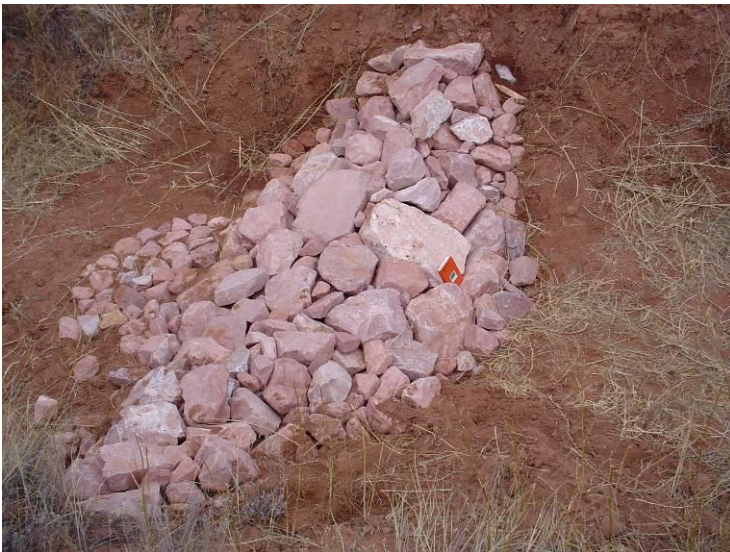
Check Riffle

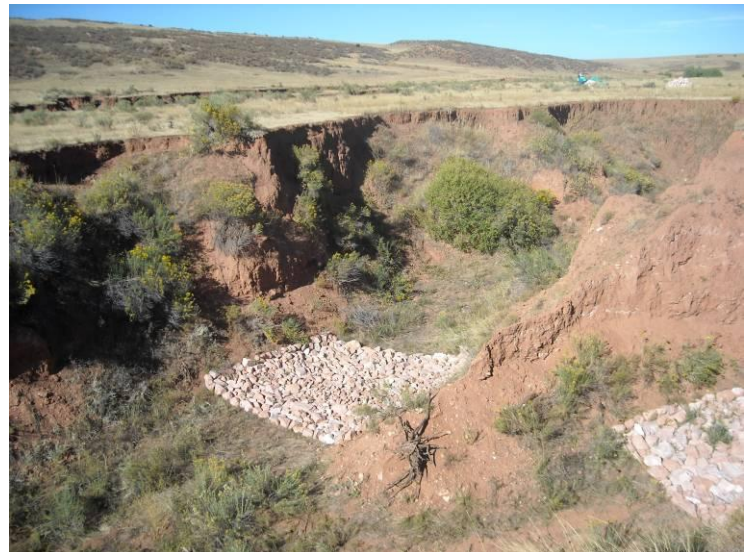
One-rock Dam

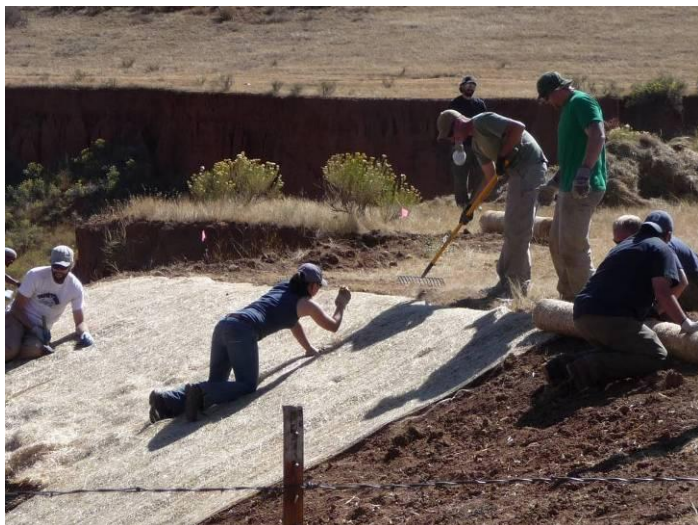
Odell Brewing staff spread seed and install erosion matting.

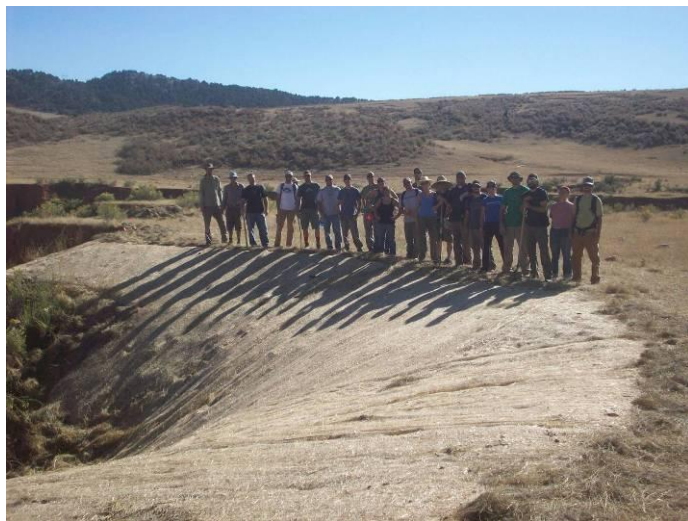
Finished erosion matting along regarded valley trench wall.

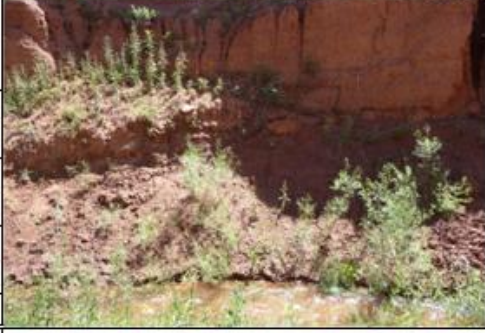
Across east fork @ river left planting	
camera height: ----- 5 ft on rebar				
approx. camera angle: ----- 0				
photo bearing: ----- 080				
intraday photo #: 14				
view #3:				
camera height: ----- 0				
approx. camera angle: ----- 0				
photo bearing: ----- 0				
intraday photo #:

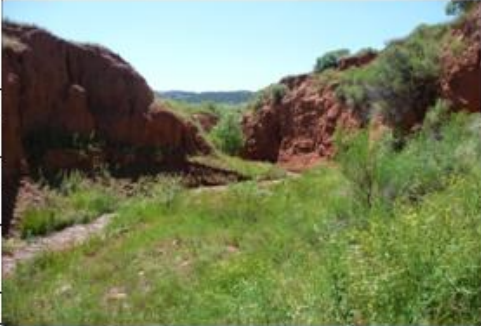
Downstream @ left and right bank riparian	
camera height: ----- 5 ft on rebar				
approx. camera angle: ----- 0				
photo bearing: ----- 160				
intraday photo #: 15				
view #2:

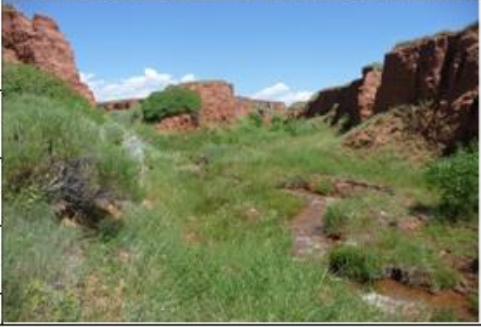
Upstream @ baseline/ current conditions un-restored	
camera height: ----- 5 ft on rebar				
approx. camera angle: ----- 0				
photo bearing: ----- 005				
intraday photo #: 16				
view #3:				
camera height: ----- 0				
approx. camera angle: ----- 0				
photo bearing: ----- 0				
intraday photo #:

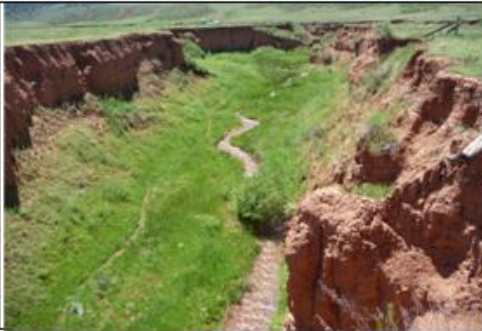
Downstream from trench top	
camera height: ----- 5 ft on rebar				
approx. camera angle: ----- -15				
photo bearing: ----- 175				
intraday photo #: 17				
view #2:

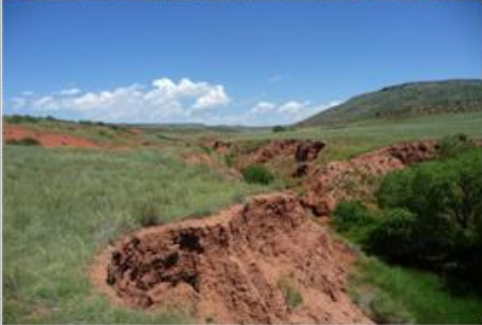
Upstream @ trench	
camera height: ----- 5 ft on rebar				
approx. camera angle: ----- 0				
photo bearing: ----- 005				
intraday photo #: 19

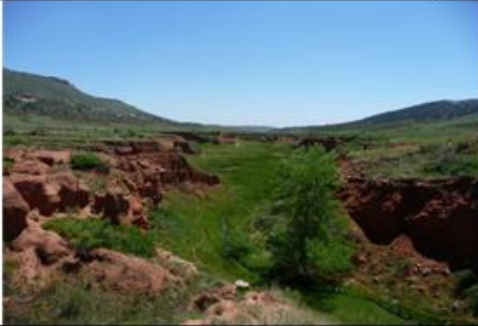
<p>Downstream view of west fork and confluence from above. Tree and potted shrub plantings</p>			
camera height: ----- 5'				
approx. camera angle: ----- 0				
photo bearing: ----- 120				
intra day photo #: 20				
view #2:				
camera height: ----- 0				
approx. camera angle: ----- 0				
photo bearing: ----- 0				
intra day photo #:				
view #3:				
camera height: ----- 0				
approx. camera angle: ----- 0				
photo bearing: ----- 0				
intra day photo #:

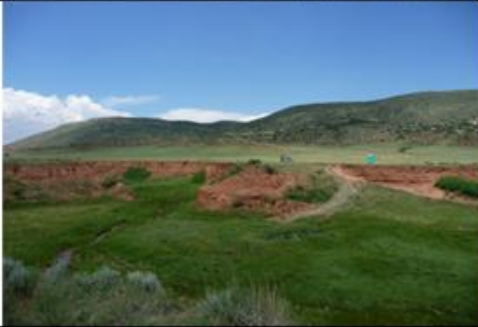
<p>Main access point at confluence erosion mat & seeded 5-16-10</p>			
camera height: ----- 5'				
approx. camera angle: ----- 0				
photo bearing: ----- 040				
intraday photo #: 29				
view #3:				
camera height: ----- 0				
approx. camera angle: ----- 0				
photo bearing: ----- 0				
intraday photo #:

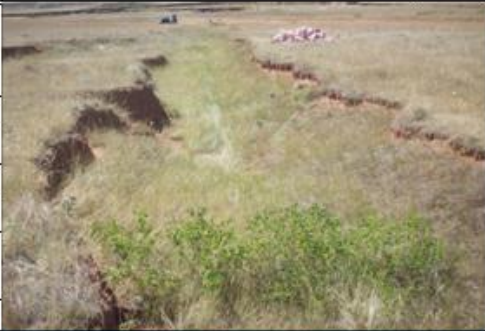
Down trench @ head cut structures zuni bowl and one rock dam	
camera height: ----- 5 ft on rebar				
approx. camera angle: ----- -10				
photo bearing: ----- 195				
intraday photo #: 12				
view #2:

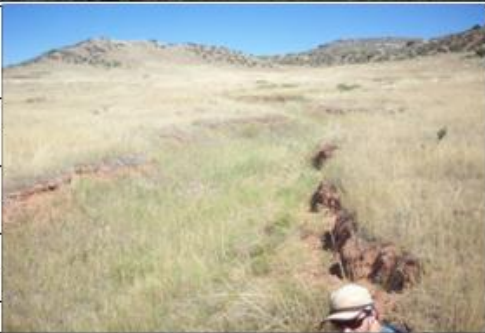
Up trench @ gully erosion	
camera height: ----- 5 ft on rebar				
approx. camera angle: ----- 5				
photo bearing: ----- 0				
intraday photo #: 13				
view #3:				
camera height: ----- 0				
approx. camera angle: ----- 0				
photo bearing: ----- 0
