END OF PROJECT REPORT

Project #2014-02-022

**Repair and Rehabilitation of Montezuma Valley Irrigation
Company Flume No.6- McElmo Creek Flume –Flume #6**

Grant Recipient: Montezuma County Colorado.

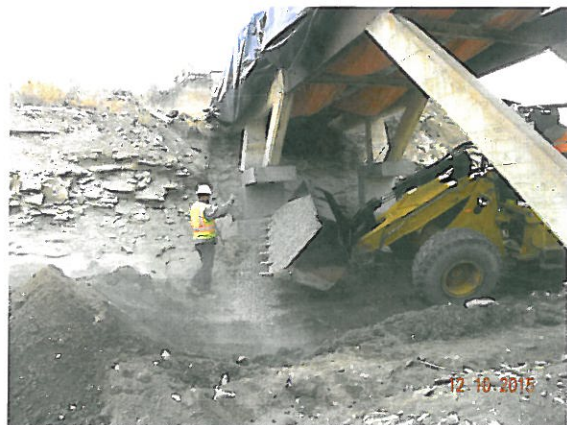
Preparing bedding for rip rap
