**CONSTRUCTION COMPLETION REPORT**  
**WEST RESERVOIR NO. 1 OUTLET WORKS**  
**REHABILITATION PROJECT**  
**DELTA COUNTY, COLORADO**

Submitted to  
**West Reservoir & Ditch Company**  
708 1250 Road  
Delta, CO 81416

Submitted by  
**RJH Consultants, Inc.**  
9800 Mt. Pyramid Court, Suite 330  
Englewood, Colorado 80112  
303-225-4611  
[www.rjh-consultants.com](http://www.rjh-consultants.com)

December 2016  
Project 13129

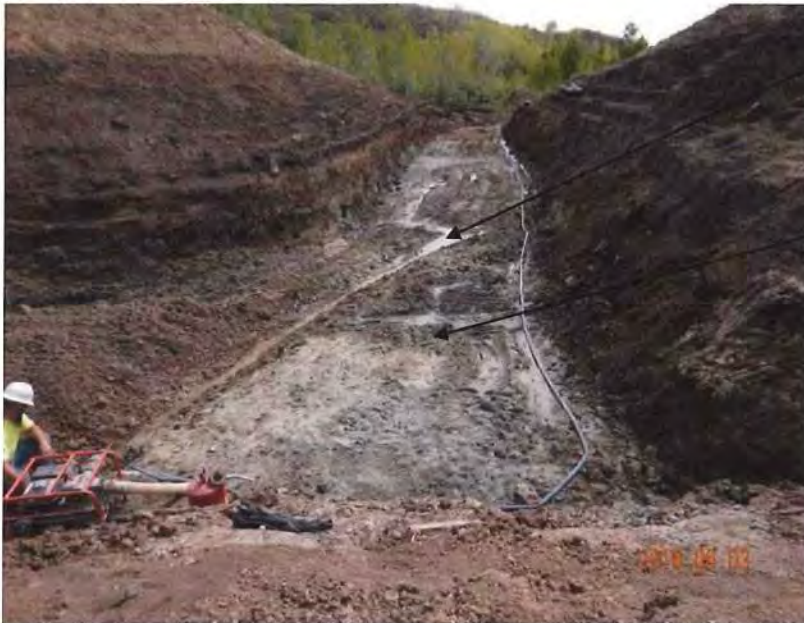
Excavated channel to control flow through excavation.

Mud and standing water on subgrade.

Photo 1 – Condition of the outlet works subgrade, looking downstream.

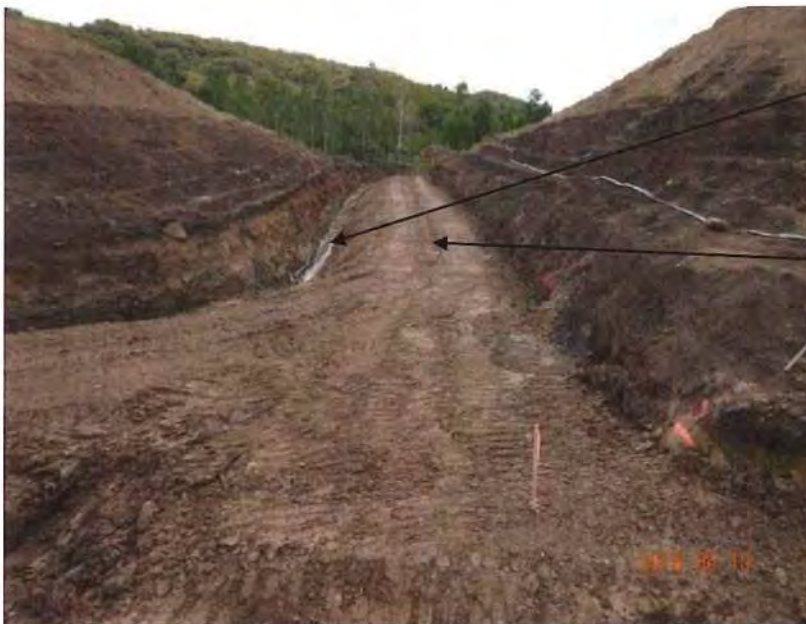
Diversion channel.

Working platform

Photo 1 – Working platform looking downstream.

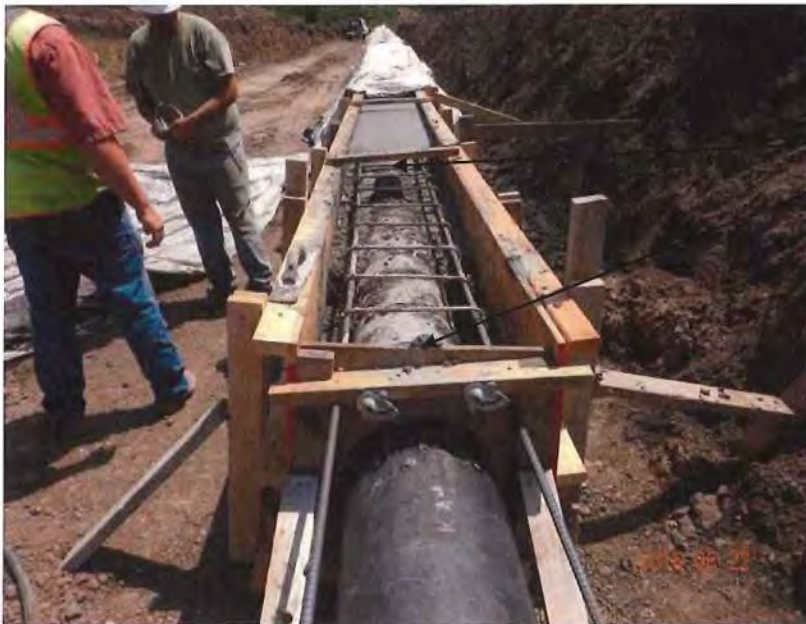
Portion of the conduit encasement that was left un-finished. This area will be completed during a subsequent placement.

Photo 8 – Placing concrete for the outlet works conduit encasement.

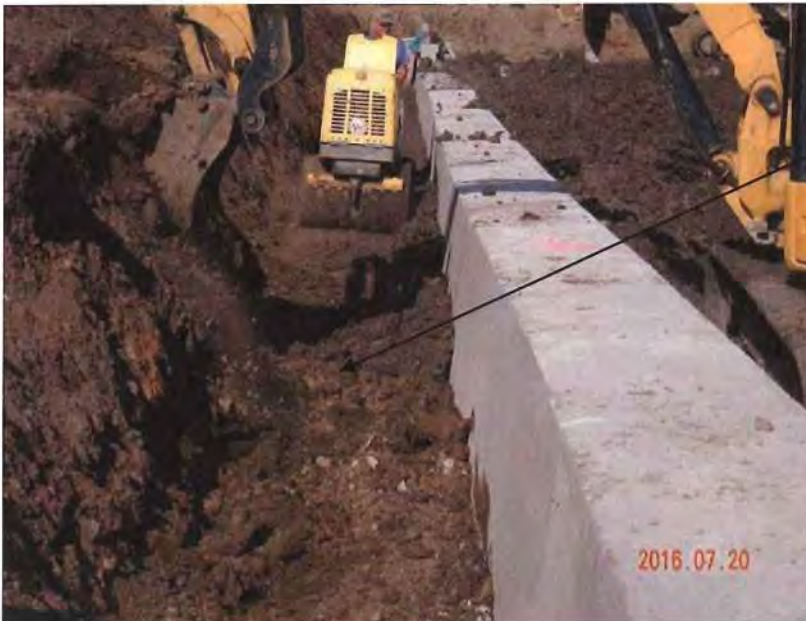
Excavating existing embankment for use as backfill. The existing embankment was sloped as much as possible prior to placing backfill.

Photo 2 – Excavating existing embankment for use as backfill on the south side of the conduit encasement.

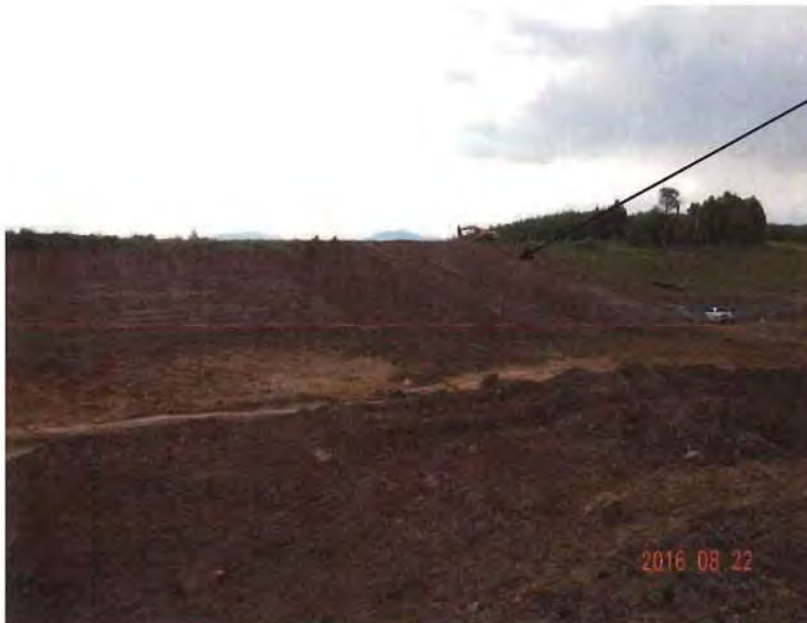
Photo 1 – Completed embankment. Looking at the upstream slope.

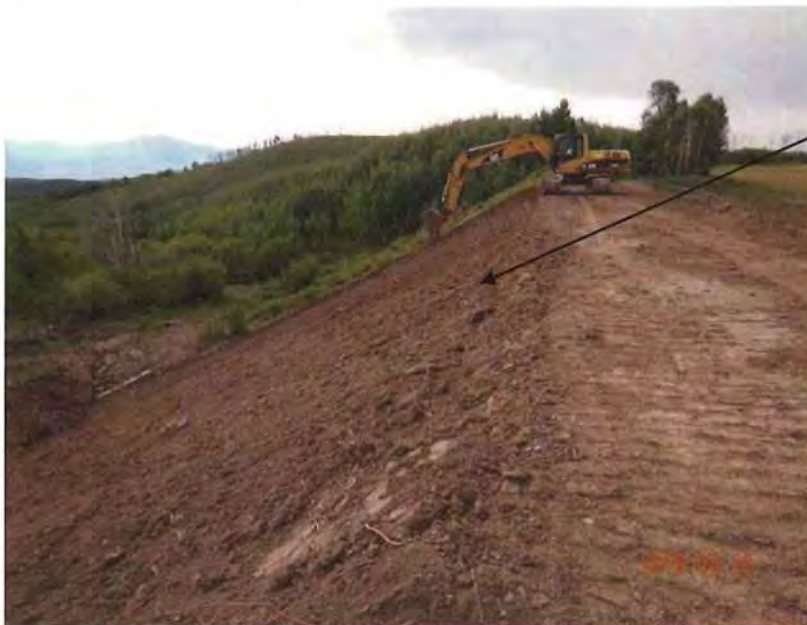
Photo 2 – Placing topsoil on the downstream slope.

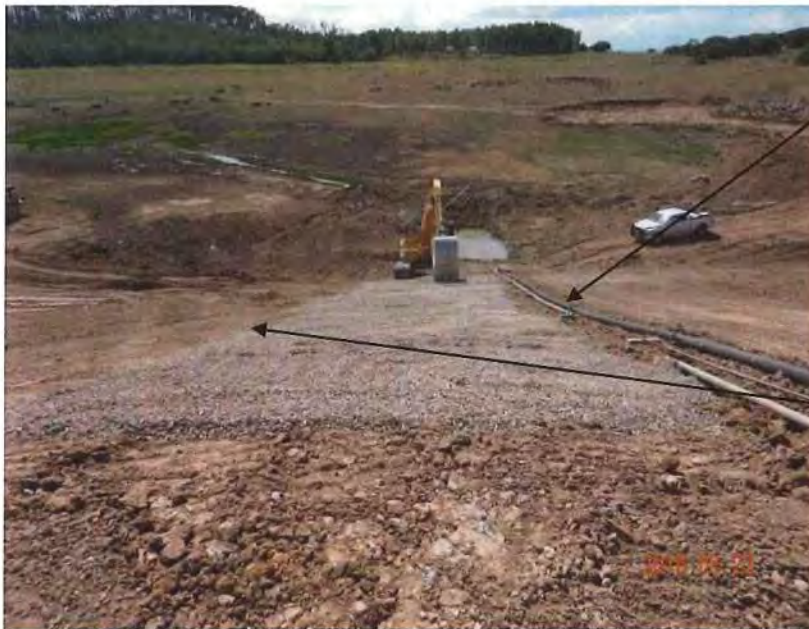
Photo 3 – Placing riprap bedding.

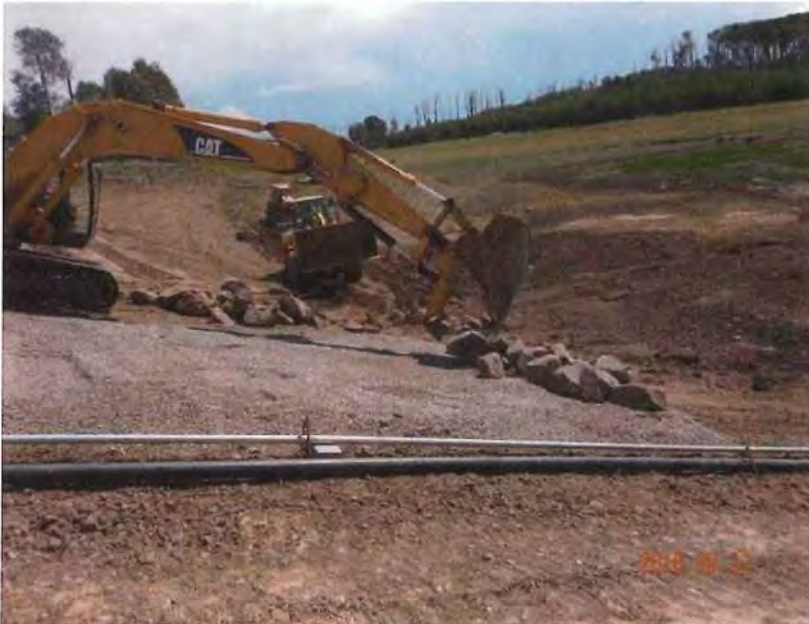
I asked Jake to make sure smaller pieces of riprap are placed in void areas (where large riprap is stacked) to protect the riprap bedding. I had observed several areas where riprap bedding was exposed.

Photo 4 – Placing riprap.

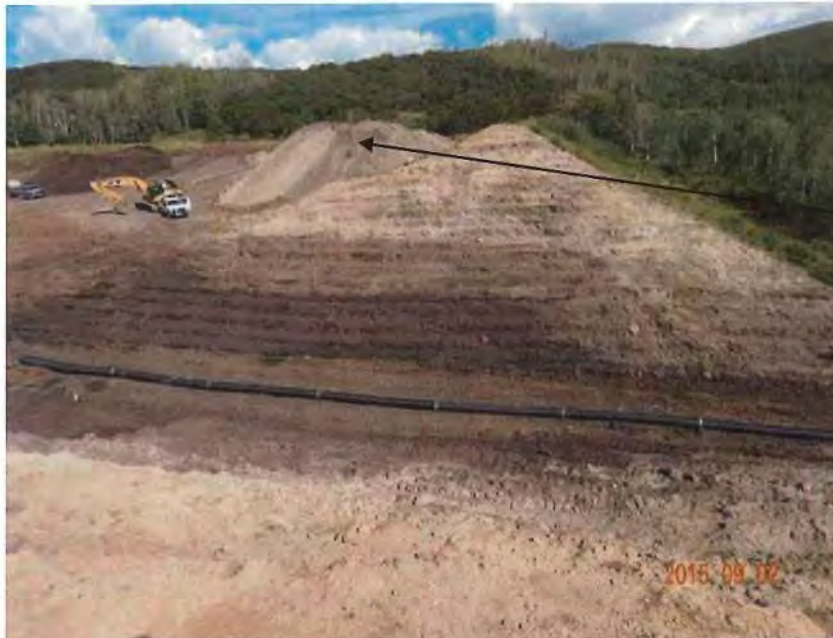
Photo 1 – Excavation through existing embankment.

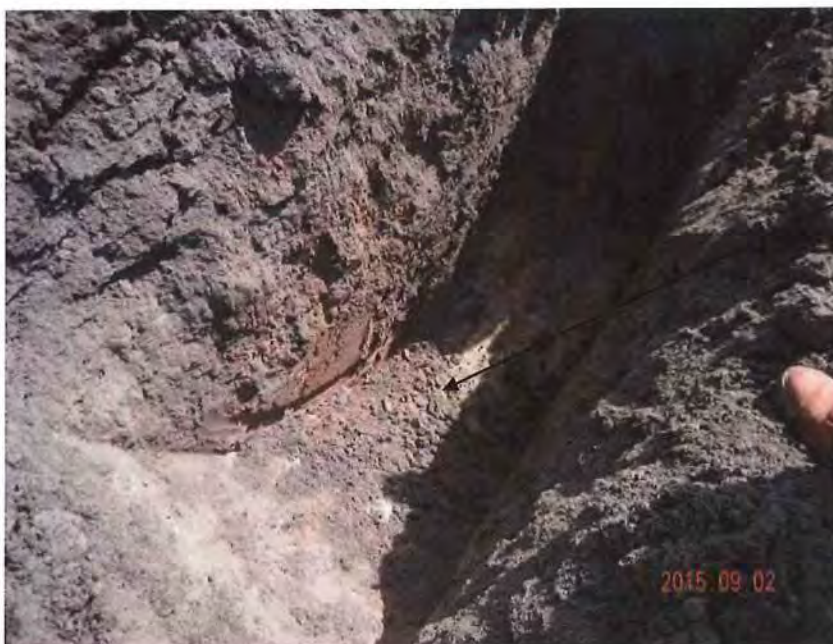
The bottom of the excavation is loose (from excavation) and dry. Rundle excavated three test pits (upstream end, middle and downstream end) to determine subgrade materials.

Gravelly clay material.

Photo 2 – Test pit at upstream toe.

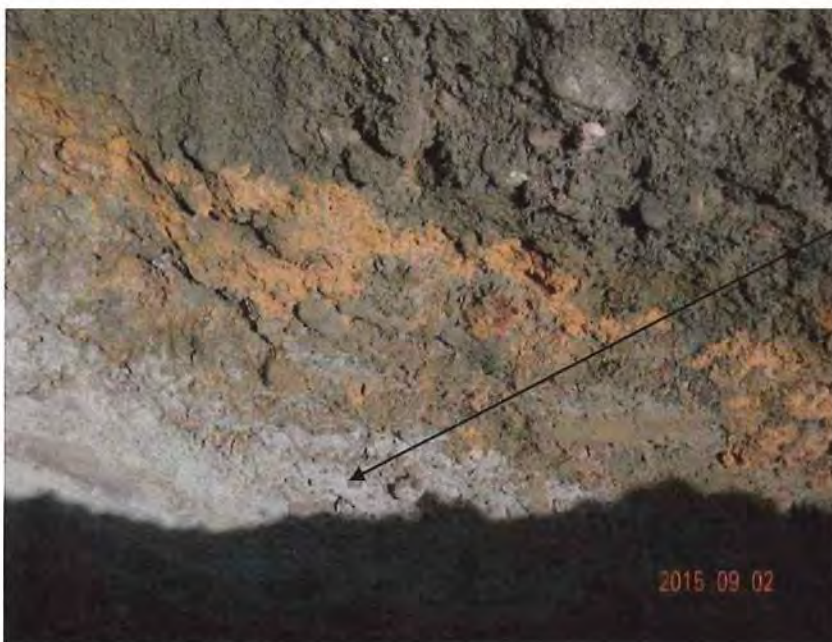
Blue/grey sandstone.

Photo 3 – Test pit near middle of excavation.

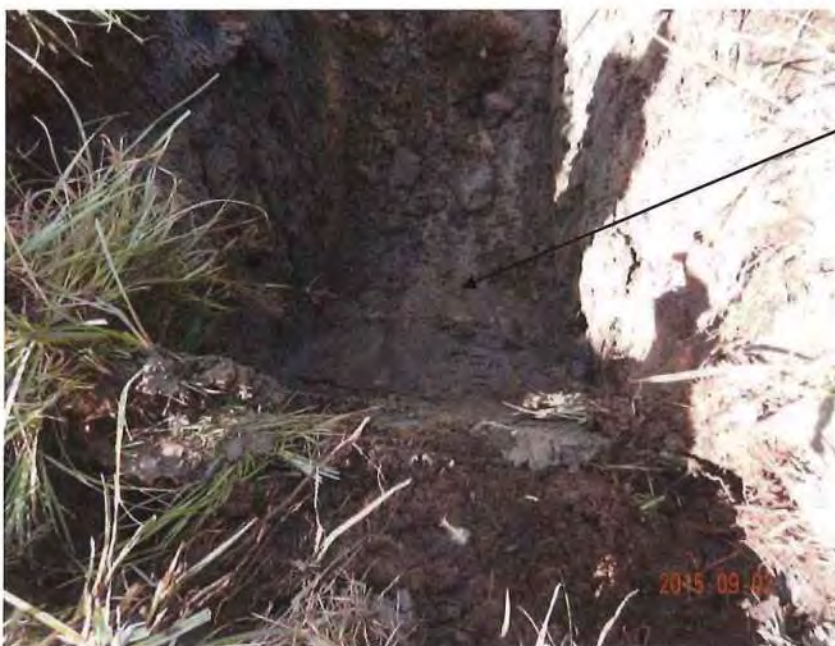
Gravely clay material.

Photo 4 – Test pit at downstream toe.

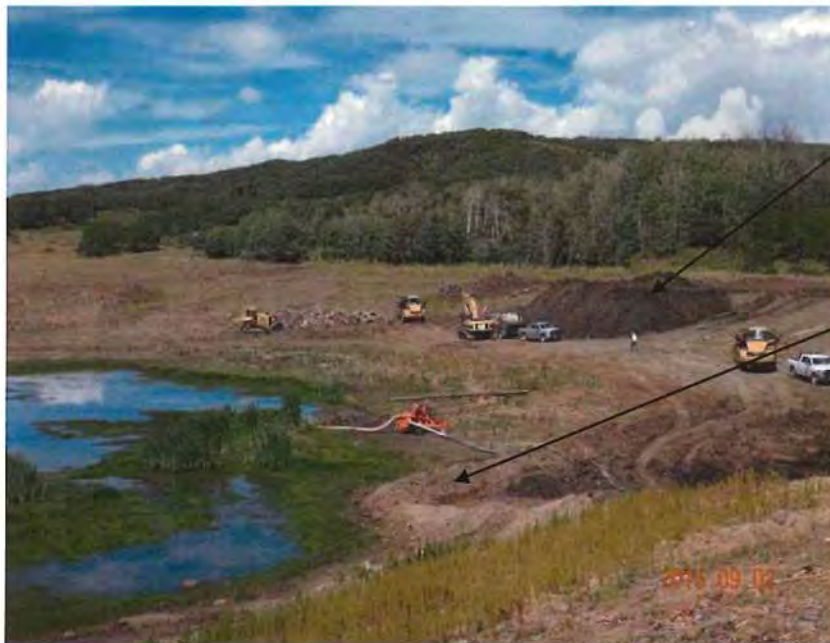
Rundle separated and stockpiled dark (apparently organic) material that was excavated from the existing embankment. The material has some organic material visible and has an organic smell. I obtained a sample for testing to determine the organic content. The stockpile is shown on Photo 5.

Rundle had constructed a cofferdam upstream of the work area (Photo 5).

Stockpile of potentially organic material.

Photo 5 – Cofferdam.

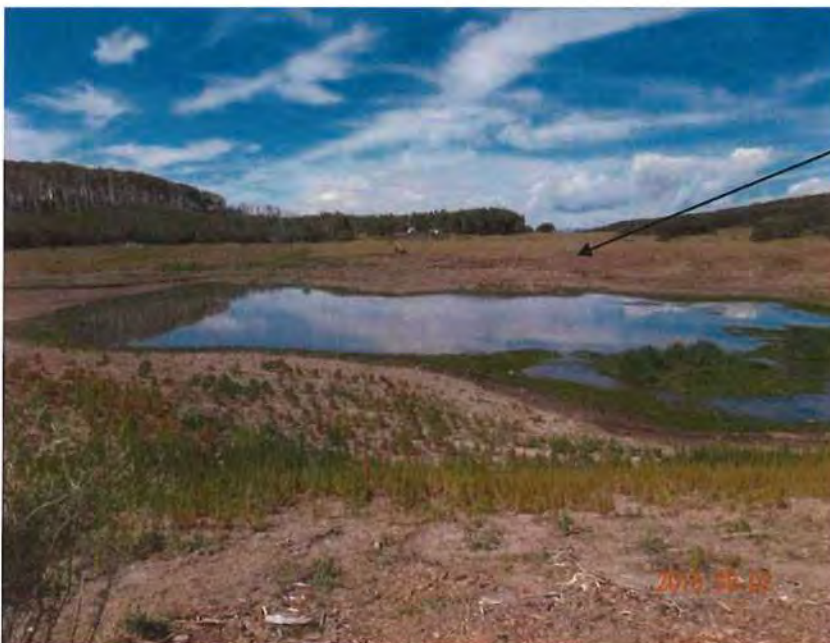
I obtained a sample of potential borrow material from the reservoir basin (Photo 6).

Photo 6 – Potential borrow area in reservoir.

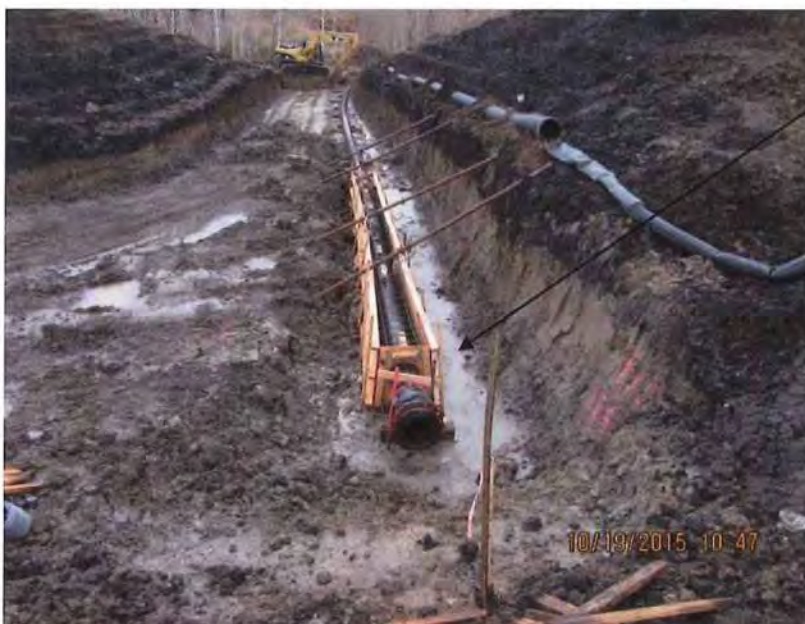
Mud and standing water for outlet works encasement subgrade.

Photo 1 – Outlet works.

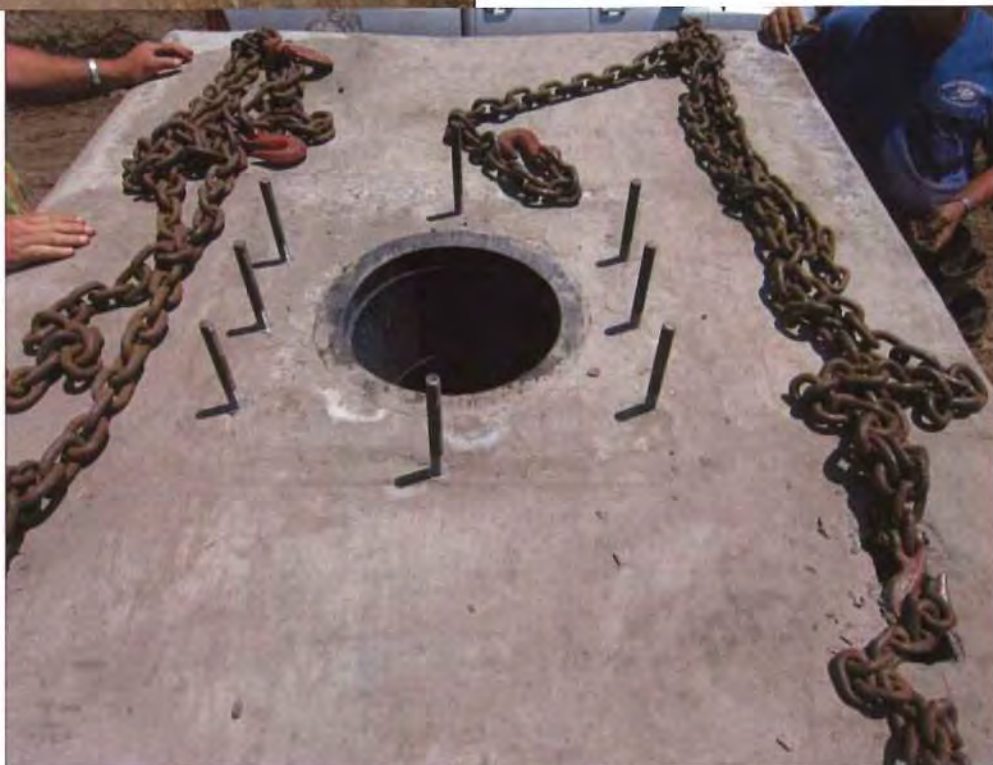
Bolt pattern for outlet valve on inclined portion of intake structure.

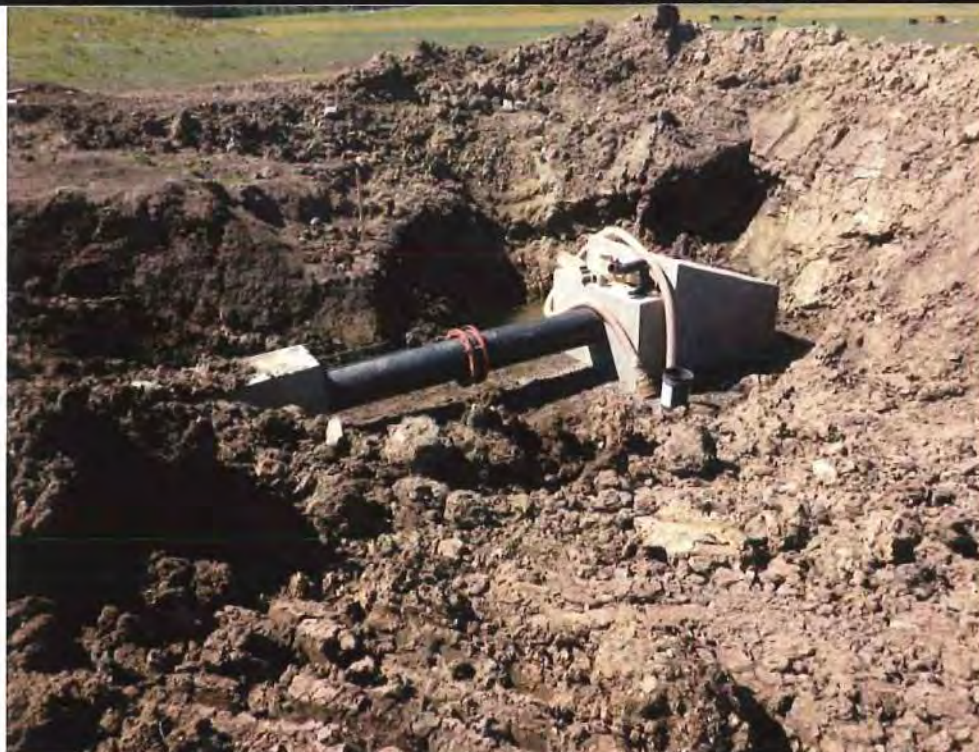
~ 10' of conduit remains to be encased after making the permanent connection to the gate structure.

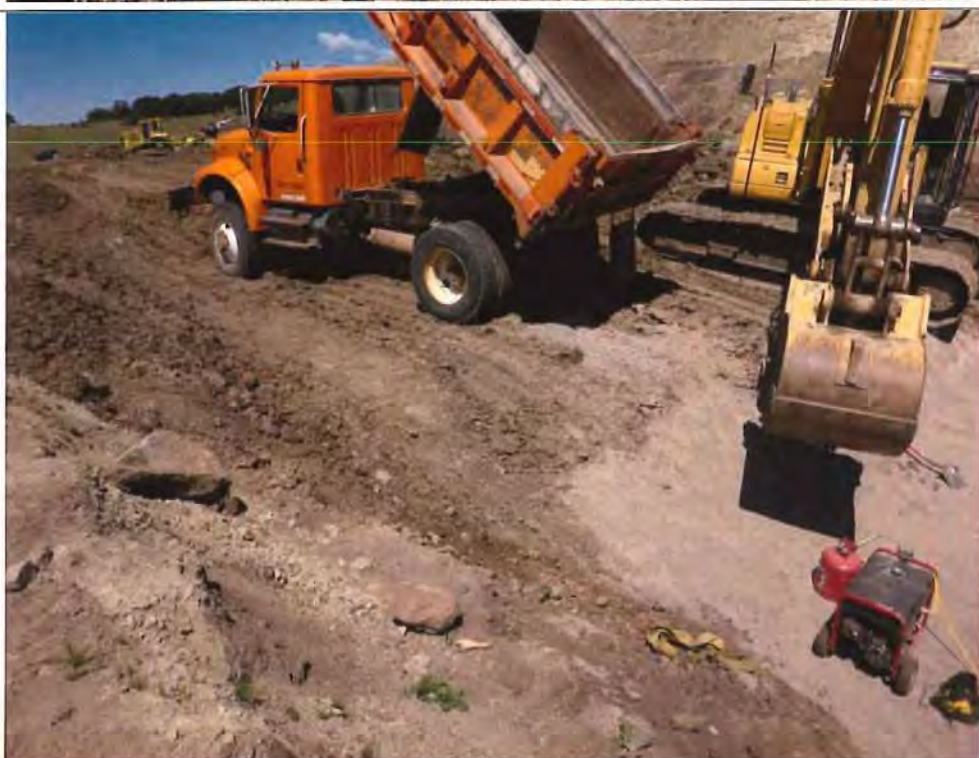
Fill has been placed upstream of the sand filter diaphragm, where the fill level in the breach is now 2'-3' above the top of the outlet encasement.

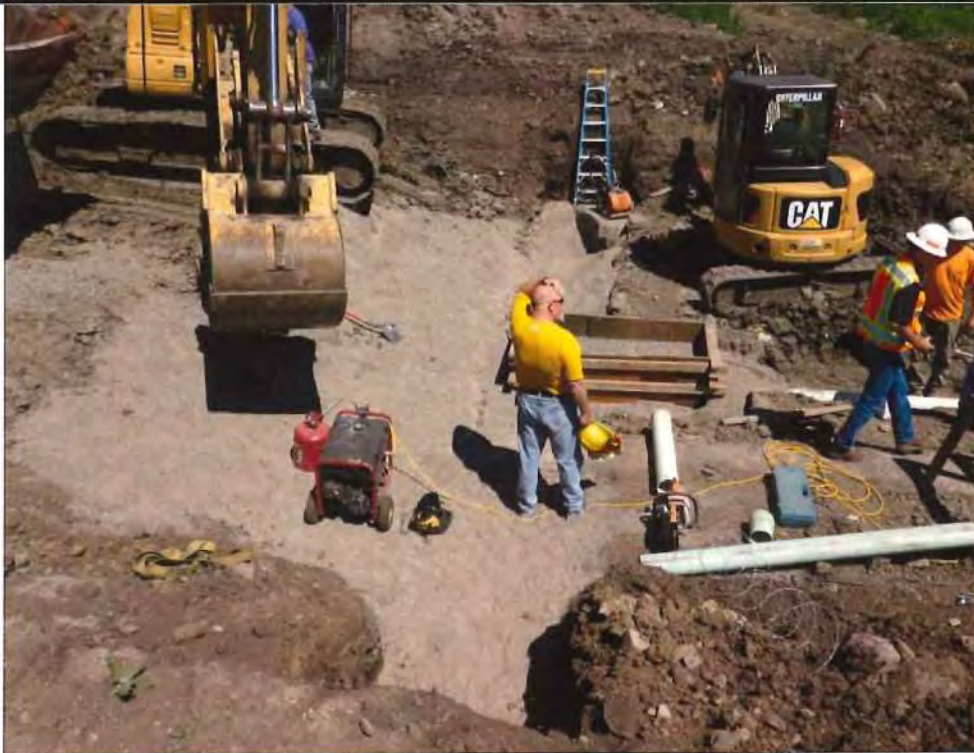
Sand diaphragm excavation is extended into the sides of the breach excavation on both sides.

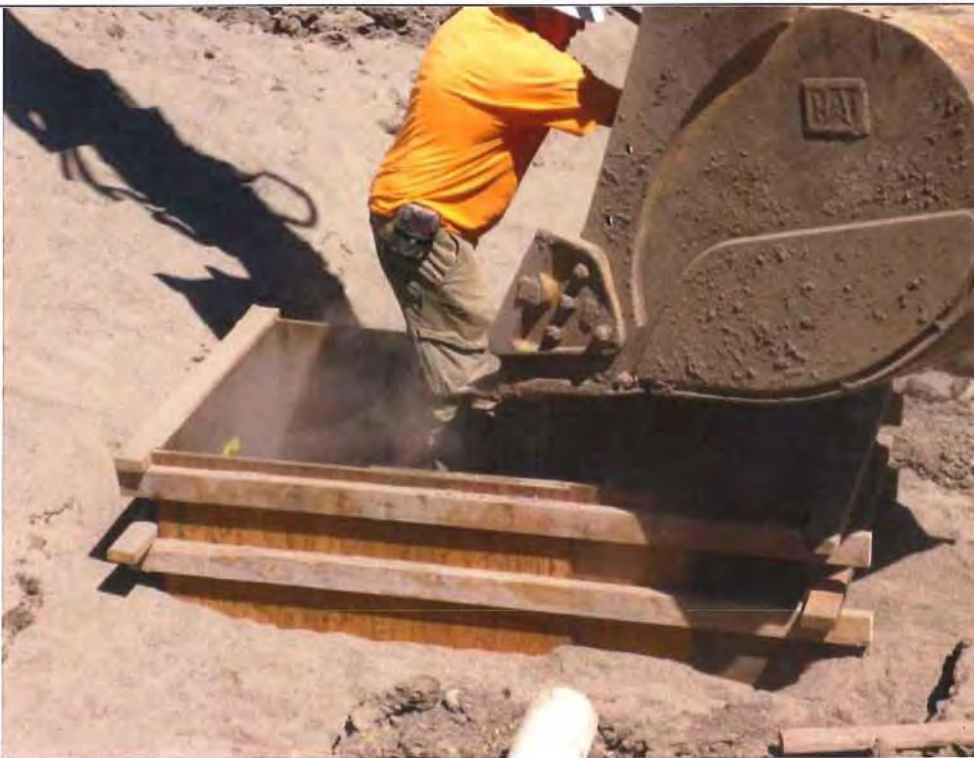
Gravel is placed in a form box, which will be lifted out of the sand.

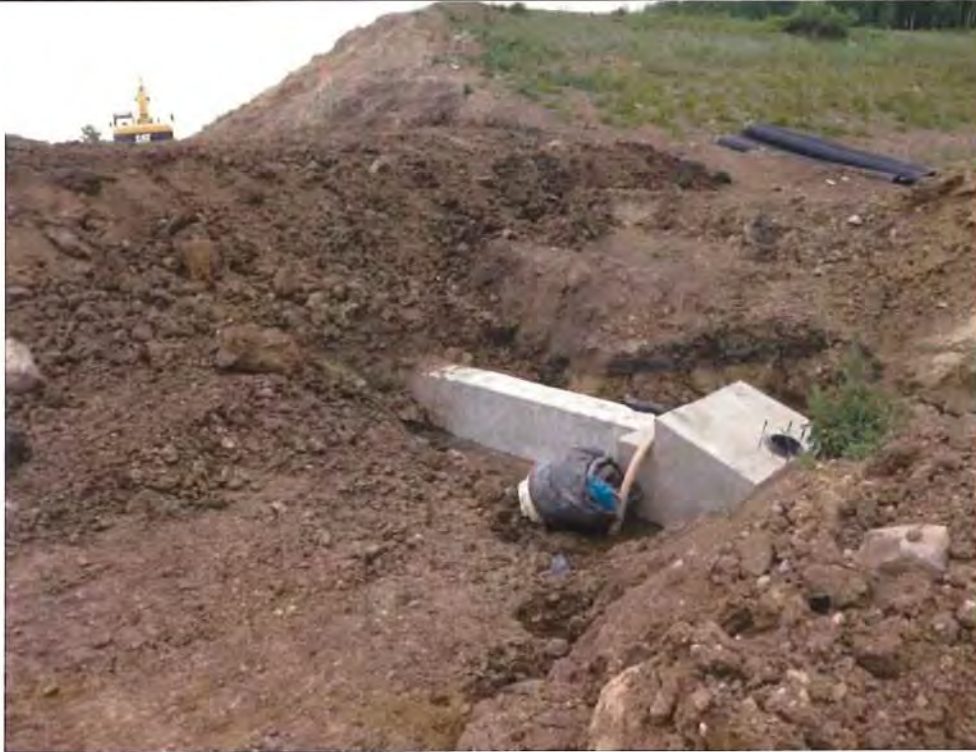
Outlet conduit encasement has been completed.

Embankment fill has been placed to about 11'-12' above the encasement to about the dam centerline.

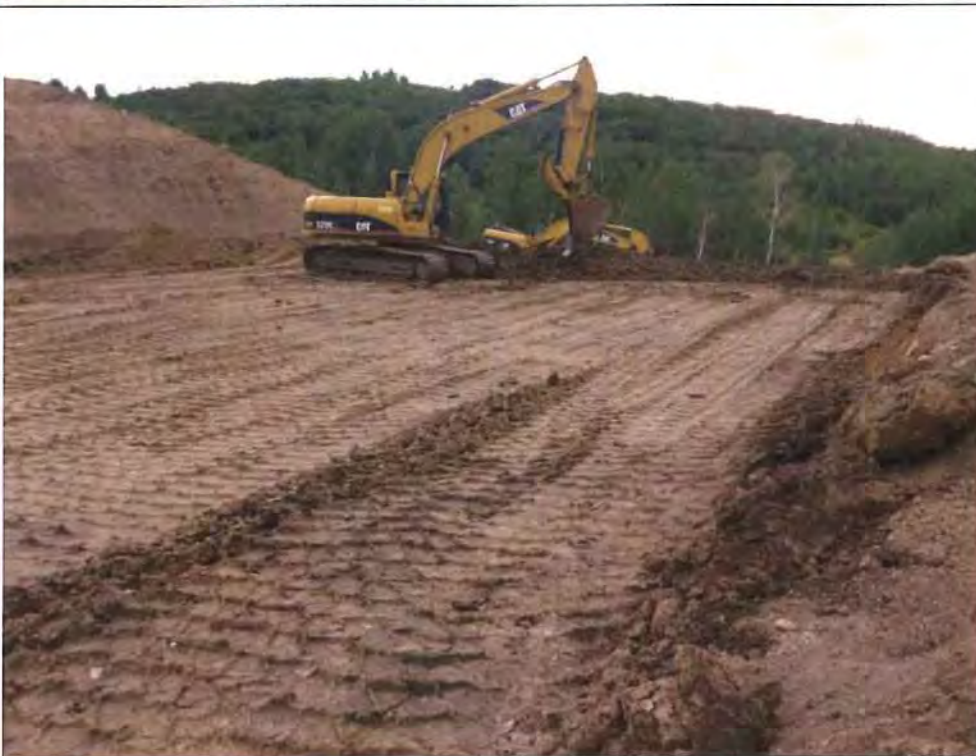
Embankment fill slopes down to the filter diaphragm from about the dam centerline.

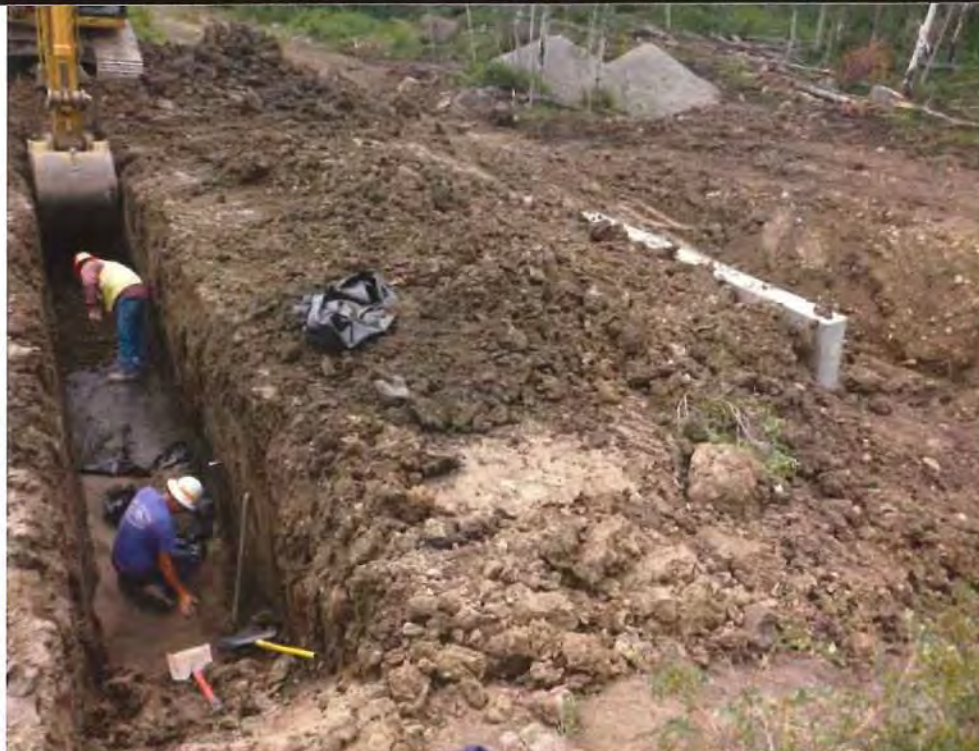
Excavating the fill to the fabric covering the previously placed sand, removing the fabric, and cleaning the top of the sand.

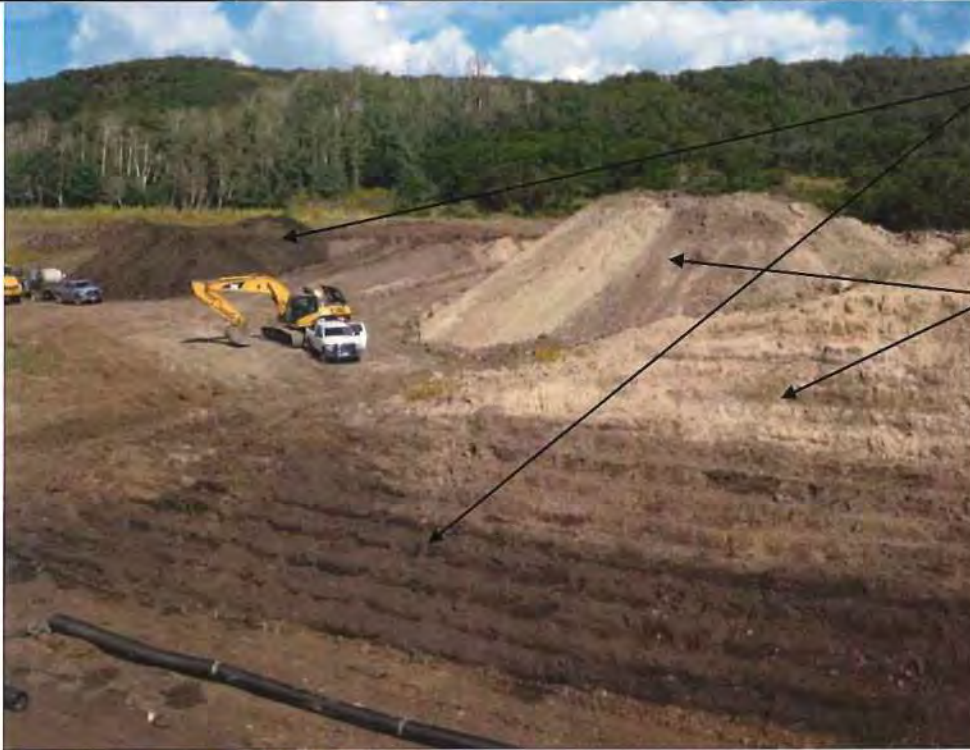
Looking across the breach towards the left abutment.

Dark brown soil in lower half of the excavation is wet and has unknown amount of organic content. This excavated material has been stockpiled separately upstream of the dam.

The lighter brown material from the upper half of the excavation is a sandy clay soil, stockpiled close to the left end of the dam.

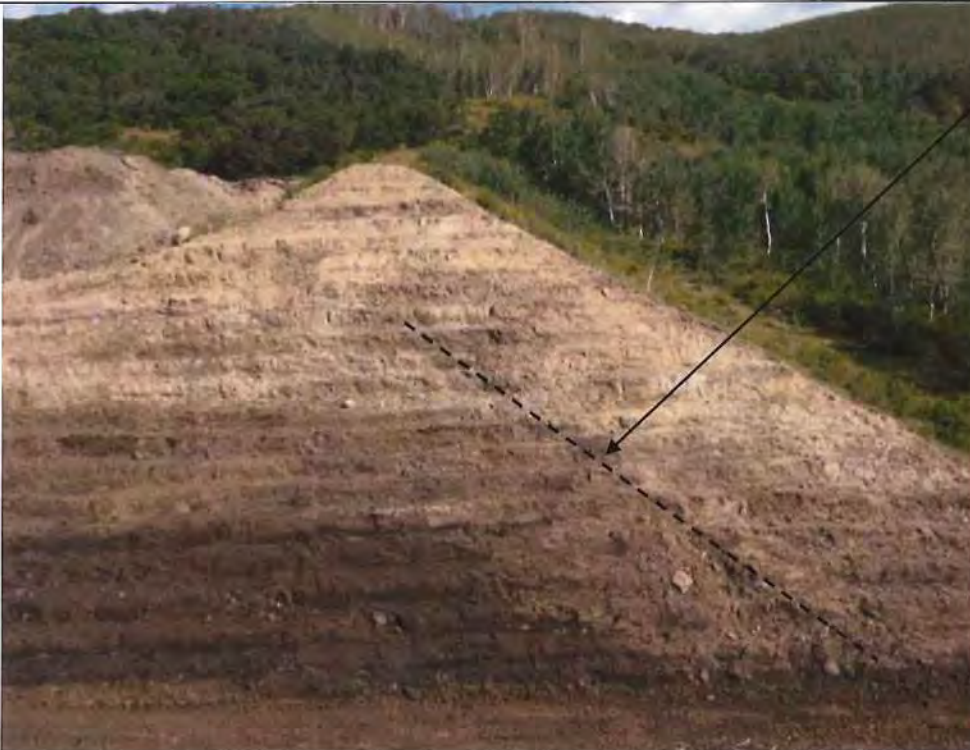
Looking across the excavation toward the left side. What appears to be the downstream slope of the old dam can be seen in the cut.

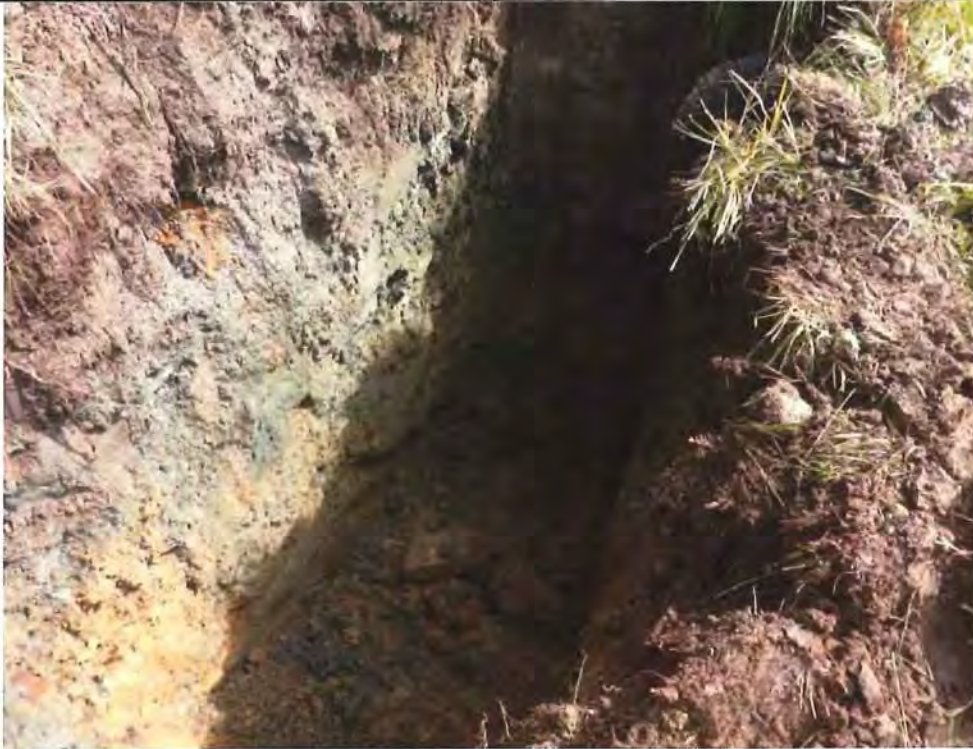
First test pit was excavated downstream of the dam in an undisturbed area. Pit exposed a layer of reddish brown topsoil with organics, underlain by a layer of grey/green silt and sand (old shale?), underlain by orange/brown gravelly clay.

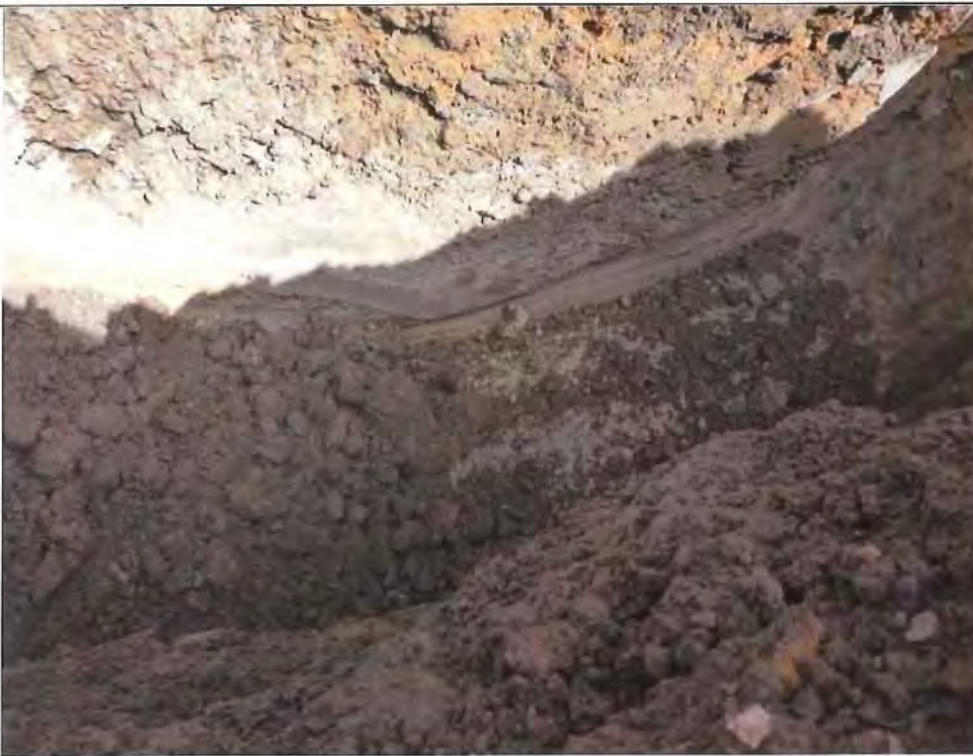
Second pit was excavated along the outlet conduit alignment in the downstream half of the dam. Pit exposed saturated soft brown clay underlain by fine blue-grey sand.

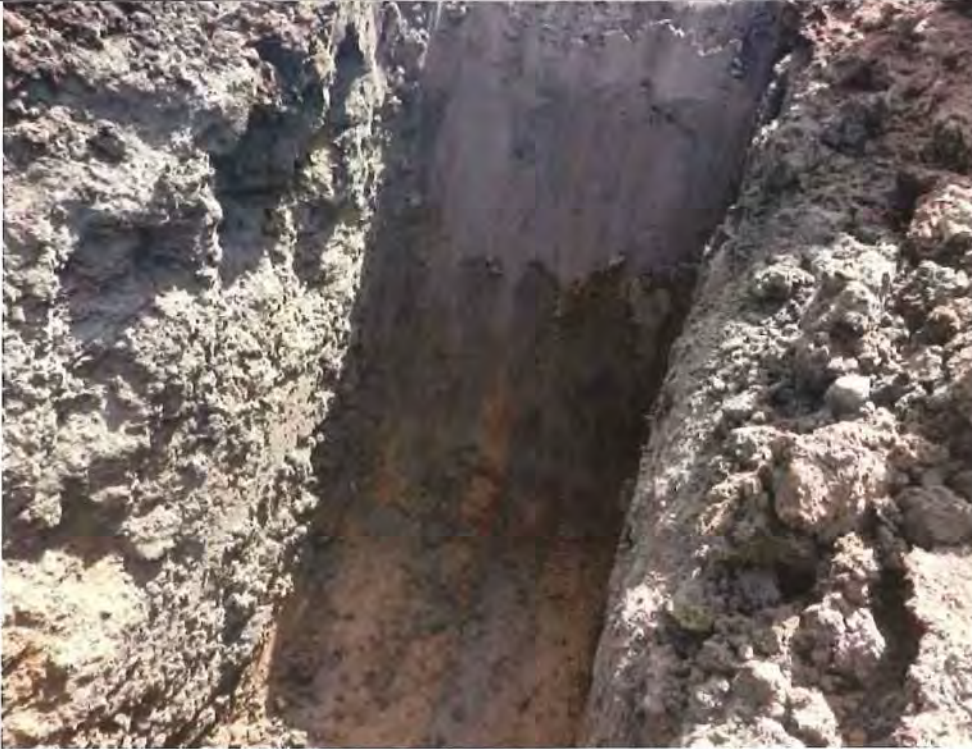
Third pit was excavated along the outlet alignment near the upstream toe. Pit exposed soft saturated blue-grey clay underlain by fine yellow and blue-grey sand.

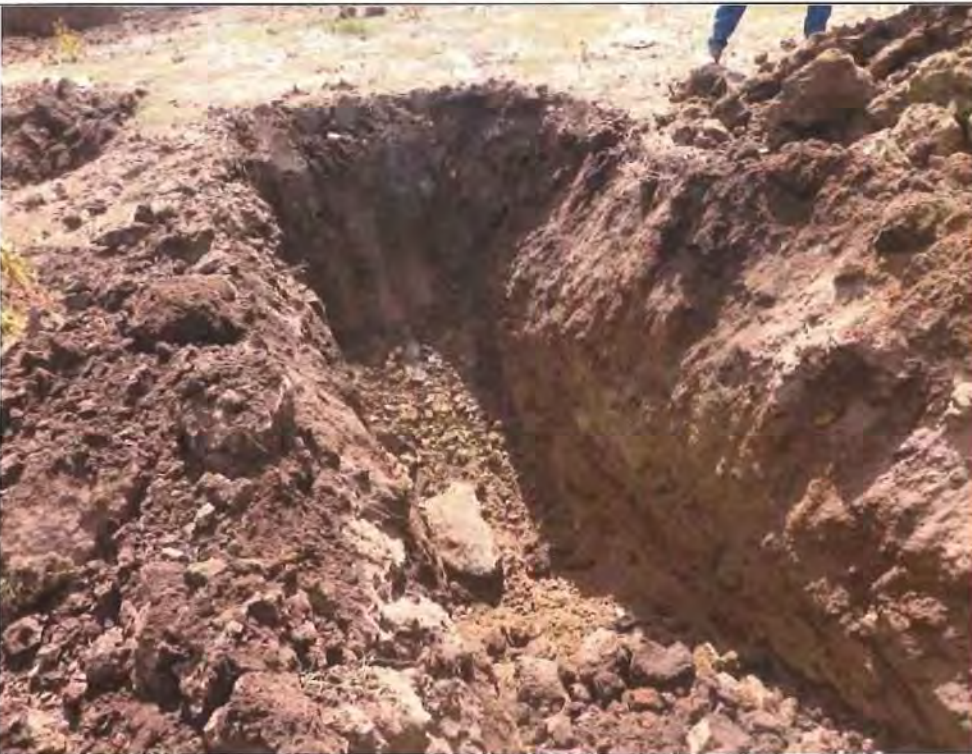
Borrow area test pit exposed gravelly reddish-brown and brown sandy clay.

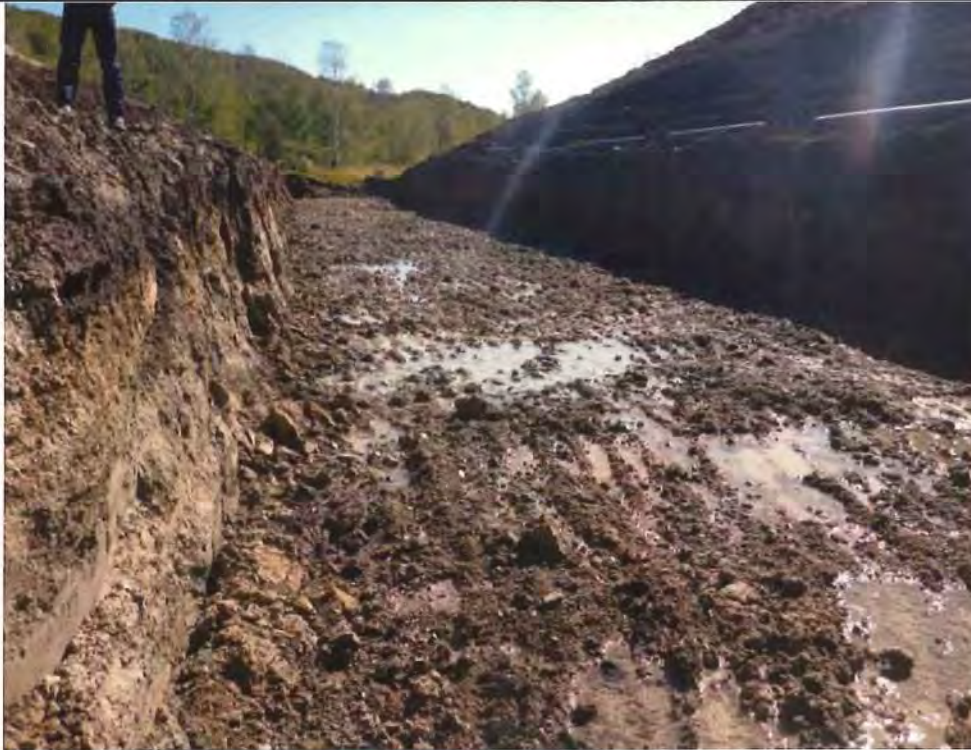
Outlet excavation looking from the upstream end. Water appears to be seeping into the excavation mainly from the sides of the cut. Contractor will cut small drain trenches at each side of the excavation and drain the water out the downstream end.

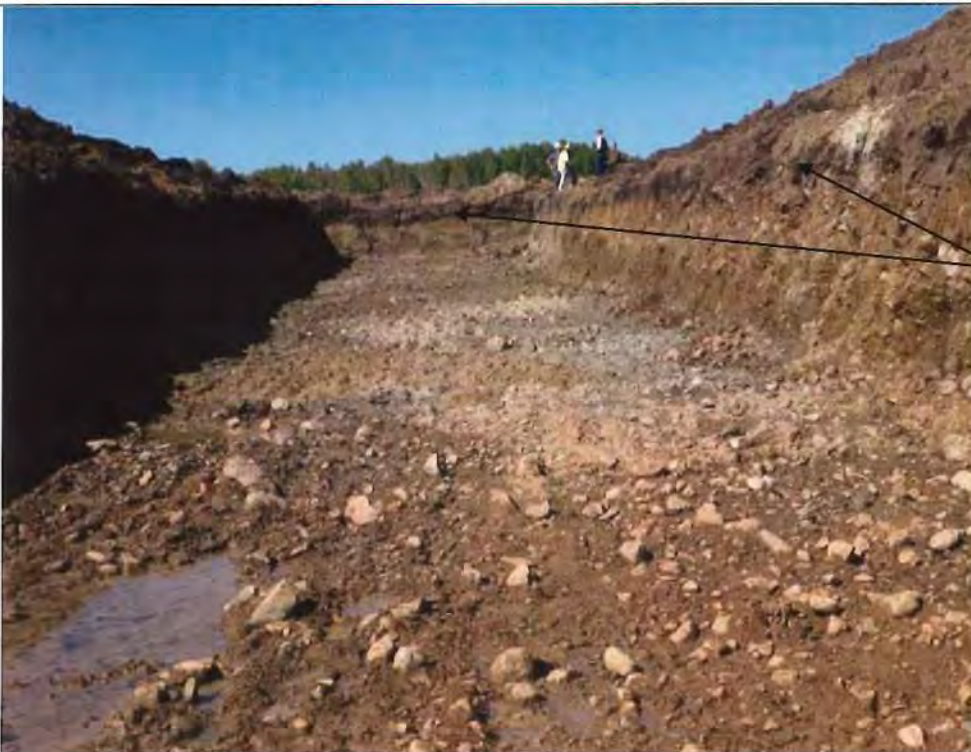
Outlet excavation looking from the downstream end. The subgrade material changes color as was indicated in last week's test pits. Probing the bottom indicates the subgrade is firm and competent for the entire length of the excavation.

Note the layer of organic topsoil around the excavation at the top of the cut.

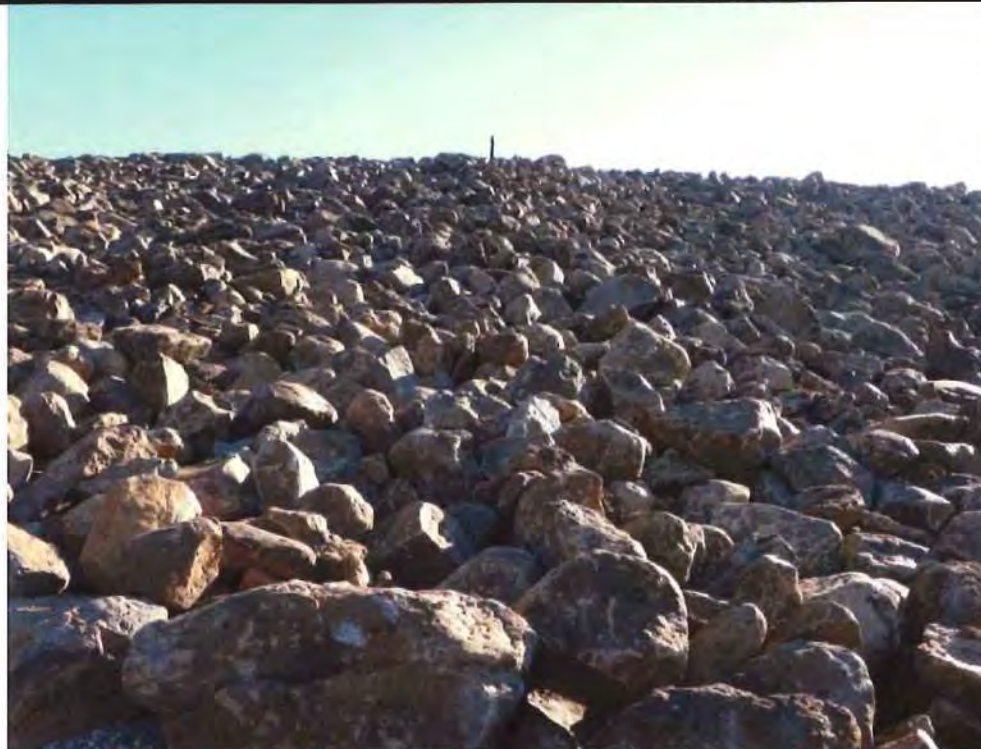
Upstream slope is slightly overbuilt at the outlet to cover the gate stem.

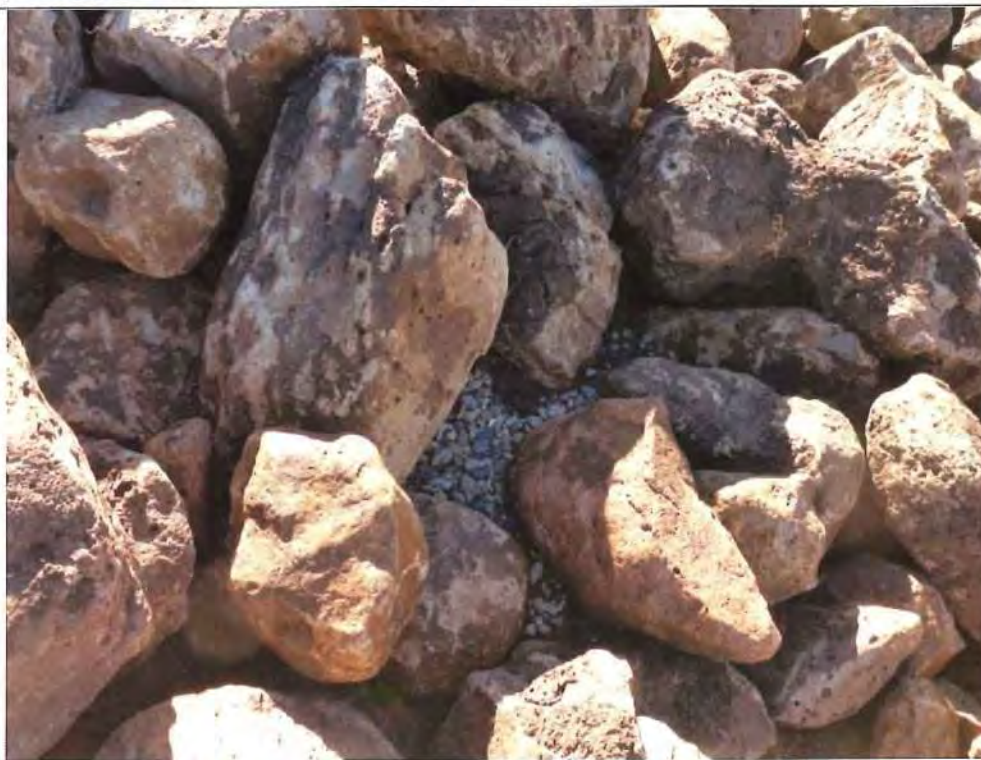
Some local areas of exposed riprap bedding near the outlet.

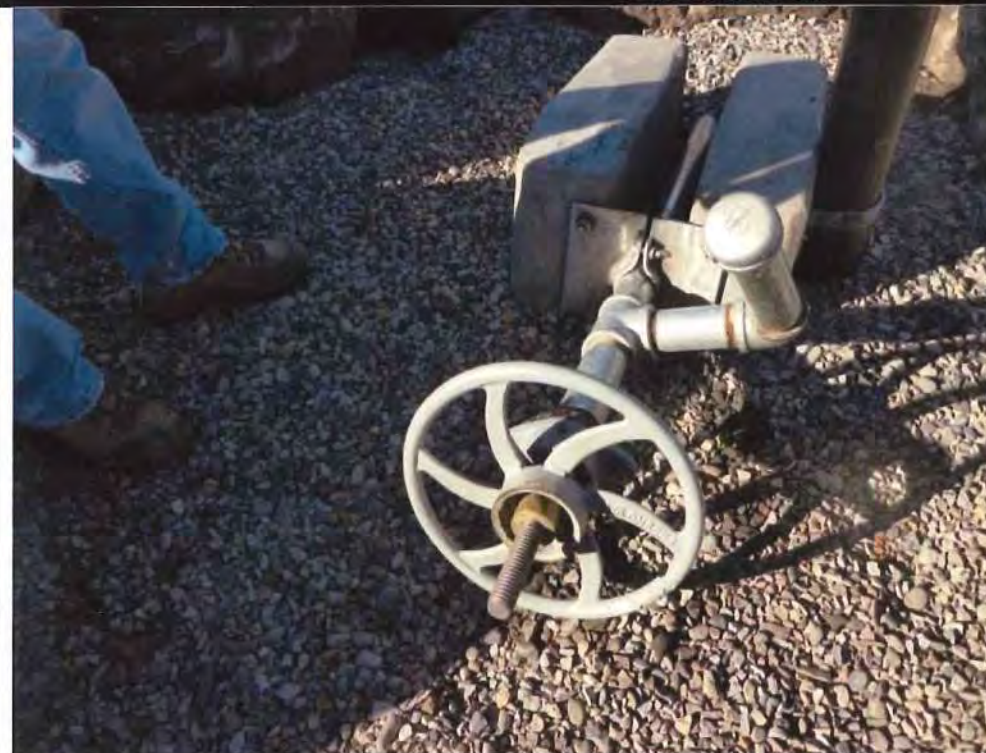
Outlet gate operator on dam crest with air vent and oil fill fitting.

Reaction force for opening and closing gate is provided by the buried gate stem guide, not the concrete block.
