**CONSTRUCTION COMPLETION REPORT**  
**WEST RESERVOIR NO. 1 OUTLET WORKS**  
**REHABILITATION PROJECT**  
**DELTA COUNTY, COLORADO**

Submitted to  
**West Reservoir & Ditch Company**  
708 1250 Road  
Delta, CO 81416

Submitted by  
**RJH Consultants, Inc.**  
9800 Mt. Pyramid Court, Suite 330  
Englewood, Colorado 80112  
303-225-4611  
[www.rjh-consultants.com](http://www.rjh-consultants.com)

December 2016  
Project 13129

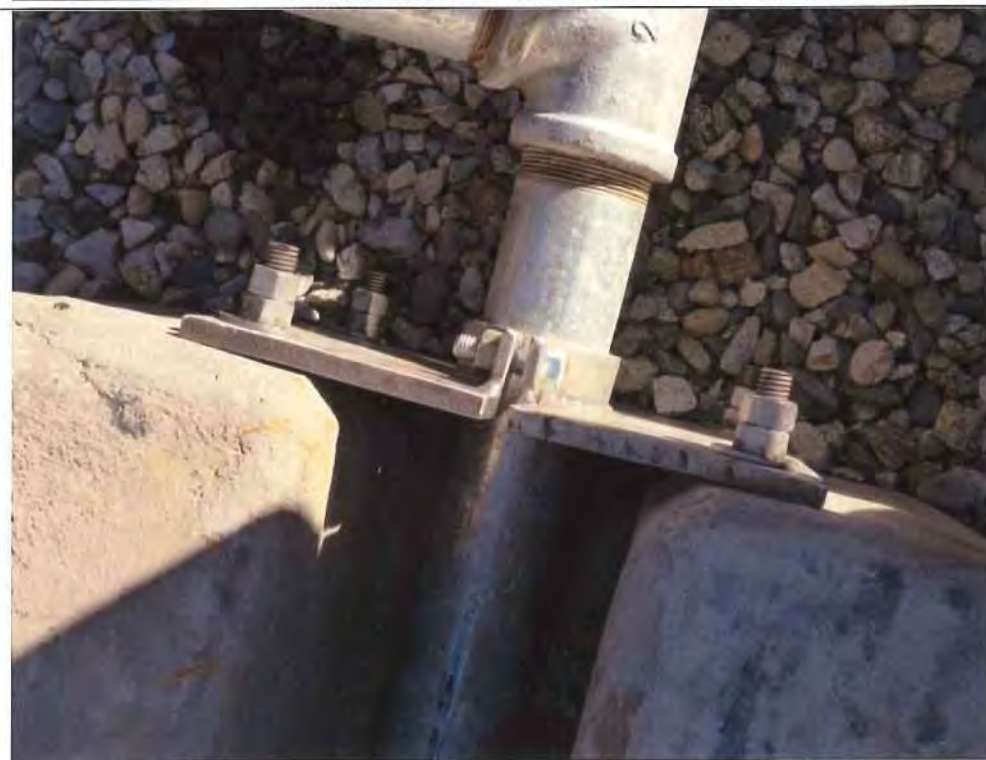
Plates bolted to concrete block are for alignment of stem guide, not thrust resistance.

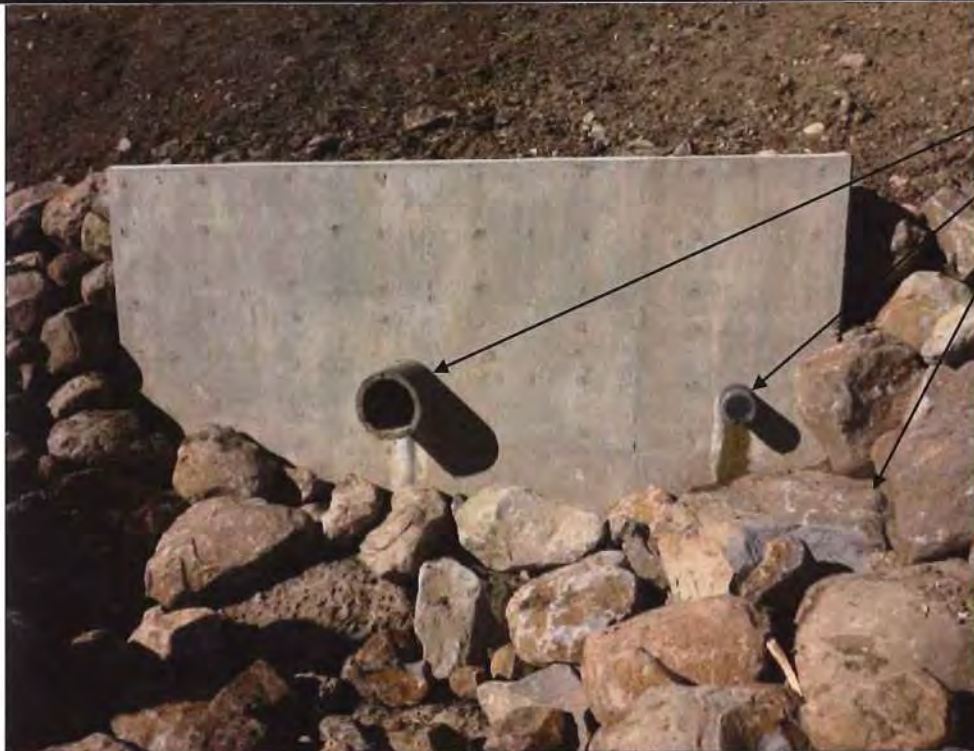
Outlet headwall at downstream toe of breached section.

Outlet conduit discharge.

Seepage diaphragm drain discharge.

Left toe drain discharge is buried in the riprap and must be daylighted.

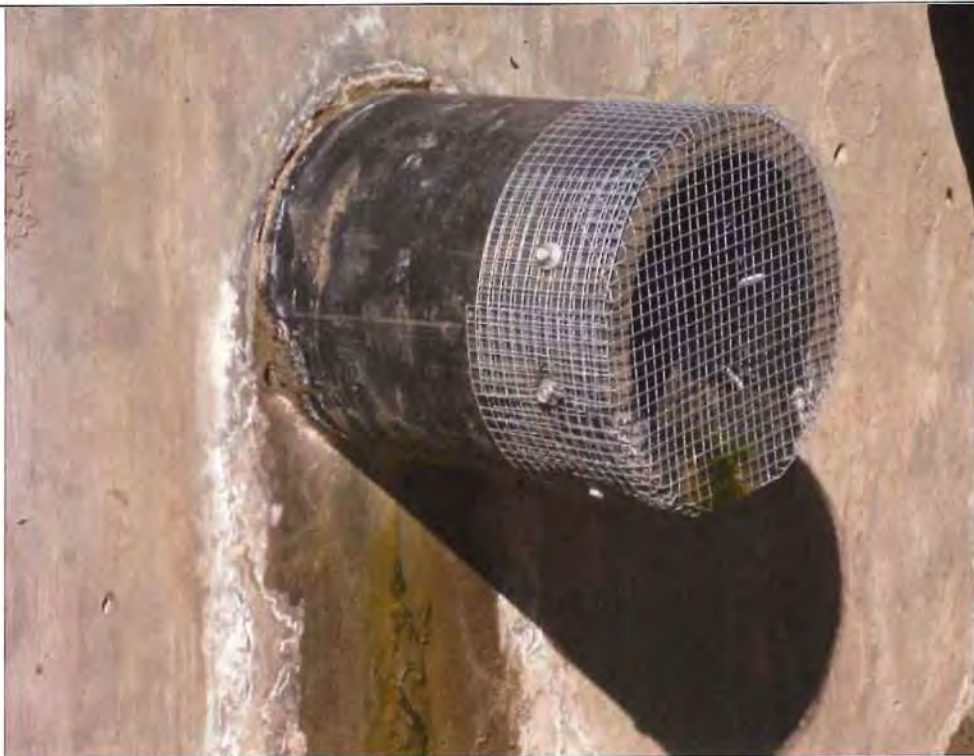
| Problems/Concerns: | <p>1. The granular bedding on the diaphragm drain pipe will likely always carry water to the headwall, and the concrete headwall will be subject to freeze-thaw damage. Recommend drilling a weephole through the headwall under the drain pipe to prevent water from standing in the trench behind the wall.</p> <p>2. The left toe drain discharge is buried in the left side of the riprapped outlet discharge basin and must be daylighted through the riprap for monitoring seepage.</p> |

Seepage through headwall under diaphragm drain is from water in the granular bedding for the drain pipe.

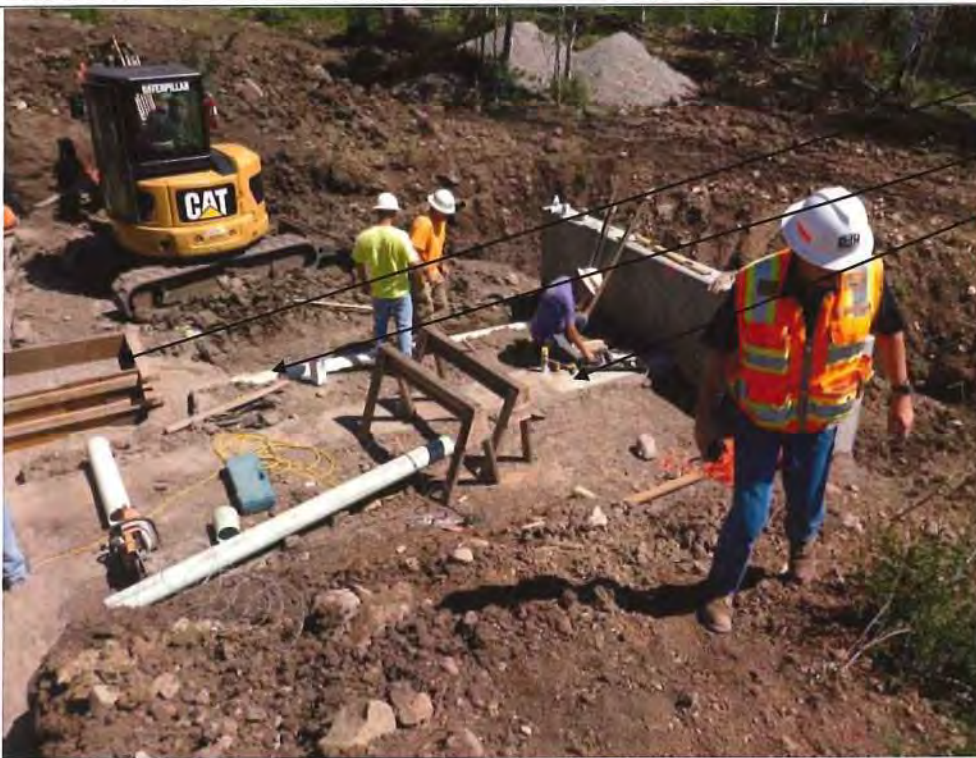
7/27/16 construction photo.

Filter diaphragm

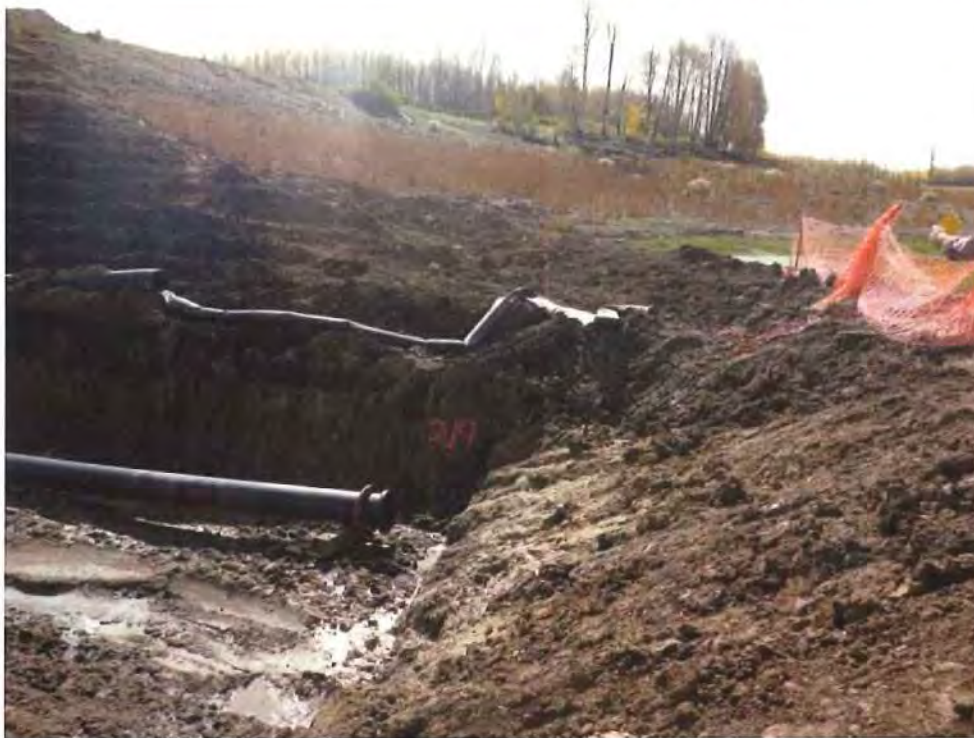
New HDPE outlet conduit has been laid in the excavation, but will need to be repositioned so the slide gate in the intake structure and the gate stem on the dam slope will be properly aligned.

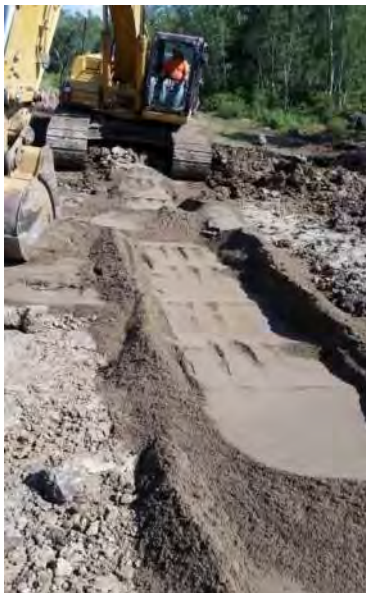
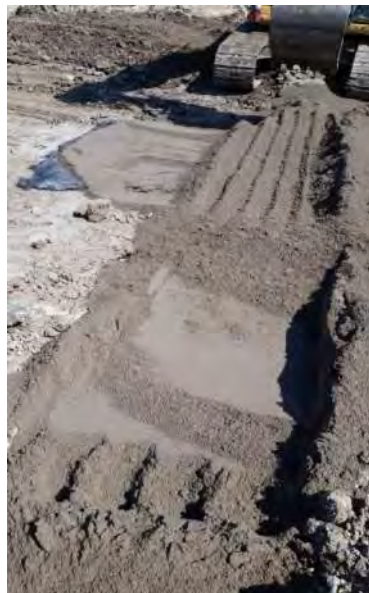
Finished sand collar to level with top of conduit. Placed fabric cover over sand extending in all directions 1-2'. Placed fill over collar area and began to compact and fill normal fill.

Pictures of fabric and sand in file.

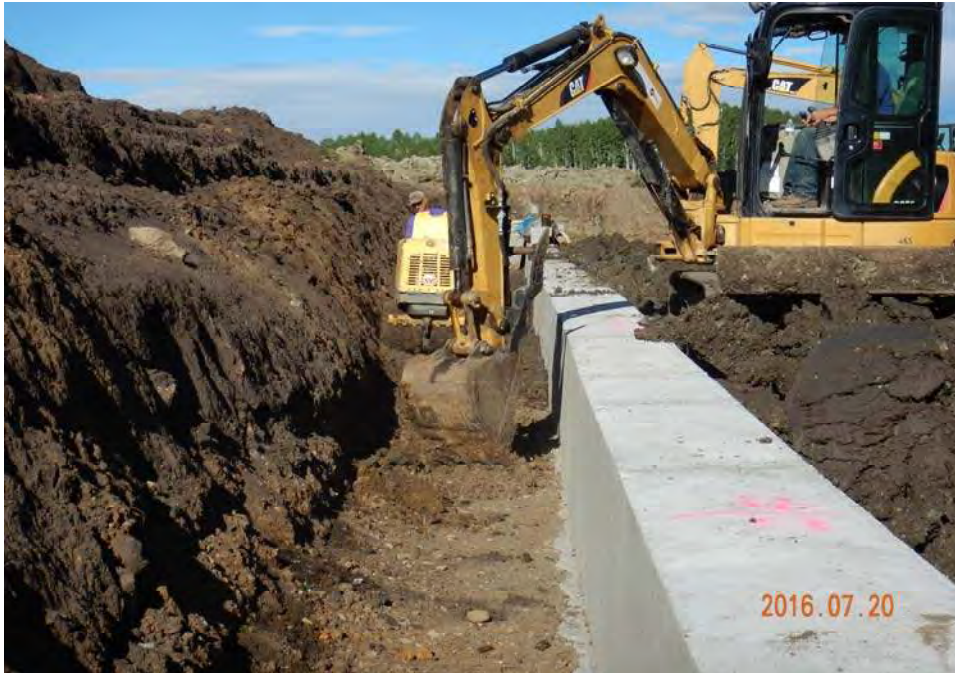
**Photograph 9:** Scarifying the subgrade on the right side of the conduit encasement prior to placing backfill.

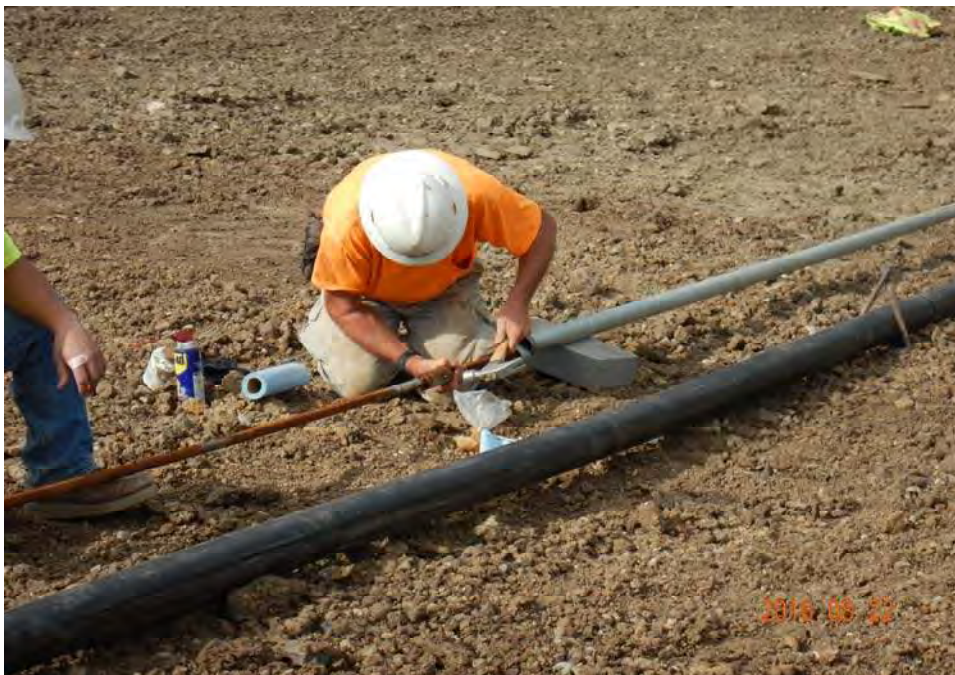
**Photograph 36:** Connecting gate stem segments.
