Lake Fork of the Gunnison River and Henson Creek Monitoring Data In-Stream Structures and Comparative Cross Sections

Camille Richard
Lake Fork Valley Conservancy (LFVC)

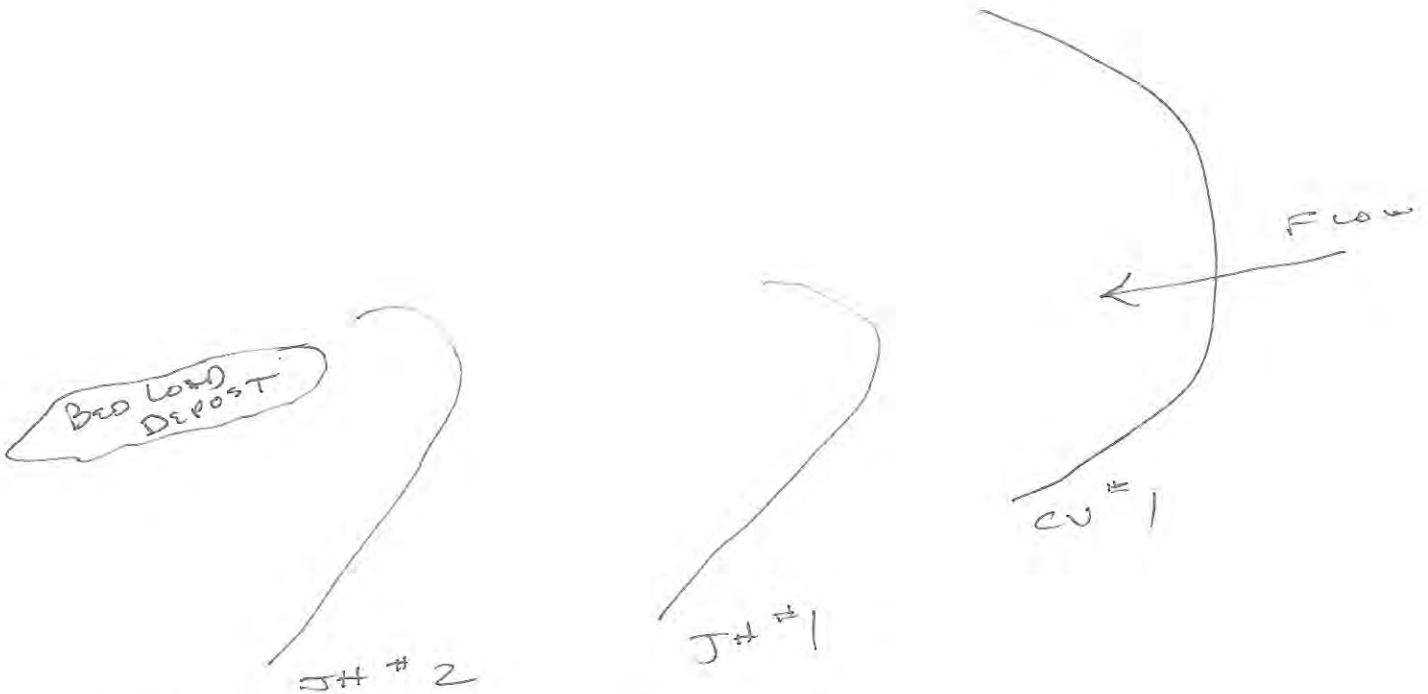
COMMENTS - NO POOL, POOR NAVIGAT
