# UPPER RIO GRANDE WATERSHED ASSESSMENT

FINAL December 2018

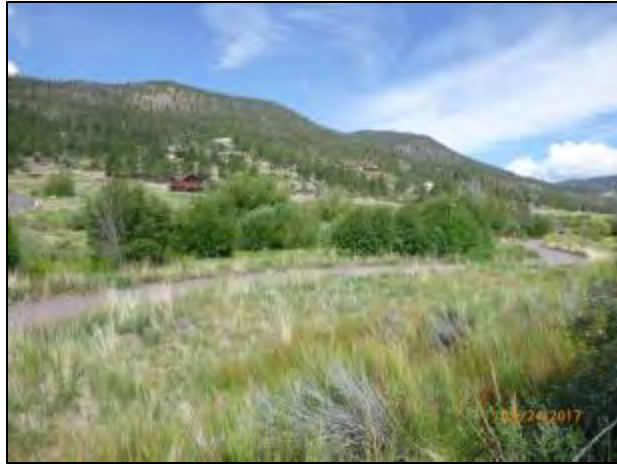
Photo 1. Impact Site No. 1, Alder Creek. Dispersed recreation impacts from trail along creek.

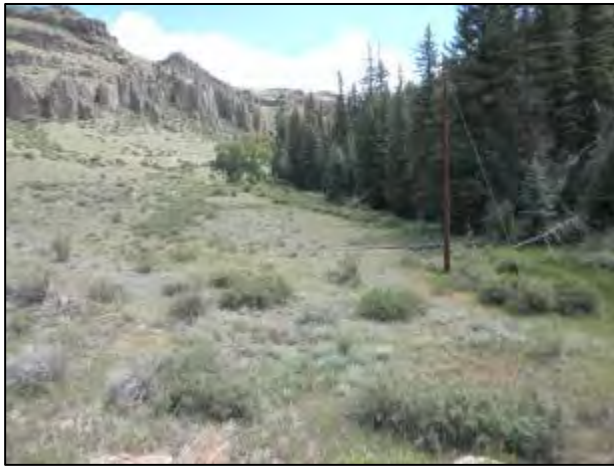
Photo 7. Impact Site No. 2, Bellows Creek. Photos taken within the vicinity of the site.

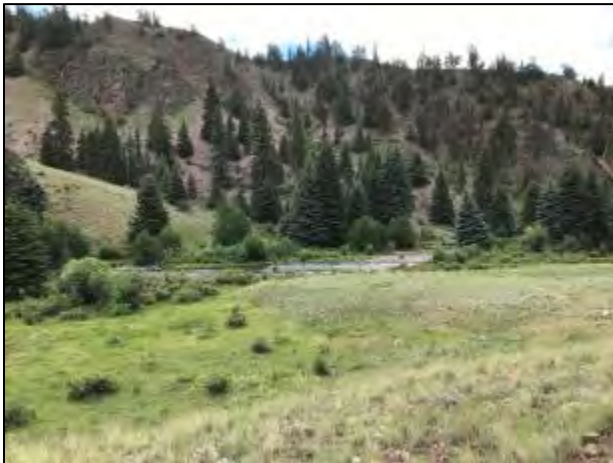
Photo 9. CNHP Site No. 3, Clear Creek. Impact from beetle kill in uplands.

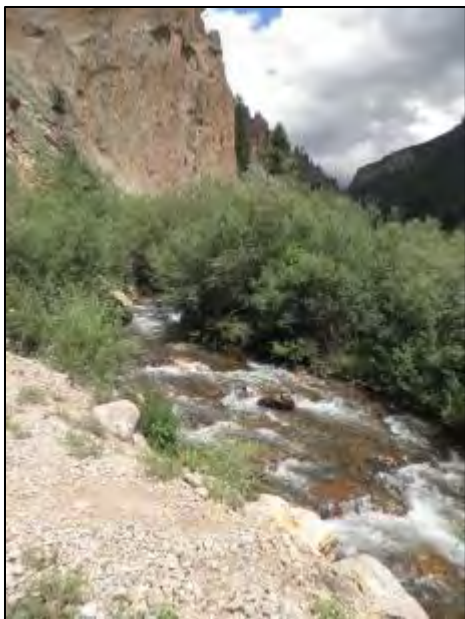
Photo 11. Impact Site No. 9, East Willow Creek. Impacts from road encroachment - looking upstream.

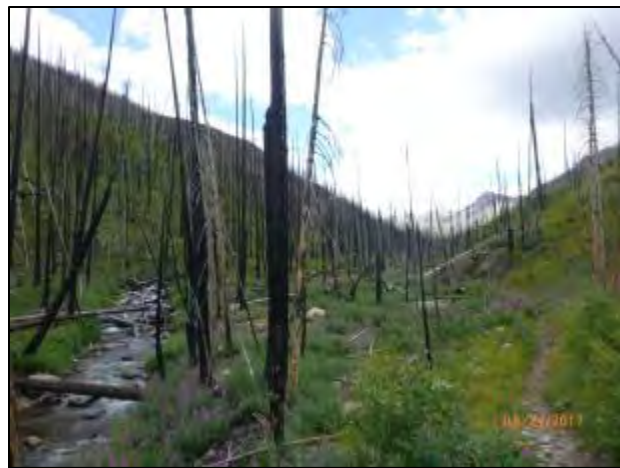
Photo 13. CNHP Site No. 37, Hope Creek. Impacted by West Fork Complex Fire in 2013.

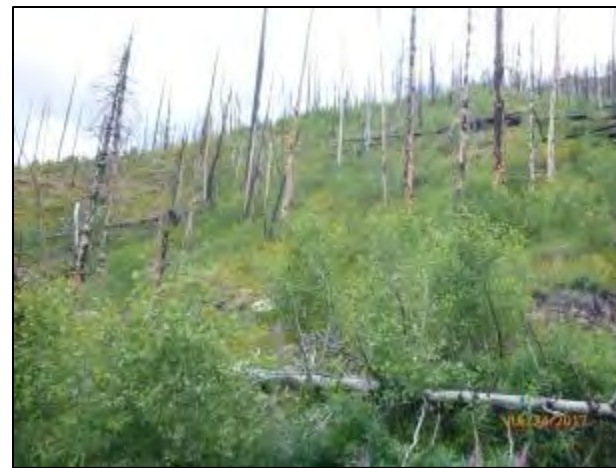
Photo 14. Dominant species after fire are mixture of grasses and forbs with aspen becoming more established.

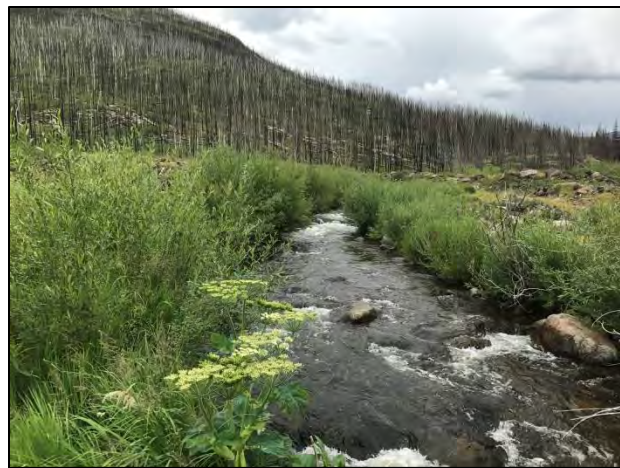
Photo 17. Impact Site No. 7, Little Squaw Creek. Impacted by West Fork Complex Fire in 2013.

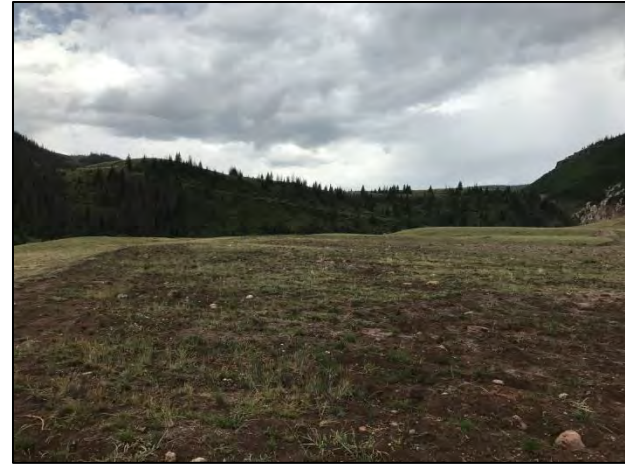
Photo 19. Impact Site No. 14, North Clear Creek.

Photo 20. Impacts include beetle kill, grazing, and road encroachment.

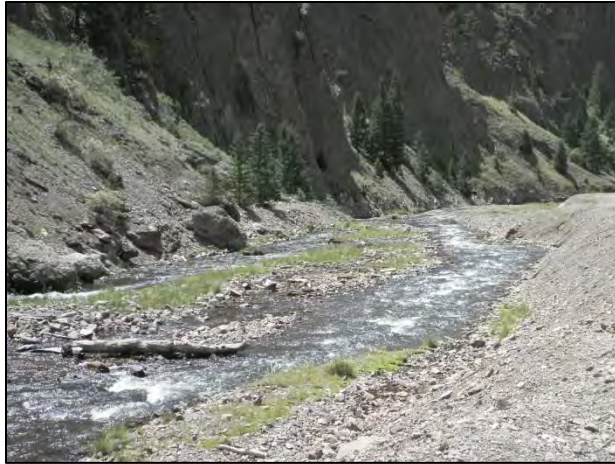
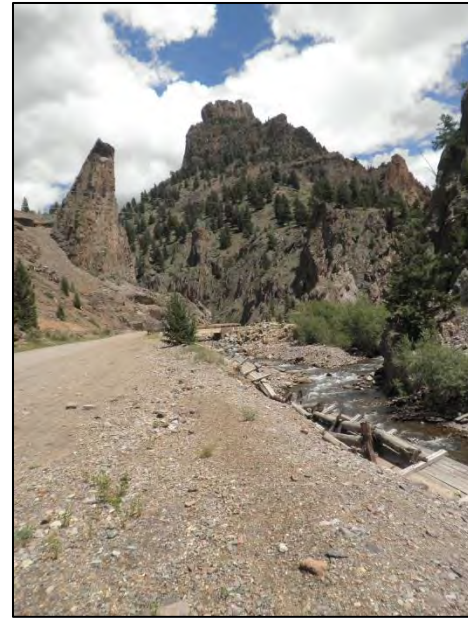
Photo 23. Impact Site No. 10, West Willow Creek.

Photo 24. West Willow Creek is highly impacted from mining.

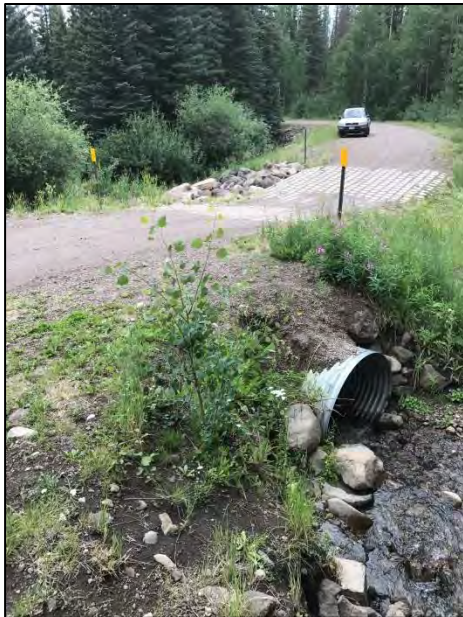
Photo 25. Impact Site No. A1, Fern Creek.

Photo 26. Impacts from road crossing and culvert.

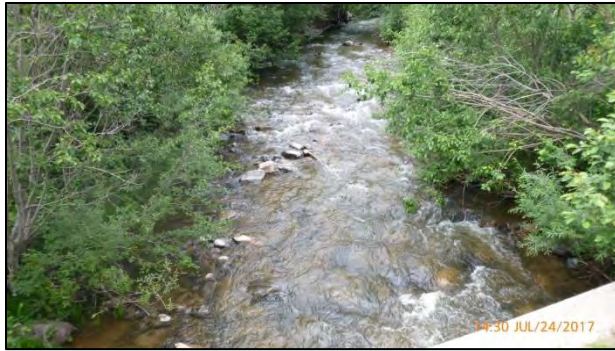
Photo 27. Impact Site No. A3, Pass Creek.

Photo 28. Road crossing at Pass Creek.

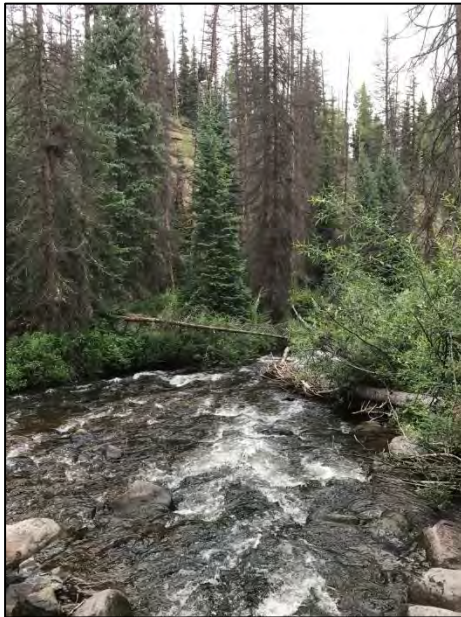
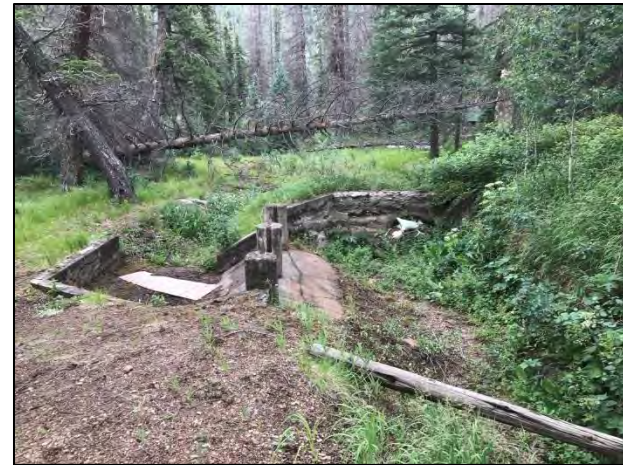
Photo 29. Impact Site No. A4, Squaw Creek.

Photo 30. Impacts from out-buildings.

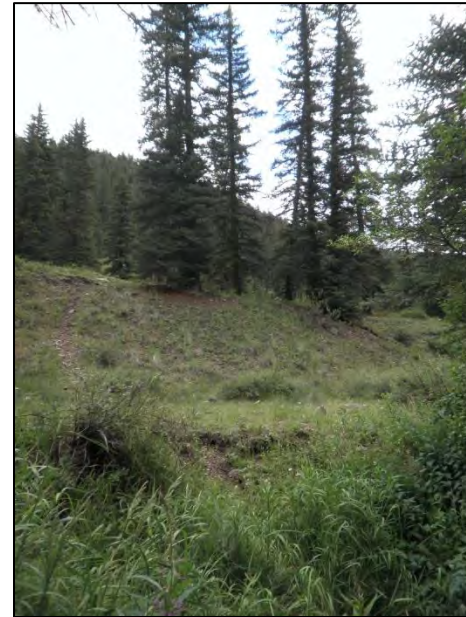
Photo 32. Dispersed recreation impacts.

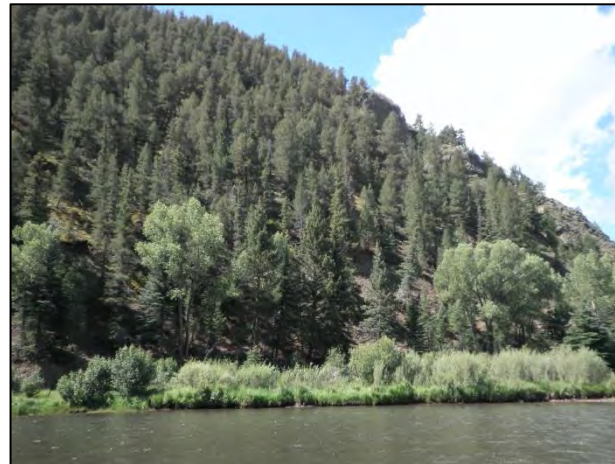
Photo 36. Photos taken within vicinity of site.

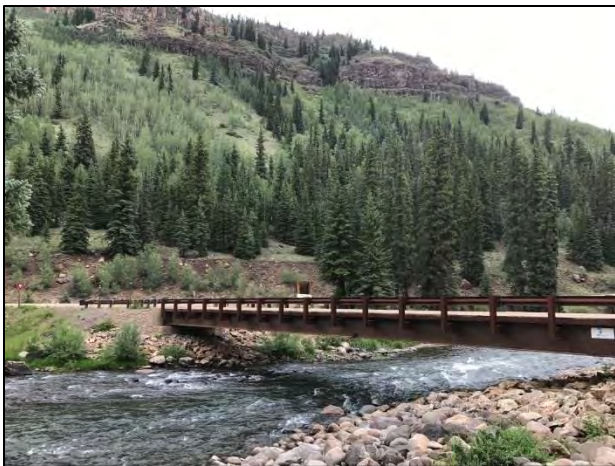
Photo 37. Impact Site No. A9, Rio Grande River. Site in coordination with water quality location.

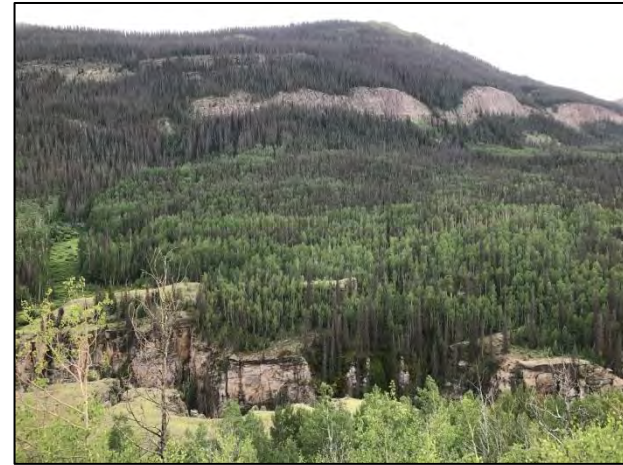
Photo 40. Photos taken within vicinity of site. Beetle kill impacts in the uplands.

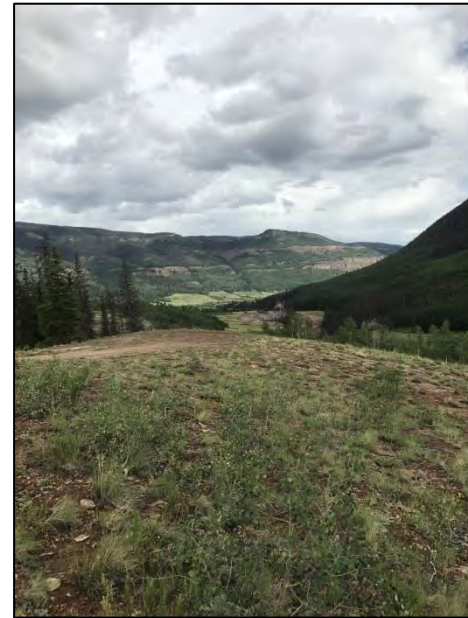
Photo 41. Impacts from dispersed recreation.
