WARD LAKE DAM OUTLET REHABILITATION  
Construction File No. C-0888A  
Dam ID No. 400533

Final Construction Report  
December 22, 2020

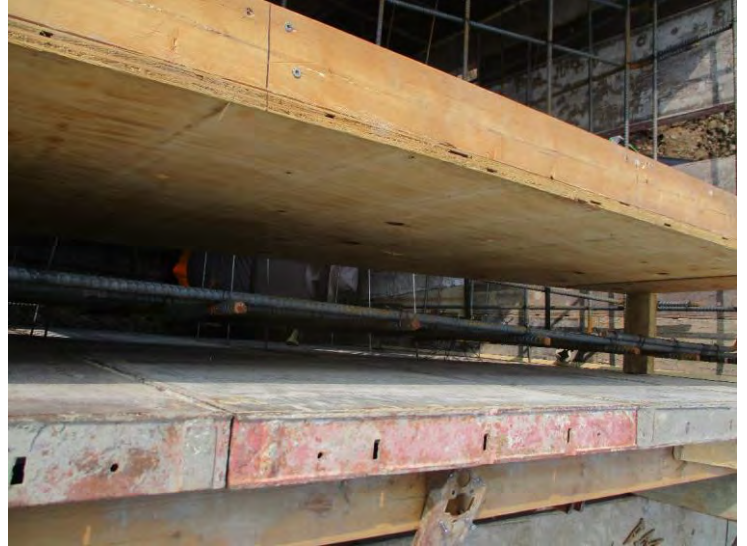
Photo 6. View into right sidewall.

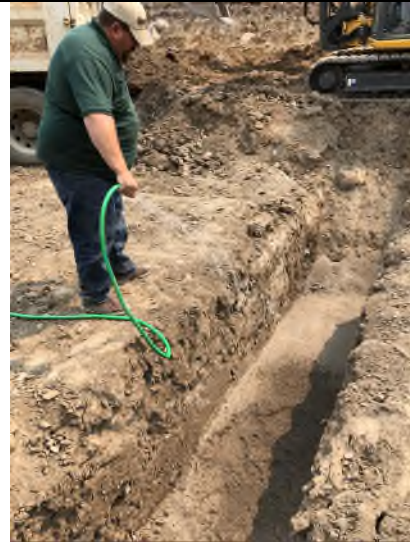
Photo 2. Moisture conditioning filter sand for Test #2. Note color variation between wet and dry sand.

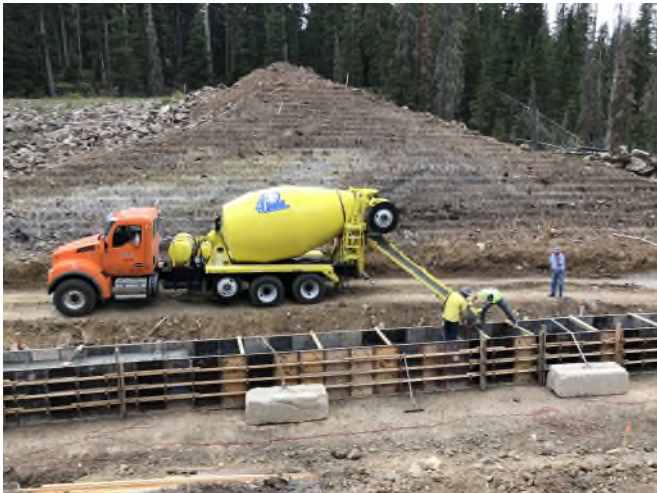
Photo 3. Concrete placement of truck 2 of 3 on August 28, 2020.

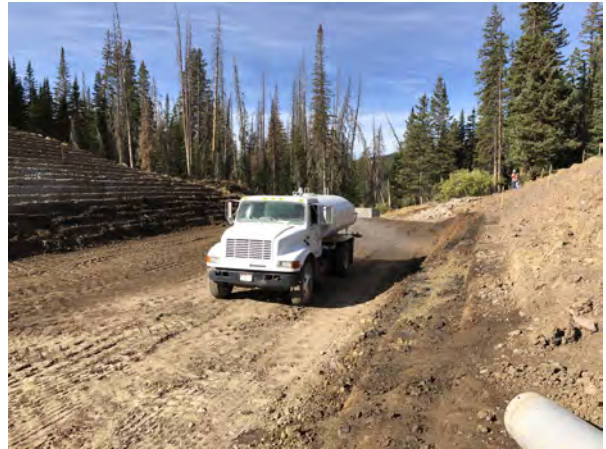
Photo 2. View looking south (downstream) at water truck moisture conditioning the subgrade prior to material placement.

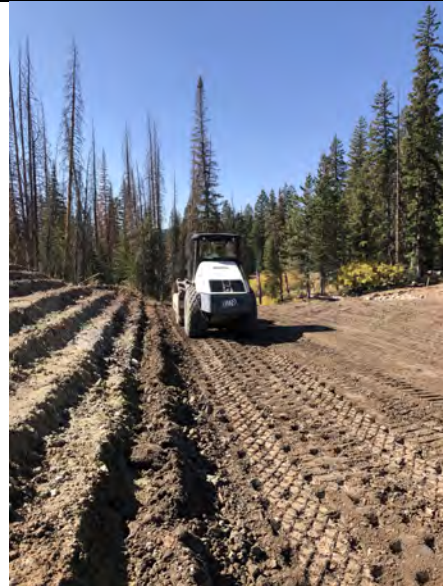
Photo 2. View looking south (downstream) at single drum sheepsfoot compactor during lift compaction on the east side of the breach.

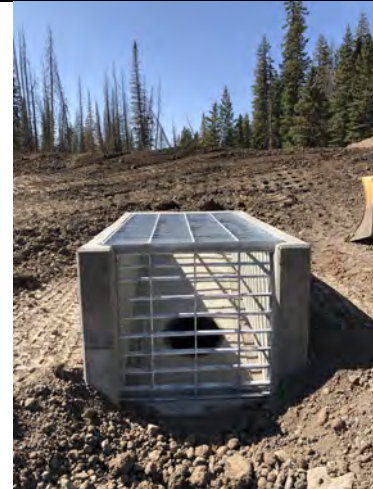
Photo 2. View looking south (downstream) at inlet structure with trash rack installed. Fresno gate was delivered to site that date.
