ESTES VALLEY WATERSHED COALITION

**WATERSHED GRANT ESTES VALLEY WC
MAINTENANCE SVCS 13 PROJECTS**

FINAL REPORT

**OCTOBER 19, 2022
GRANT AMOUNT: \$18,684.25**

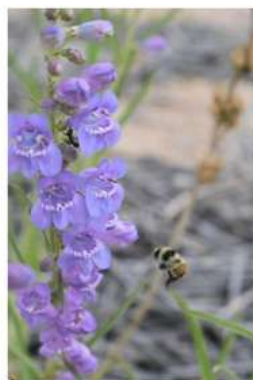
Lower Fish Creek R1: Pollinators are utilizing seeded revegetation.

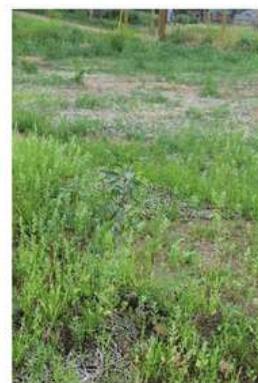
Elkhorn: Up-Stream portion of project showing cottonwood establishment
