October 28, 2024

**Re: FINAL REPORT**  
**Lower Beaver Brook Dam, Upper Beaver Brook Outlet Works and SCADA System**  
**CT2021-3115, WSRF Grant POGG1 2021-2565**

Attachments: pdf photos

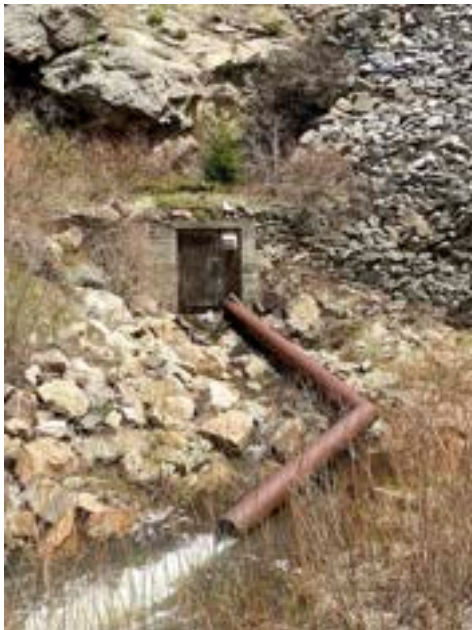
Outlet Pipe from man tunnel

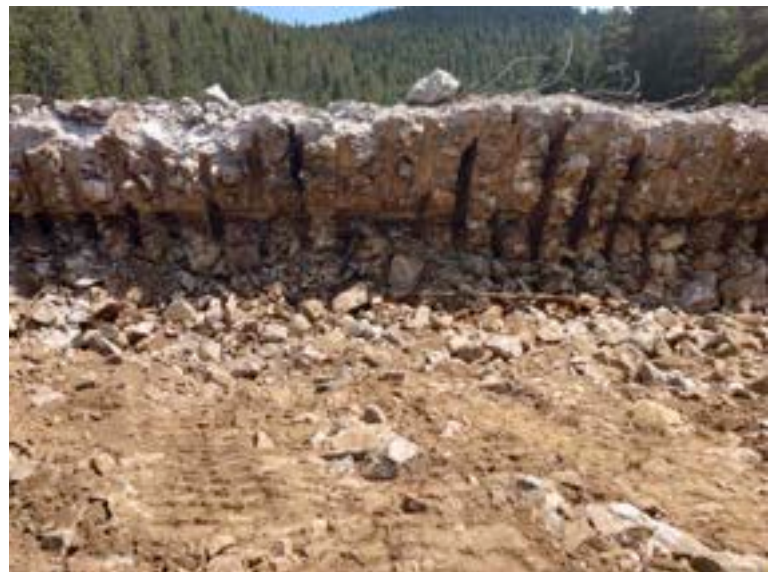
Wood timbers and concrete from 1903 construction

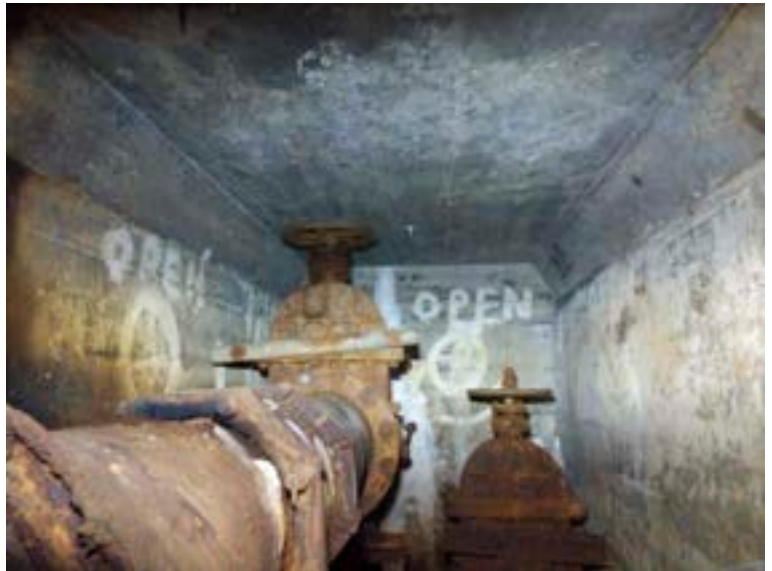
Original outlet and WTP plant pipe in man tunnel

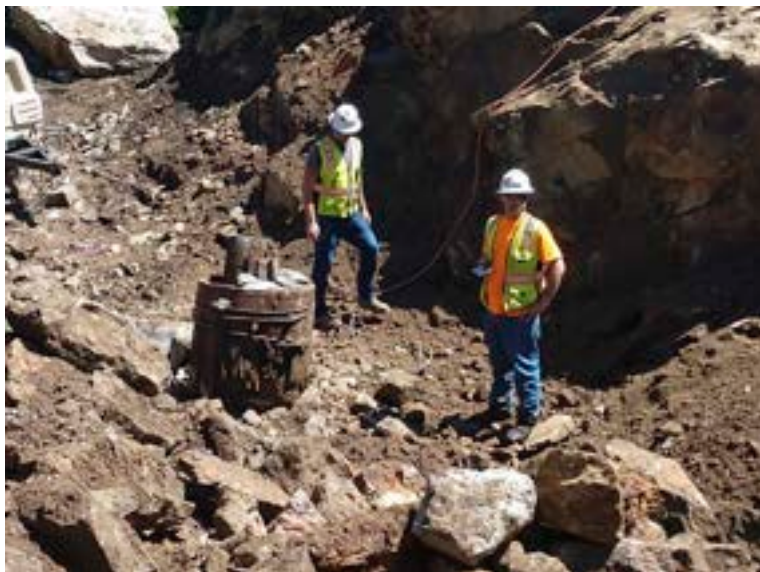
Original 1903 reservoir outlet, pipe with cement in a barrel

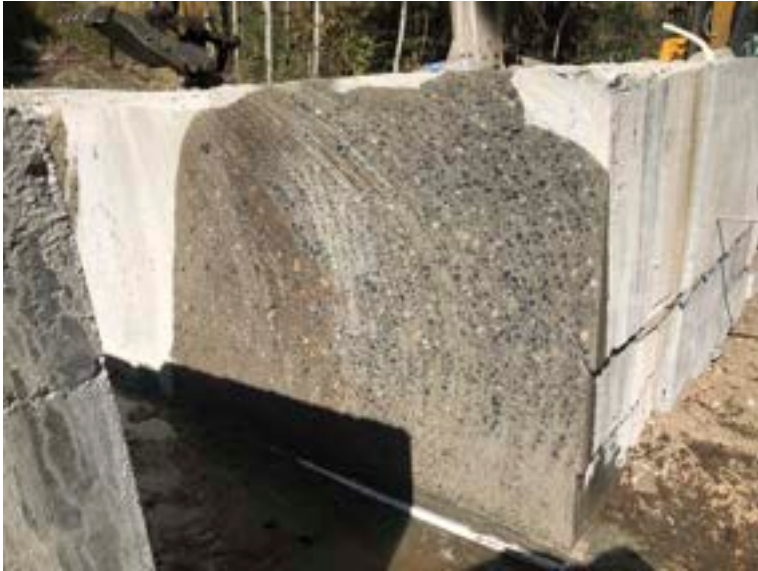
Test patch is cut to be evaluated by engineers, it was good to go

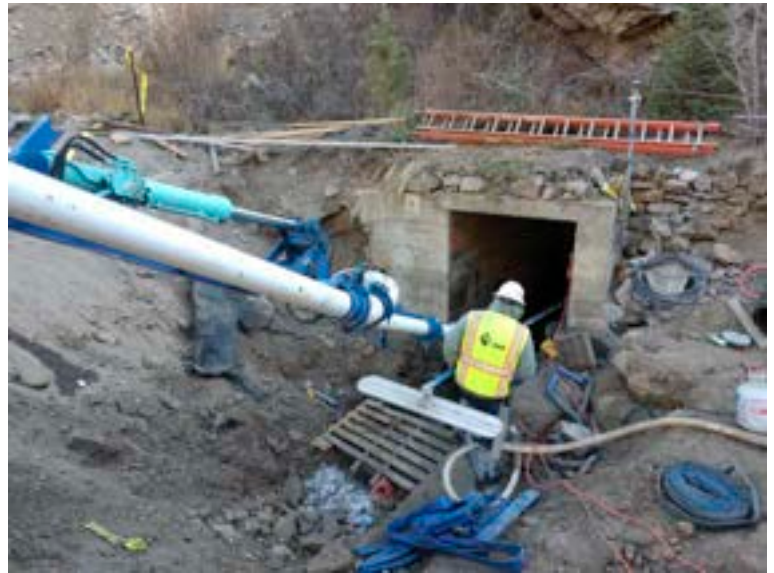
Working to fill and seal the man tunnel

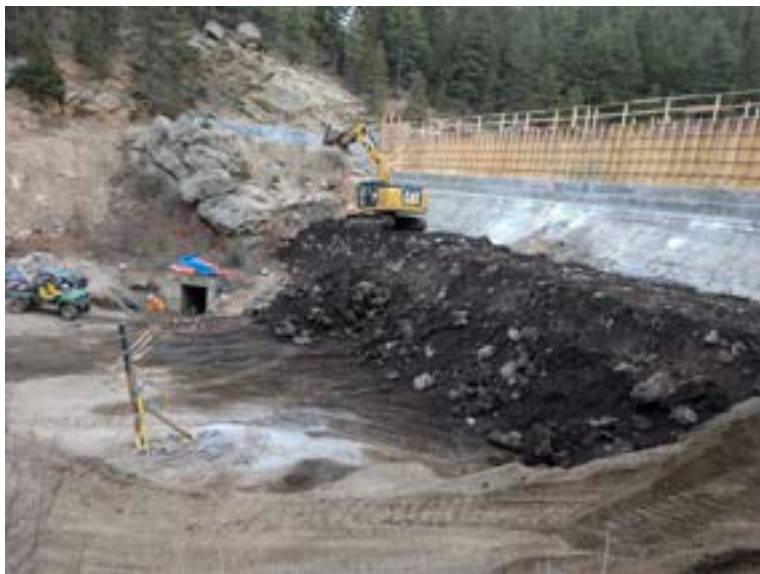
Bed is laid on downstream face for rip rap to be placed

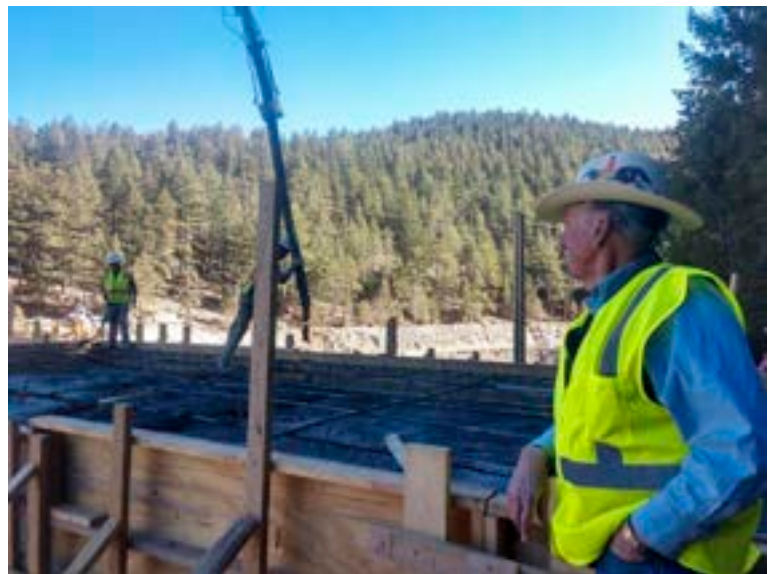
Dean Snyder watching conventional concrete final levels being placed

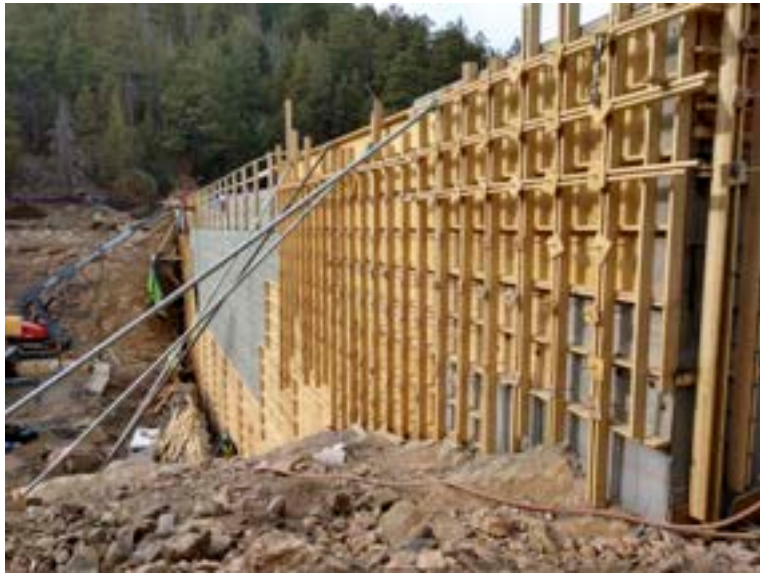
Upstream forms start to come down

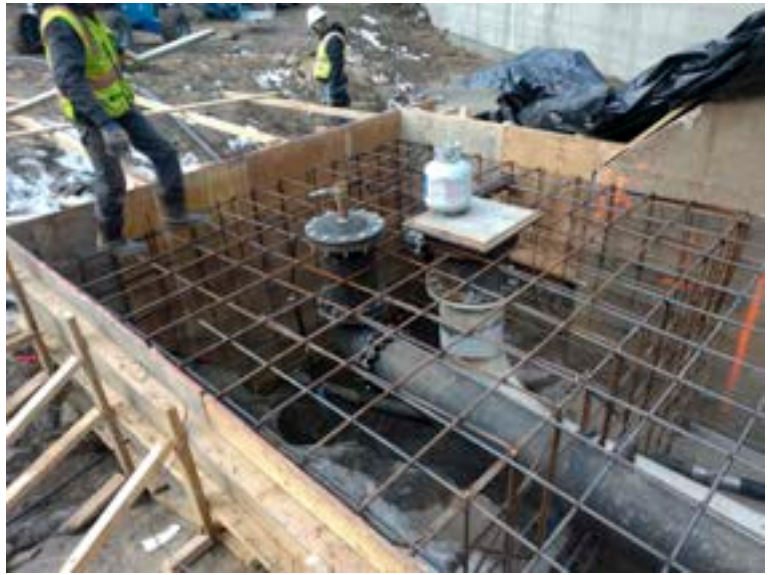
Outlet base getting ready to be poured

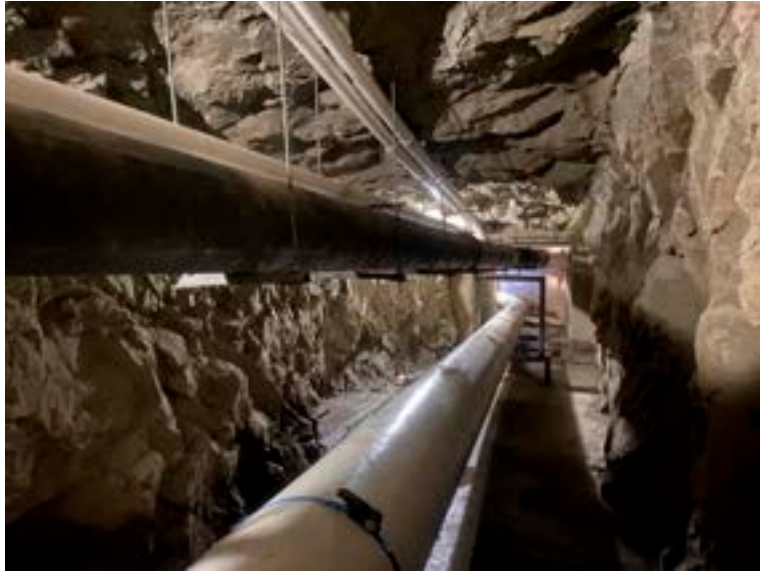
New outlet pipes in man tunnel

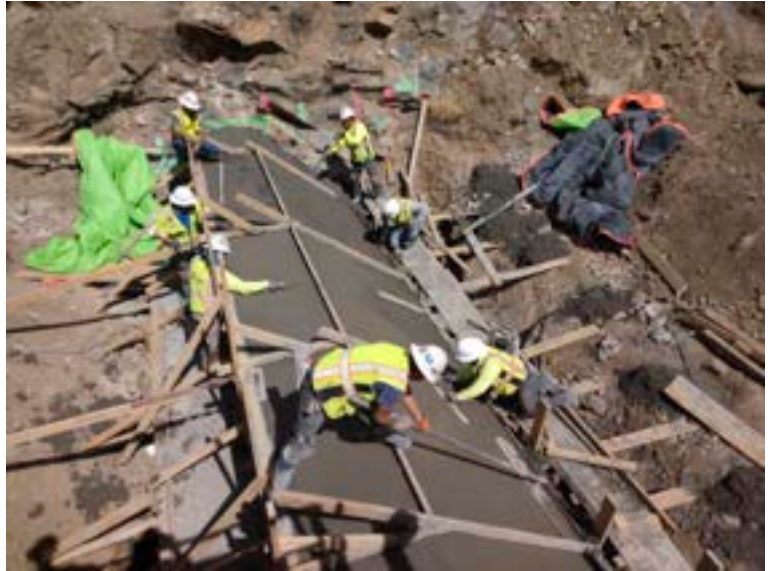
New spillway being finished

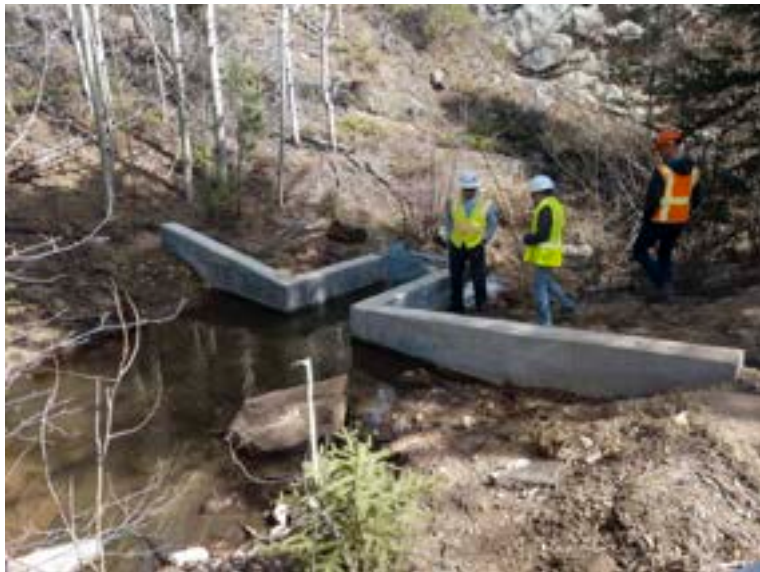
New Beaver Brook confluence flume

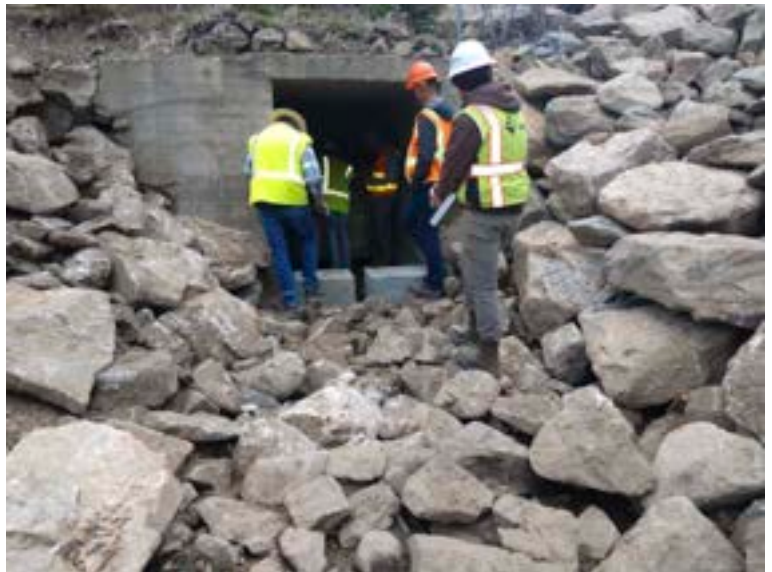
Man tunnel being inspected

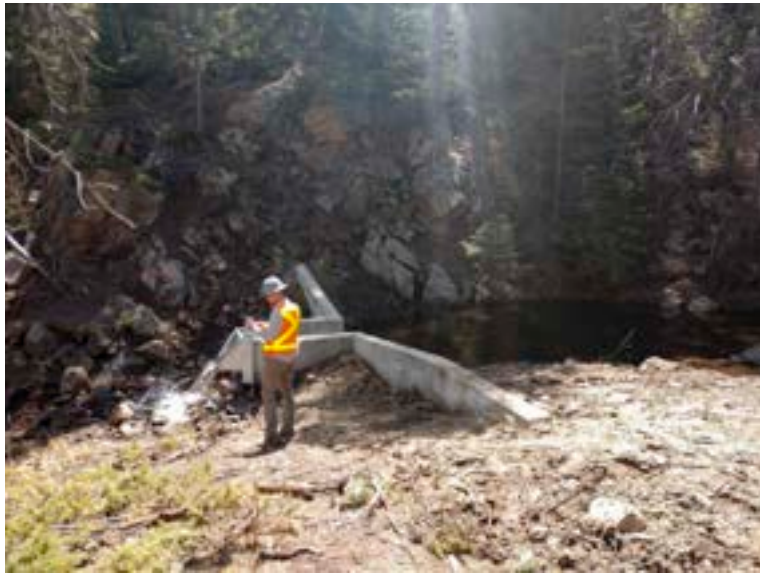
New Lower Beaver Brook inlet flume

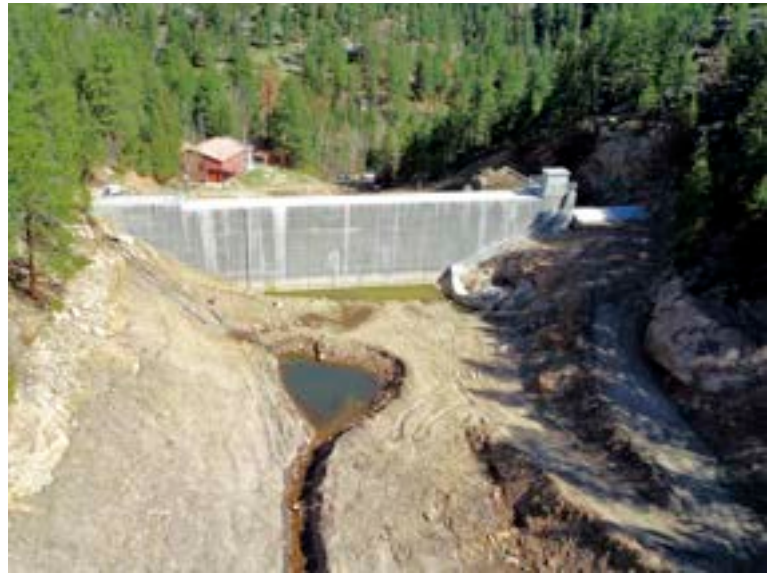
New Lower Beaver Brook dam before first fill

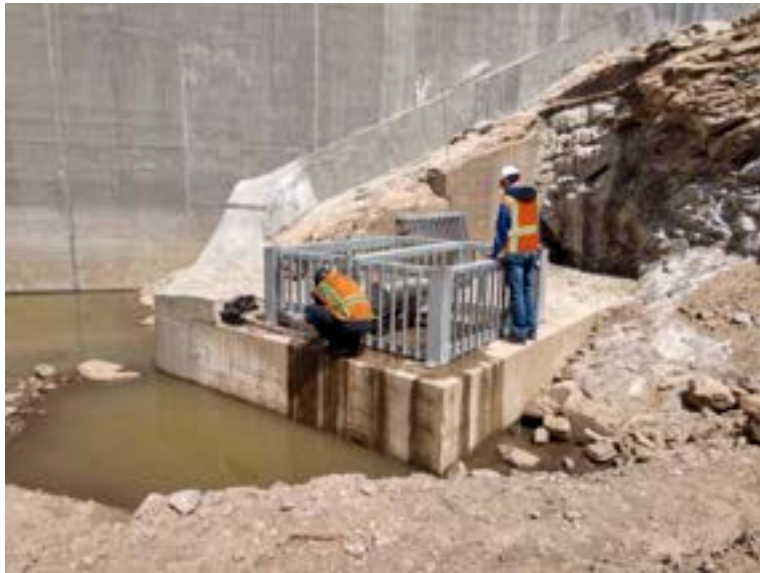
New trash rack over outlet valves

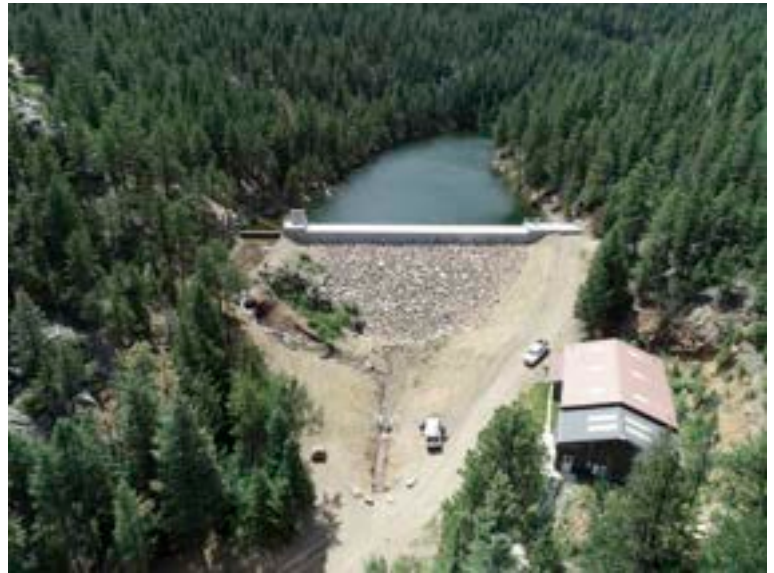
Lower Beaver Brook dam, outlet flume being worked on by HydroLogik

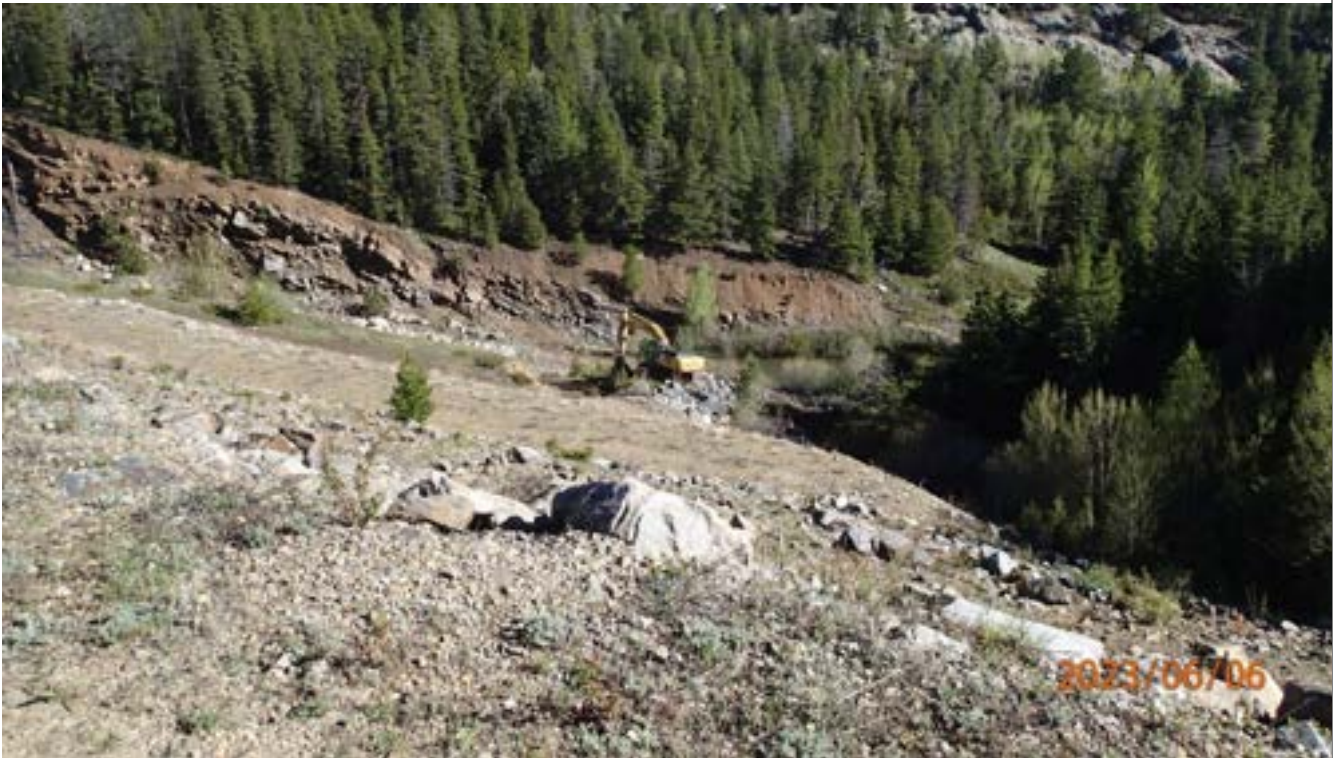
Photo 1: Excavator staged at dam toe

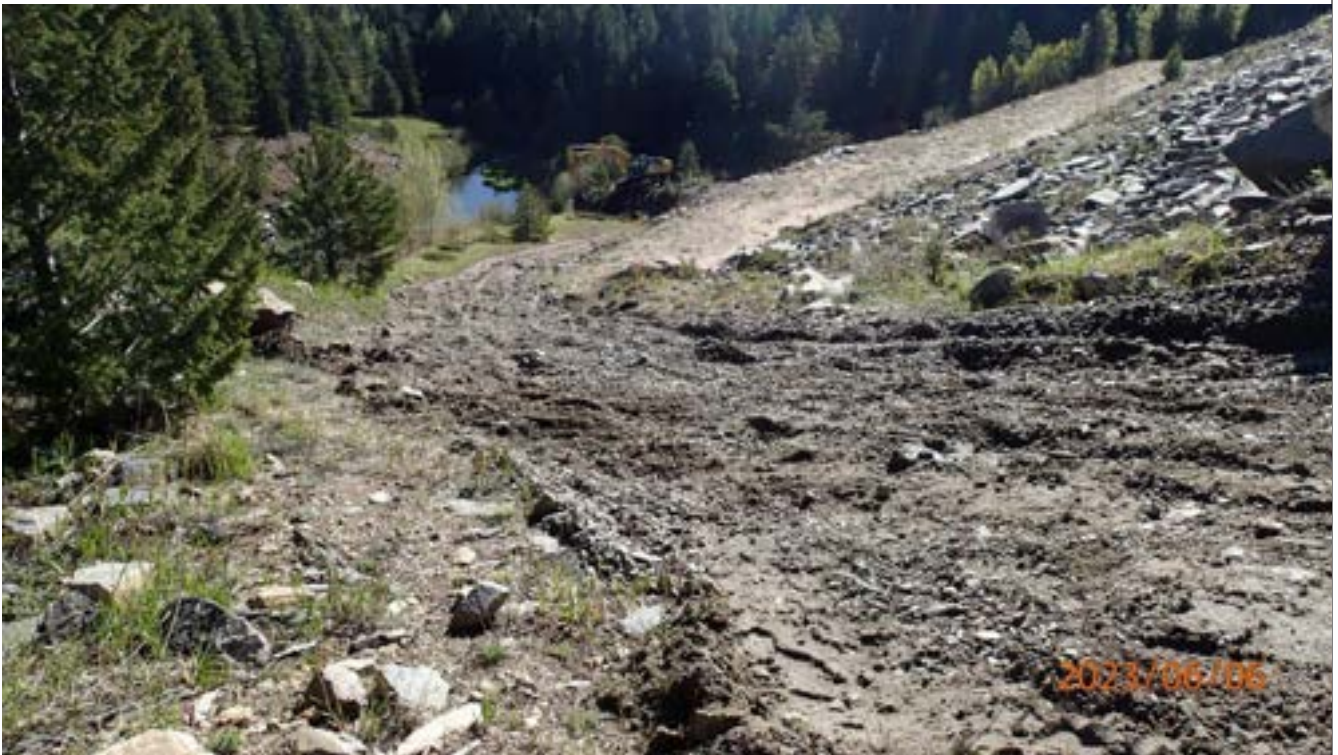
Photo 2: Fill material placed along access road to provide more even travel surface.

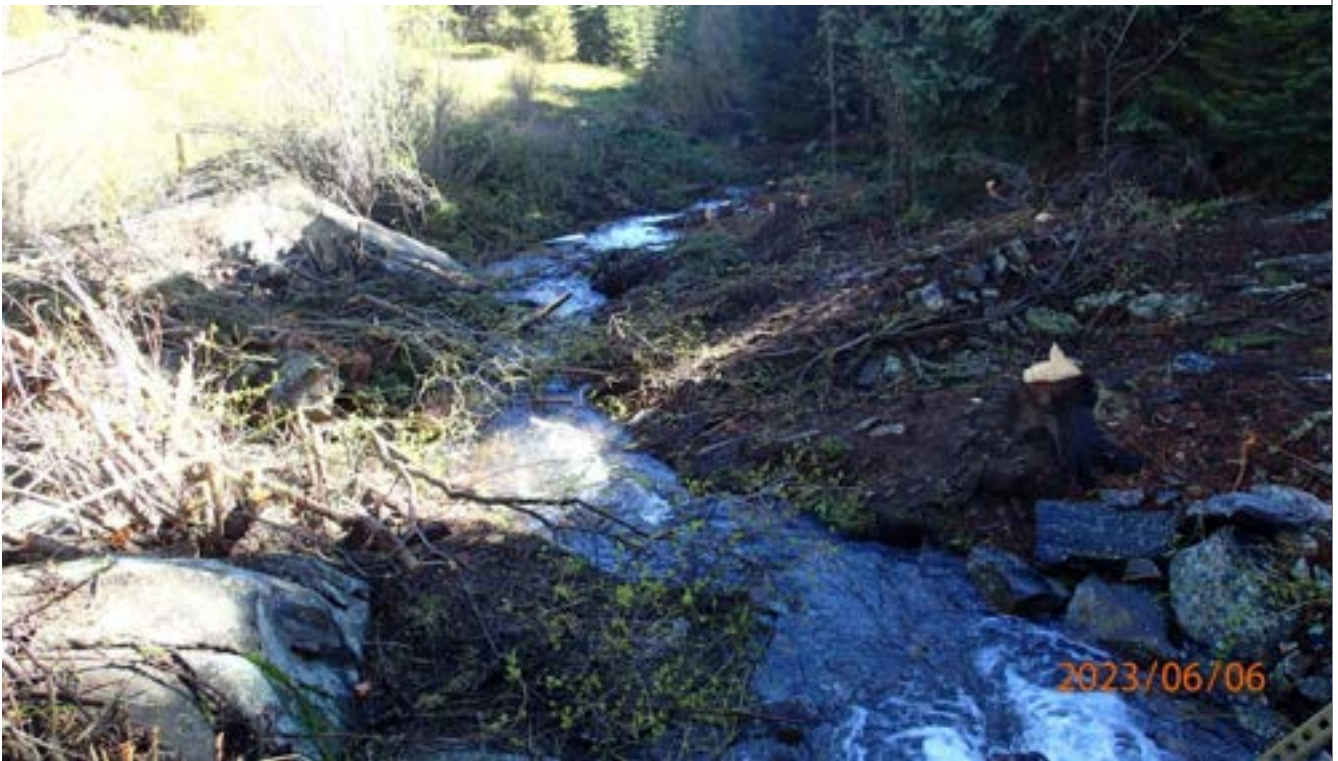
Photo 3: Completed clearing / grubbing near outlet.

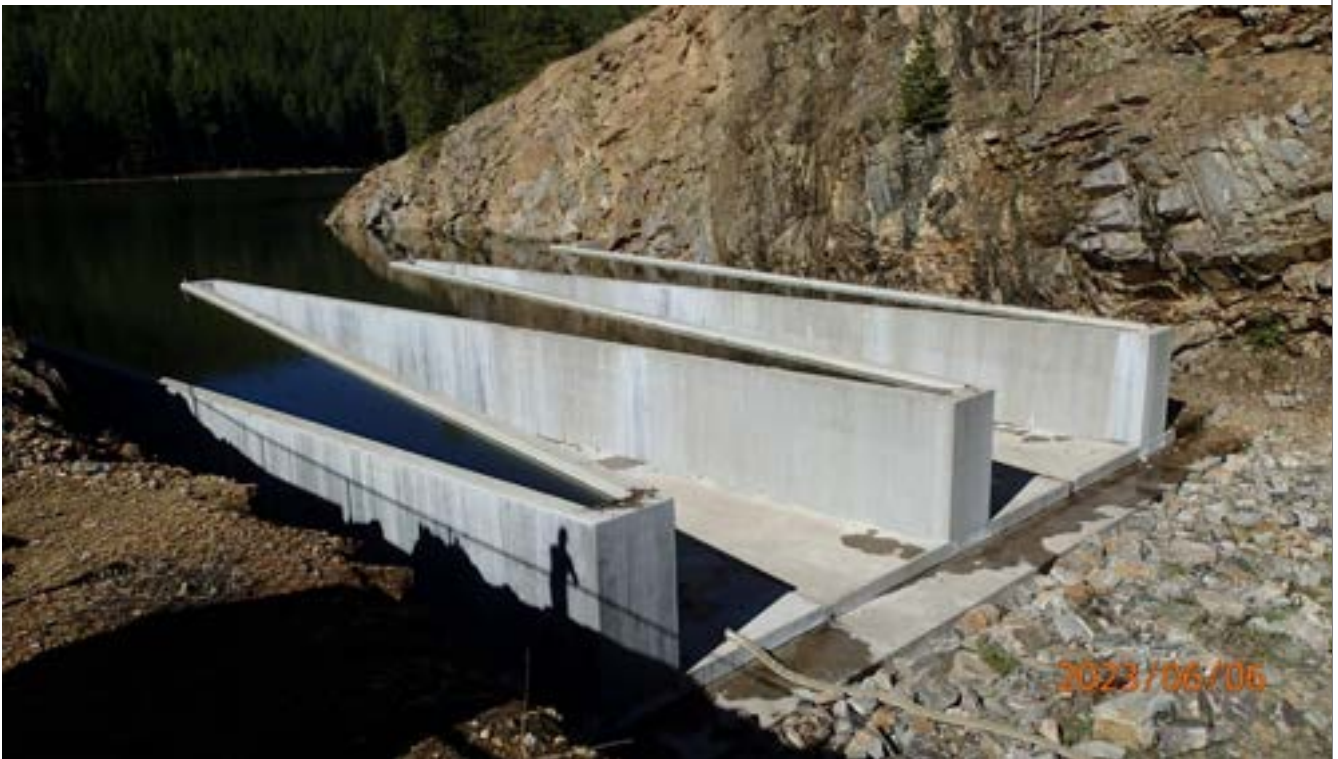
Photo 4: Reservoir level has been draw down below spillway crest elevation due to operation of the outlet works.

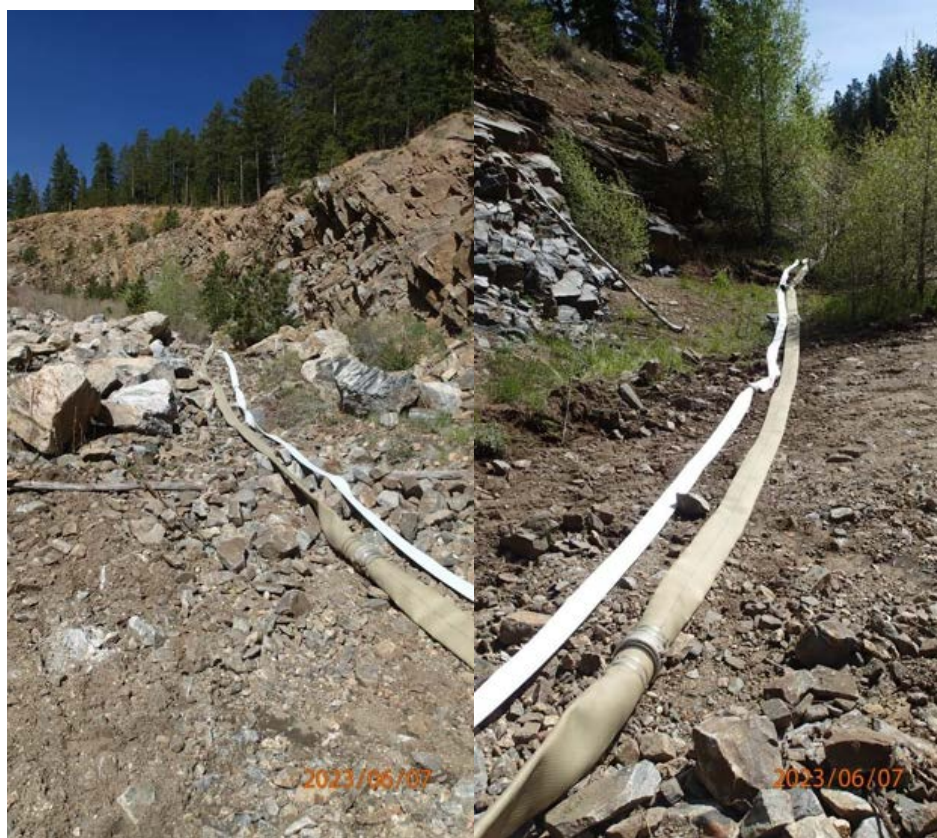
Photo 5: Bypass hoses setup along spillway.

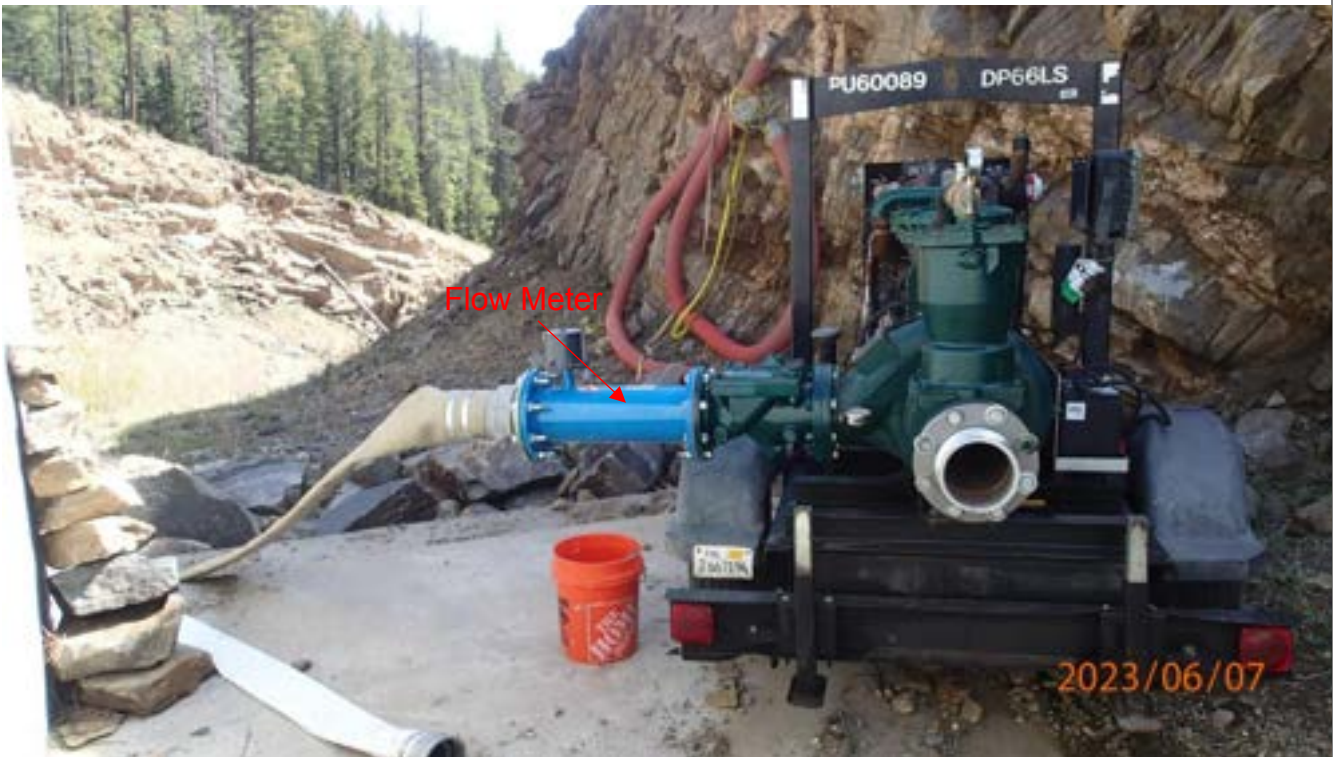
Photo 6: 6-inch trash pump setup with inline flow meter.

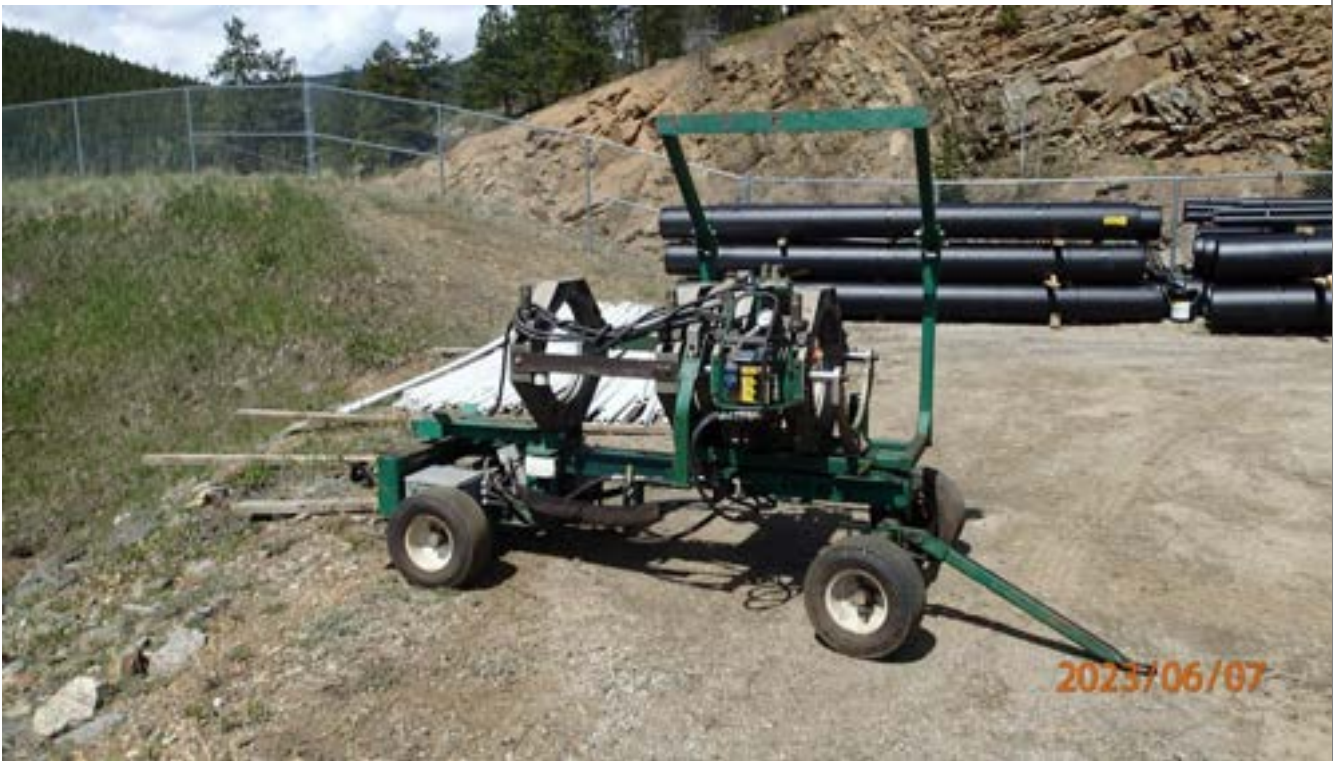
Photo 7: McElroy 18" HDPE fusion machine staged on-site.

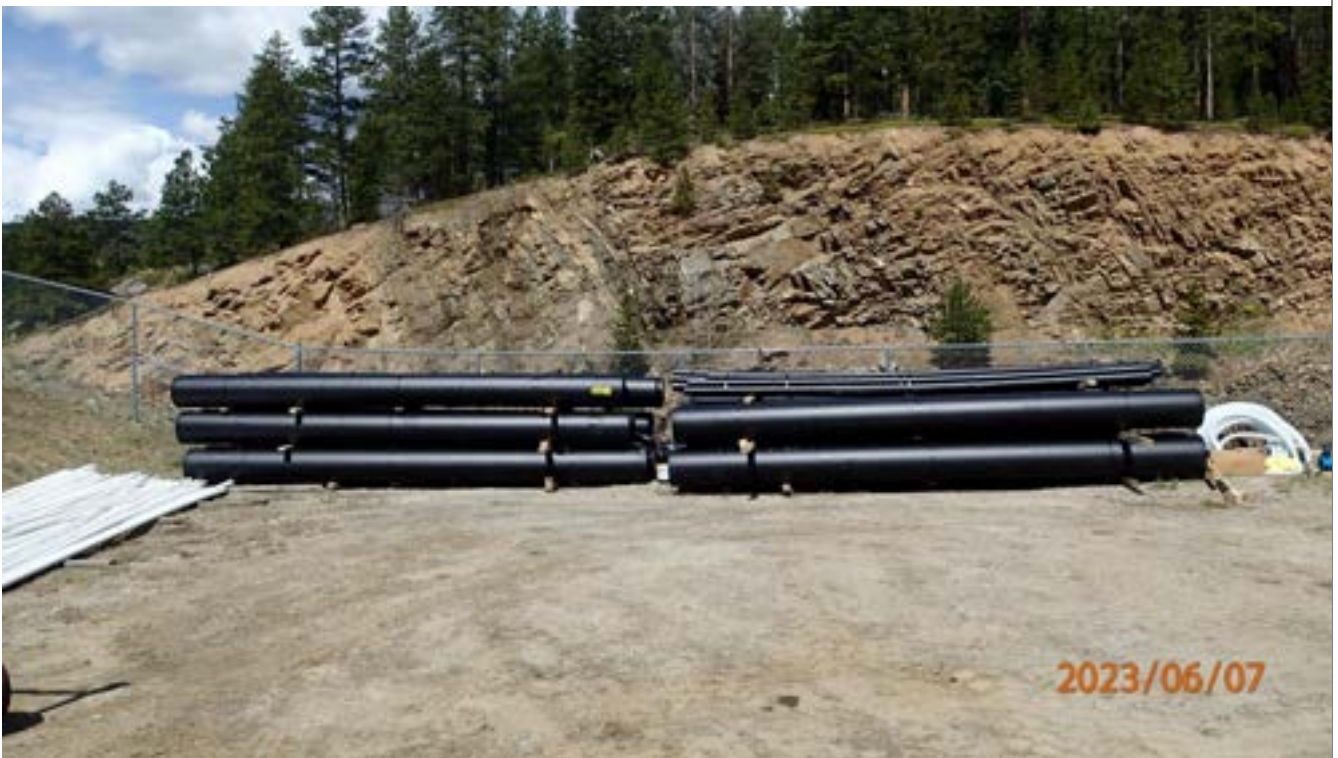
Photo 8: HDPE staged at dam crest.

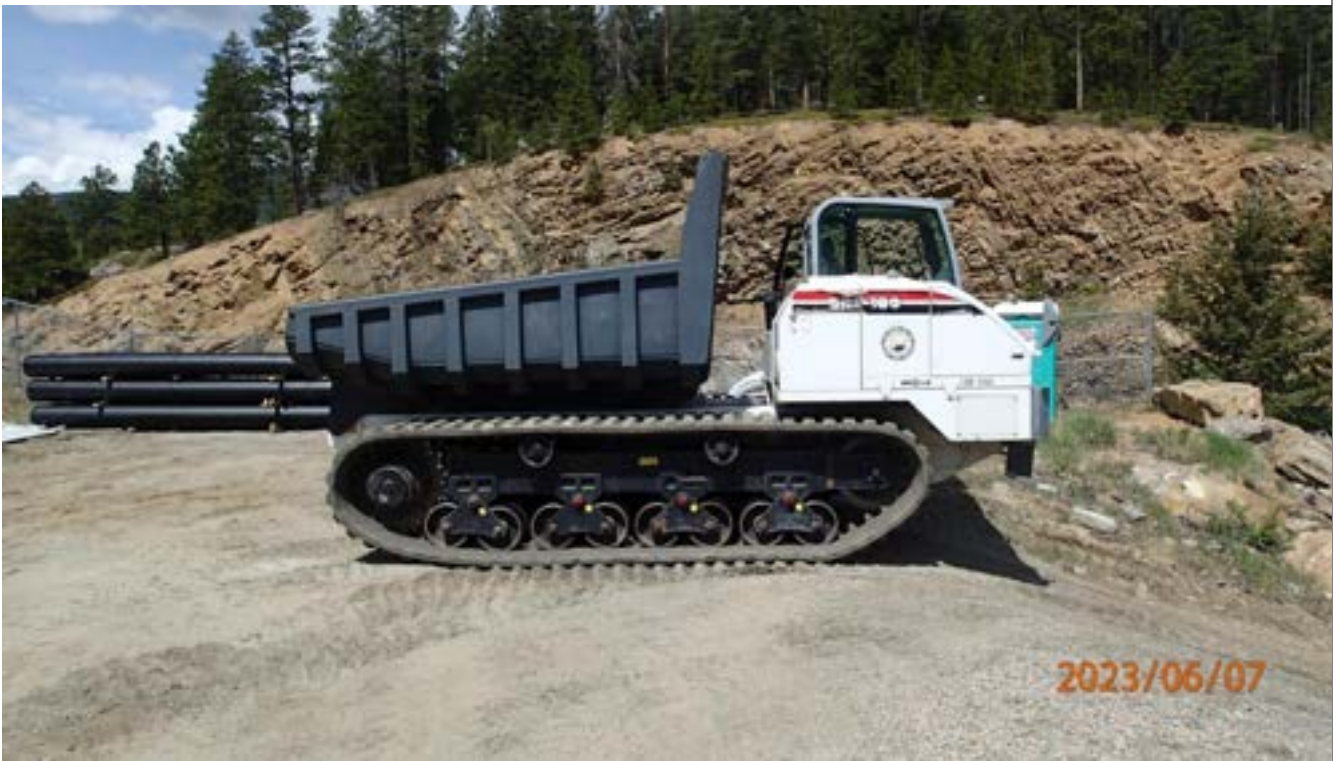
Photo 9: Crawler-carrier delivered on-site for equipment transport between dam crest and toe.

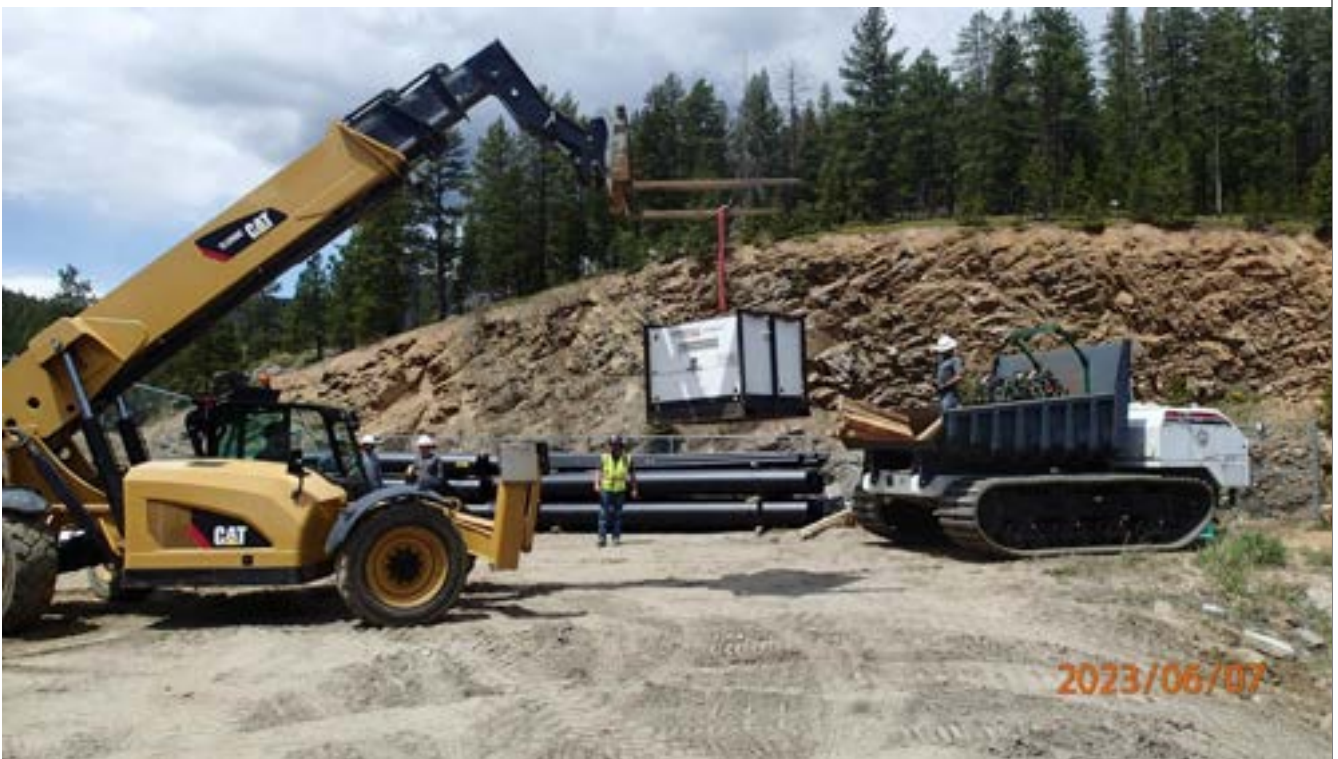
Photo 10: Loading crawler-carrier with HDPE fusion equipment.

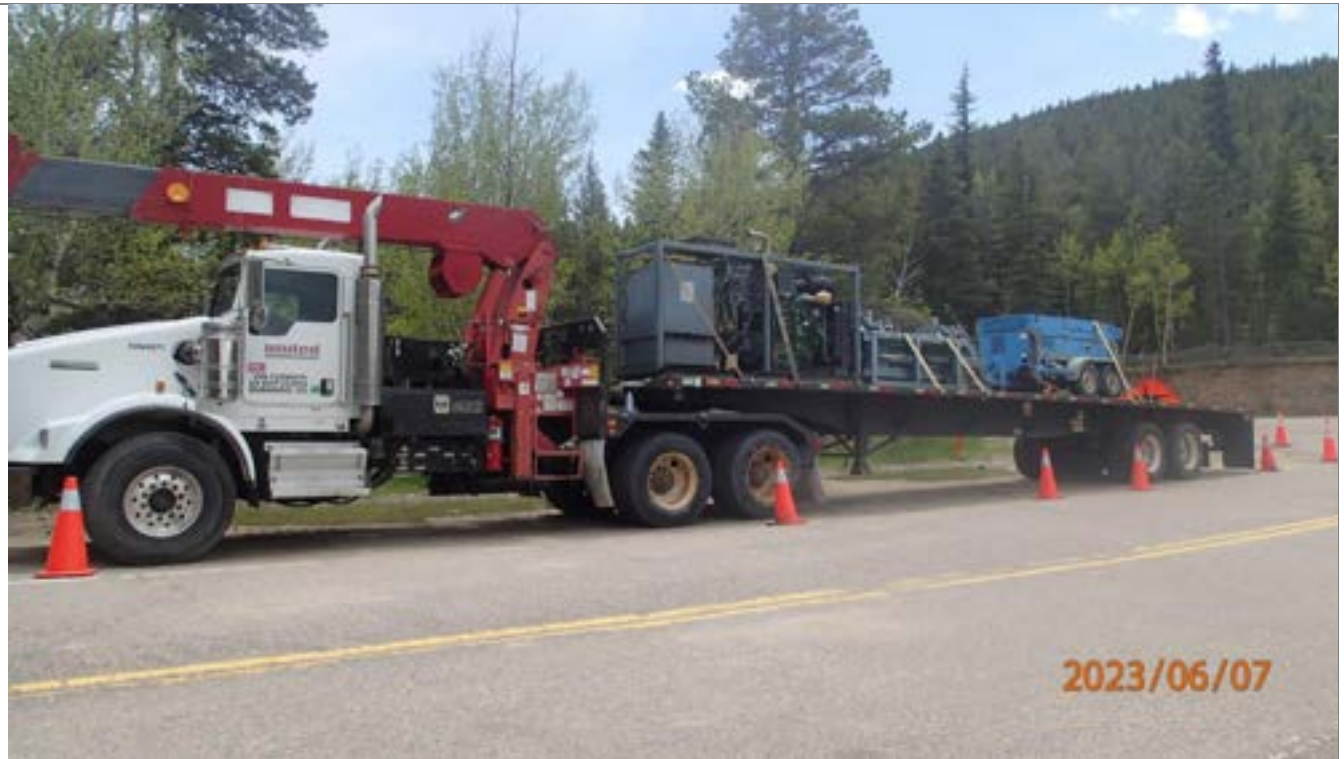
Photo 11: HDPE pushing machine staged near access gate.

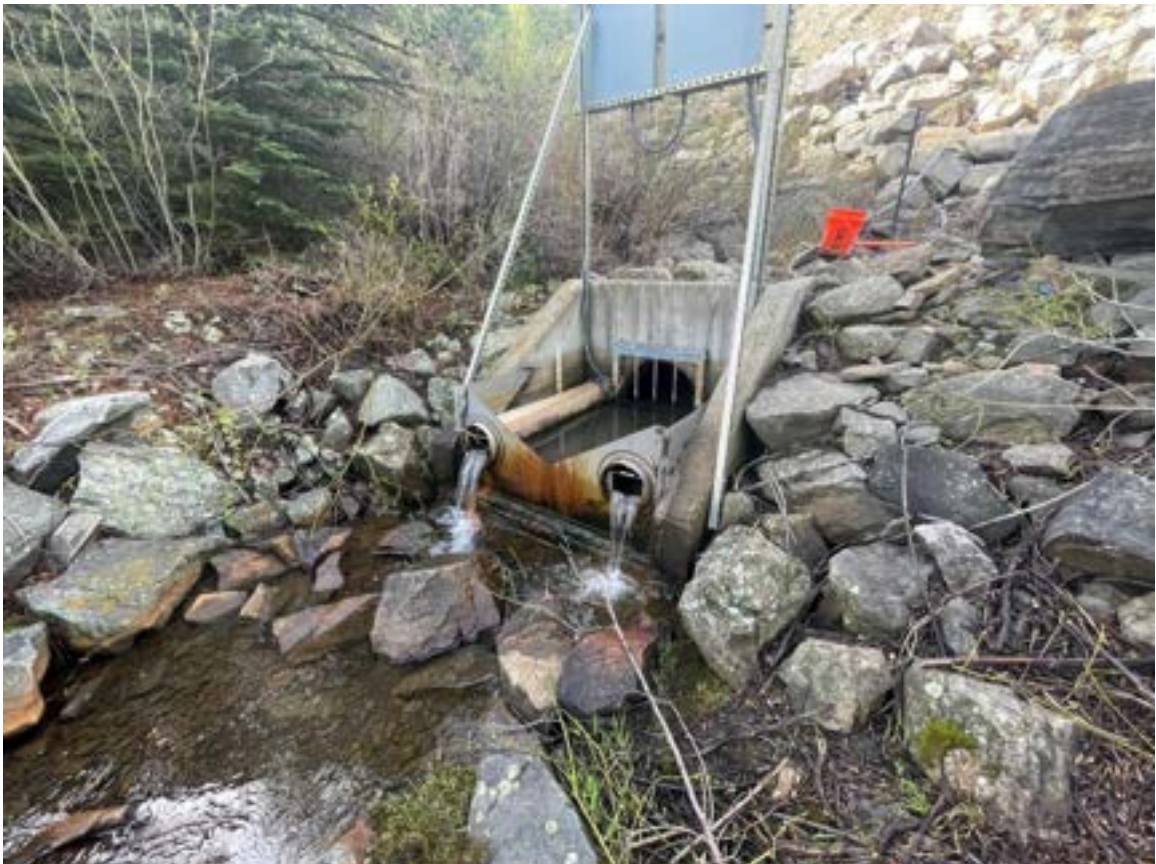
Photo 12: Outlet closed in preparation for conduit jetting / sliplining operations.

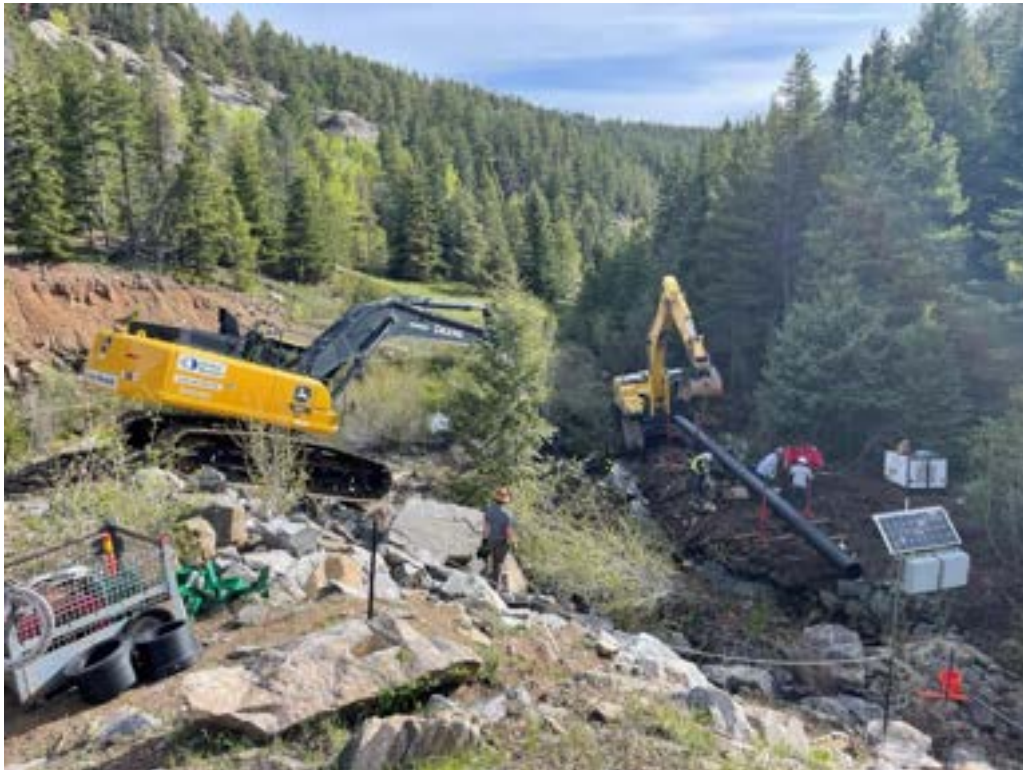
Photo 13: Site layout for HDPE fusion operations. Excavator on left is used to transport HDPE sections to the work area, excavator on right is used to pull HDPE string back as sections are fused.

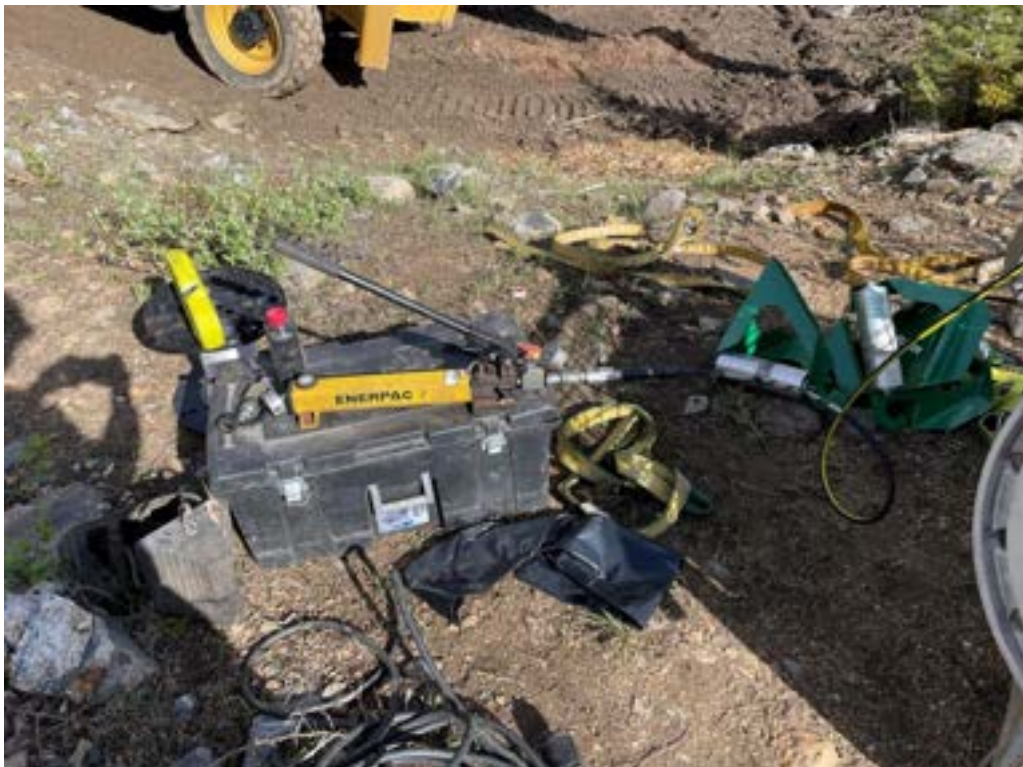
Photo 14: Hydraulic press used to perform reverse back-bend test on HDPE test weld.

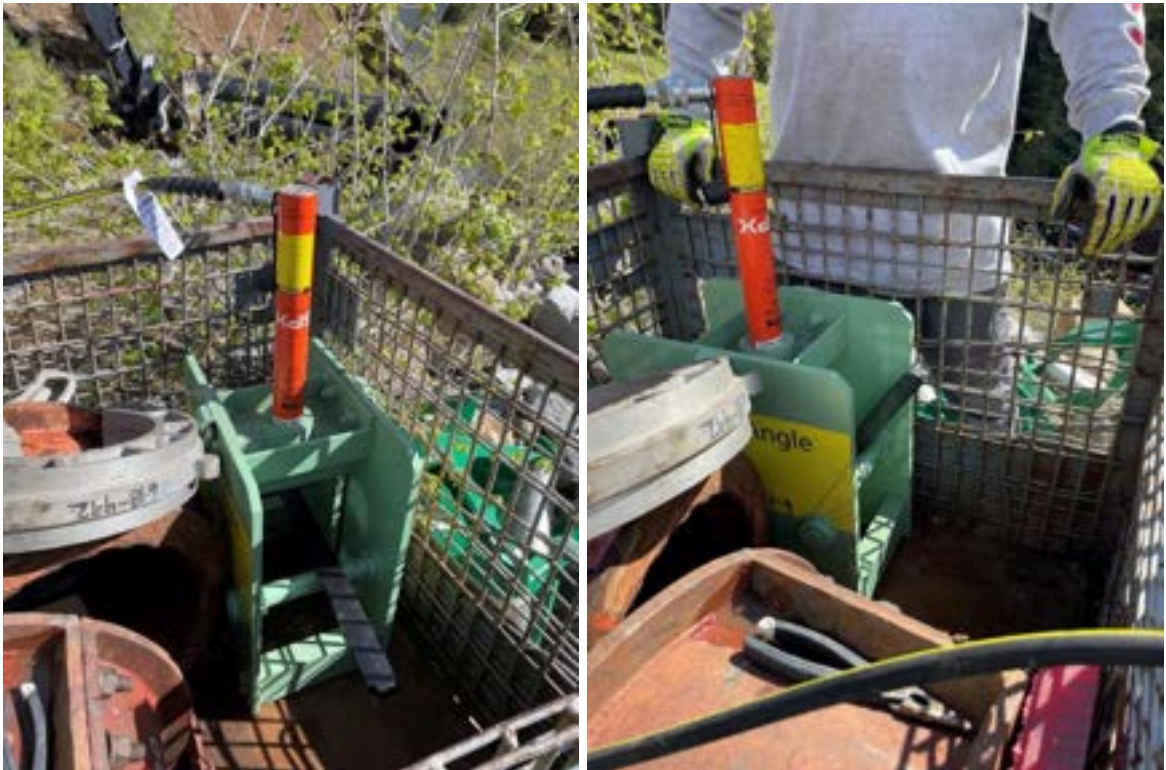
Photos 15 & 16: Performing reverse back bend test. Hydraulic press used to bend HDPE test section to 120°.
