October 28, 2024

**Re: FINAL REPORT**  
**Lower Beaver Brook Dam, Upper Beaver Brook Outlet Works and SCADA System**  
**CT2021-3115, WSRF Grant POGG1 2021-2565**

Attachments: pdf photos

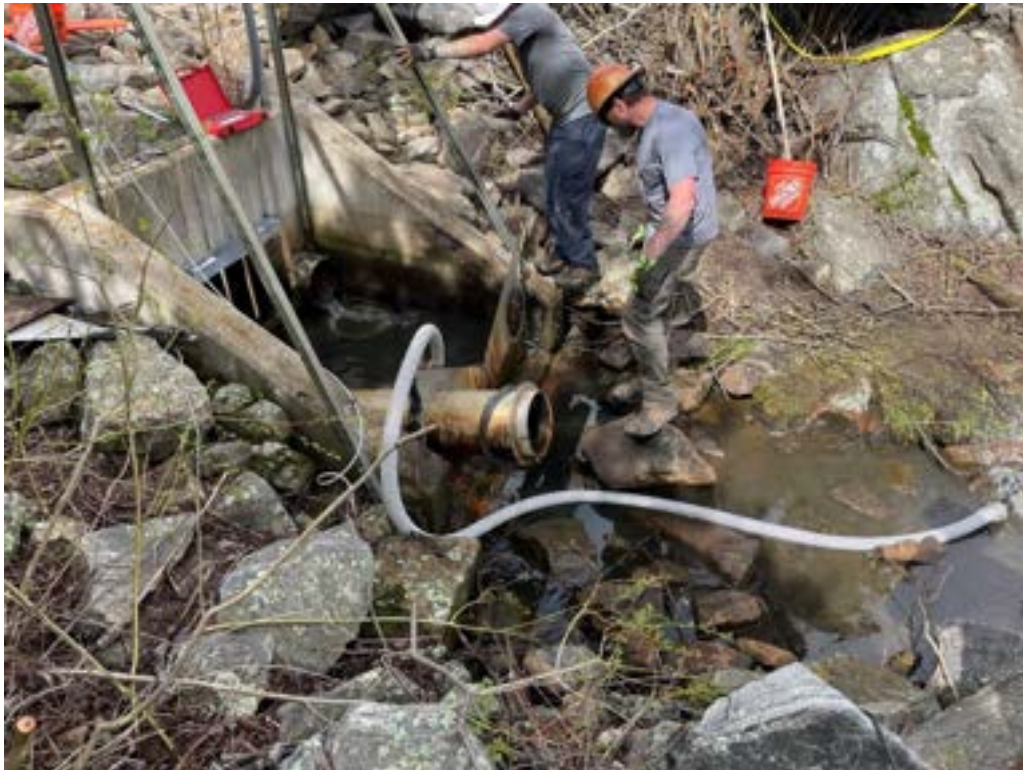
Photo 18: MDS deconstructing v-notch weir to drain outlet structure and facilitate conduit access.

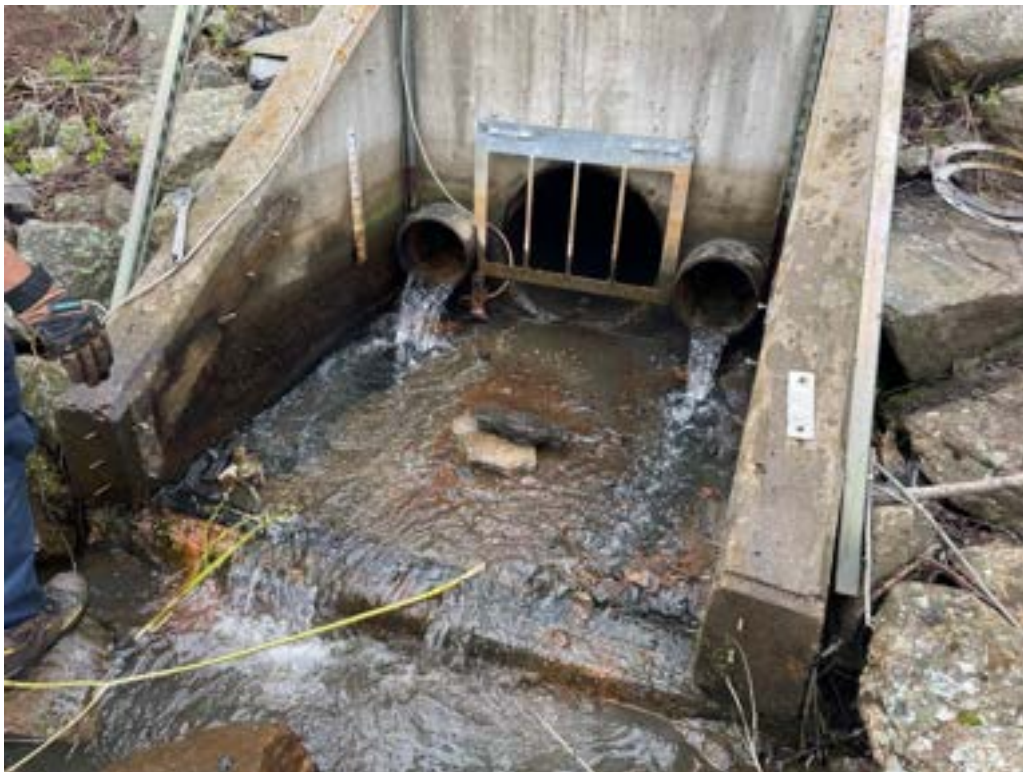
Photo 19: V-notch weir removed at outlet.

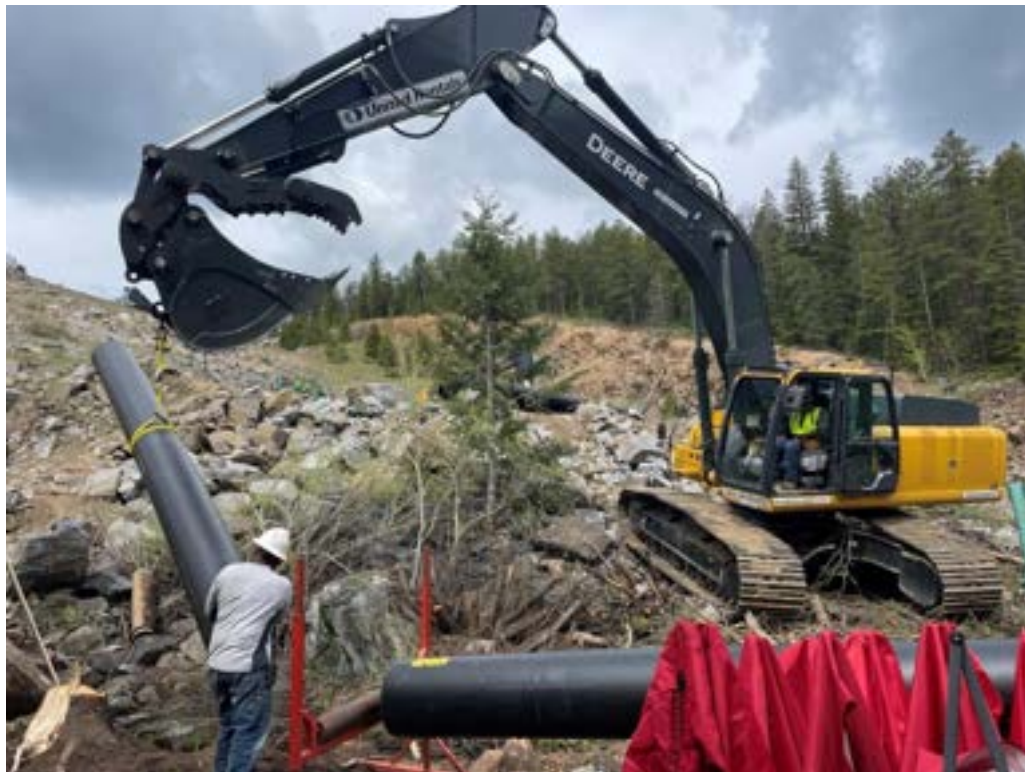
Photo 20: Excavator transferring HDPE section to prep for fusion.

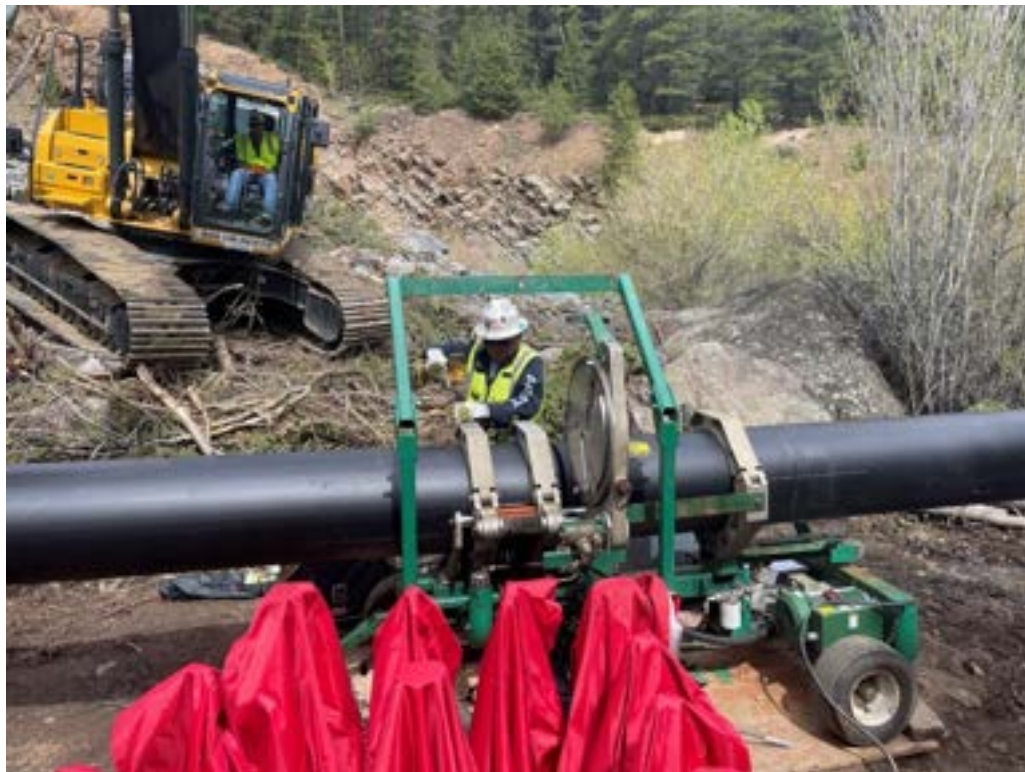
Photo 21: HDPE sections in place for surfacing/fusion

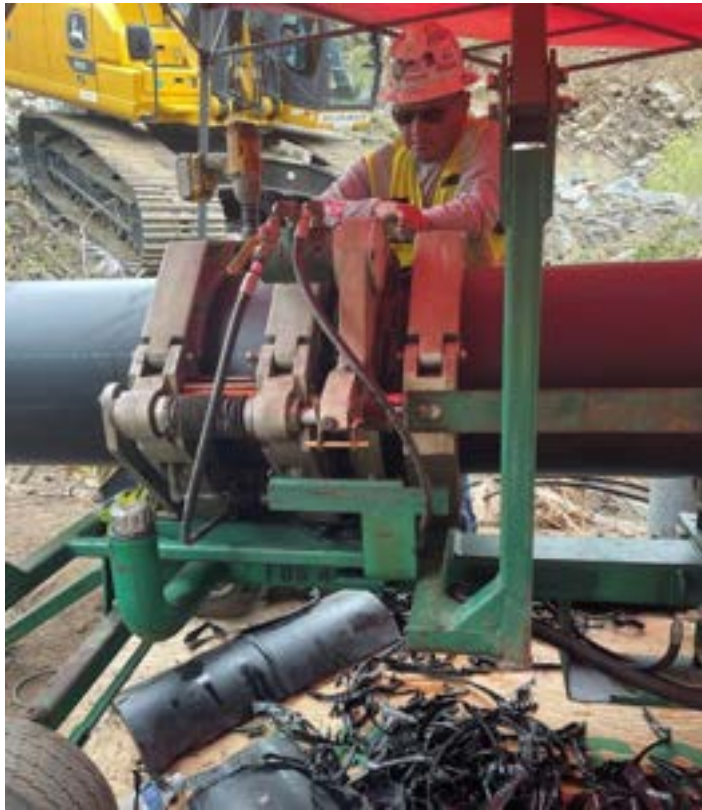
Photo 21: Pipe surfacing and welding performed using McElroy 18" HDPE Fusion Machine.

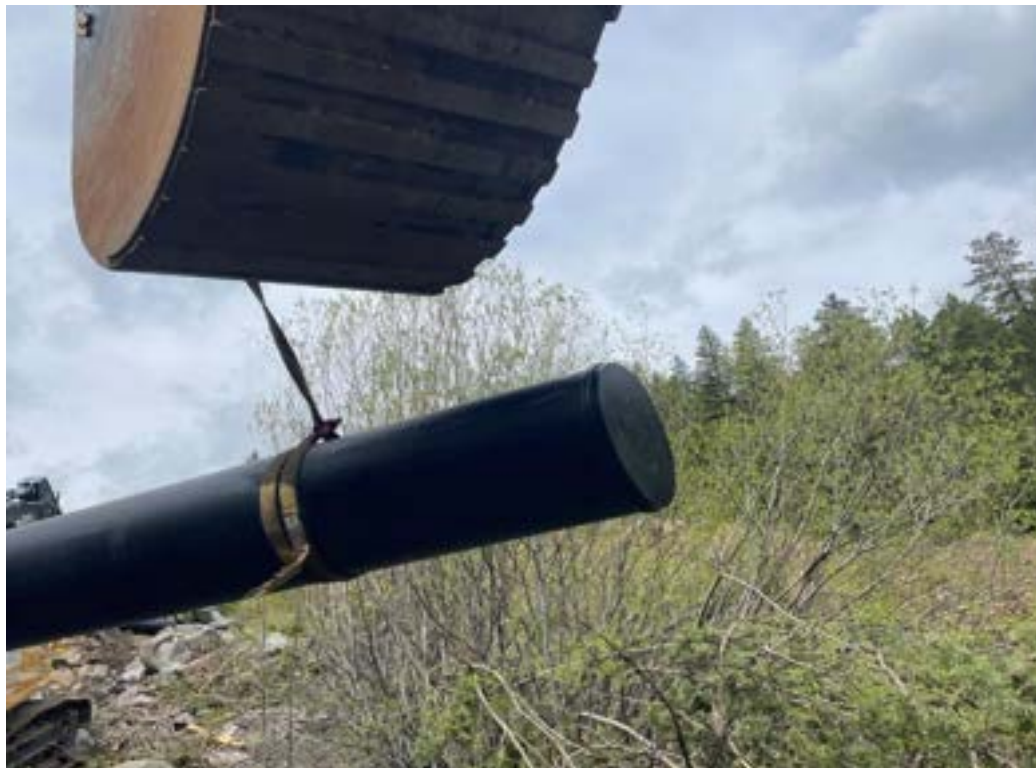
Photo 23: Downstream end has temporary cap to allow pressure testing upon completion of welding.

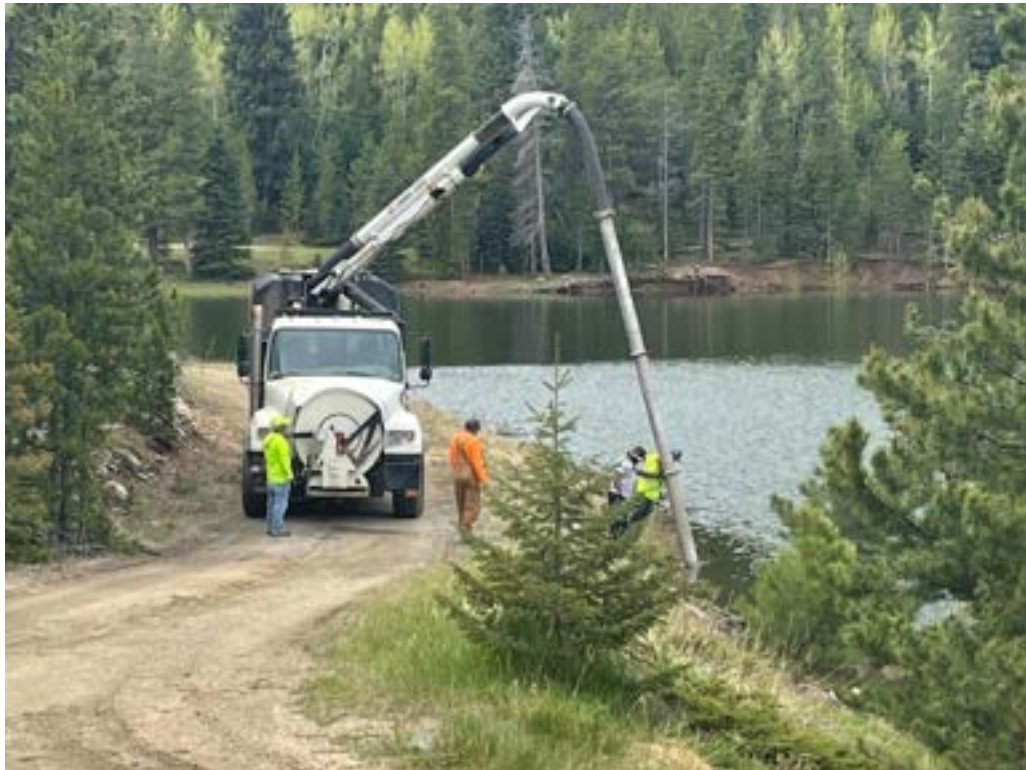
Photo 24: Vac truck used to collect water for jetting operations. 600-ft hose reel is affixed to front of vac truck.

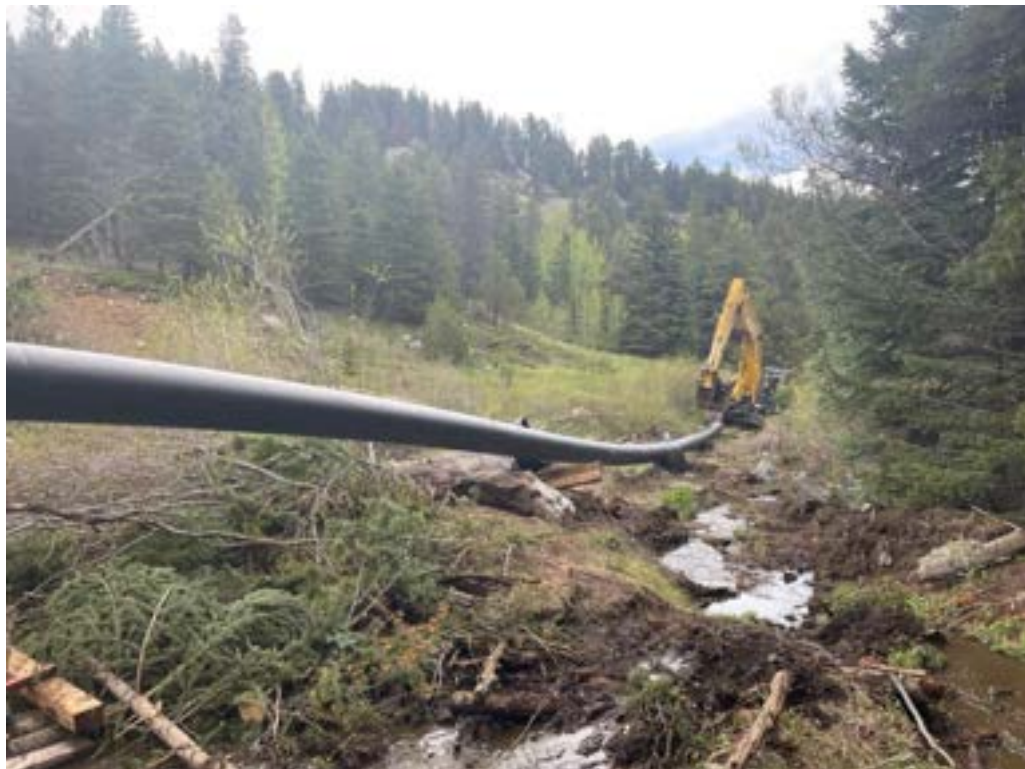
Photo 29: 80-ft string of fused 18" HDPE.

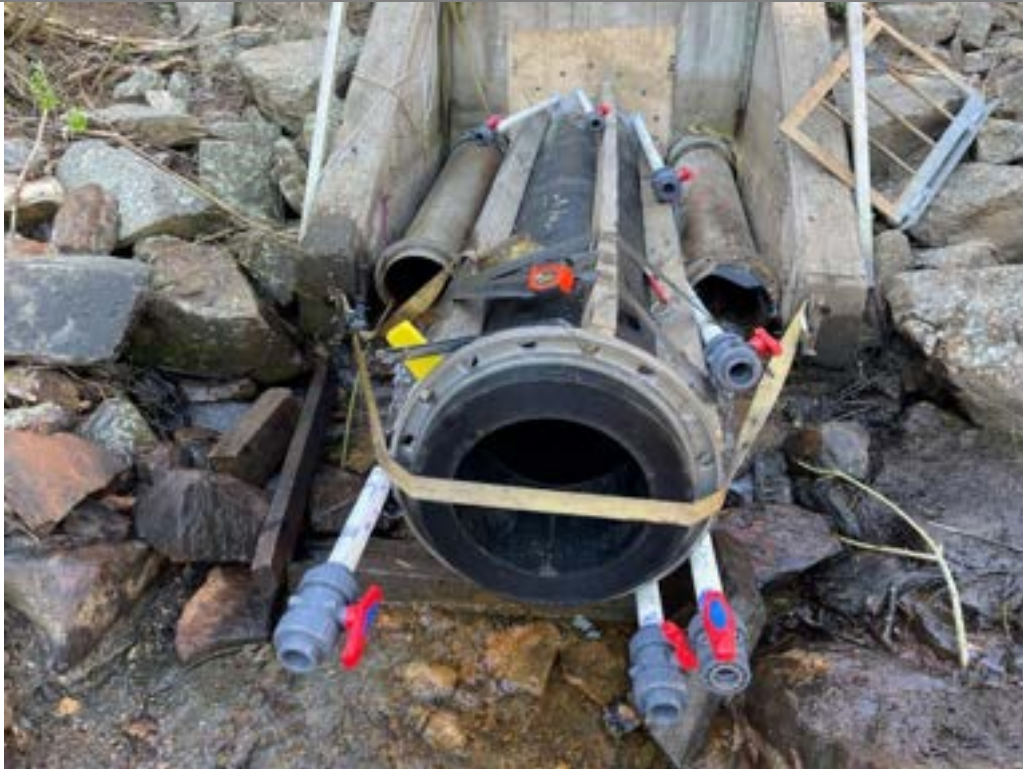
Photo 1: Downstream bulkhead and grout injection / vent pipe assembly.

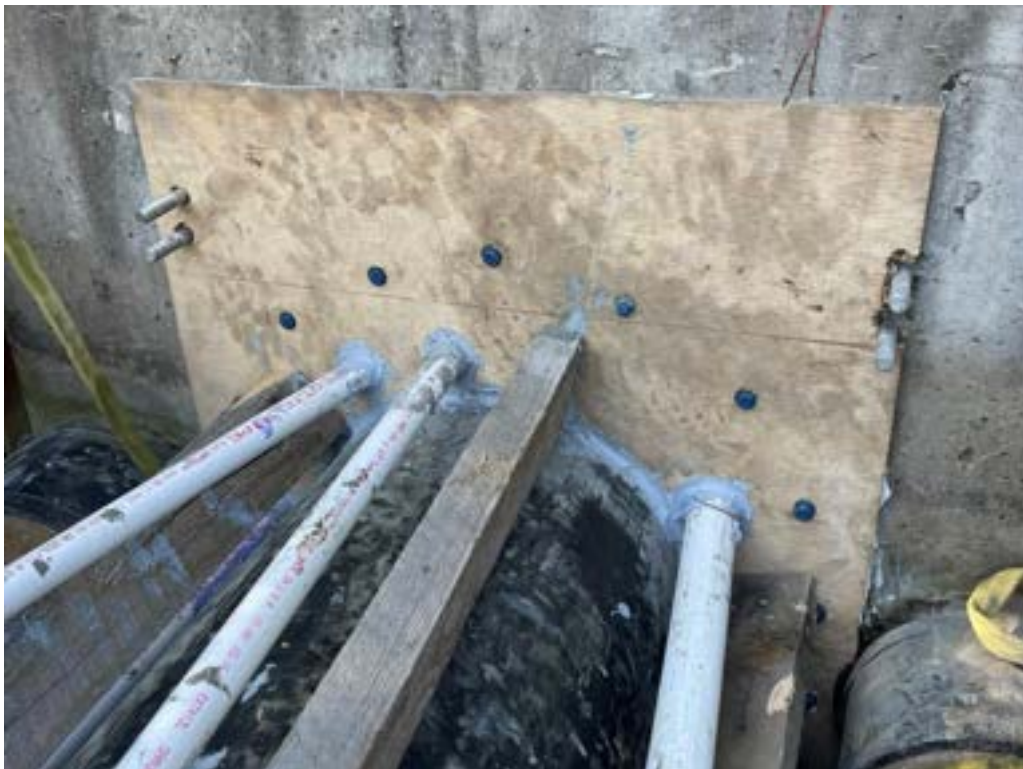
Photo 2: Downstream bulkhead anchoring and sealing.

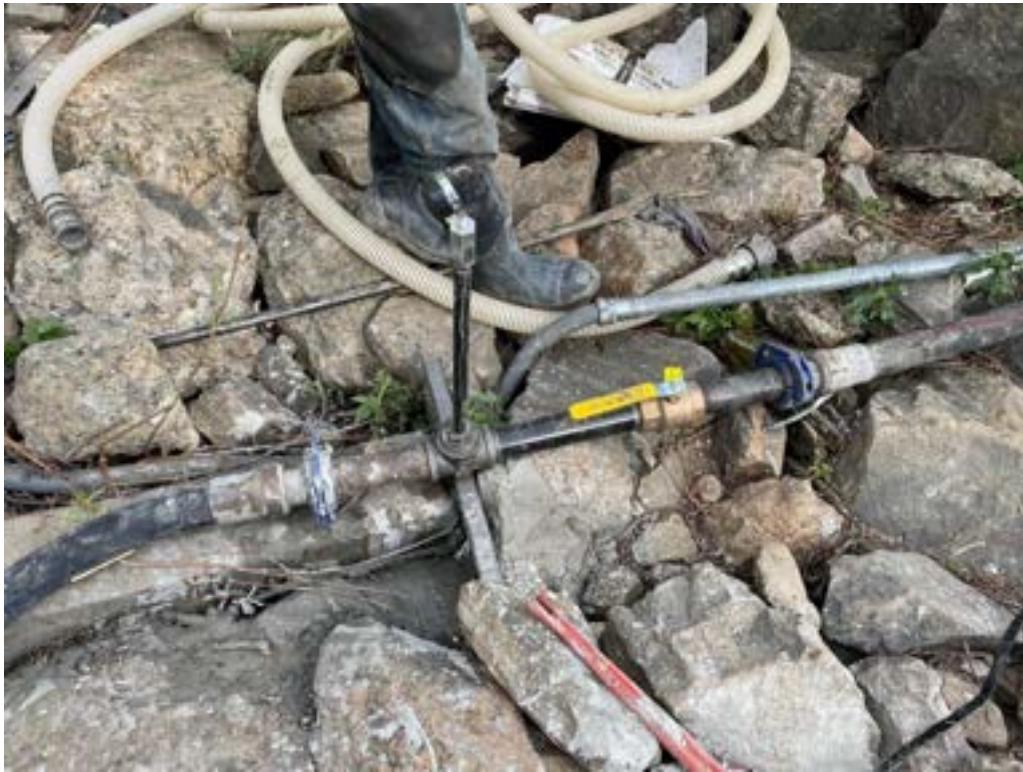
Photos 11: Downstream pressure gauge and flow control.

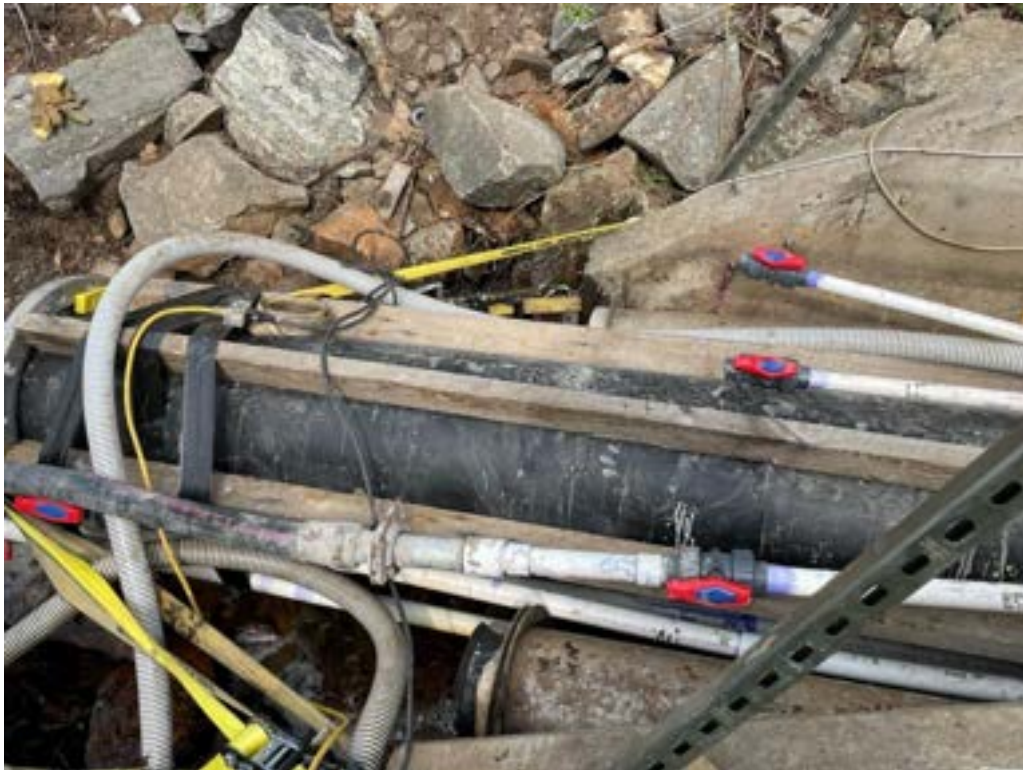
Photo 13: Grout hose connected to grout injection pipe.

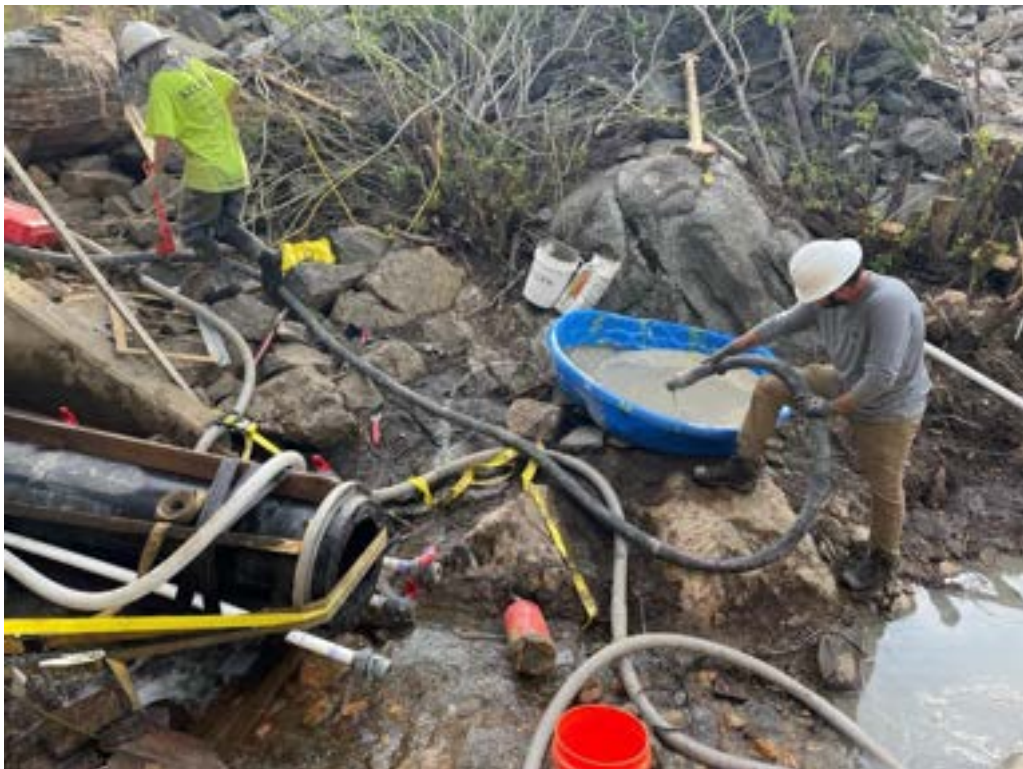
Photo 16: Contractor performing final line cleanout following completion of grouting.

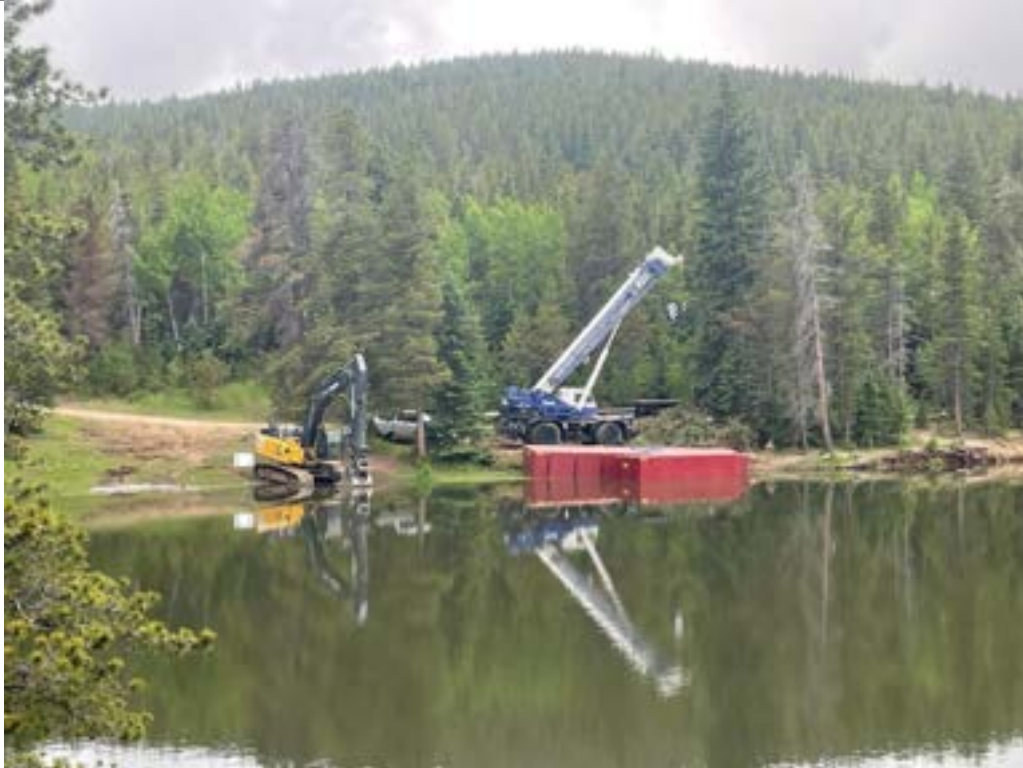
Photo 1: Barge setup and launch area. Crane staged for transferring barge segments to launch area.

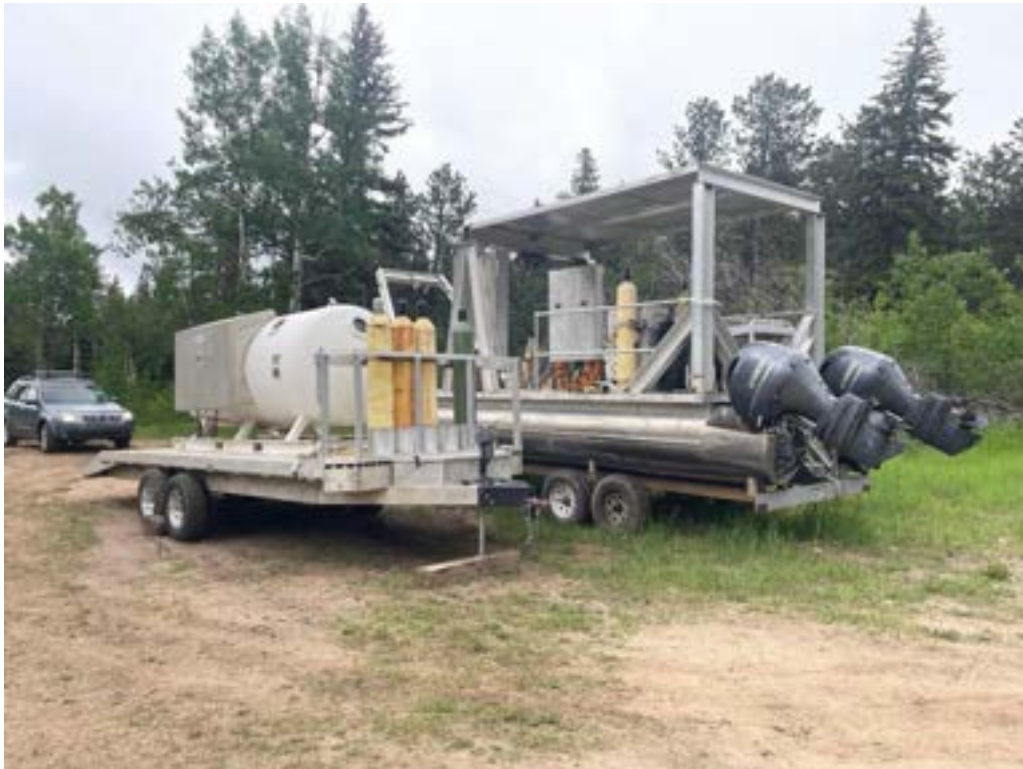
Photo 2: Hyperbaric chamber and boat staged at laydown area.

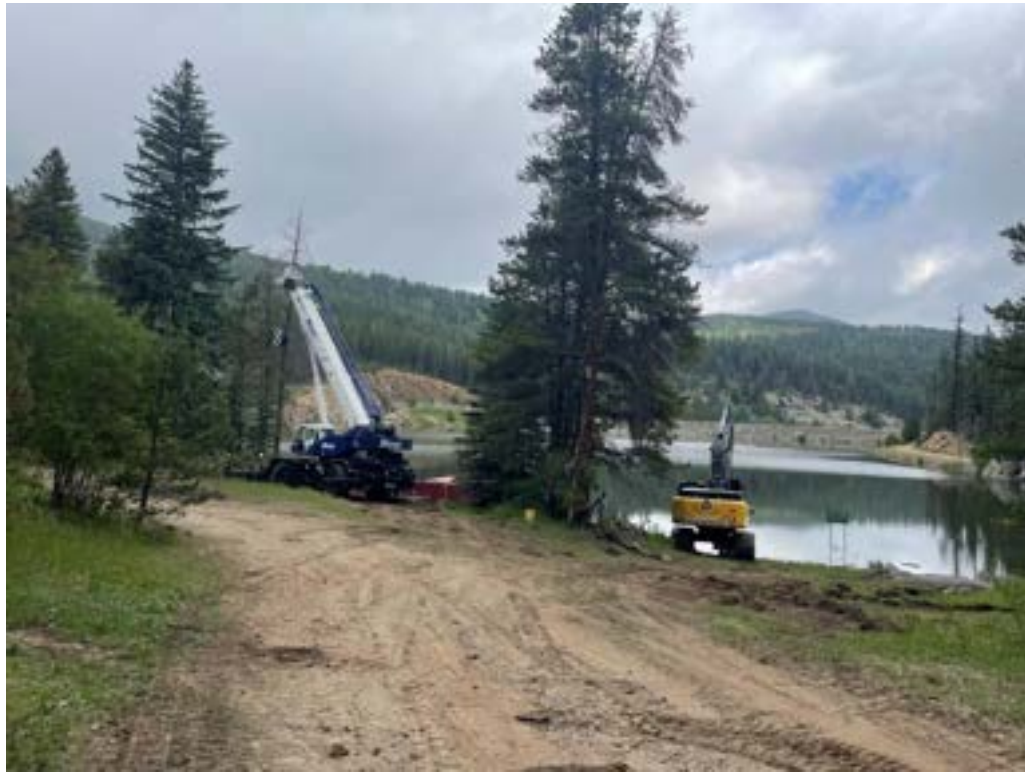
Photo 3: Truck turnaround area near launch site.

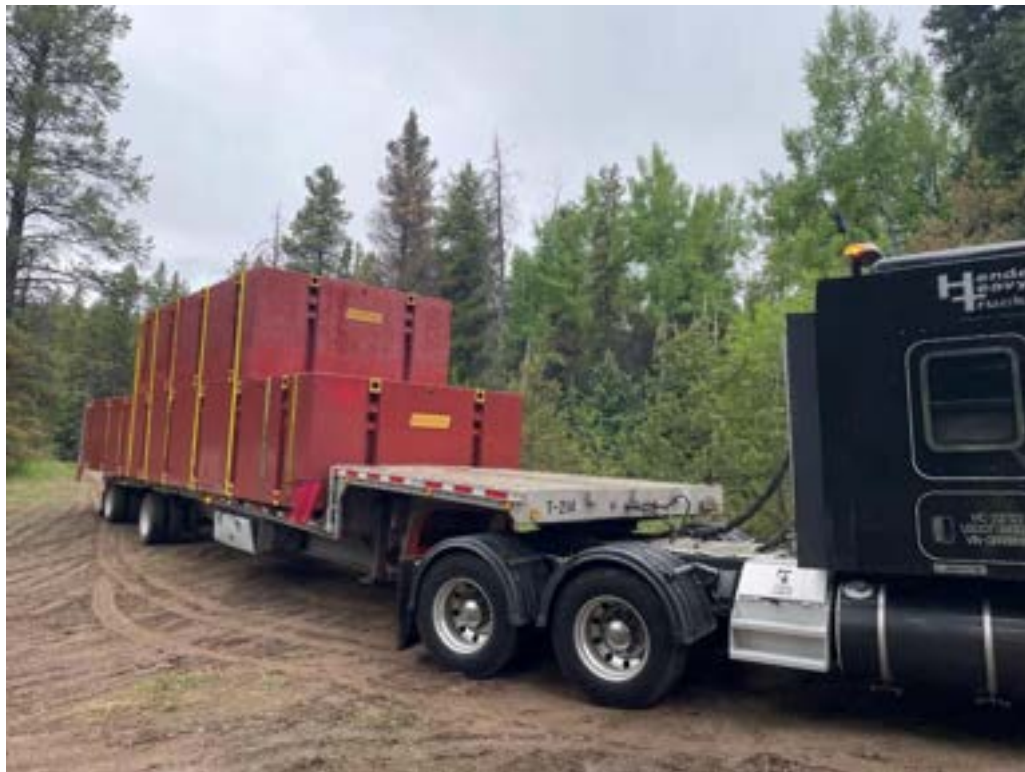
Photo 4: Barge segments being delivered to site.

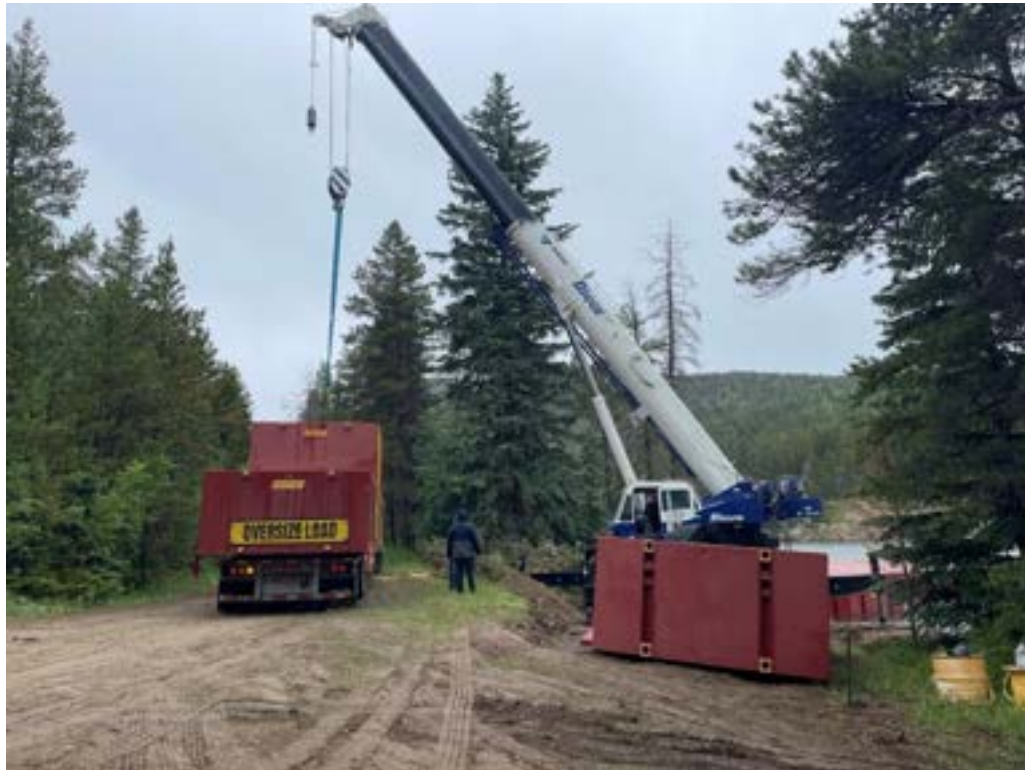
Photo 5: Crane picking Flexifloat barge segment from delivery truck.

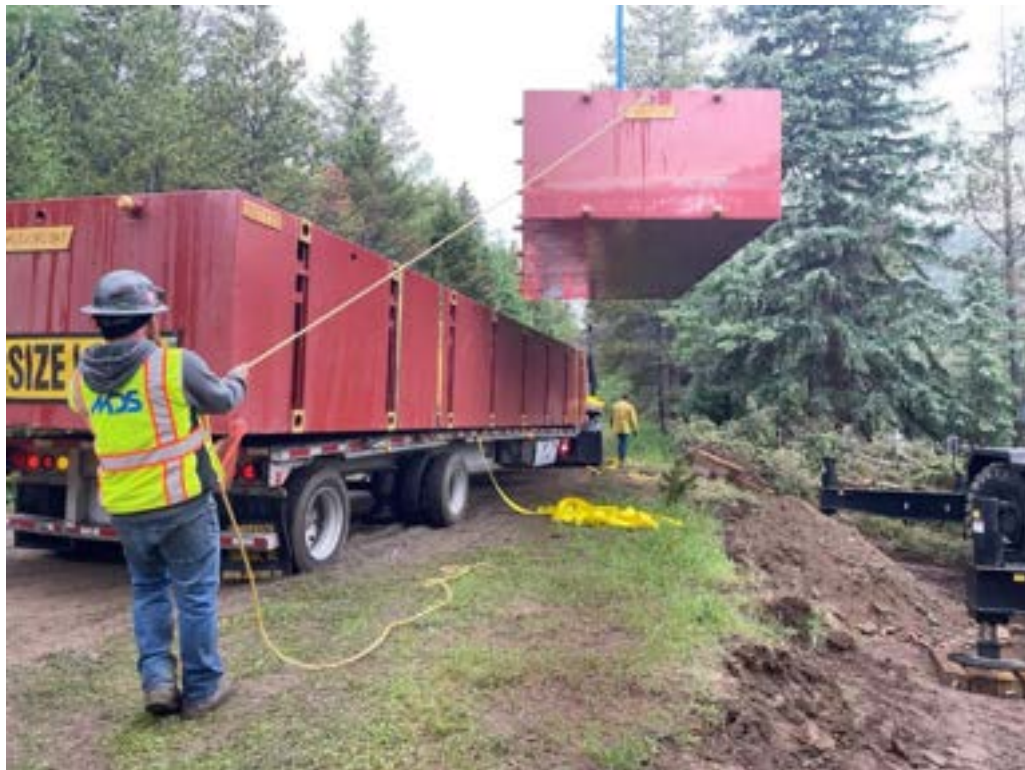
Photo 5: Transferring Flexifloat barge segment.

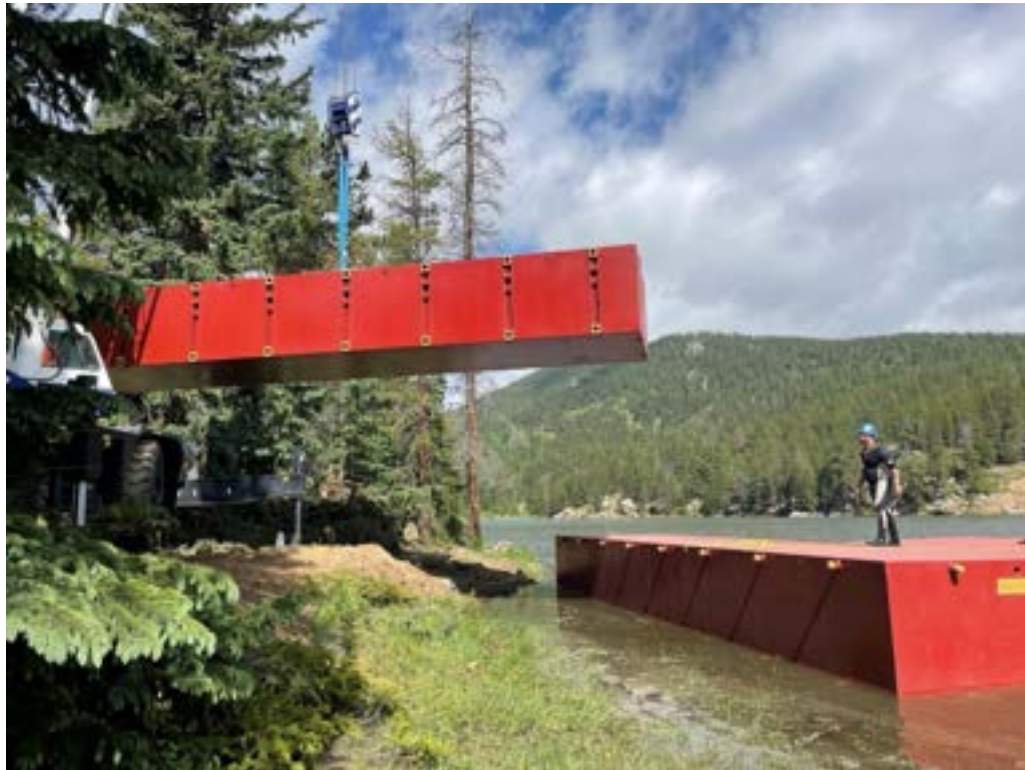
Photo 6: Placing Flexifloat barge segment at launch area.

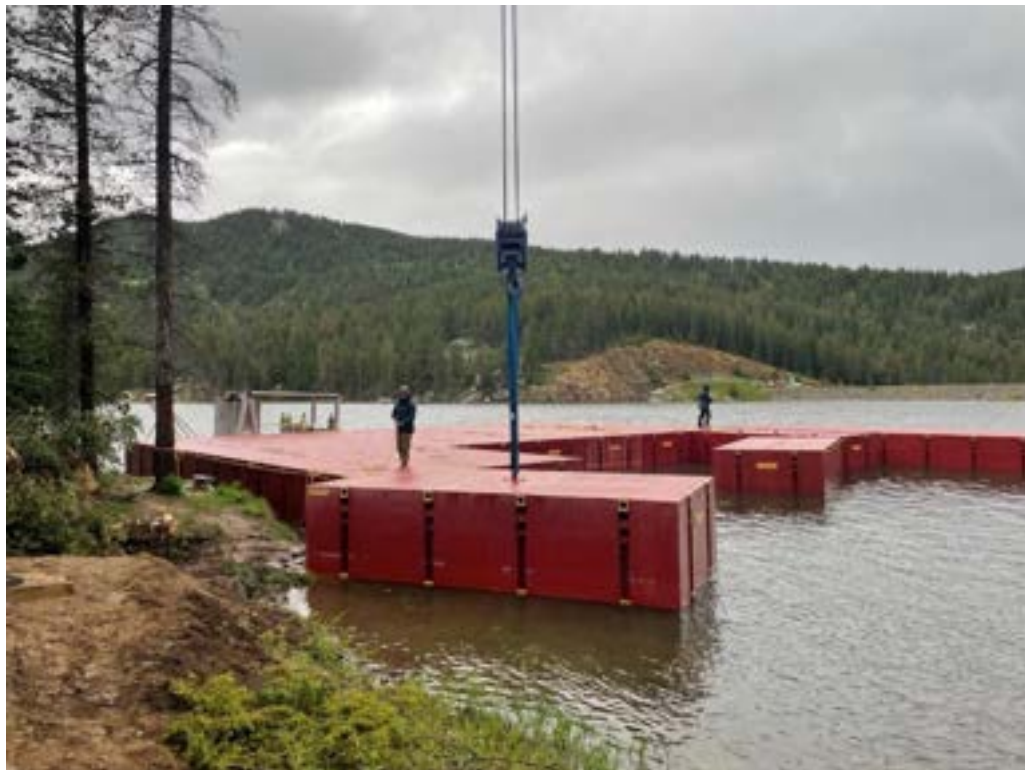
Photo 7: Contractor working on assembly of barge segments.

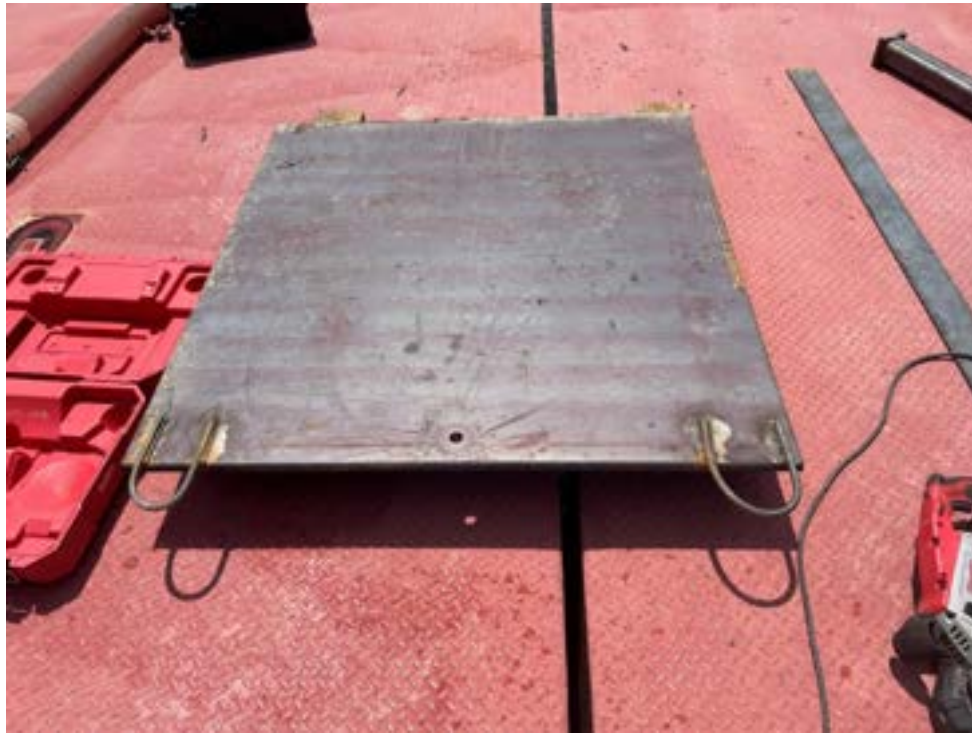
Photo 1: One of two 4'x4' steel plates placed against downstream headwall to brace hydraulic ram and push of tee at bell and spigot.

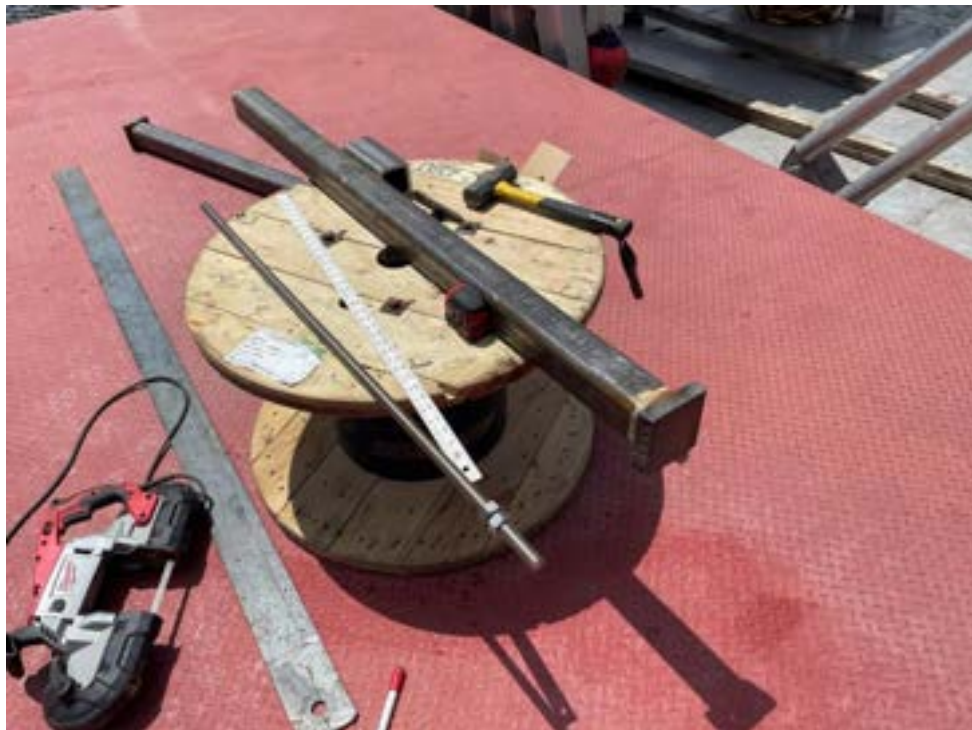
Photo 2: HSS section placed between steel plate and hydraulic ram.

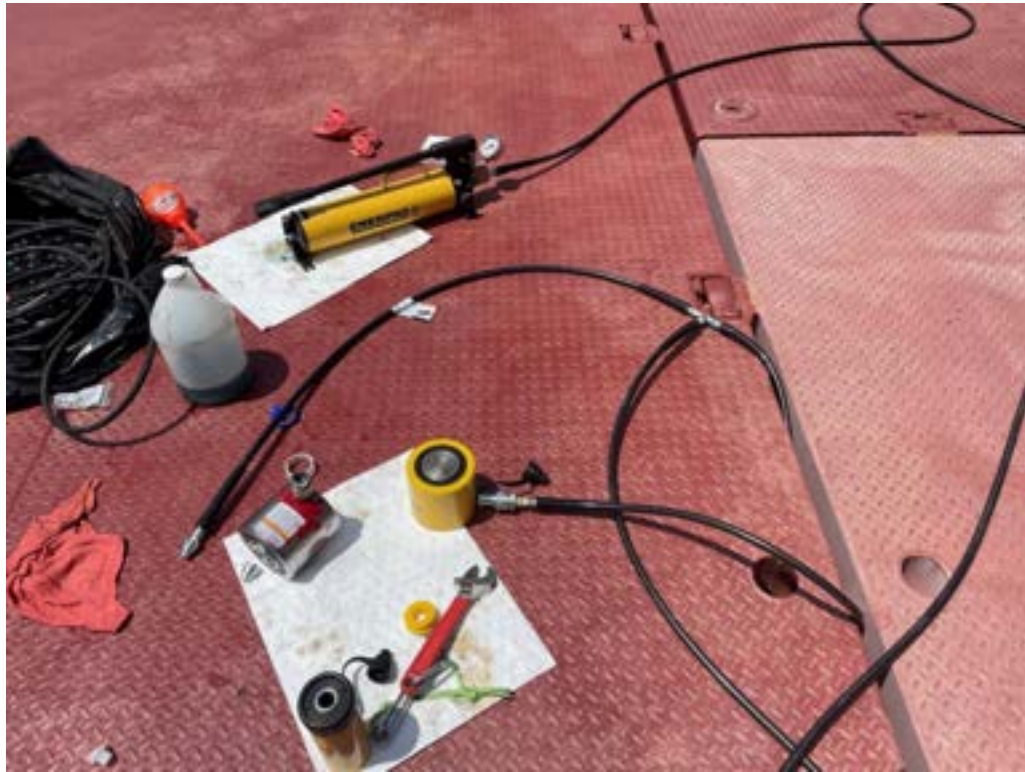
Photo 3: Hydraulic pump and ram with 2-inch stroke.

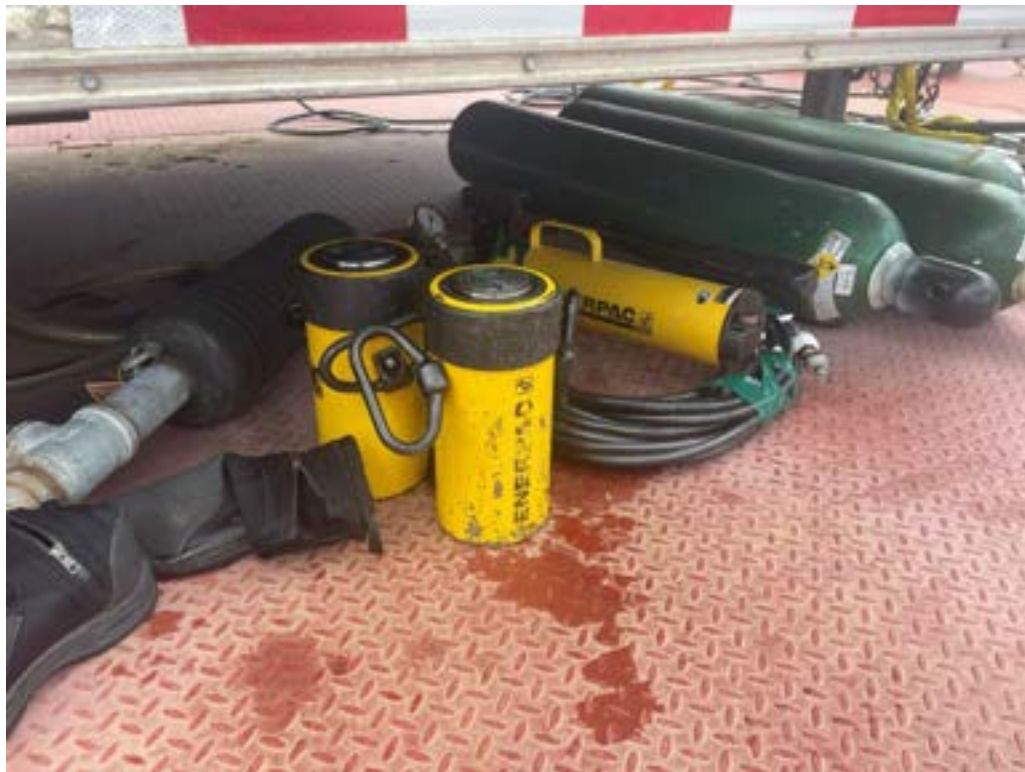
Photo 4: Hydraulic rams with 6-inch stroke

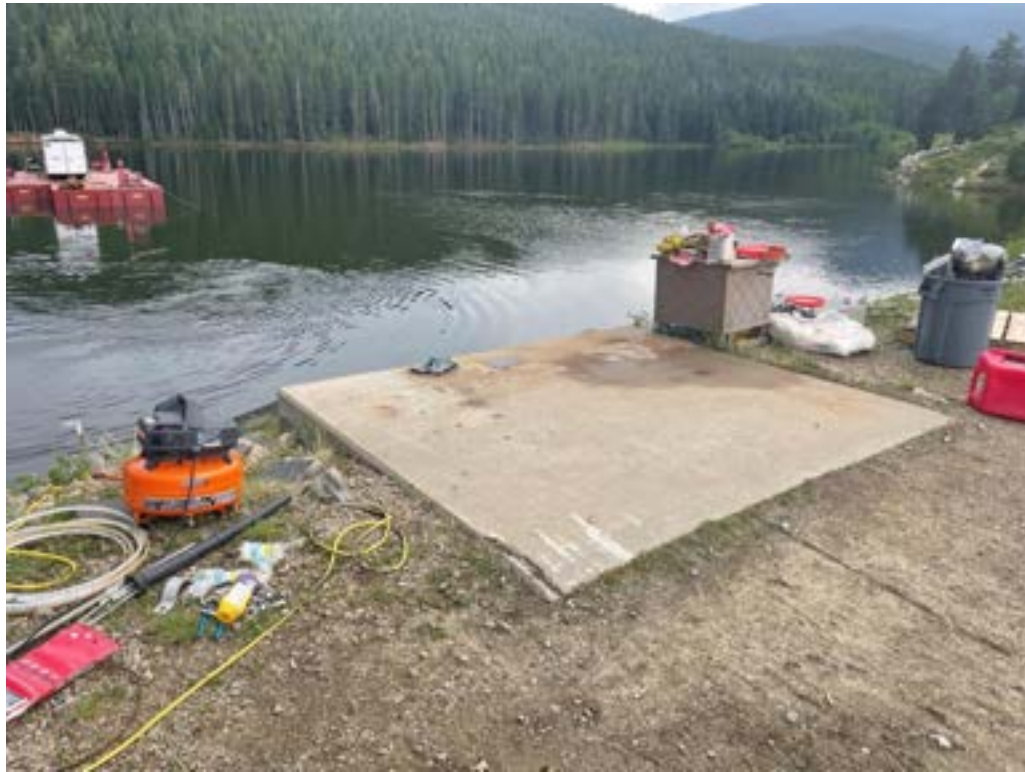
Photo 4: Existing equipment fully removed from HPU building pad.

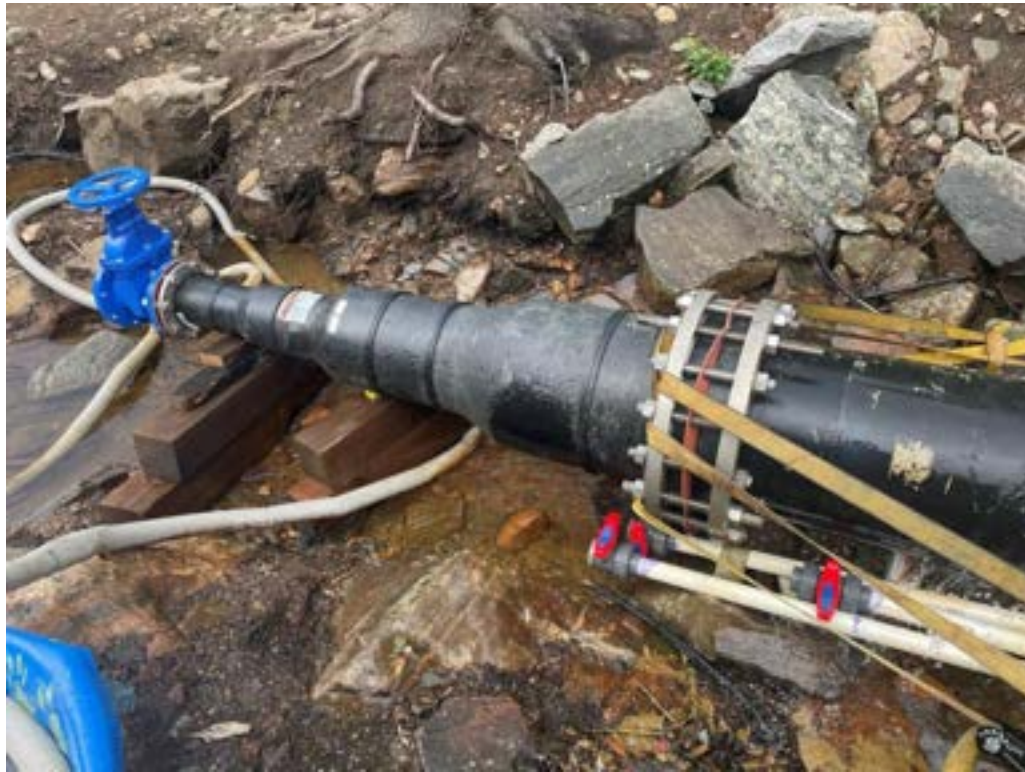
Photo 6: Temporary valve placed on downstream end of pipe.

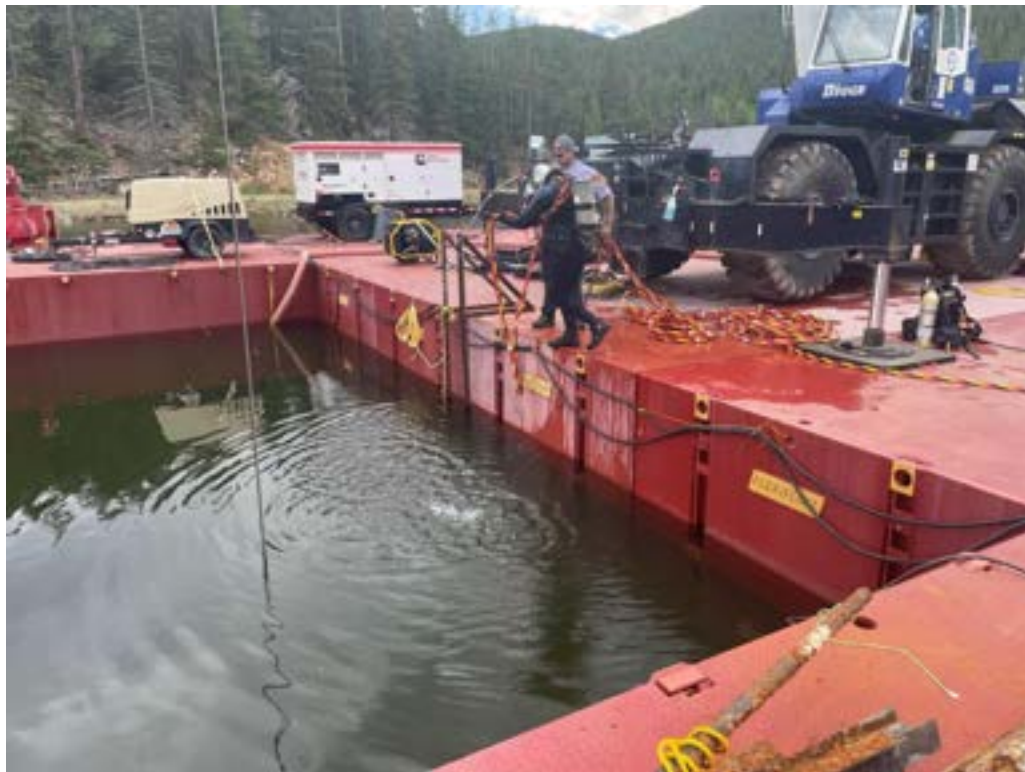
Photo 7: Diving operations continue.
