## TR100 VLF2 Recertification (9750-9900)

Attachment 2:  
Record of Construction Report  
VLF2 Recertification Project  
Subgrade and Geomembrane 9750' – 9900' Elevations

## **VLF2 RECERTIFICATION PROJECT RECORD OF CONSTRUCTION REPORT FOR SUBGRADE AND GEOMEMBRANE 9750' – 9900' ELEVATIONS**

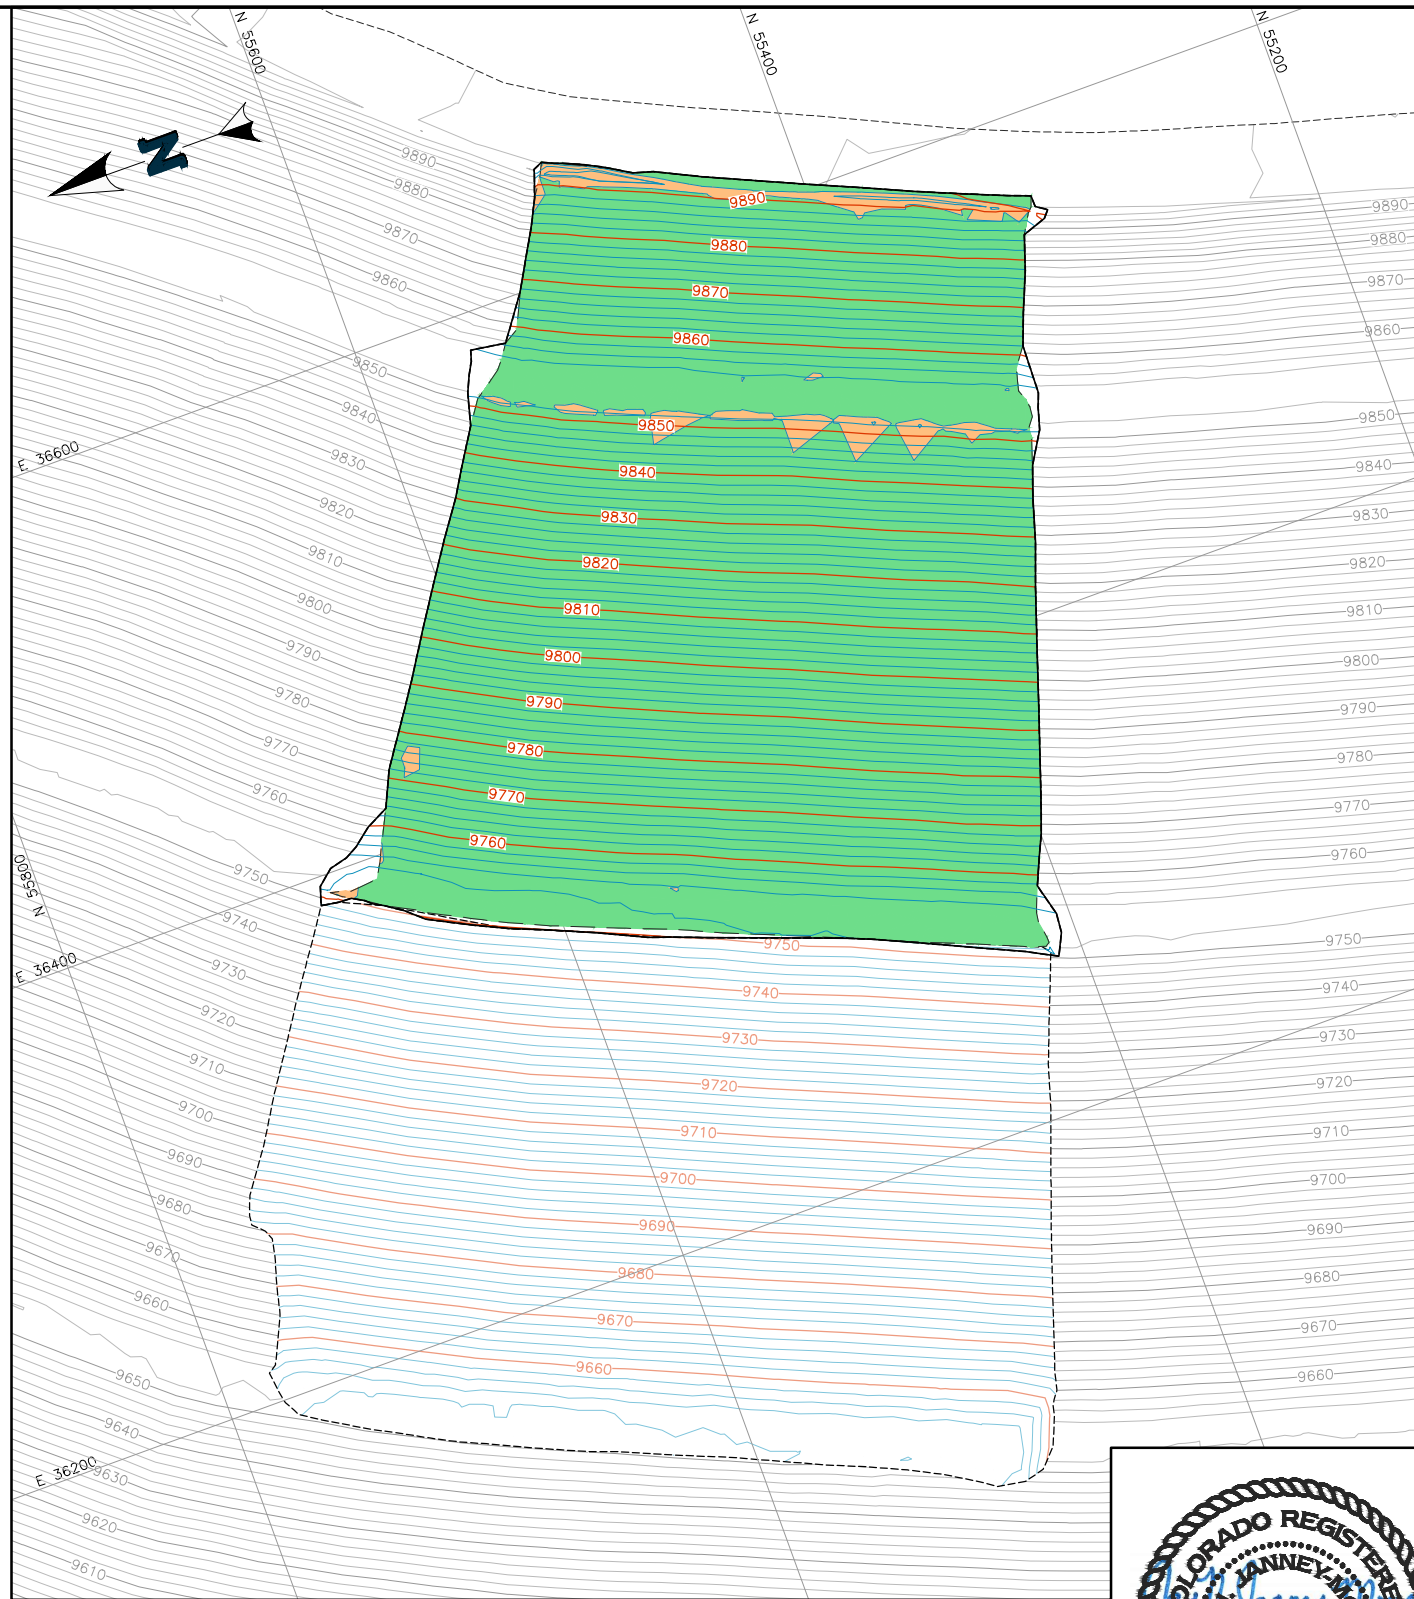
## **Appendix A – Record of Construction Drawing**

1. THE AS-BUILT TOP OF DRAIN COVER FILL (DCF) (2016) WAS DEVELOPED BY AMES AS PART OF THE RECORD OF CONSTRUCTION REPORT FOR THE SQUAW GULCH VALLEY LEACH FACILITY PHASE 1 COMPLETION, DATED OCTOBER 14, 2016.
2. THE ISOPACH OF DCF DEPTH WAS DEVELOPED BY COMPARING THE AS-BUILT SLF SURFACE (BETWEEN 9750'-9900') TO THE AS-BUILT DCF SURFACE (BETWEEN 9750'-9900').
3. THE TOP OF SLF (BETWEEN 9750'-9900') (2018) WAS SURVEYED BY FORSIGHT WEST AND PROVIDED TO NEWFIELDS ON JULY 10, 2018 IN A FILE CALLED "MLE2 VLF Clay Topo thru 7-10-18.dwg"
4. THE TOP OF DCF (BETWEEN 9750'-9900') (2018) WAS SURVEYED BY FORSIGHT WEST AND PROVIDED TO NEWFIELDS ON AUGUST 15, 2018 IN A FILE CALLED "MLE2 VLF DCF Checks 8-14-18.dwg".
5. THE TOP OF DCF (BETWEEN 9650'-9750') (2018) WAS SURVEYED BY FORSIGHT WEST AND PROVIDED TO NEWFIELDS ON JULY 10, 2018 IN A FILE CALLED "MLE2 VLF DCF Checks 7-09-18.dwg".

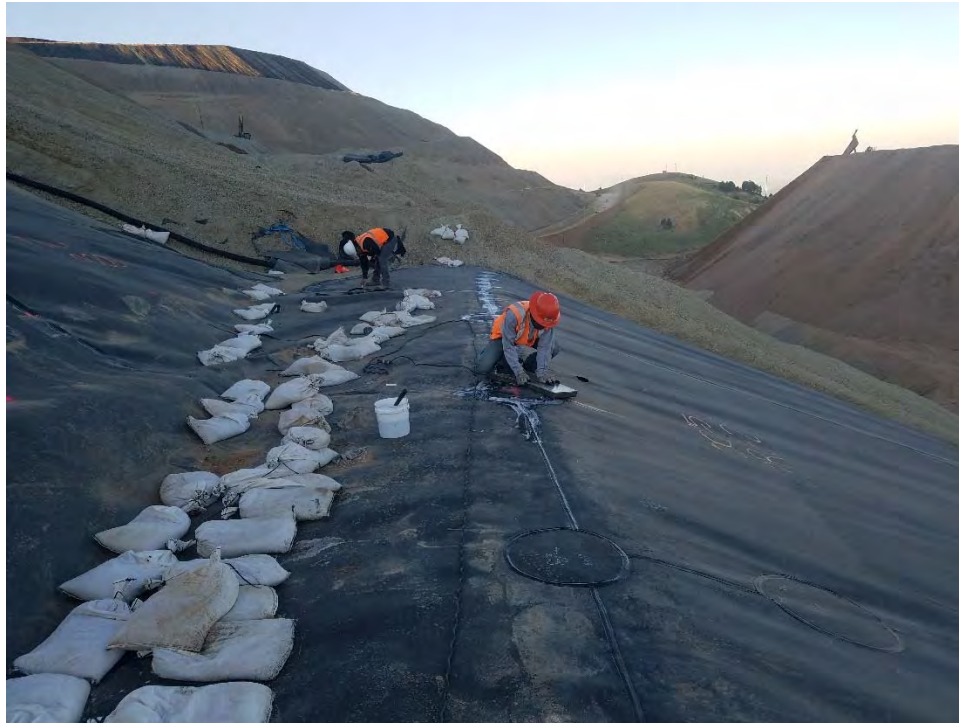
Repairs were performed using the extrusion welding method. A total of 46 linear feet of extrusion seaming was completed. All repairs and extrusion welded seams were vacuum tested during the shift. All the destructive testing was performed and met project specifications.

Vacuum Tested

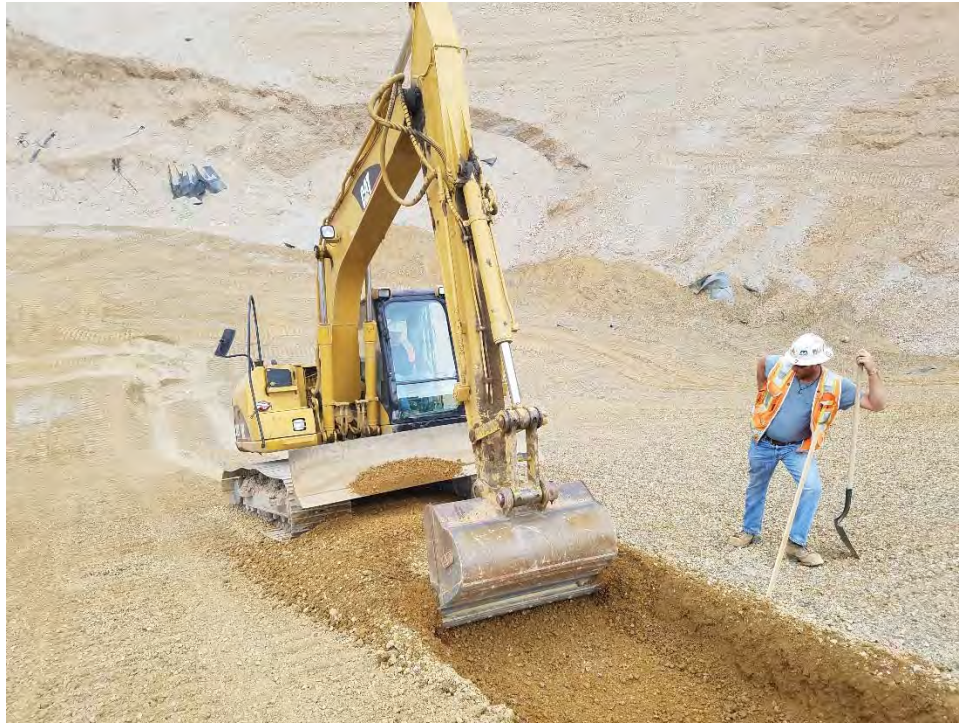
A CAT 321C L excavator was utilized to remove Drain Cover Fill (DCF) from the recently installed geomembrane between 9673' and 9716' elevation. Four test holes were excavated. The geomembrane was cut to expose SLF for density and moisture testing. The density and moisture testing were performed using the CPN Nuclear Moisture/Density Gauge with passing results.

**DCF Removal**

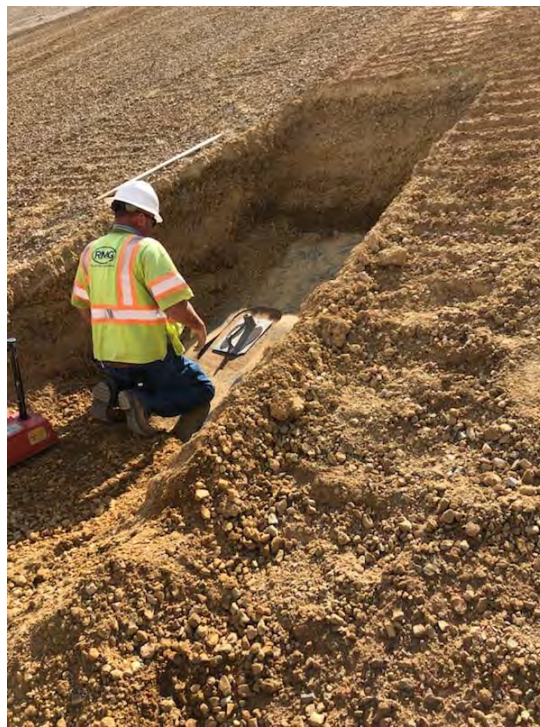
NewFields personnel observed the test hole excavation, performed SLF nuclear density testing, and geomembrane repairs. SLF density testing was performed for the VLF2 Recertification area with passing results.

**Density and Moisture Testing**

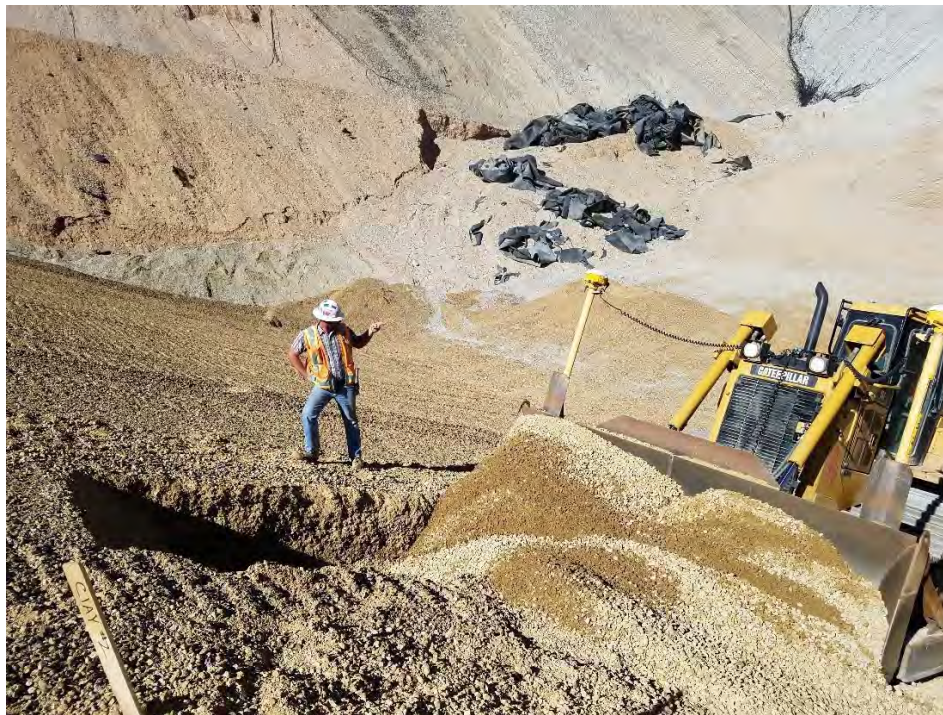
After geomembrane repairs were vacuum tested and approved, a CAT D6T LGP dozer was used to backfill the nuclear density test holes.

**Backfilling Test Holes**

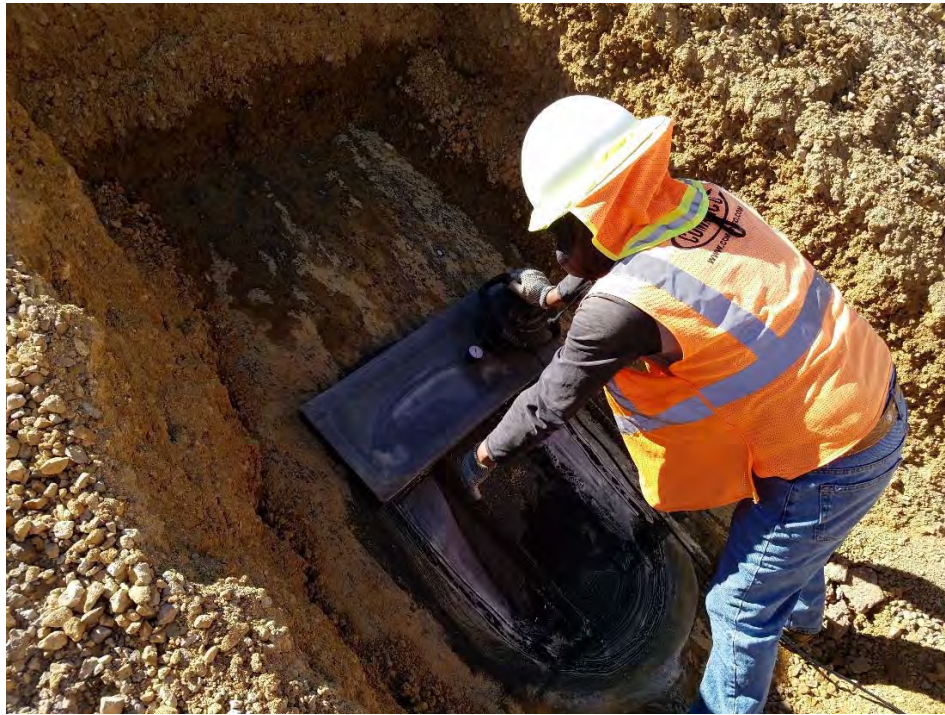
NewFields personnel observed test hole backfill, geomembrane vacuum testing, and approved geomembrane repairs during the shift.

**Vacuum Testing**

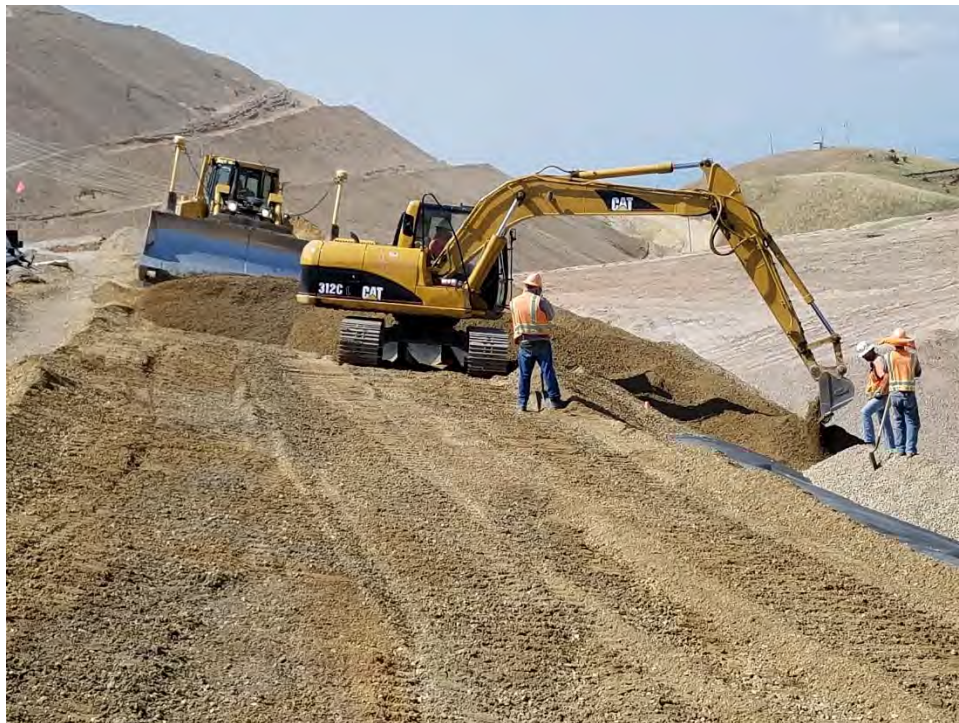
**DCF Placement**

A 312C L excavator was used to remove the DCF on the Northeast corner of the Geomembrane Recertification VLF2 to locating damaged geomembrane.

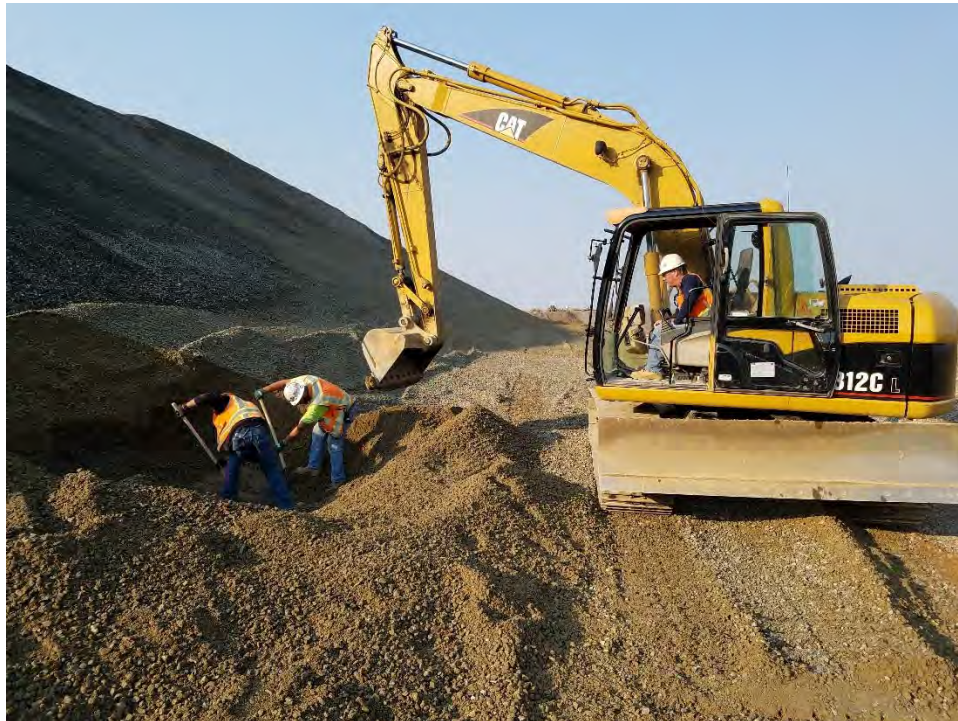
**Geomembrane Exposure**

A Cat D6T LGP dozer and a 312C L excavator were used to remove the Ore material on the 9850' bench at Northeast corner of Geomembrane Recertification VLF2 to find the damaged geomembrane.

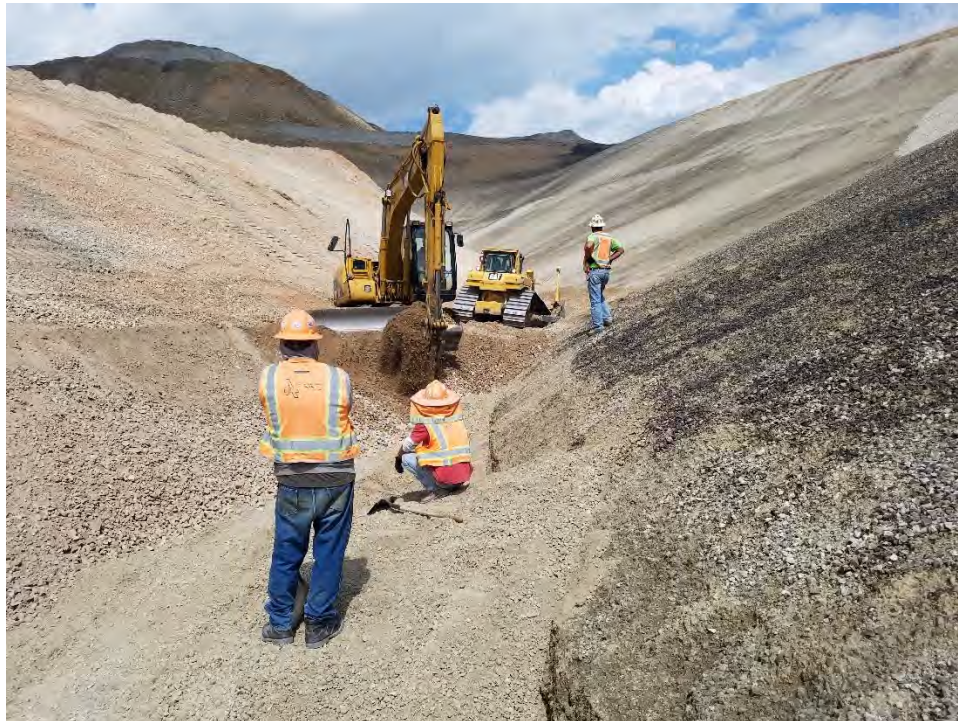
**Ore removal**

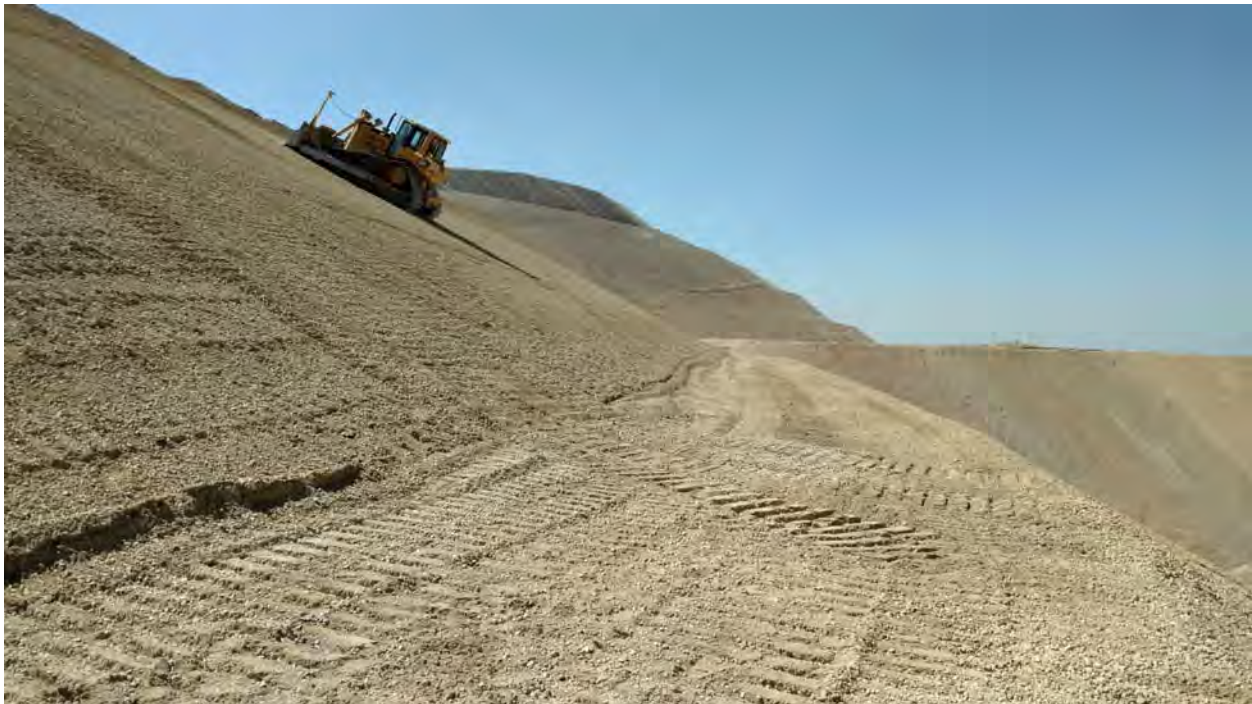
**DCF Regrading**

A Cat D6T LGP dozer and 312C L excavator were used to place drain cover over the completed repairs. The dozer completed regrading along the side slopes. Drain cover was surveyed to ensure minimum 2' of cover over liner.

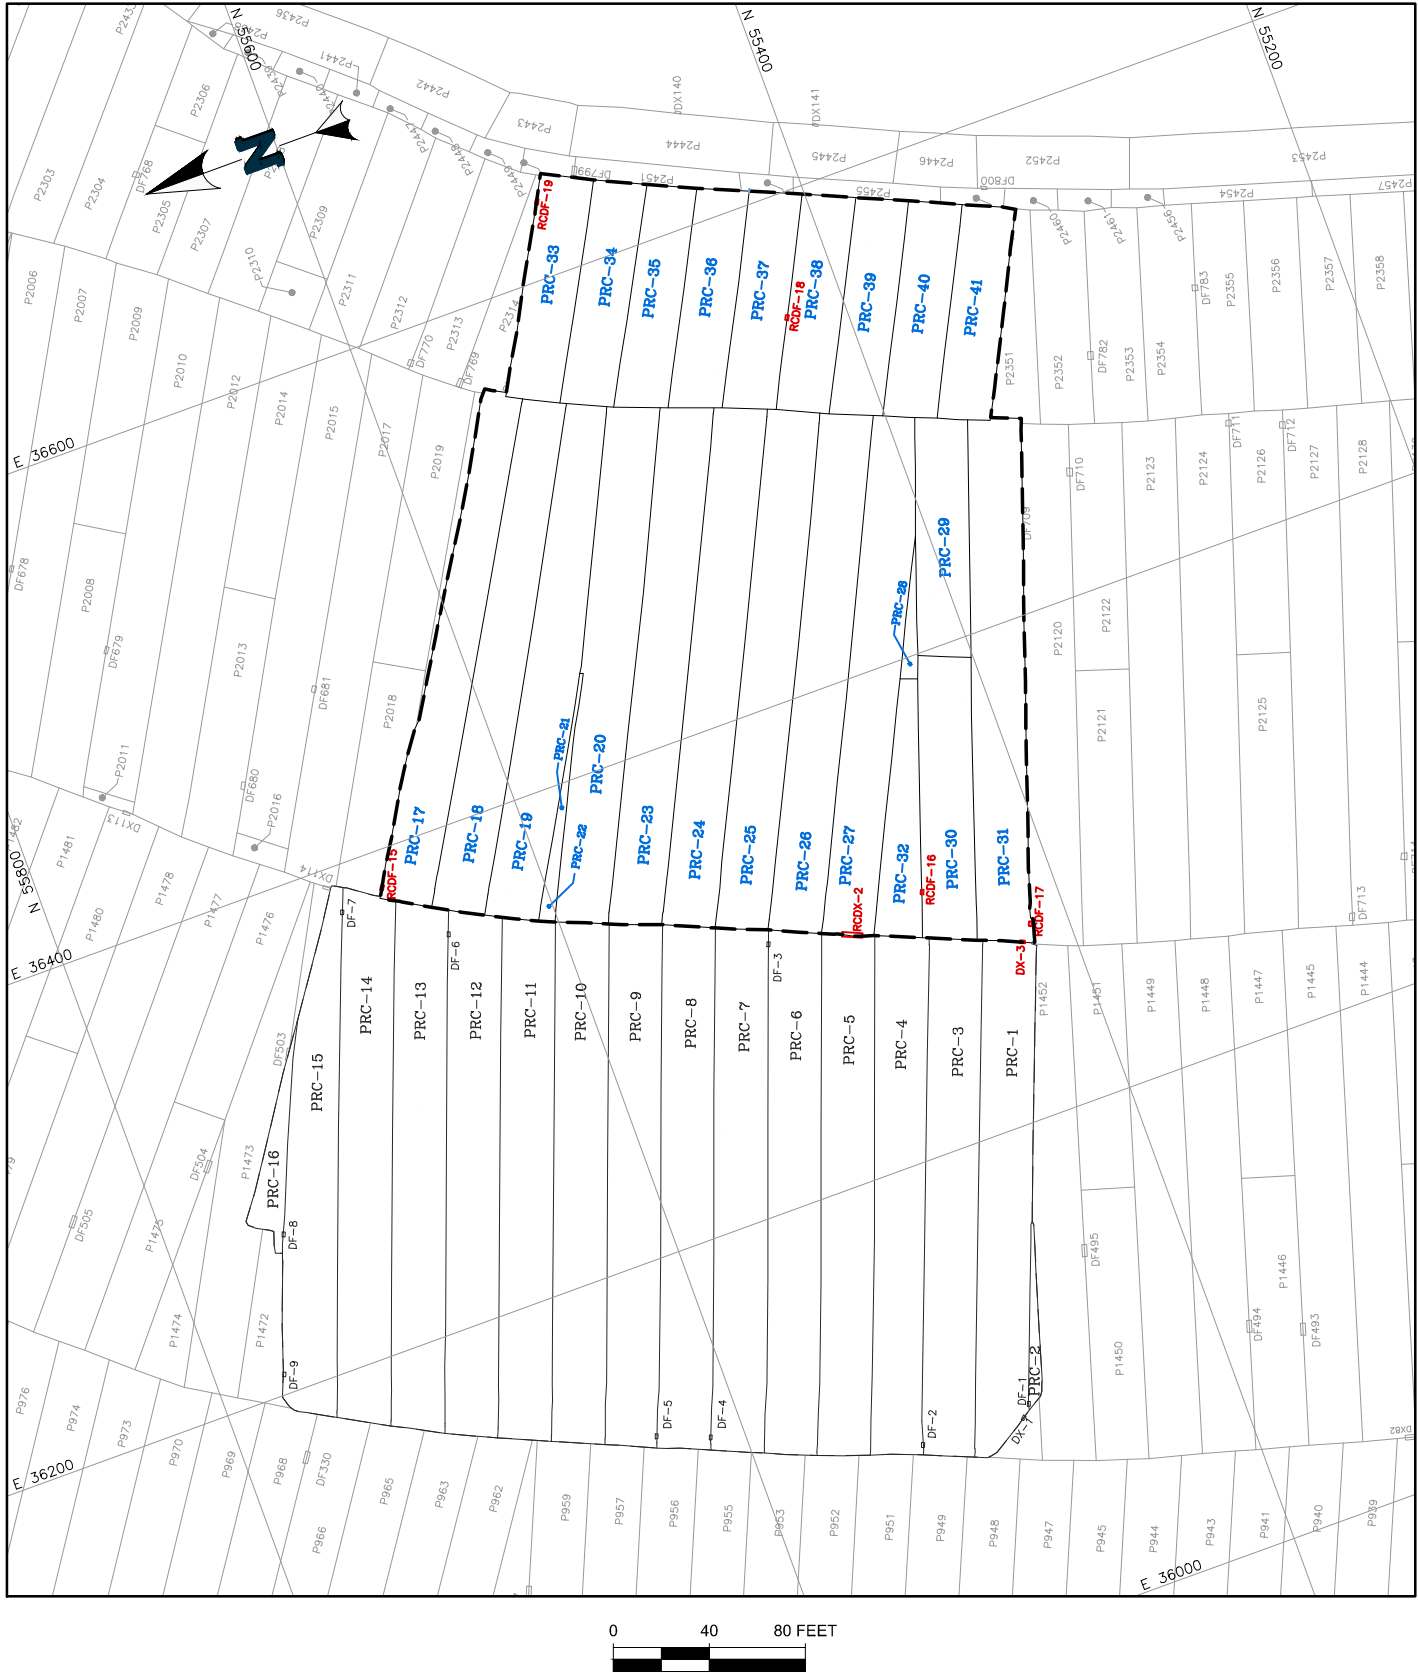
5. THE DESTRUCTS AND REPAIRS SHOWN AS PART OF THE RECORD OF CONSTRUCTION FOR THE VLF2 RECERTIFICATION BETWEEN THE 9750' AND 9900' BENCH WAS SURVEYED BY FORSIGHT WEST AND PROVIDED TO NEWFIELDS ON JULY 11, 2018 IN A FILE CALLED "MLE2 Liner Tests thru 7-10-18.dwg".

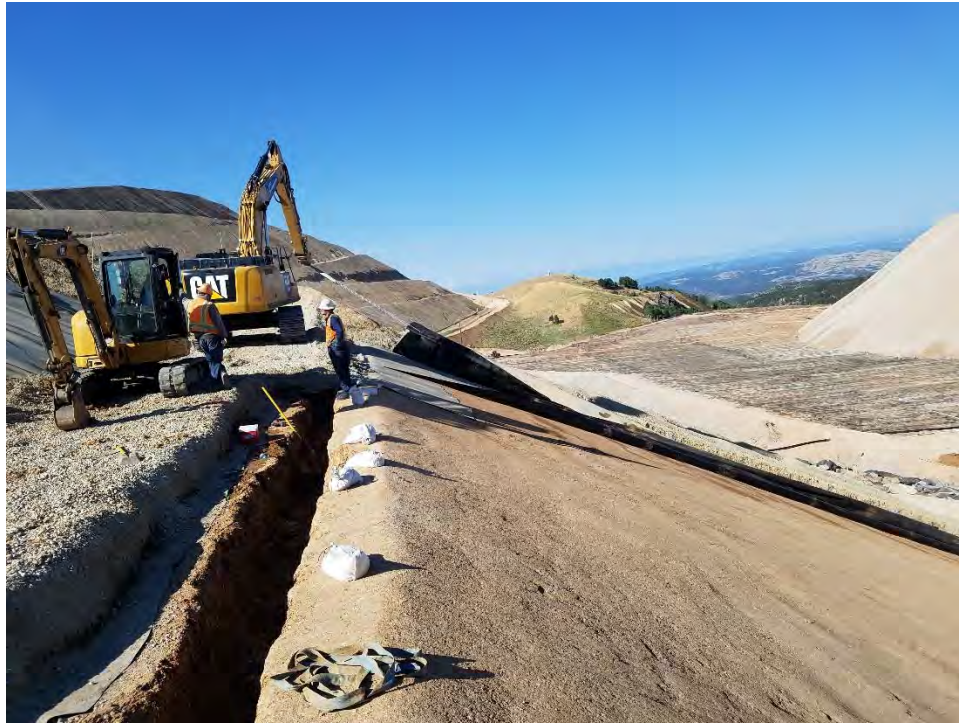
**Geomembrane Removal**

After the geomembrane was exposed and the damaged area was identified, it was removed using a CAT track mounted excavator. The removed geomembrane was discarded into roll off trash receptacles and removed from site.

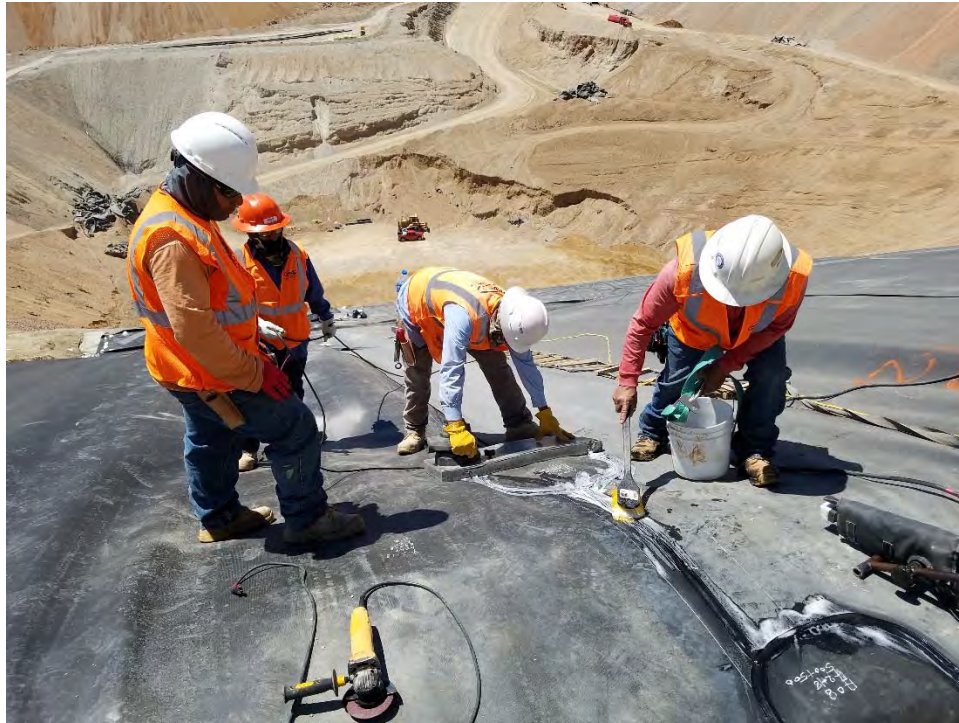
**Non-destructive Testing**

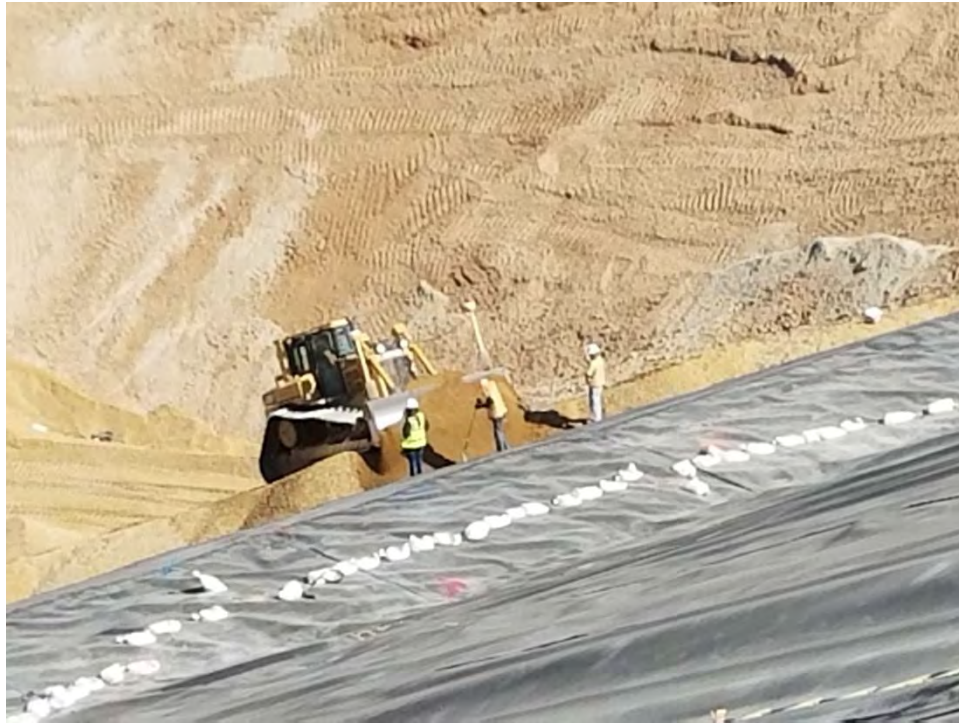
**DCF Placement**

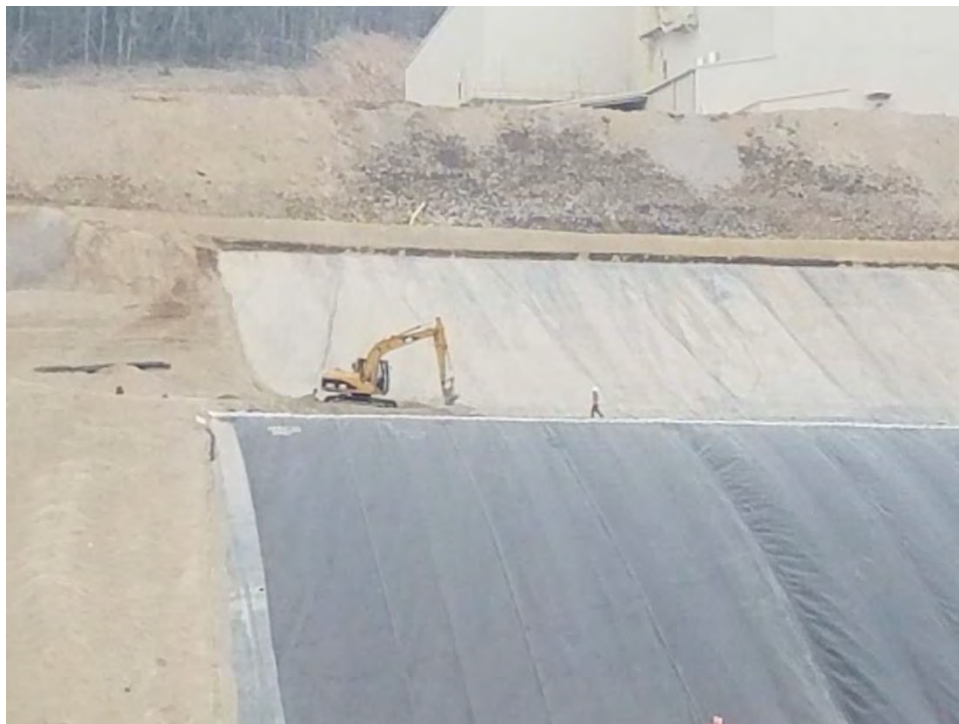
**DCF Removal**

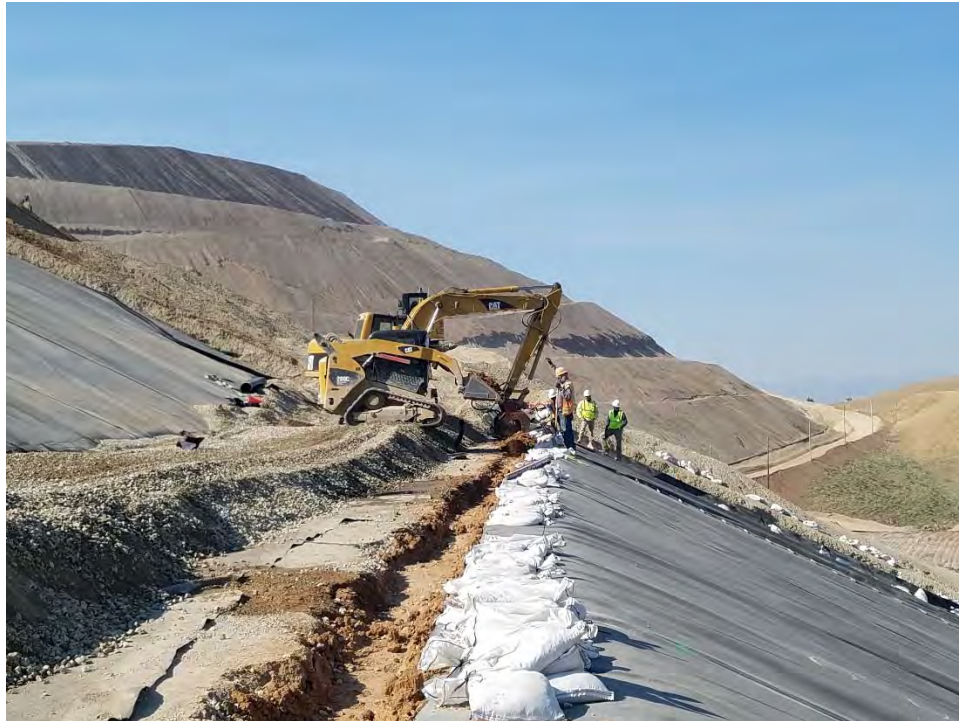
**Anchor Trench Backfill**

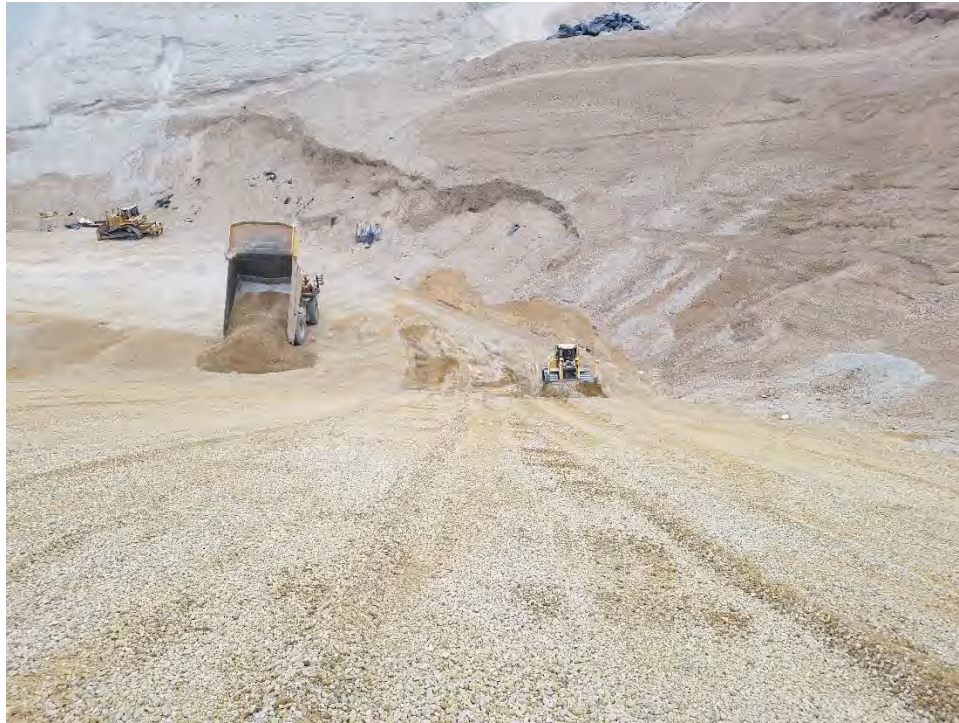
**DCF Placement**

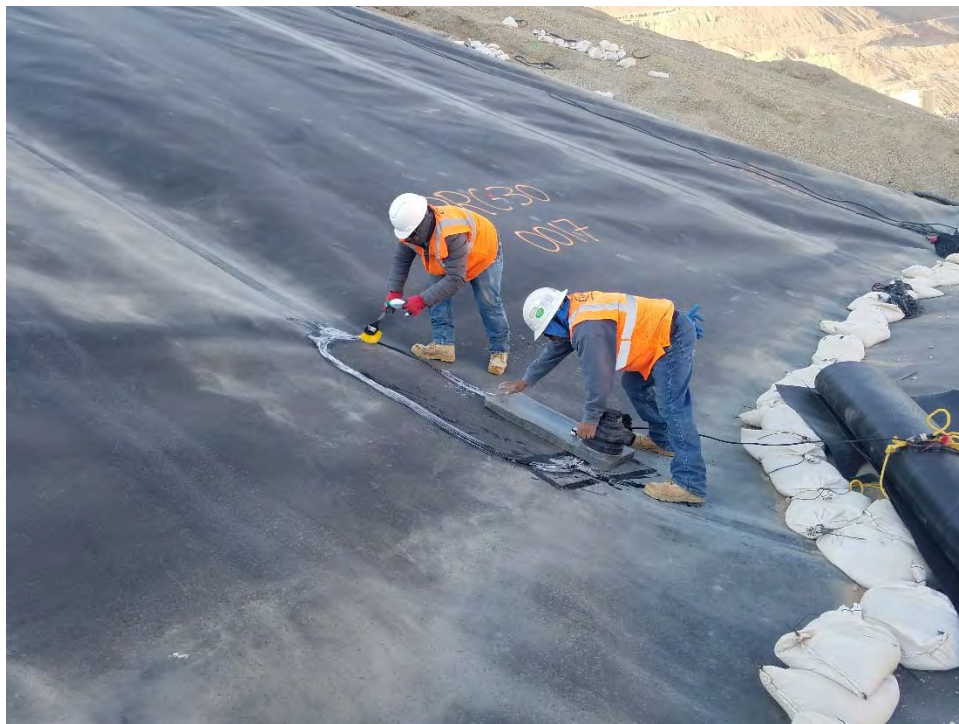
All completed repairs and extrusion welded seams were vacuum tested during the shift.

**Vacuum Testing**

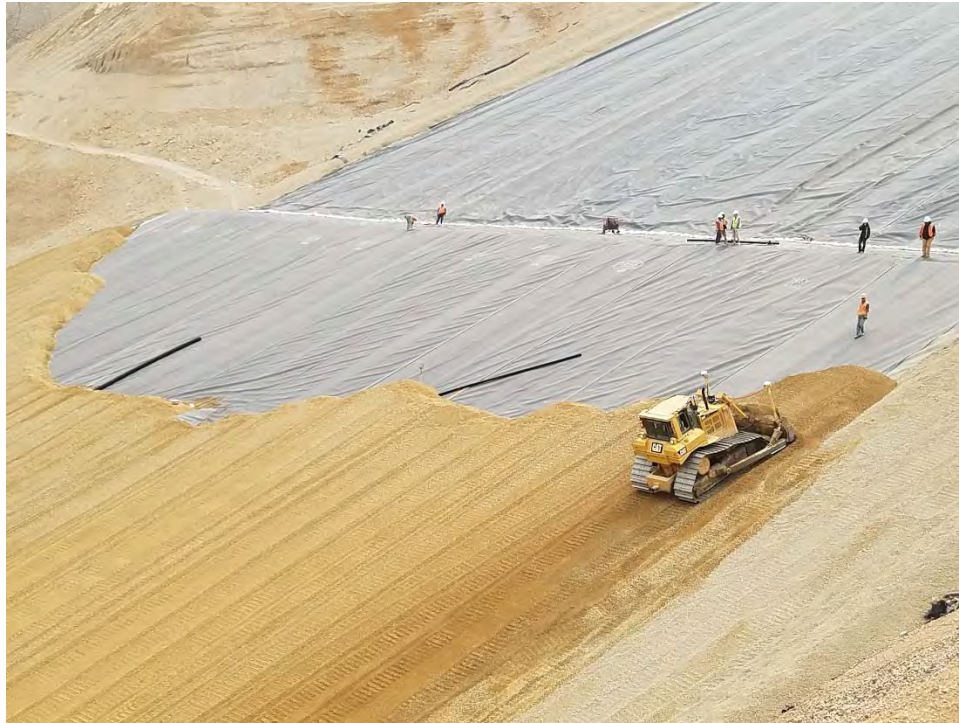
**DCF Placement**

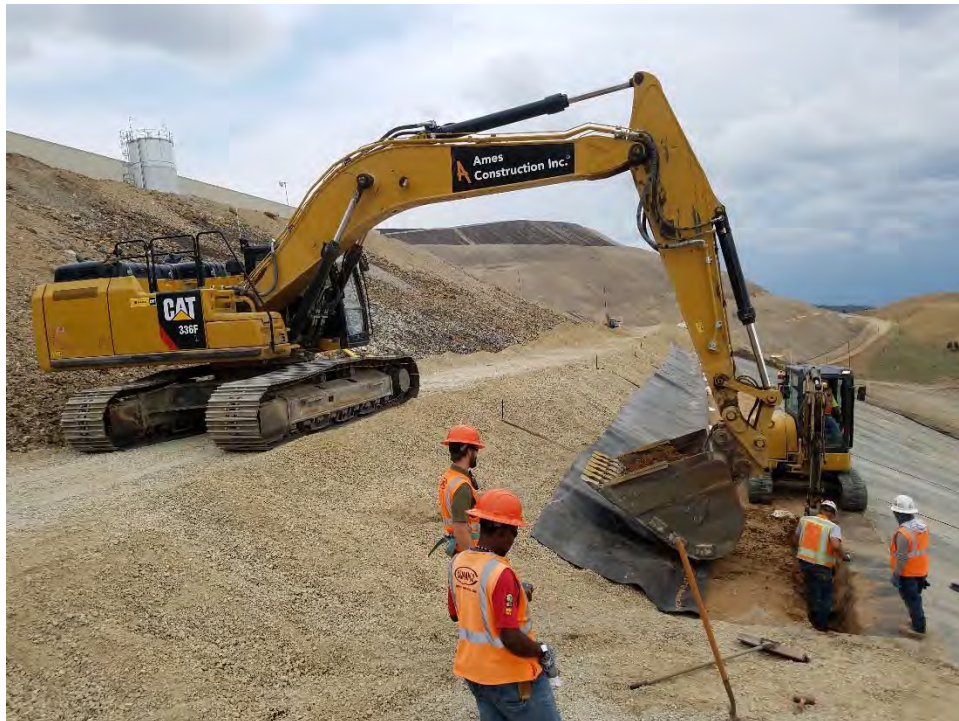
**Anchor Trench Excavation**

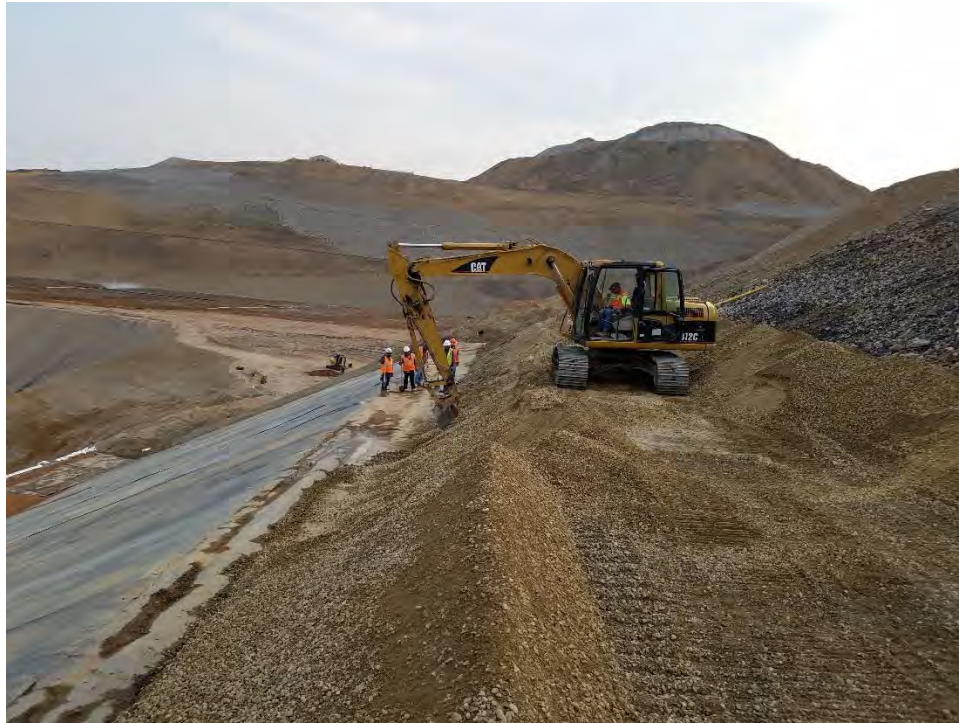
**DCF Removal**

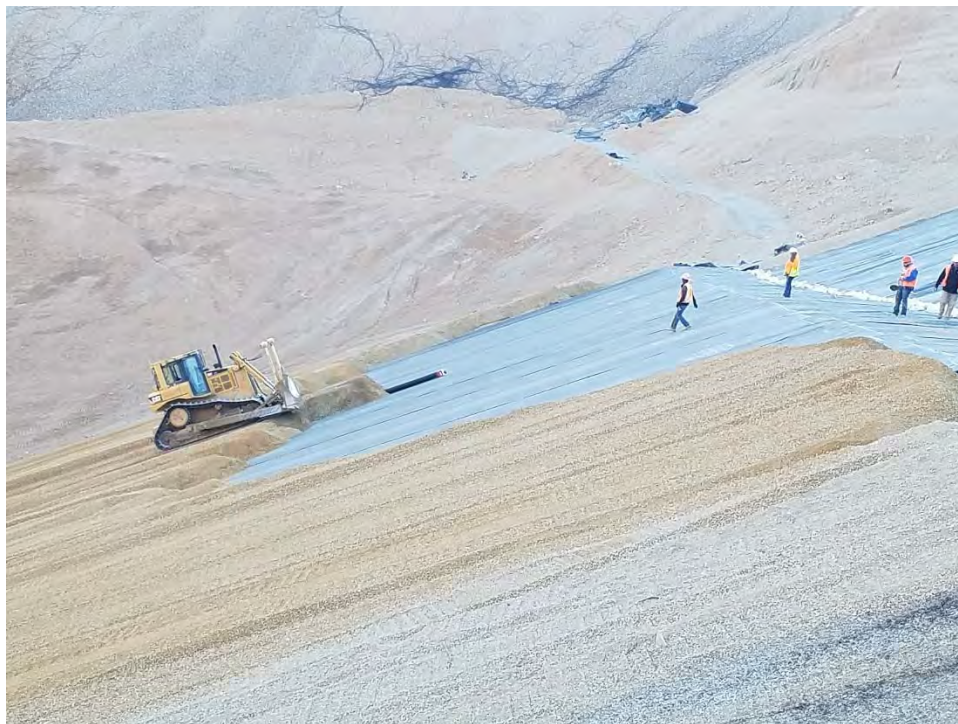
**DCF Placement**

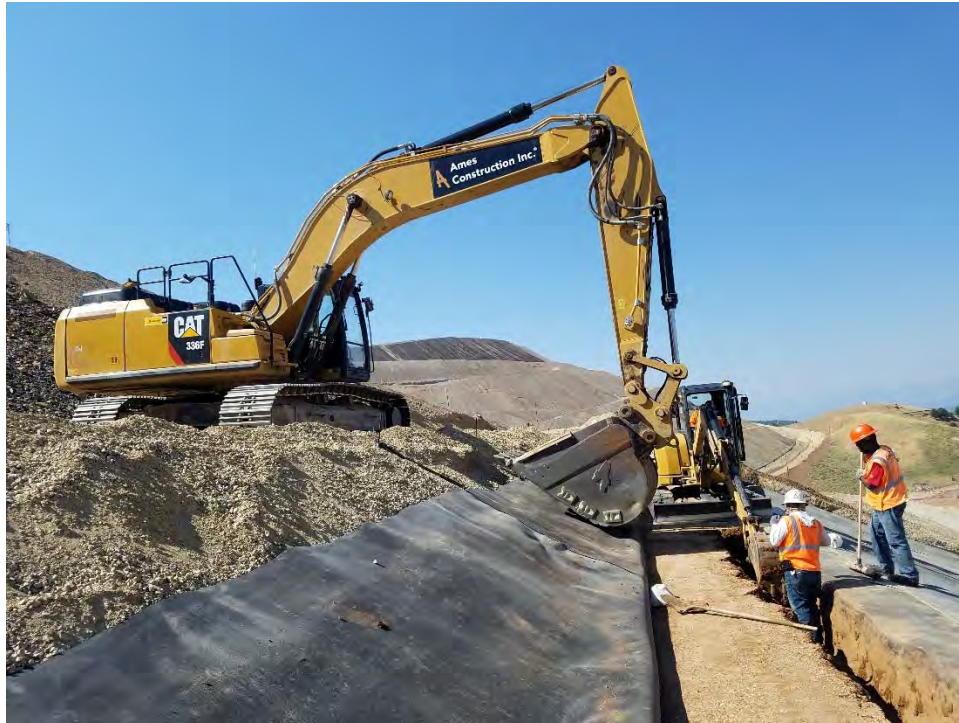
**Anchor Trench Excavation**

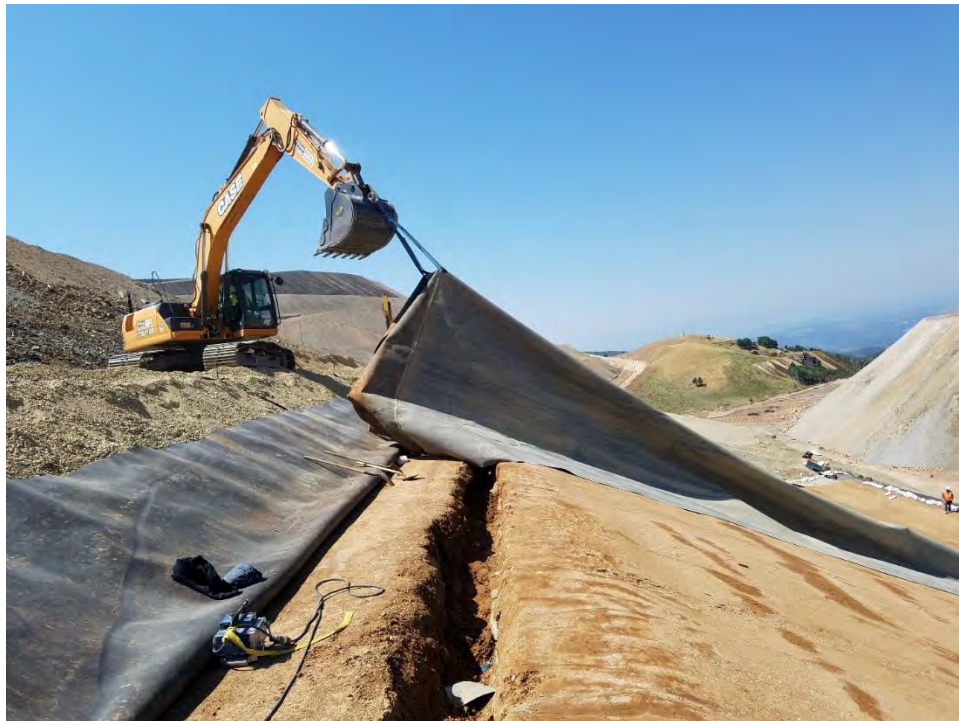
**Geomembrane Removal**

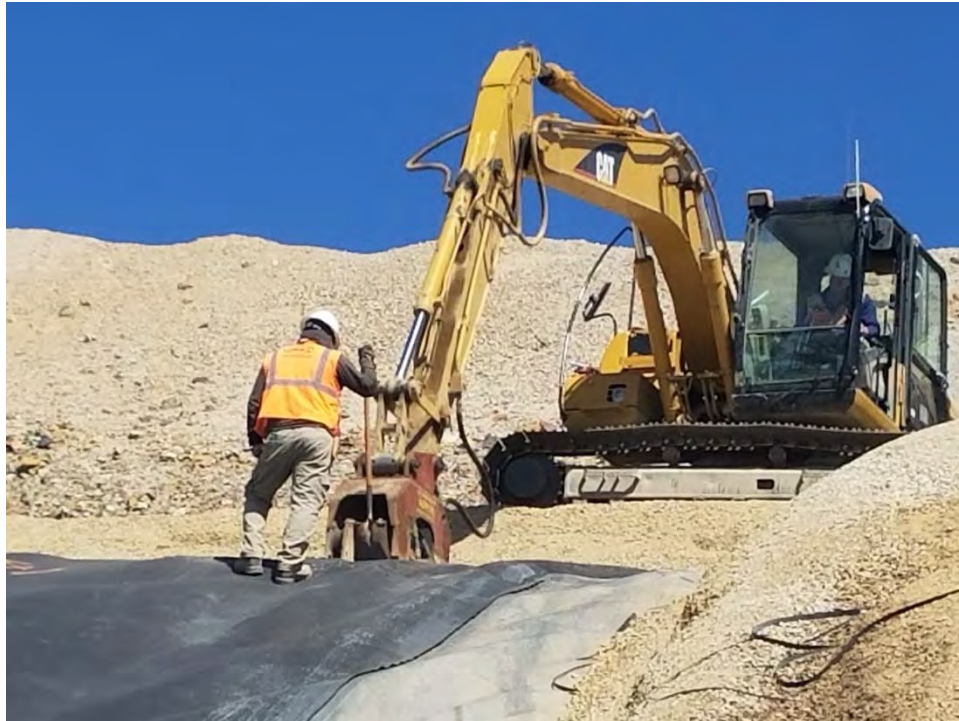
**Anchor Trench Backfill**

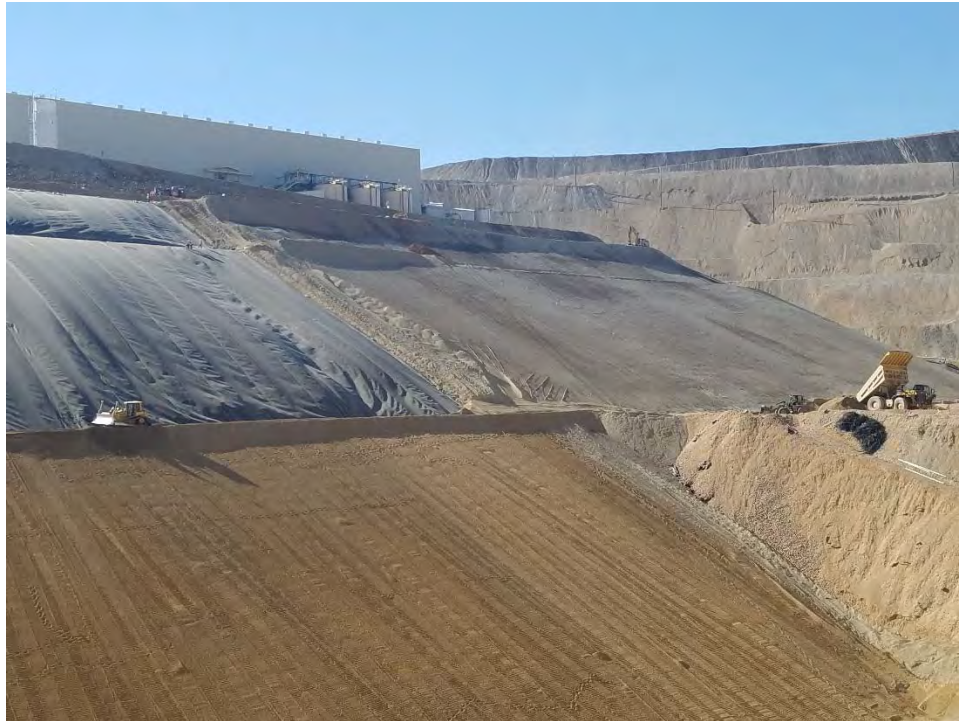
**DCF Placement**

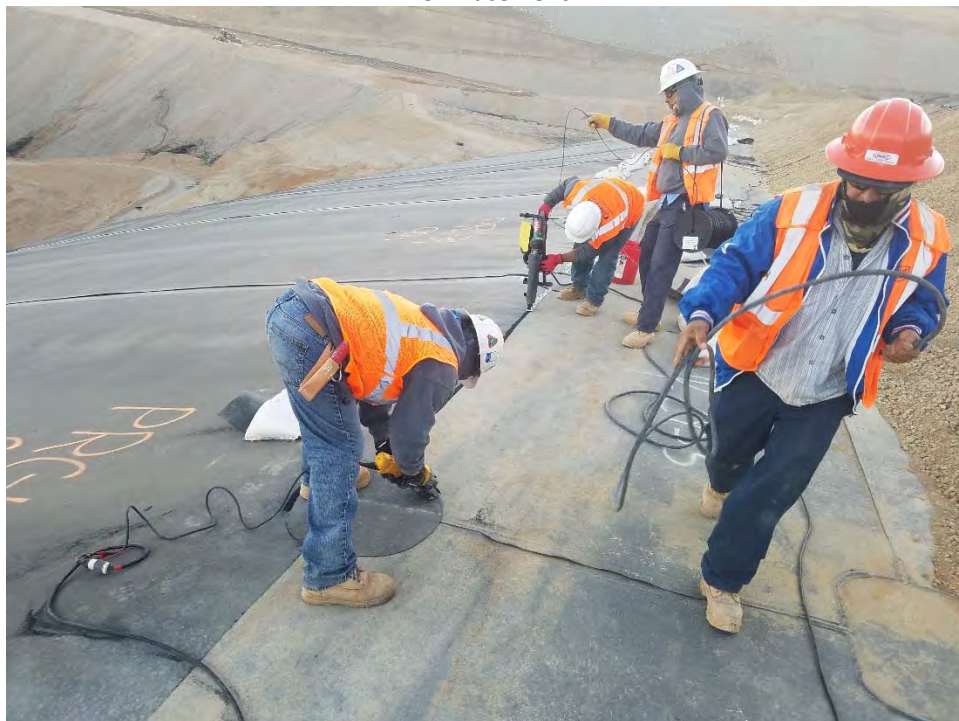
Repairs were performed using the extrusion welding method. A total of 46 linear feet of extrusion seaming was completed. All repairs and extrusion welded seams were vacuum tested during the shift. All the destructive testing was performed and met project specifications.

**Extrusion Seaming and Repairs Performed**
