## TR100 VLF2 Recertification (9750-9900)

Attachment 2:  
Record of Construction Report  
VLF2 Recertification Project  
Subgrade and Geomembrane 9750' – 9900' Elevations

## **VLF2 RECERTIFICATION PROJECT RECORD OF CONSTRUCTION REPORT FOR SUBGRADE AND GEOMEMBRANE 9750' – 9900' ELEVATIONS**

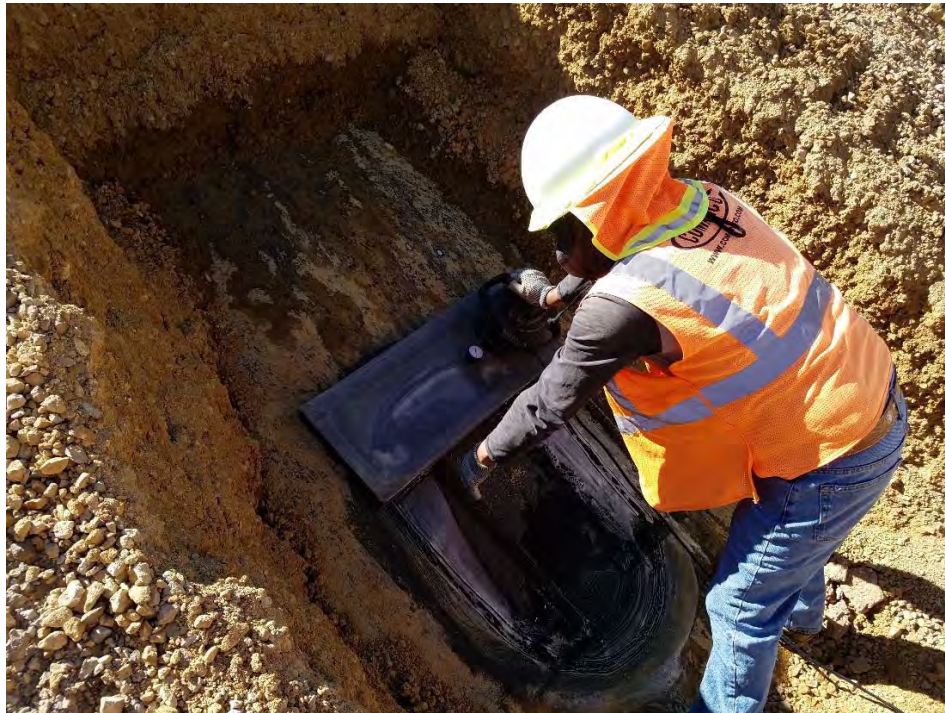
After geomembrane repairs were vacuum tested and approved, a CAT D6T LGP dozer was used to backfill the nuclear density test holes.

**Vacuum Testing**

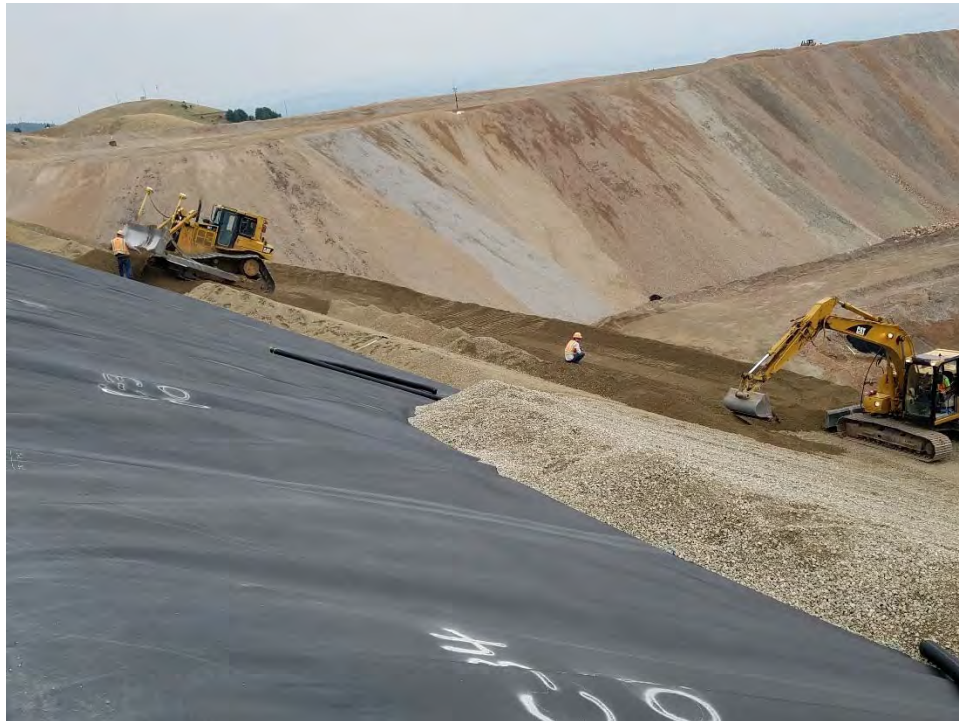
**DCF Placement**

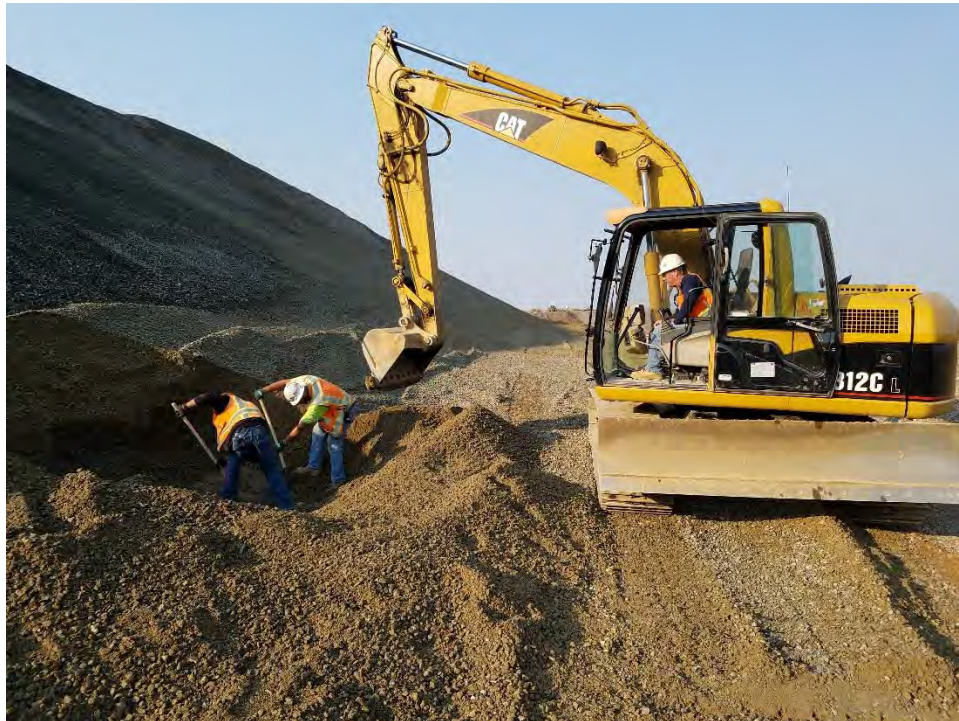
**Geomembrane Exposure**

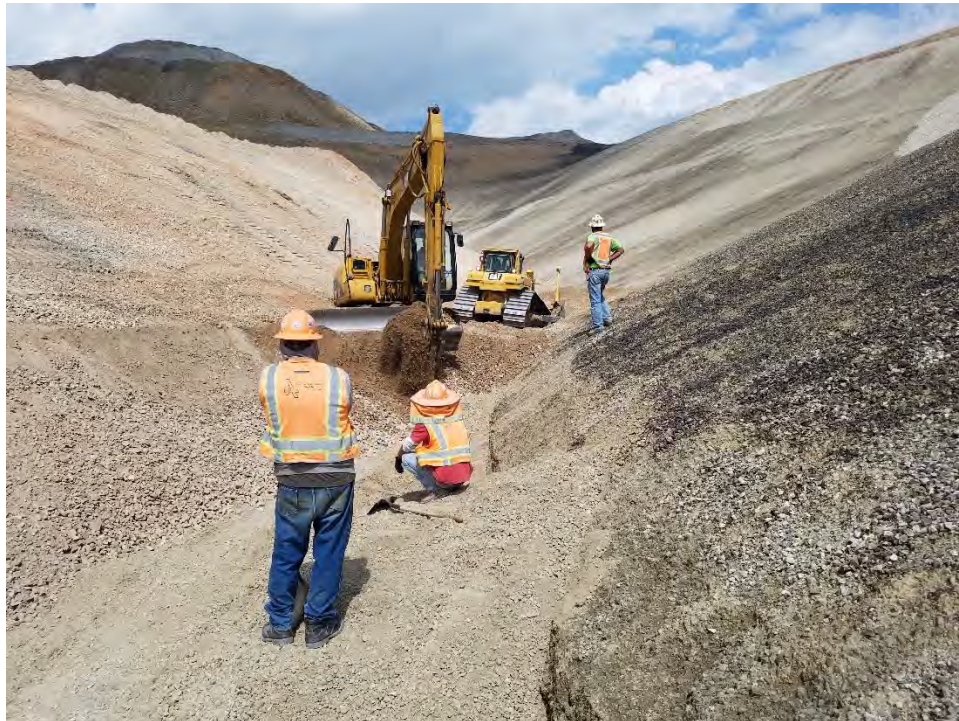
**Ore removal**
