Re: Cripple Creek & Victor Mining, Co., Cresson Project, M-1980-244; Review of Record of Construction Report, VLF2 Recertification Report, Subgrade and Geomembrane 9750 – 9900' Elevations.

Review of Record of Construction Report, VLF2 Recertification Report,
Subgrade and Geomembrane 9750-9900' Elevations
Response to Comments

October 5, 2018
NewFields Job 475.0106.026

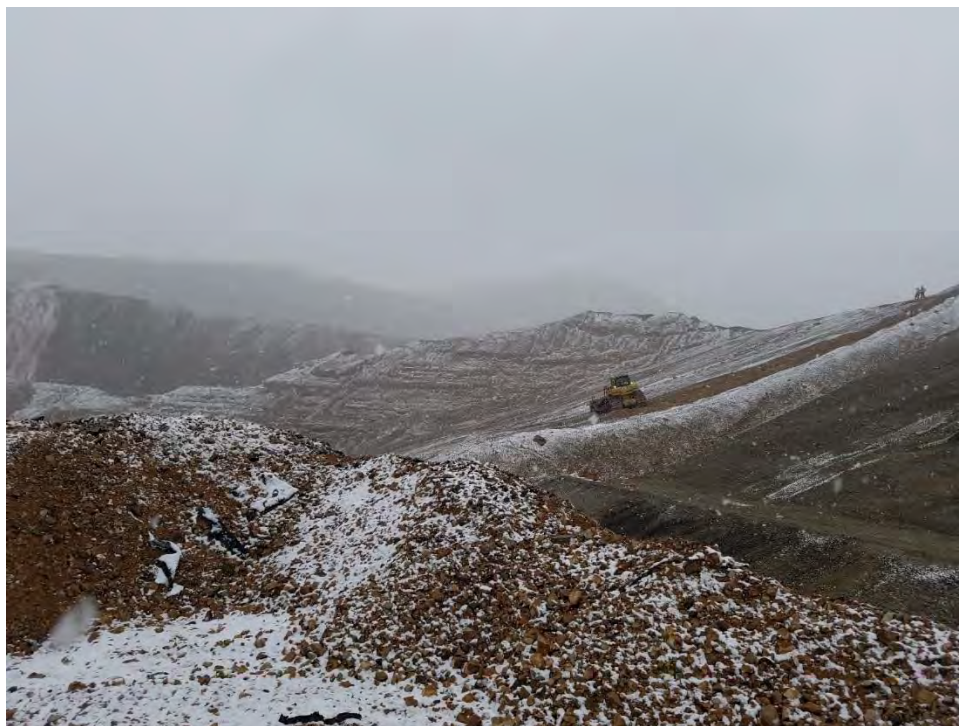
Ore removal

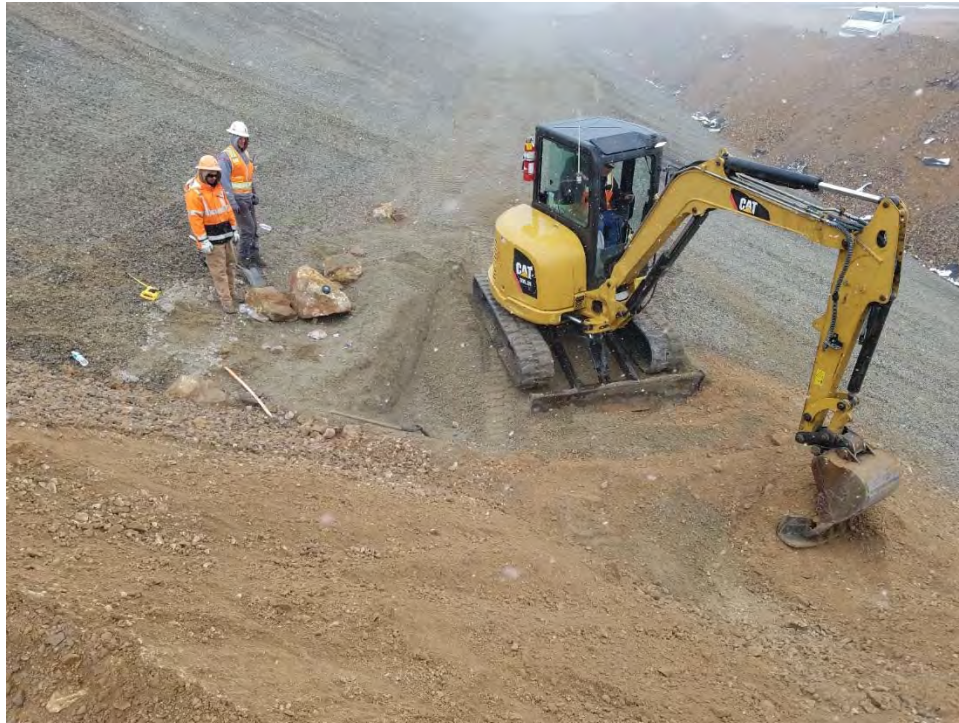
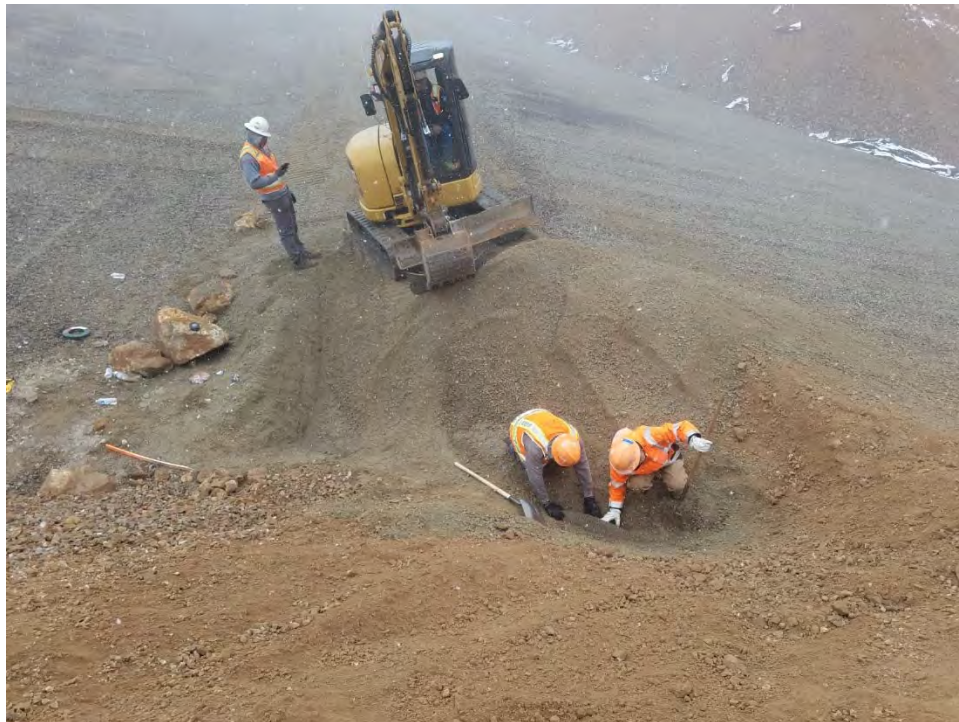
Exposing 4" CPe Pipe

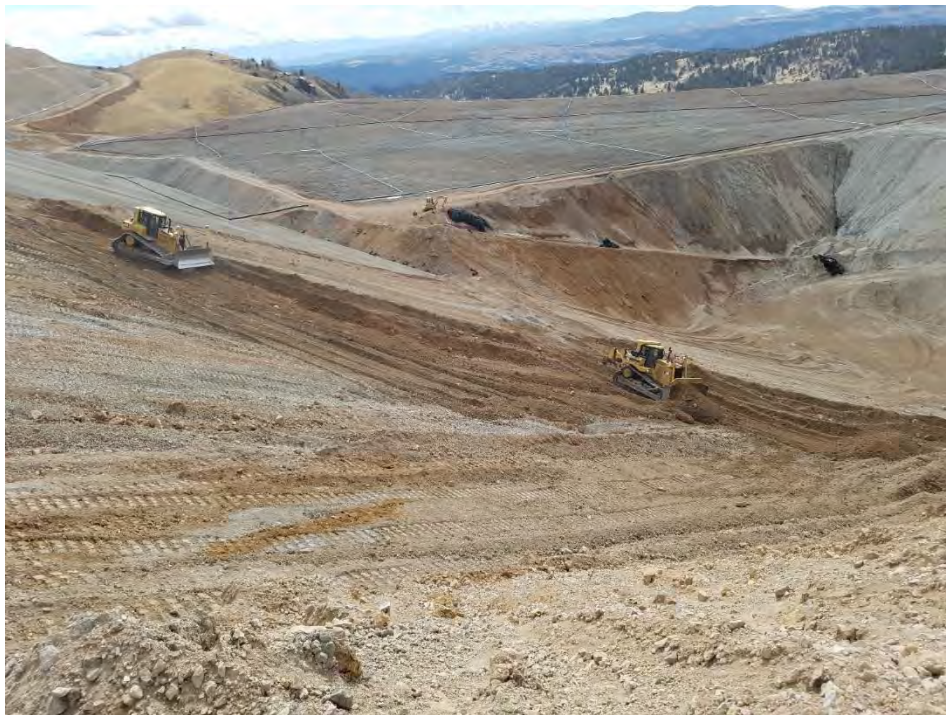
Ore removal

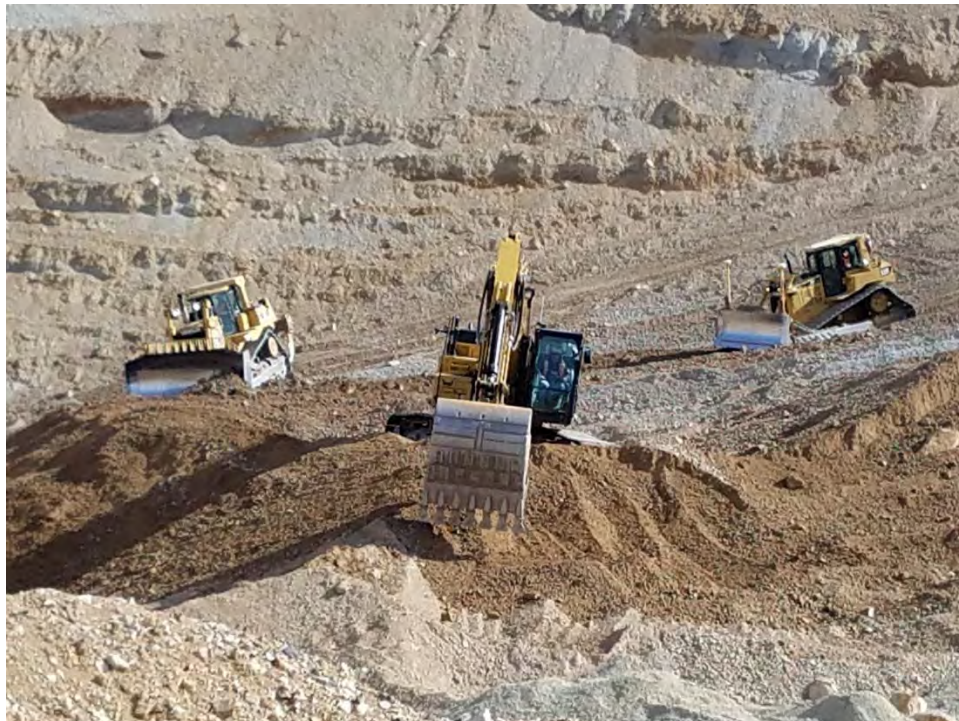
Ore Removal

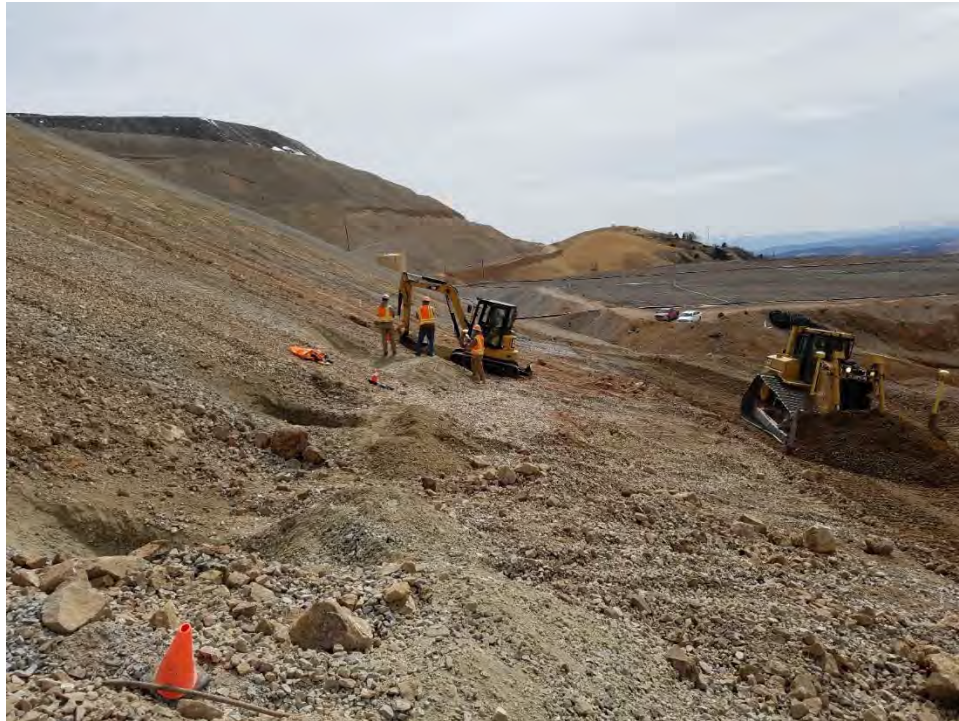
Exposing Geomembrane

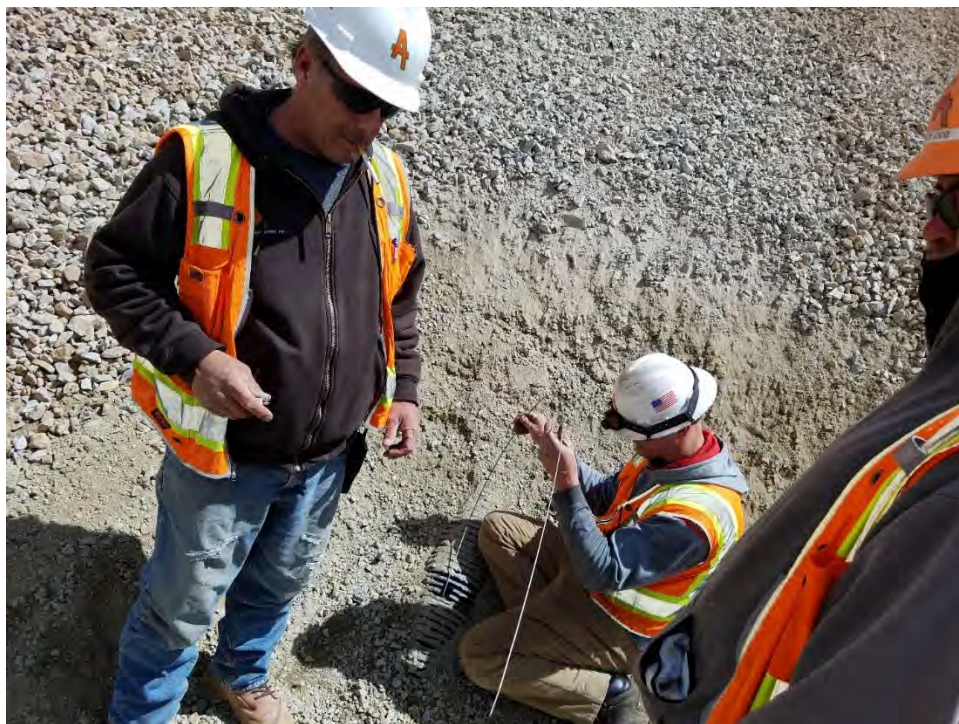
Pipe Measurement

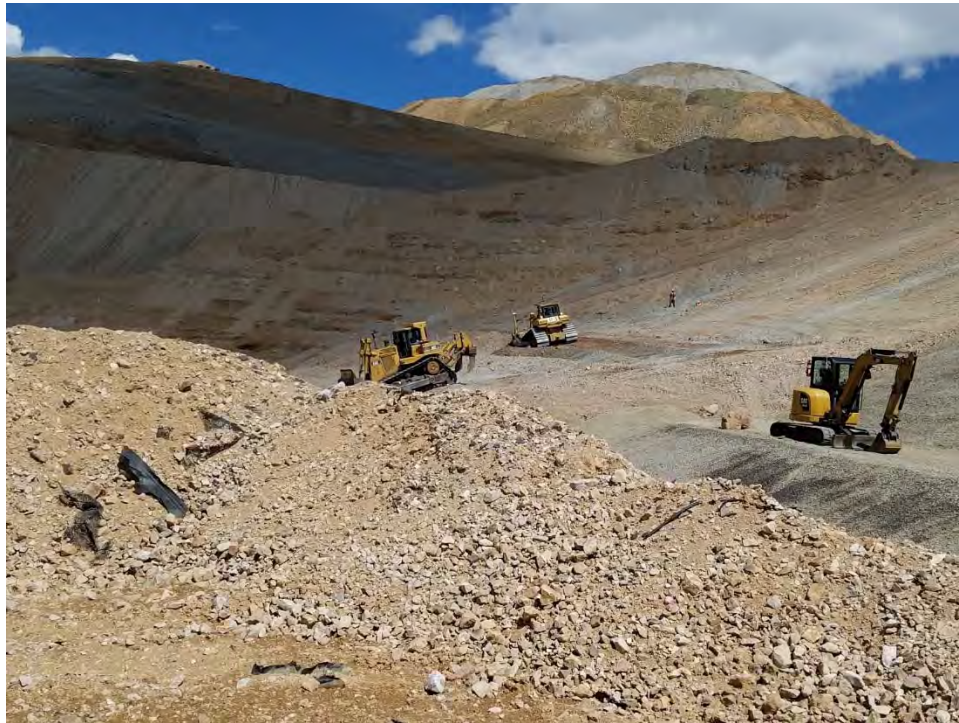
Ore Removal

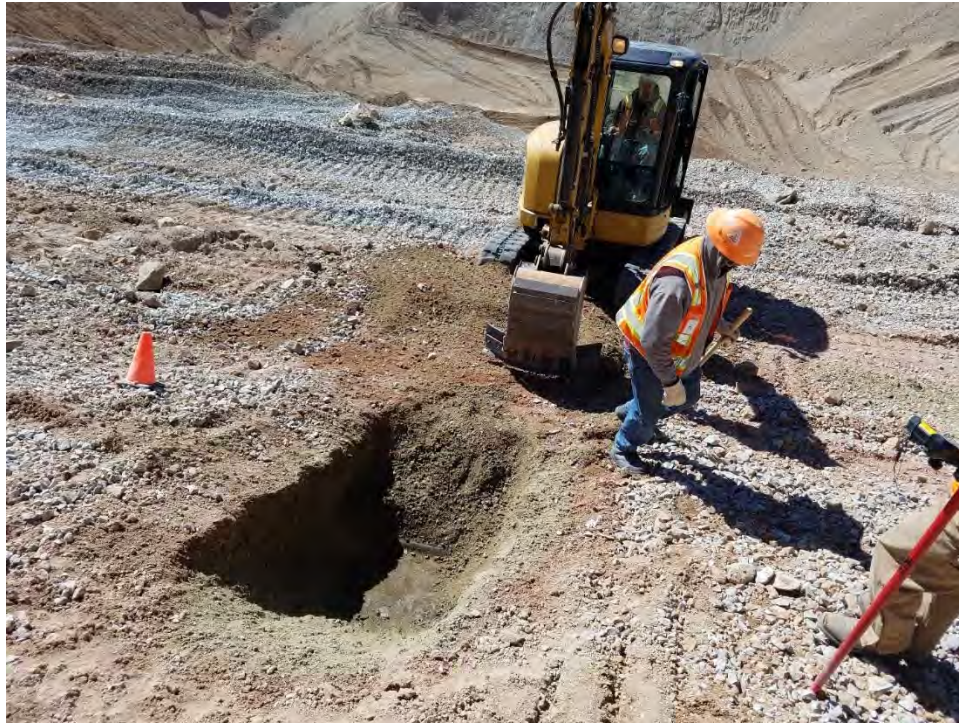
The mini excavator was utilized to excavate test pits to locate the geomembrane along the 9758' elevation. Six test pits were excavated at an interval of twenty feet. All liner and DCF materials were found to be in place as installed.

Excavating Test Pits

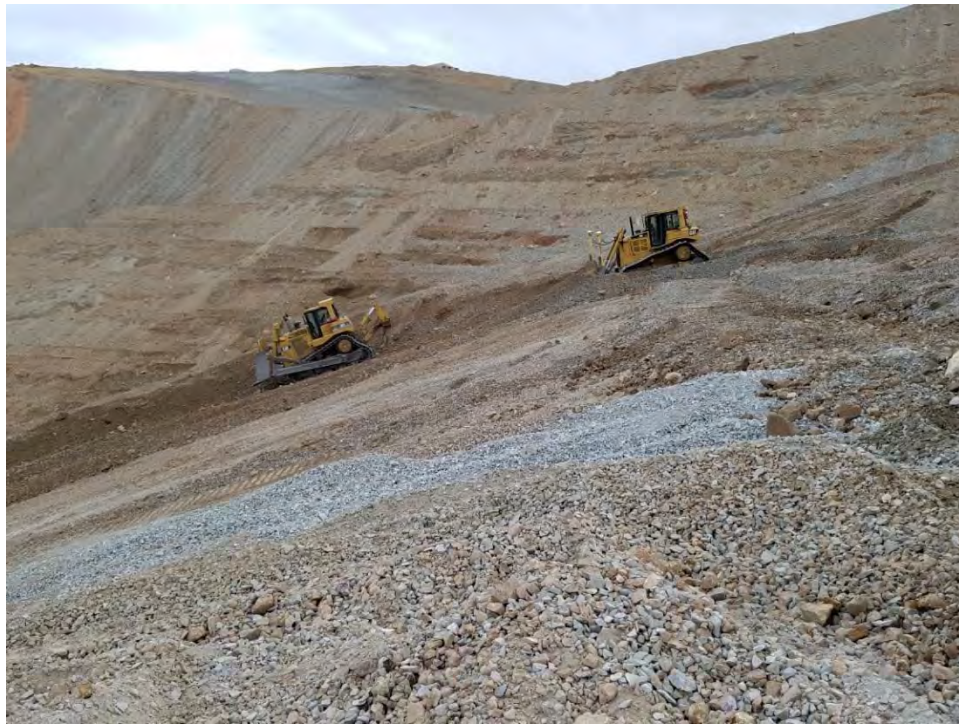
Ore removal

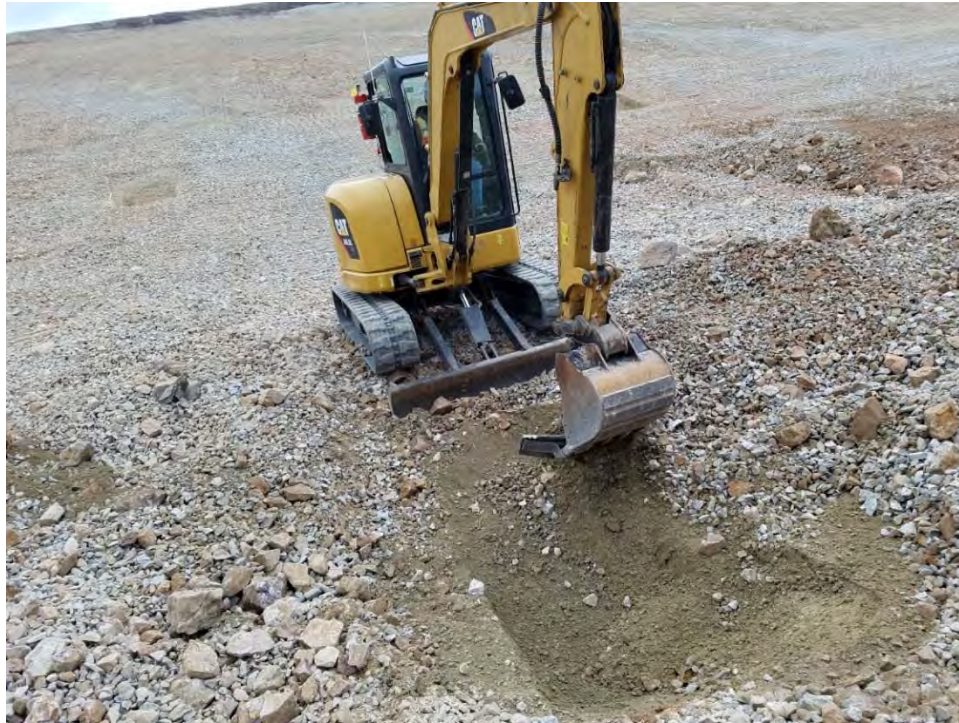
A mini excavator was used to excavate and locate an eight-inch CPe pipe near the 9750' bench approximately 80' west of the previously measured eight-inch pipe. The pipe was disconnected at the joint and measured using a fish tape. The pipe appeared to be blocked at approximately 42.5' down slope. The DCF material was soft and moist near the opening in the eight-inch pipe.

Eight-inch CPe pipe Exposure

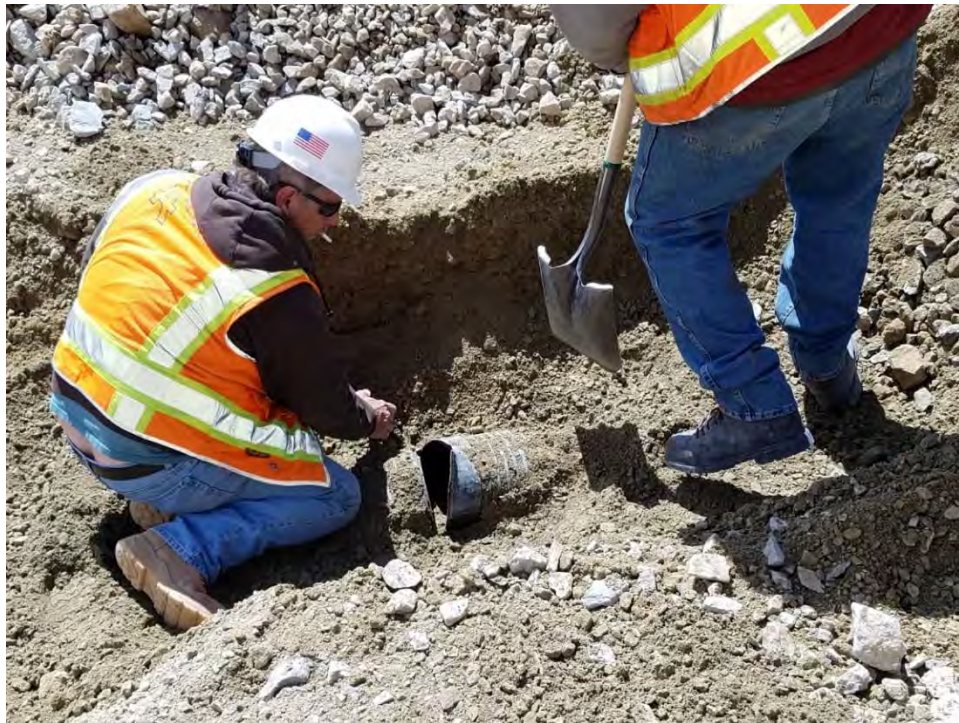
Pipe Disconnection

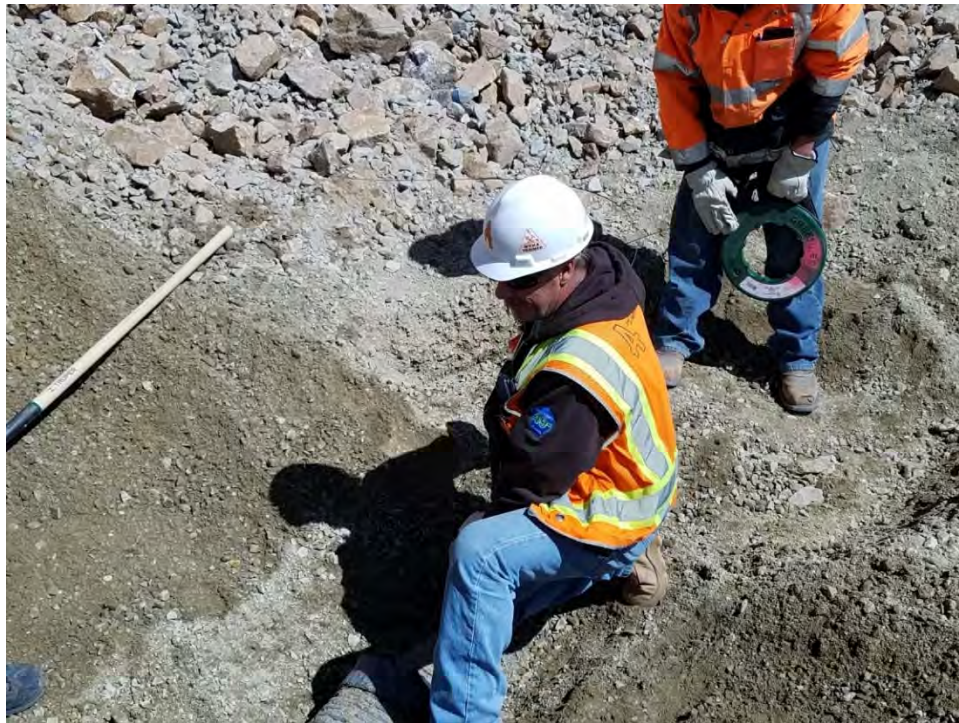
Pipe Measurement

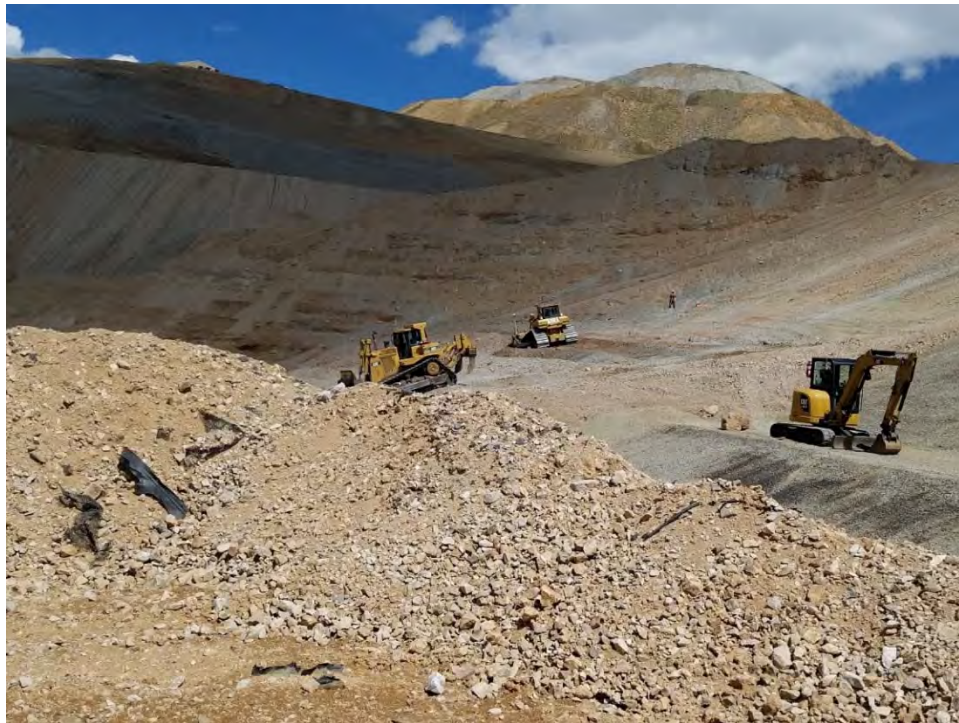
Ore Removal

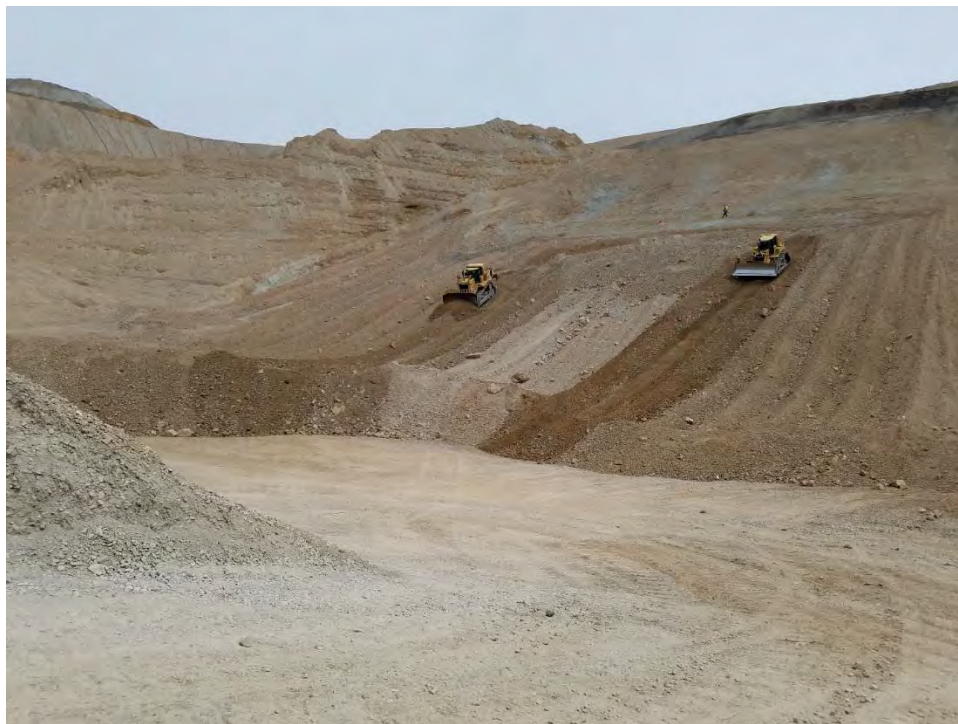
Ore Removal

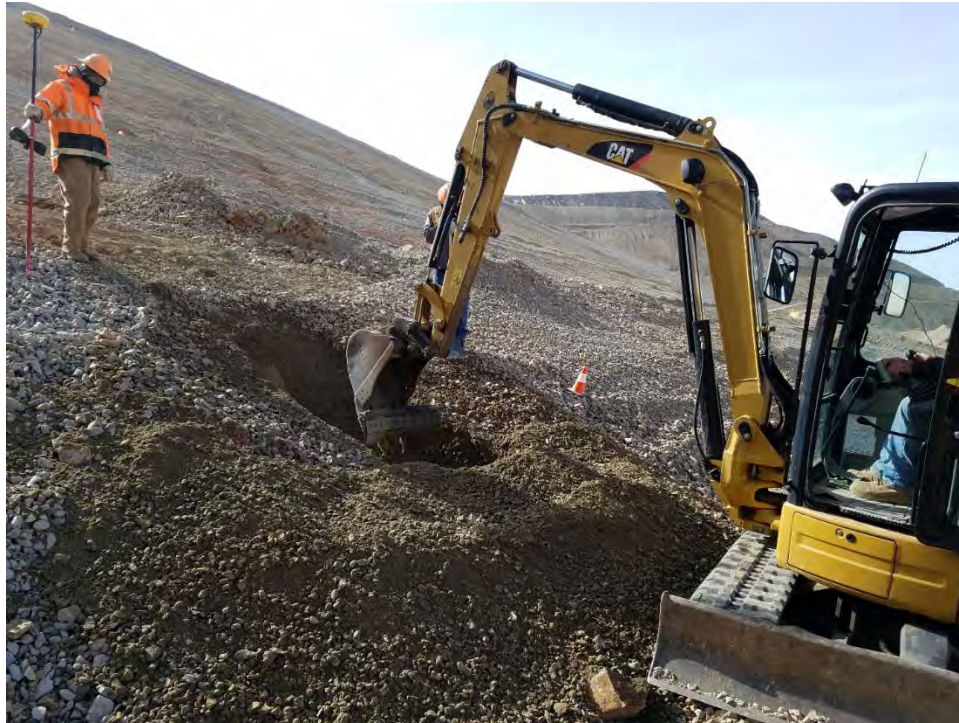
The mini excavator was used to excavate test pits to locate the geomembrane along the 9740' elevation. Nine test pits were excavated at an approximate interval of 20'. All existing DCF, geomembrane, and pipe exposed were found to be undisturbed and in as-built condition.

Test Pit Excavation

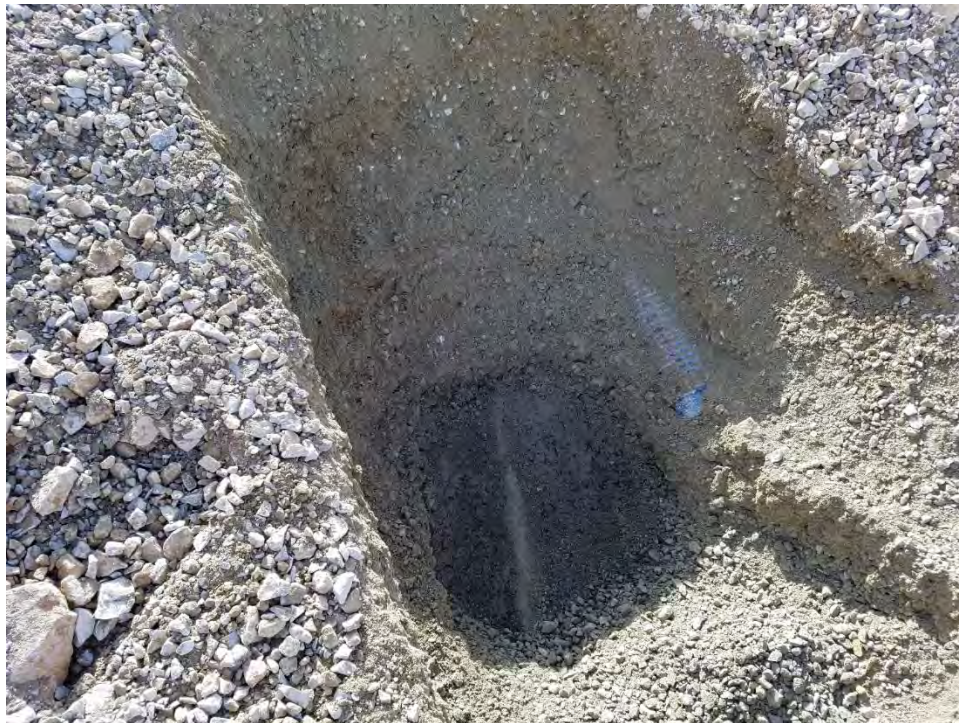
Exposed Pipe and Geomembrane

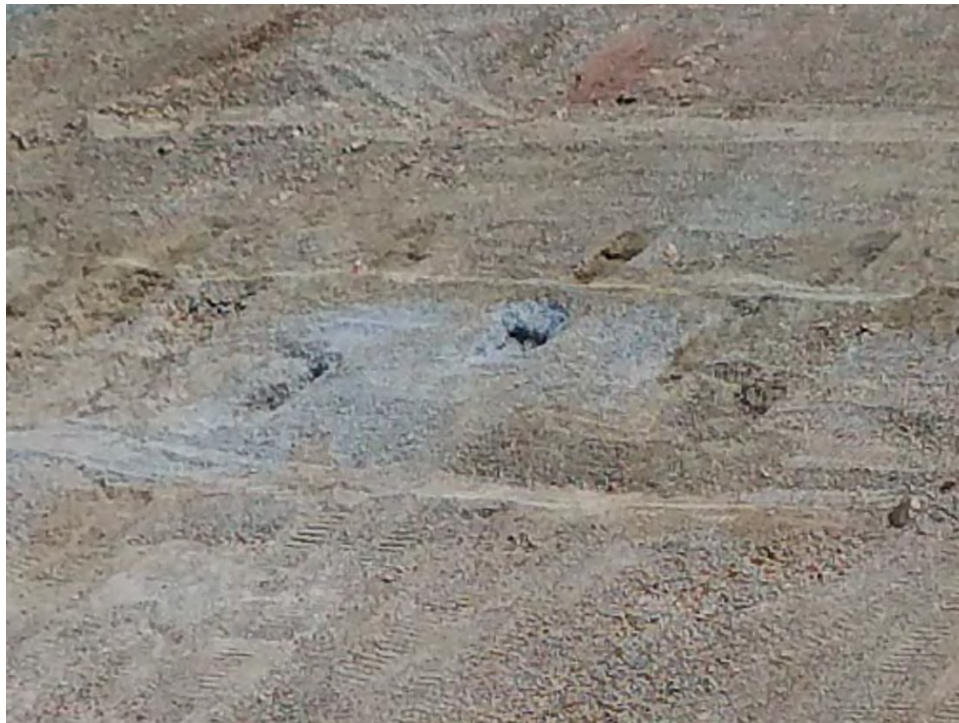
The mini excavator was used to excavate test pits to locate the geomembrane along the 9720' elevation. Seventeen test pits were excavated at an interval of approximately ten-feet. A damaged area of geomembrane was discovered. The excavation continued with a D6T LGP dozer and a mini excavator to identify the extent of the geomembrane damage. The damage is currently found to be approximately 200' wide running along the 9720' elevation and extends into the existing ore stockpile. Ore removal continued in the area between the 9720' and 9650' benches pushing downhill and stockpiling the material near the 9650' bench to allow for further investigation. All equipment worked on at least 2' of geomembrane cover at all times.

Excavated Test Pits

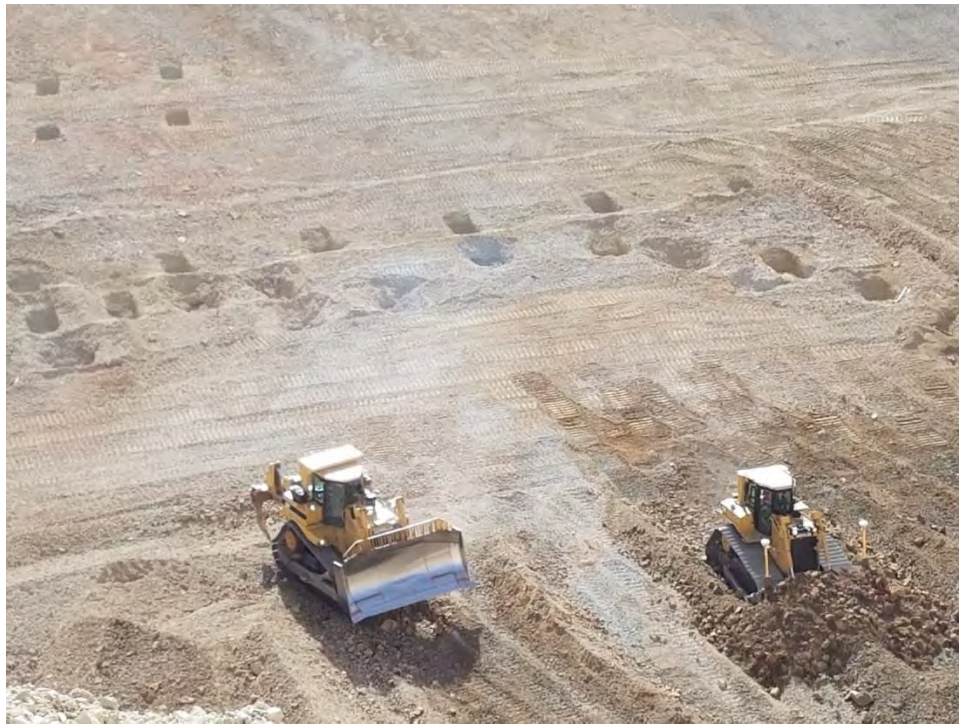
Ore Removal

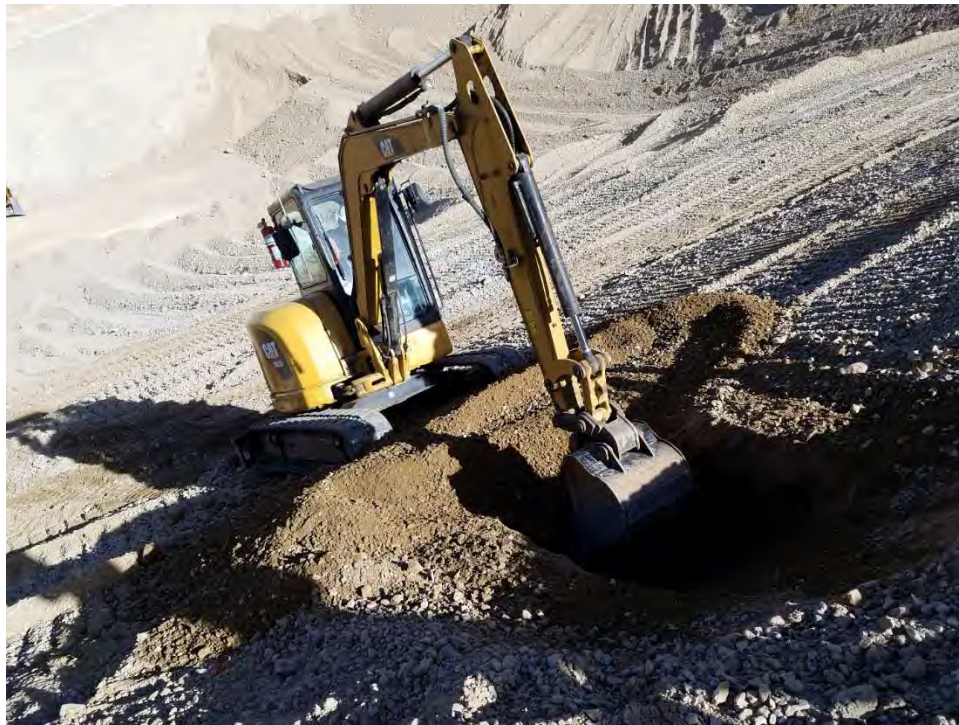
Geomembrane Exposure

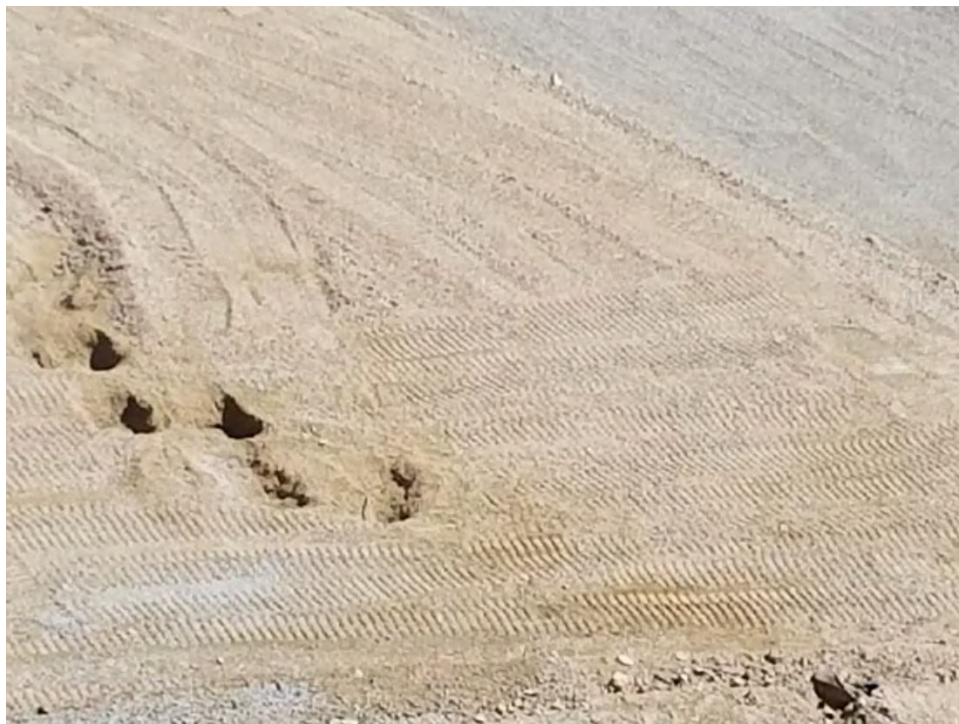
The mini excavator was used to excavate test pits to locate the geomembrane along the 9710' elevation. Five test pits were excavated at an approximate interval of ten feet. The damaged geomembrane was exposed to the toe of stockpile on the north side. Exposure of damaged geomembrane will continue on the south side tomorrow.

Excavated Test Pits

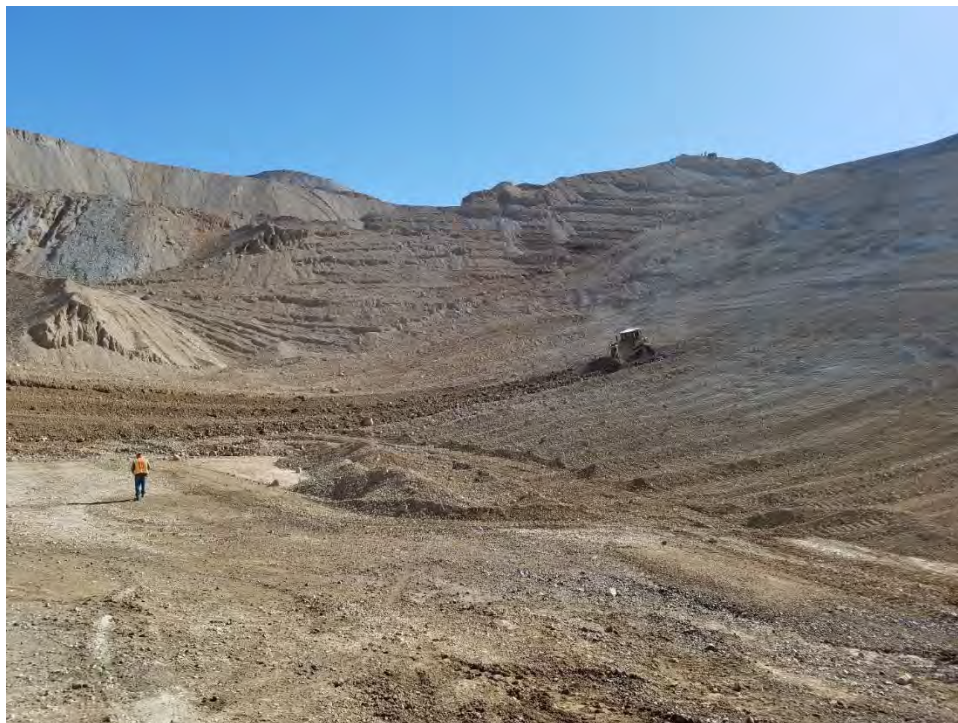
Ore Removal

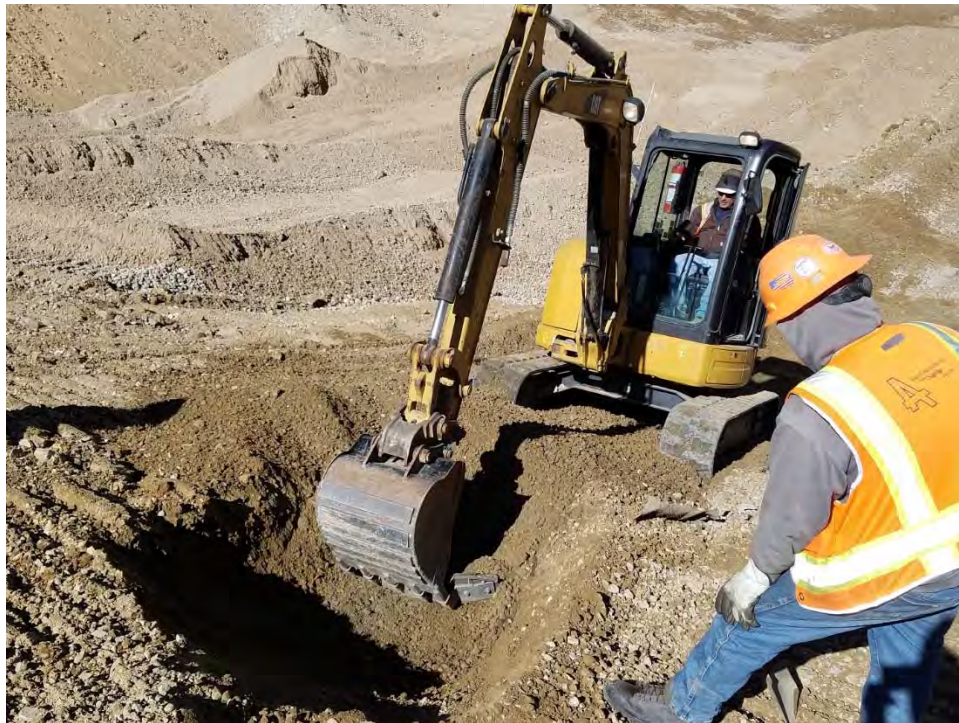
Geomembrane Exposure

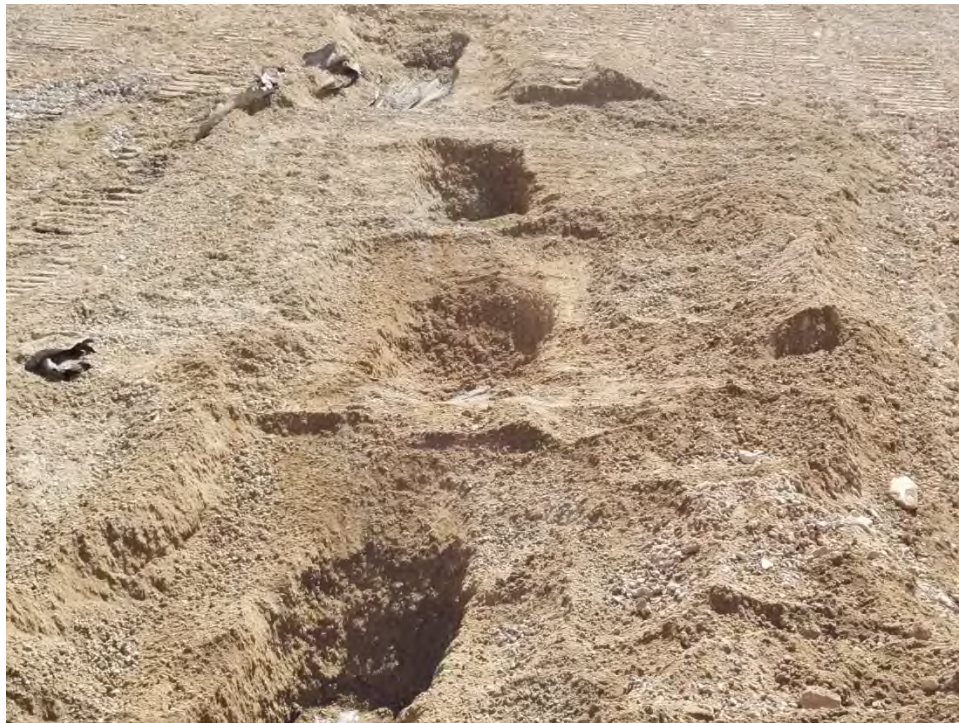
The mini excavator was used to excavate test pits locating the geomembrane along the 9660' elevation. Four test pits were excavated at an approximate interval of ten feet. Damaged geomembrane was exposed on the south side of the recertification area.

Excavated Test Pits

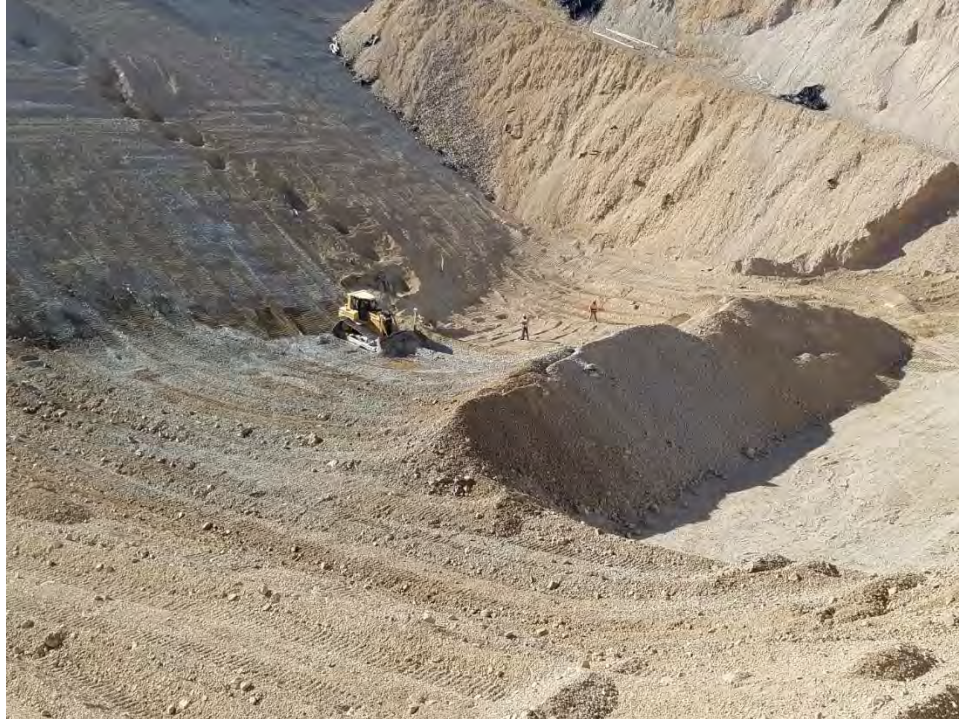
Ore Removal

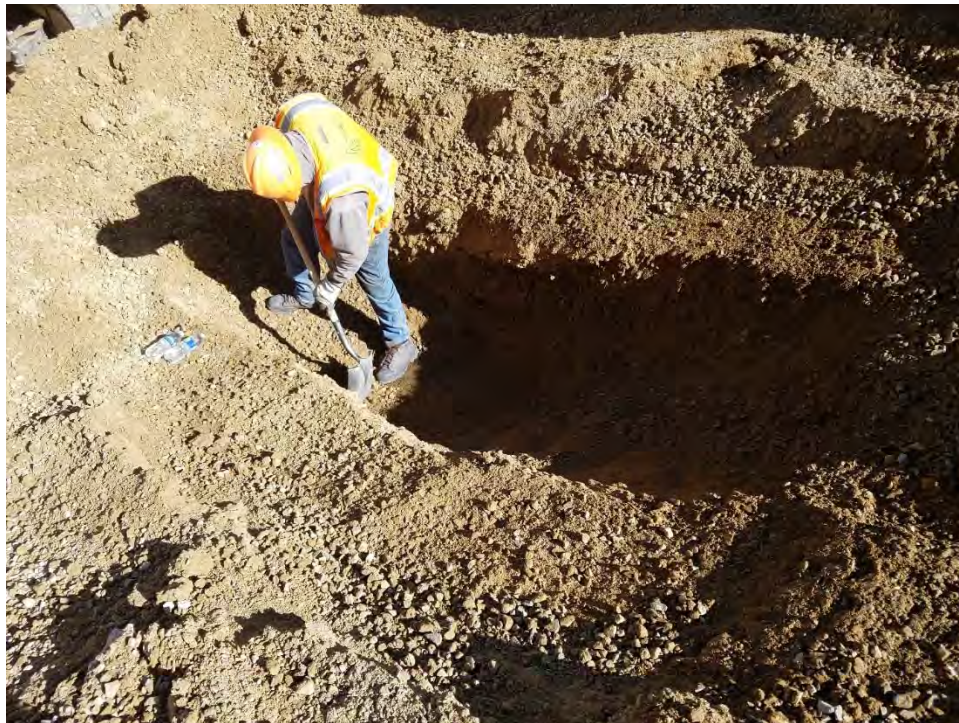
Geomembrane Exposure

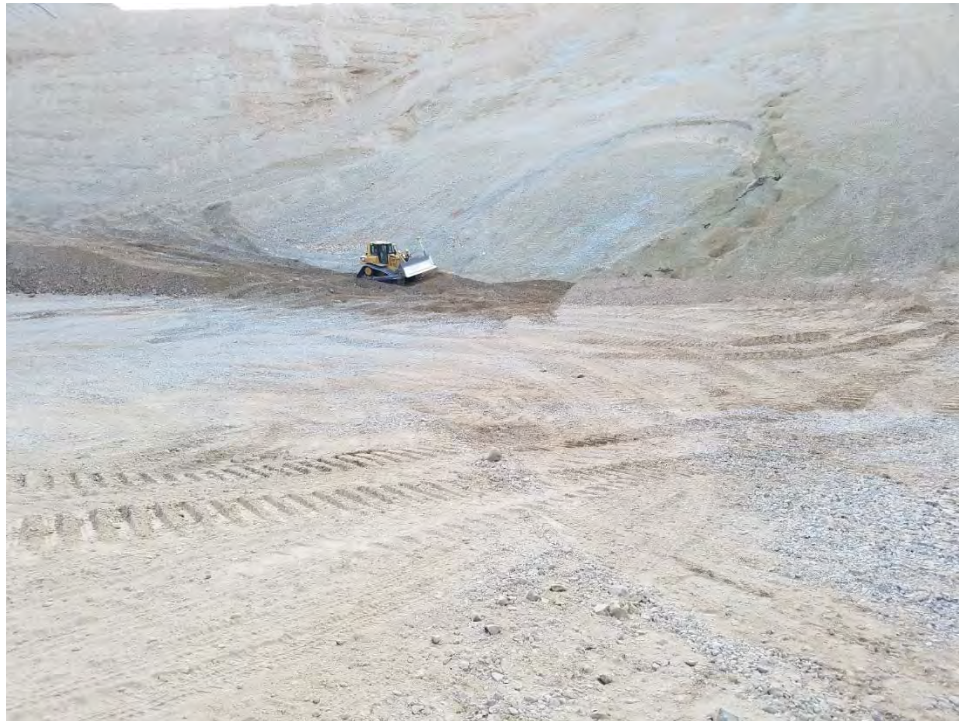
Buttress Construction

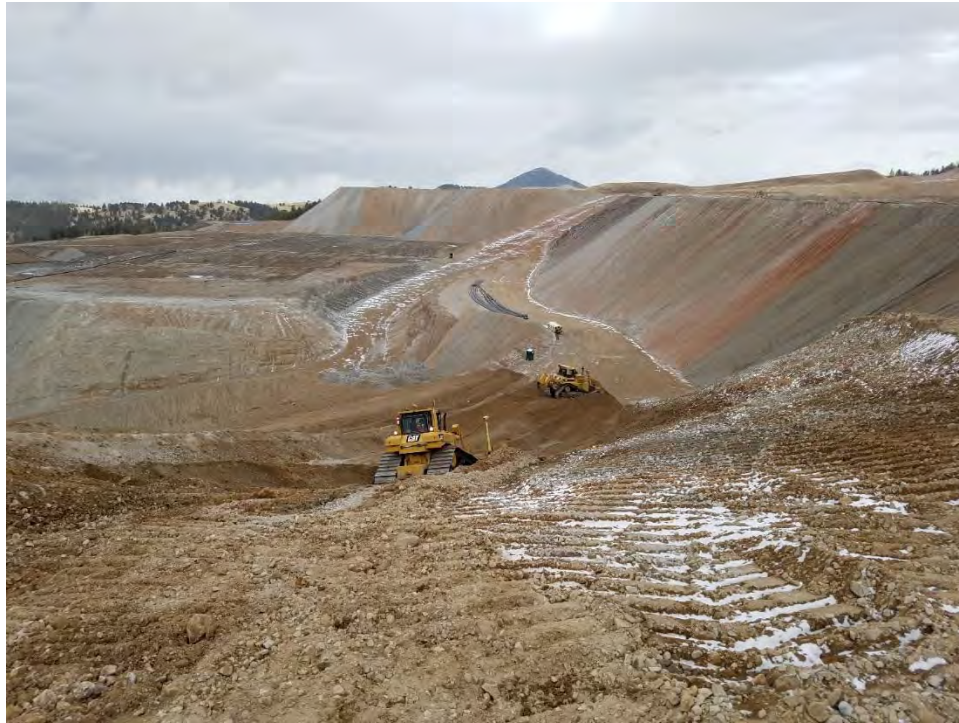
Ore Removal

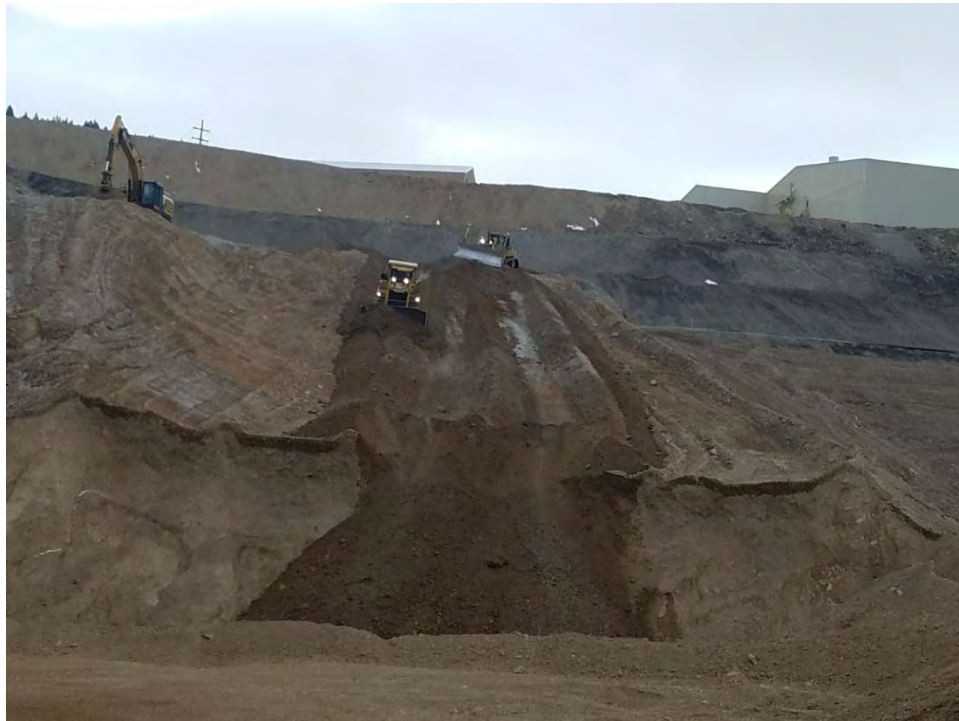
Ore Removal

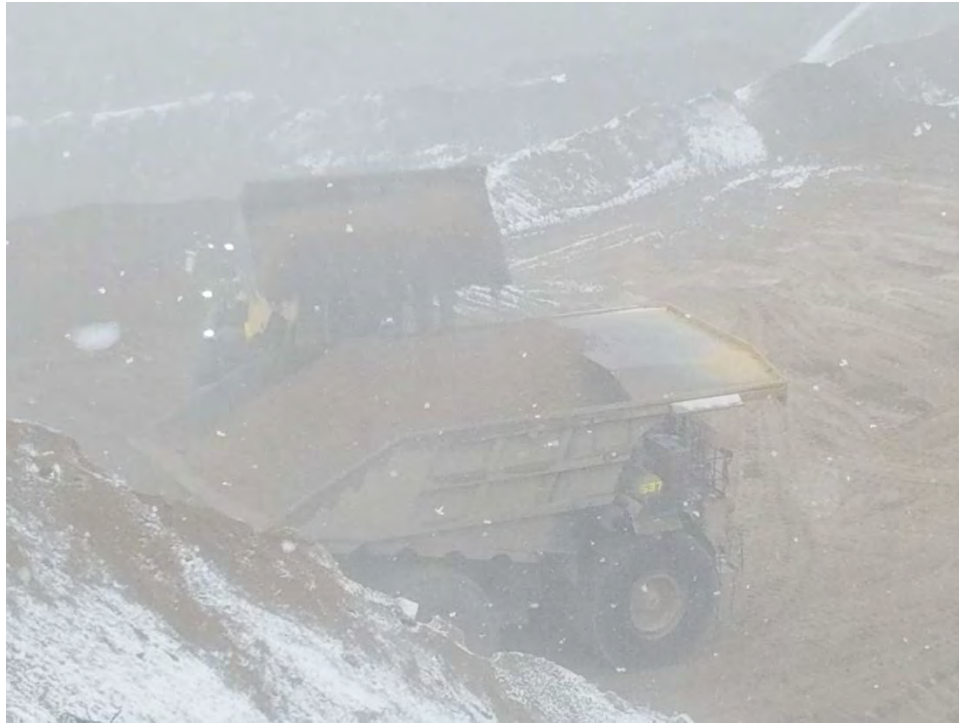
Mine Equipment Loading Ore

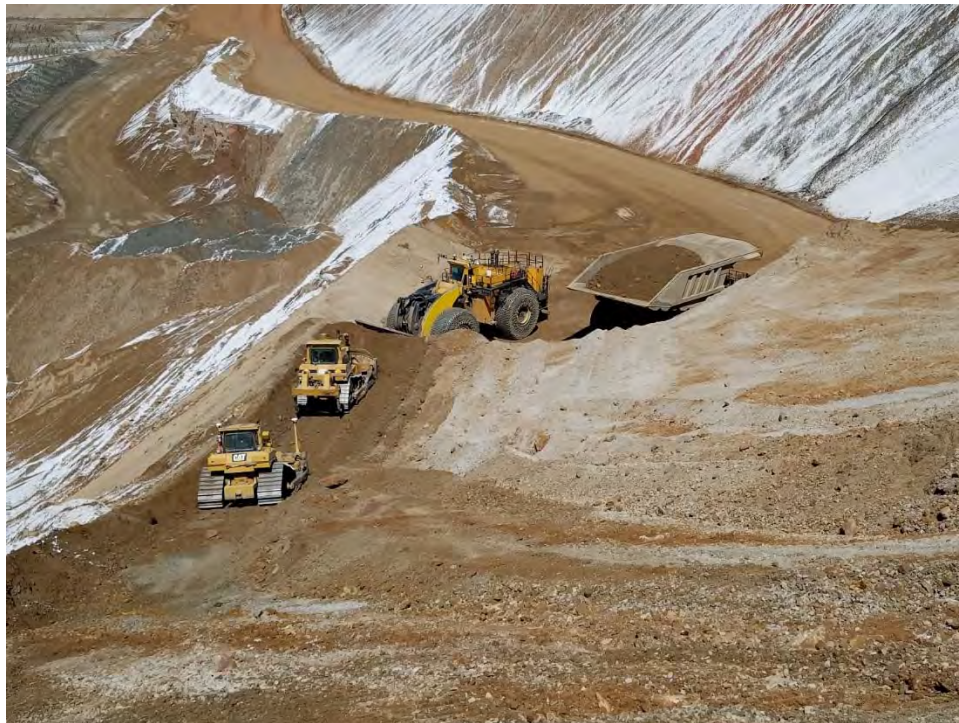
Ore Removal

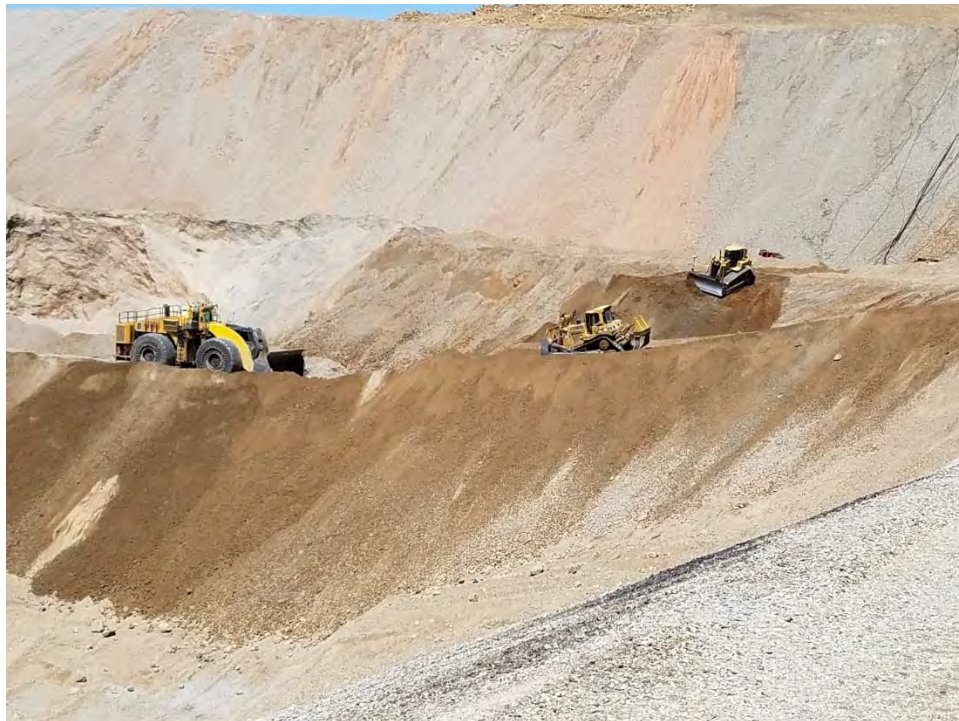
Ore Removal
