Re: Cripple Creek & Victor Mining, Co., Cresson Project, M-1980-244; Review of Record of Construction Report, VLF2 Recertification Report, Subgrade and Geomembrane 9750 – 9900' Elevations.

Review of Record of Construction Report, VLF2 Recertification Report,
Subgrade and Geomembrane 9750-9900' Elevations
Response to Comments

October 5, 2018
NewFields Job 475.0106.026

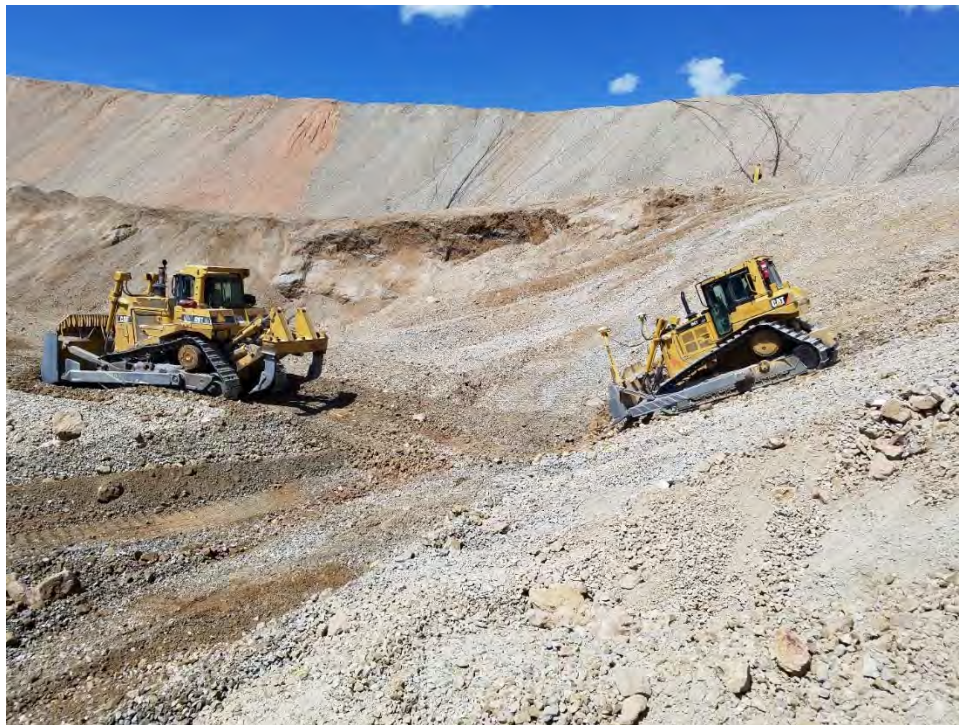
Ore Removal

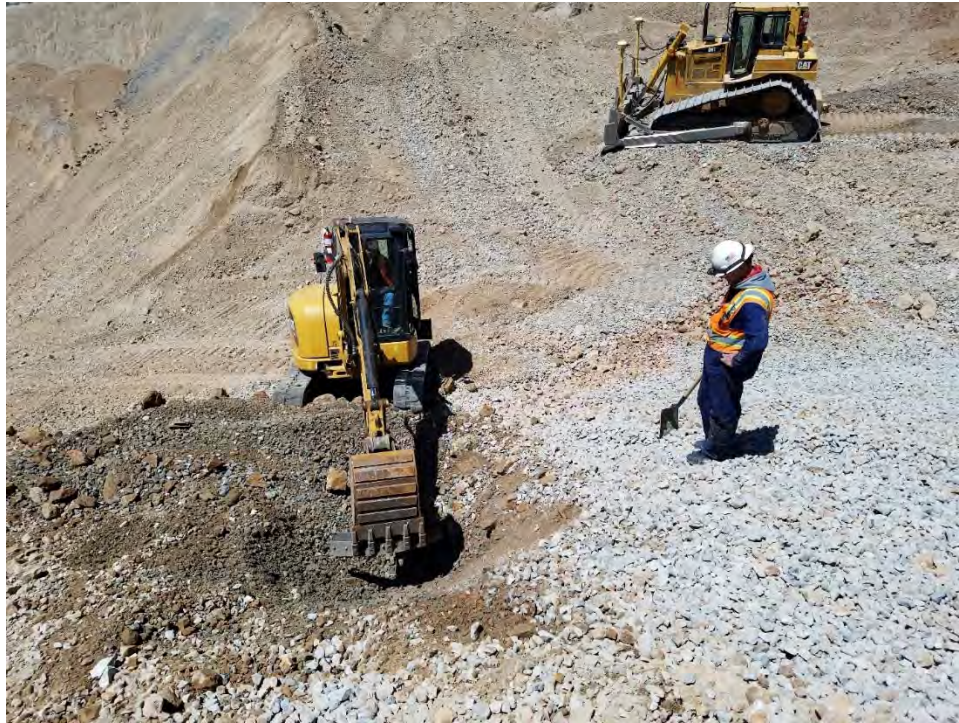
Test Pit Excavation

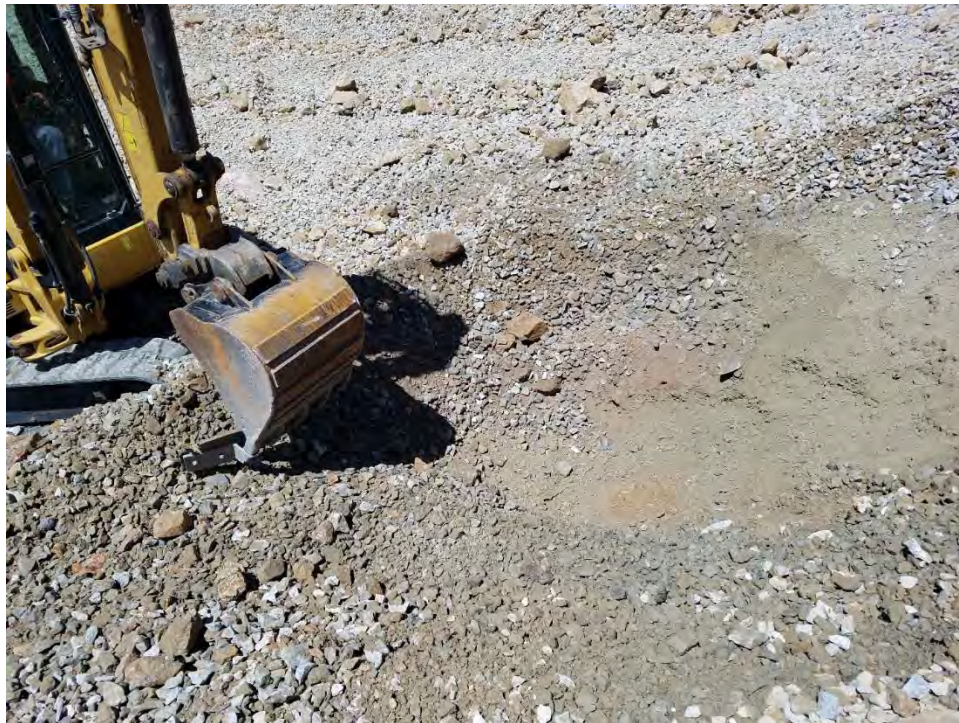
SLF Exposure

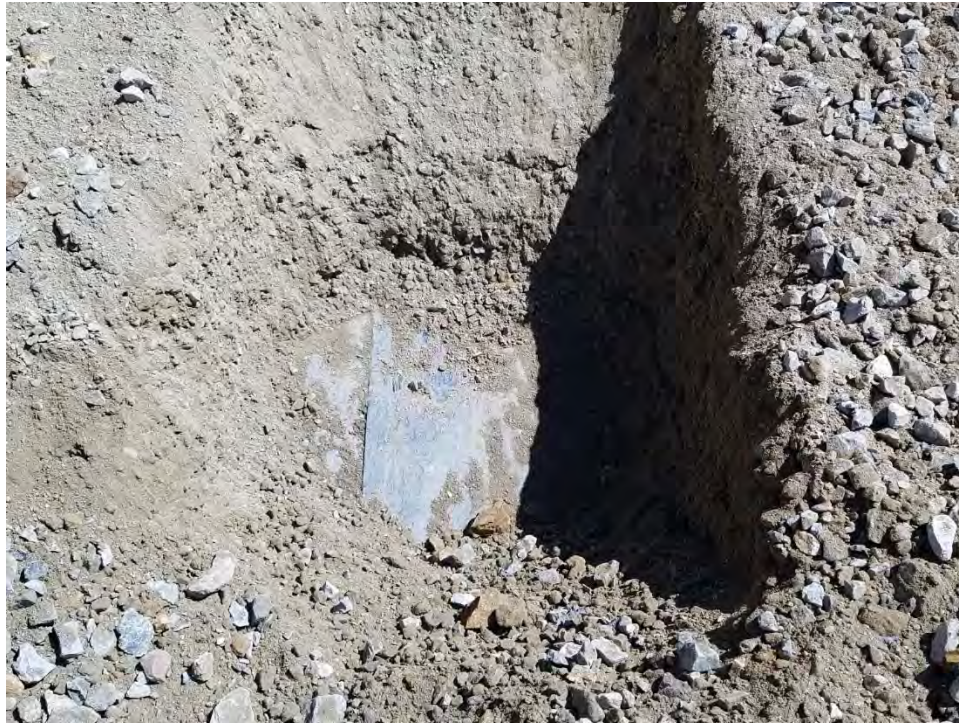
Geomembrane Exposure

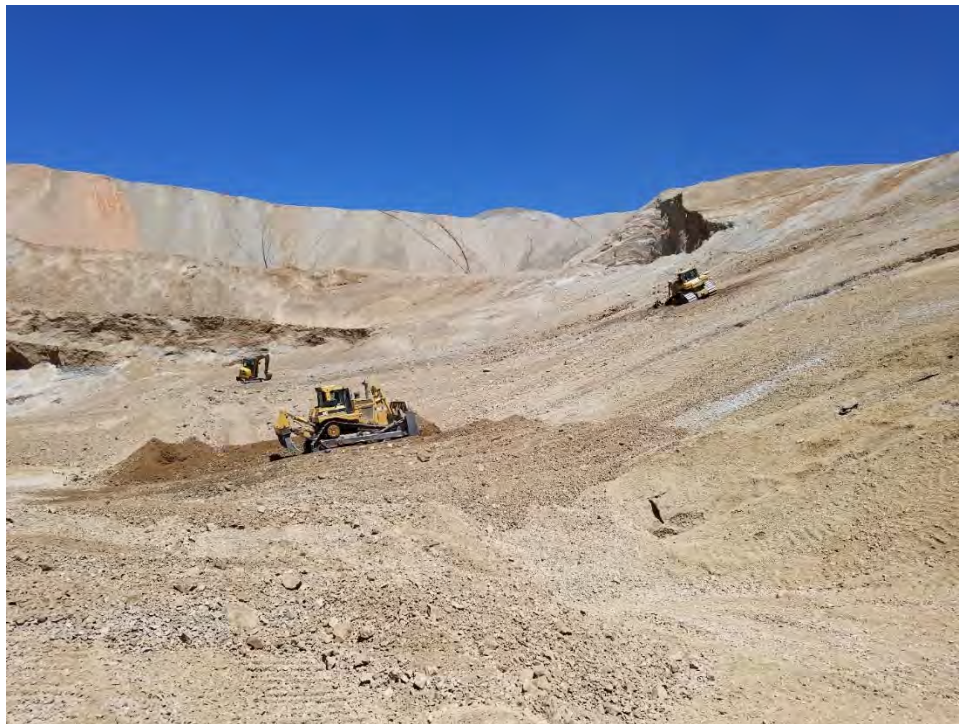
Ore Removal

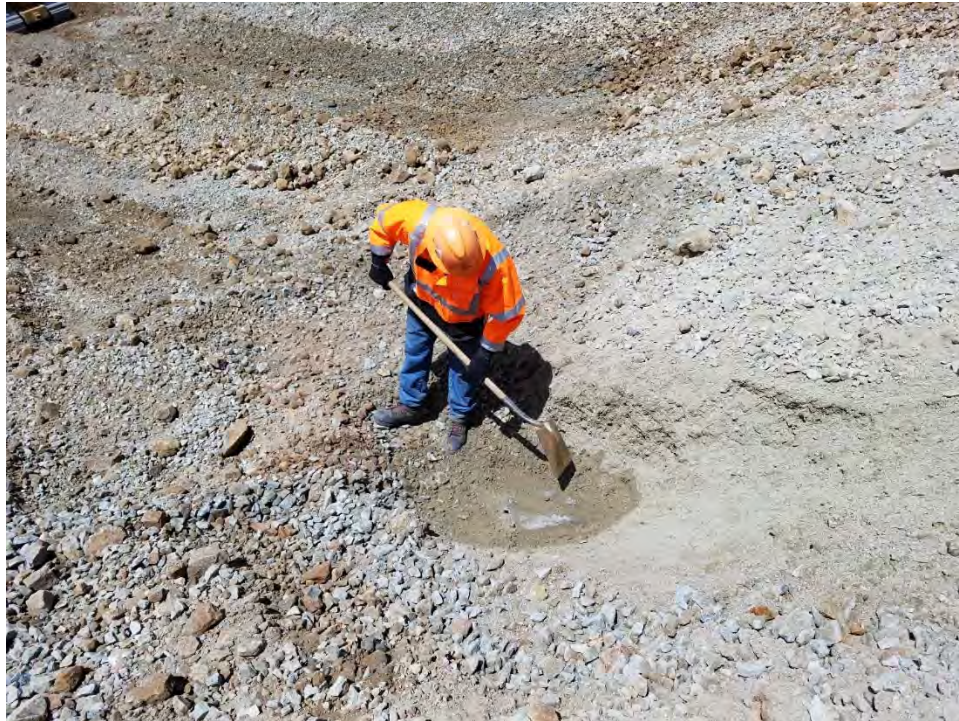
Geomembrane Exposed

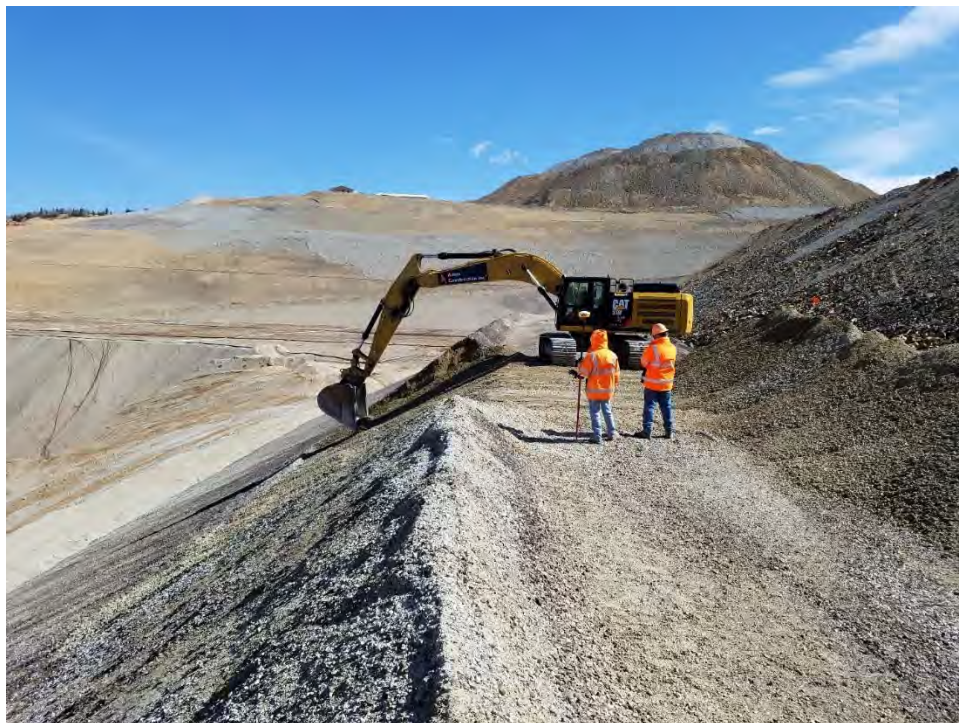
DCF removal

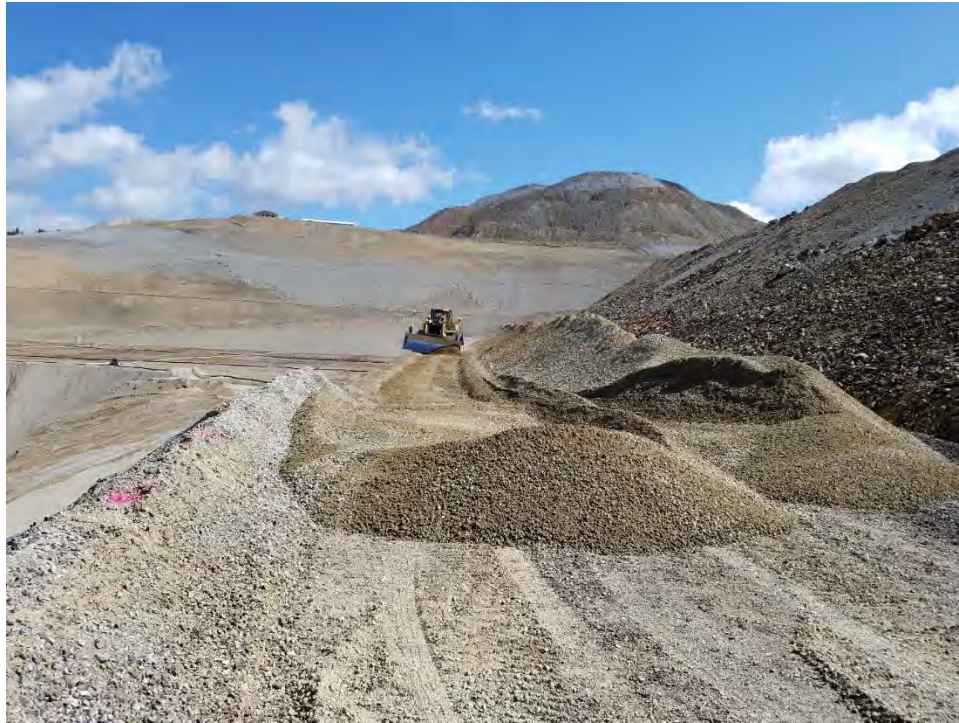
DCF Removal

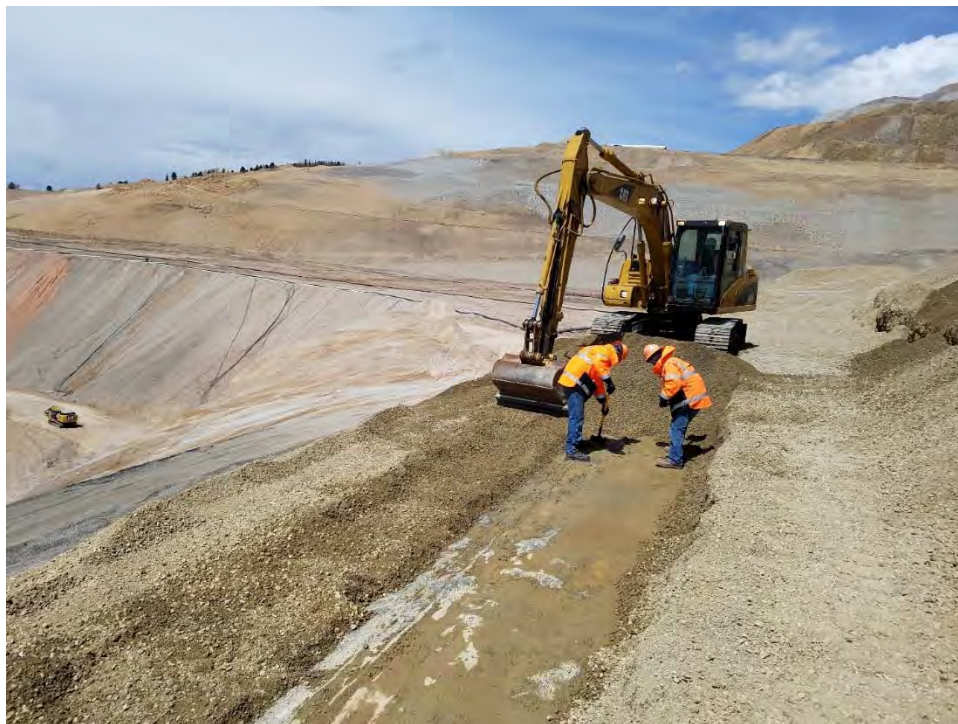
Geomembrane Exposure

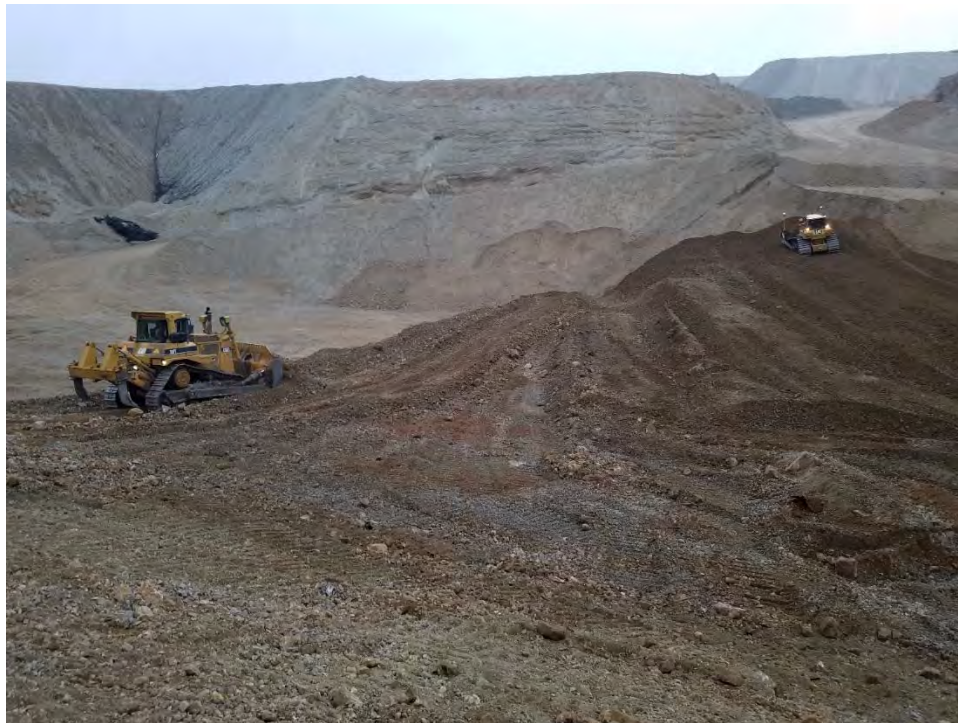
Ore Removal

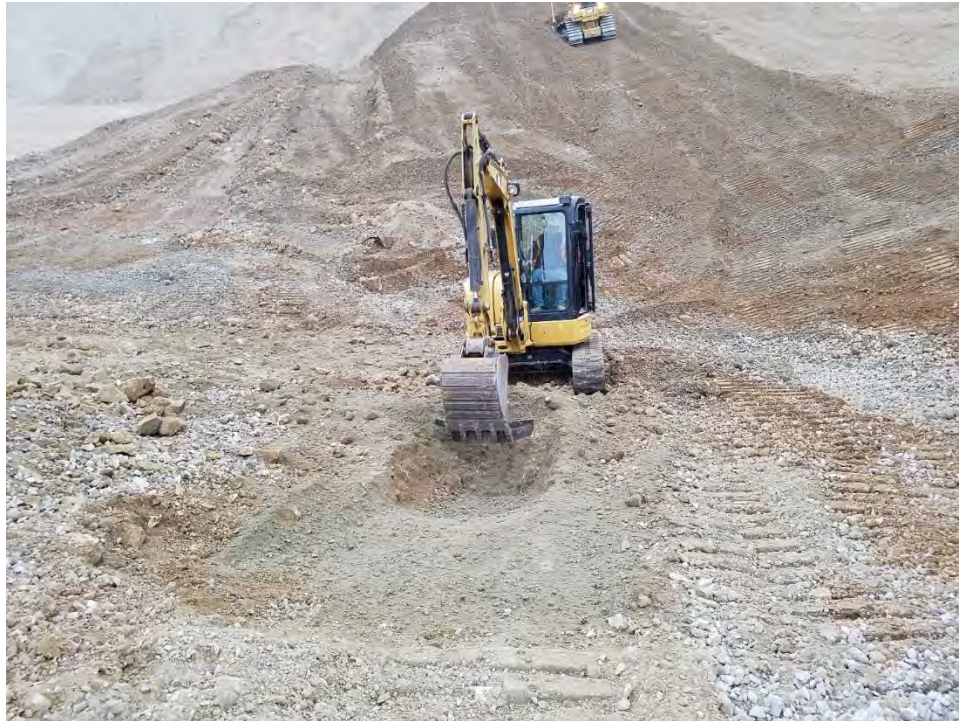
Geomembrane Exposure

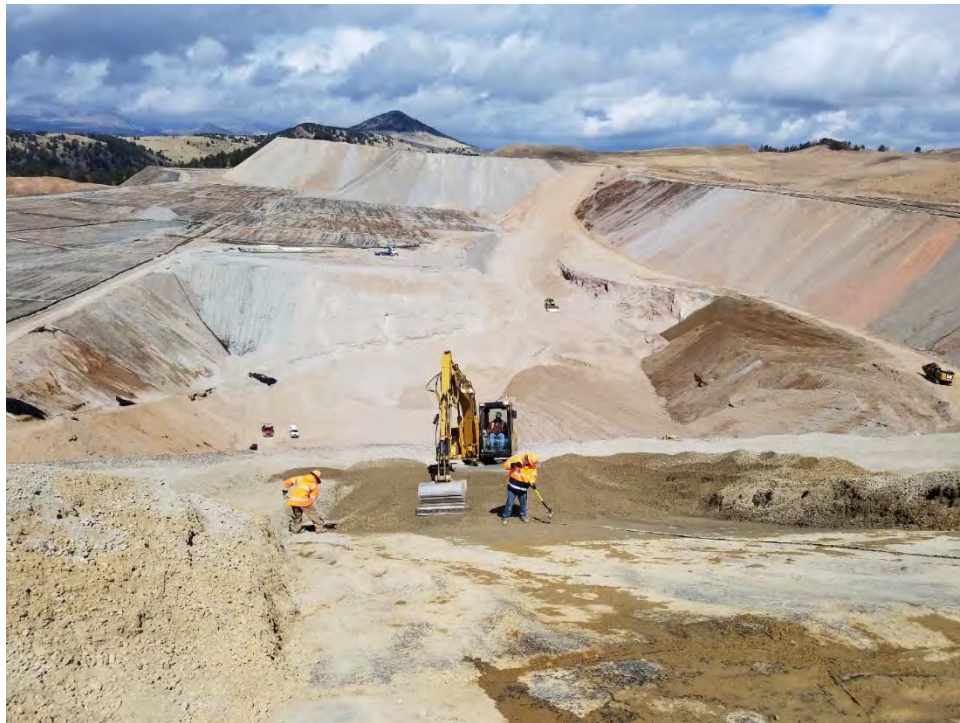
DCF Removal

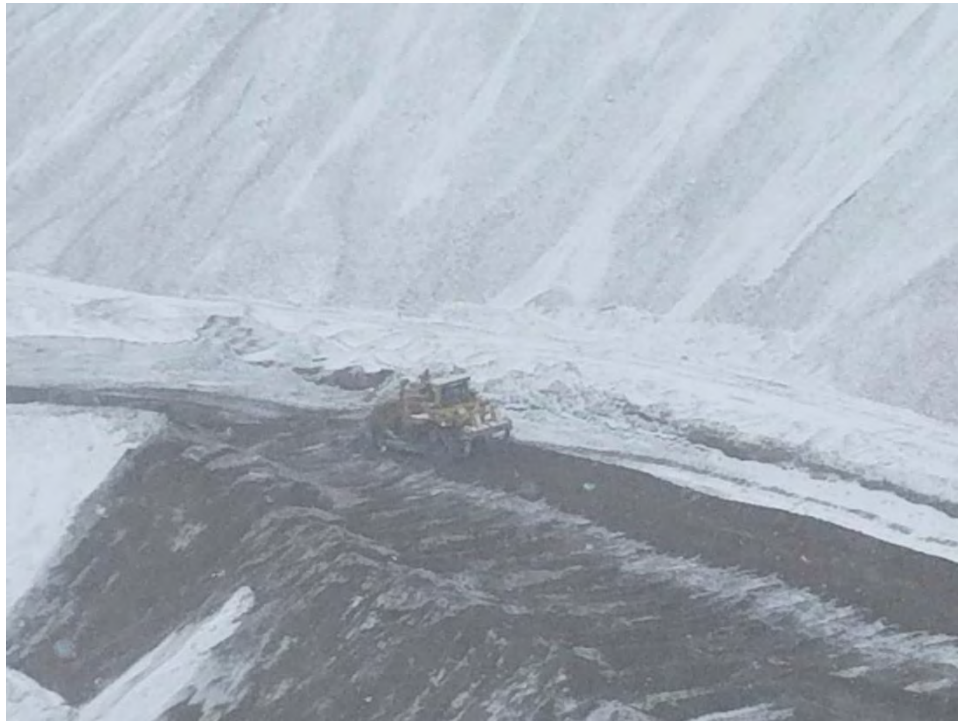
Ore Removal

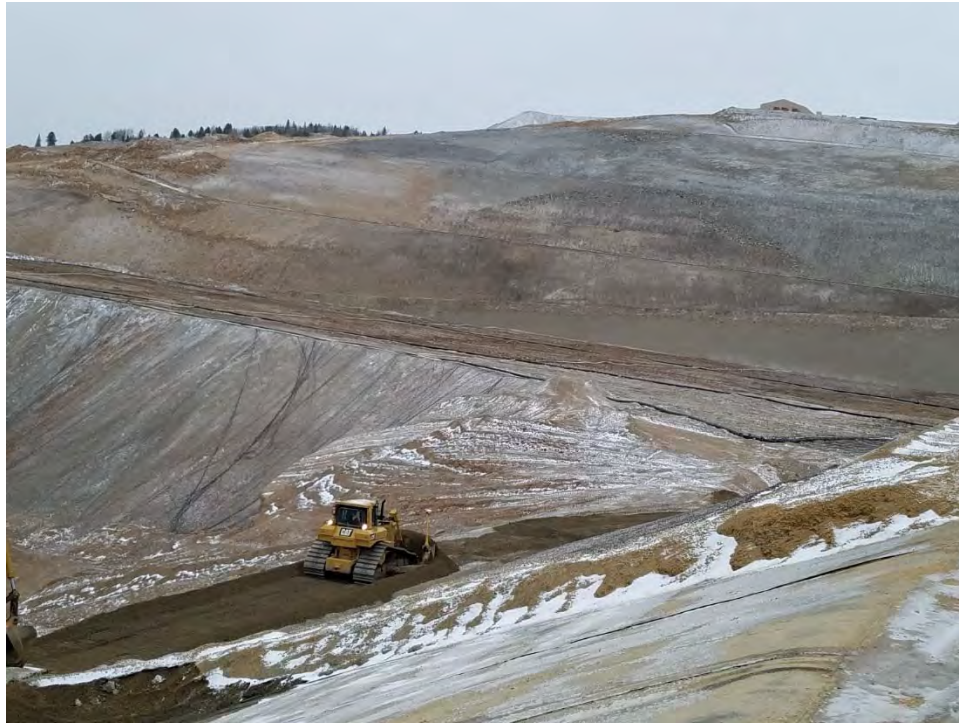
DCF Removal

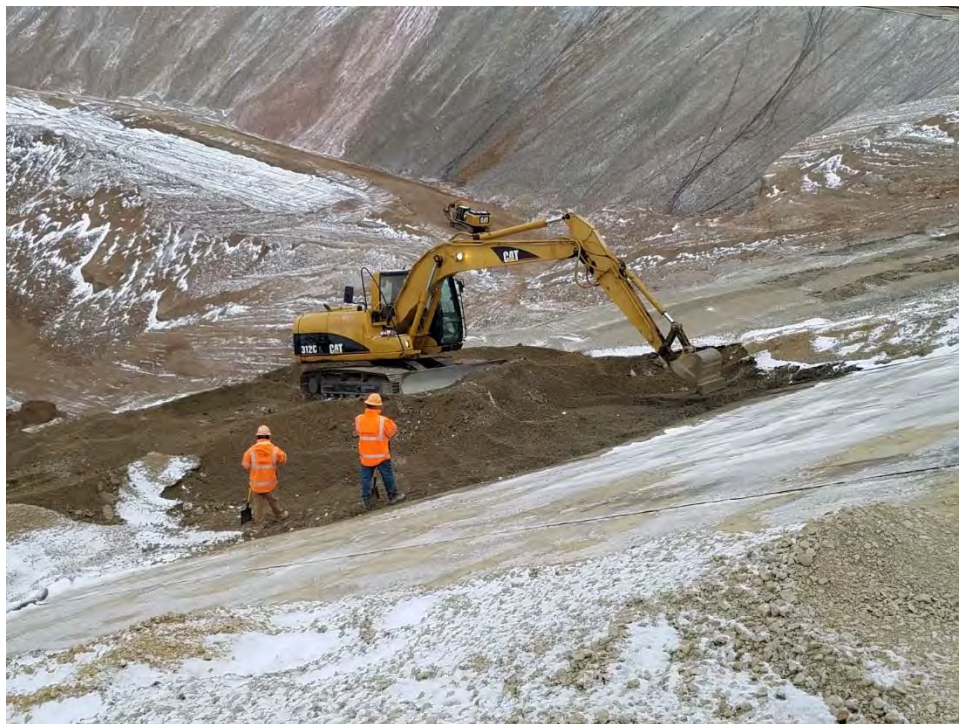
Geomembrane Exposure

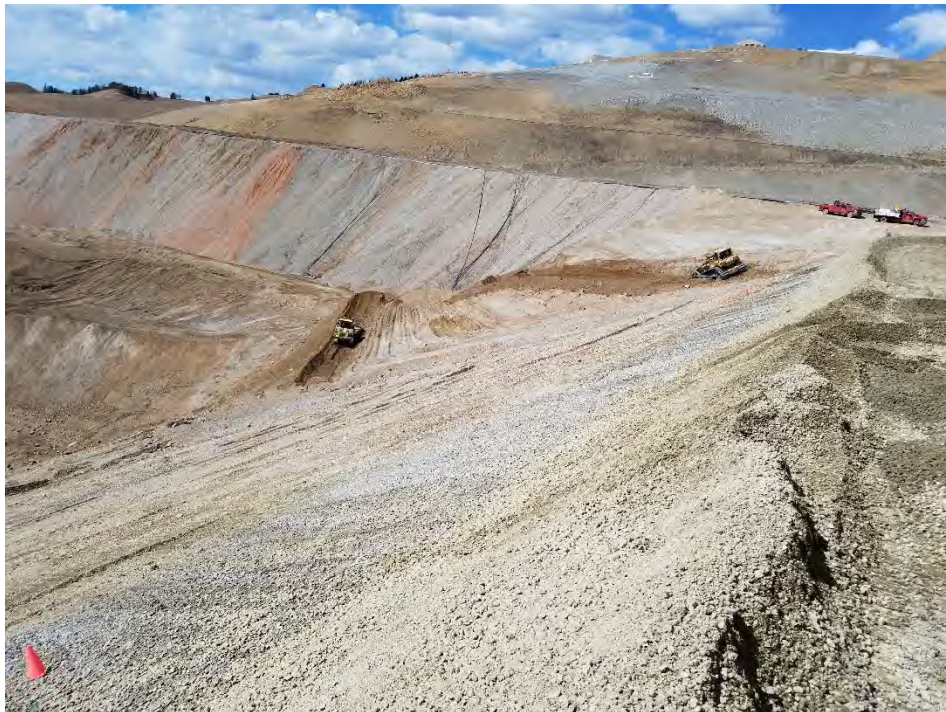
Ore removal

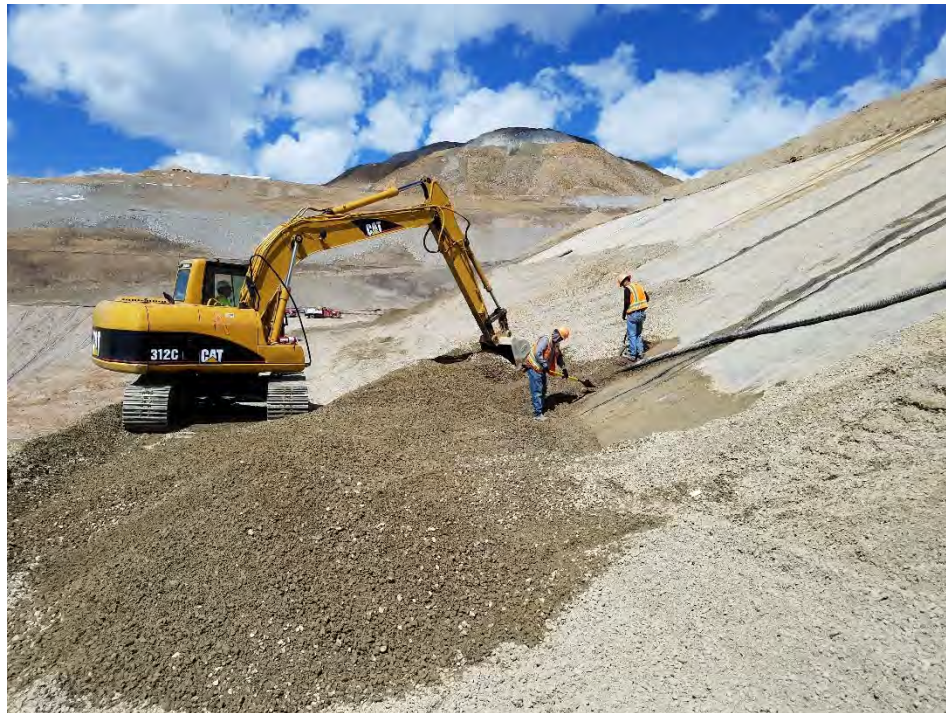
Geomembrane Exposure

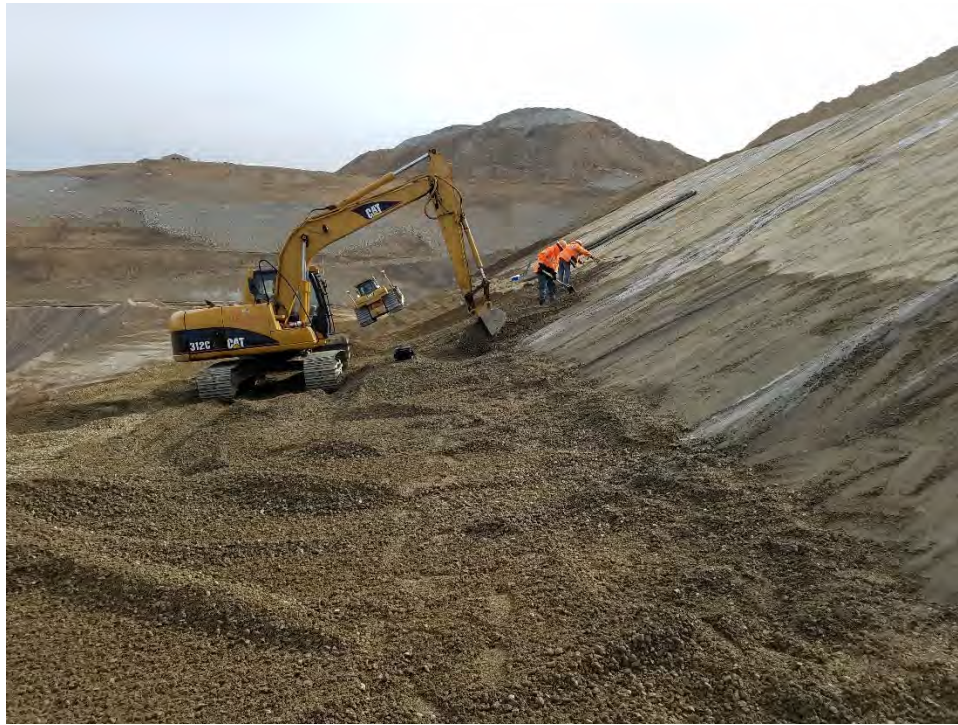
DCF Removal and Geomembrane Exposure

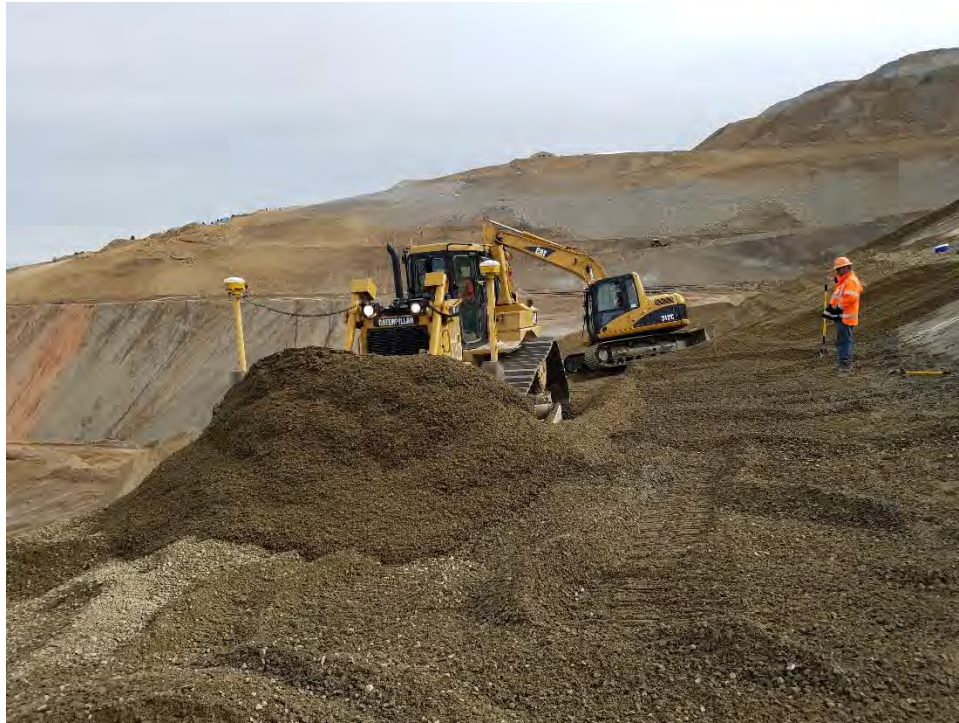
Stockpiling DCF

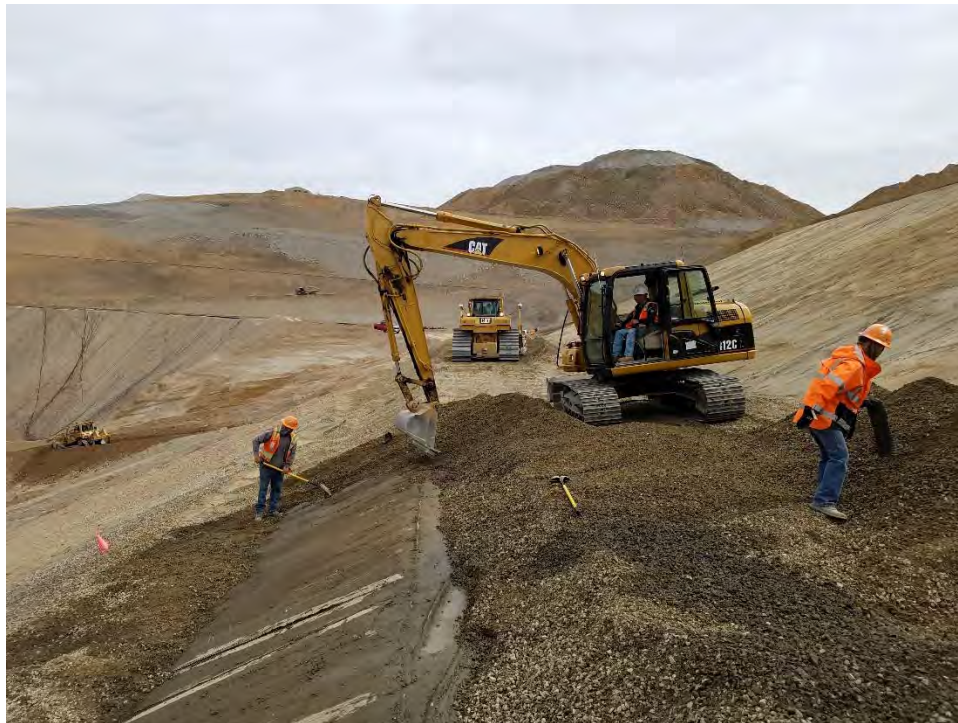
Geomembrane Exposure

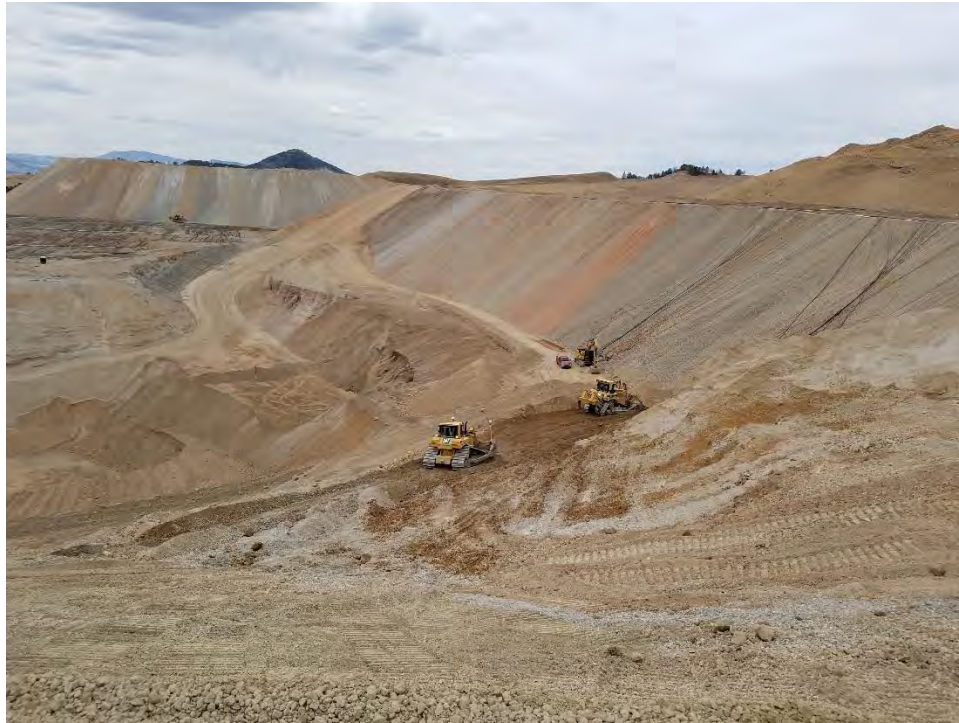
Ore Removal

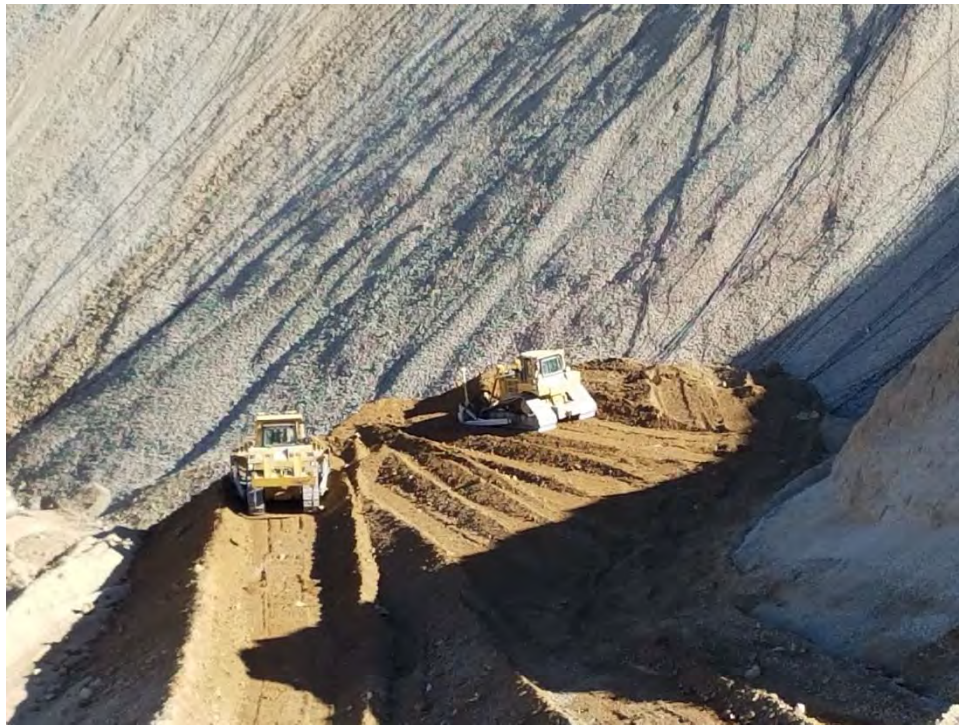
Ore Removal

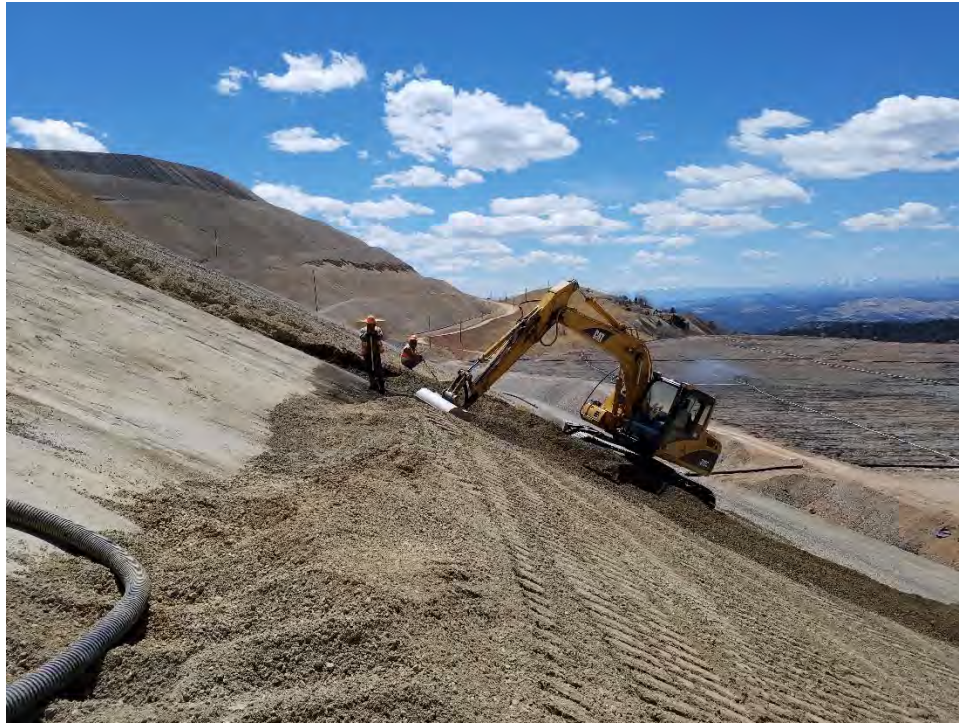
Geomembrane Exposure

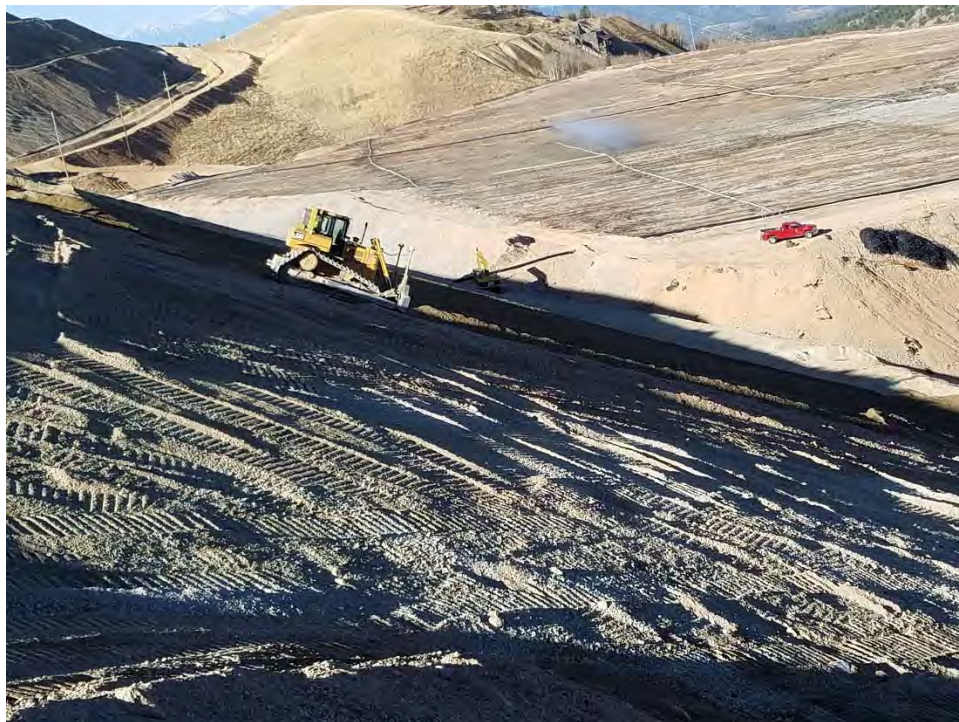
Drain Cover Removal

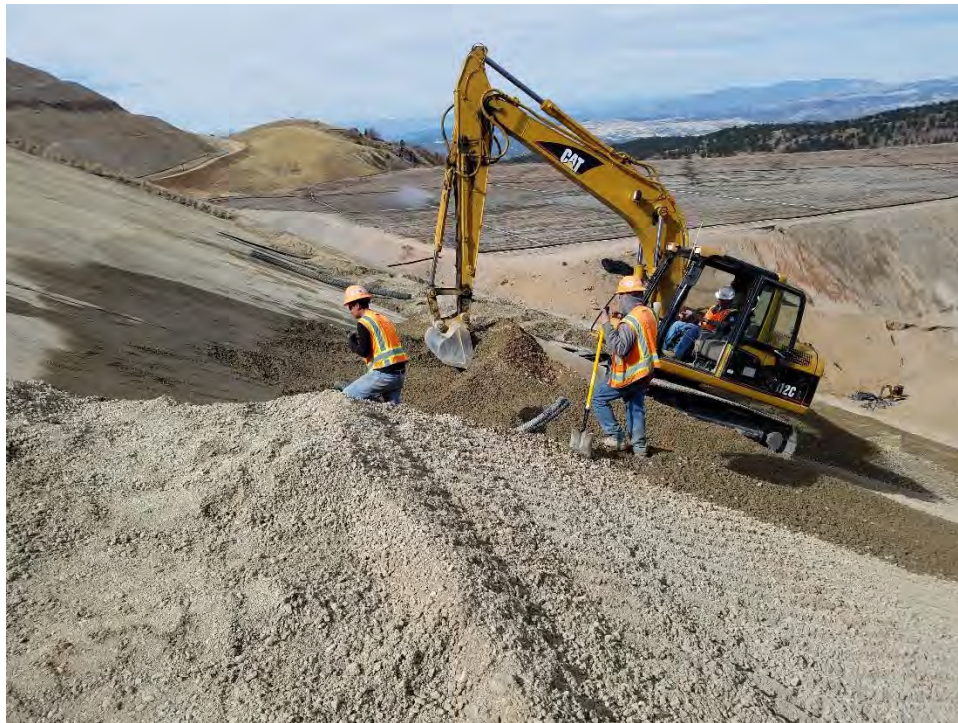
Geomembrane Exposure

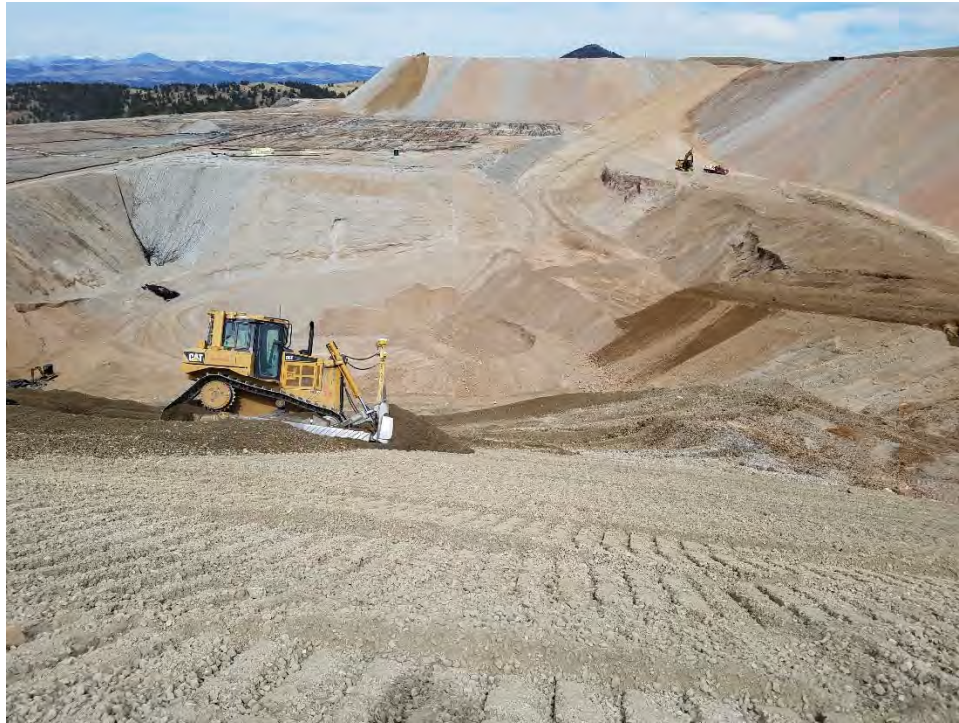
Drain Cover Removal

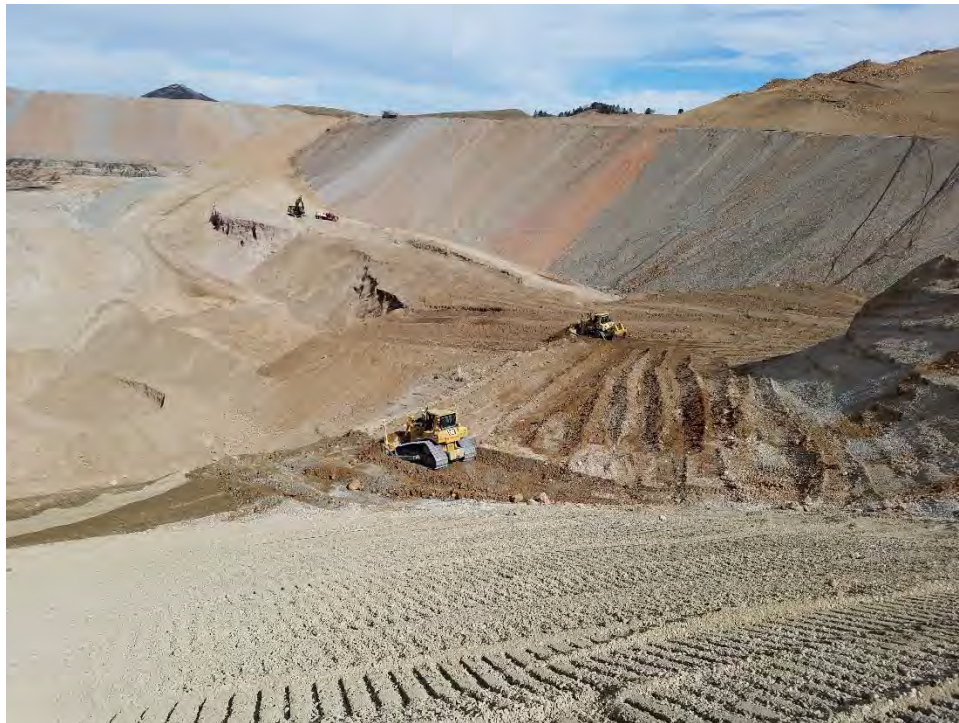
Ore Removal

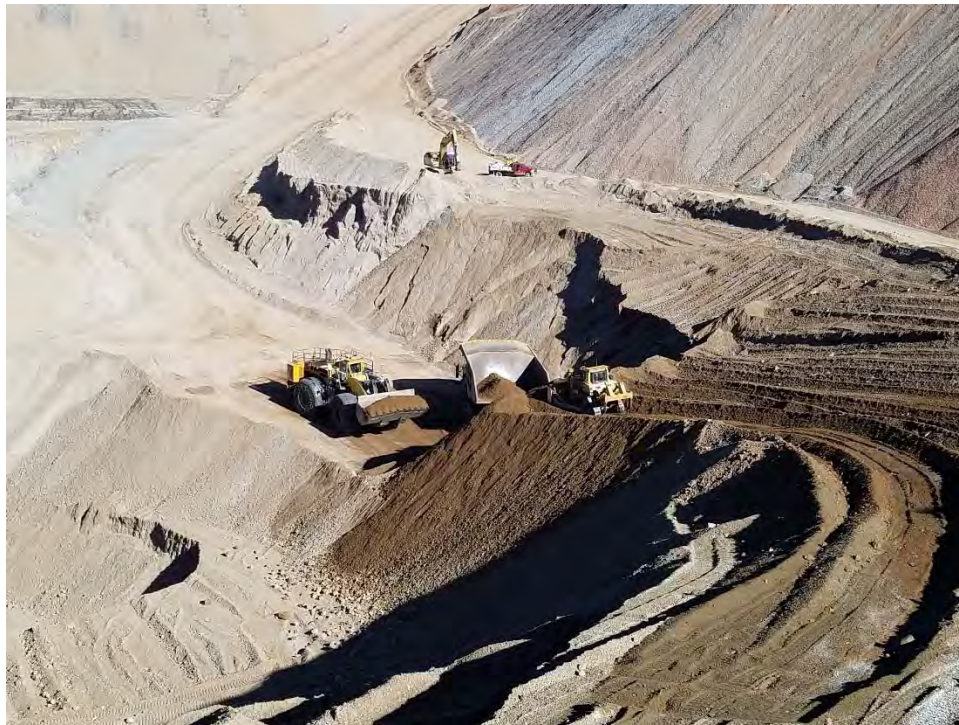
Ore Removal

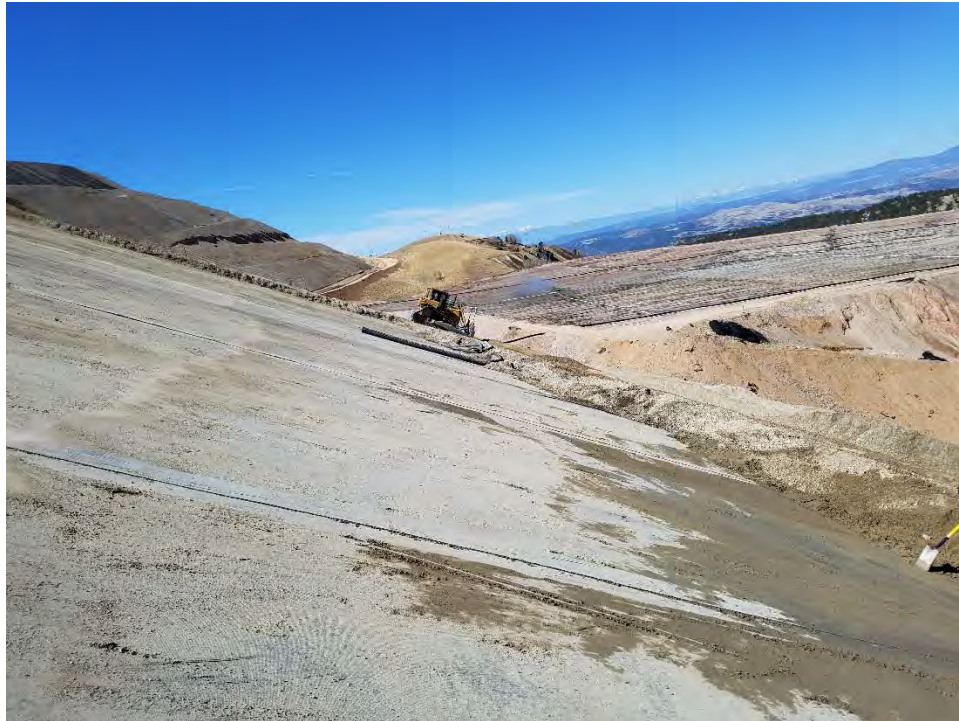
Drain Cover Removal

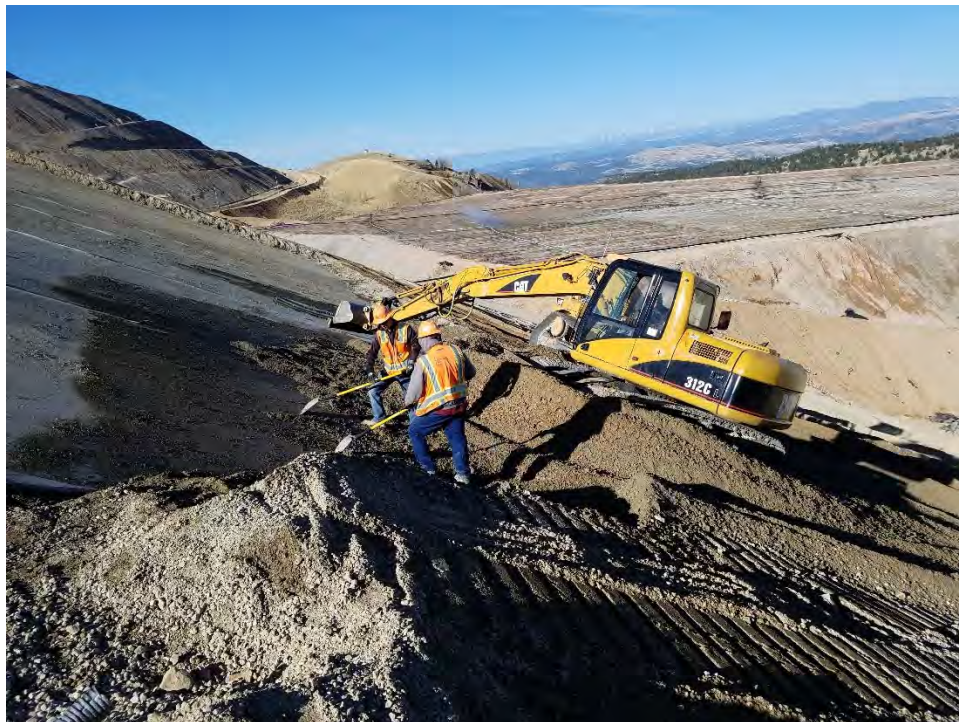
Geomembrane Exposure

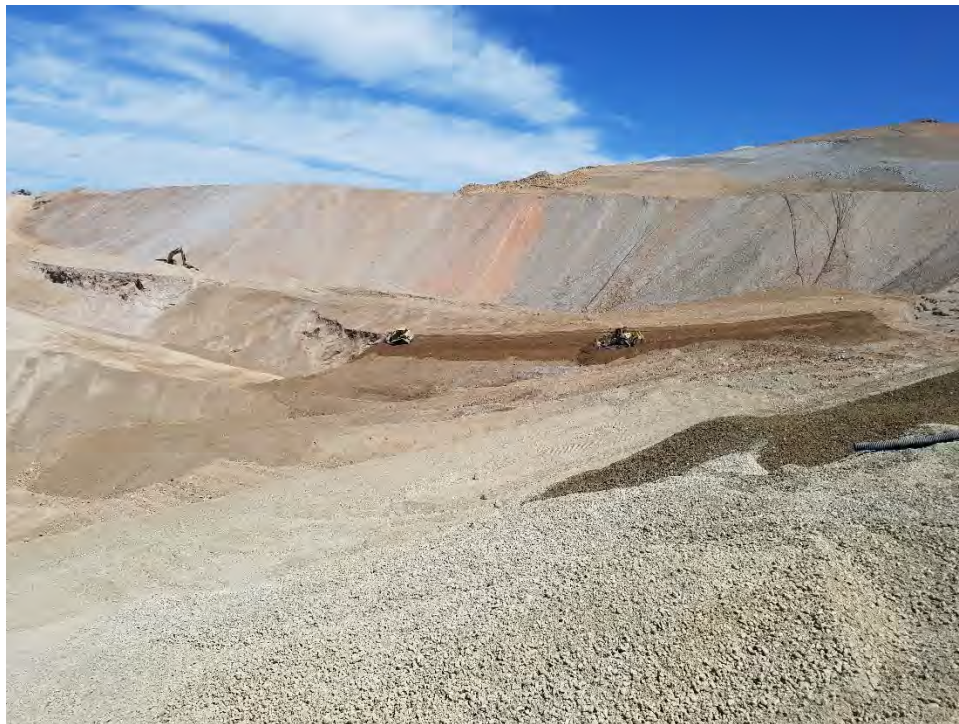
Ore Removal

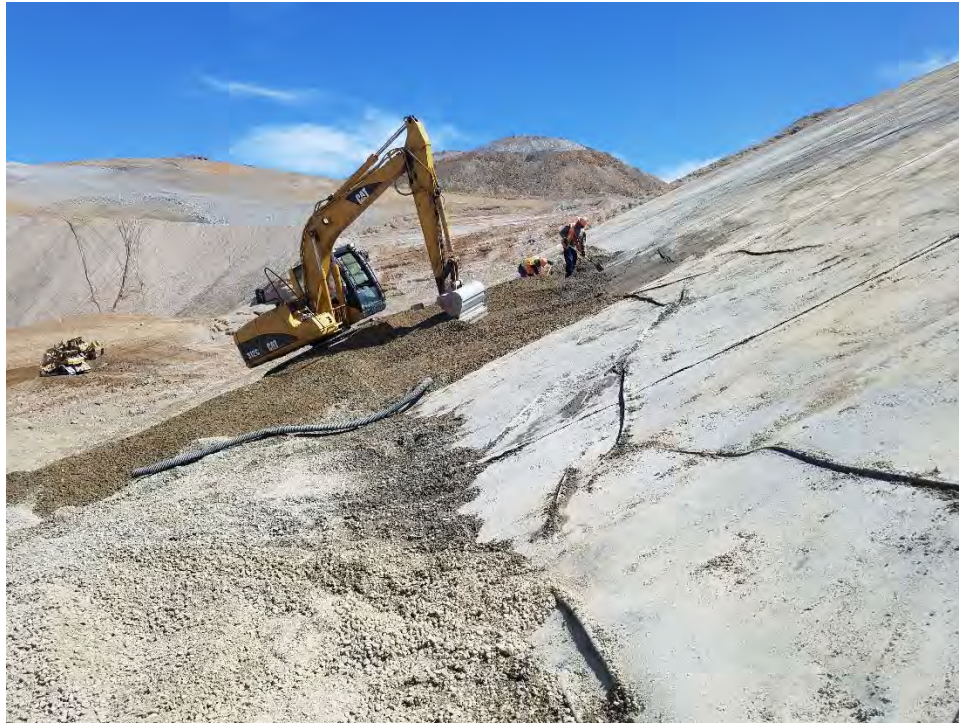
Geomembrane Exposure and DCF Removal

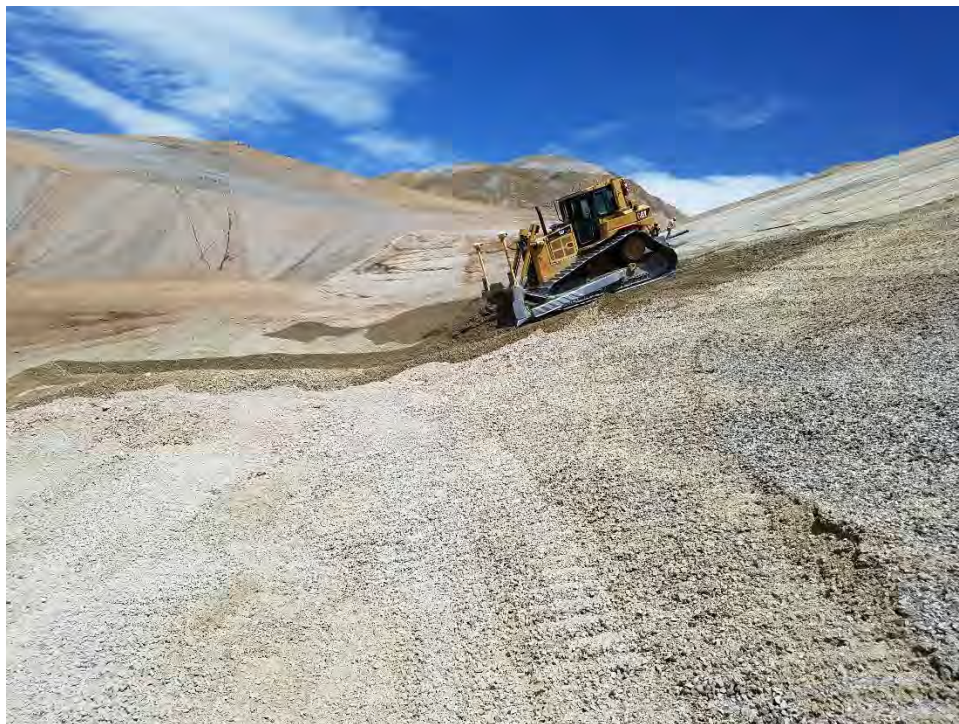
Drain Cover Removal
