Re: Cripple Creek & Victor Mining, Co., Cresson Project, M-1980-244; Review of Record of Construction Report, VLF2 Recertification Report, Subgrade and Geomembrane 9750 – 9900' Elevations.

Review of Record of Construction Report, VLF2 Recertification Report,
Subgrade and Geomembrane 9750-9900' Elevations
Response to Comments

October 5, 2018
NewFields Job 475.0106.026

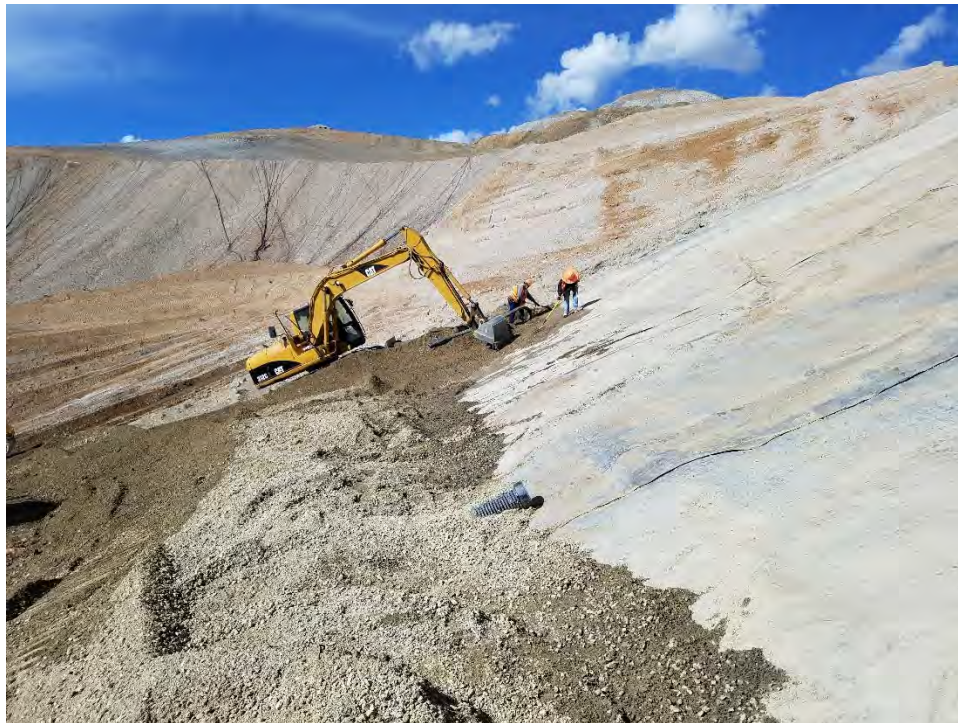
Geomembrane Exposure and DCF Removal

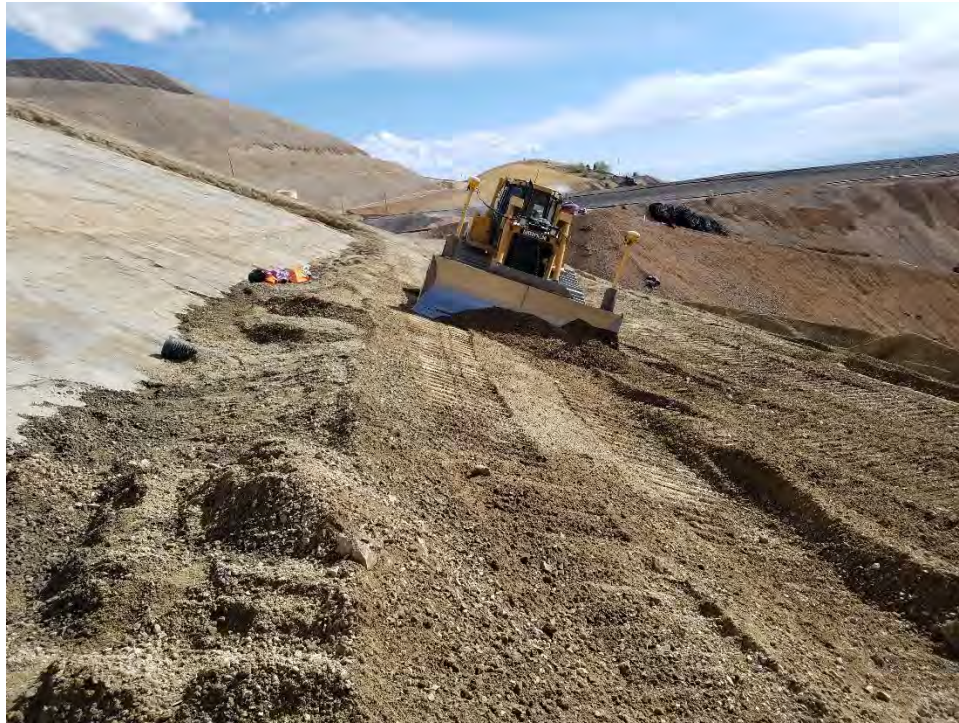
DCF Removal

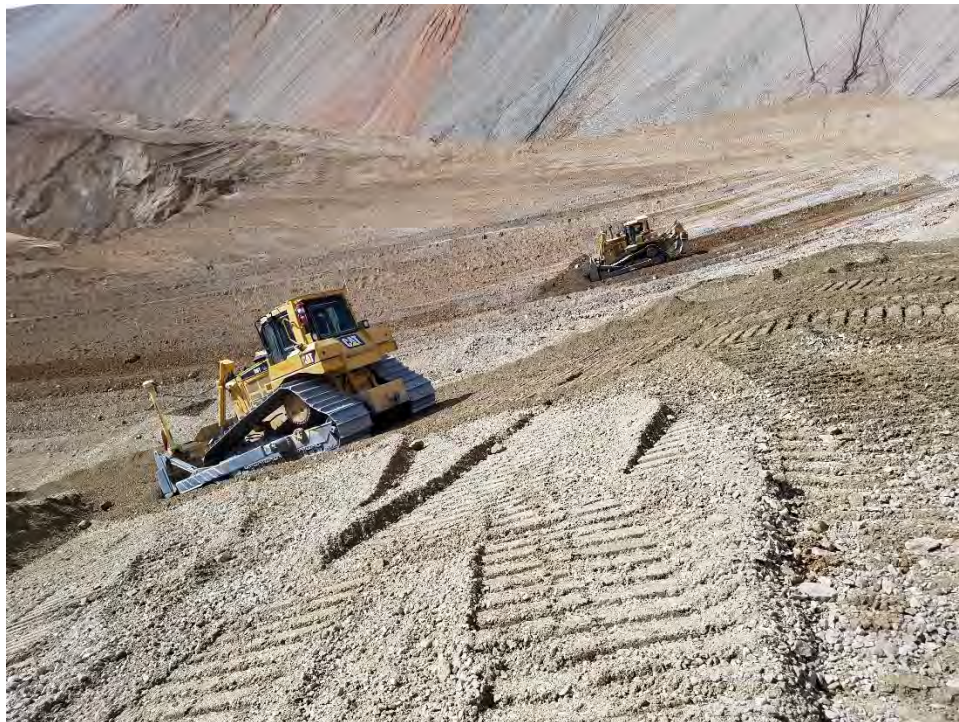
Ore and DCF Removal

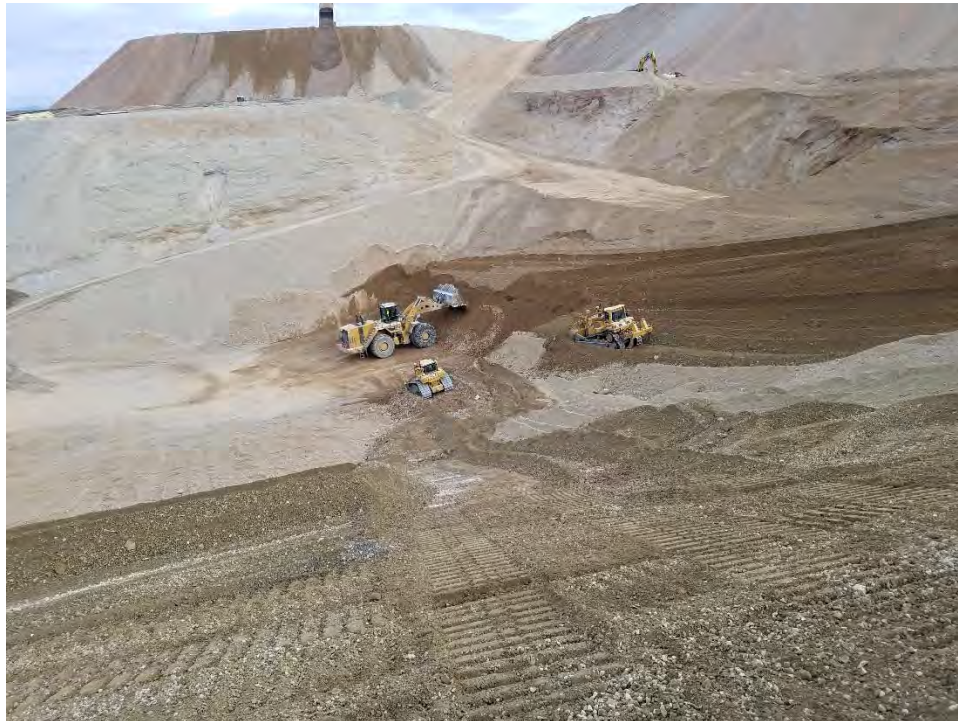
Ore and DCF Removal

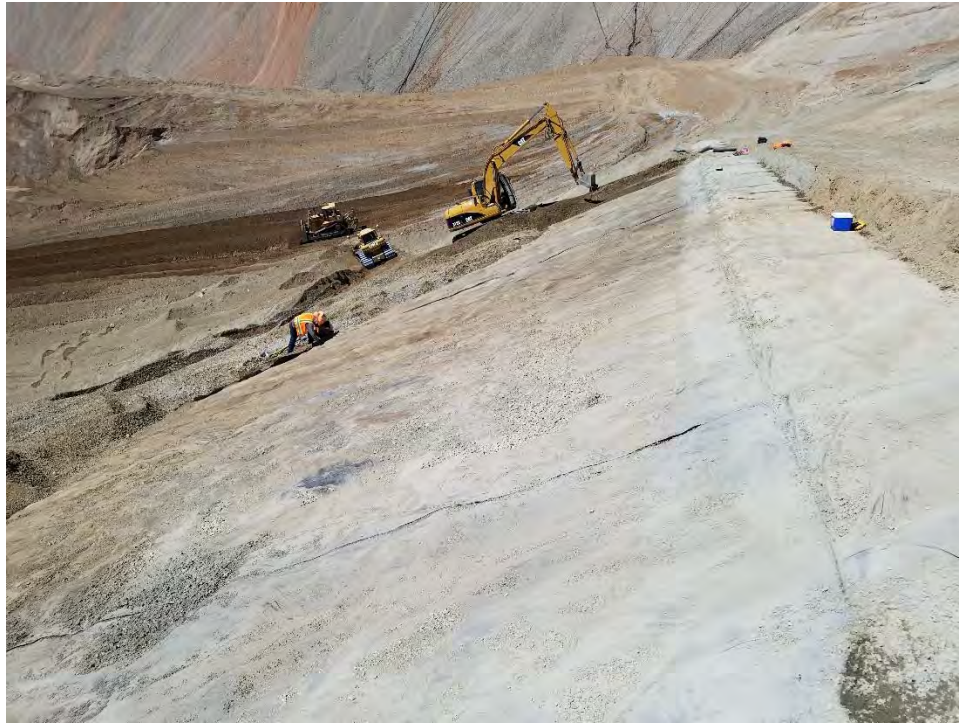
Geomembrane Exposure and DCF Removal

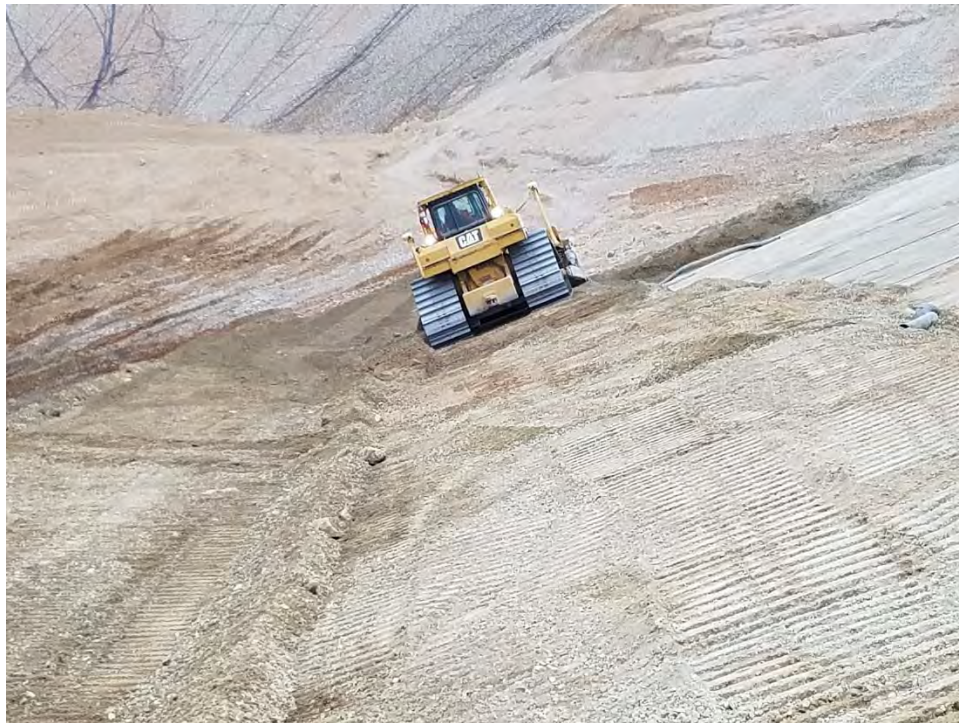
DCF Removal

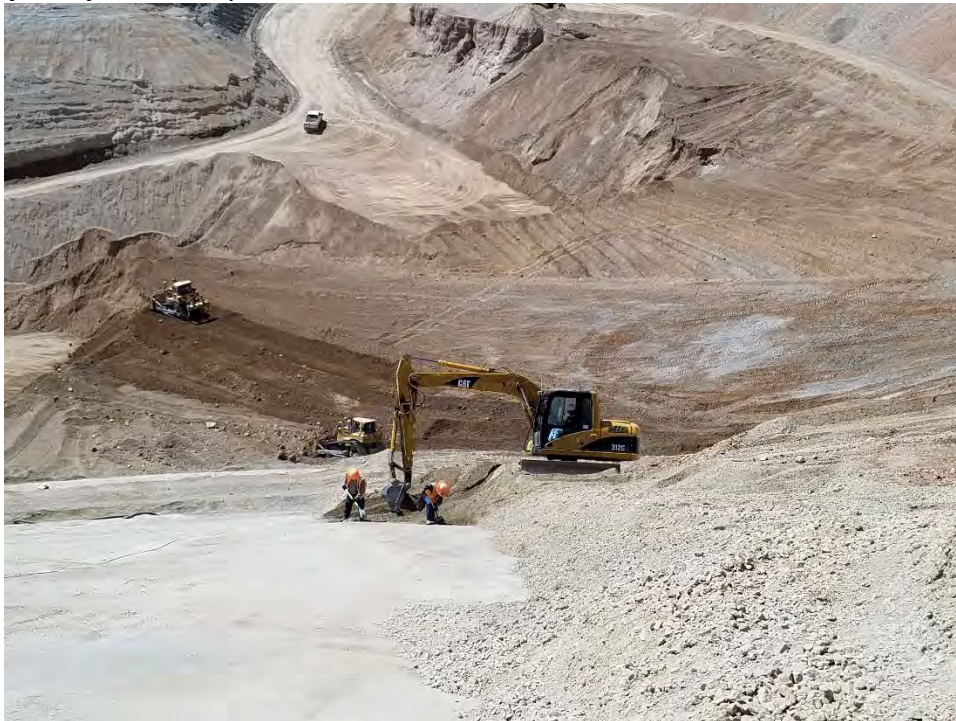
Geomembrane Exposure and DCF Removal

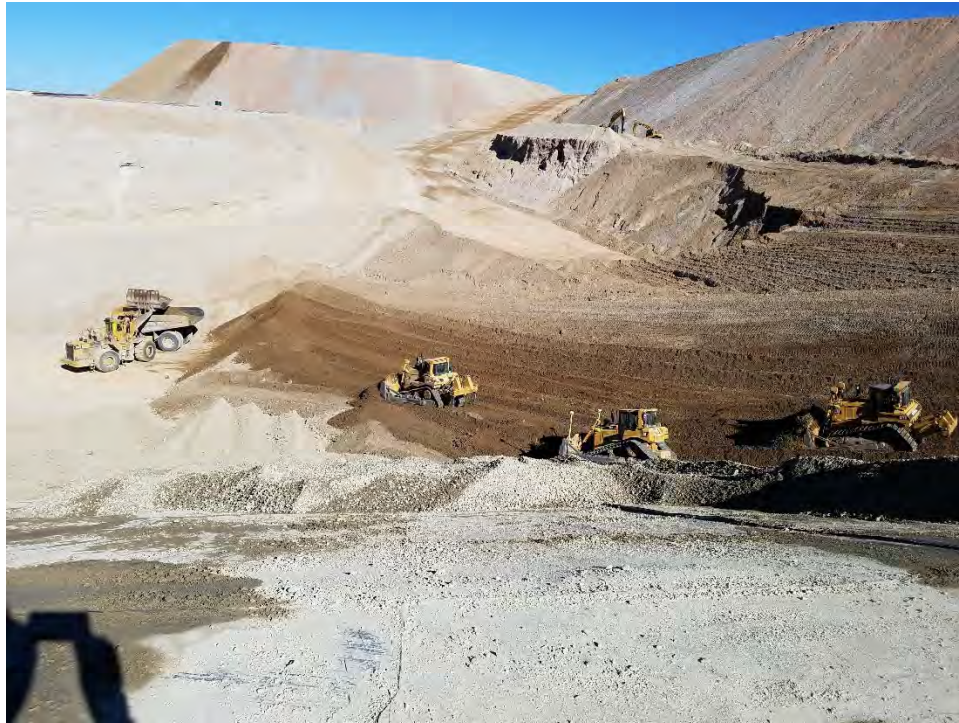
Ore Removal

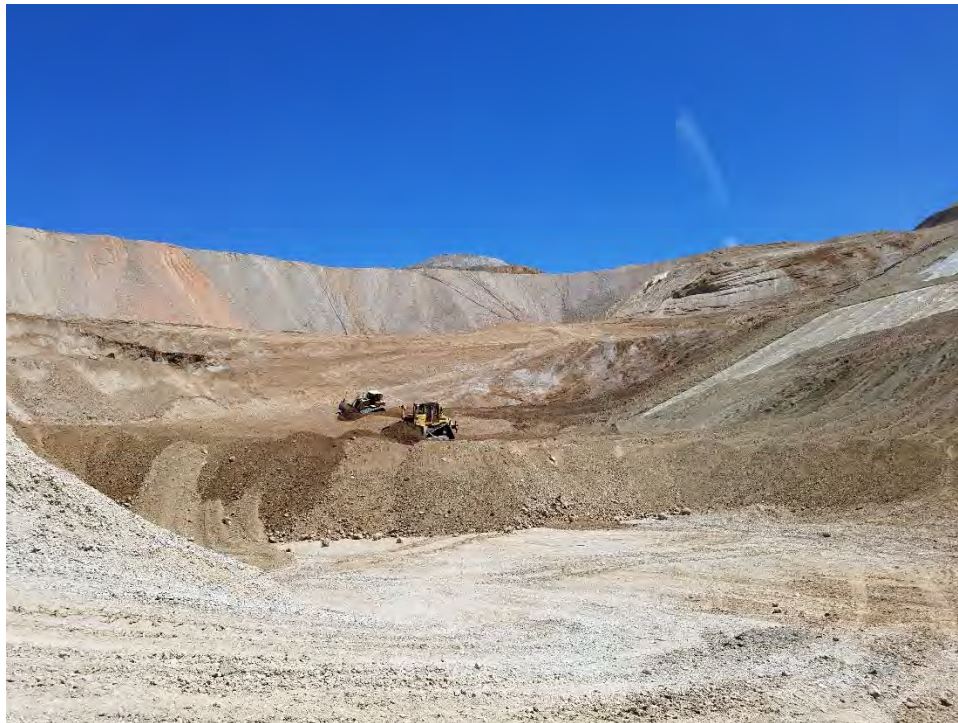
Ore Removal

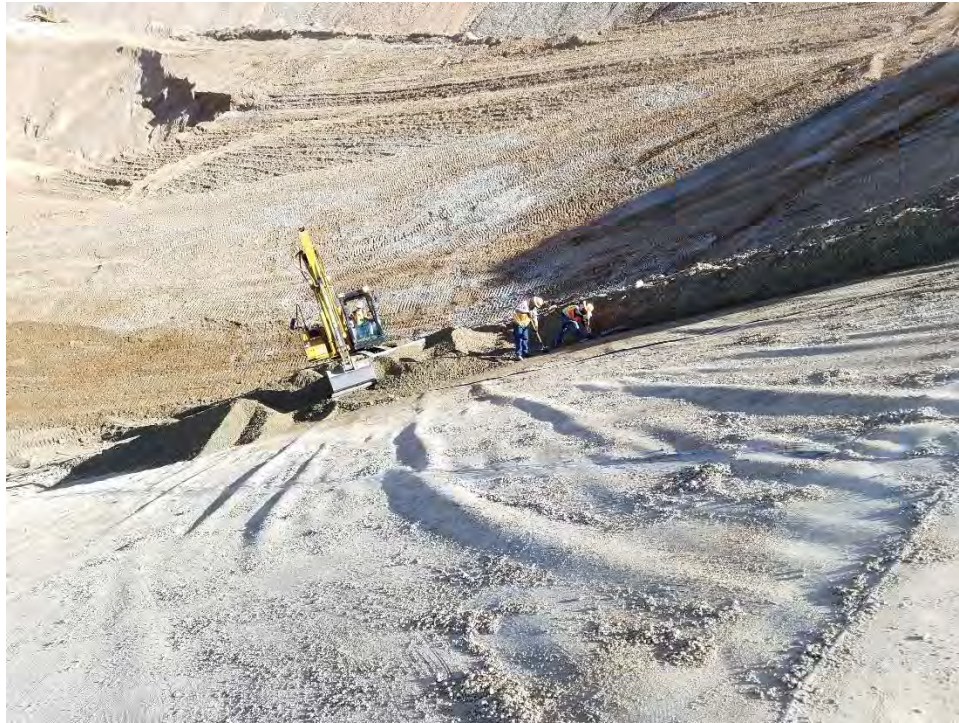
Geomembrane Exposure and DCF Removal

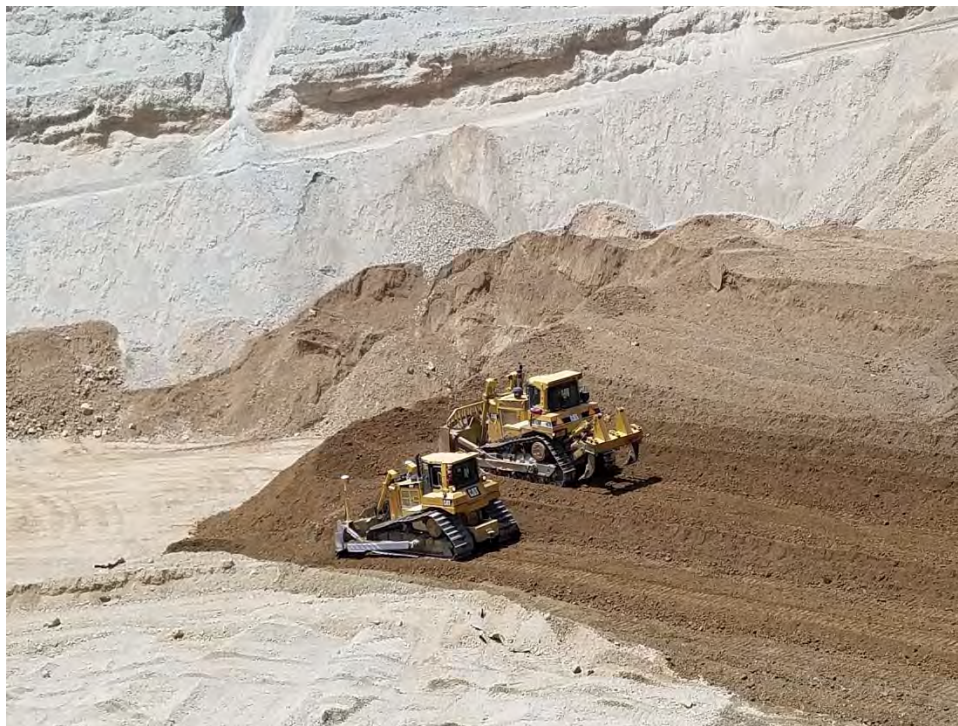
Ore Removal

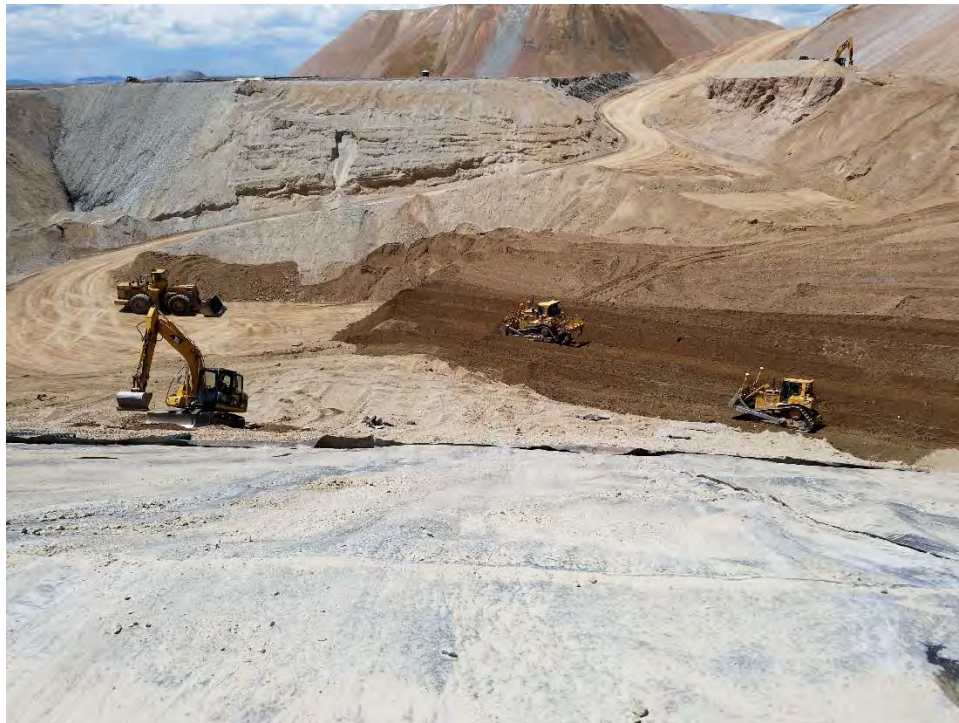
DCF Removal

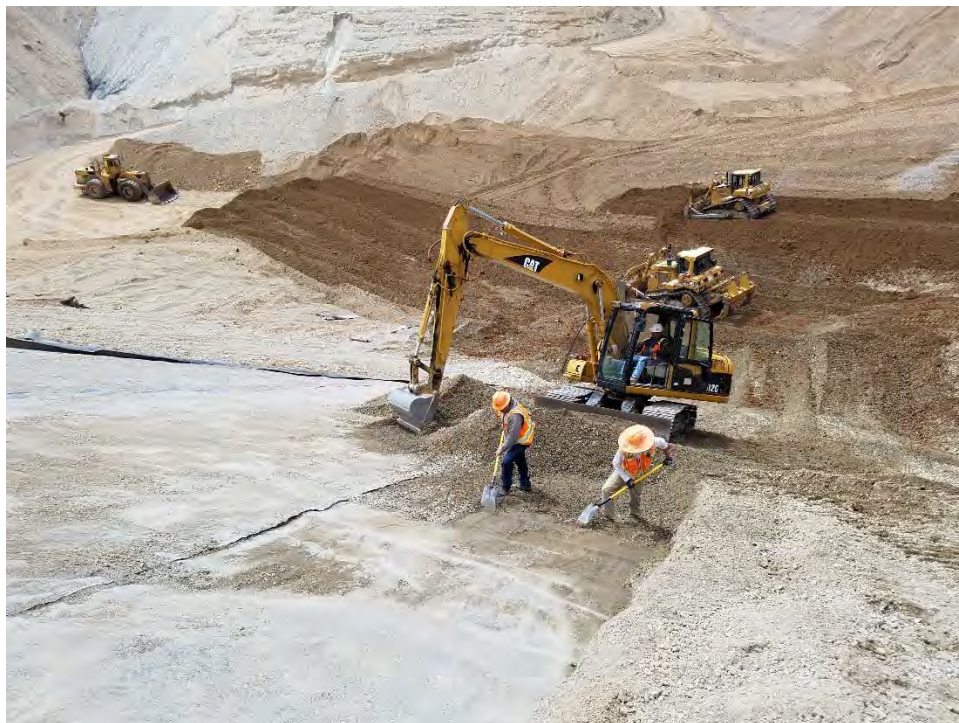
Geomembrane Exposure and DCF Removal

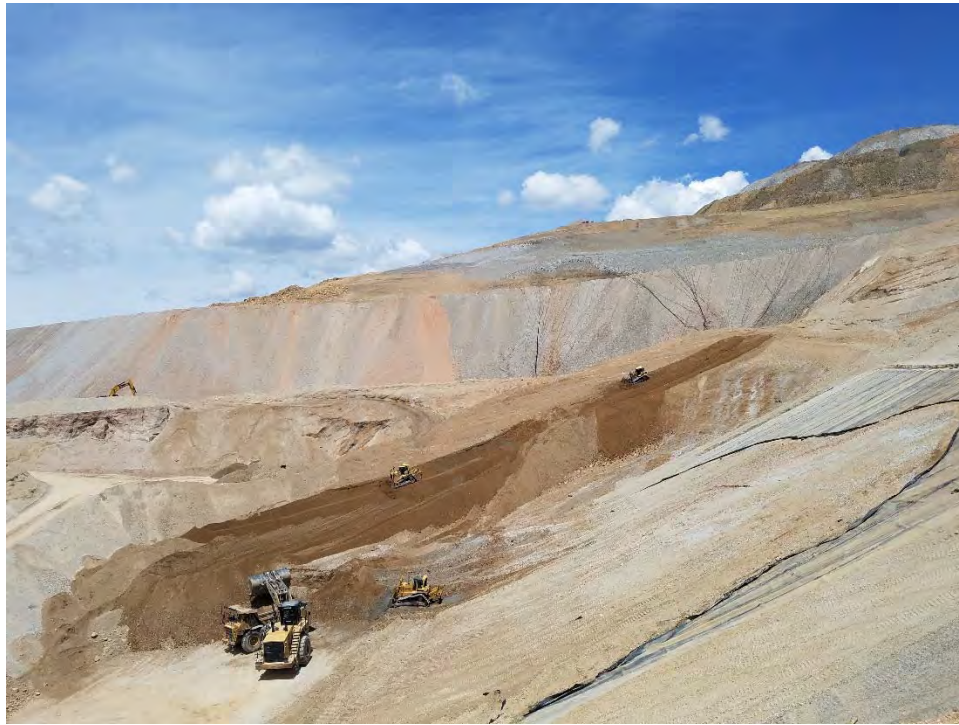
Ore Removal

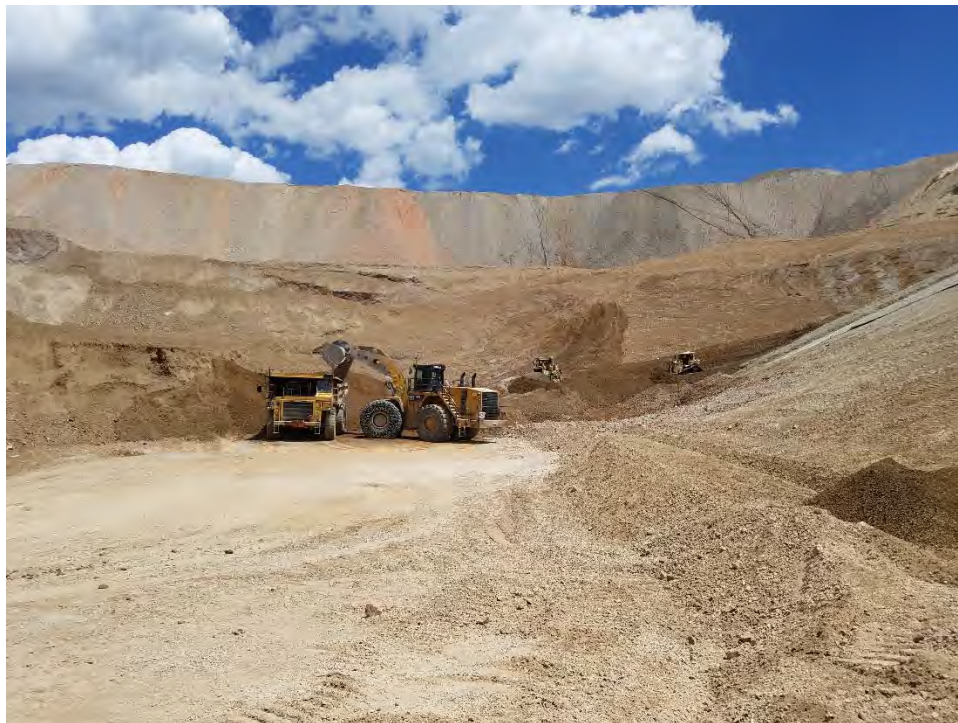
Ore Removal

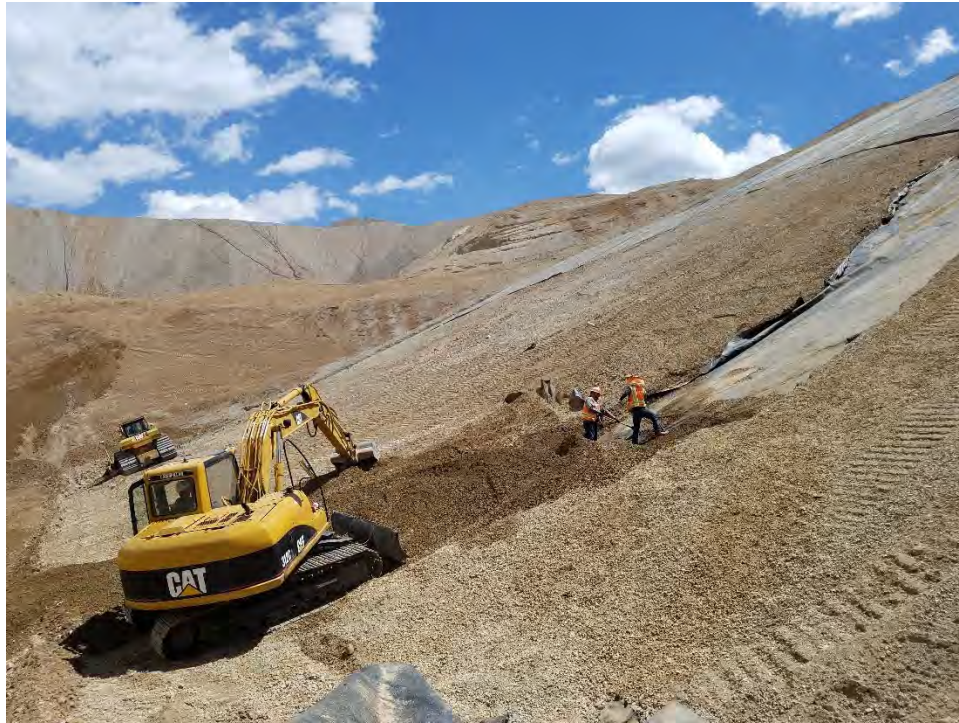
A CAT 321C L excavator was used to expose geomembrane by removing the Drain Cover Fill (DCF) between 9650' and 9695' elevations and between 9750' and 9850' benches. The south extent of geomembrane damage was located during the shift.

Geomembrane Exposure

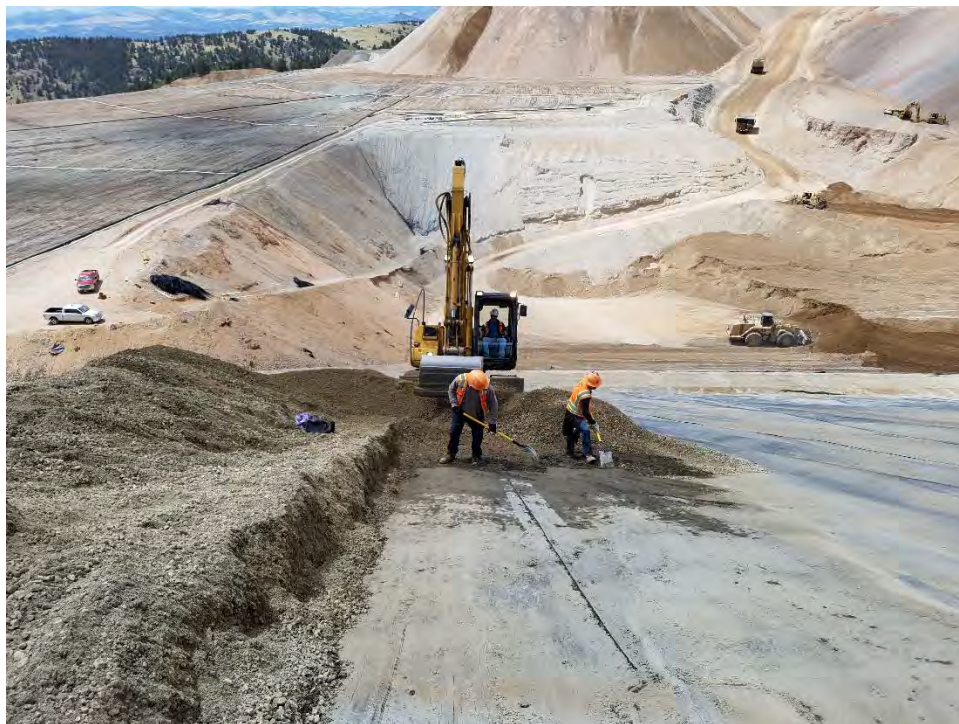
Geomembrane Exposure and DCF Removal

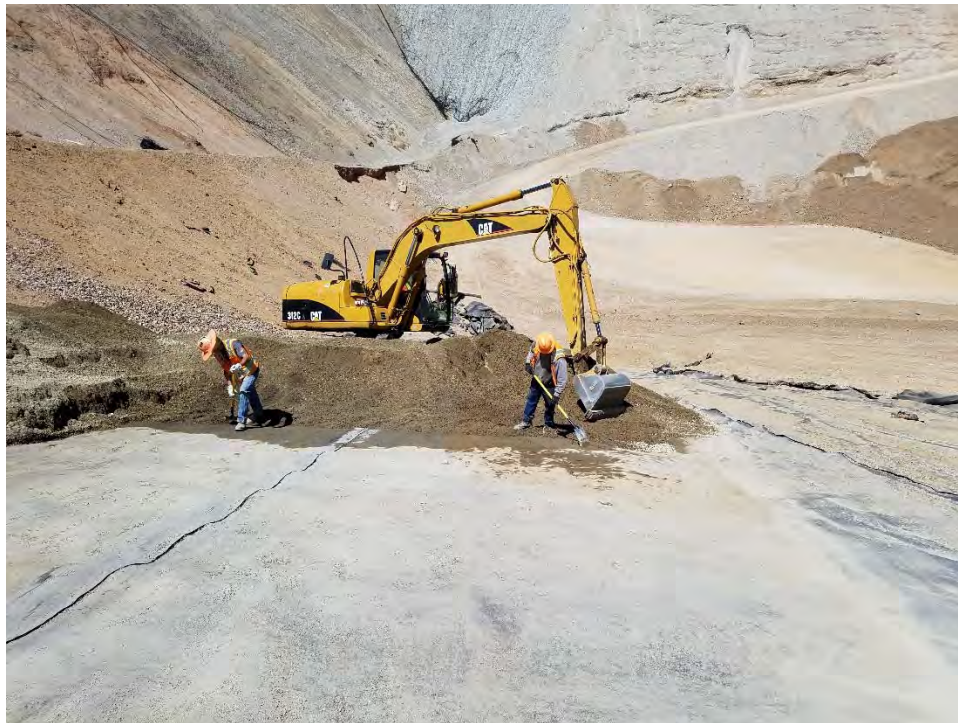
Geomembrane Exposure

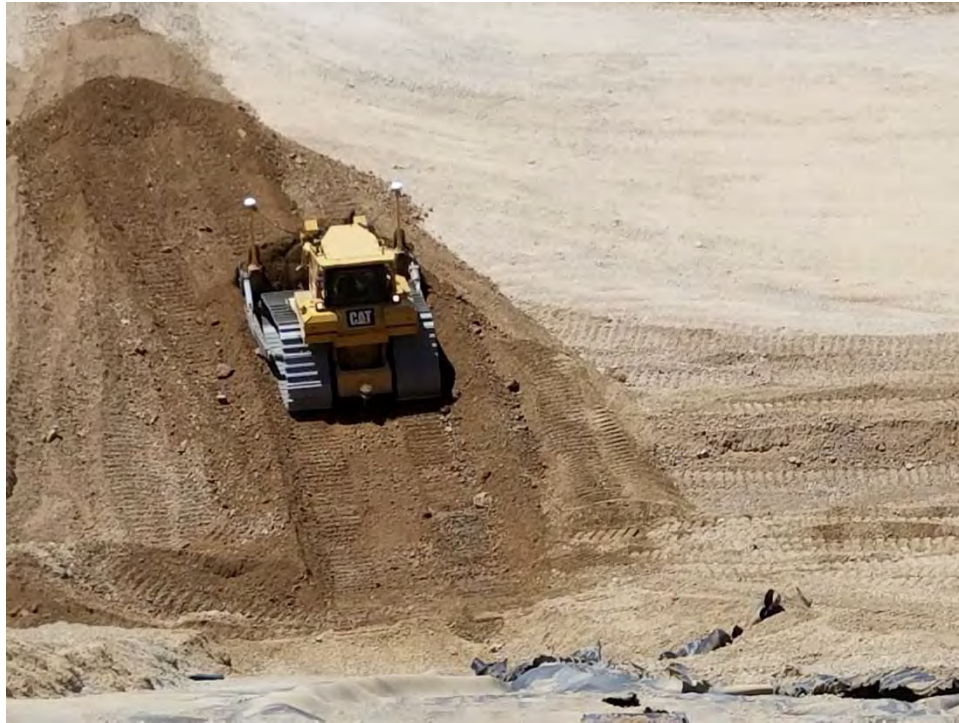
Ore Removal

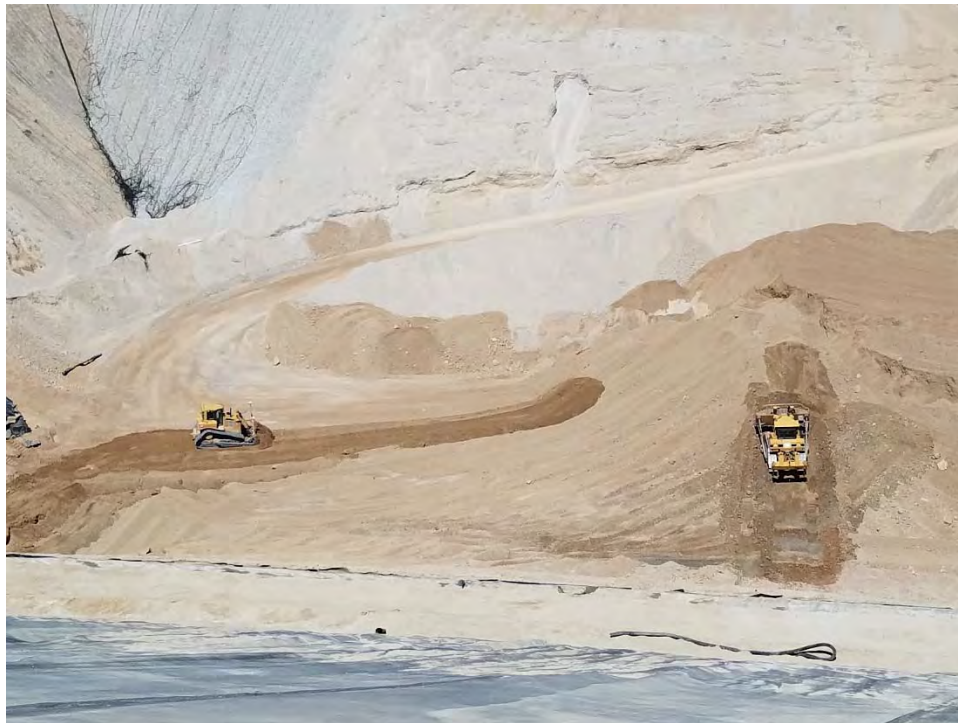
Ore Removal

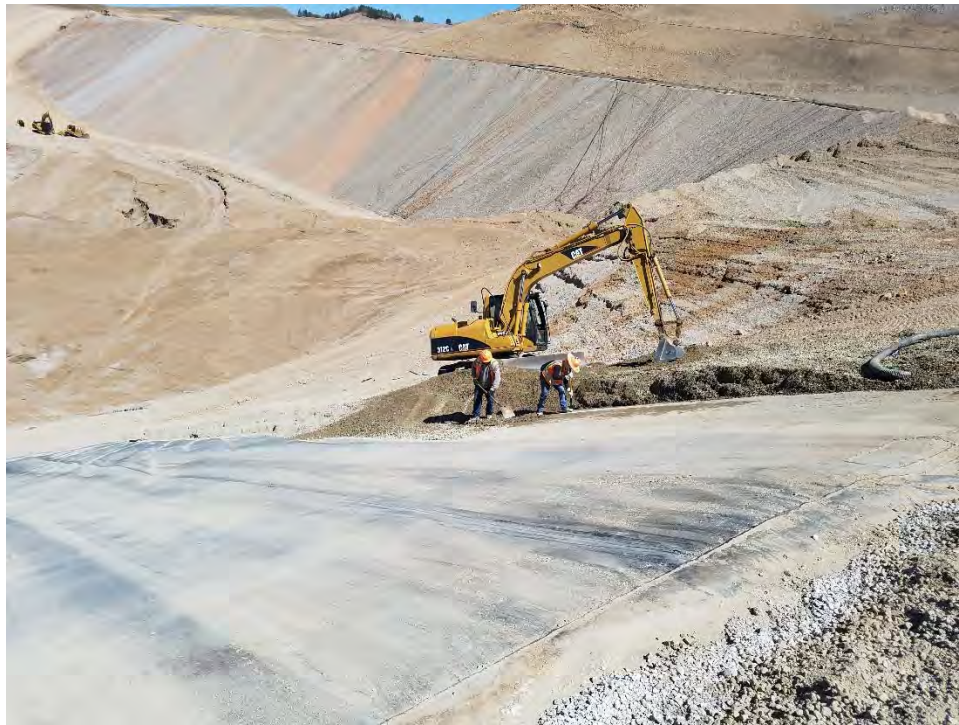
Geomembrane Exposure

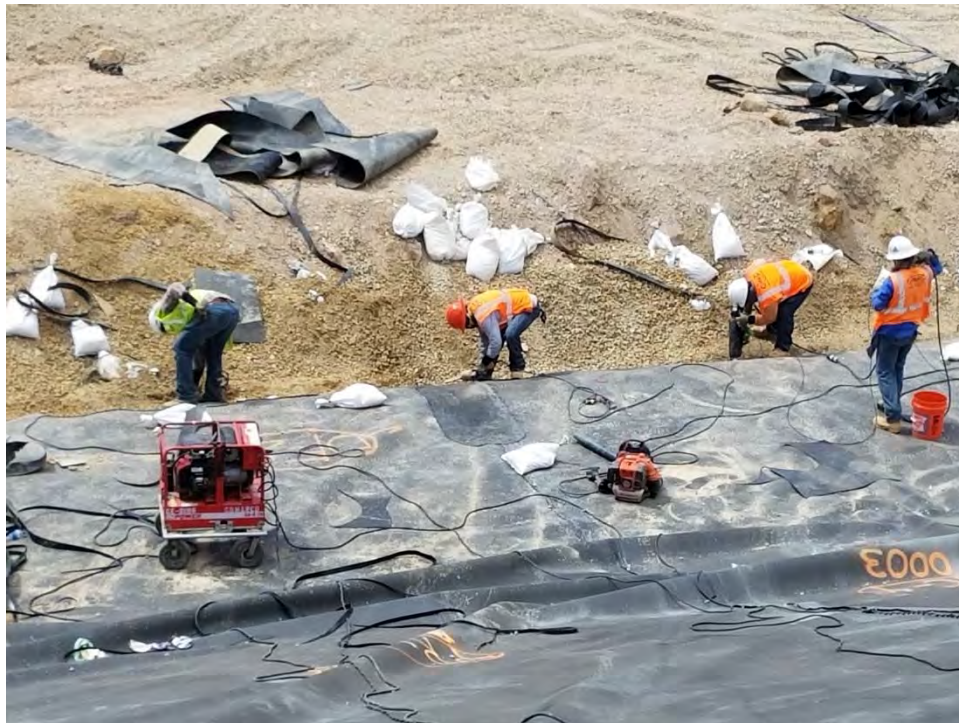
Tie-in Extrusion Seaming

Approximately 322 linear feet of extrusion seaming was performed using one extrusion welding machine/operator method. One destructive testing sample was marked during extrusion seaming for future testing. Repairs were performed using the extrusion welding method for most marked defects.

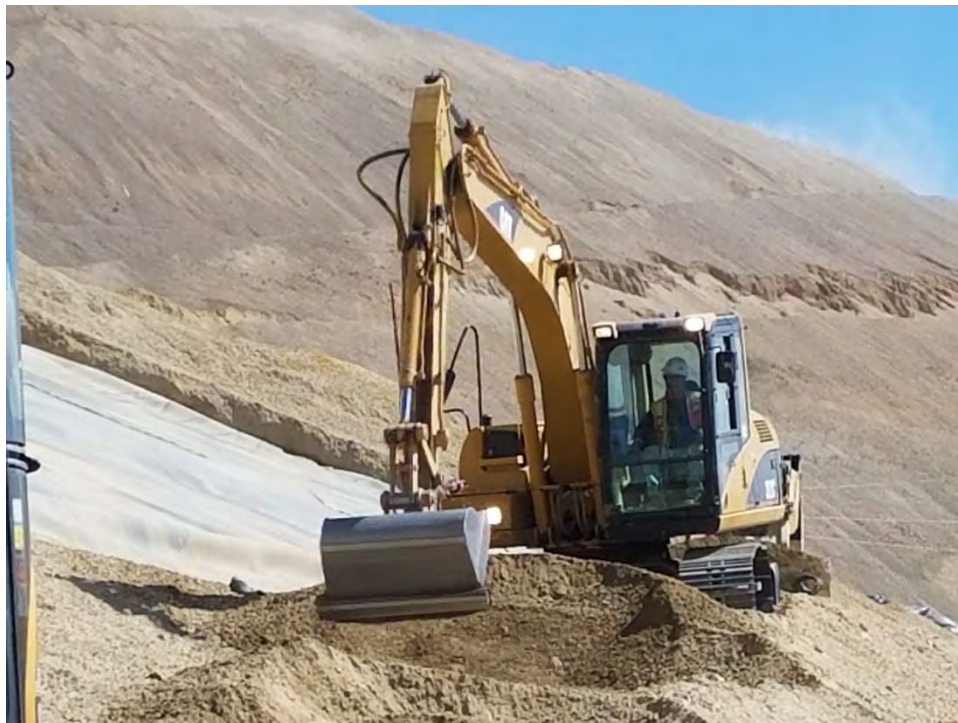
DCF Removal

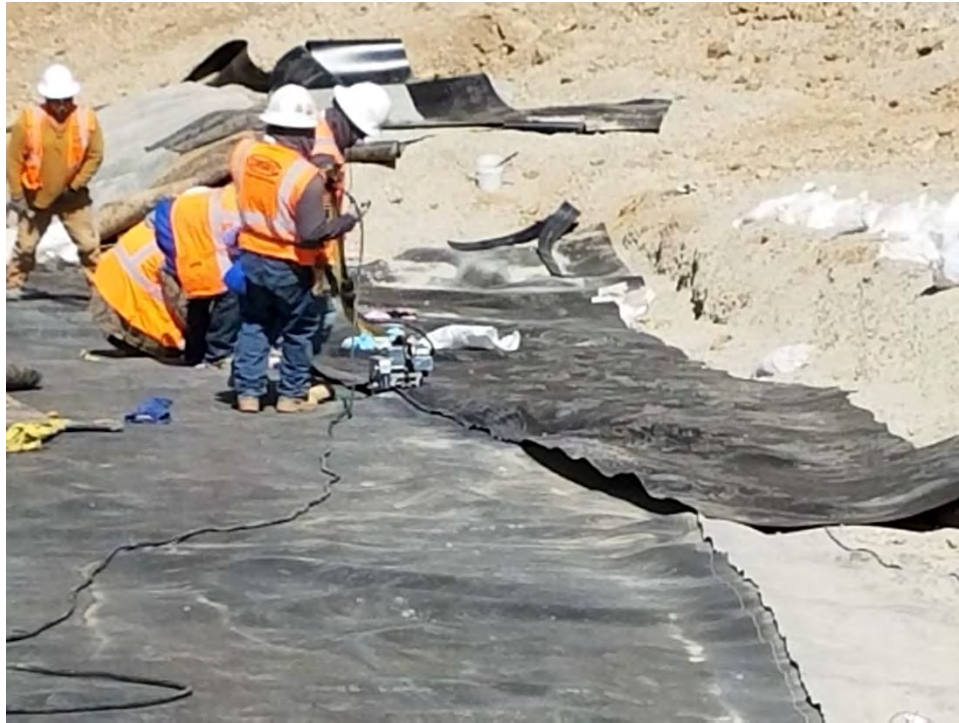
Extrusion Seaming

All the marked defects were repaired using the extrusion welding method. No vacuum testing was performed.

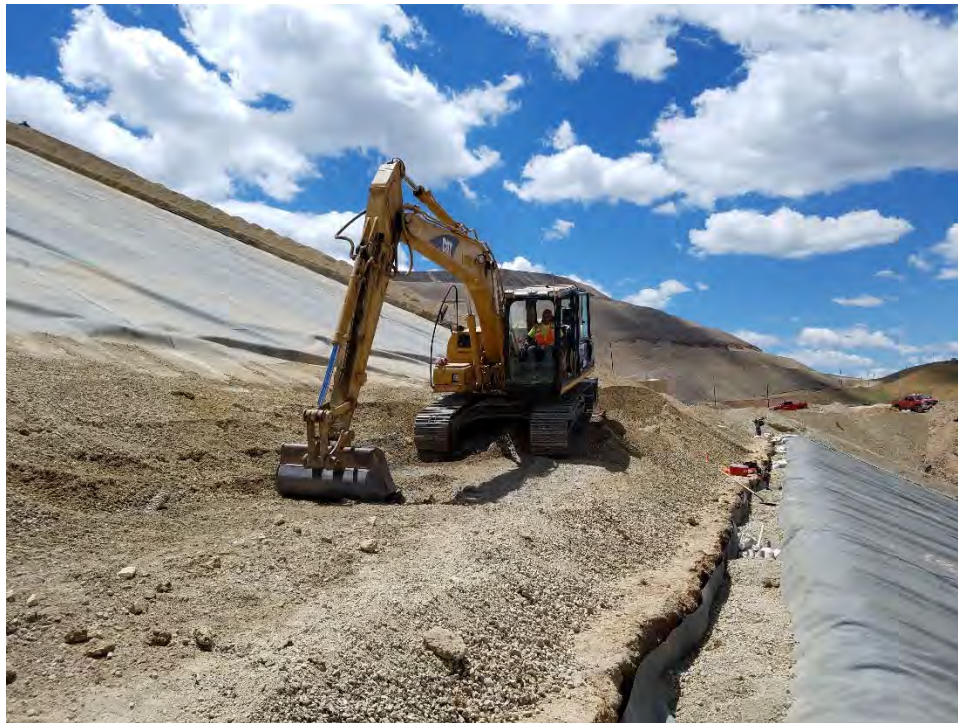
DCF Removal

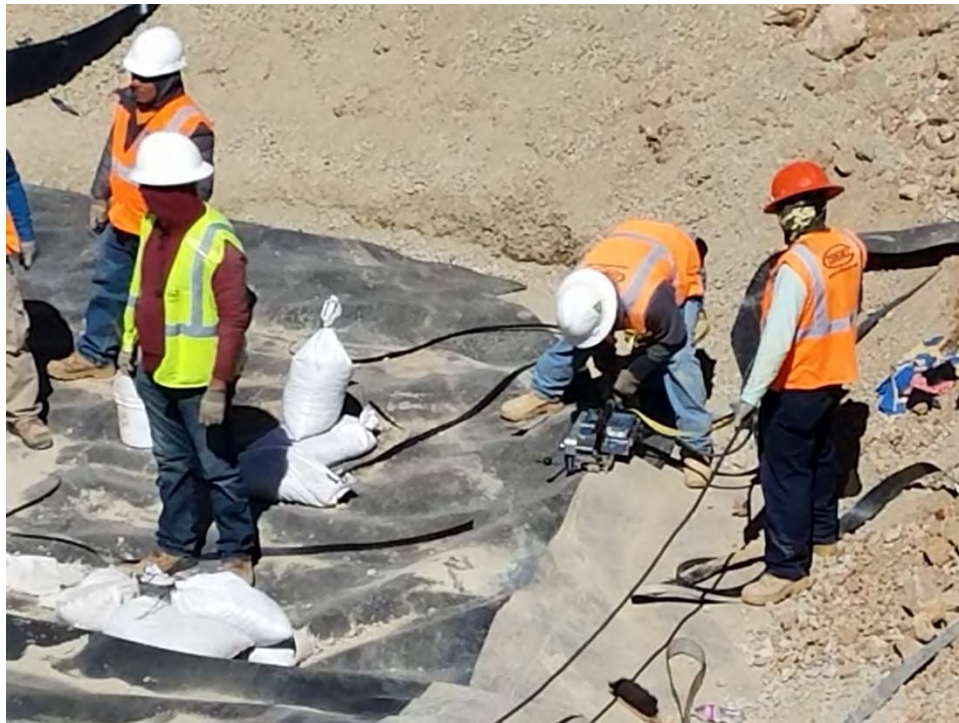
Fusion seaming performed on the tie-in

The tie-in for PRC-15 and PRC-16 to the existing geomembrane was welded using one fusion welding machine/operator combination. A total of 172' linear feet of seam was completed. Repairs were performed using the extrusion welding method. All repairs and extrusion welded seams were vacuum tested and passed. All pressure testing was performed and passed. All the destructive testing was performed and met project specifications excluding RCDF-9. The destructive test location is at the end of the seaming performed by the machine/operator combination. The failing test will be back tracked during tomorrow's shift and necessary repairs will be made.

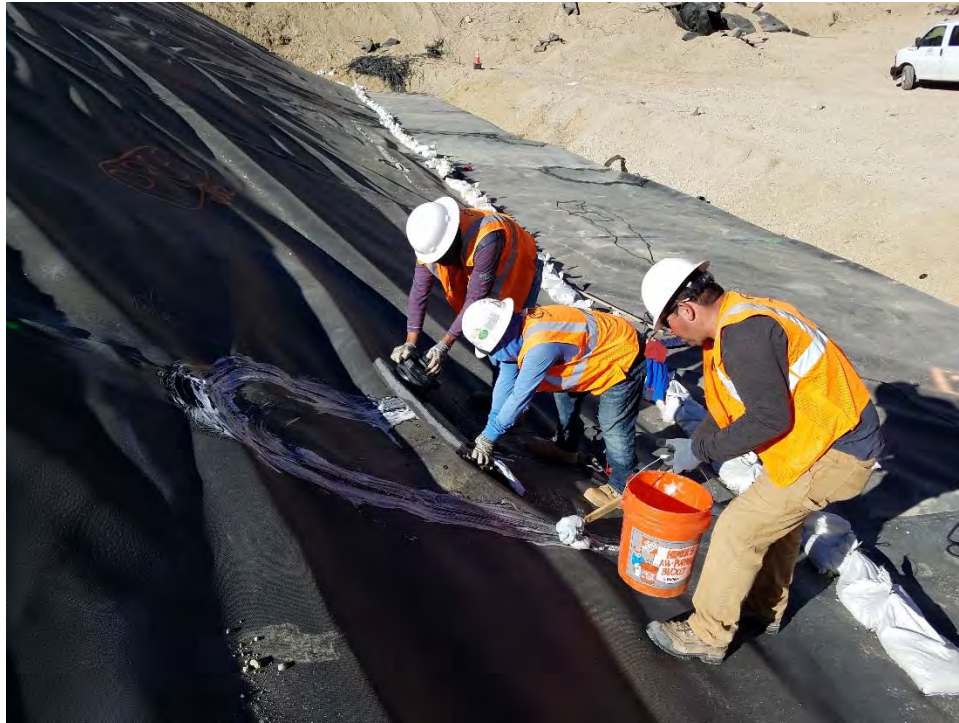
Vacuum Testing

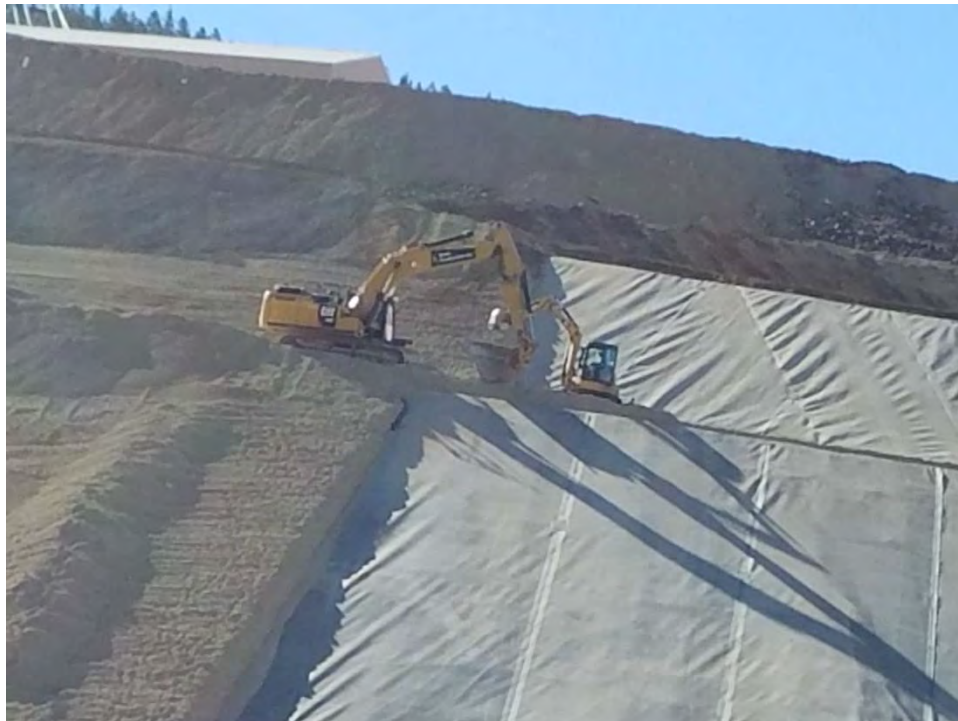
DCF Removal

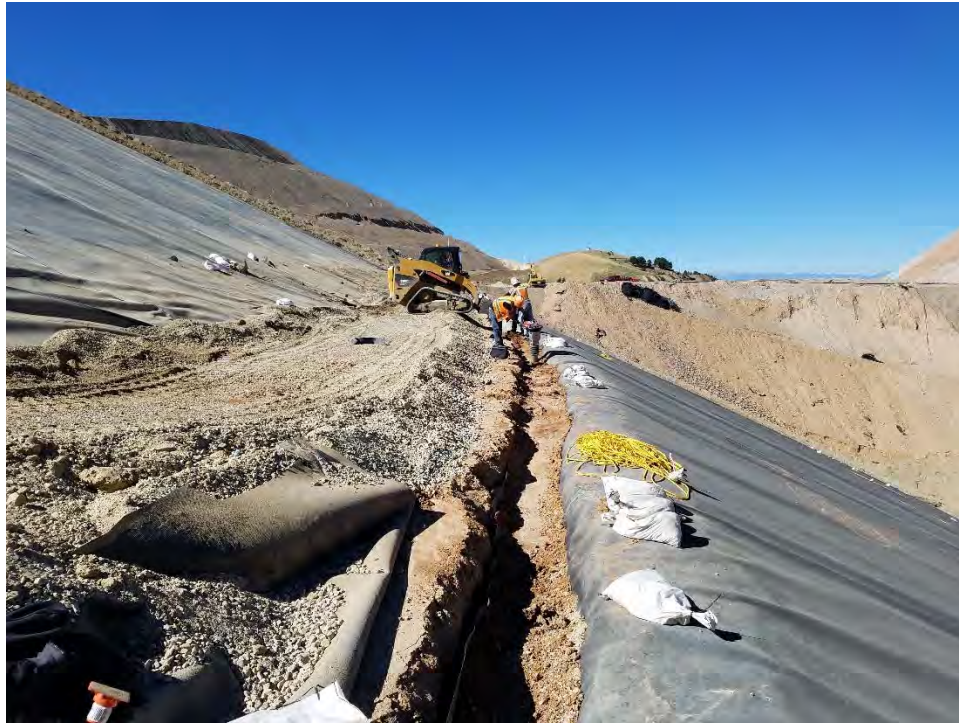
Anchor Trench Backfill

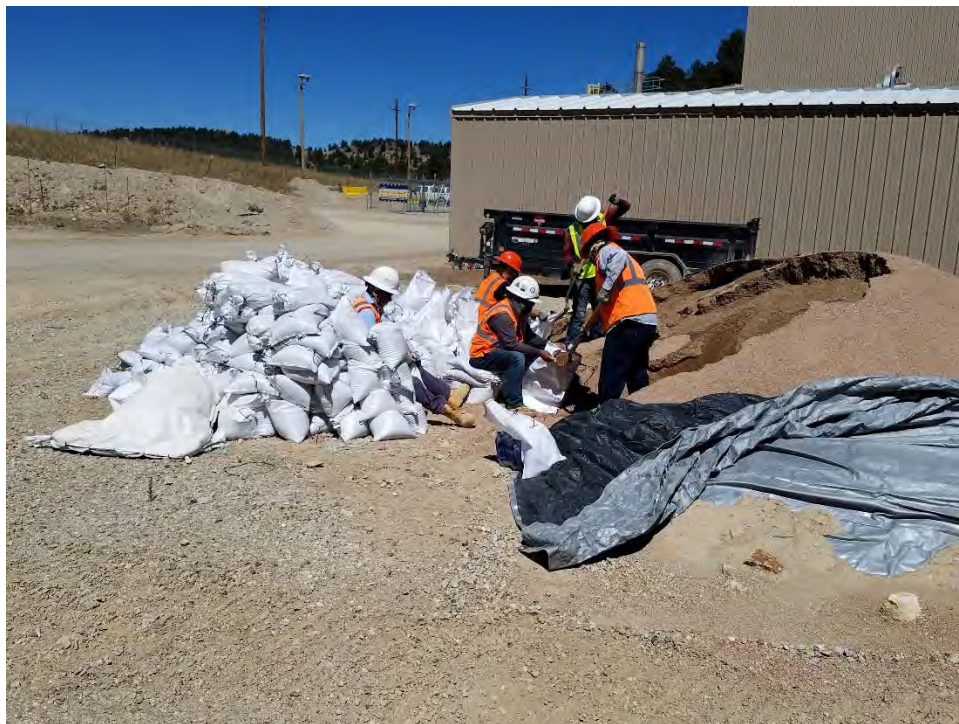
Filling Sand Bags

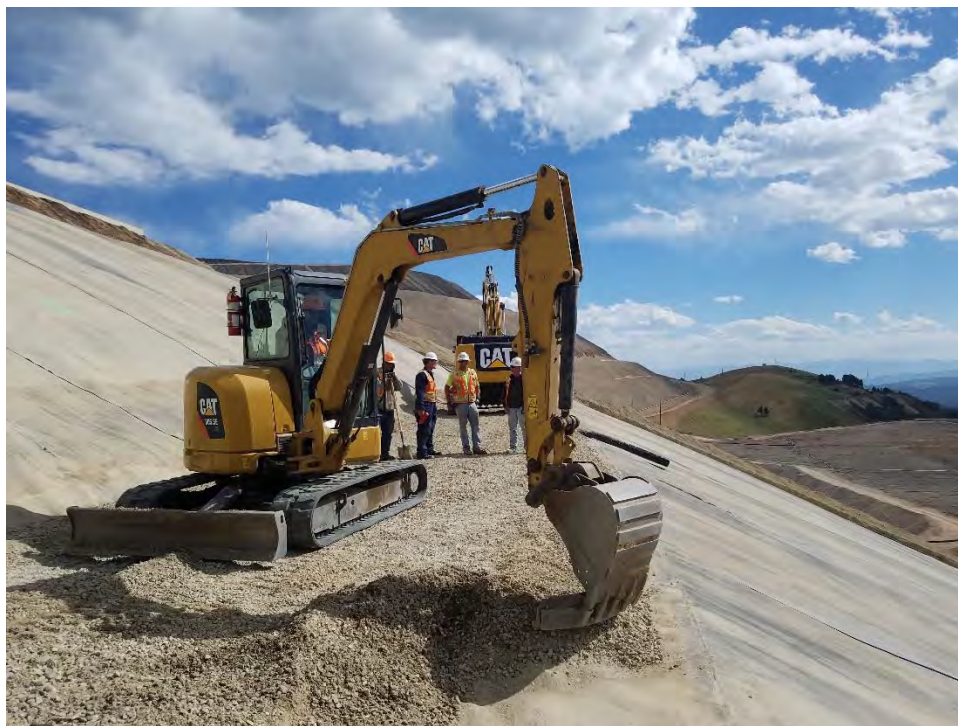
DCF Removal

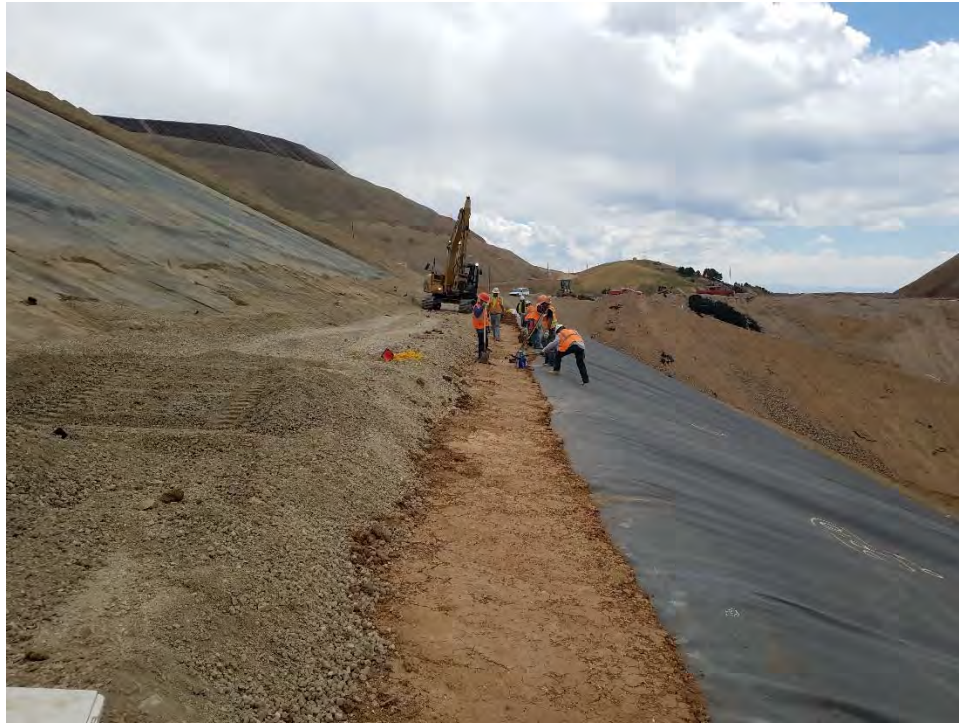
Anchor Trench Backfill
