Re: Cripple Creek & Victor Mining, Co., Cresson Project, M-1980-244; Review of Record of Construction Report, VLF2 Recertification Report, Subgrade and Geomembrane 9750 – 9900' Elevations.

Review of Record of Construction Report, VLF2 Recertification Report,
Subgrade and Geomembrane 9750-9900' Elevations
Response to Comments

October 5, 2018
NewFields Job 475.0106.026

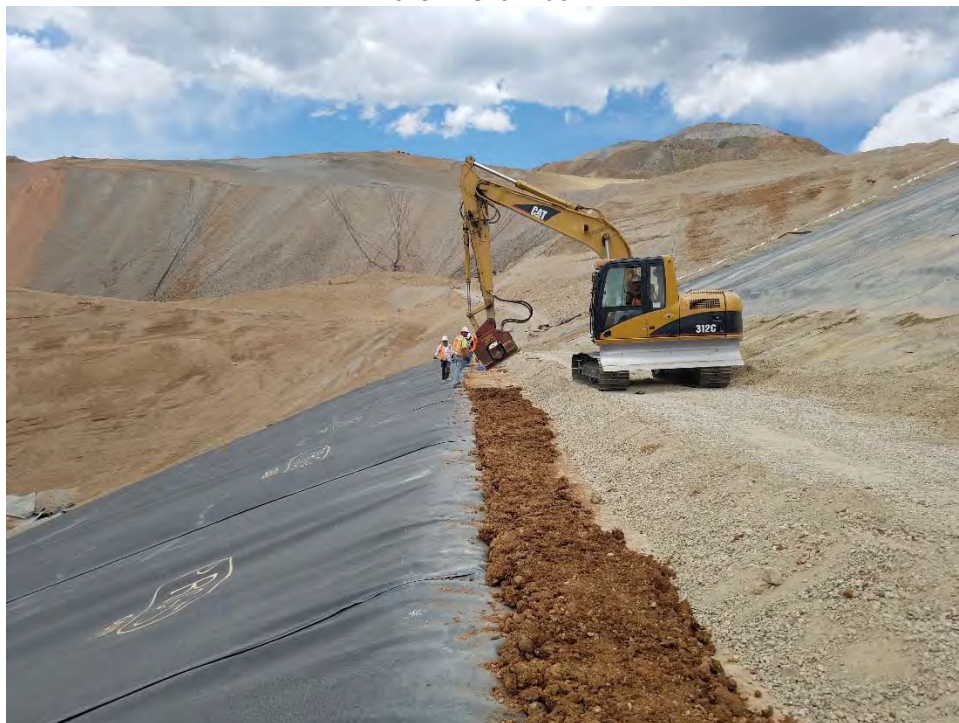
Anchor Trench Backfill

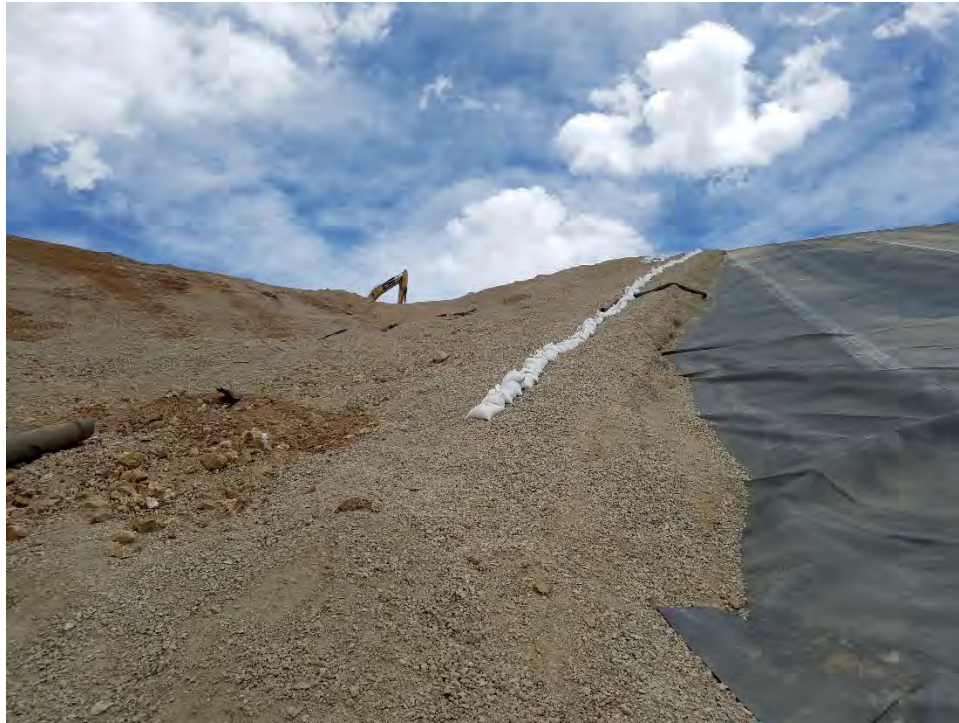
Staging Sand Bags

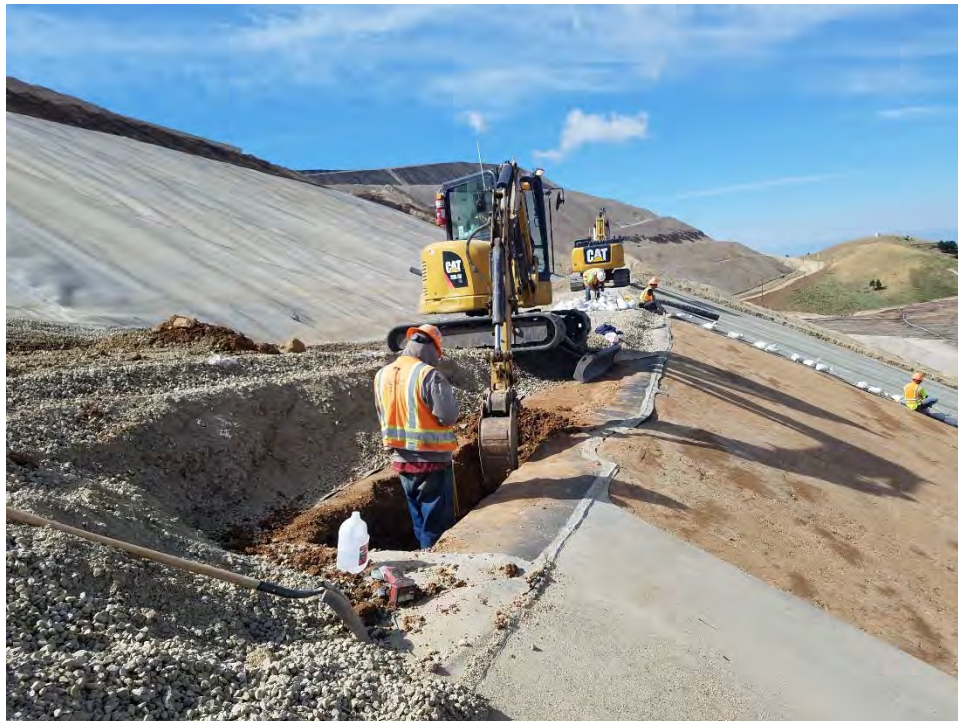
Anchor Excavation

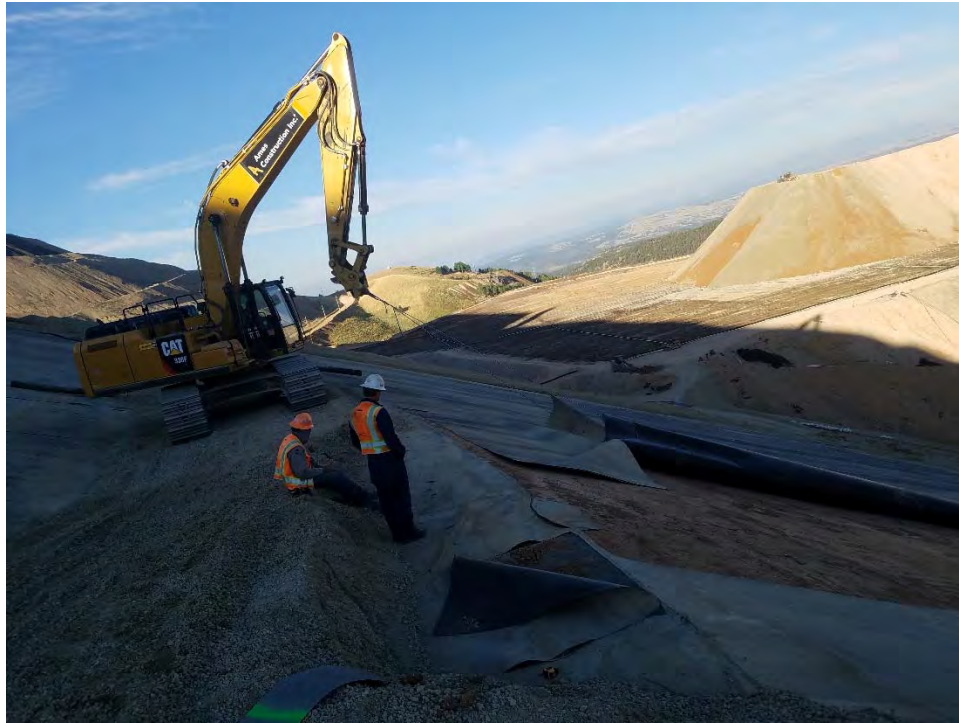
Geomembrane Removal
