Re: Permit No. M-1980-244; Cripple Creek & Victor Gold Mining Company; Cresson Project; Technical Revision 135 – Initial Adequacy Review Response

**VALLEY LEACH FACILITY 2
PHASE 3 STAGE A.1
RECORD OF CONSTRUCTION REPORT
REVISION-1**

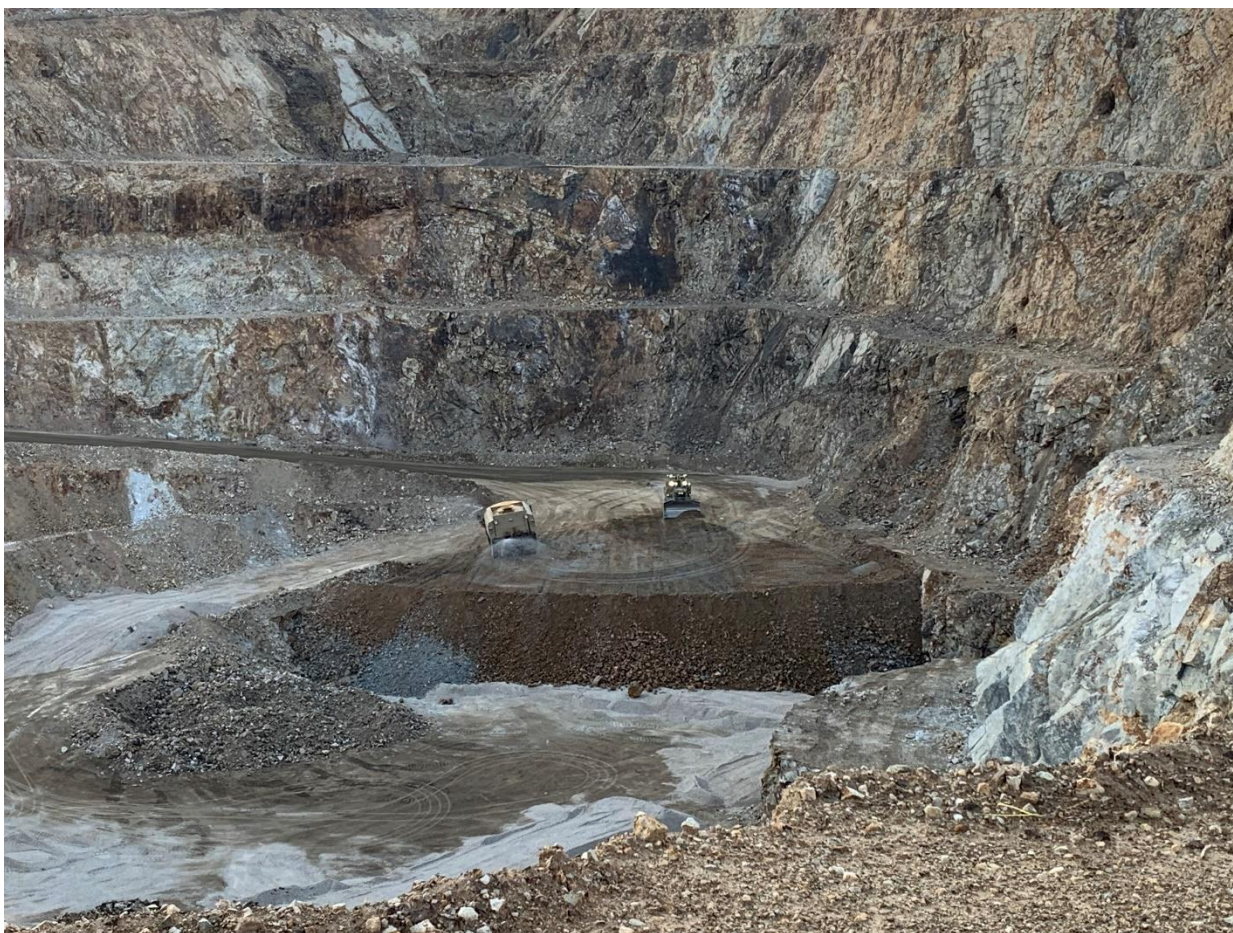
3. ACTIVE BACKFILL AREA PHOTOGRAPH:

Report Period: Thursday-Wednesday	Ambient Temperature		Weather Conditions
	High	Low	Precipitation
Date: 8/31/21 – 9/1/21	60	50	Heavy rain for 3 hrs, night shift of 9/1
Observations & Comments	Started dumping first backfill lift on the 9850 elevation with a 20-foot lift. Good rock/fines mix, rocks are 3-4 ft minus. Sourced from Schist Island phase 2 (10075 elevation) and South Cresson (9915 elevation).

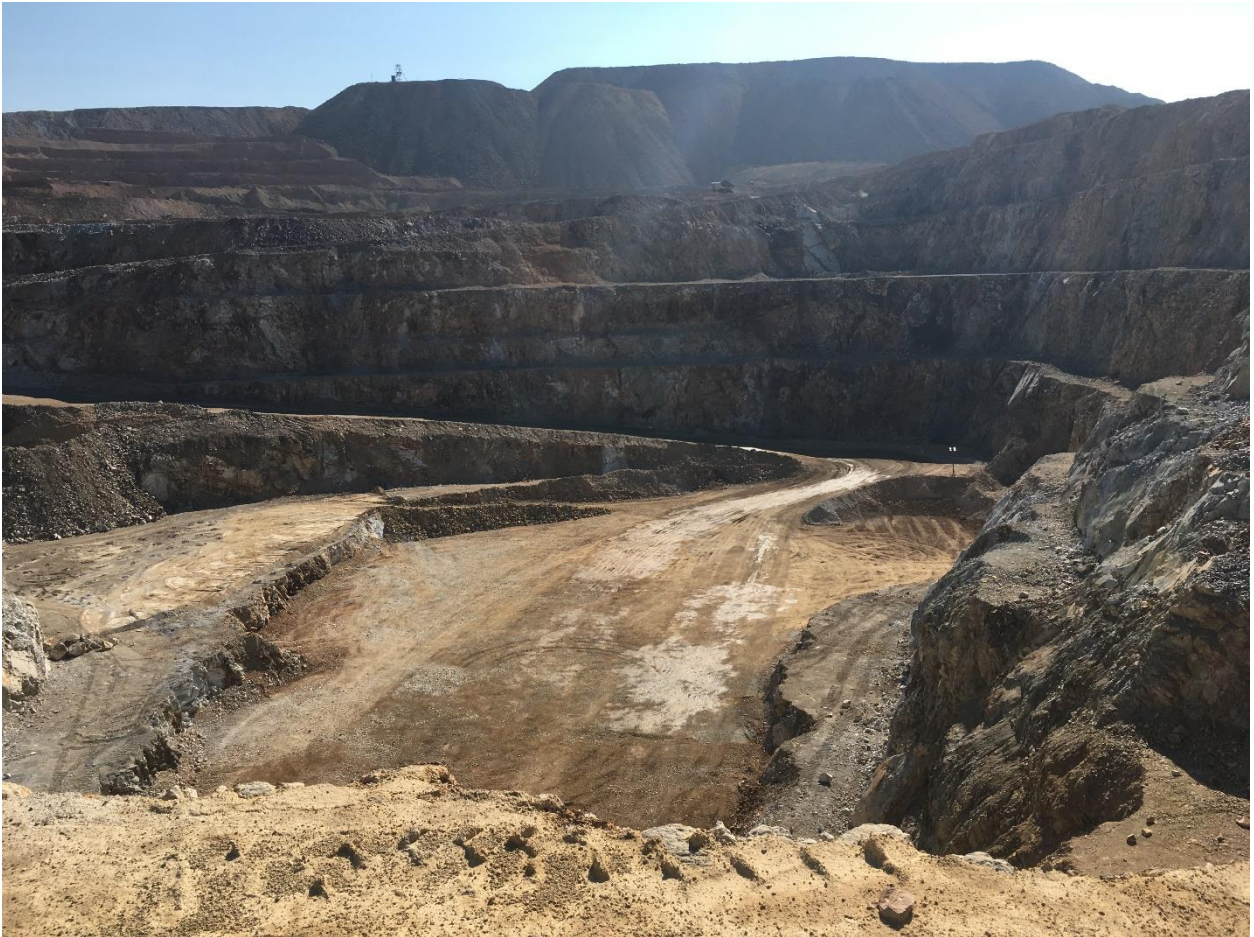
3. ACTIVE BACKFILL AREA PHOTOGRAPH:

Report Period: Thursday-Wednesday	Ambient Temperature		Weather Conditions
	High	Low	Precipitation
Date: 9/2/21 – 9/8/21	68	45	None
Observations & Comments	Continued dumping on the 9850 elevation with a 20-foot lift. Good rock/fines mix from South Cresson (9915 elevation) and Schist Island phase 2 (10075 elevation). Some material also delivered from West Cresson (9900 elevation) – any loads with large boulders were hauled to ECOSA.

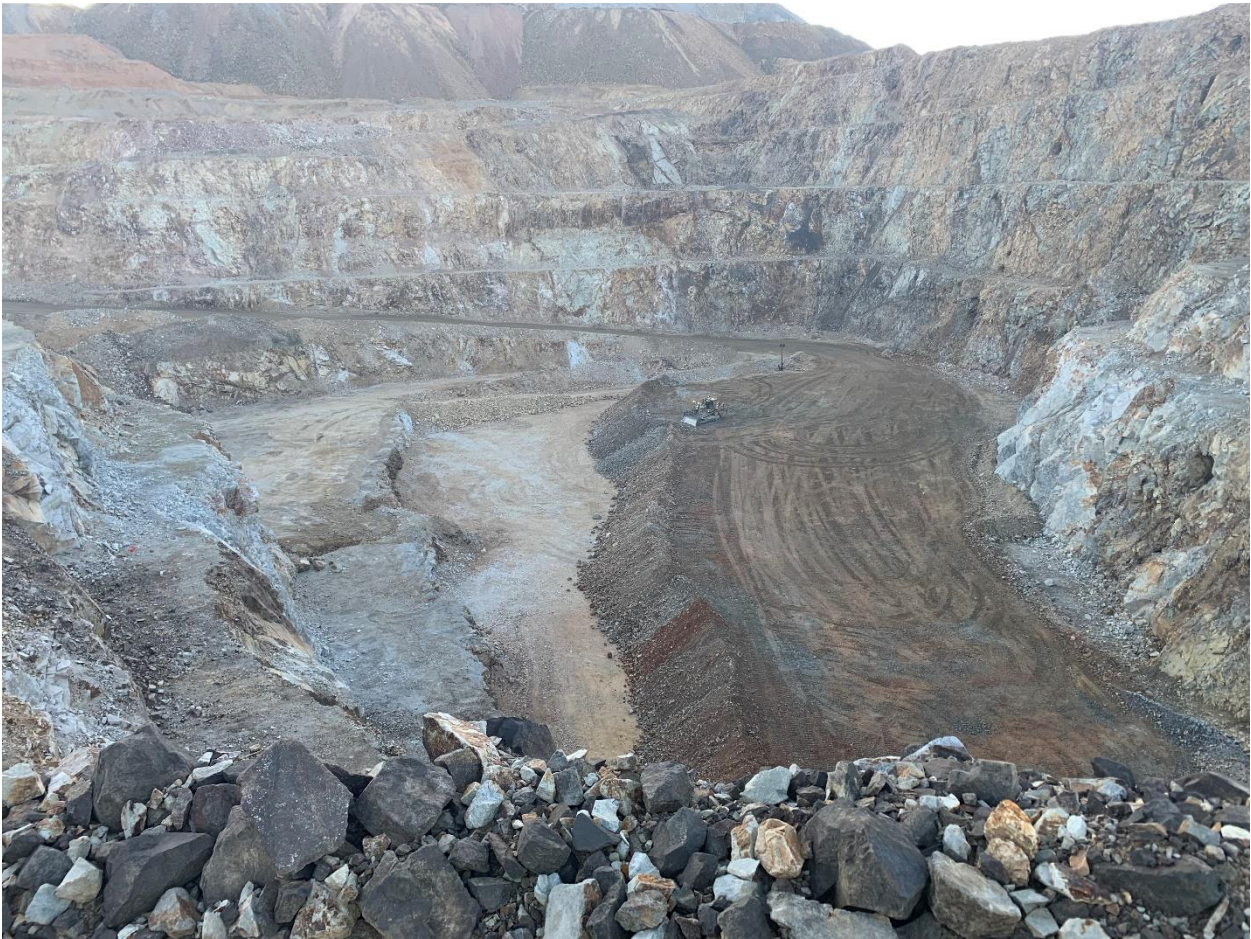
3. ACTIVE BACKFILL AREA PHOTOGRAPH:

Report Period: Thursday-Wednesday	Ambient Temperature		Weather Conditions
	High	Low	Precipitation
Date: 9/9/21 – 9/15/21	71	55	Minimal during 2 shifts
Observations & Comments	Completed dumping on the 9850 elevation with a 20-foot lift. Started dumping on the 9865 elevation with a 15-foot lift. Good rock/fines mix from South Cresson (9915 elevation), Schist Island phase 2 (10110 and 10075 elevations) and West Cresson (9865 elevation).

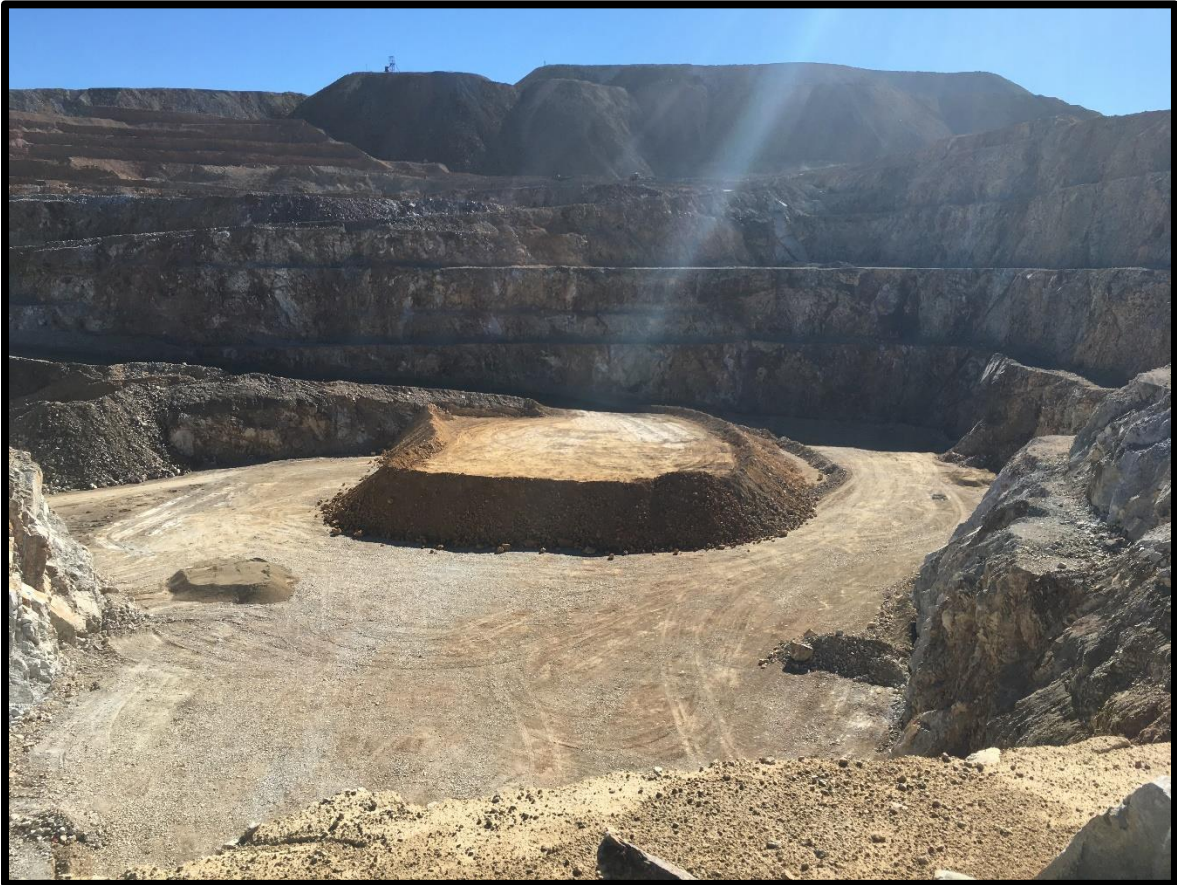
3. ACTIVE BACKFILL AREA PHOTOGRAPH:

Report Period: Thursday-Wednesday	Ambient Temperature		Weather Conditions
	High	Low	Precipitation
Date: 9/16/21 – 9/22/21	74	32	none
Observations & Comments	Completed dumping on the 9865 elevation with a 15-foot lift. Started dumping on the 9885 elevation with a 20-foot lift. Good rock/fines mix from South Cresson (9915 elevation) and Schist Island phase 2 (10110 elevation). Some material meeting specs was hauled from West Cresson towards the end of the week (9830 elevation).

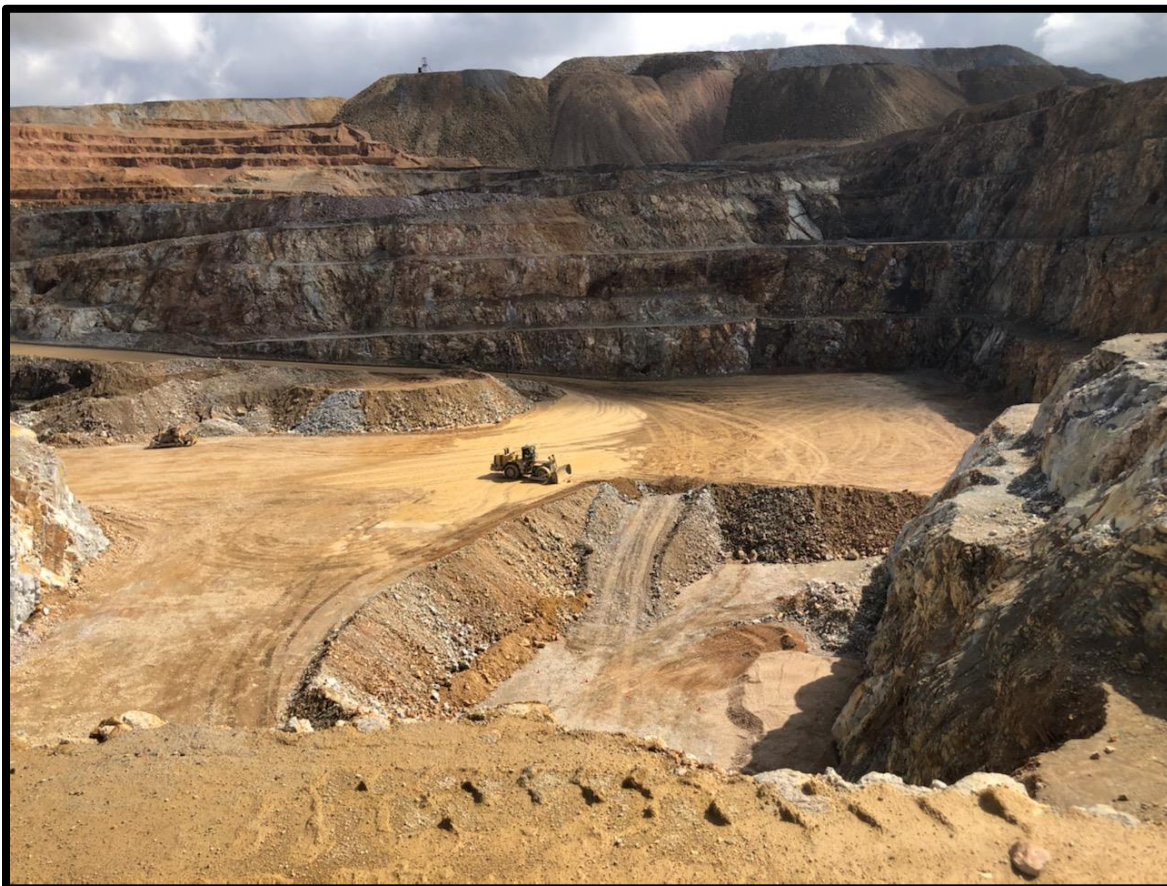
3. ACTIVE BACKFILL AREA PHOTOGRAPH:

Report Period: Thursday-Wednesday	Ambient Temperature		Weather Conditions
	High	Low	Precipitation
Date: 9/23/21 – 9/29/21	71	36	Yes, ~0.25 inch total
Observations & Comments	Completed dumping on the 9885 elevation with a 20-foot lift. Started dumping on the 9905 elevation with a 20-foot lift. Good rock/fines mix from South Cresson, West Cresson, and Schist Island phase 2.

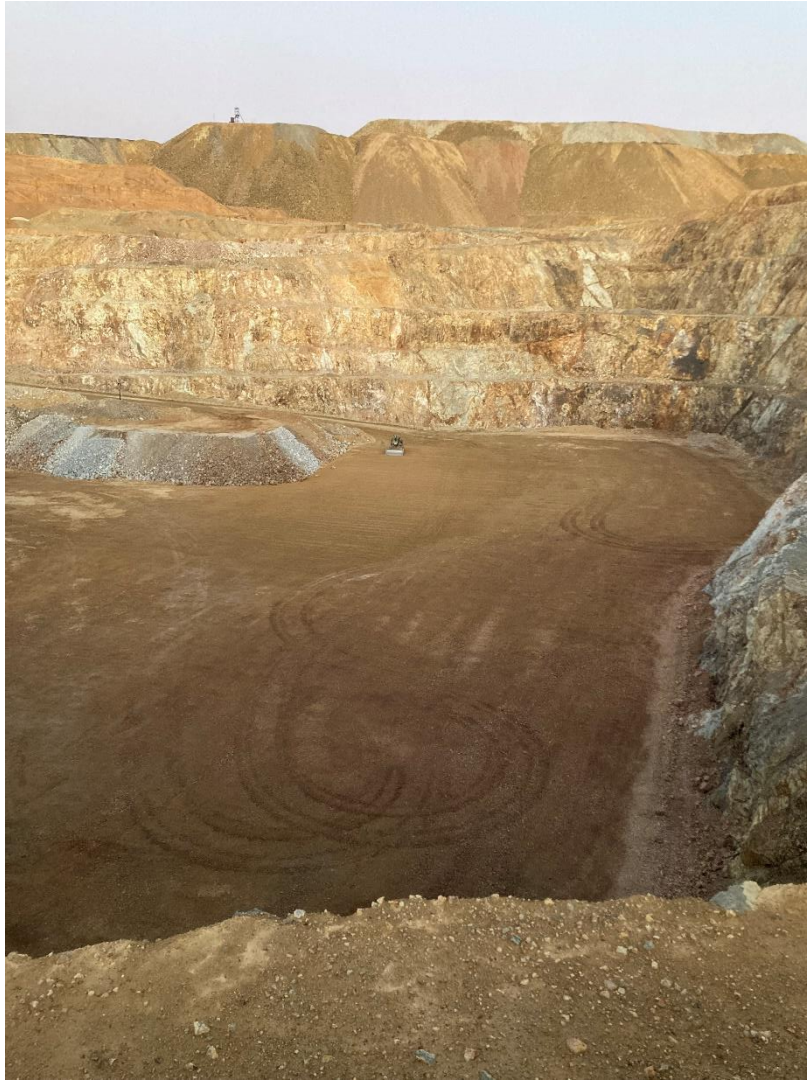
3. ACTIVE BACKFILL AREA PHOTOGRAPH:

Report Period: Thursday-Wednesday	Ambient Temperature		Weather Conditions
	High	Low	Precipitation
Date: 9/30/21 – 10/06/21	66	32	Yes, ~0.25 inch total
Observations & Comments	Progressed dumping on the 9905 elevation with a 20-foot lift. Good rock/fines mix from South Cresson, West Cresson, and Schist Island phase 2. Prepped the high compaction backfill test pads on the North end of the work area.

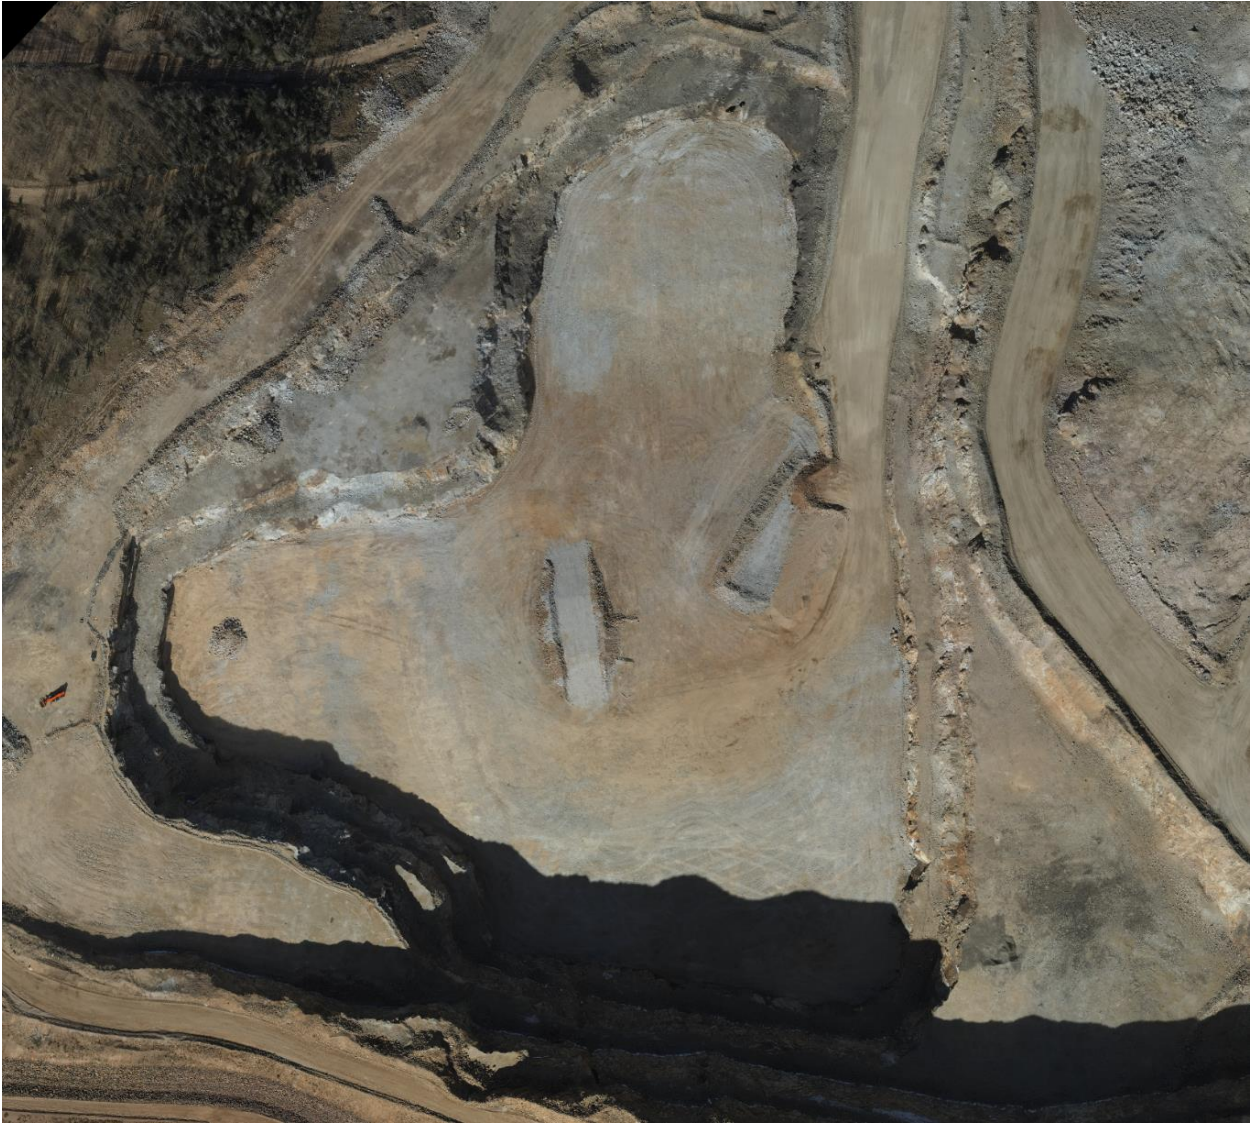
3. ACTIVE BACKFILL AREA PHOTOGRAPH:

Report Period: Thursday-Wednesday	Ambient Temperature		Weather Conditions
	High	Low	Precipitation
Date: 10/13/21 – 10/20/21	62	16	Yes
Observations & Comments	Completed the final low compaction lift on the 9505 and established the last high compaction test areas. Good rock/fines mix from South Cresson, West Cresson, and Schist Island phase 2.

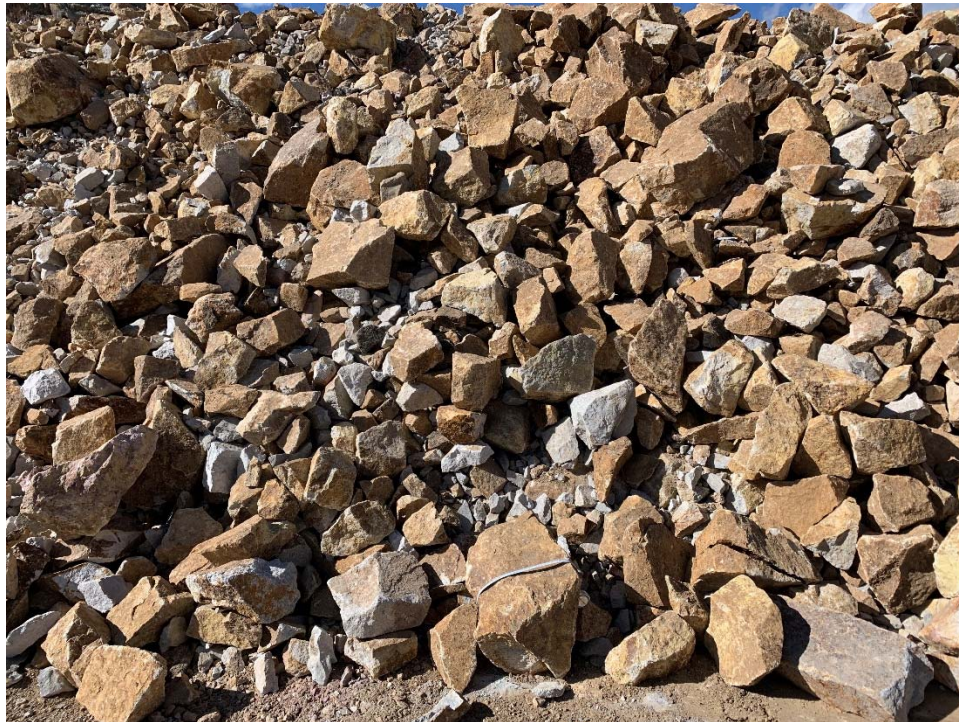
October 18, 2021 – Material size on plug dump test fill with tape measure for scale (TW)

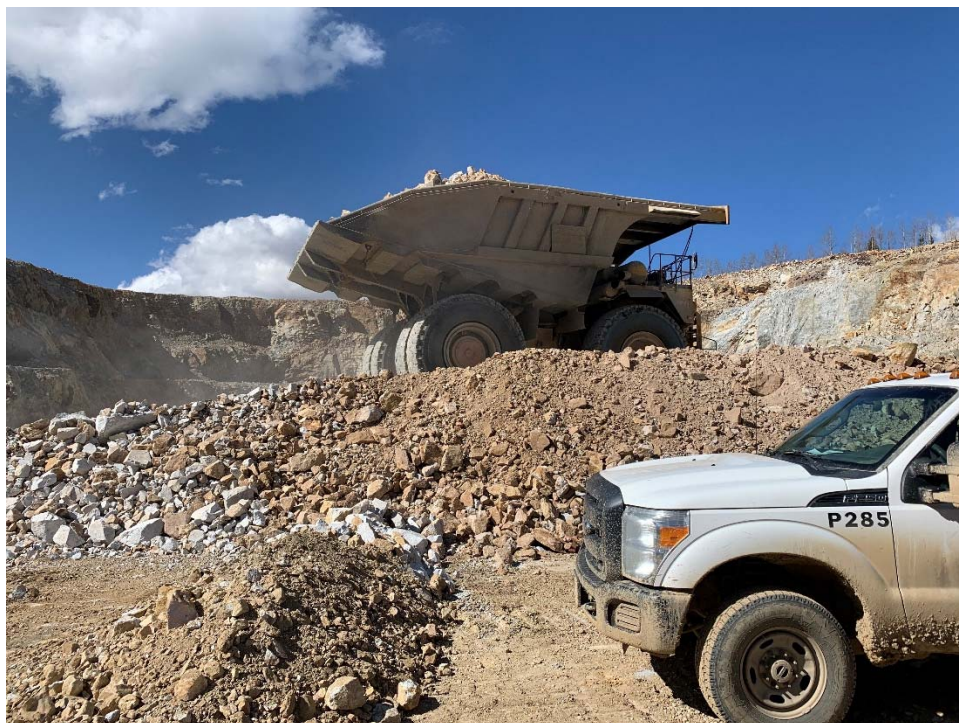
October 18, 2021 – High Compaction Backfill Test Pad wheel rolling progress (TW)

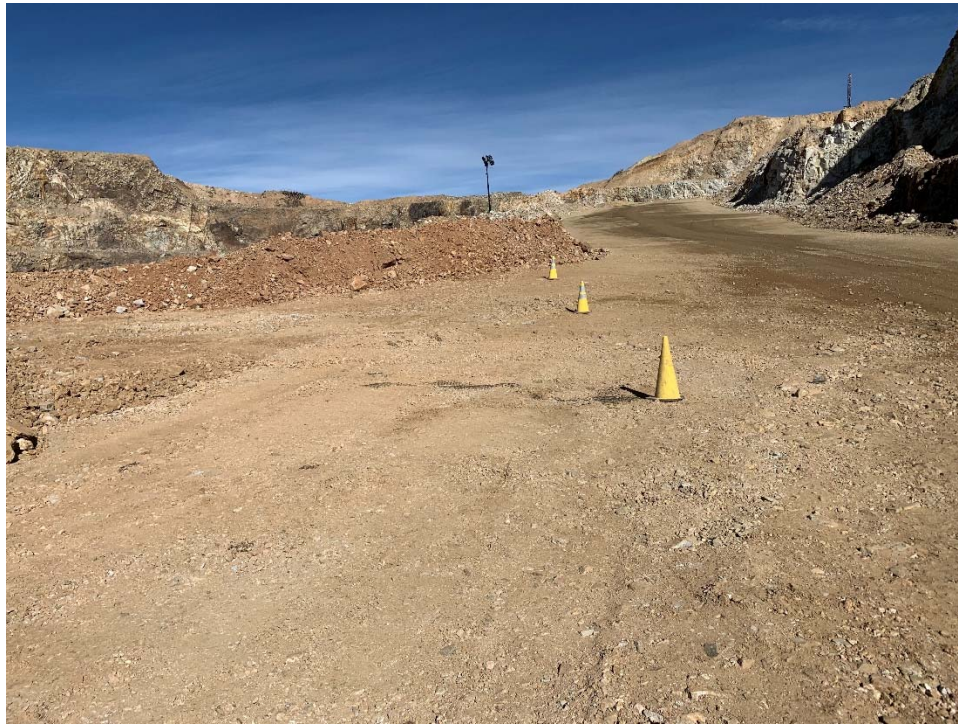
October 25, 2021 – Chevy Underground Working remediation exposed geogrid (TW)

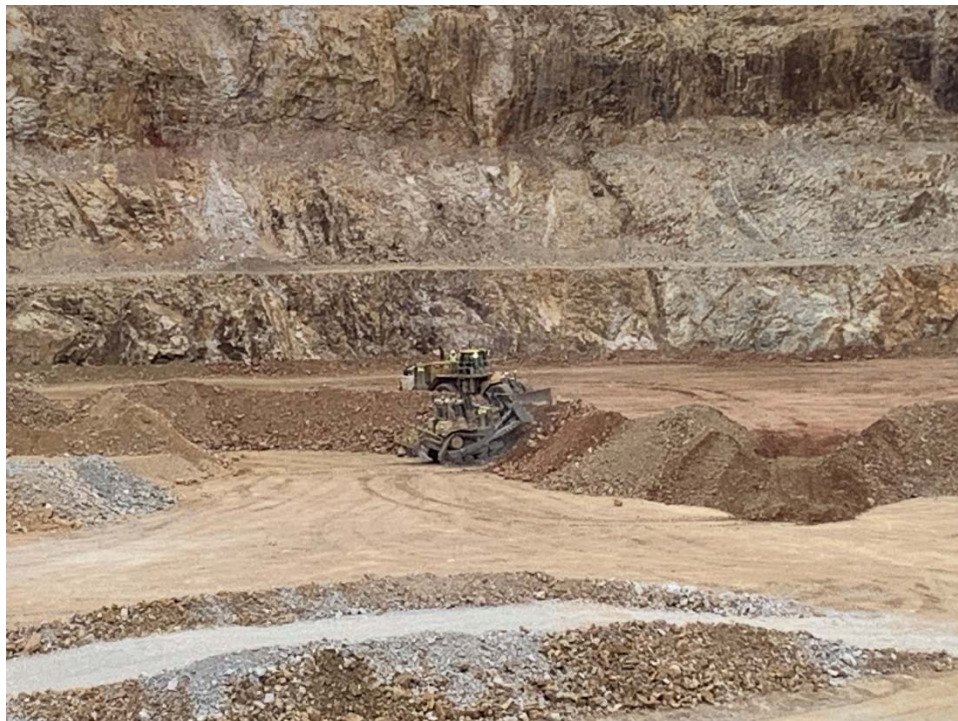
October 26, 2021 – High Compaction Backfill oversized material removal (TW)

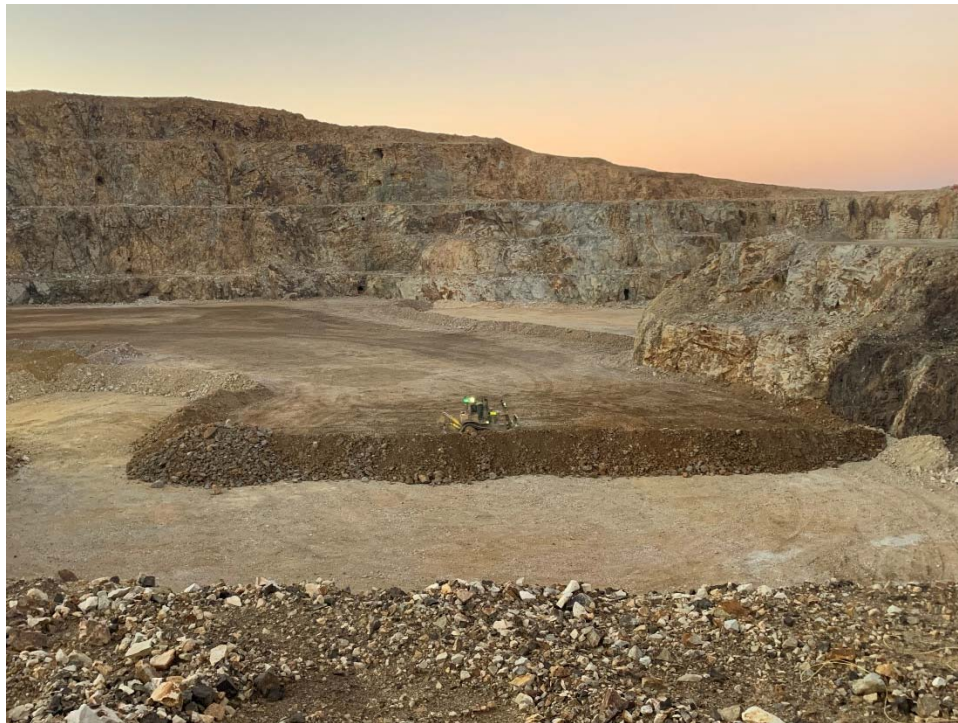
October 29, 2021 – High Compaction Backfill Progress (TW)

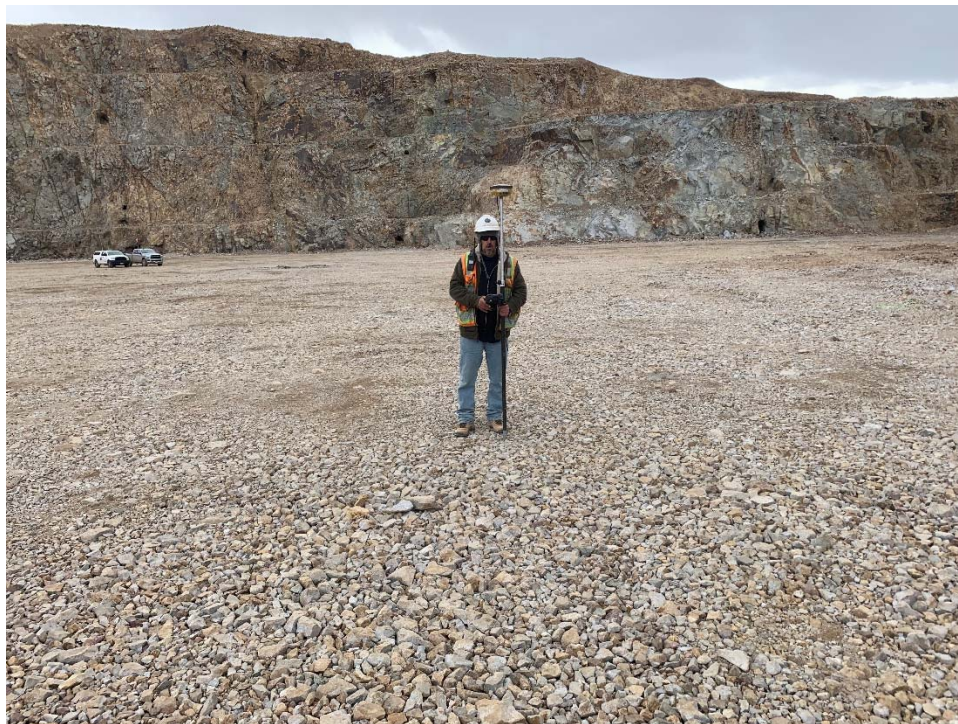
October 30, 2021 – High Compaction Backfill controlled survey grid (TW)

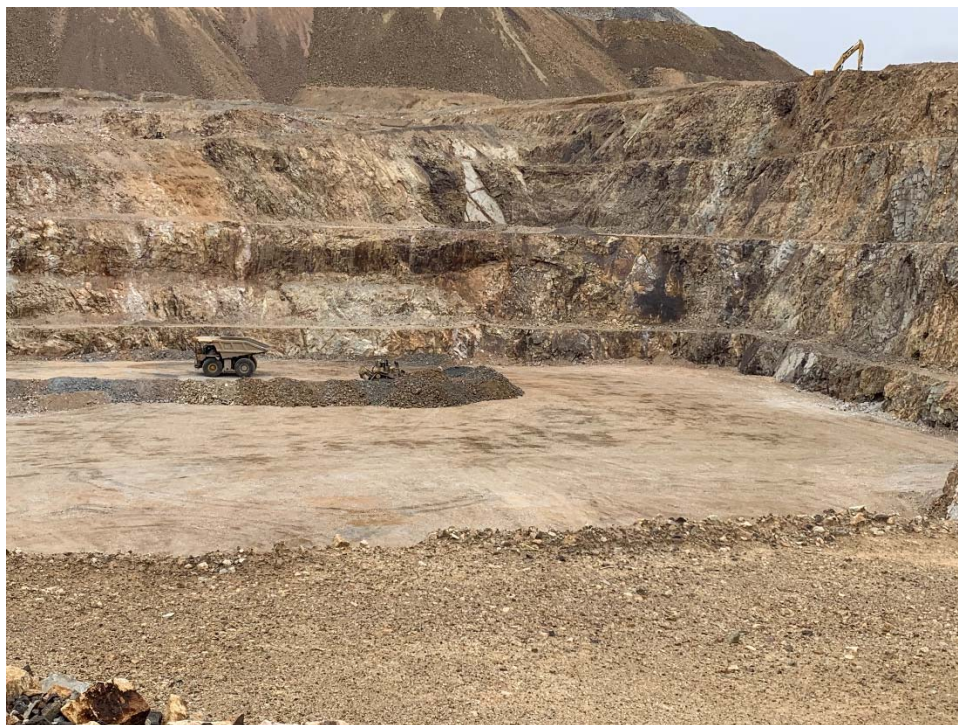
October 30, 2021 – High Compaction Backfill progress (TW)

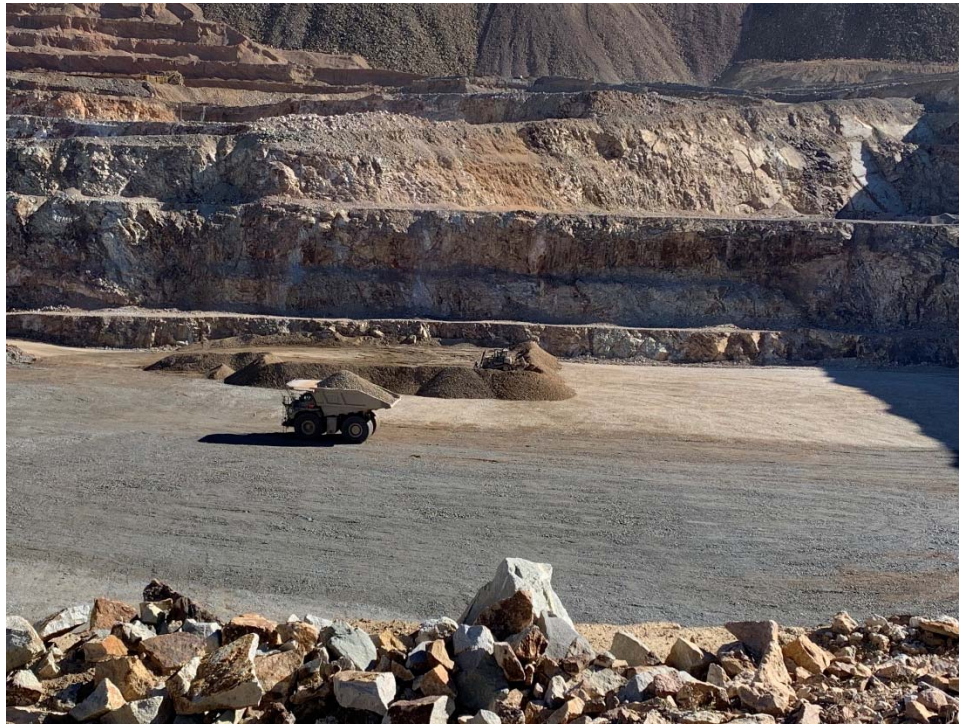
November 7, 2021 – High Compaction Backfill placement and wheel rolling (TW)

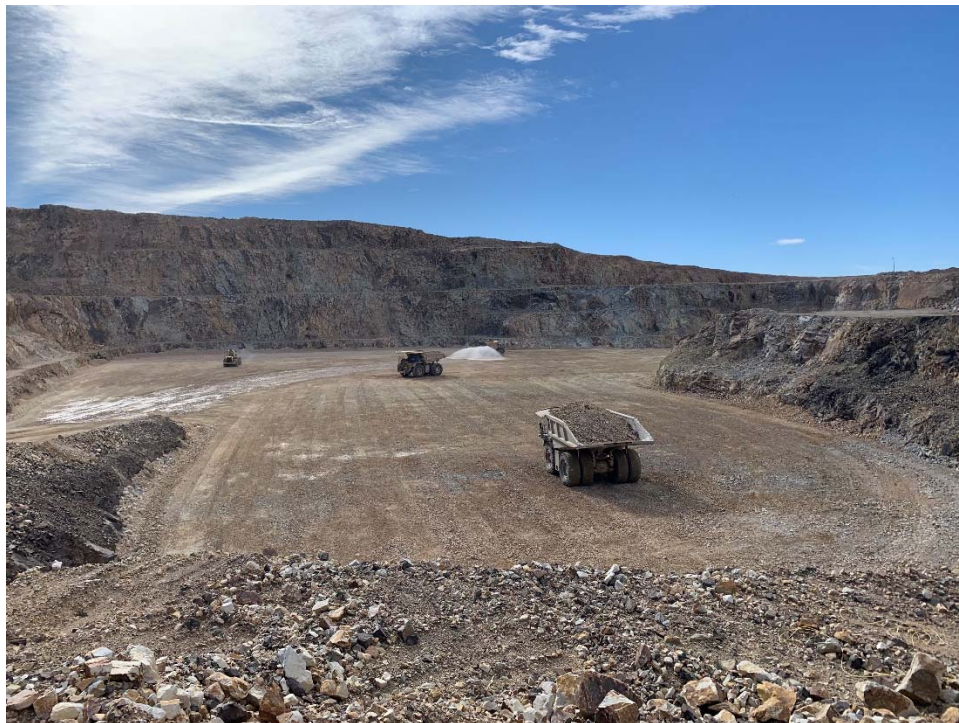
November 11, 2021 – High Compaction Backfill wheel rolling (TW)

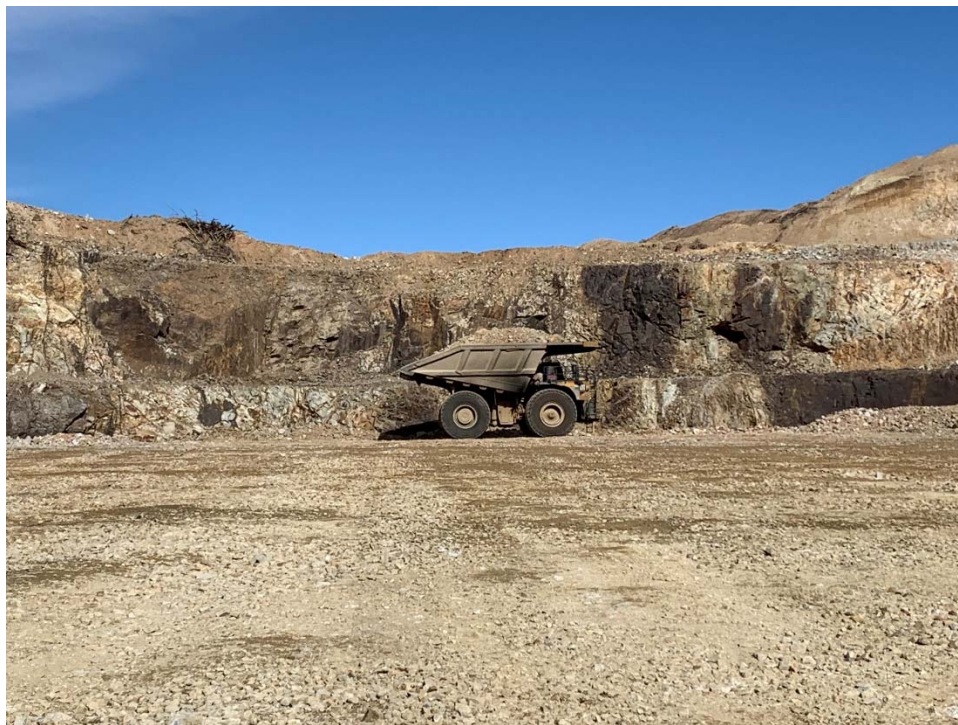
November 11, 2021 – High Compaction Backfill wheel rolling (TW)

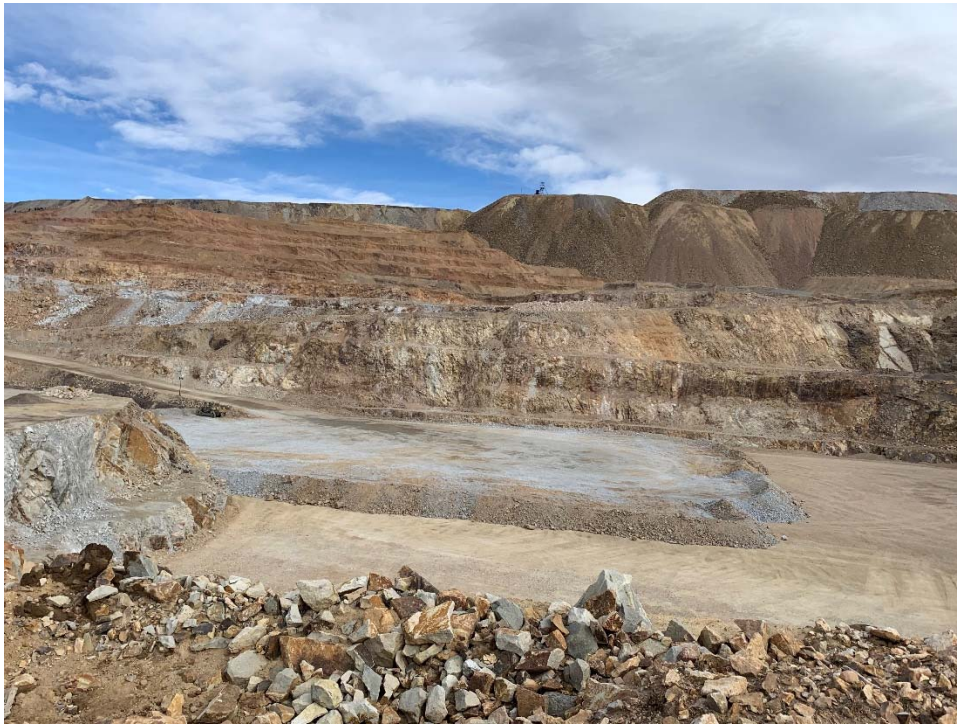
November 14, 2021 – High Compaction Backfill placement (TW)

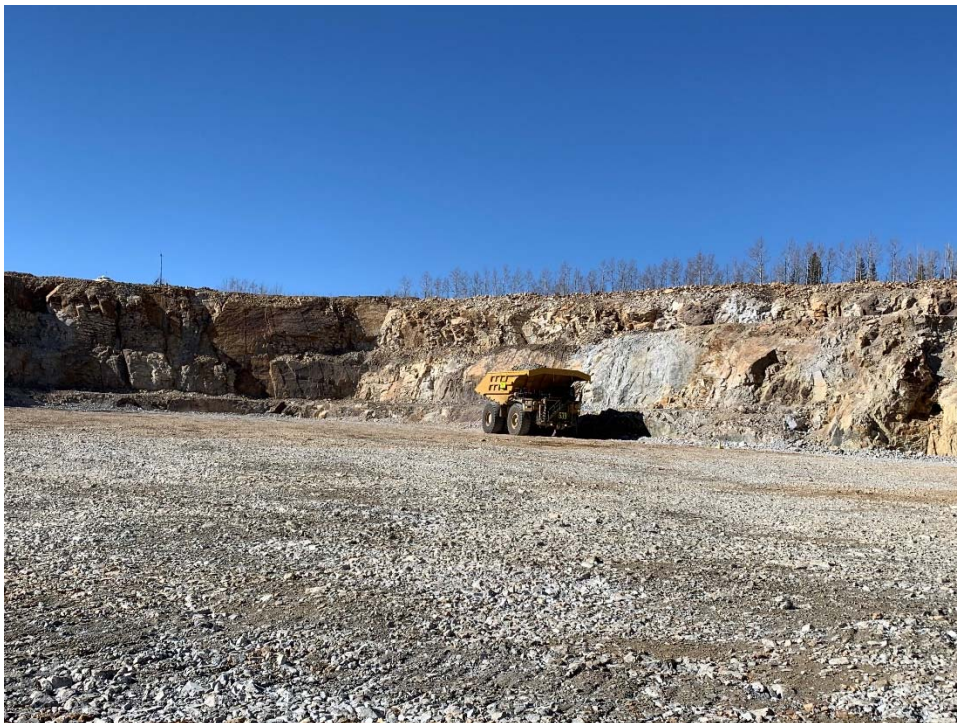
November 17, 2021 – High Compaction Backfill wheel rolling (TW)

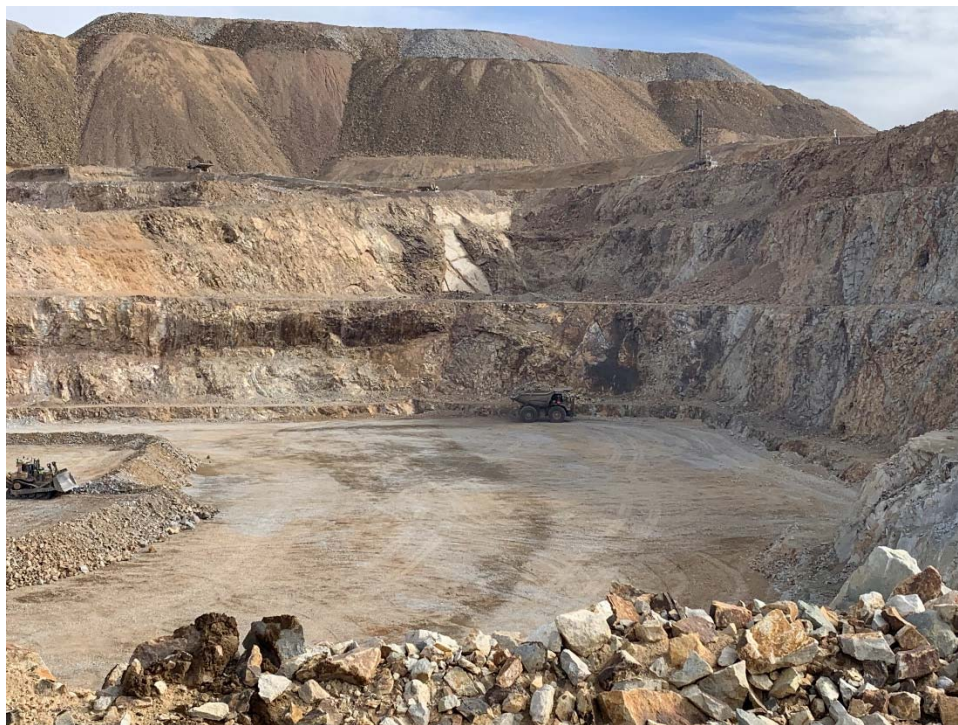
November 18, 2021 – High Compaction Backfill wheel rolling and placement (TW)

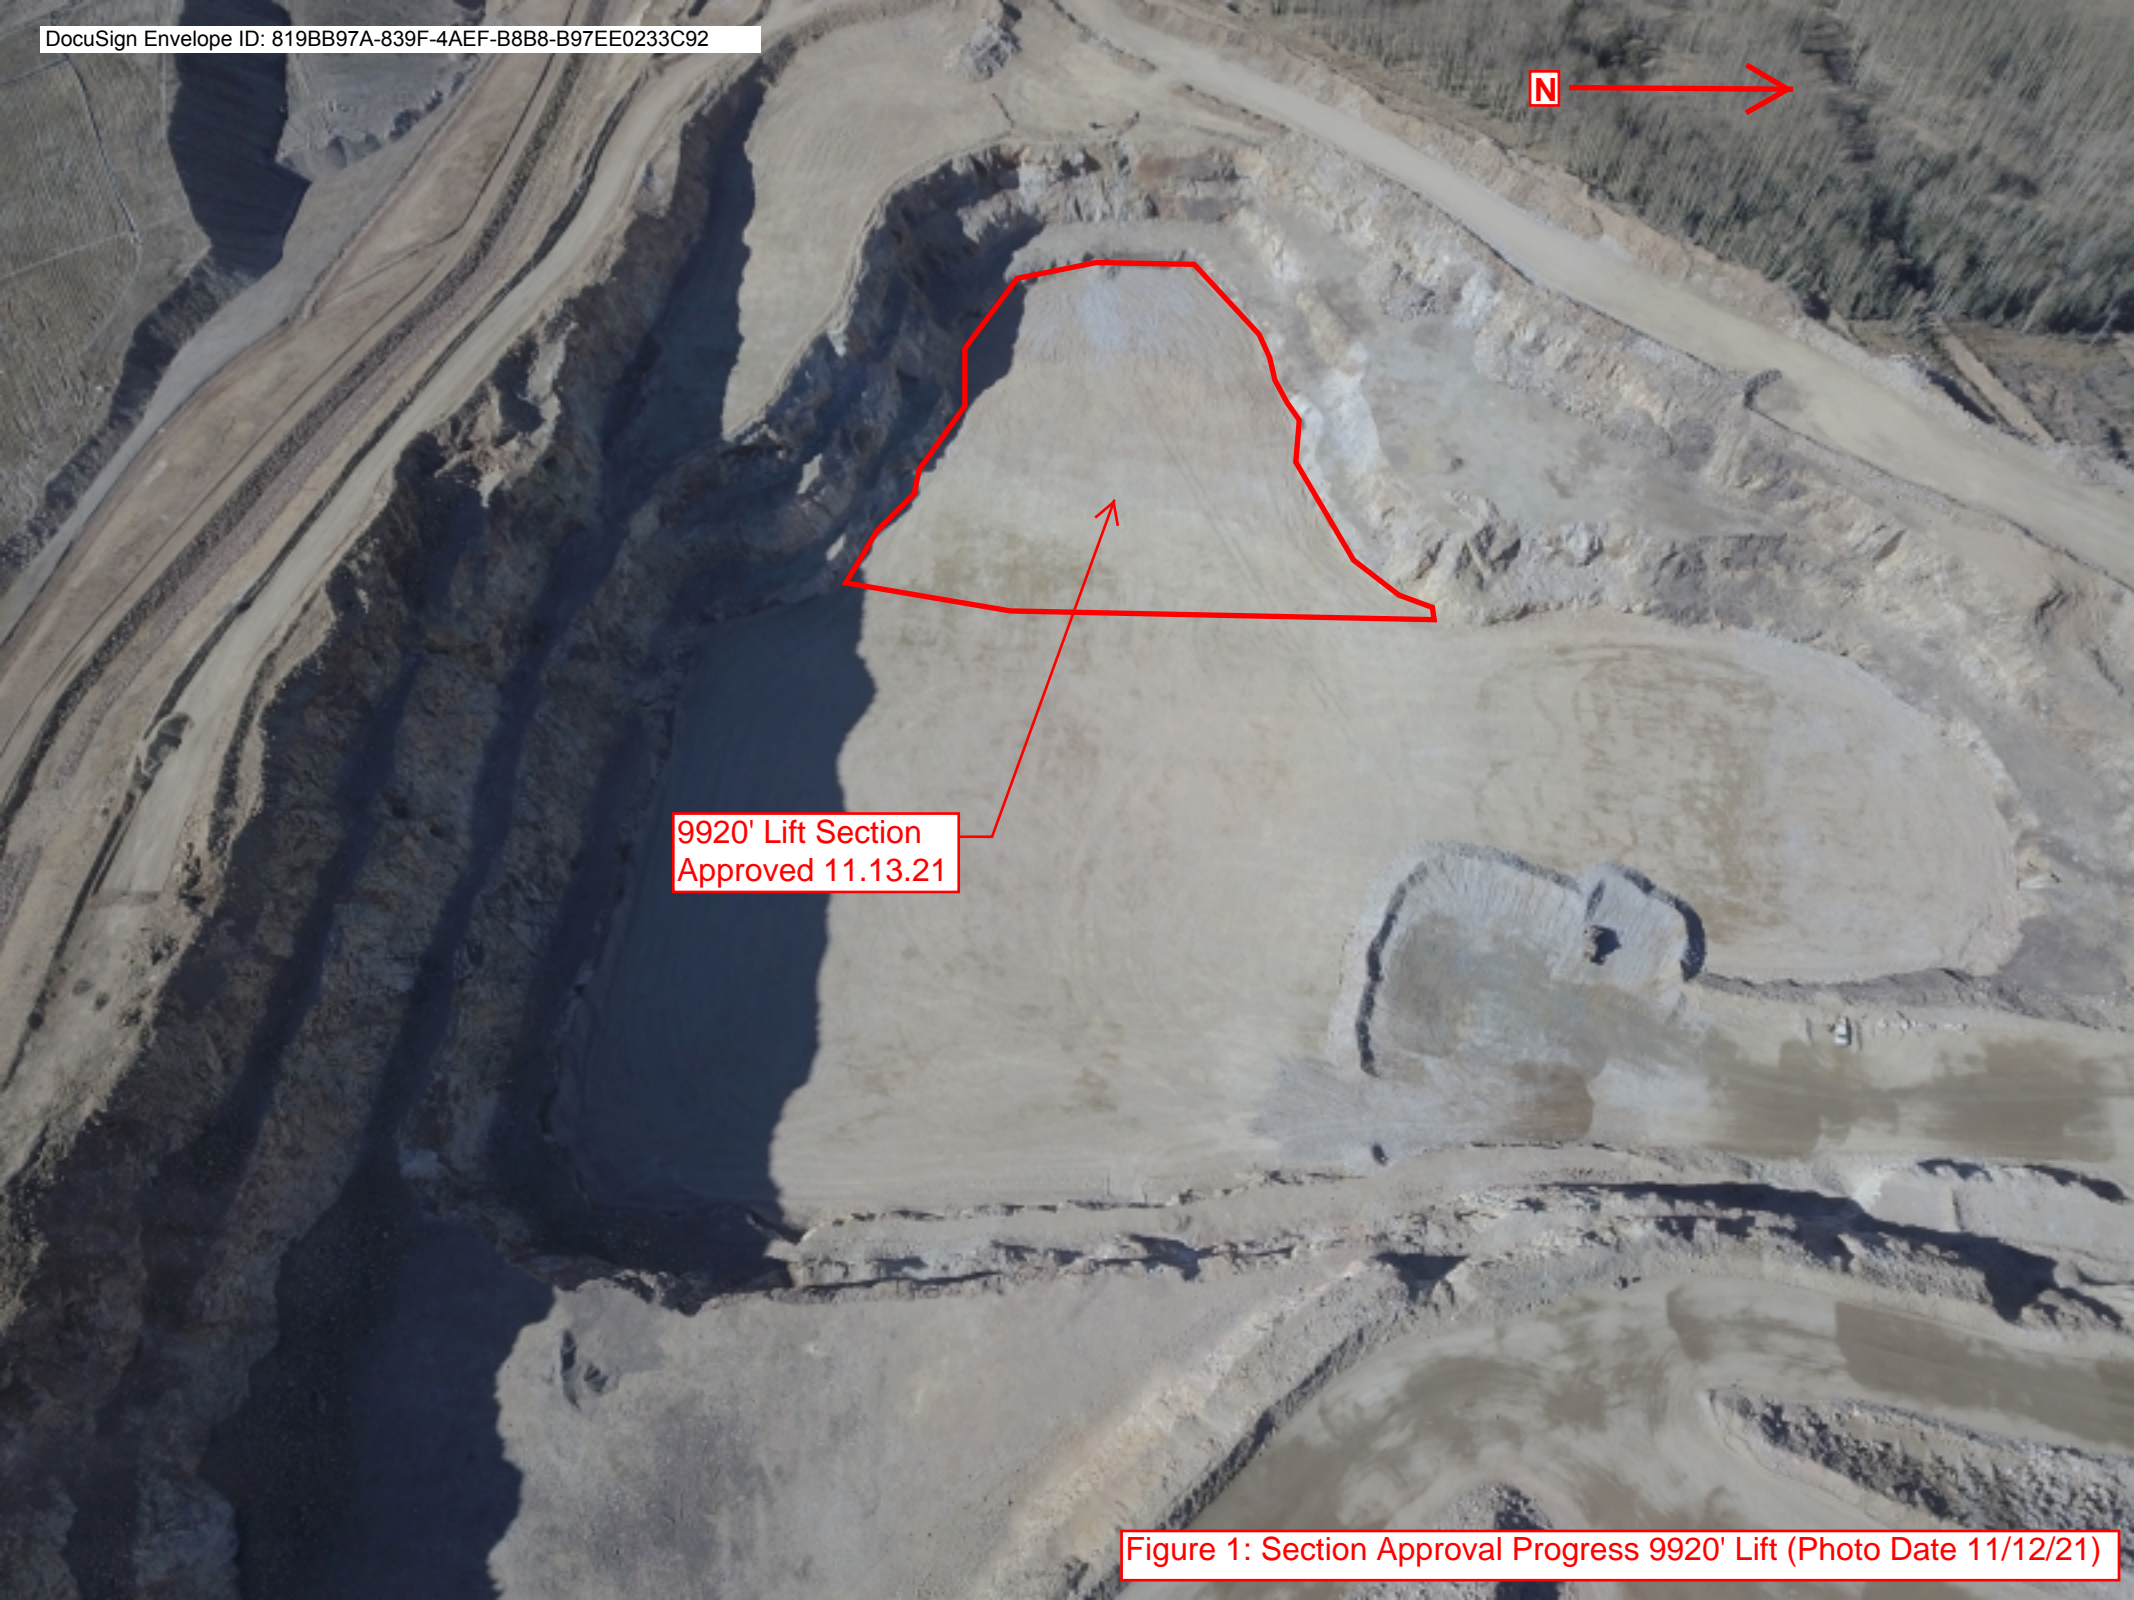
9920' Lift Section
Approved 11.13.21

Figure 1: Section Approval Progress 9920' Lift (Photo Date 11/12/21)
