Re: Permit No. M-1980-244; Cripple Creek & Victor Gold Mining Company; Cresson Project; Technical Revision 135 – Initial Adequacy Review Response

**VALLEY LEACH FACILITY 2
PHASE 3 STAGE A.1
RECORD OF CONSTRUCTION REPORT
REVISION-1**

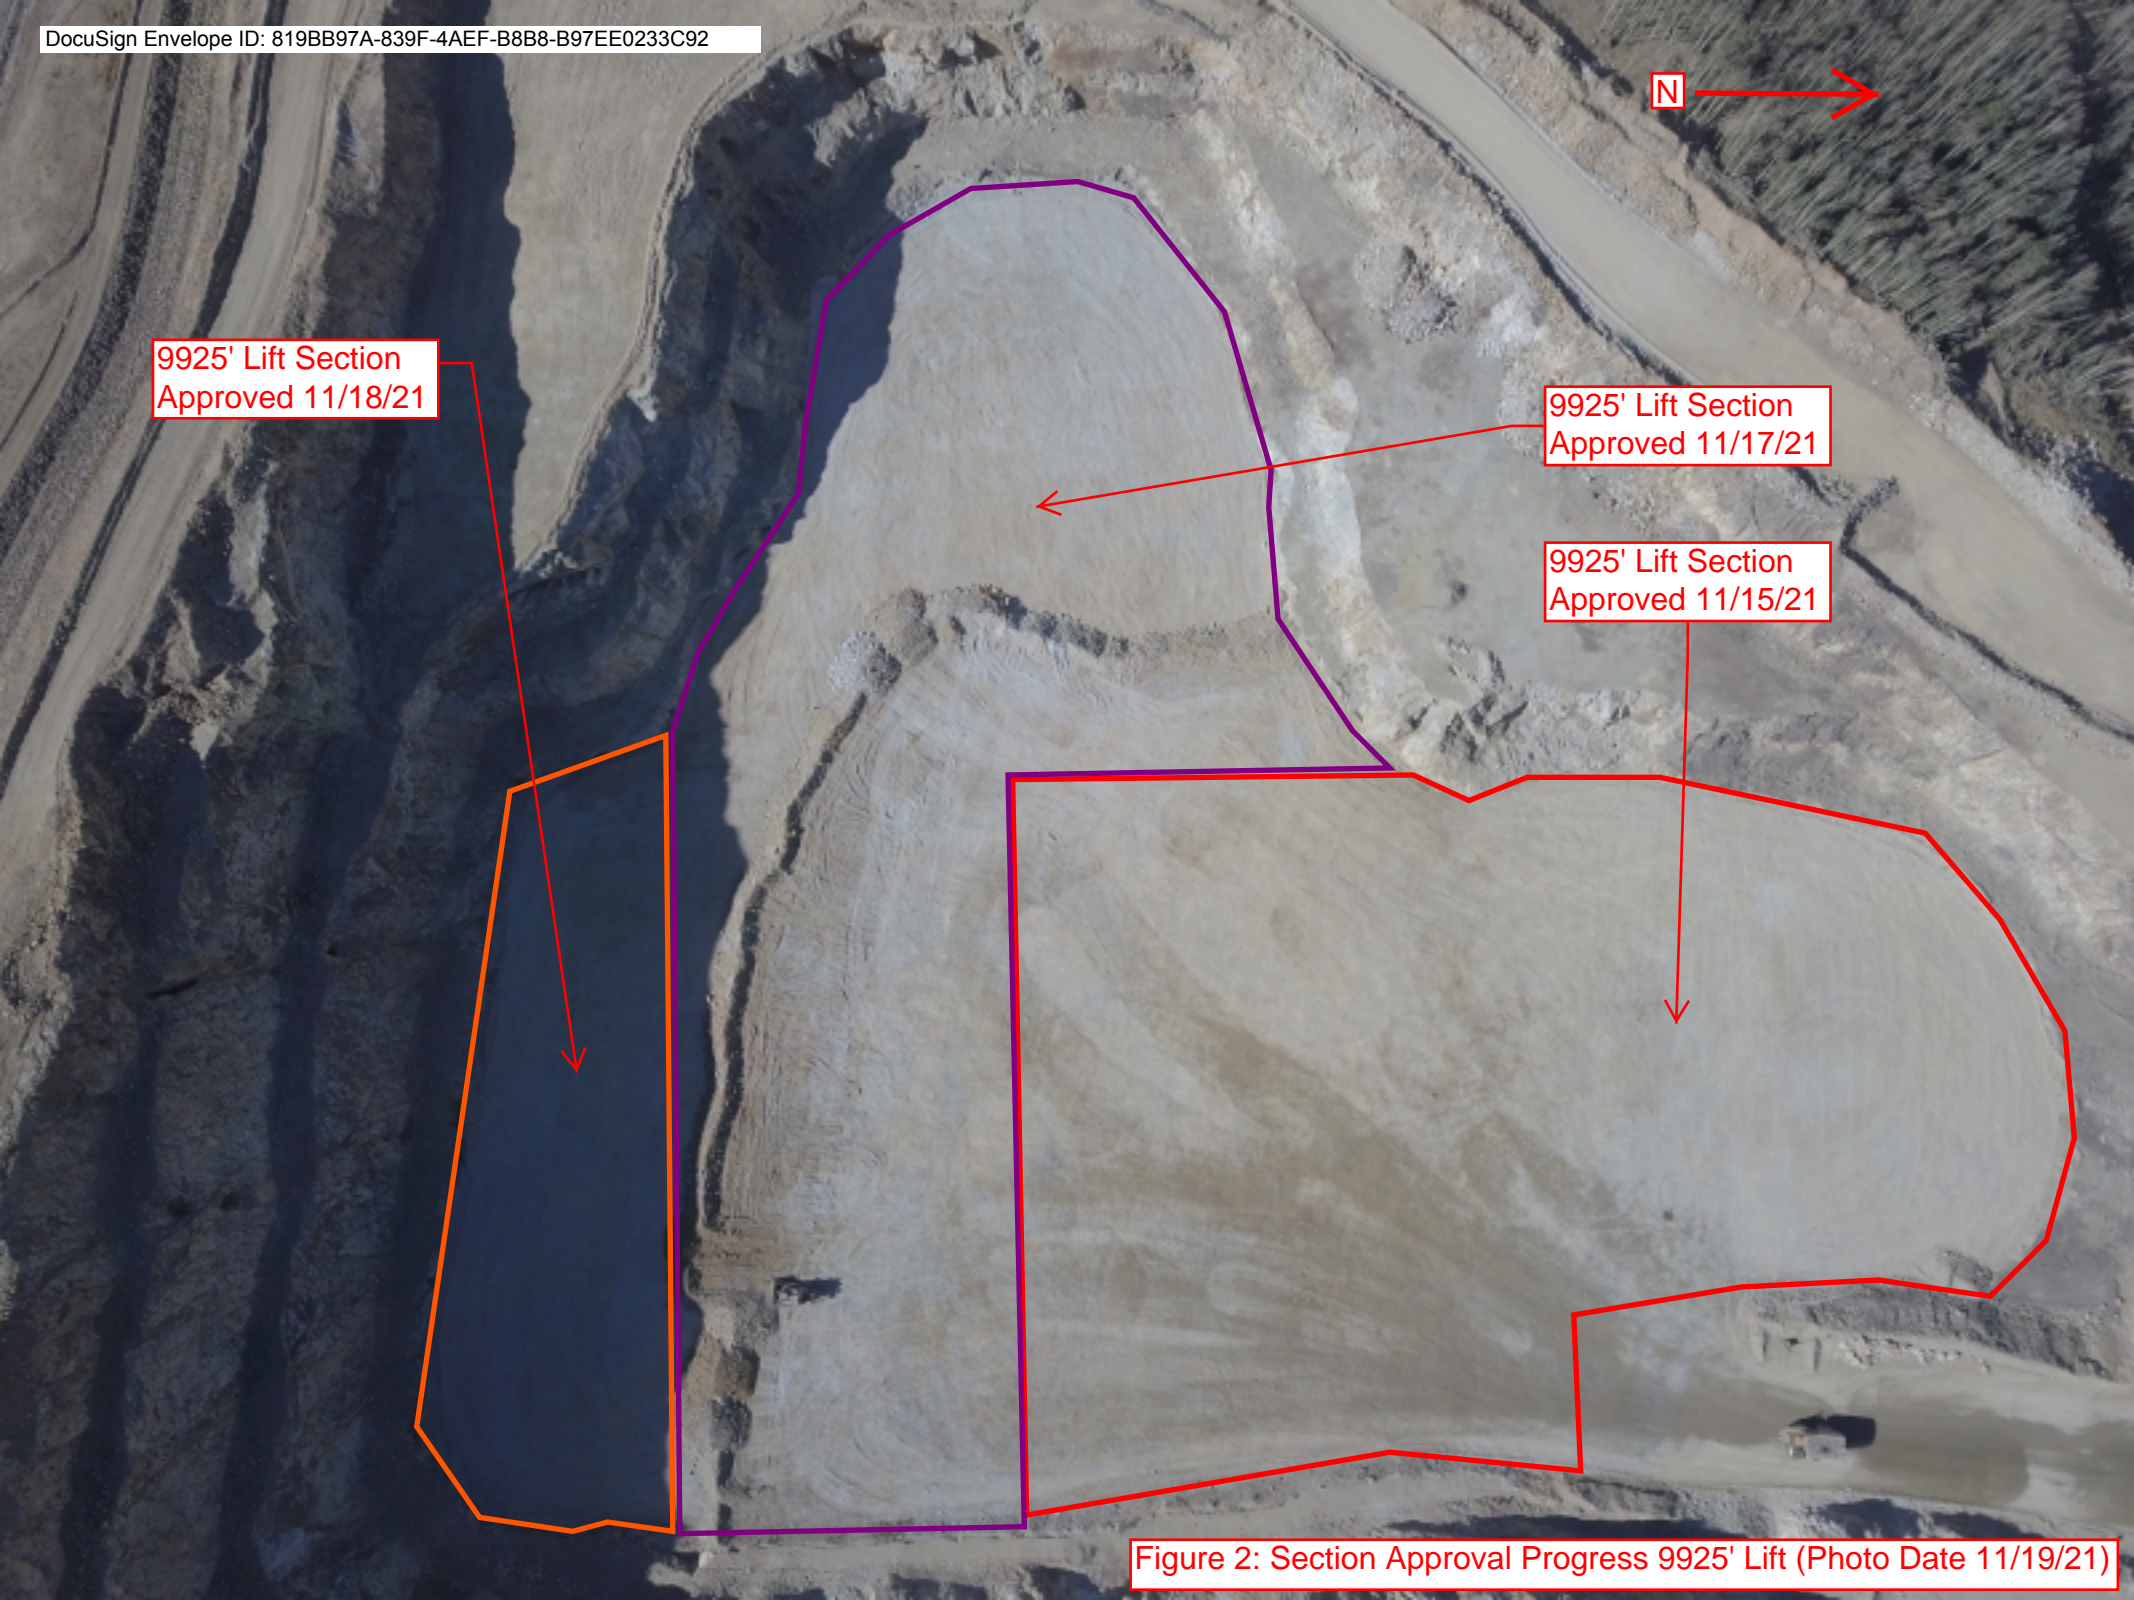
9925' Lift Section
Approved 11/18/21

9925' Lift Section
Approved 11/17/21

9925' Lift Section
Approved 11/15/21

Figure 2: Section Approval Progress 9925' Lift (Photo Date 11/19/21)

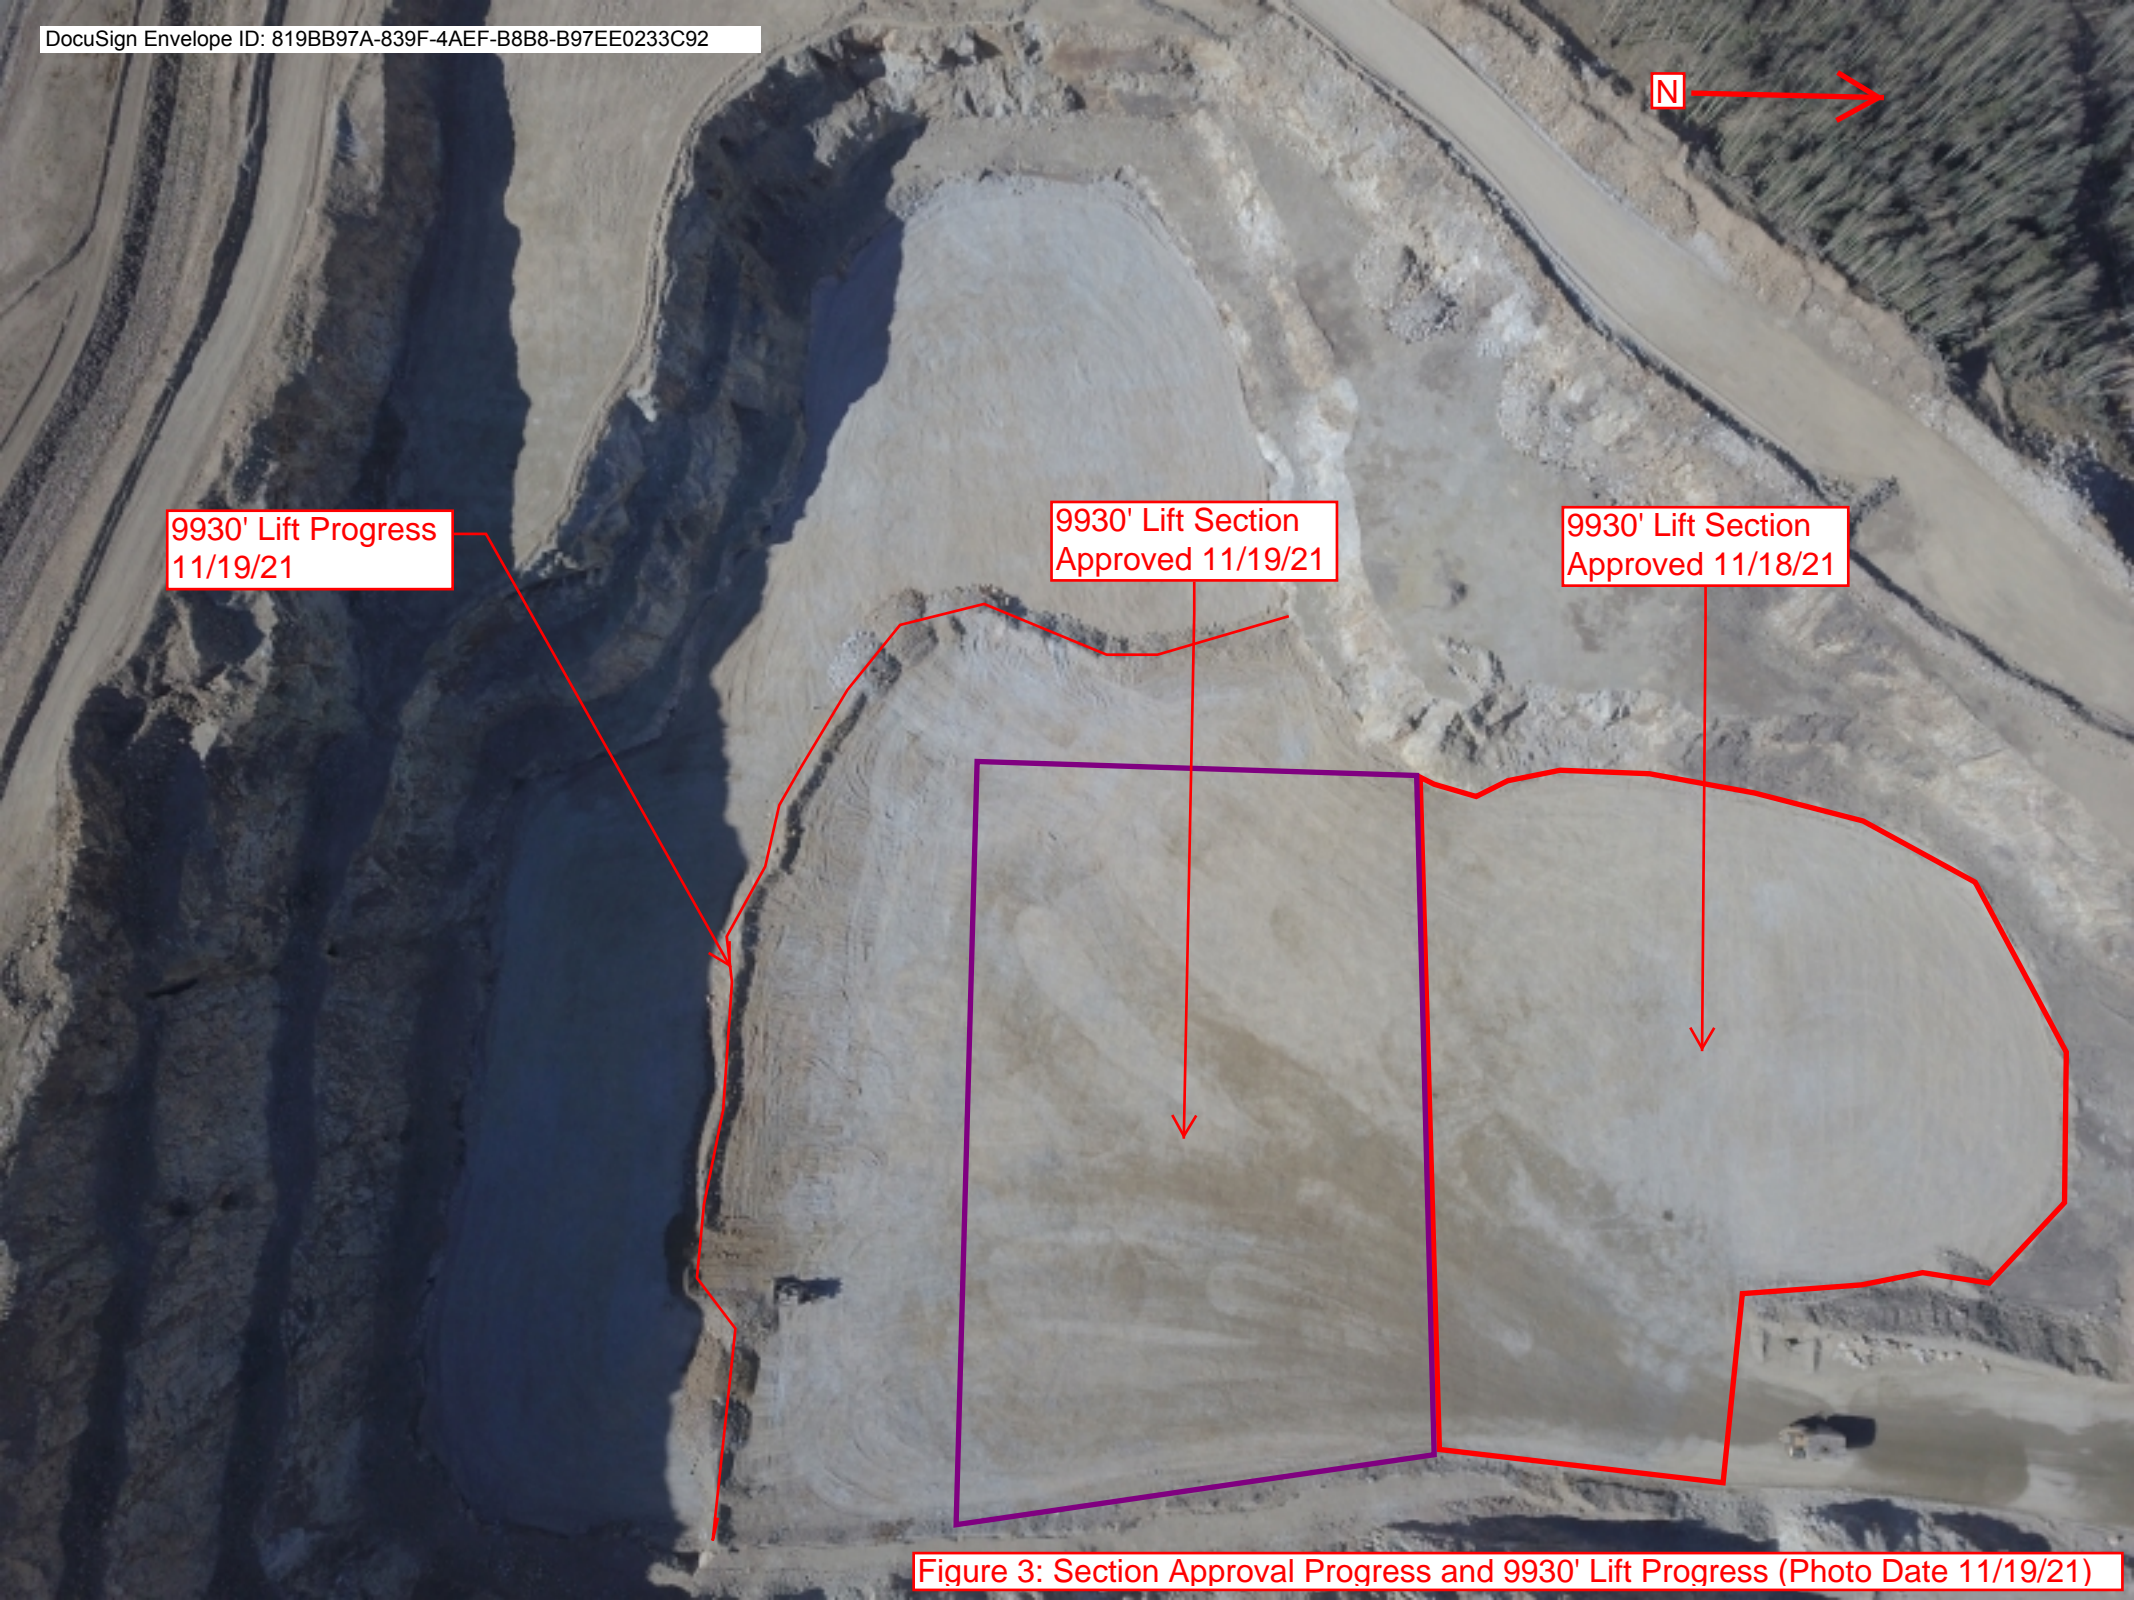
9930' Lift Progress
11/19/21

9930' Lift Section
Approved 11/19/21

Figure 3: Section Approval Progress and 9930' Lift Progress (Photo Date 11/19/21)

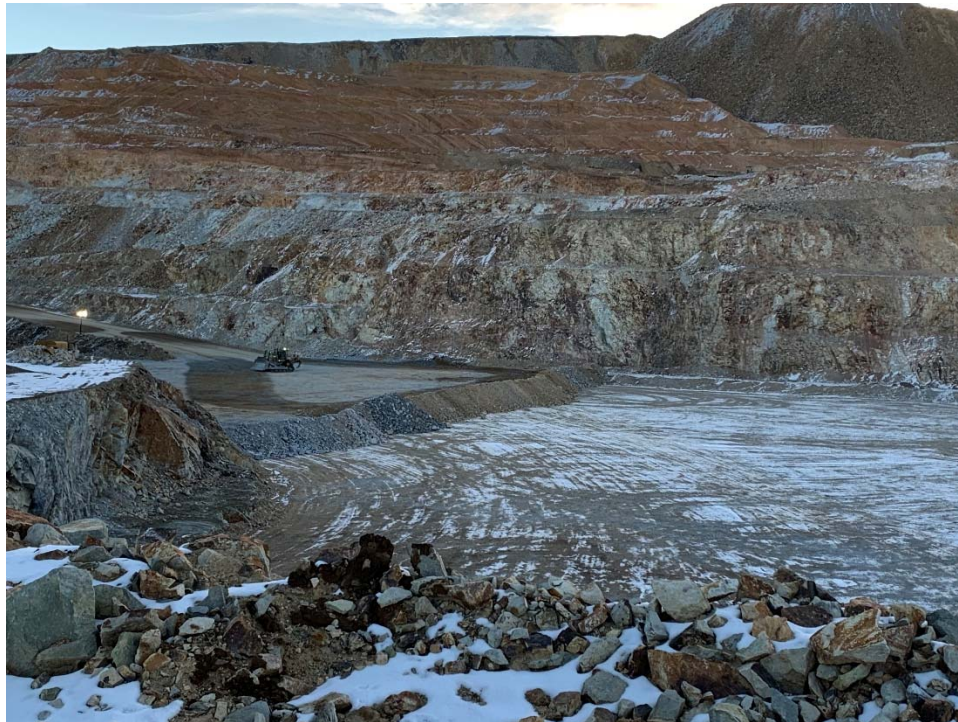
November 22, 2021 – High Compaction Backfill placement (TW)

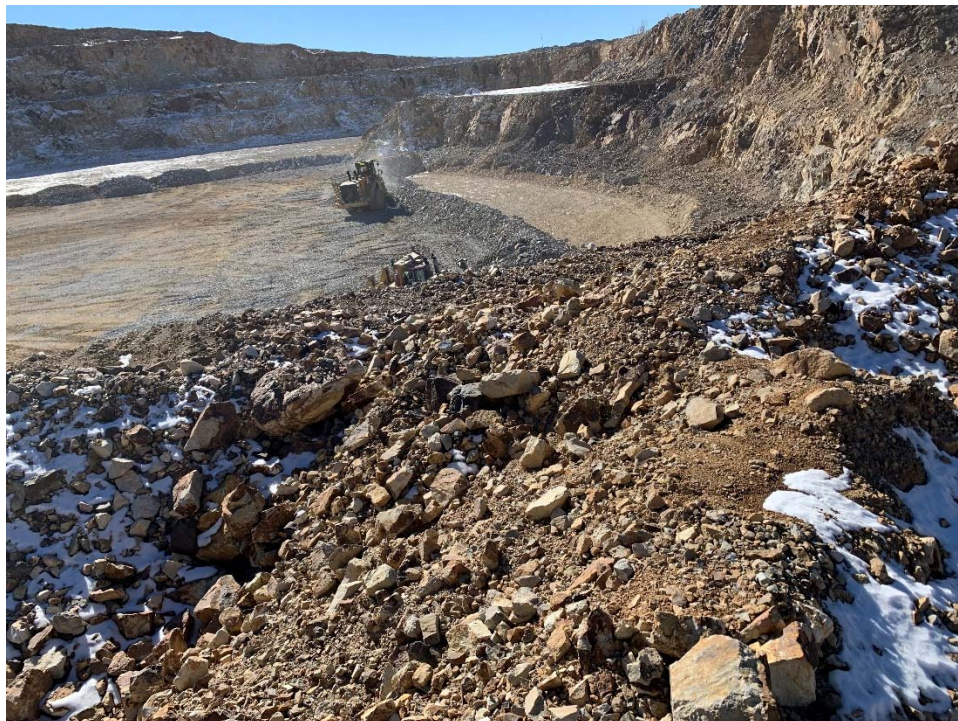
November 22, 2021 – High Compaction Backfill placement (TW)

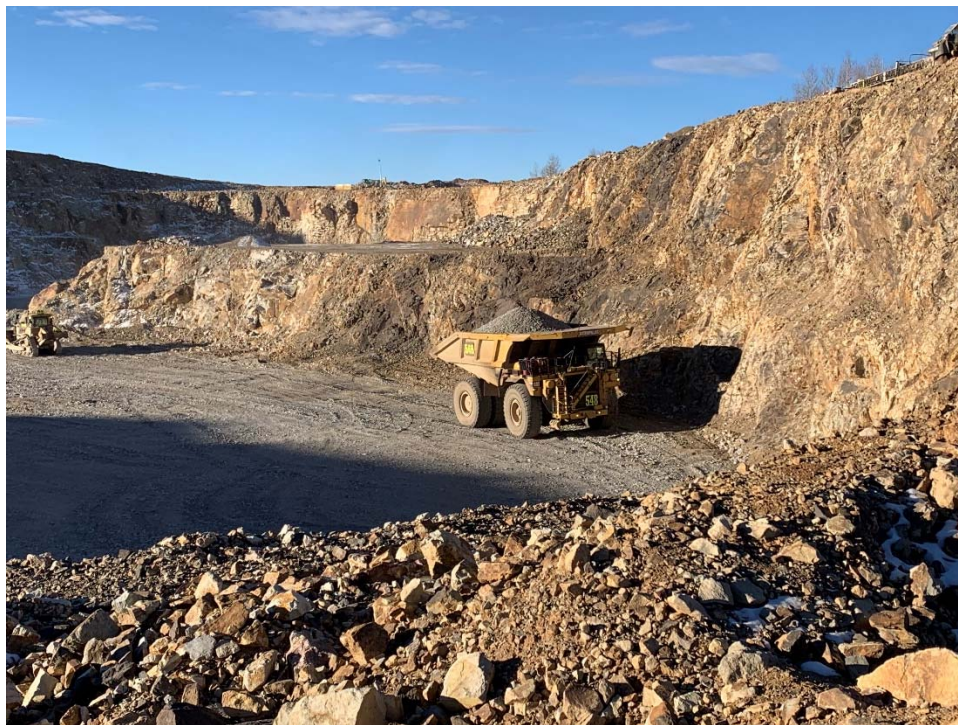
November 23, 2021 – High Compaction Backfill wheel rolling (TW)

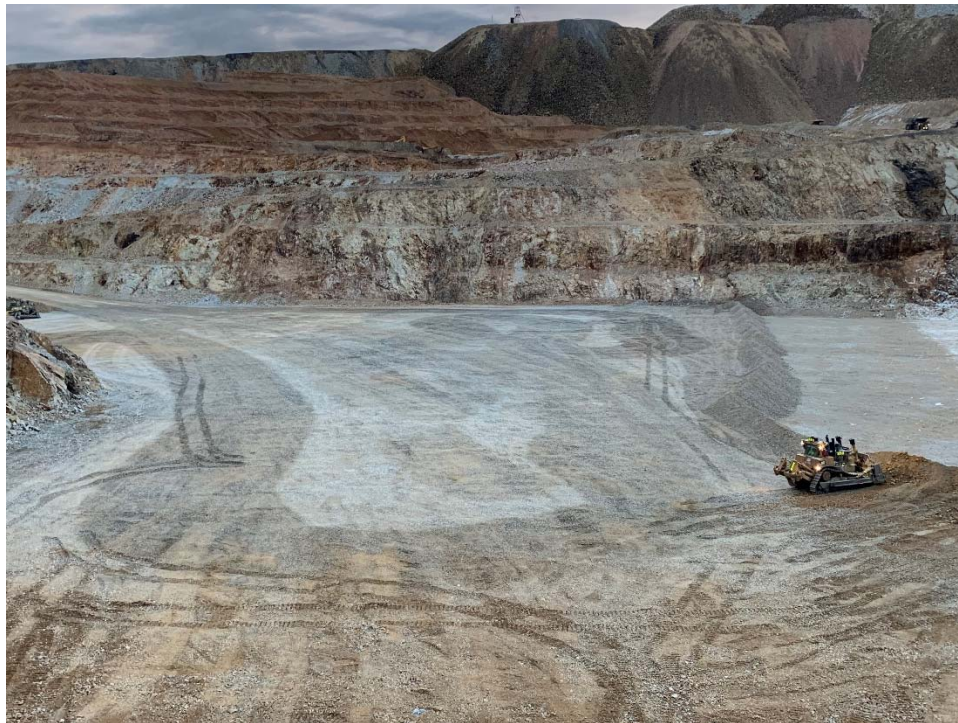
November 24, 2021 – High compaction backfill placement (TW)

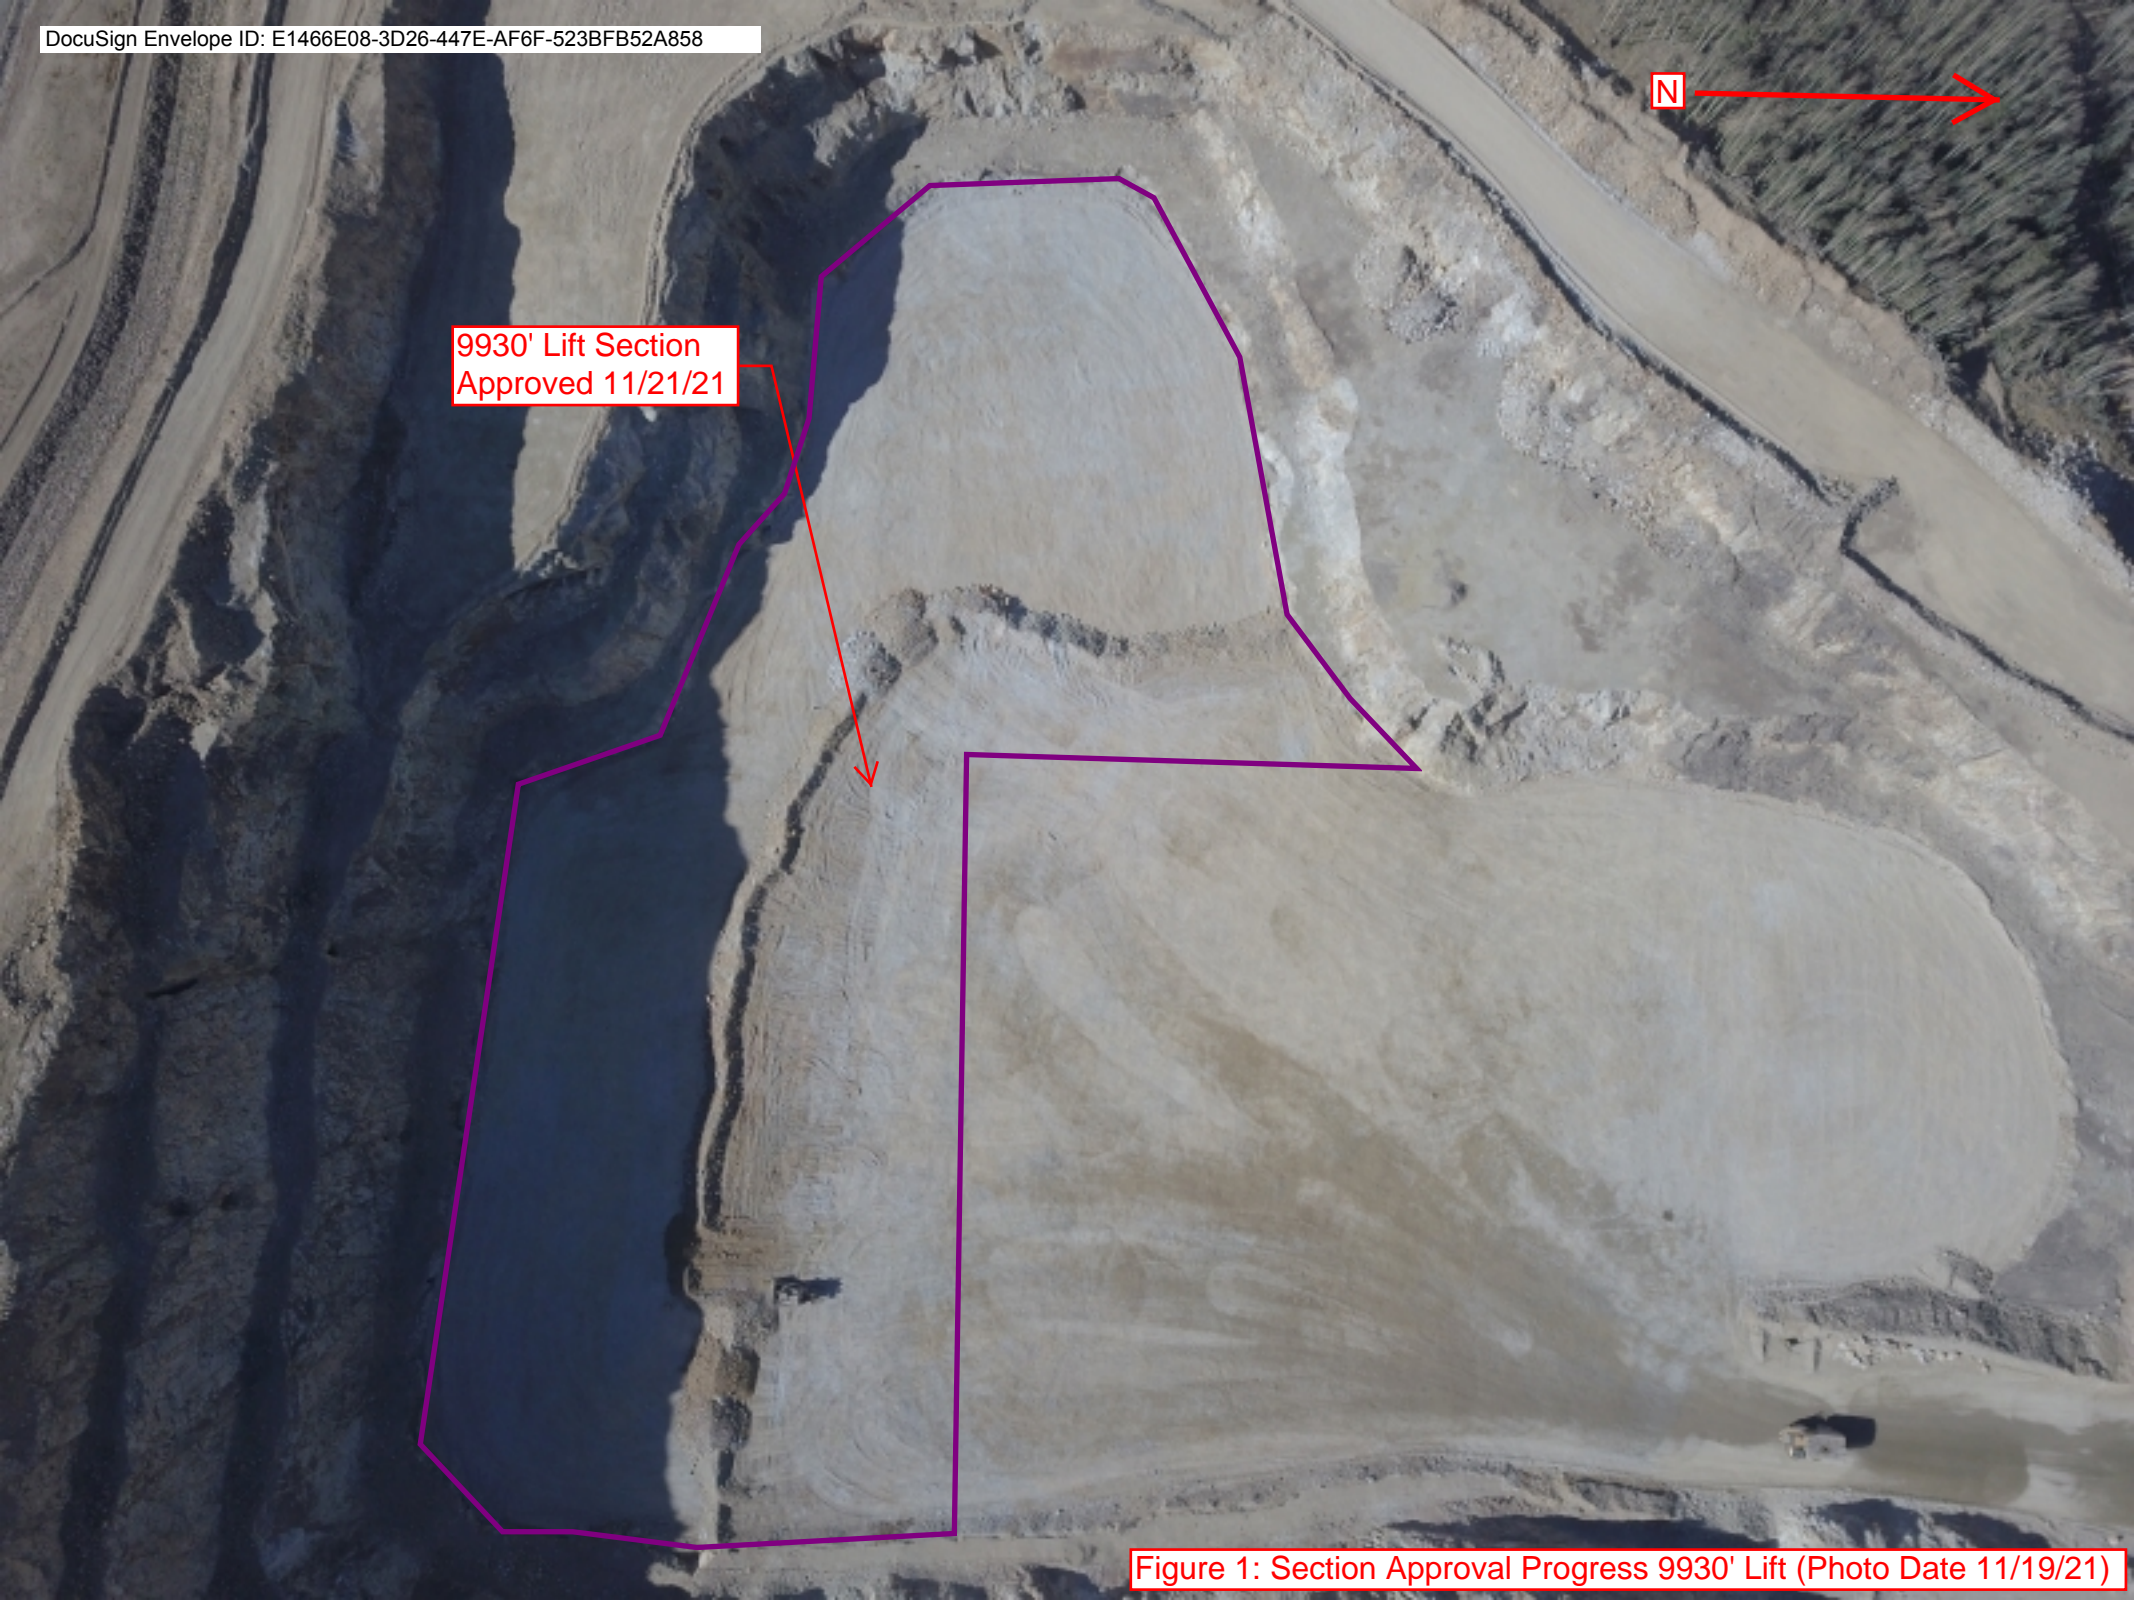
9930' Lift Section
Approved 11/21/21

Figure 1: Section Approval Progress 9930' Lift (Photo Date 11/19/21)

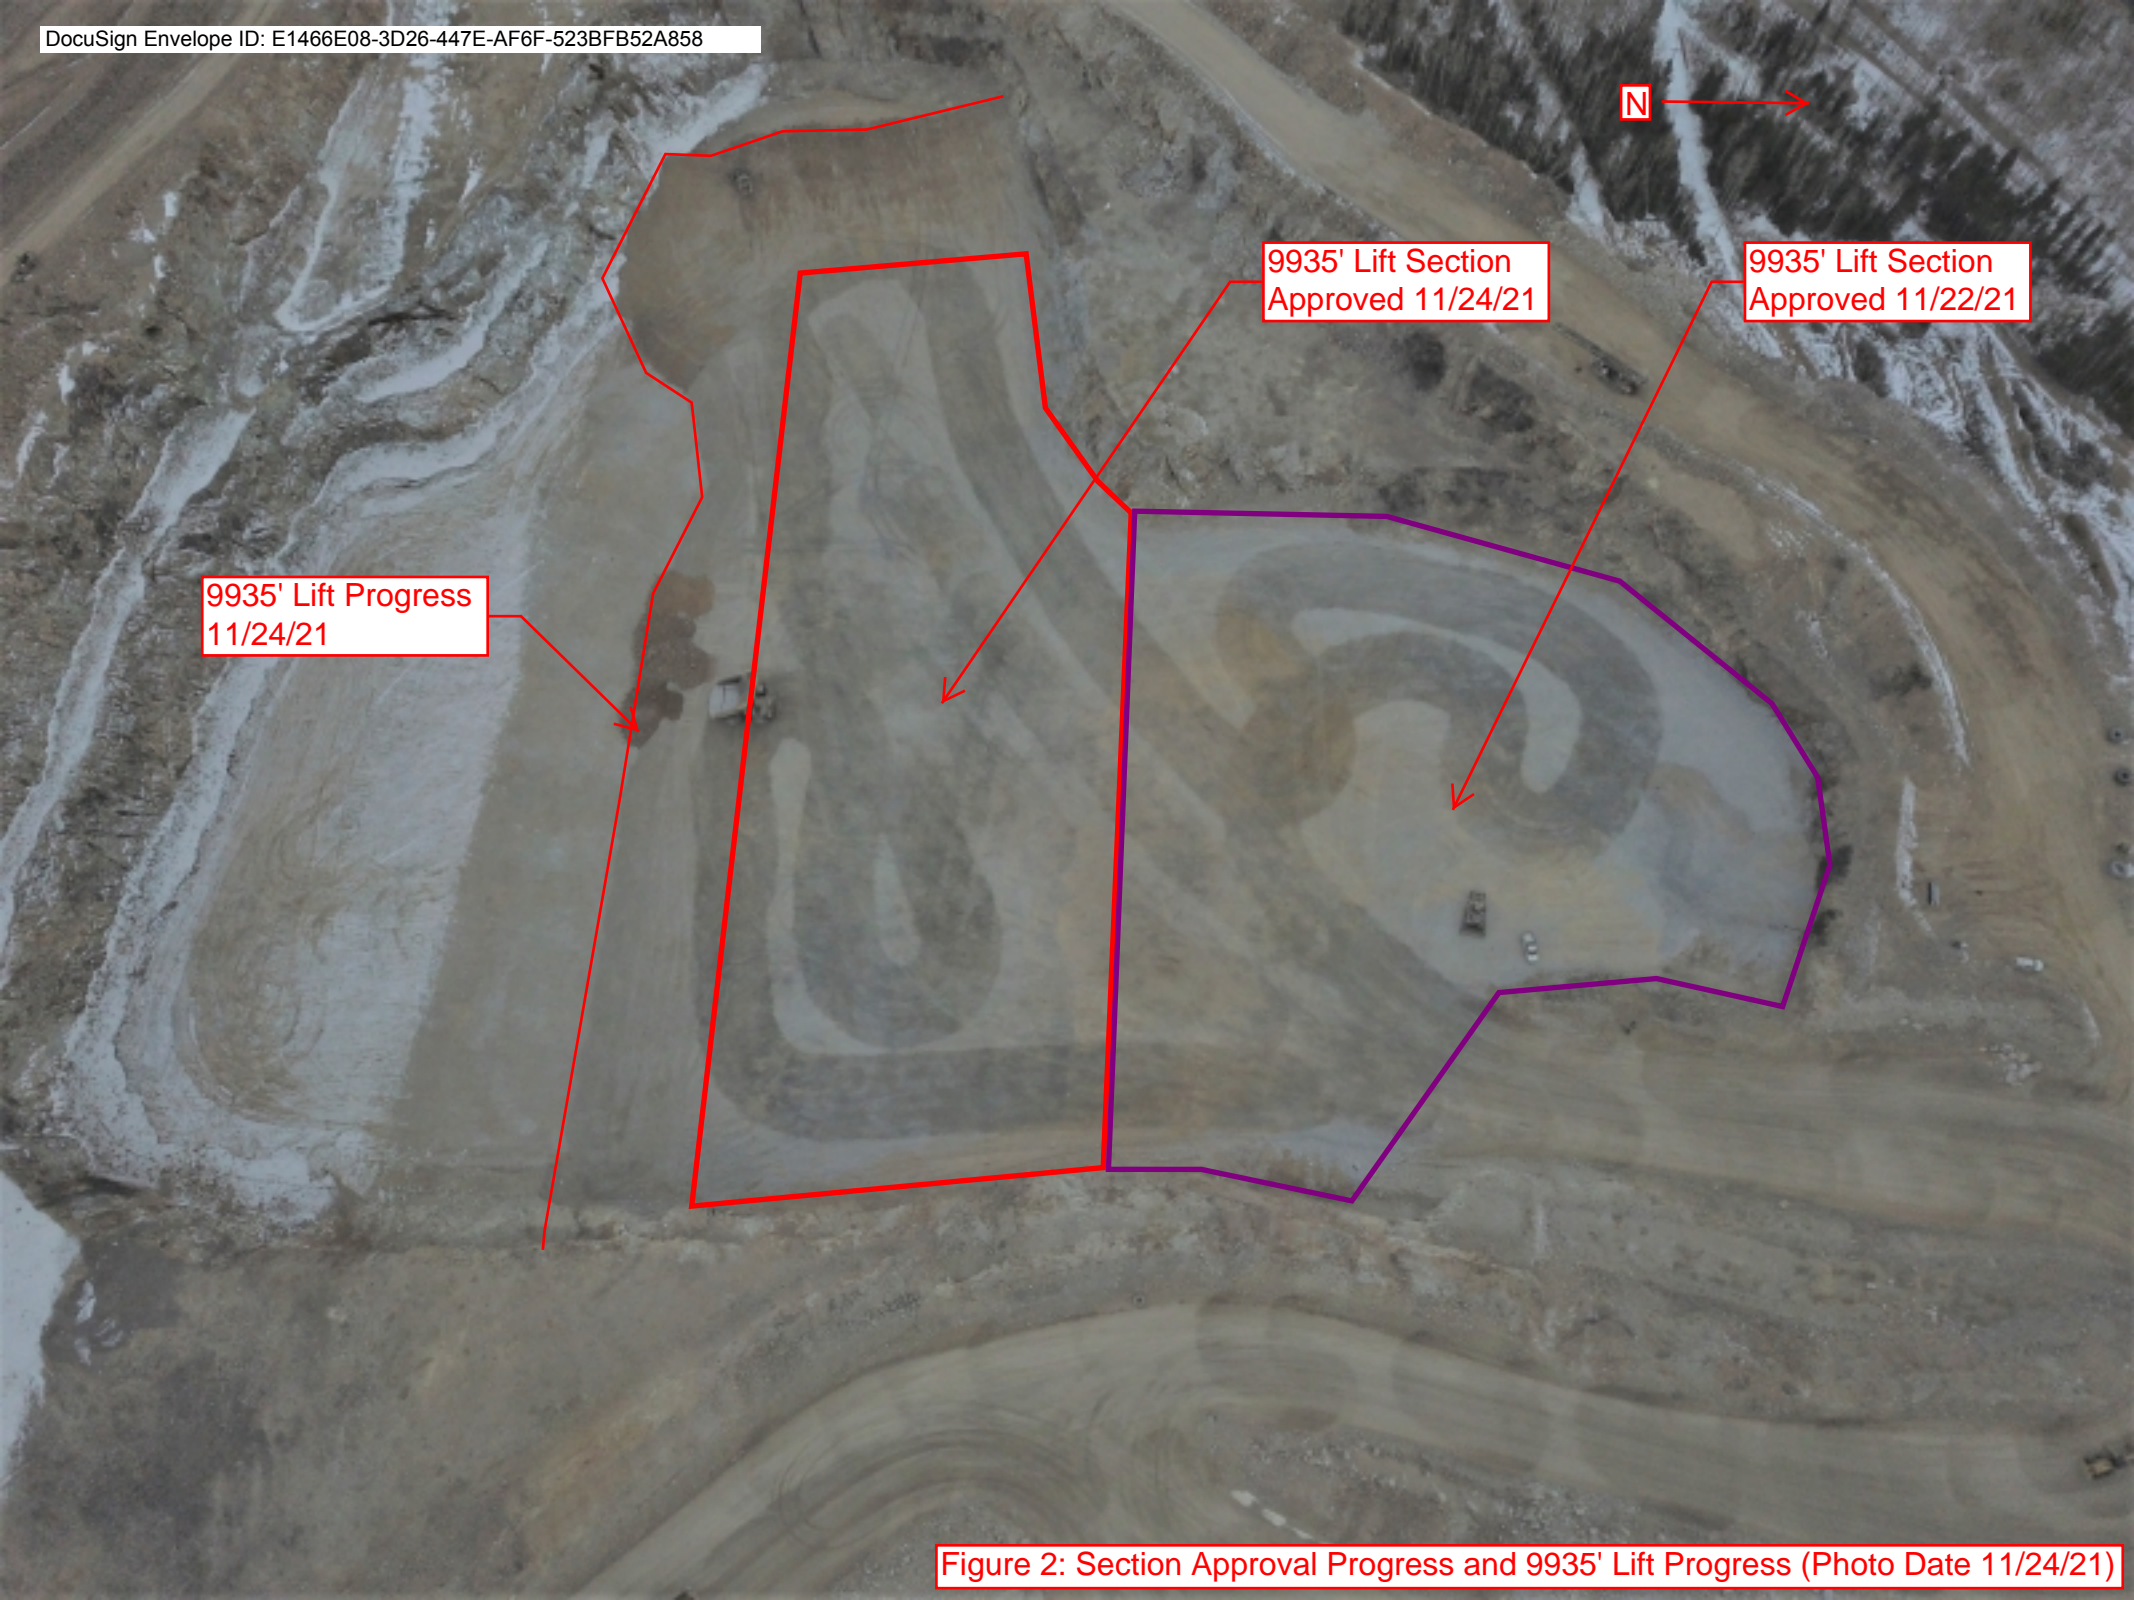
9935' Lift Section
Approved 11/24/21

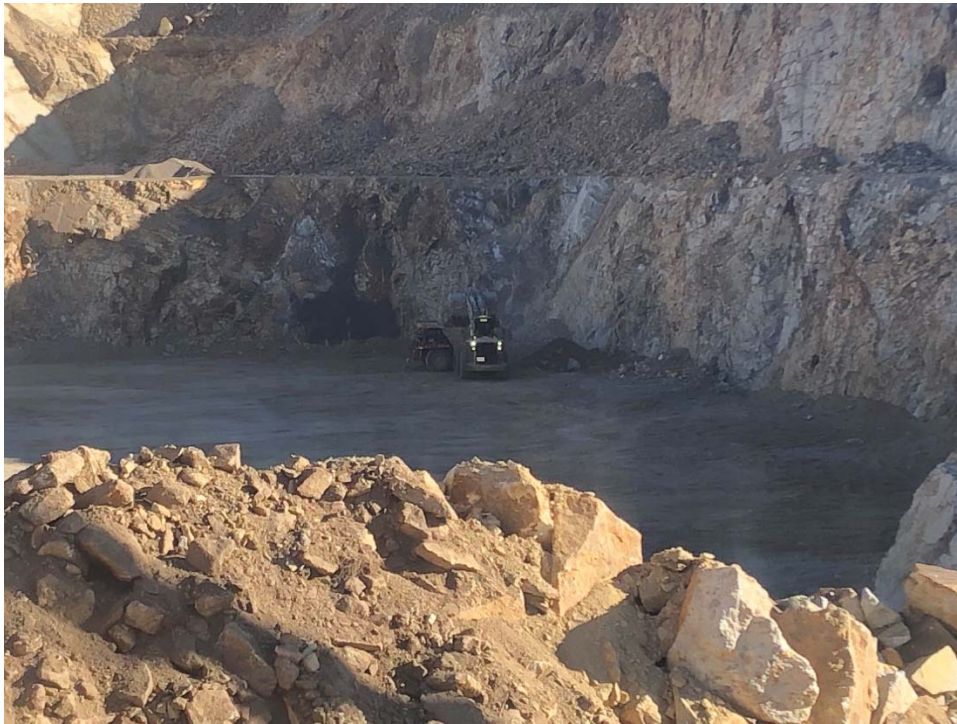
December 1, 2021 – Unsuitable and windrowed material removal (GF)

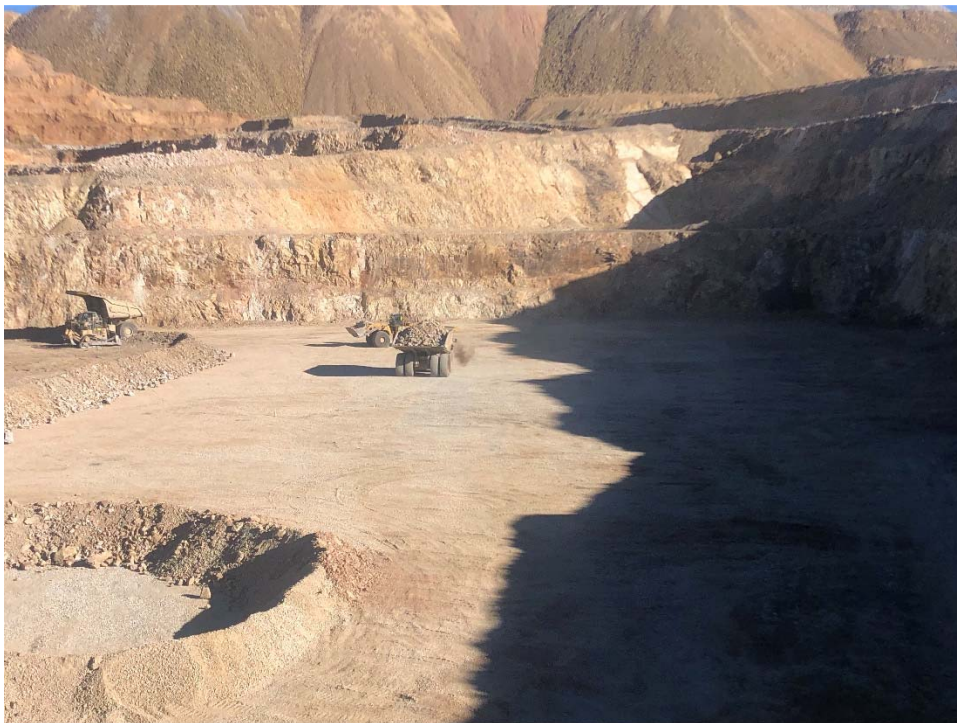
December 1, 2021 – High Compaction Backfill wheel rolling and placement progress (GF)

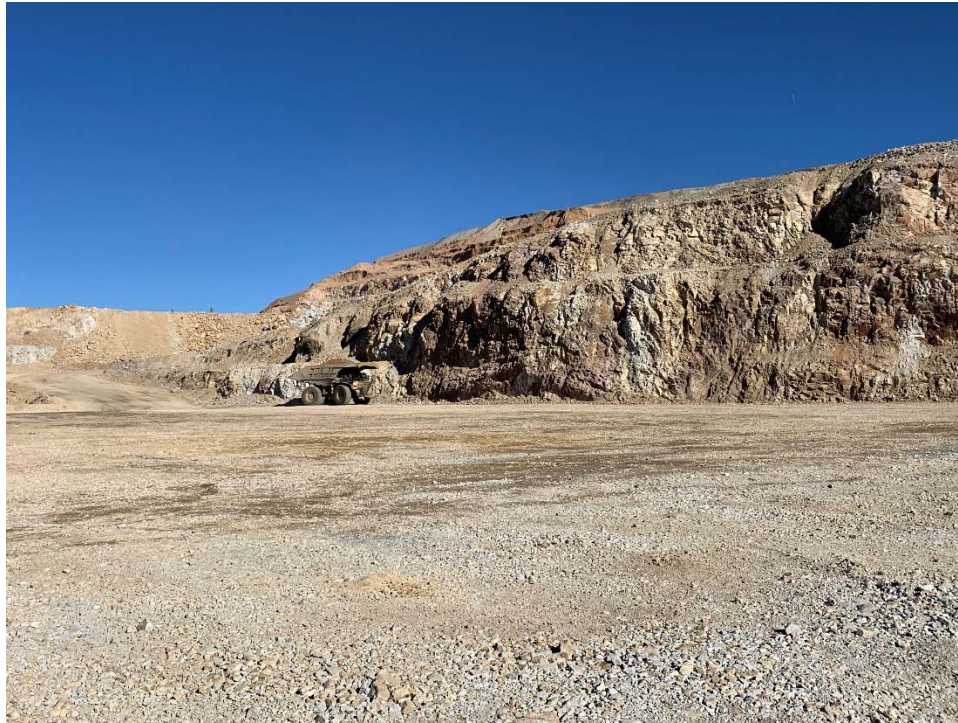
December 3, 2021 – High Compaction Backfill wheel rolling (TW)

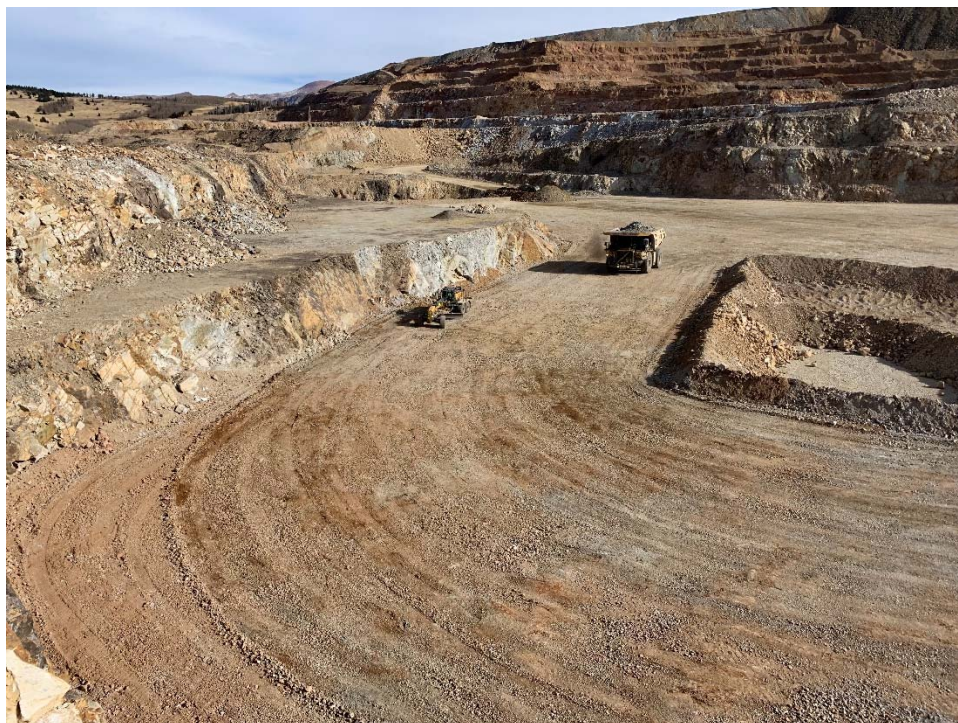
December 5, 2021 – High Compaction Backfill wheel rolling and leveling (TW)

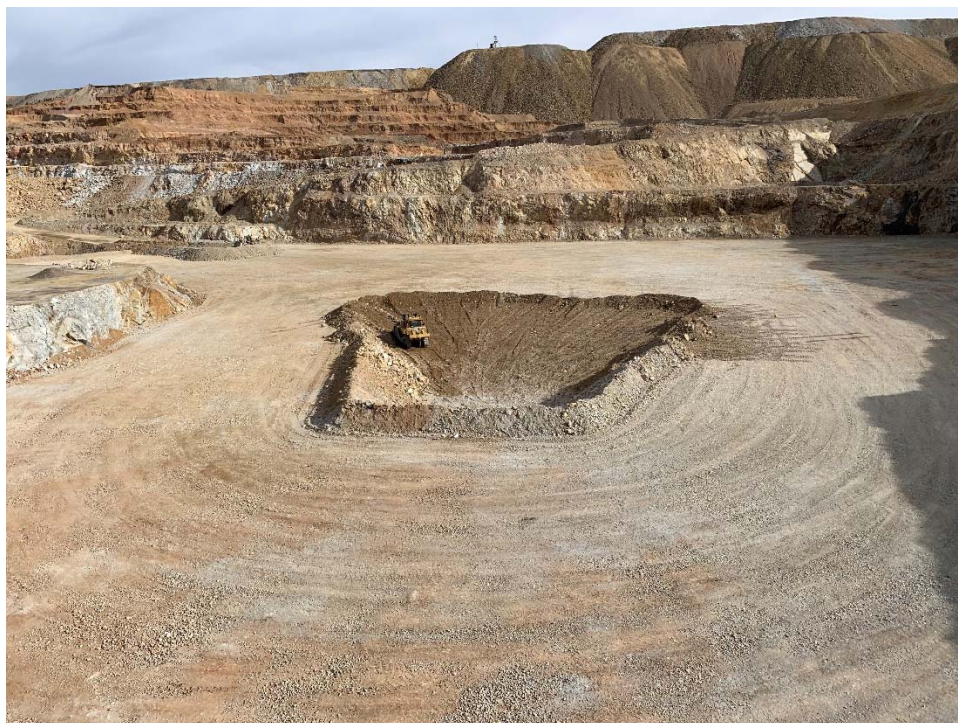
December 1, 2021 – High Compaction Backfill cut contouring (TW)

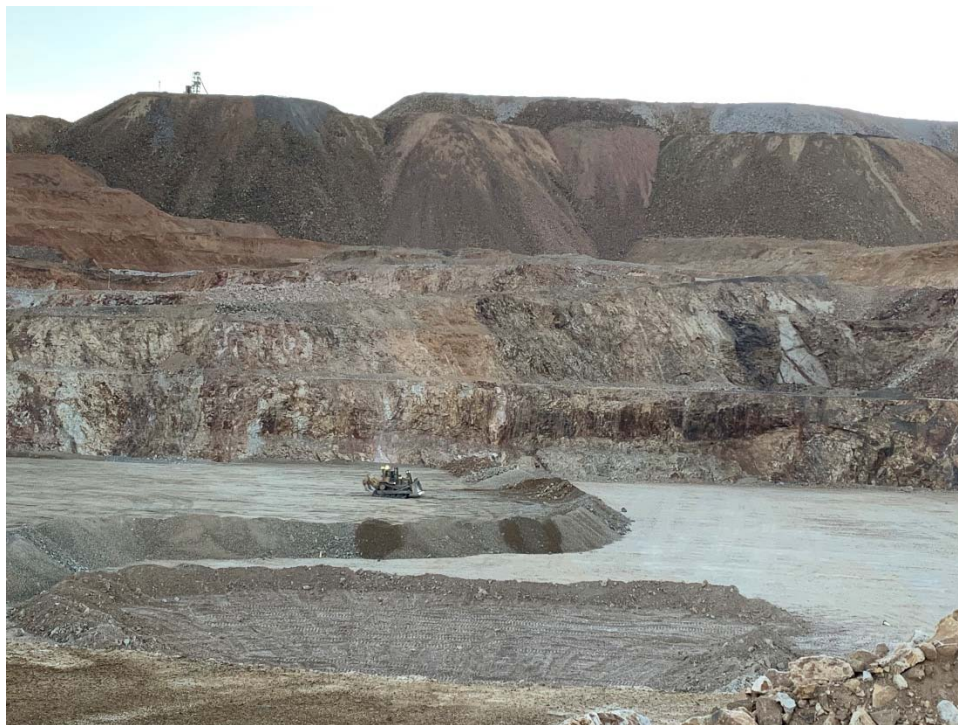
December 9, 2021 – High Compaction Backfill placment (TW)

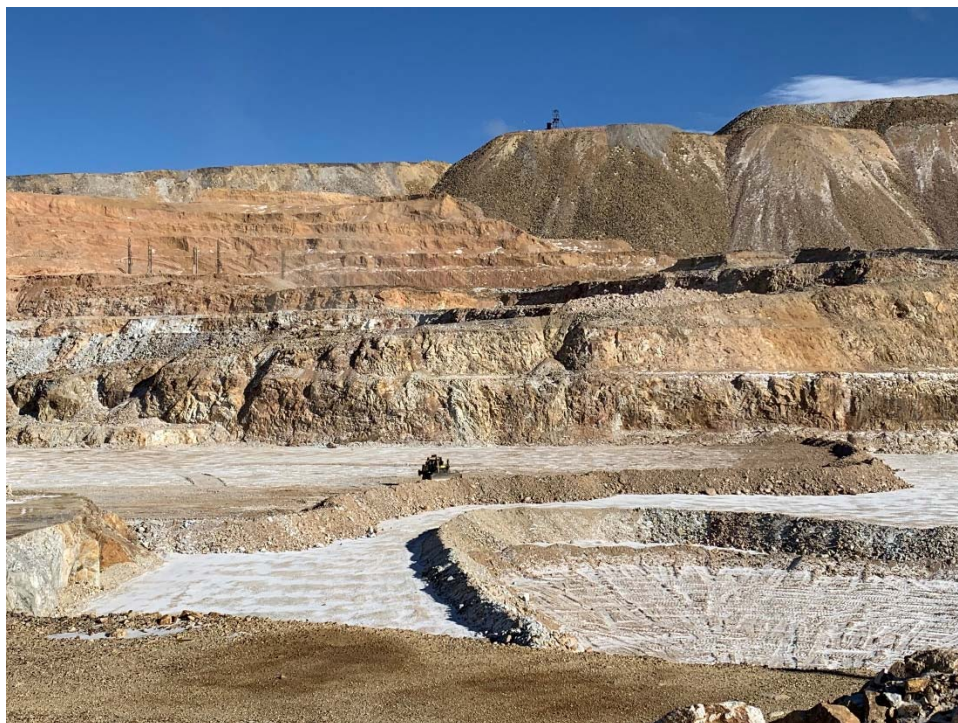
December 16, 2021 – High Compaction Backfill placement (TW)

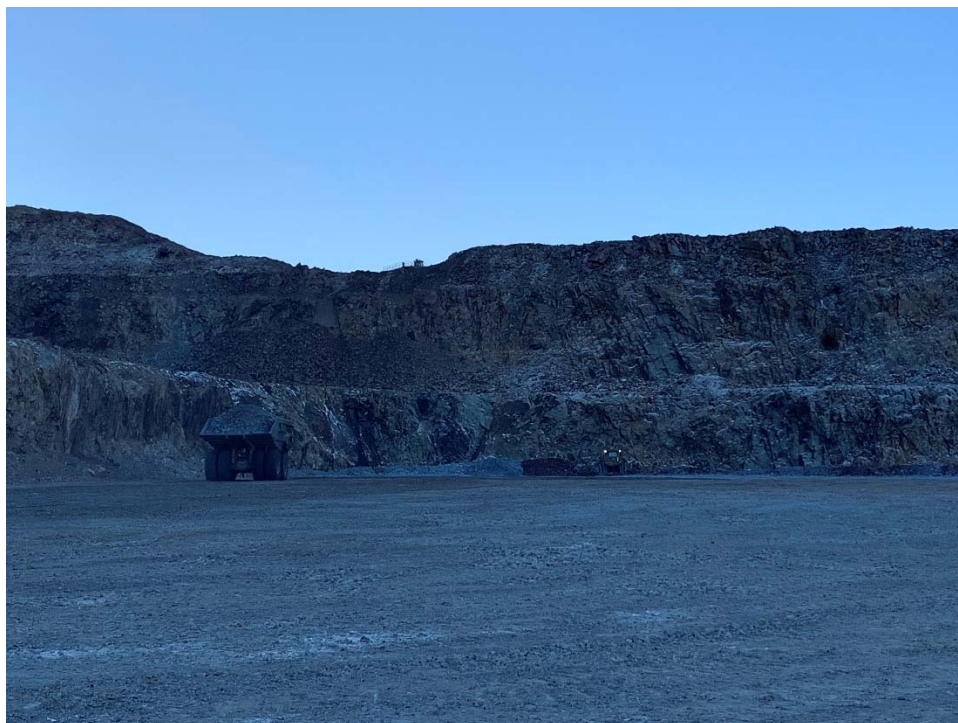
December 17, 2021 – High Compaction Backfill placement (TW)

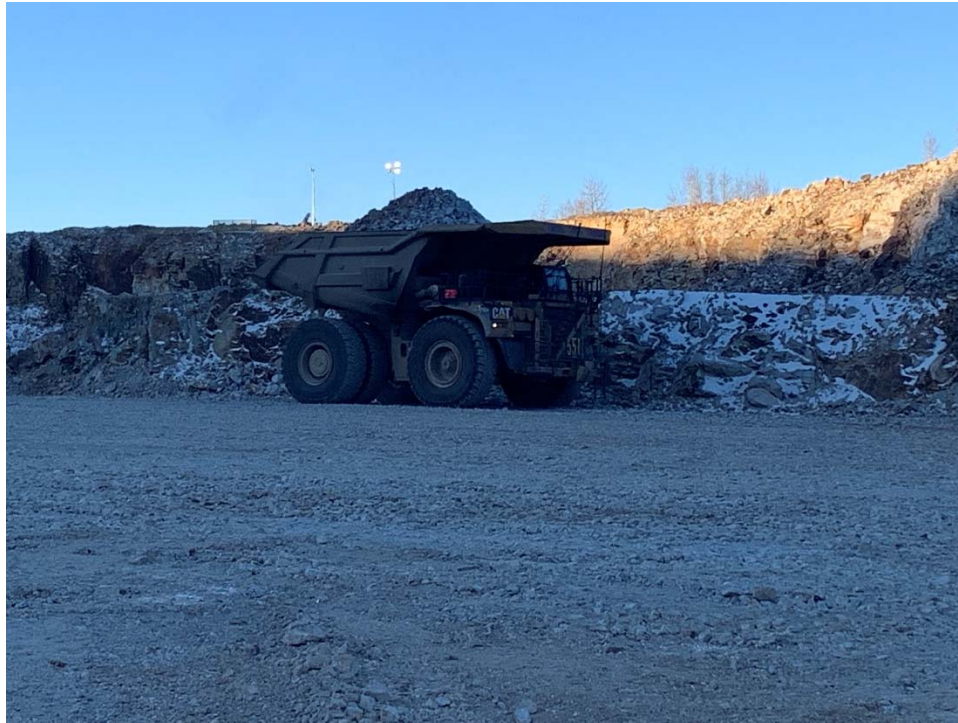
December 17, 2021 – High Compaction Backfill wheel rolling (TW)
