Re: Permit No. M-1980-244; Cripple Creek & Victor Gold Mining Company; Cresson Project; Technical Revision 135 – Initial Adequacy Review Response

**VALLEY LEACH FACILITY 2
PHASE 3 STAGE A.1
RECORD OF CONSTRUCTION REPORT
REVISION-1**

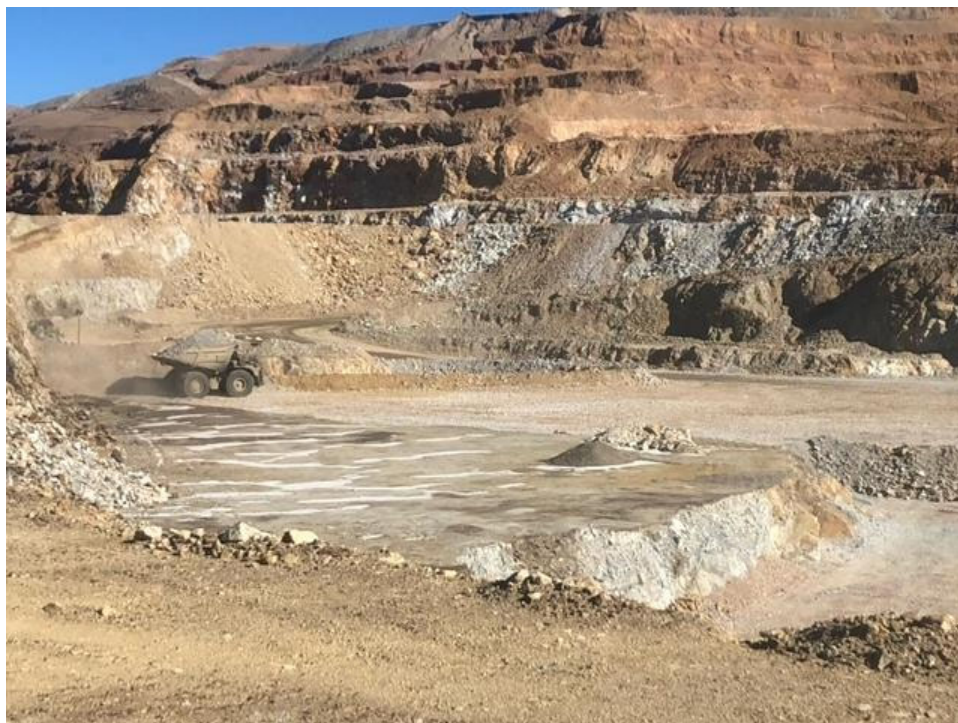
December 20, 2021 – High Compaction Backfill wheel rolling and leveling (GF)

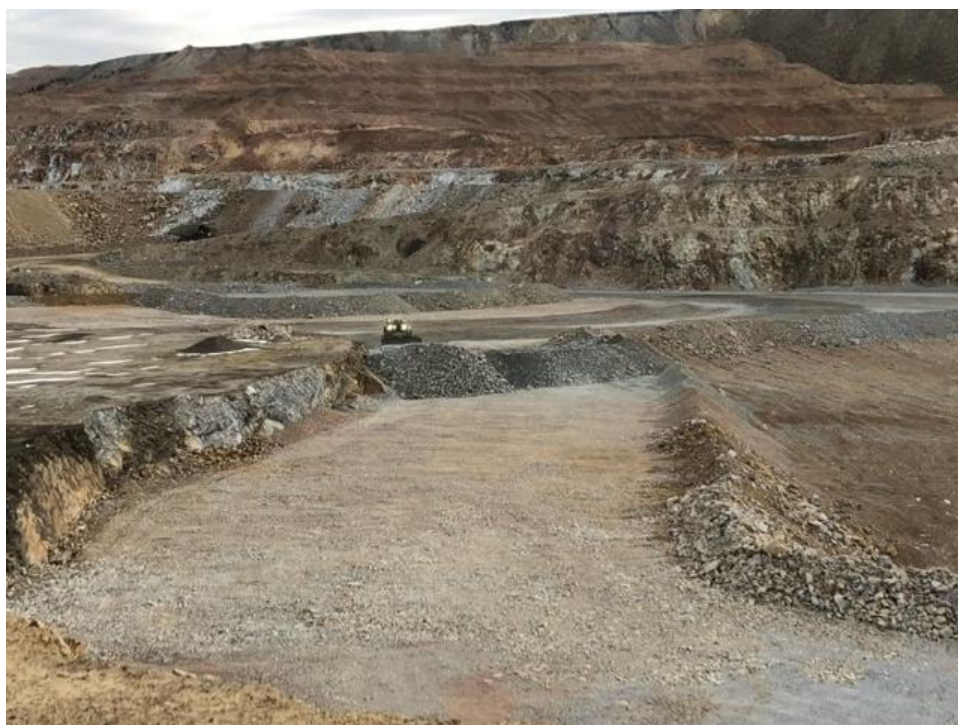
December 21, 2021 – High Compaction Backfill placement (GF)

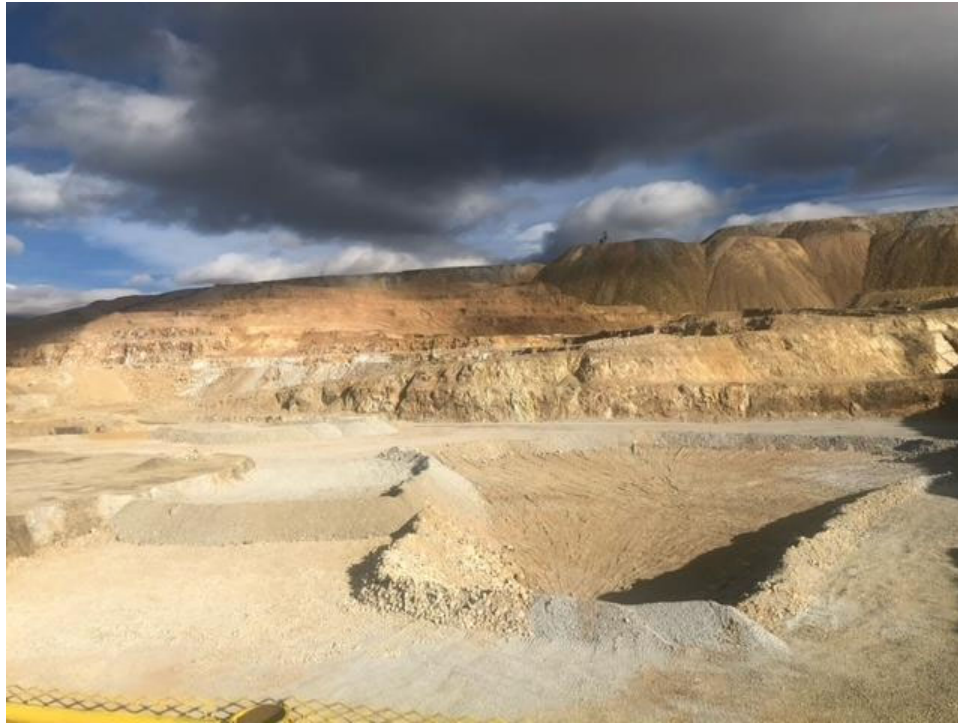
December 23, 2021 – Overview of 9960' lift of High Compaction Backfill placement (GF)

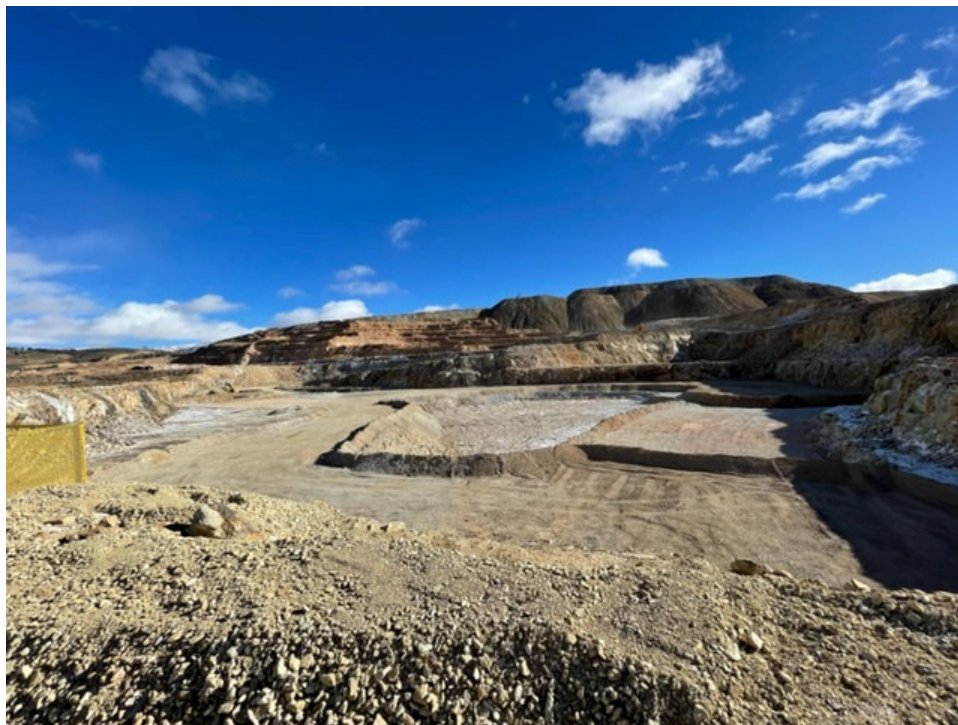
December 29, 2021 – Overview of 9960' lift of High Compaction Backfill placement (GF)

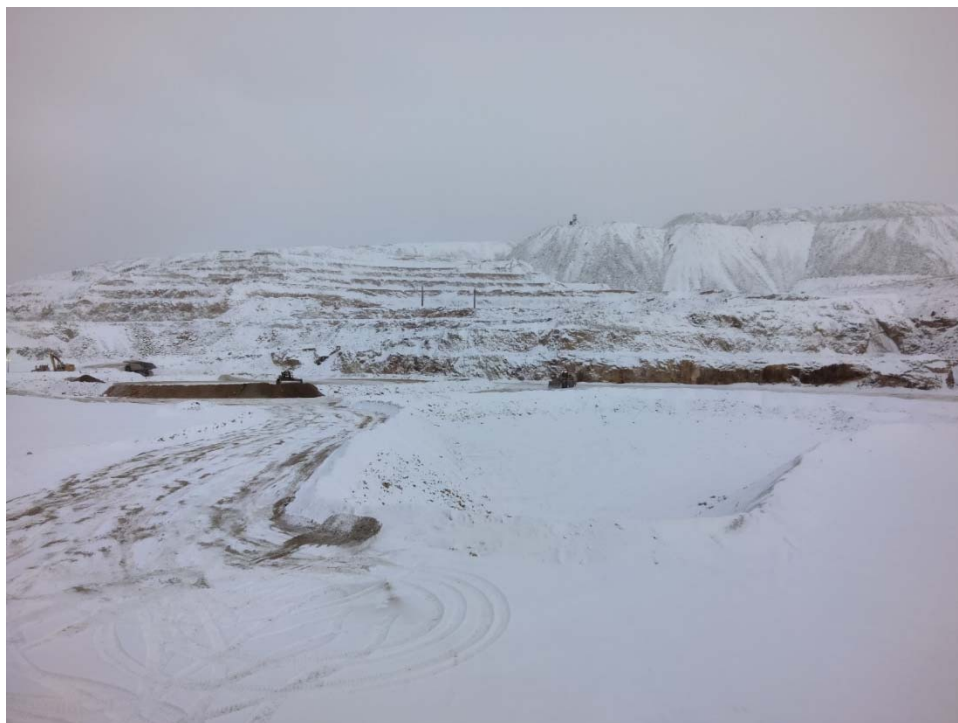
January 1, 2022 – High Compaction Backfill snow removal with loader (CC&V Supervisor)

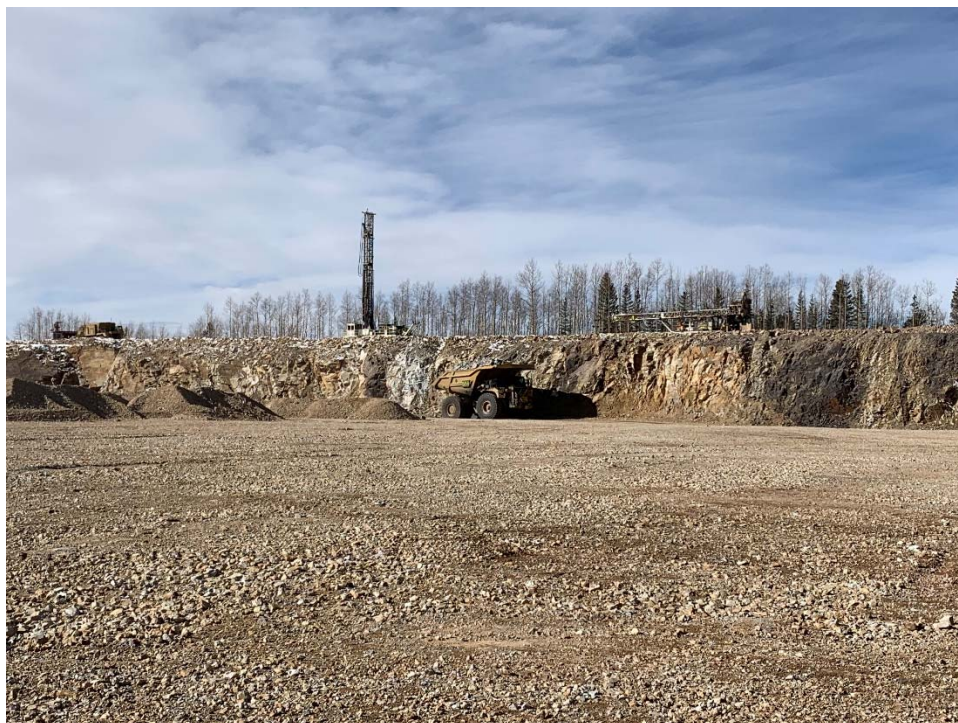
January 4, 2022 – High Compaction Backfill wheel rolling (TW)

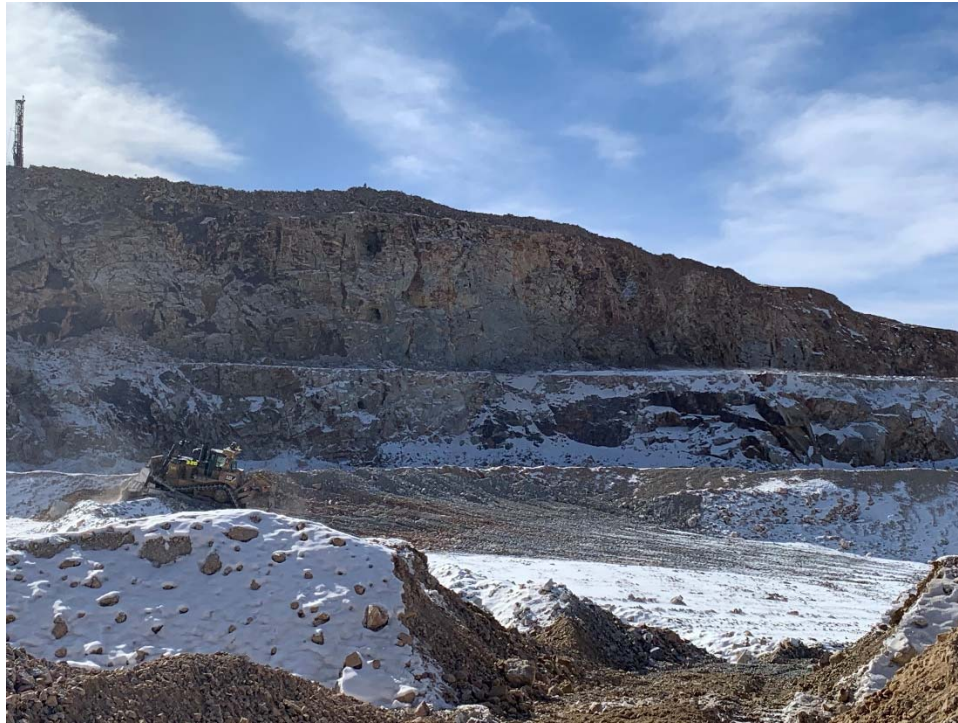
January 4, 2022 – Contour Grading of the PSSA floor (TW)

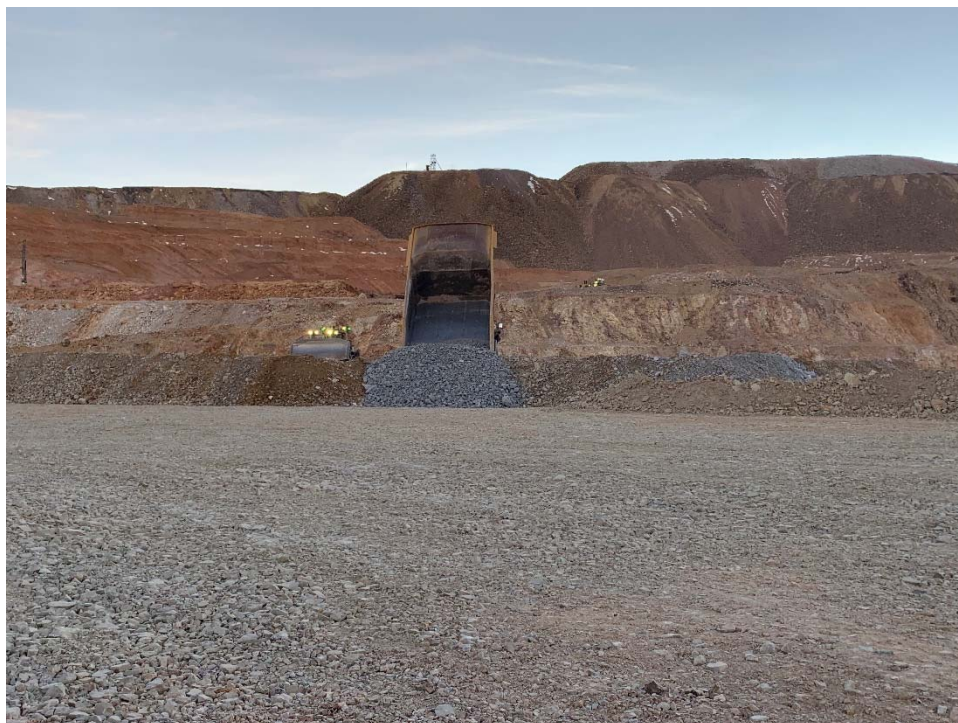
January 11, 2022 – High Compaction Backfill placement (TW)

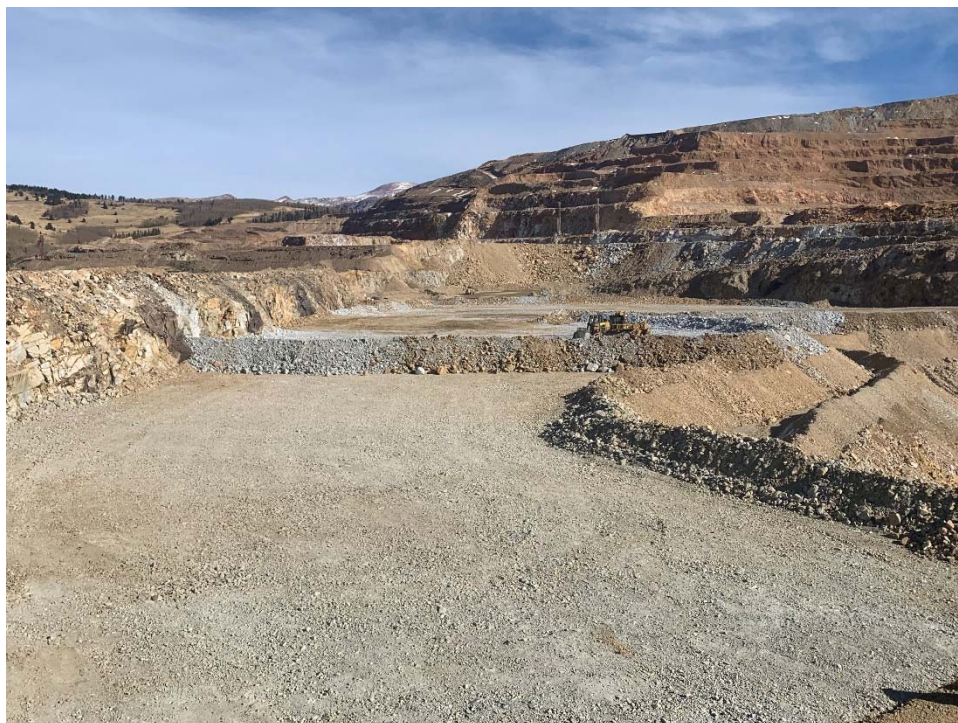
January 12, 2022 – High Compaction Backfill placement (TW)

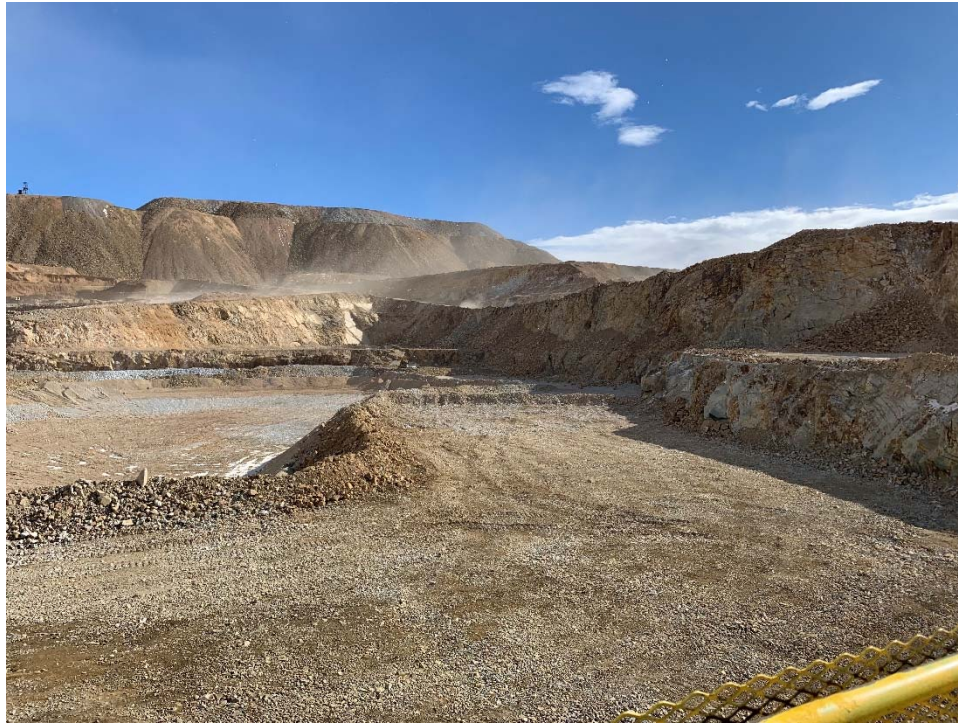
January 14, 2022 – High Compaction Backfill progress (TW)

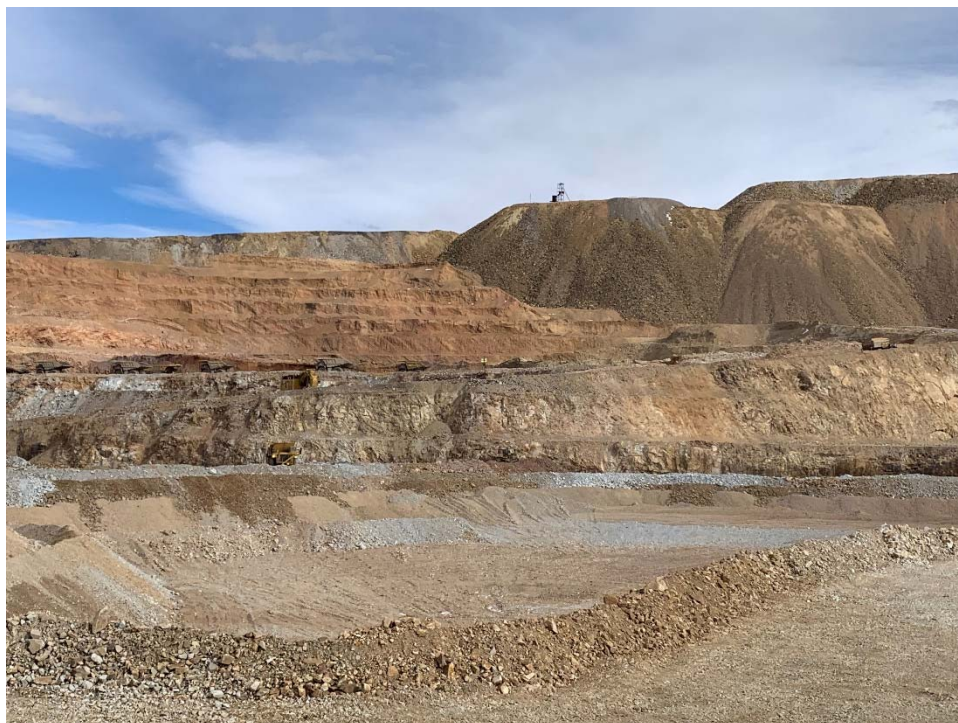
January 17, 2022 – High Compaction Backfill overview (TW)

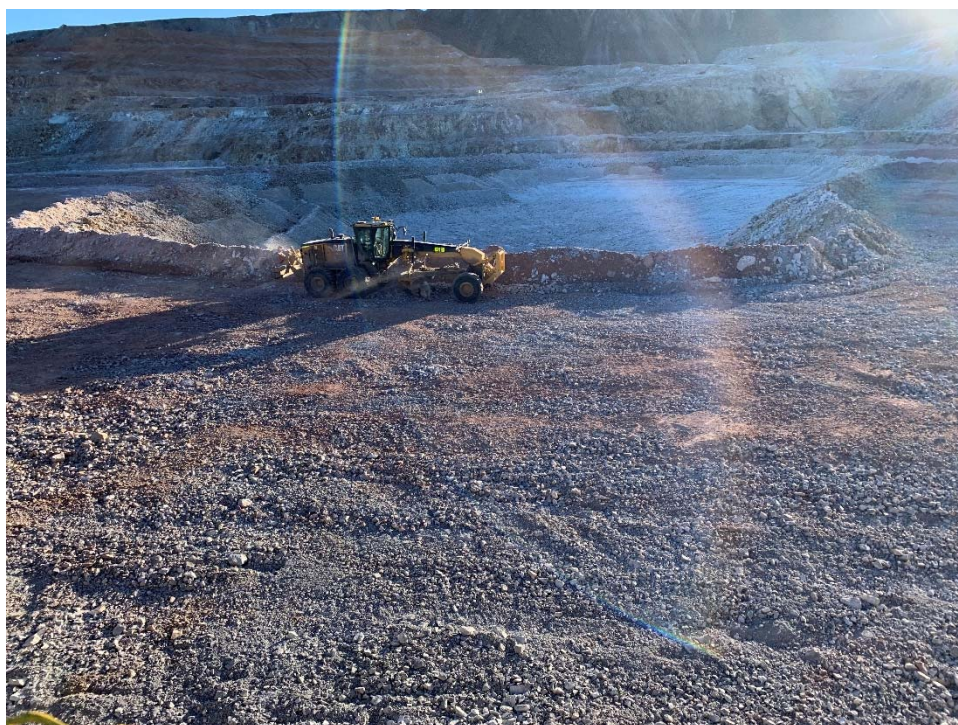
January 21, 2022 – High Compaction Backfill grading (TW)

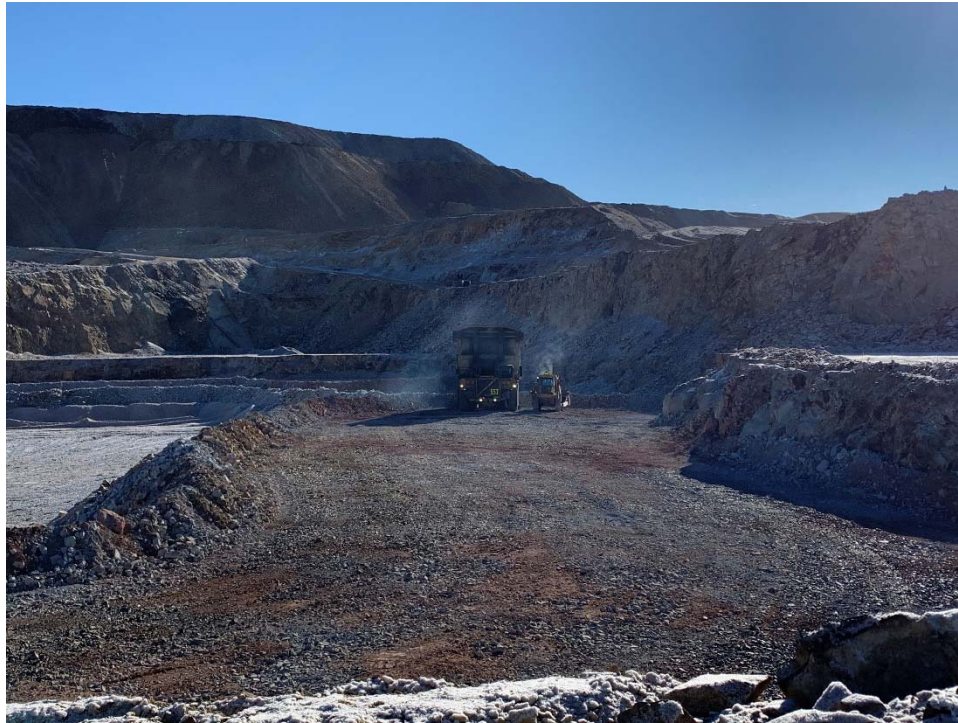
January 21, 2022 – High Compaction Backfill placement (TW)

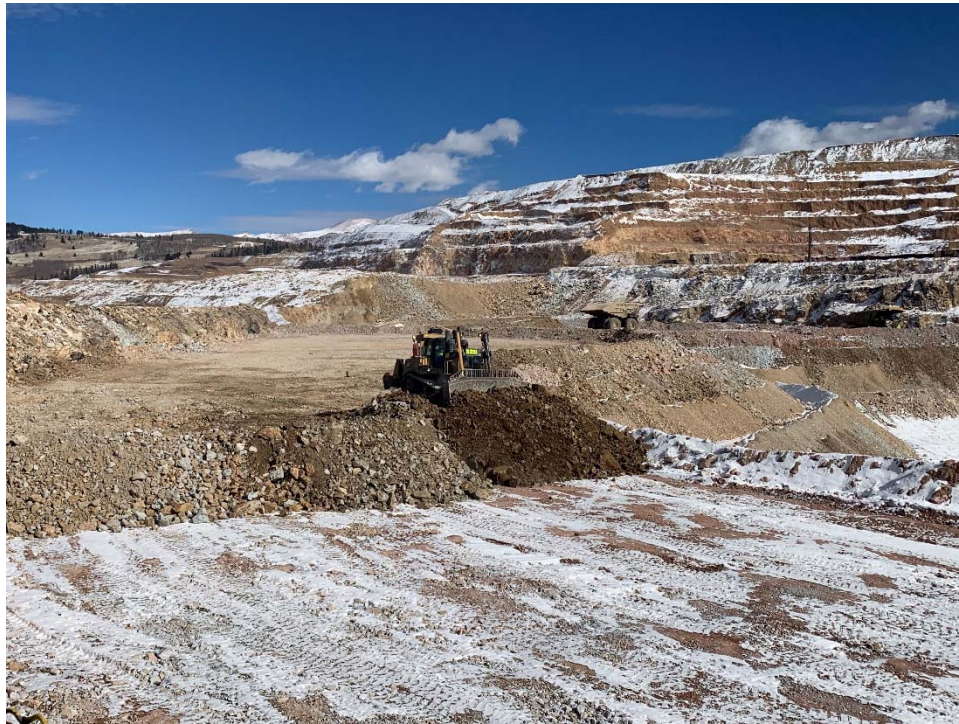
January 24, 2022 – High Compaction Backfill placement (TW)

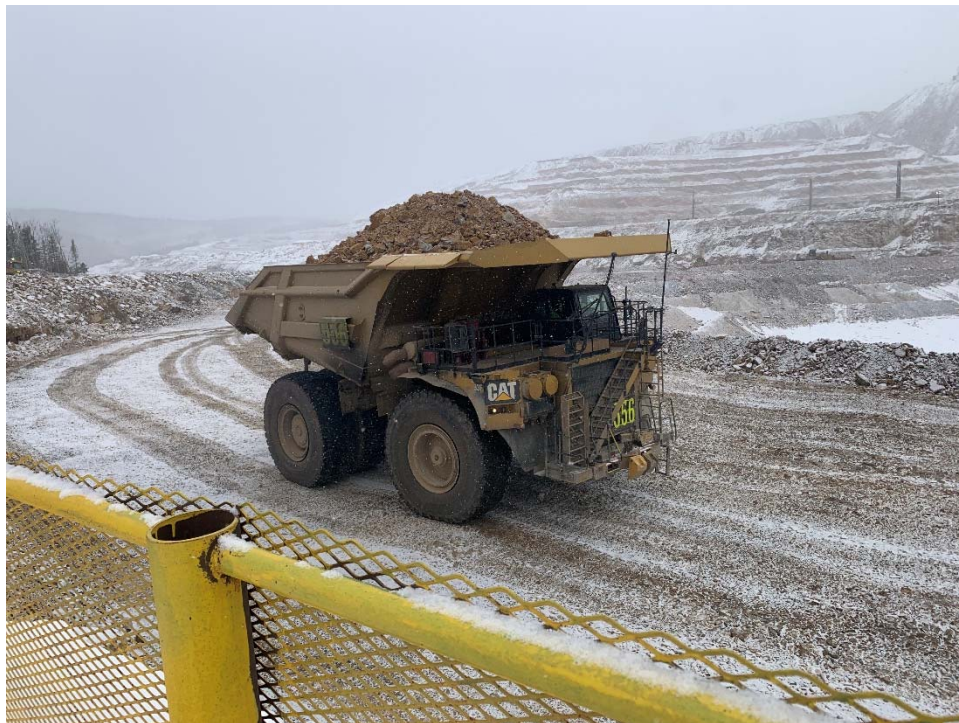
January 25, 2022 – High Compaction Backfill wheel rolling (TW)

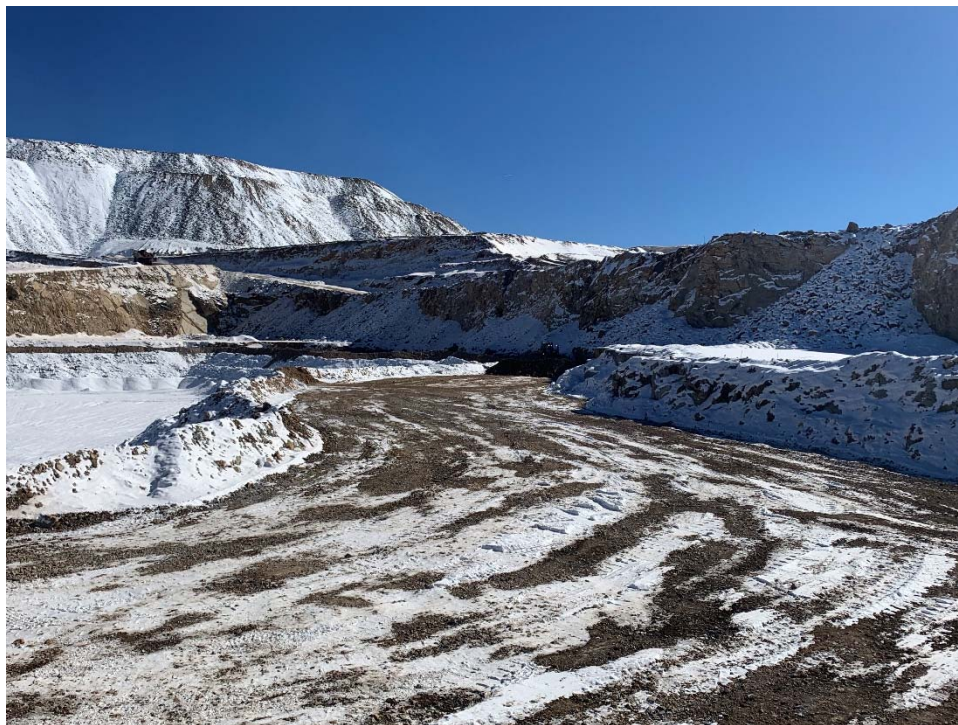
January 28, 2022 – High Compaction Backfill placement (TW)

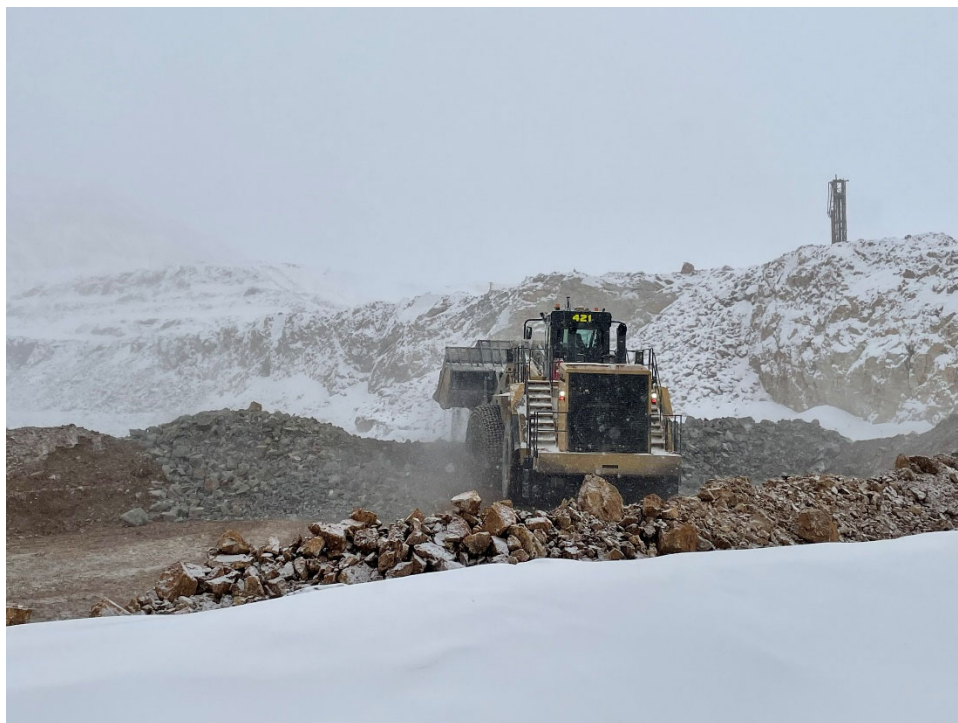
February 2, 2022 – High Compaction Backfill placement (GF)

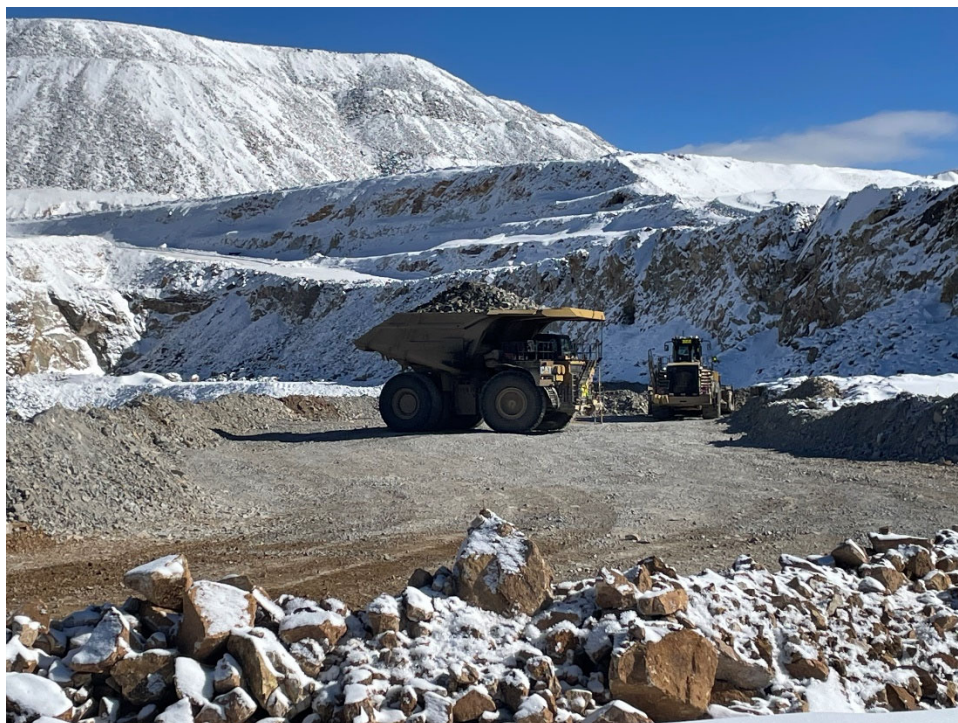
February 3, 2022 – High Compaction Backfill wheel rolling and leveling (GF)

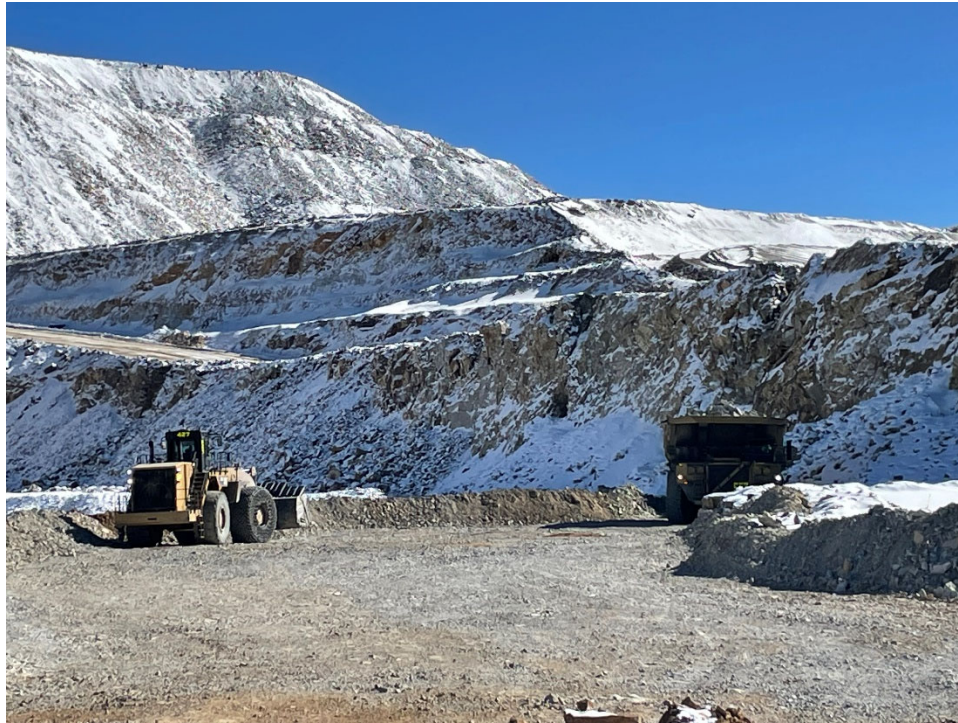
February 4, 2022 – High Compaction Backfill placement (GF)

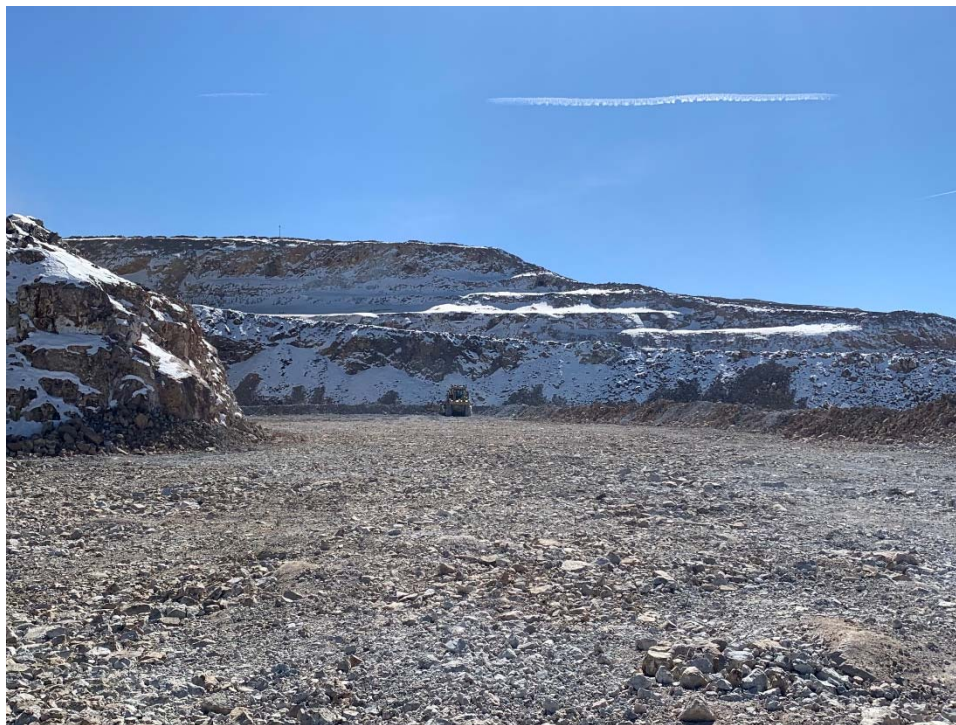
February 11, 2022 – High Compaction Backfill placement (TW)

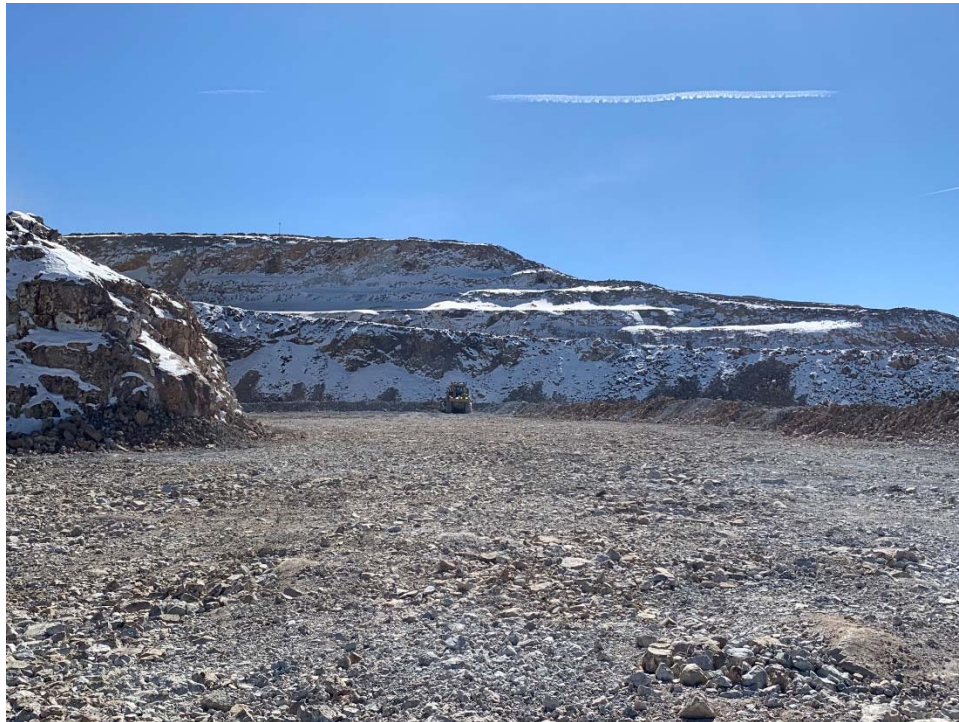
February 14, 2022 – High Compaction Backfill placement (TW)

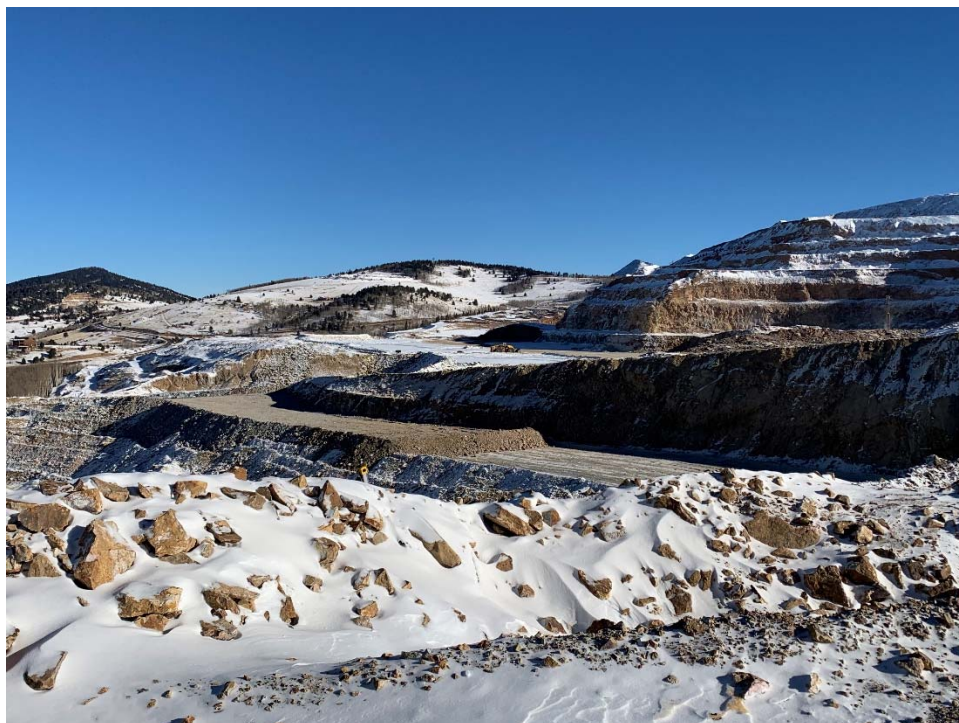
February 18, 2022 – High Compaction Backfill progress (TW)

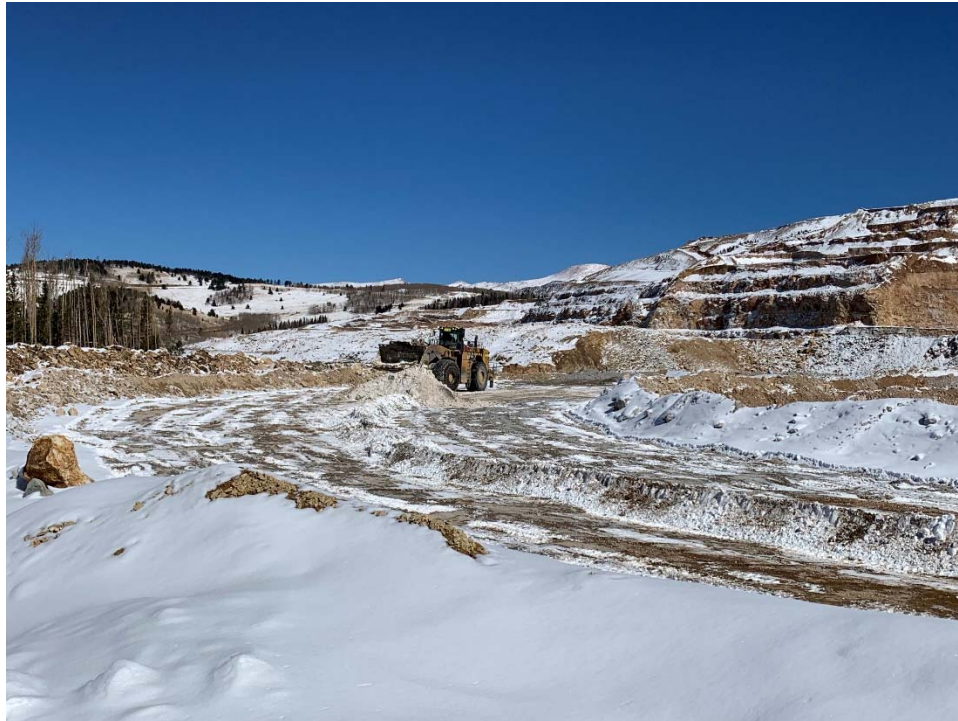
February 18, 2022 – High Compaction Backfill snow removal (TW)

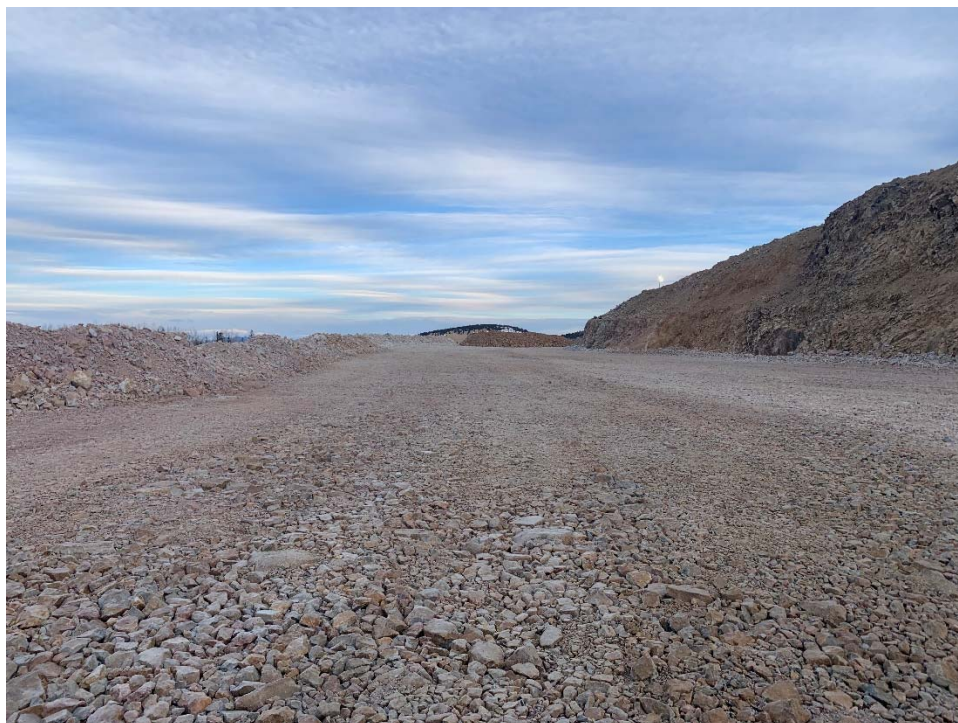
February 21, 2022 – High Compaction Backfill visual inspection (TW)

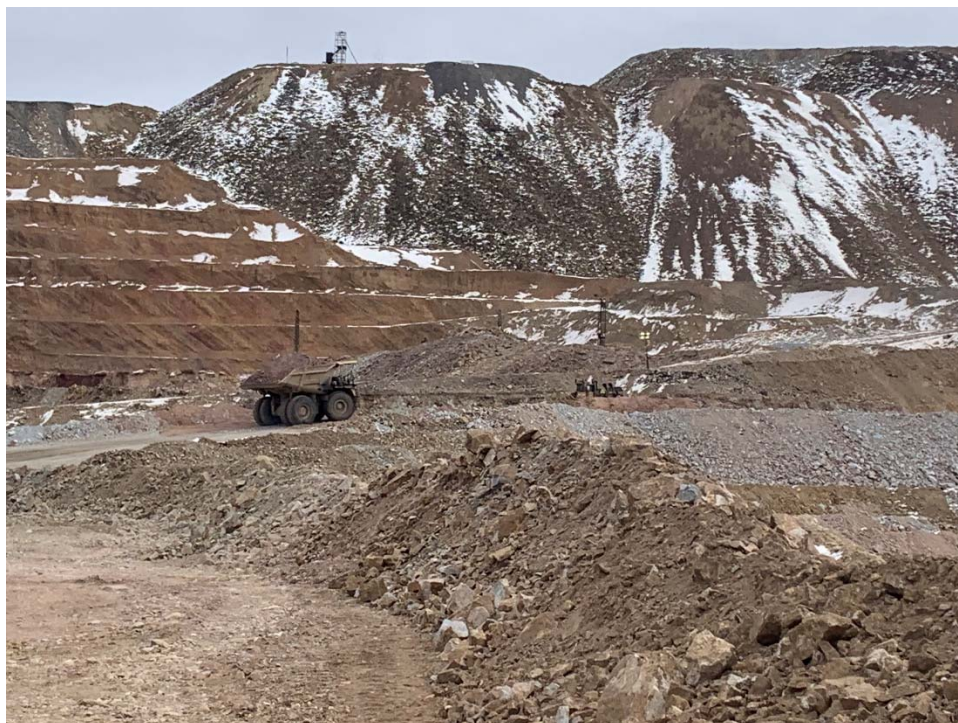
February 21, 2022 – High Compaction Backfill placement (TW)

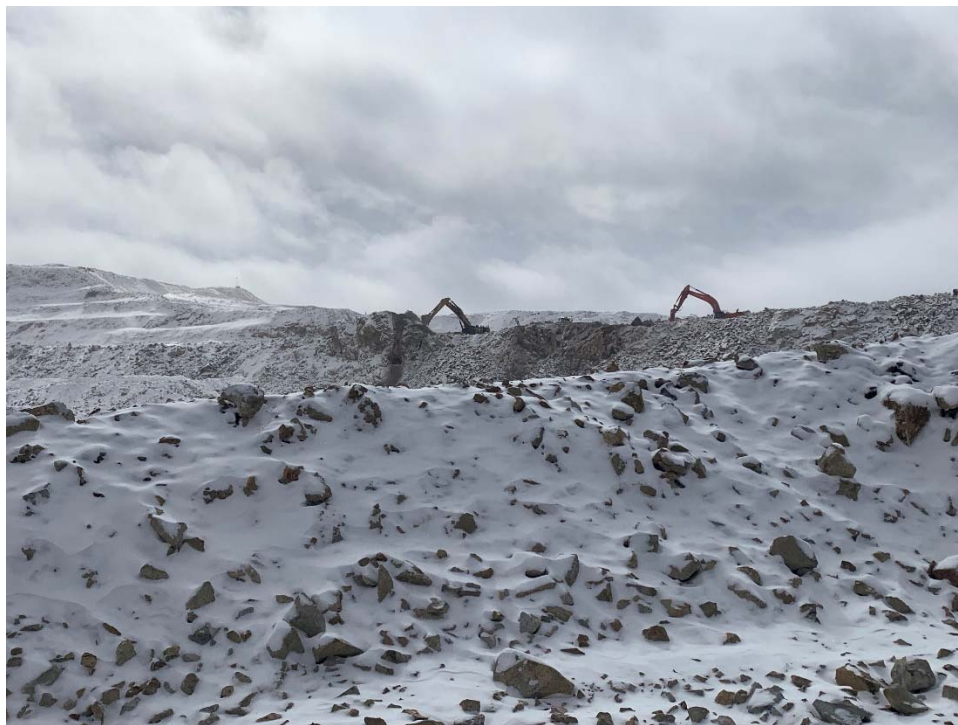
February 24, 2022 – Turkey Ridge mining (TW)

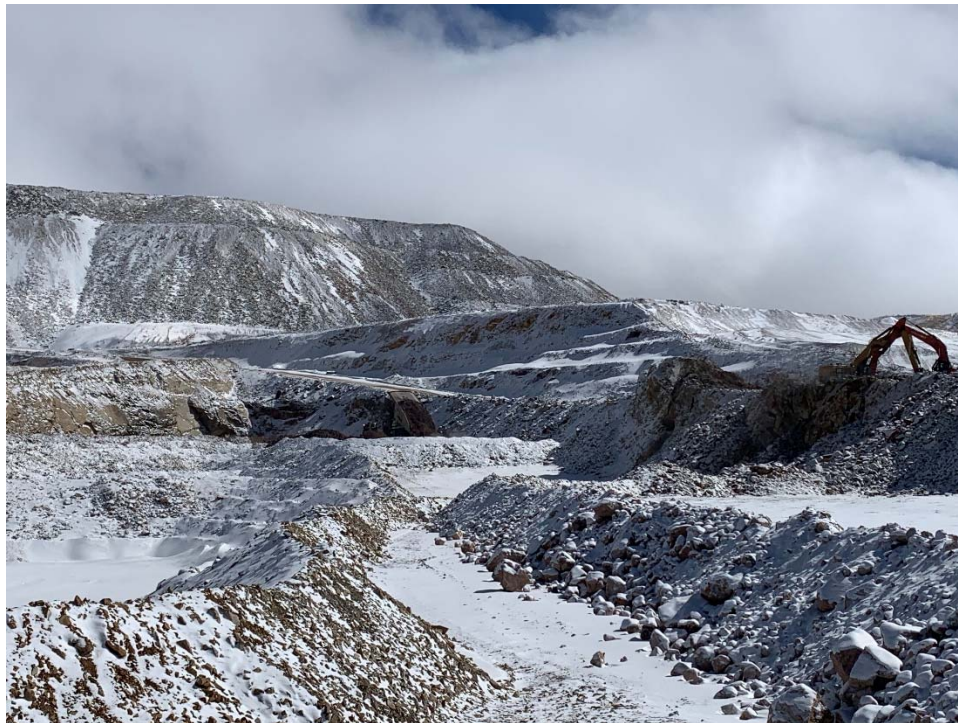
February 24, 2022 – High Compaction Backfill placement; Turkey ridge mining (TW)

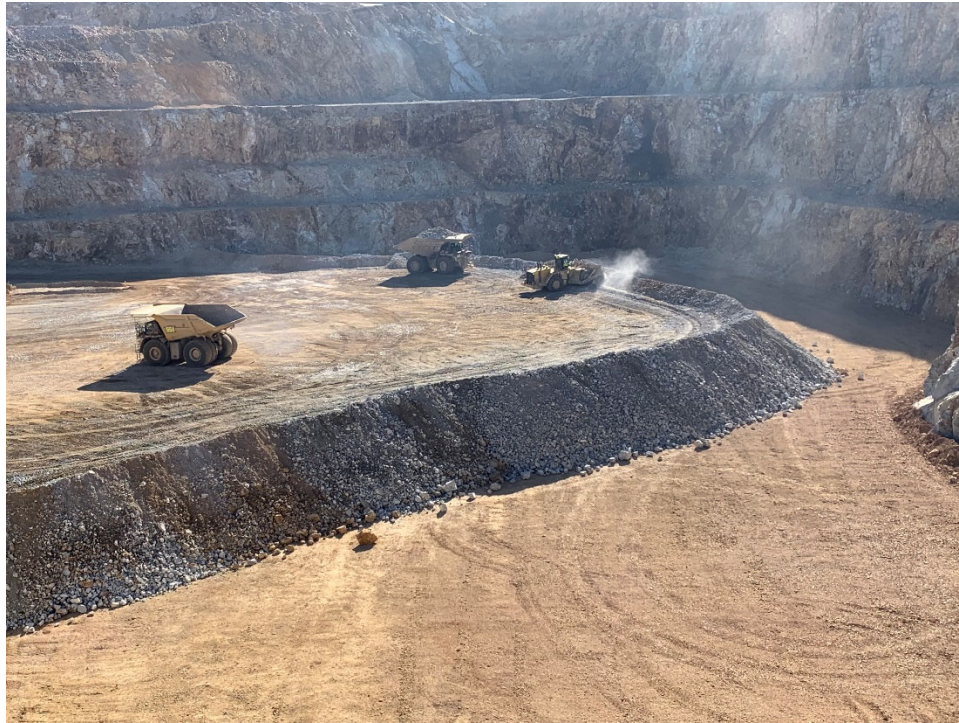
Photo 1 – Overburden Fill placement (October 11, 2021)

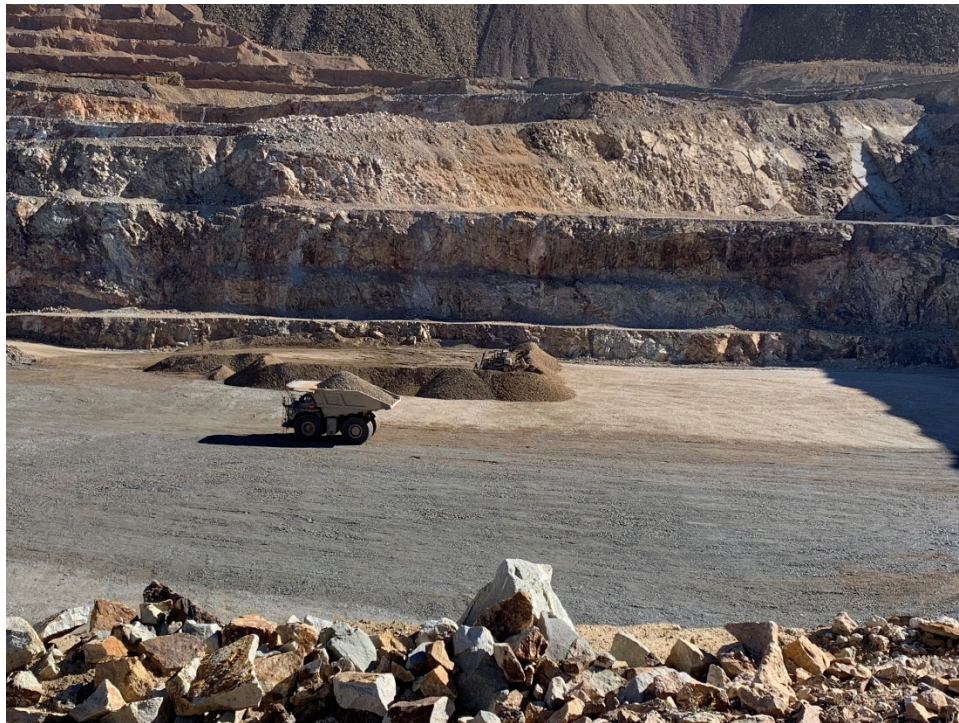
Photo 2 – Structural Fill/High Compaction Backfill placement (November 7, 2021)

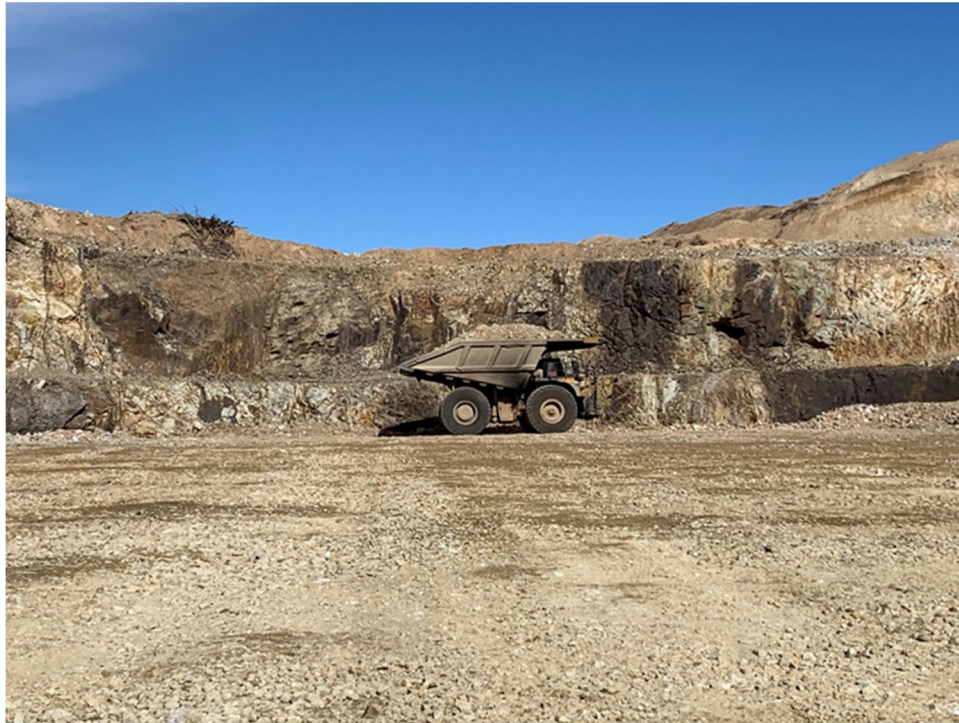
Photo 3 – Structural Fill/High Compaction Backfill compaction (November 11, 2021)
