## **APPENDIX E – WEEKLY REPORTS**

## FIELD WEEKLY PROGRESS REPORT

**PROJECT:** VALLEY LEACH FACILITY 2 PHASE 3 2023 QUALITY ASSURANCE OVERSIGHT  
**SITE:** CRIPPLE CREEK & VICTOR GOLD MINE (COLORADO)  
**CONTRACTOR:** NEWMONT CC&V MINING OPERATIONS  
JHL CONSTRUCTORS  
KELLEY TRUCKING INC.  
**WEEK ENDING:** FRIDAY, APRIL 21, 2023

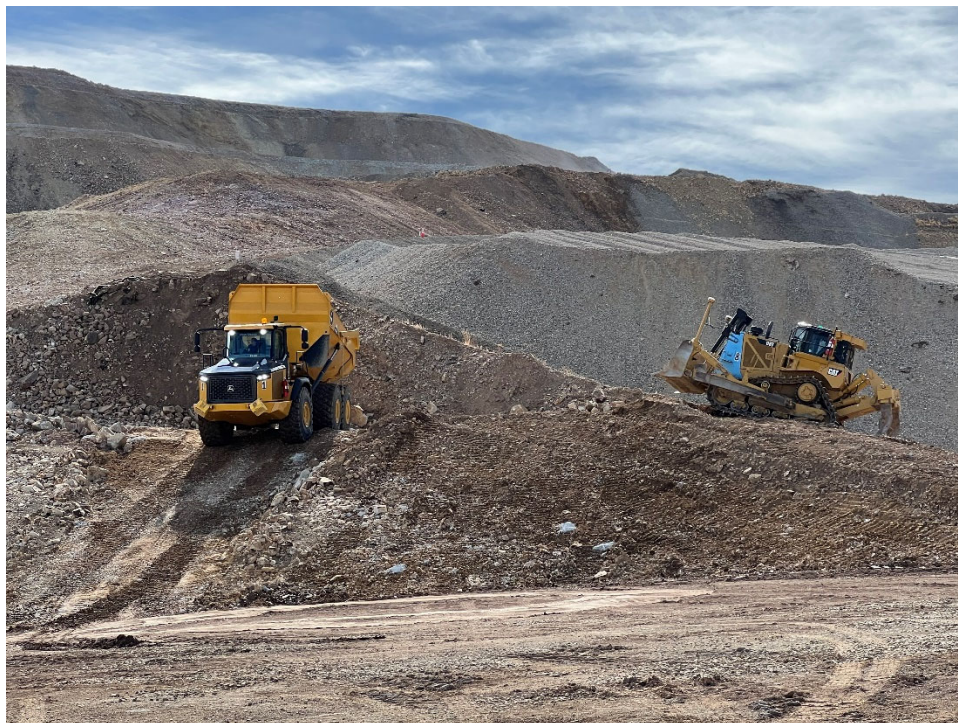
**April 18, 2023 – Lift placement of structural fill near the Phase 2 tie-in**

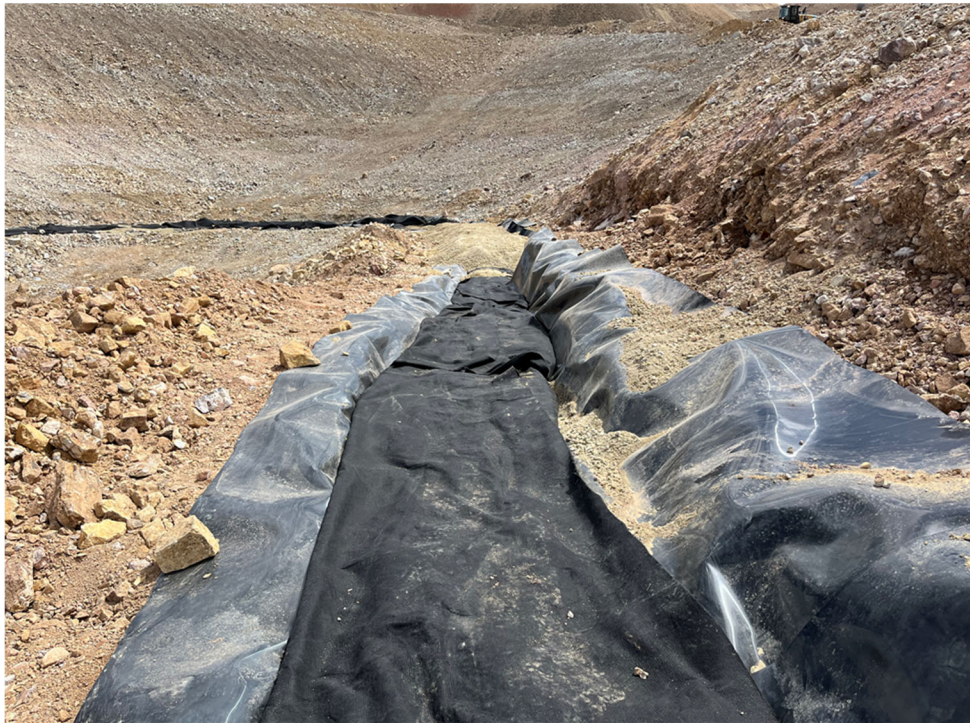
**April 18, 2023 – Construction of LDT1 above the 10,000' bench**

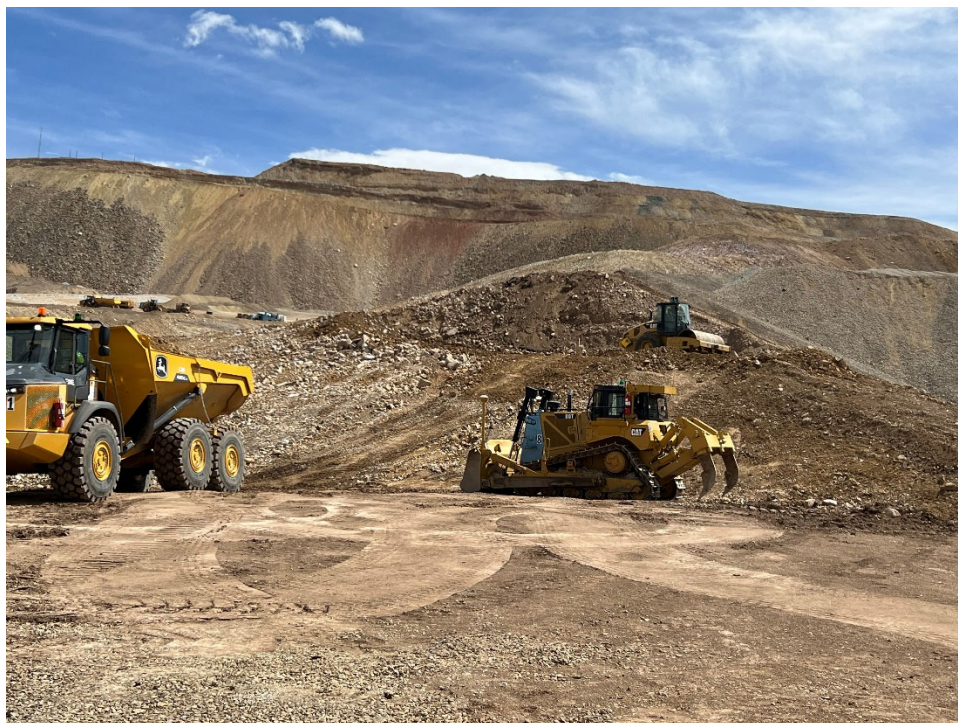
**April 19, 2023 – Lift placement and compaction near the Phase 2 tie-in**

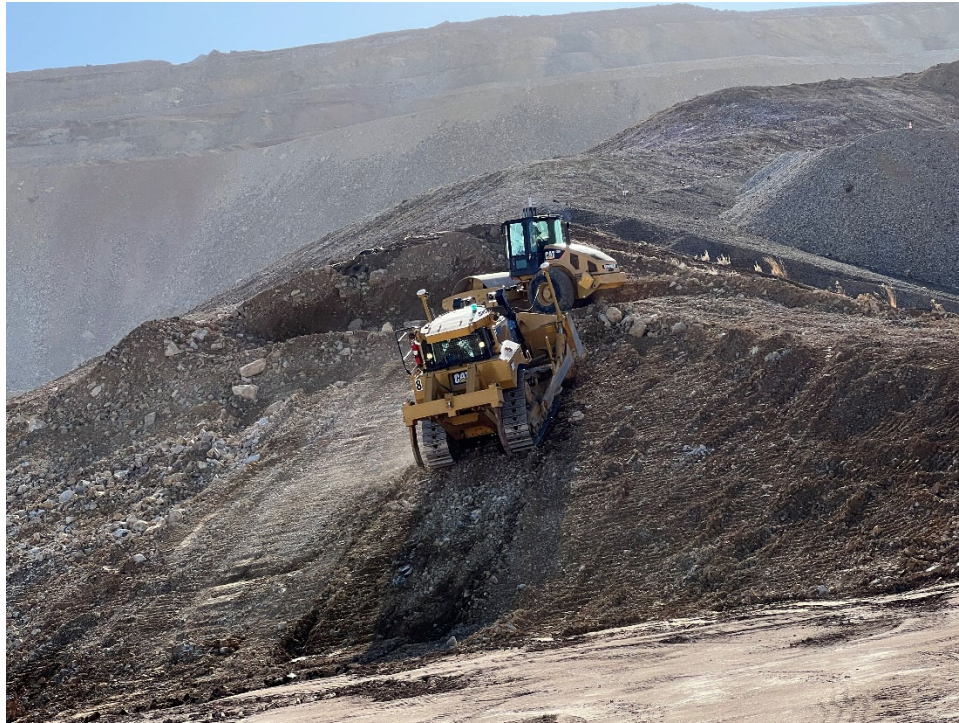
**April 19, 2023 - Lift placement and compaction near the Phase 2 tie-in**

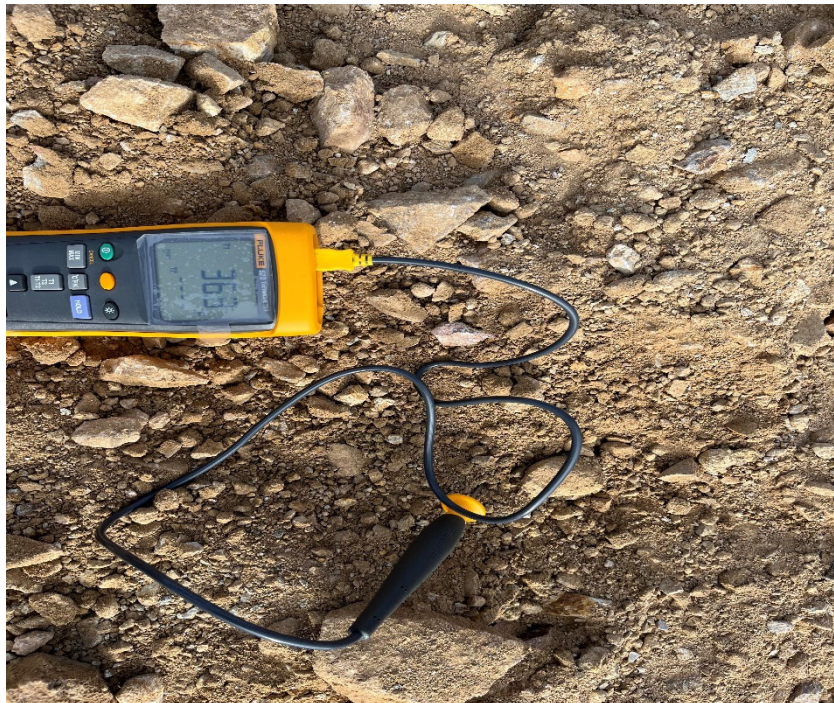
**April 21, 2023 – Monitoring structural fill temperatures**

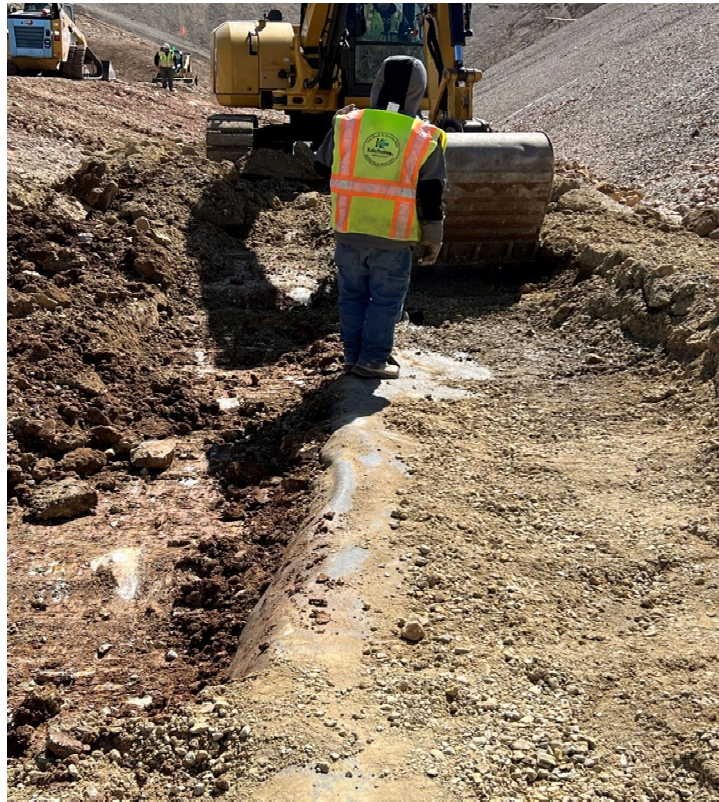
**April 21, 2023 – Geomembrane exposure along Phase 2 tie-in**

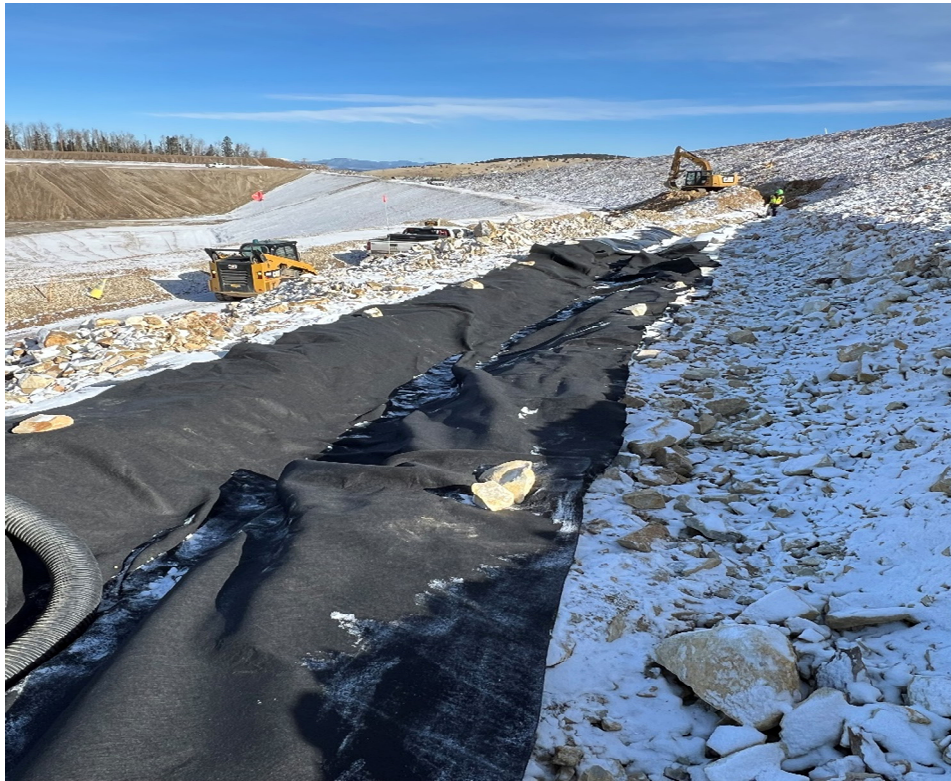
**April 23, 2023 – Construction of LDT1**

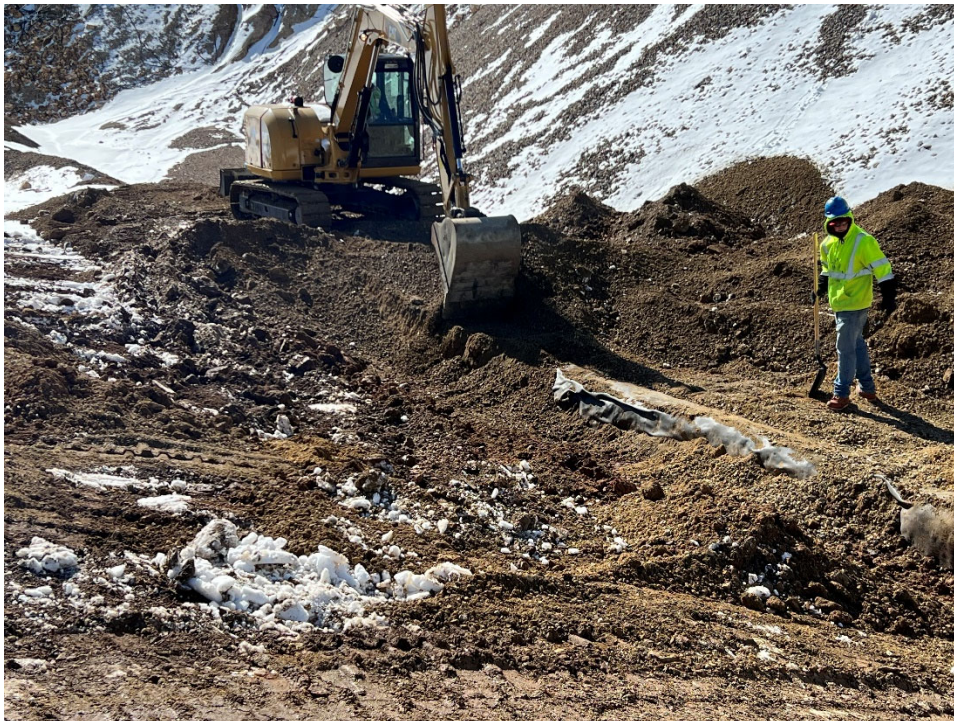
Kelley Trucking continued exposing the LLDPE geomembrane anchor trench along the Phase 2 tie-in. Any damage was marked for easy identification during geomembrane installation on Phase 3.

**April 27, 2023 – Anchor trench exposure at the VLF2 tie-in**

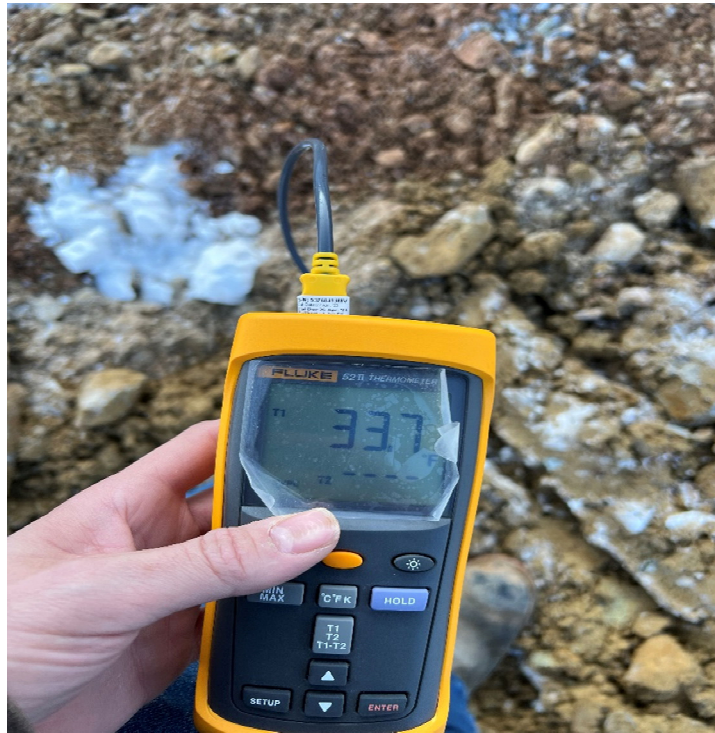
**April 28, 2023 – Temperature monitoring of structural fill**

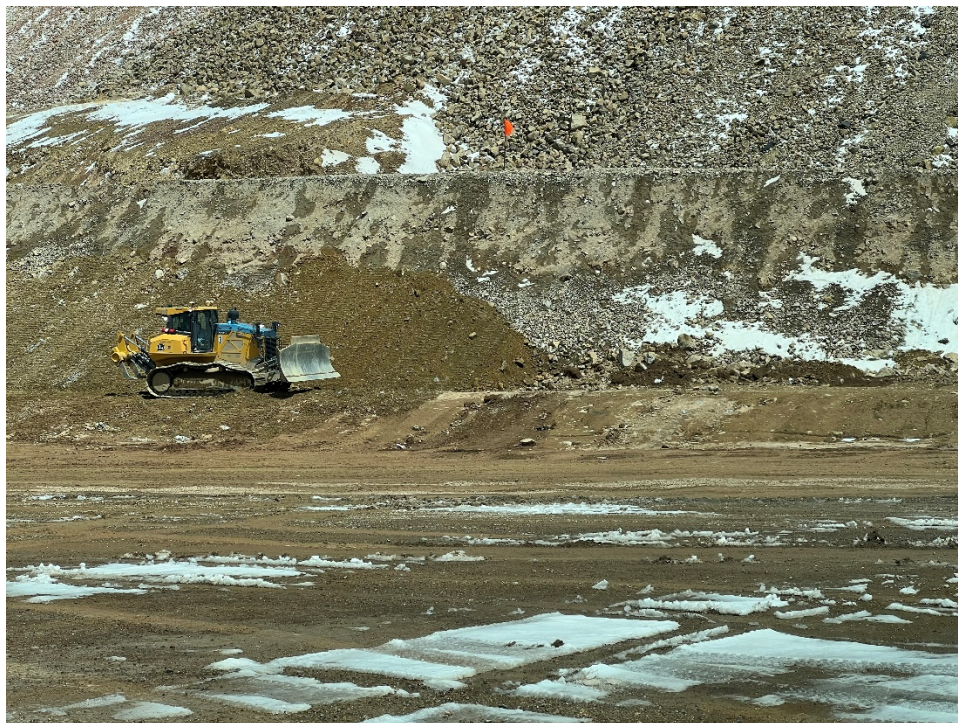
**April 28, 2023 – Structural fill placement below the Schist Haul Road**

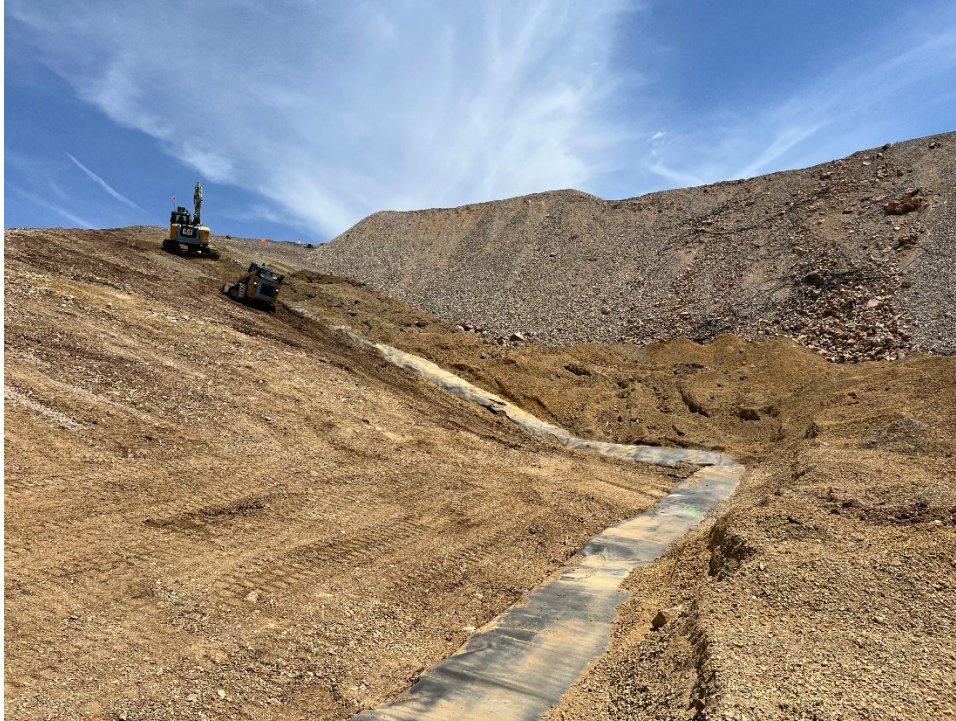
**May 2, 2023 – Exposure of Phase 2 tie in**

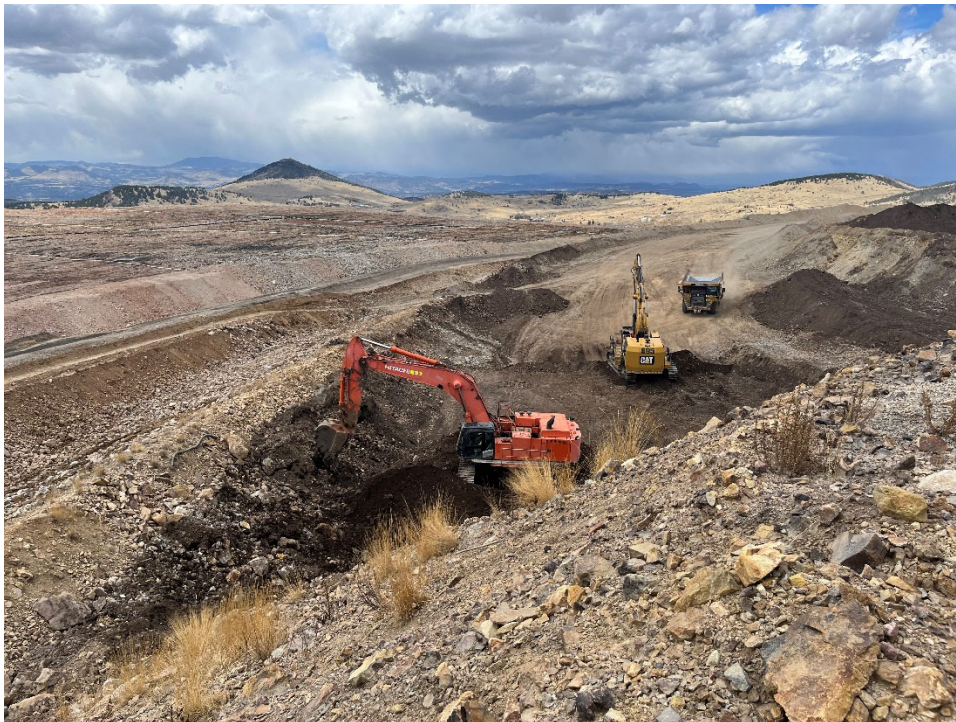
**May 3, 2023 – Topsoil removal from topsoil triangle**

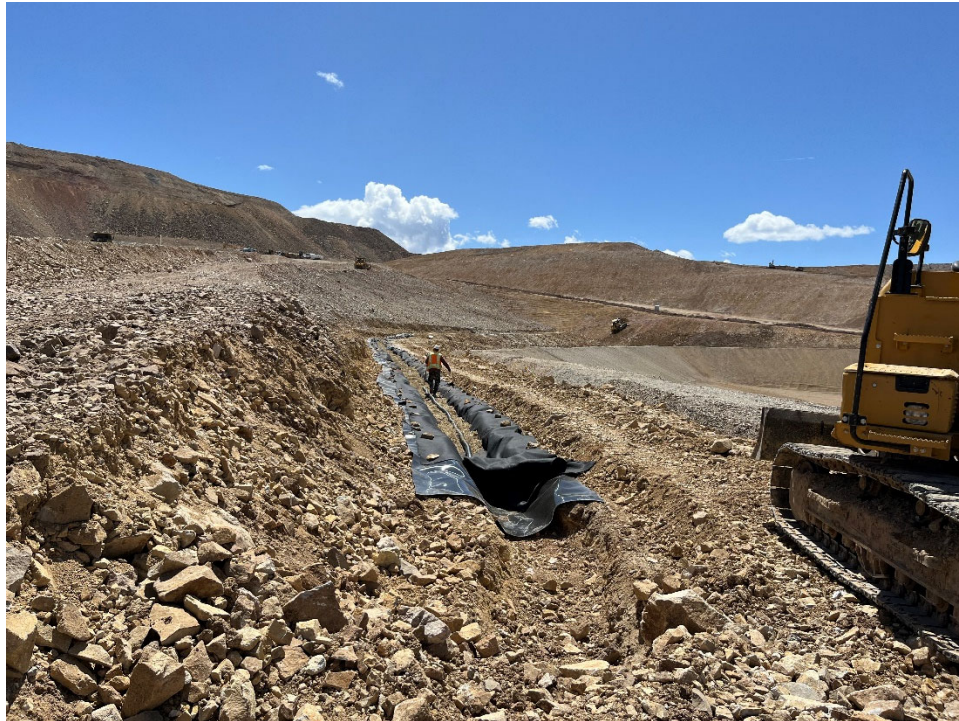
**May 3, 2023 – Survey of the leak detection trench**

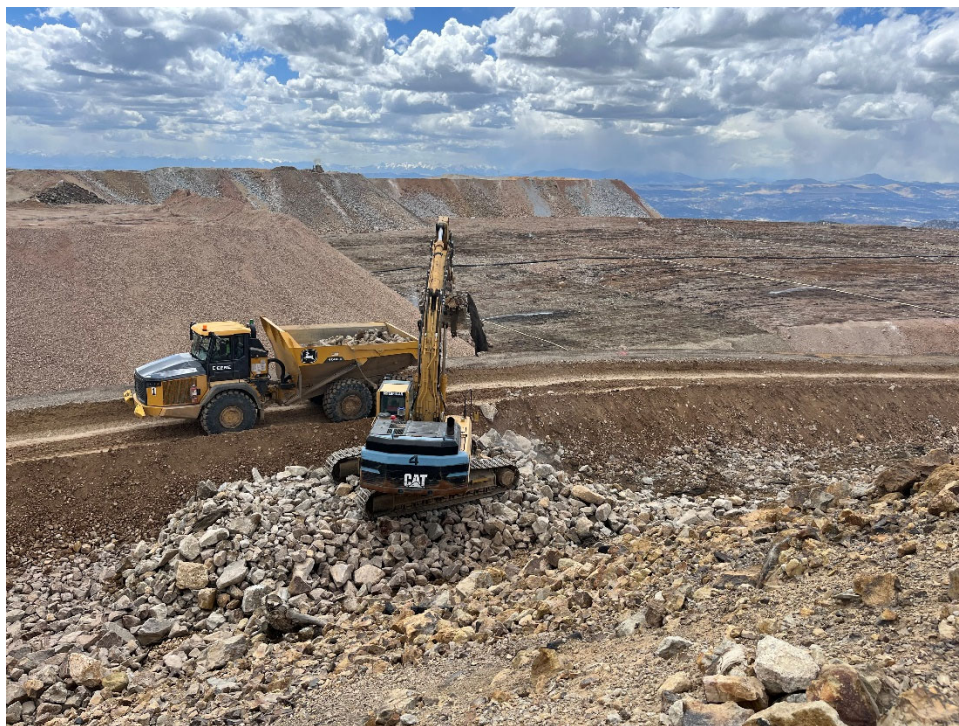
**May 4, 2023 – Removal of rip-rap from abandoned VLF2 stormwater channel**

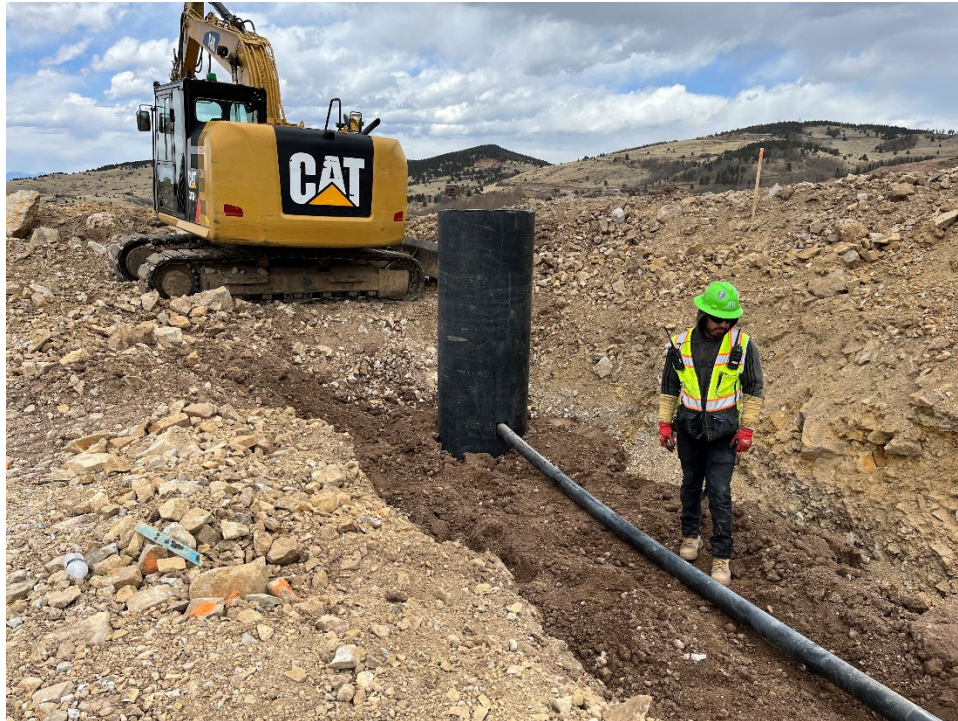
**May 5, 2023 – Construction of the LDT 1 manhole and SLF plug**

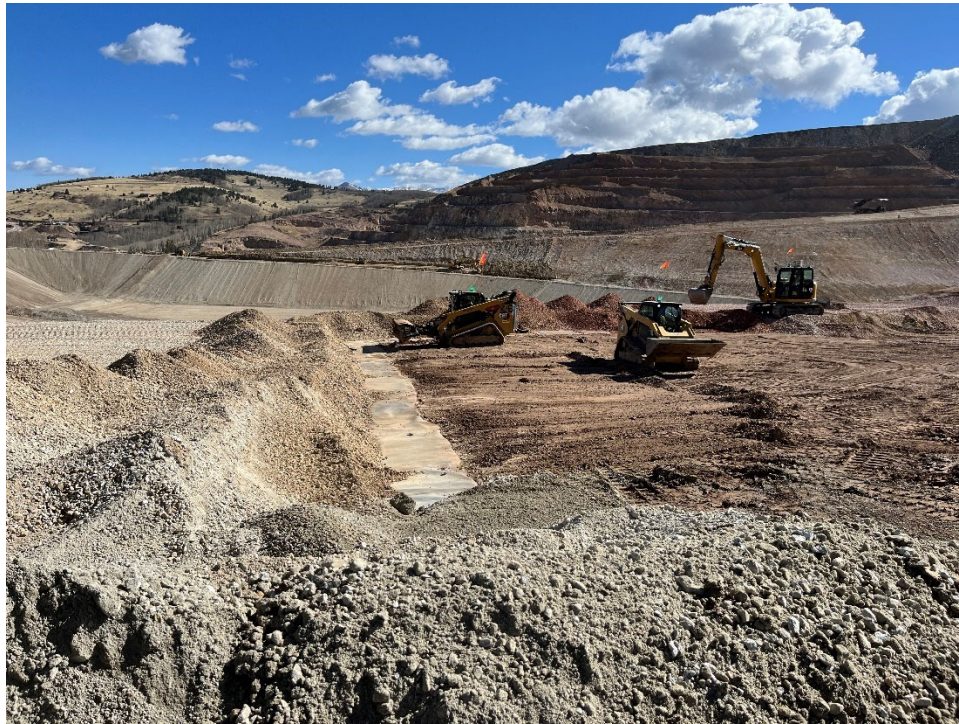
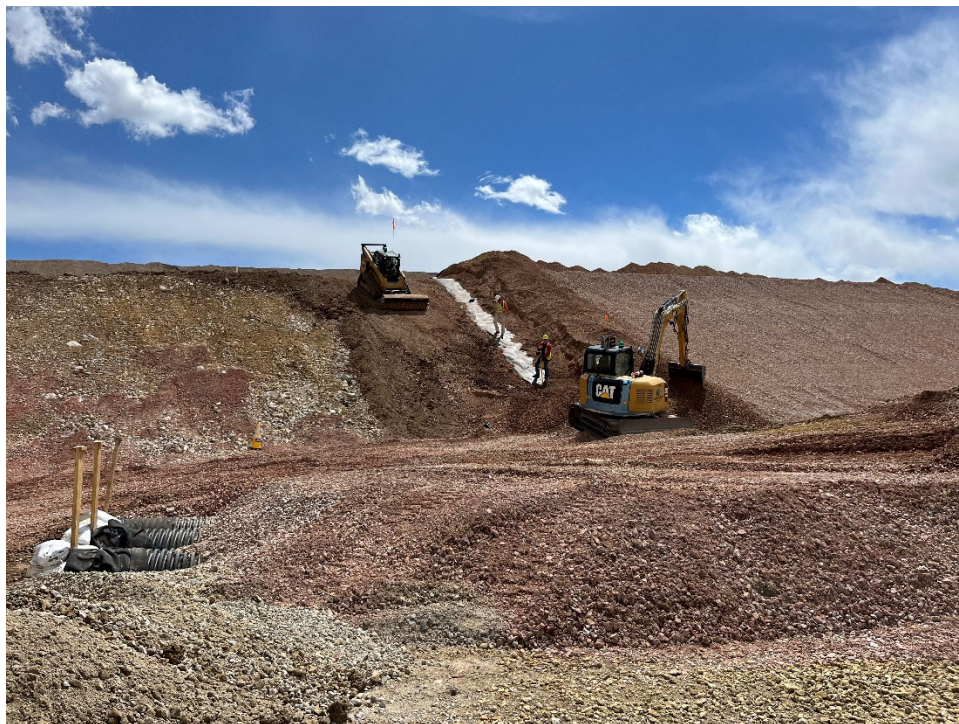
Kelley Trucking began exposing the LLDPE geomembrane temporary anchor trench along the Phase 3 A.1 tie-in. Any damage was marked for easy identification during geomembrane installation on Phase 3.

**May 8, 2023 – Exposure of Phase 3 A.1 tie in**

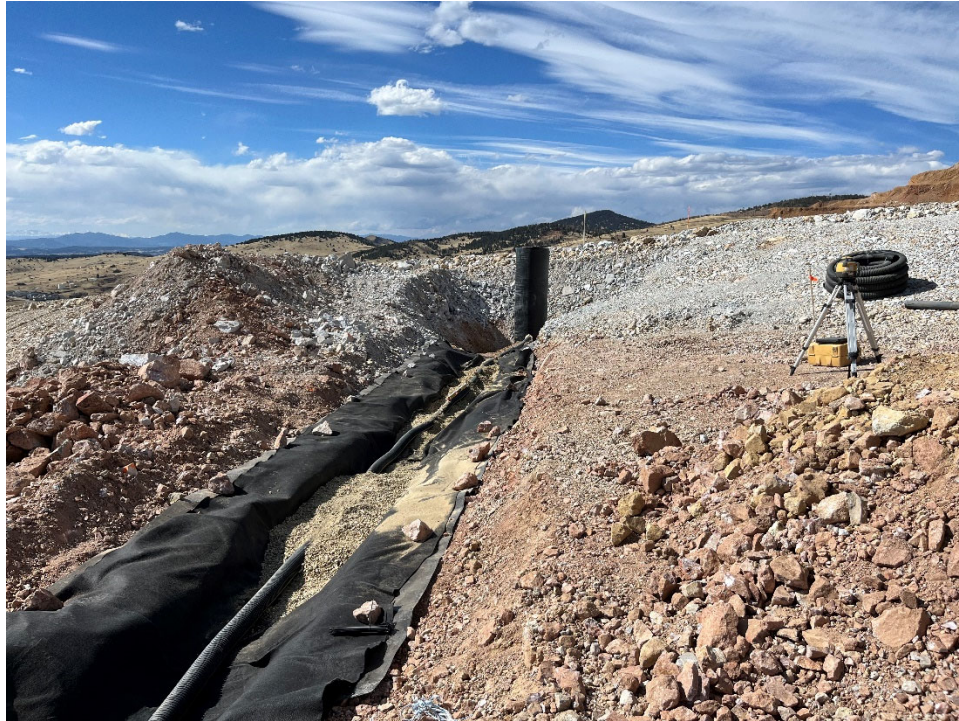
**May 9, 2023 – Construction of the LDT 2 manhole and SLF plug**

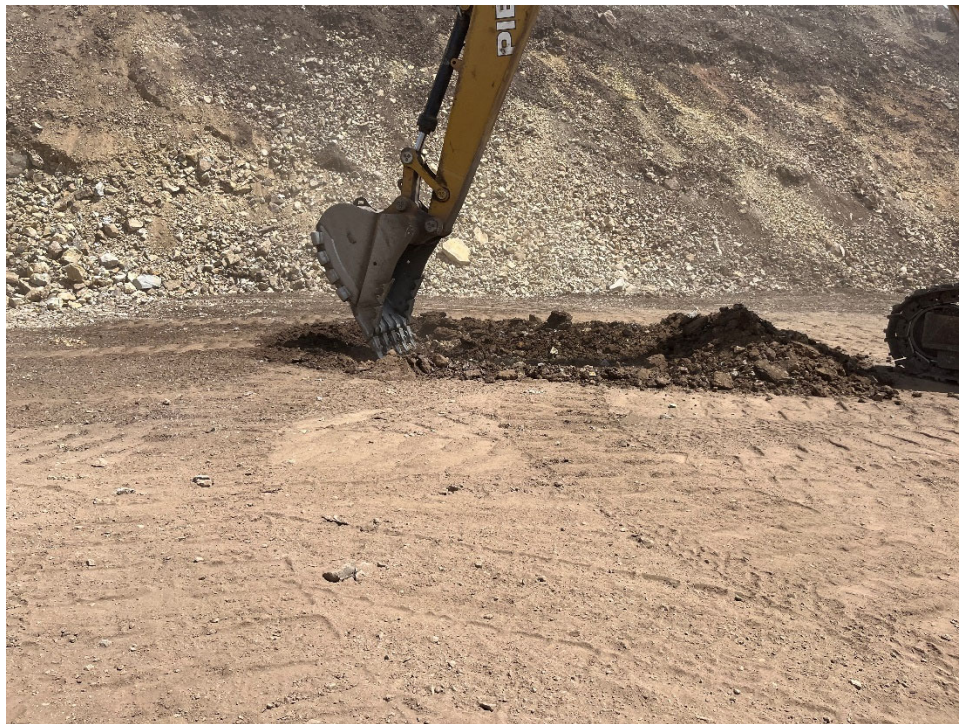
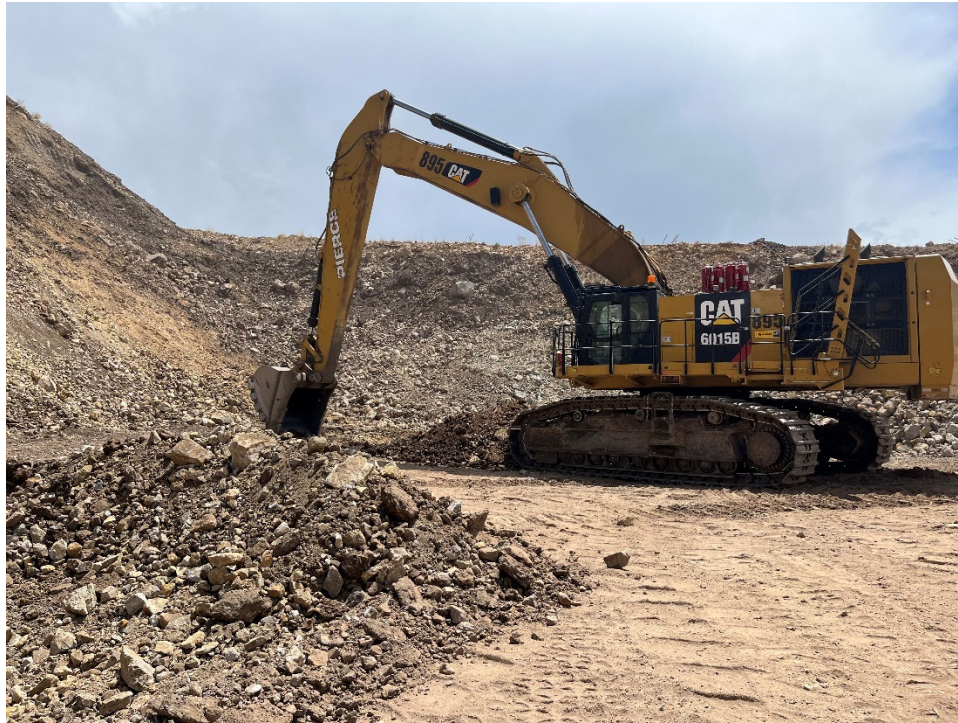
**May 10, 2023 – Topsoil removal verification**

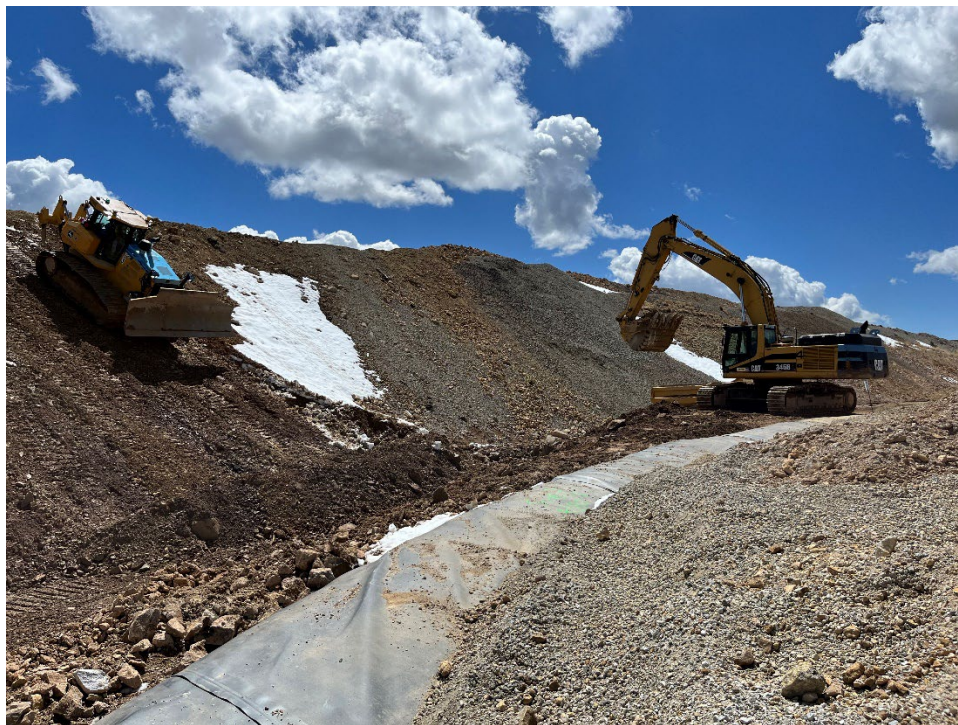
May 16, 2023 – Anchor trench exposure at the VLF2 tie-in

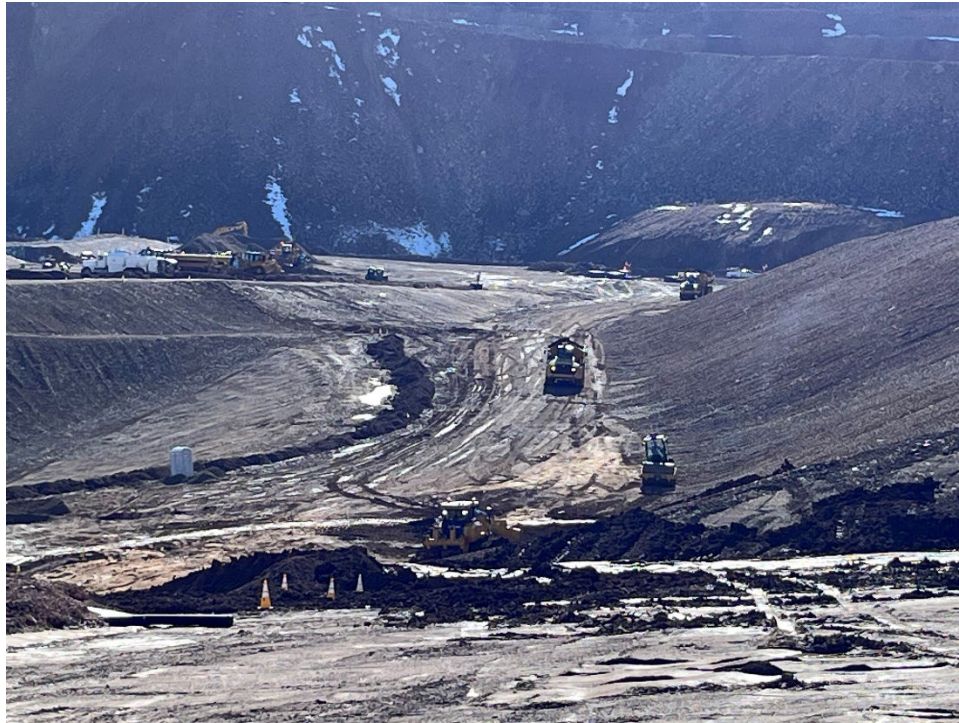
**May 17, 2023 – SLF placement progress**

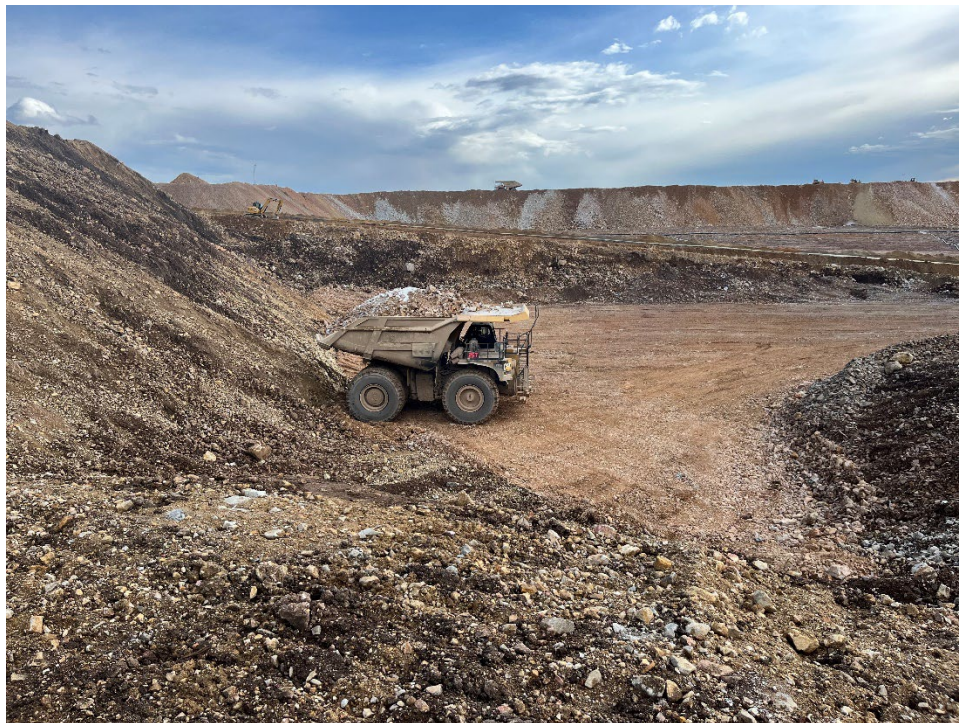
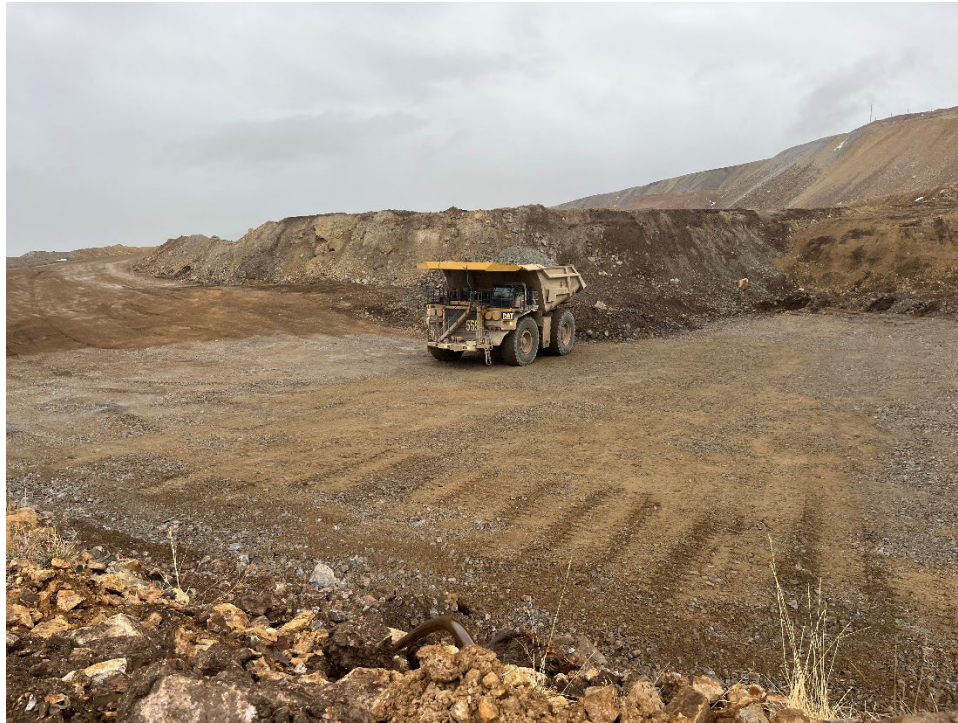
**May 17, 2023 – Wheel rolling of High Compaction Backfill in topsoil triangle**

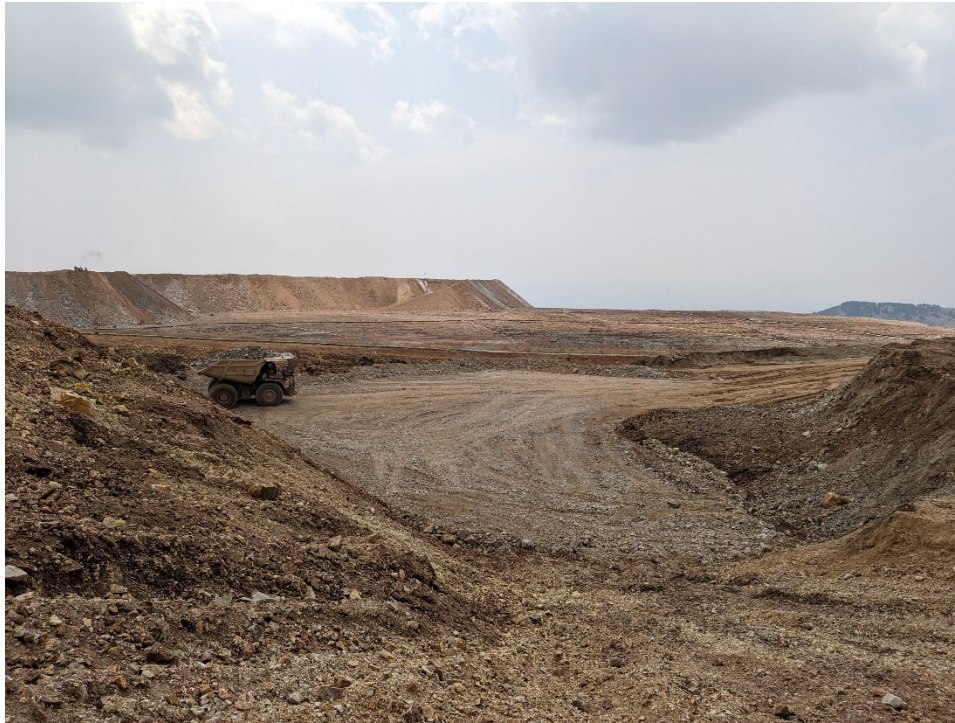
**May 22, 2023 – Wheel rolling of HCBF lift TS10,155**

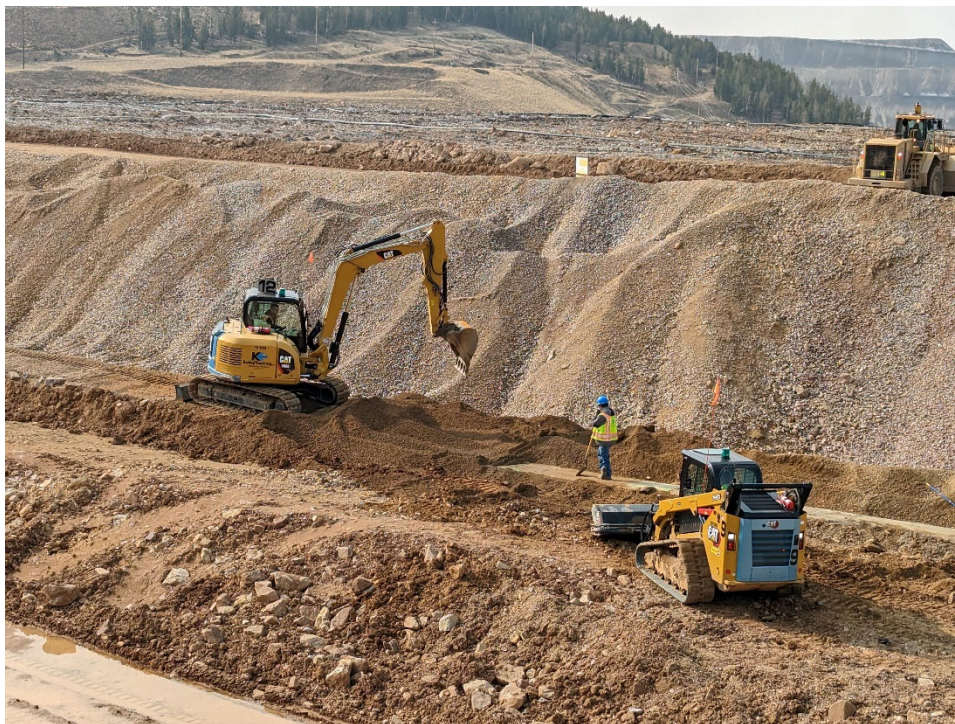
**May 22, 2023 – Anchor trench exposure at the VLF2 tie-in**

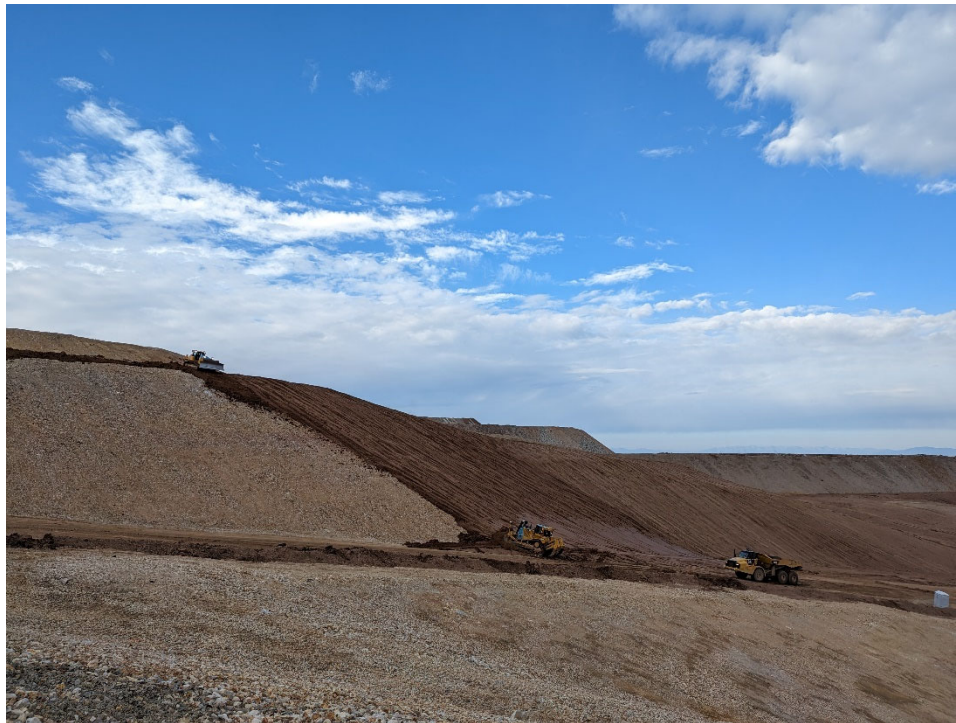
**May 24, 2023 – SLF placement on the slopes south of the PSSA**

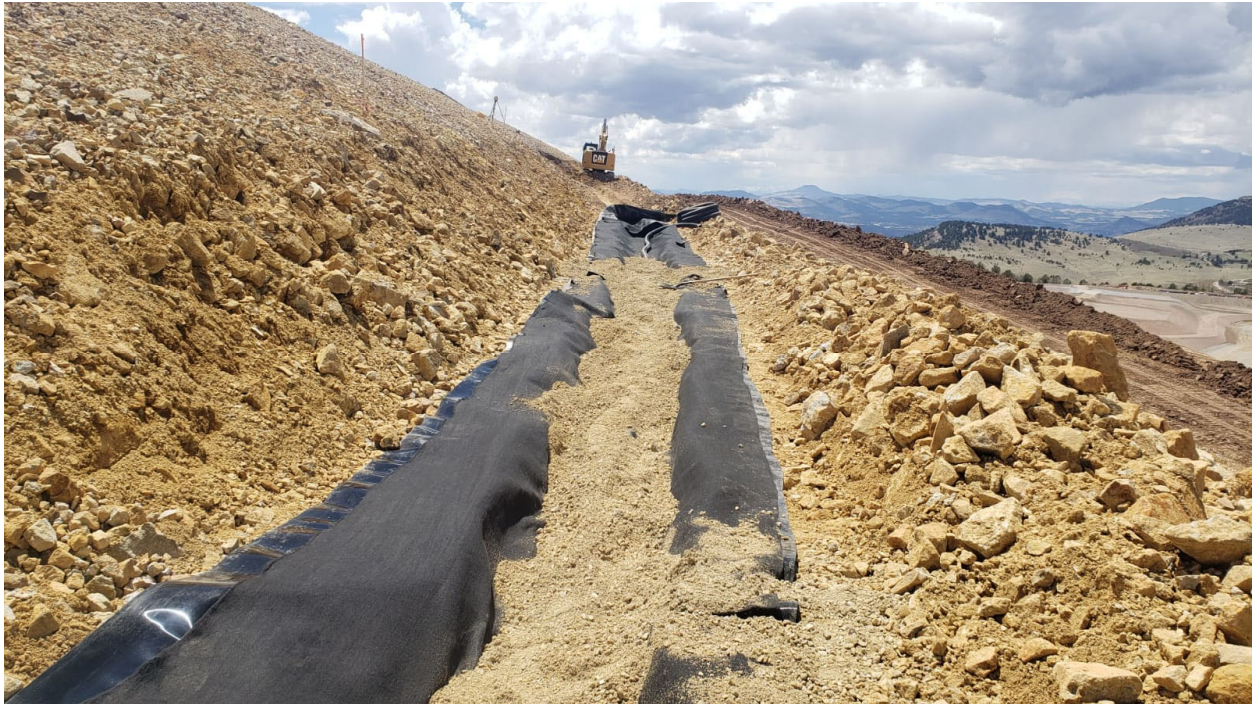
**May 25, 2023 - Leak detection trench construction**

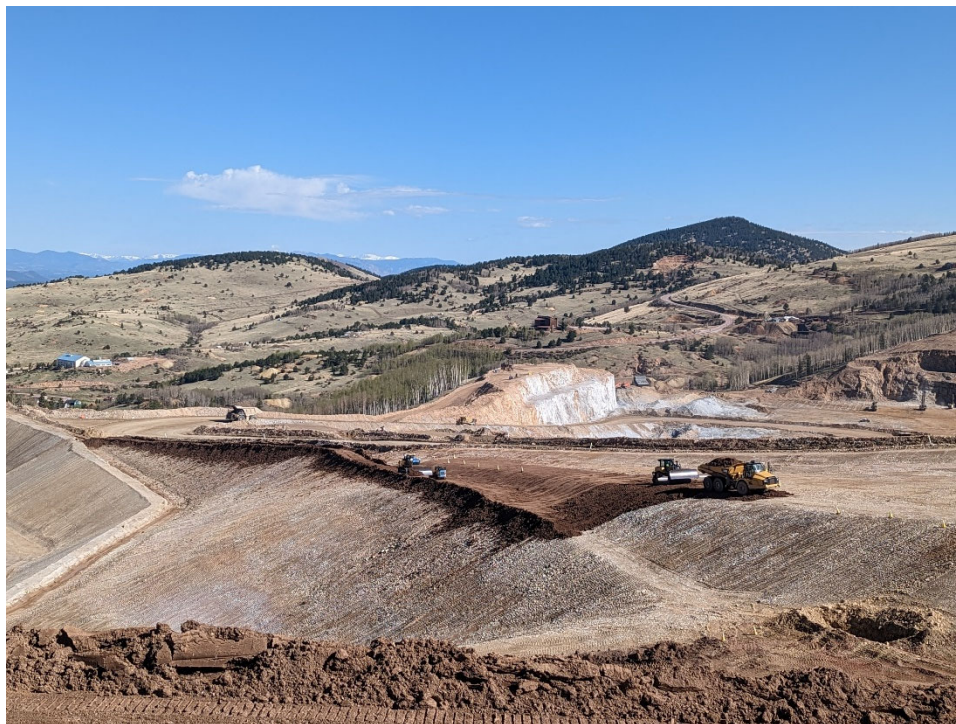
**May 26, 2023 – SLF placement east of the PSSA**

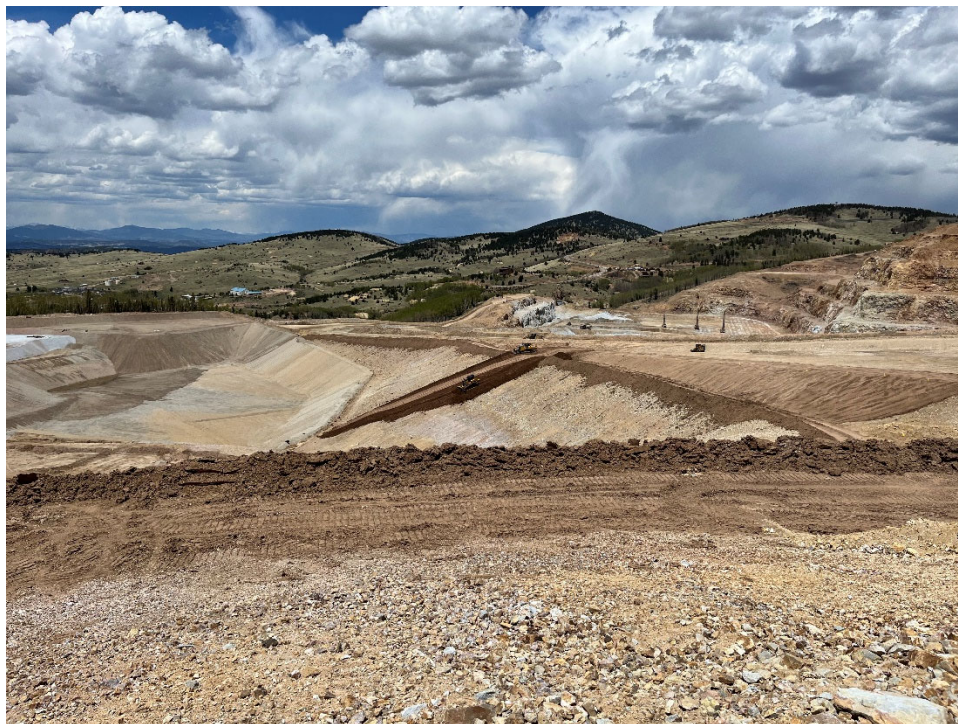
**May 30, 2023 – Placement of SLF above the 10,000' bench**

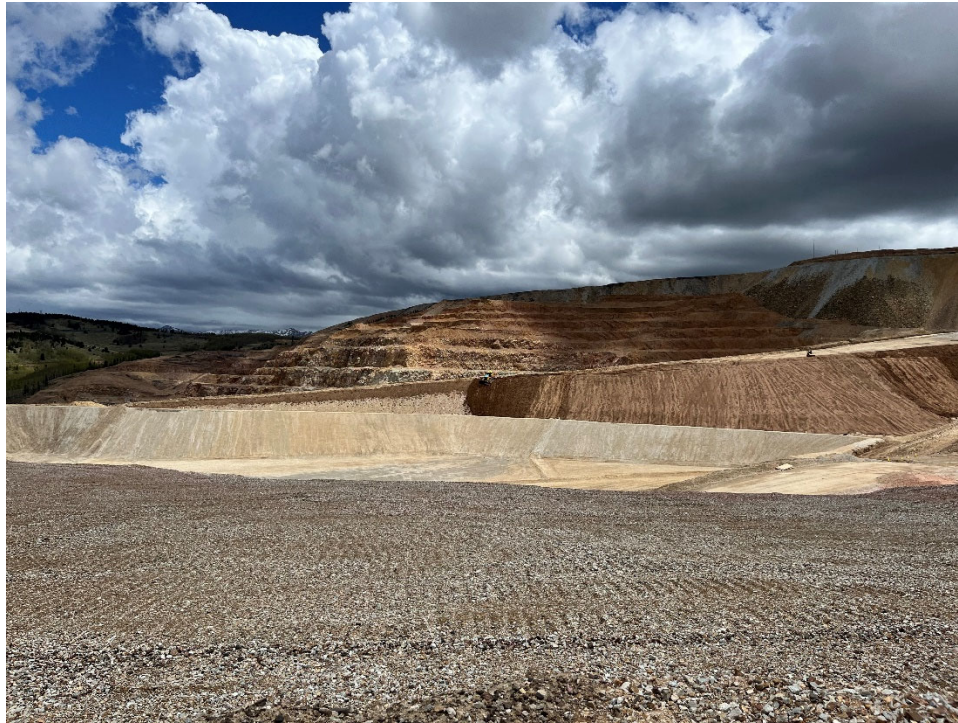
**June 1, 2023 - Placement of SLF above the 10,000' bench**

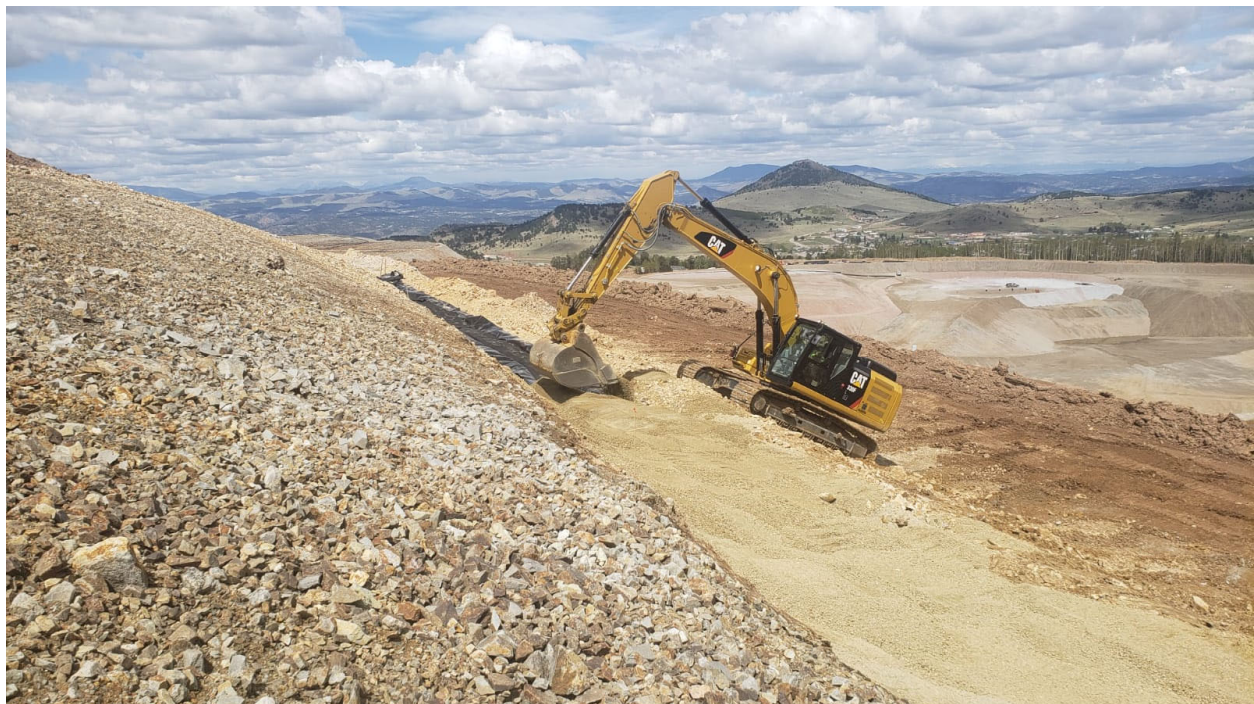
**June 2, 2023 – Backfilling of LDT2 with gravel to protect geotextile**
