## **APPENDIX E – WEEKLY REPORTS**

## FIELD WEEKLY PROGRESS REPORT

**PROJECT:** VALLEY LEACH FACILITY 2 PHASE 3 2023 QUALITY ASSURANCE OVERSIGHT  
**SITE:** CRIPPLE CREEK & VICTOR GOLD MINE (COLORADO)  
**CONTRACTOR:** NEWMONT CC&V MINING OPERATIONS  
JHL CONSTRUCTORS  
KELLEY TRUCKING INC.  
**WEEK ENDING:** FRIDAY, APRIL 21, 2023

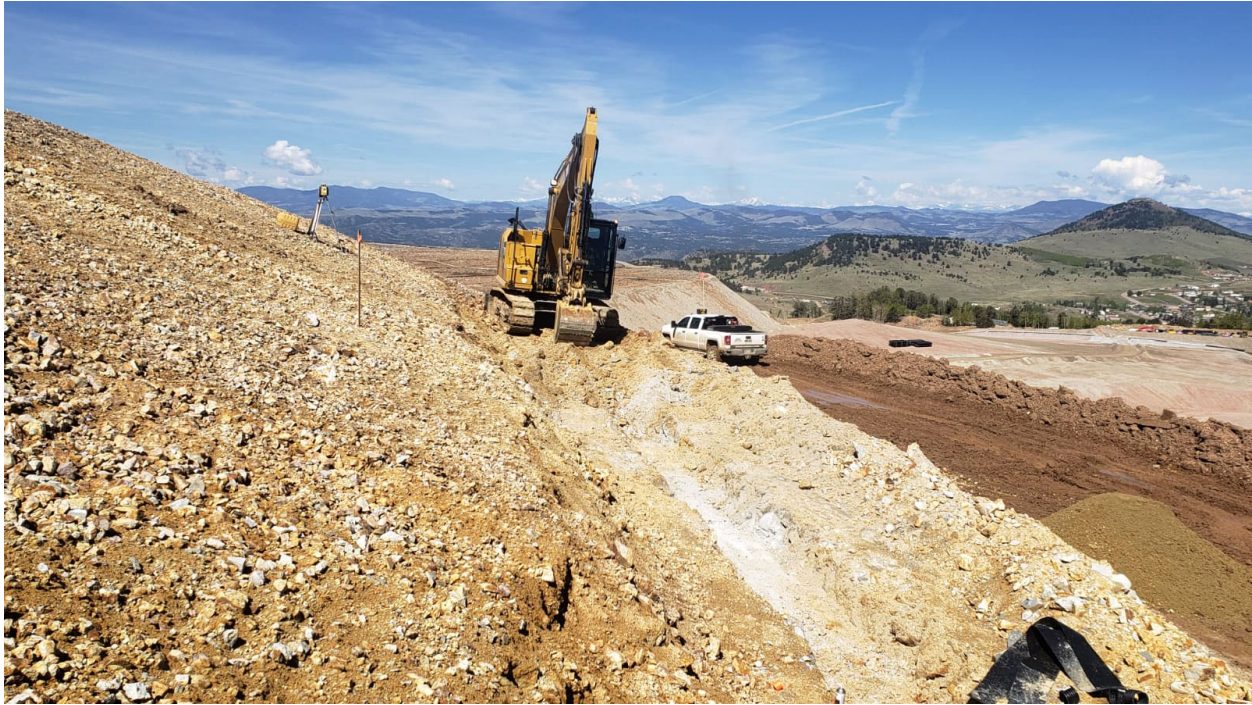
July 6, 2023 – Excavation of LDT2 trench

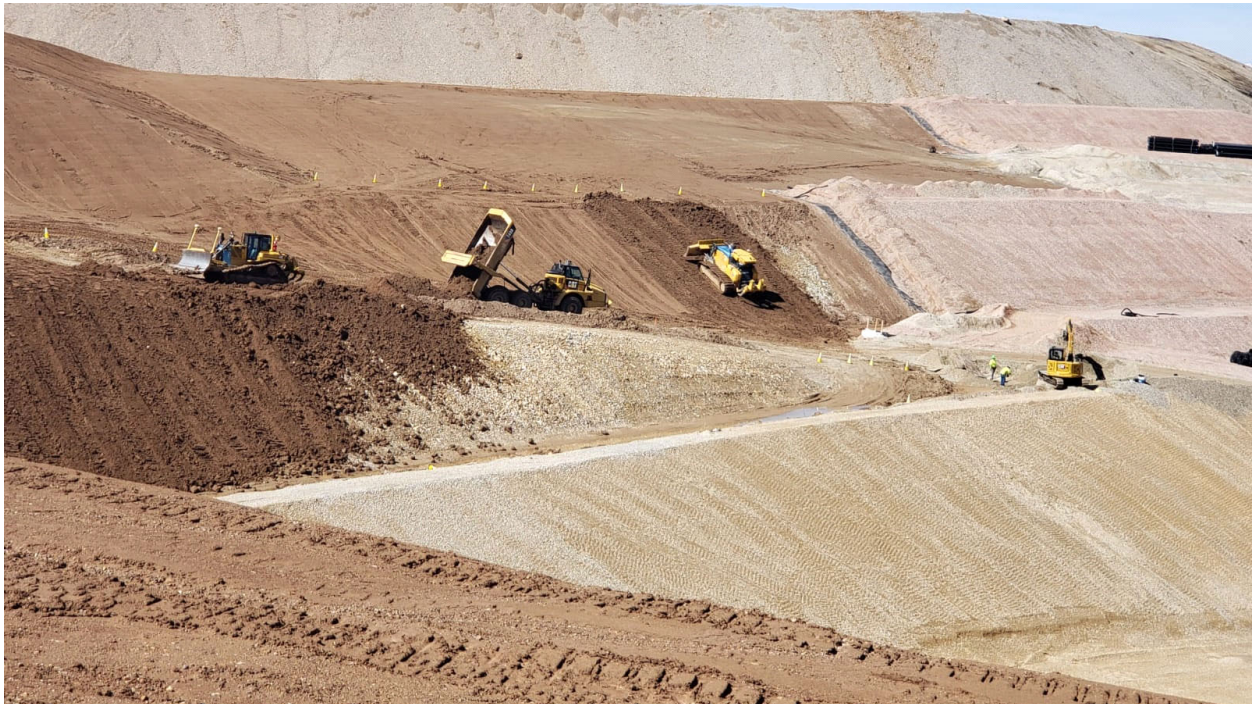
**July 6, 2023 – Placement of SLF above the 10,000' bench**

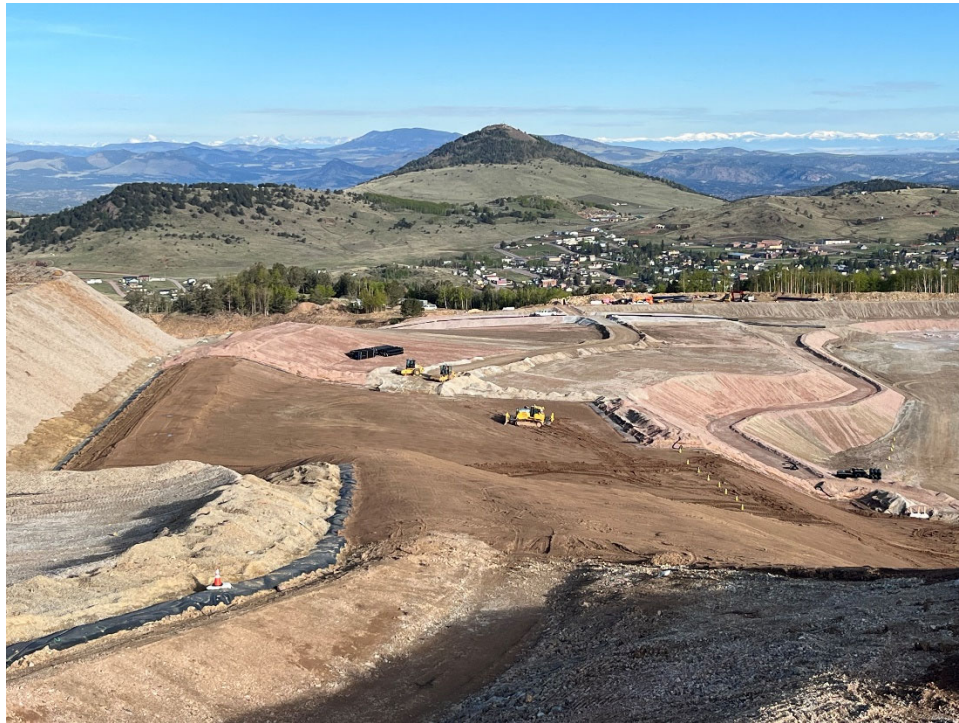
**July 6, 2023 – Geomembrane exposure along the 10,000' bench**

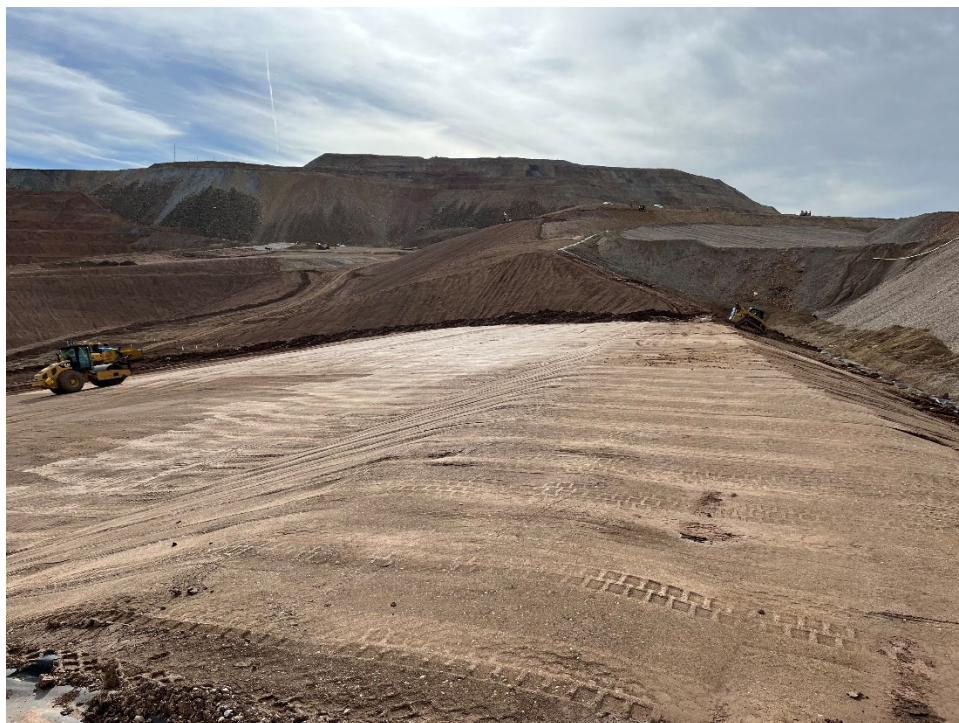
**June 7, 2023 – Preparation of SLF over the Honda Area**

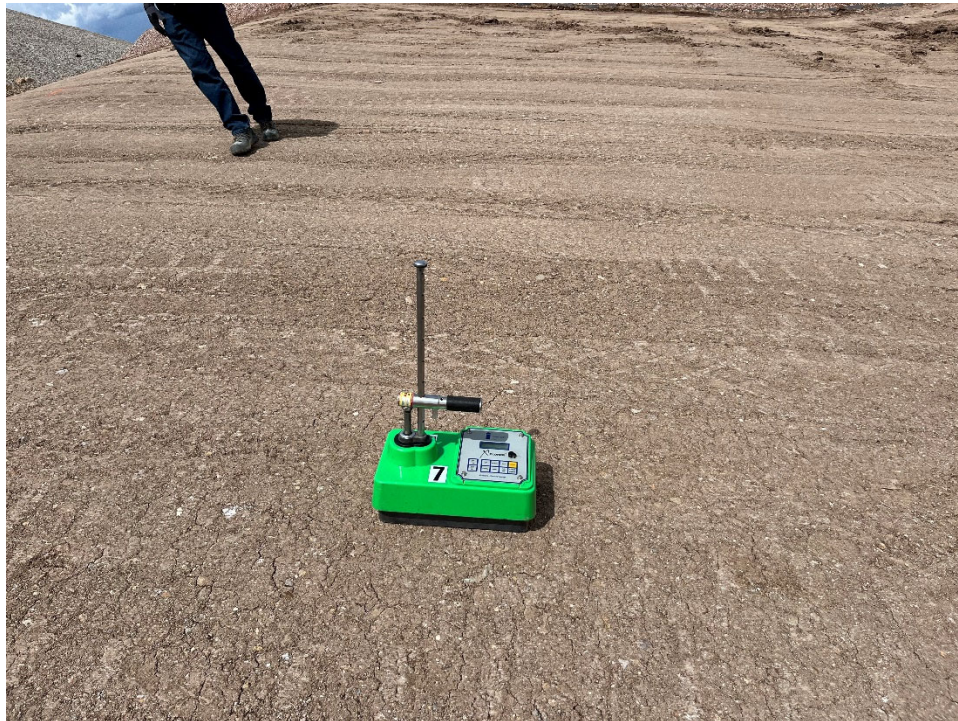
**June 09, 2023 – Preparation of SLF over the Honda Area**

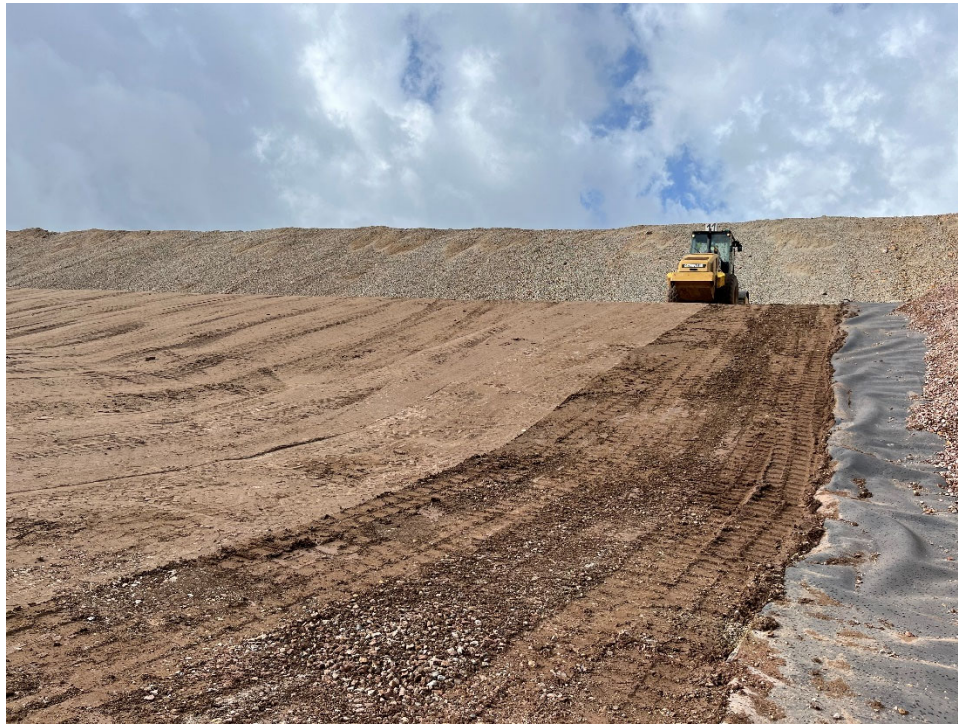
**June 14, 2023 – SLF re-compaction and preparation along 80-mil tie-in**

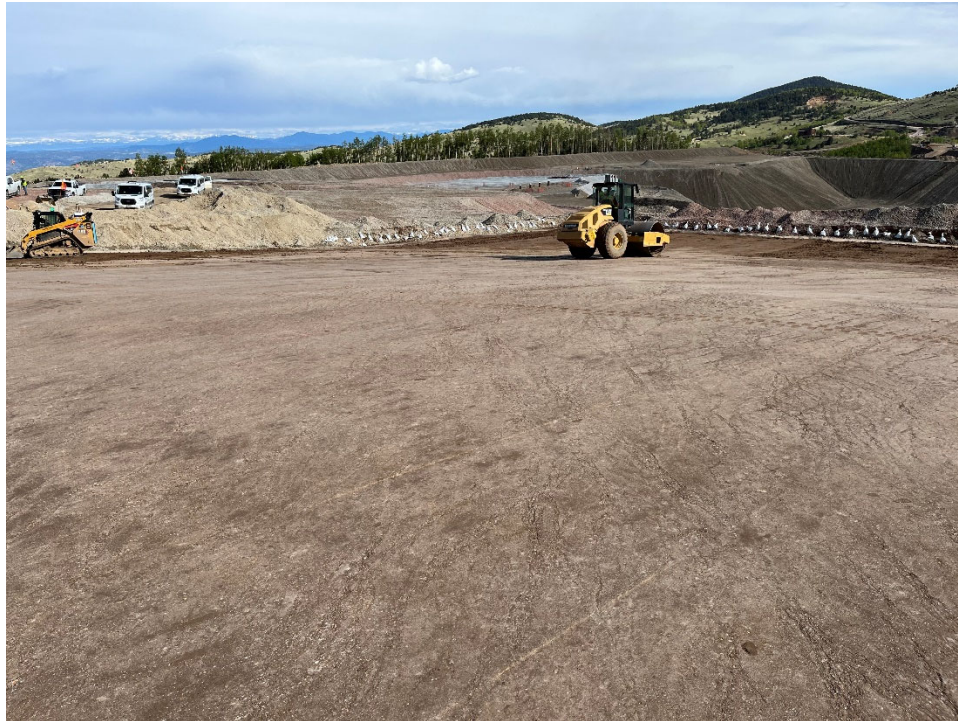
**June 15, 2023 – SLF compaction and surface preparation**

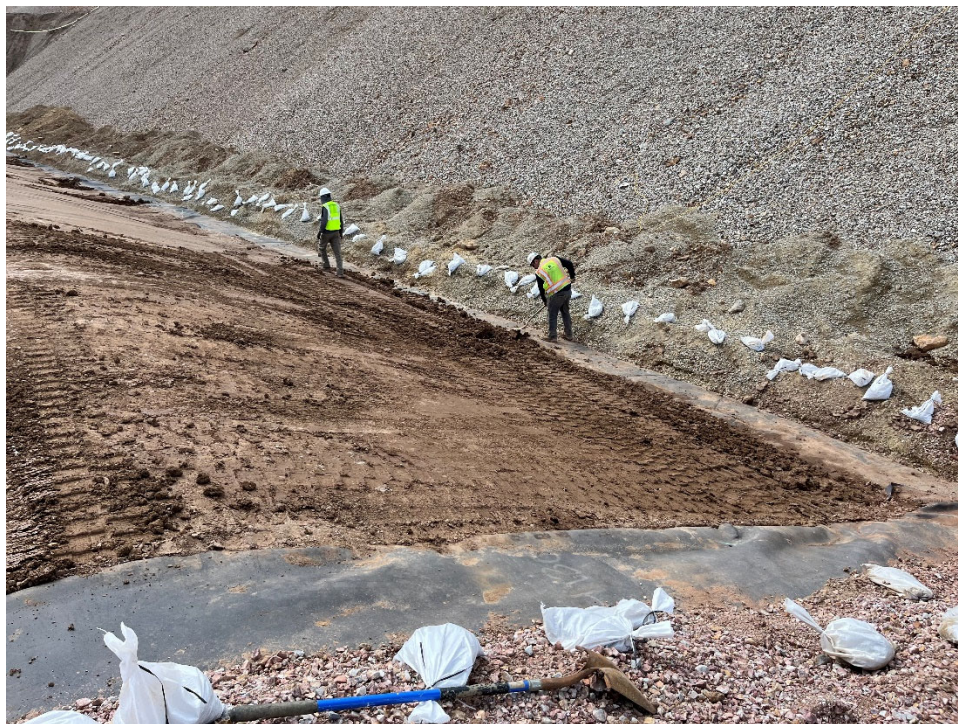
**June 15, 2023 – VLF2 Phase 2/Phase 3 Tie in preparation**

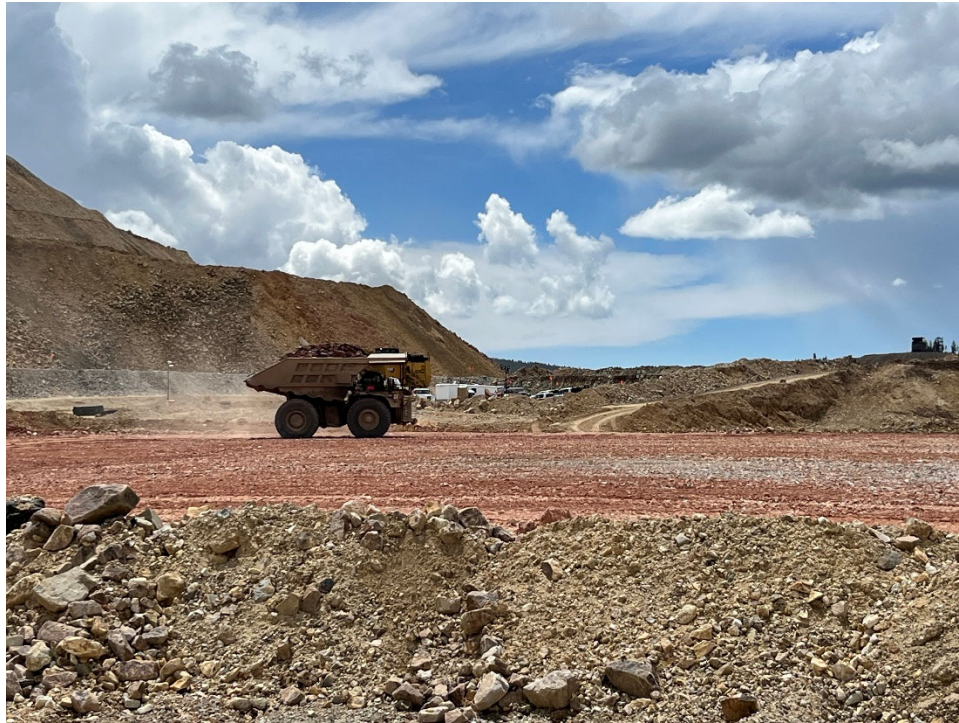
**June 15, 2023 – High Compaction Backfill wheel rolling**

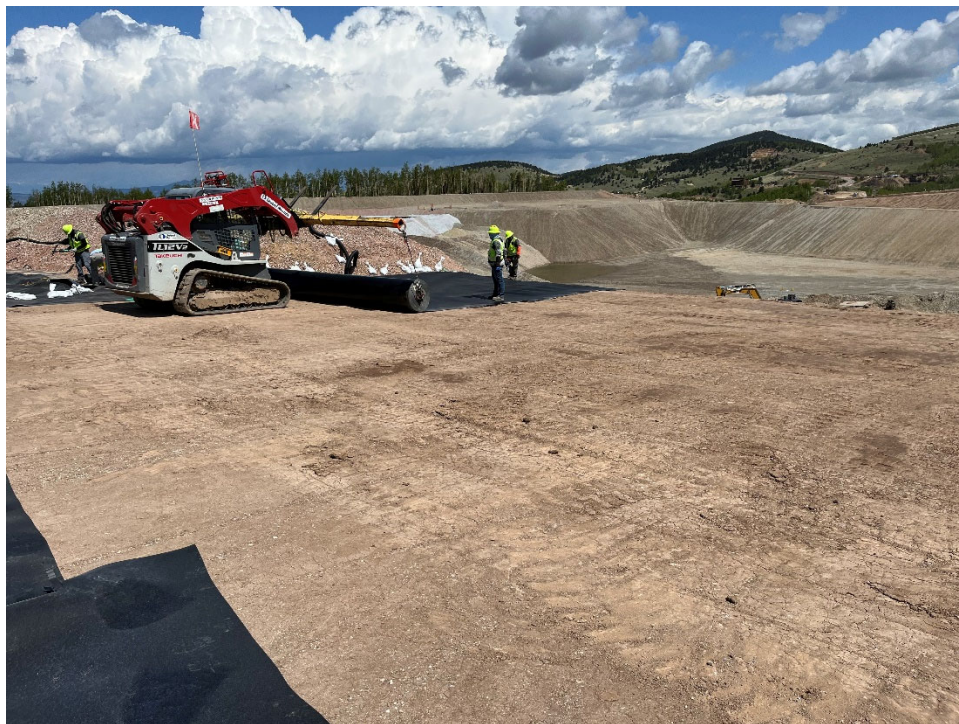
**June 16, 2023 – Geomembrane deployment**

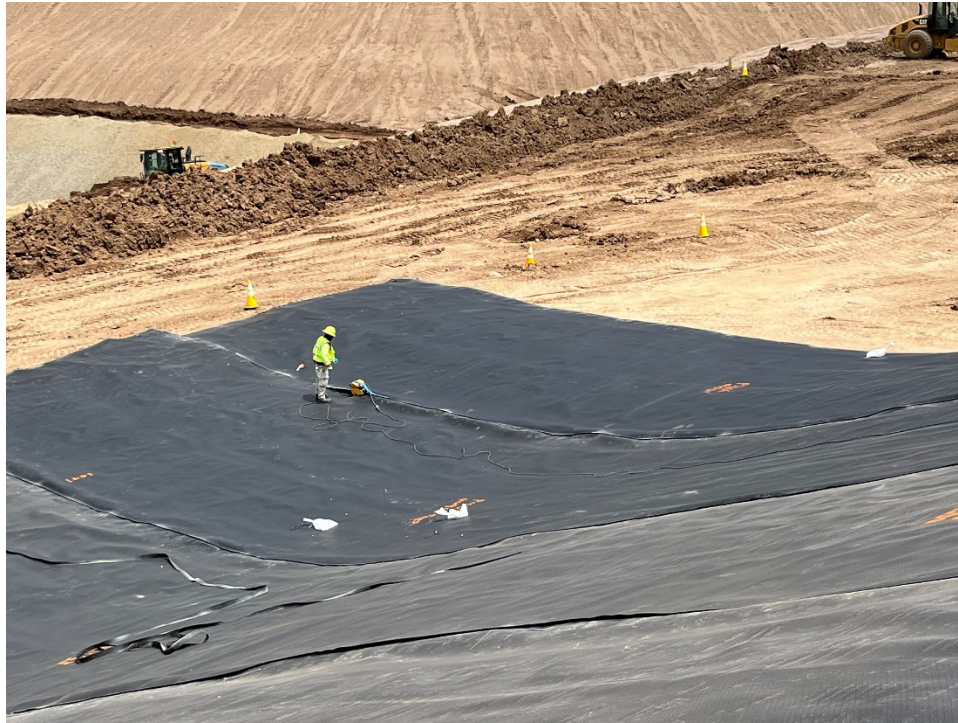
**June 16, 2023 – Geomembrane fusion welding**

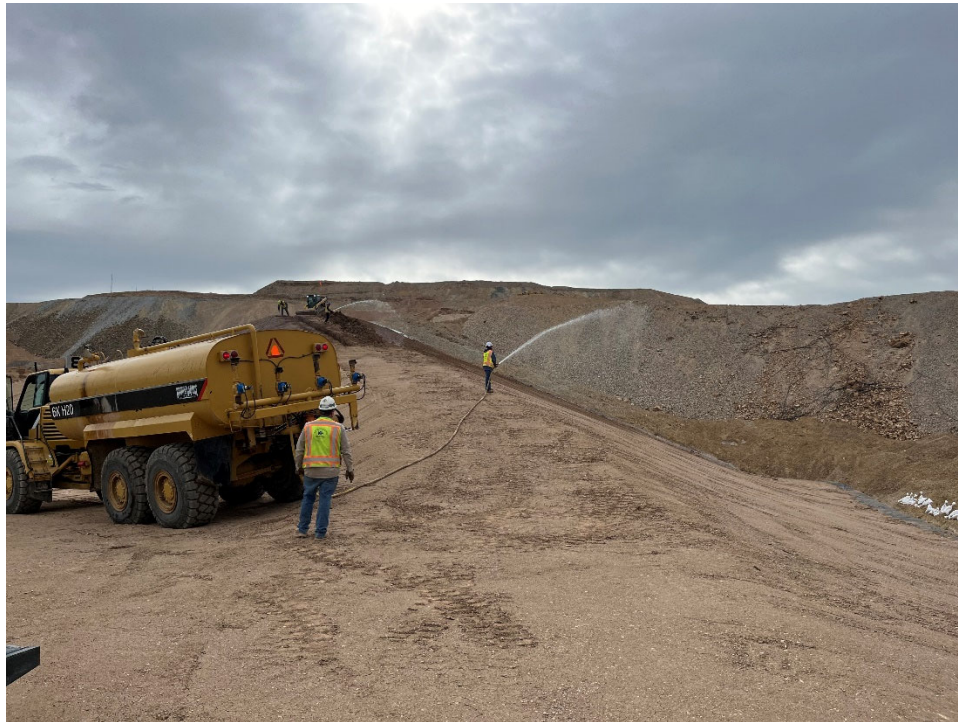
**June 20, 2023 – SLF moisture conditioning by VLF2 P2/P3 tie-in**

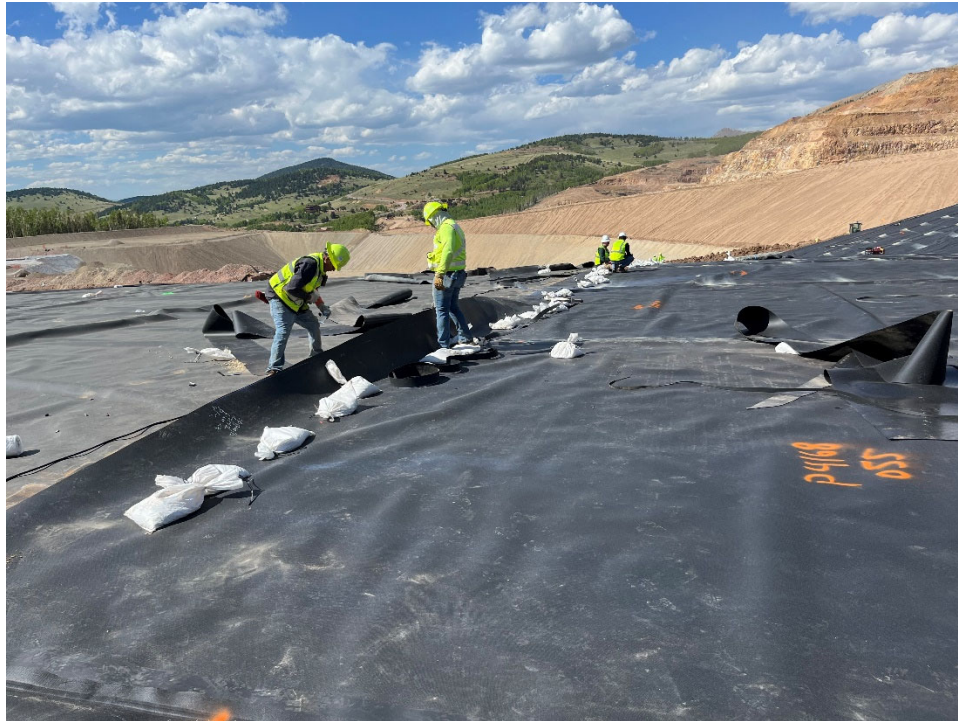
**June 20, 2023 – Geomembrane fusion welding preparation**

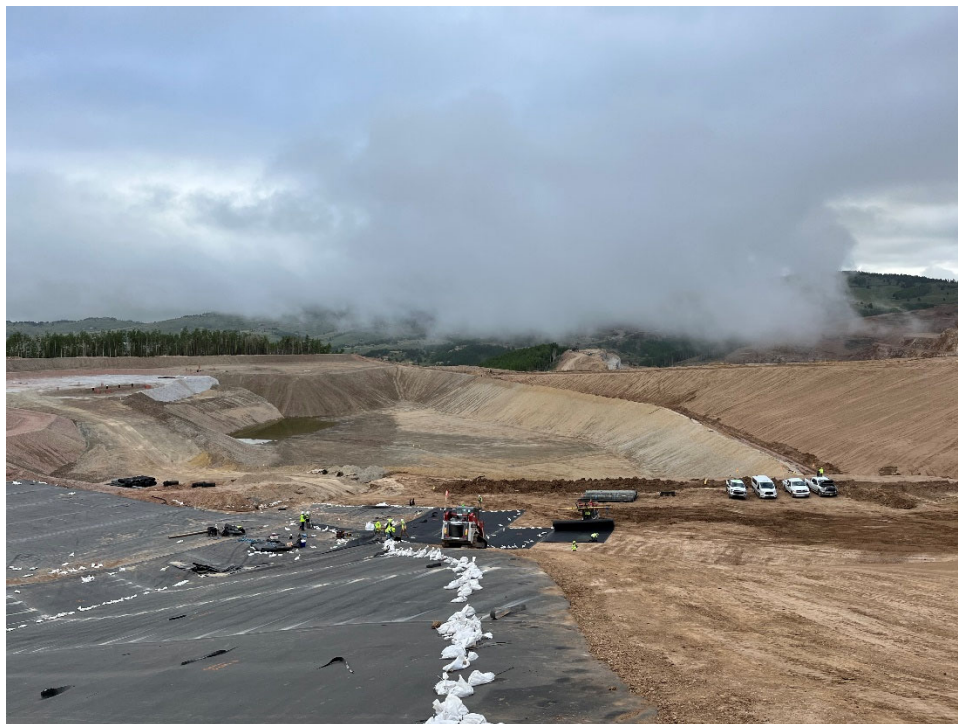
**June 23, 2023 – Temporary anchor trench securing geomembrane during deployment on Turkey Ridge**

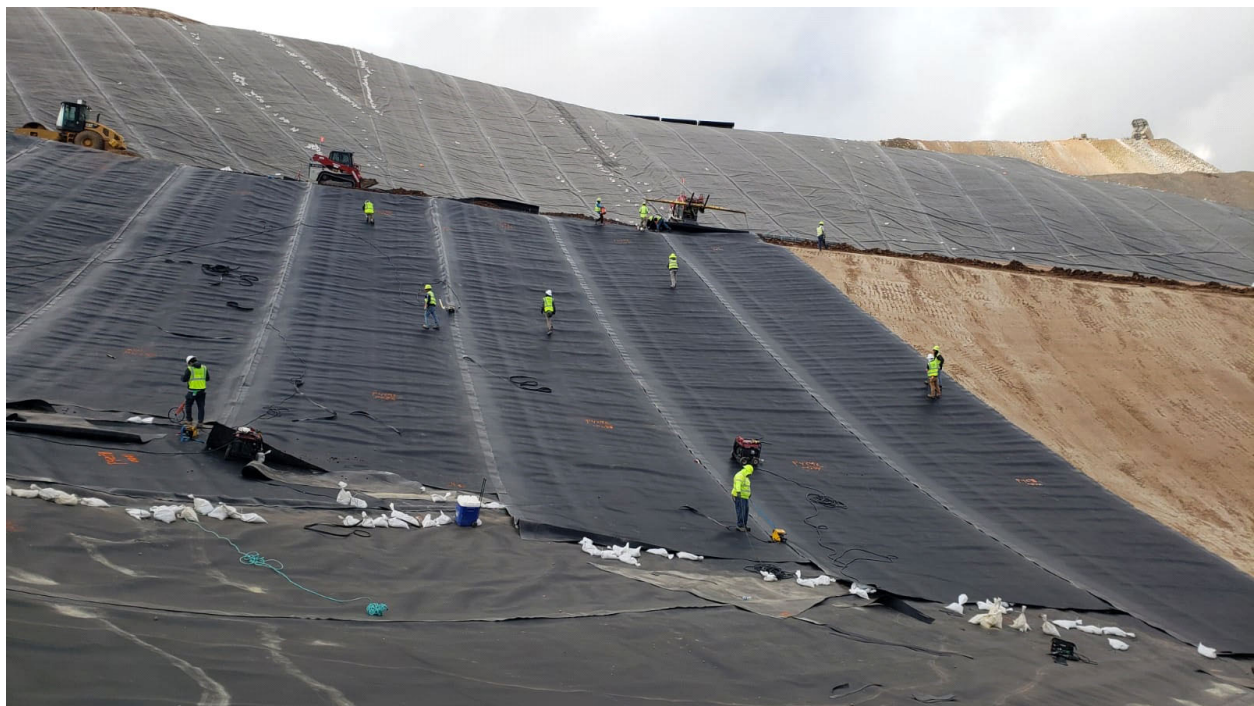
**June 30, 2023 – Deployment of LLDPE over approved SLF on schist slopes**

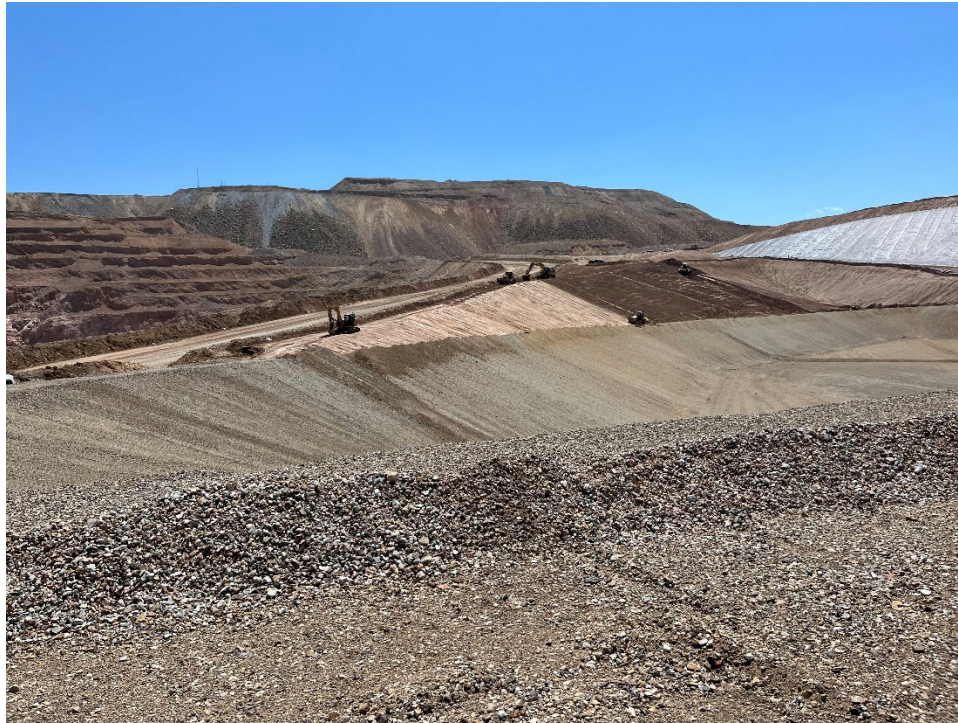
**June 27, 20223 – Soil Liner Fill surface preparation by tether method**

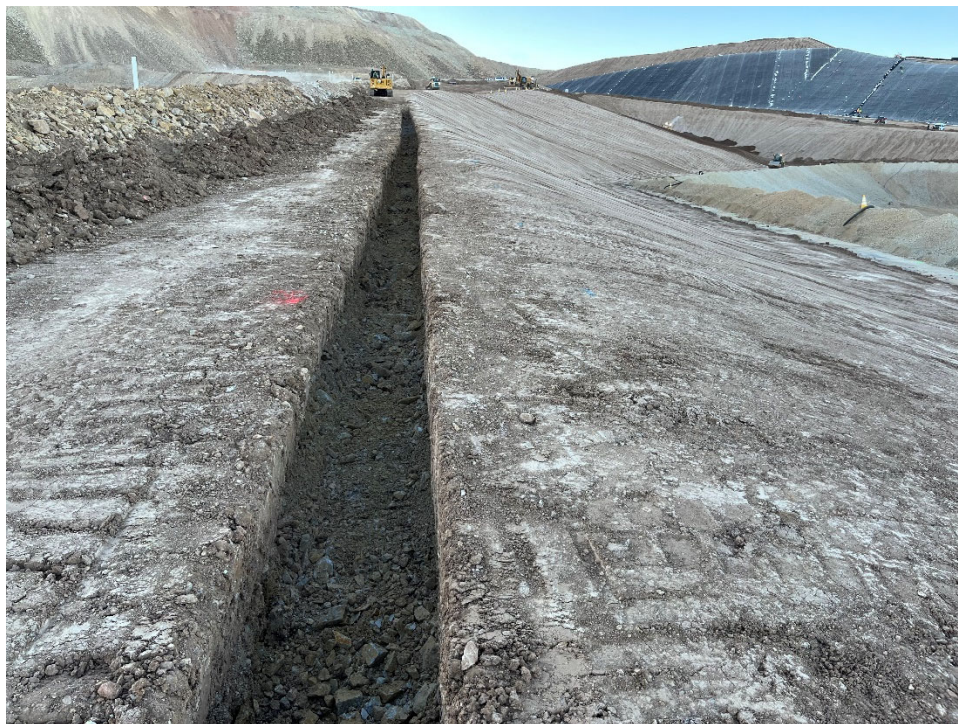
**July 29, 2023 – Anchor Trench construction along northern limits of Stage A**

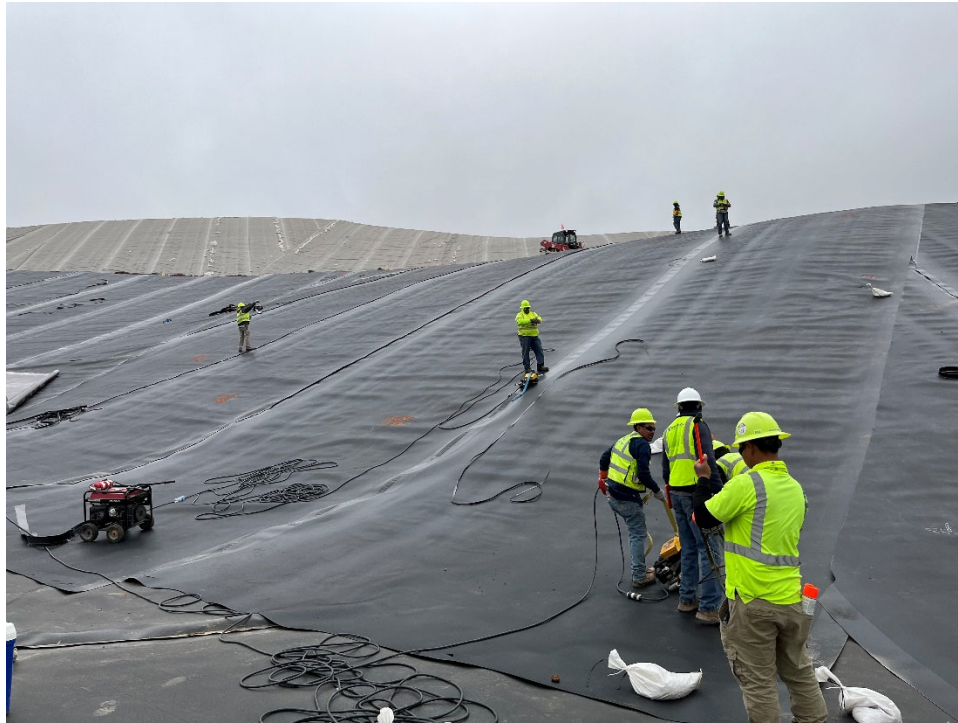
**June 30, 2023 – Fusion welding of seams below backfill ramp**

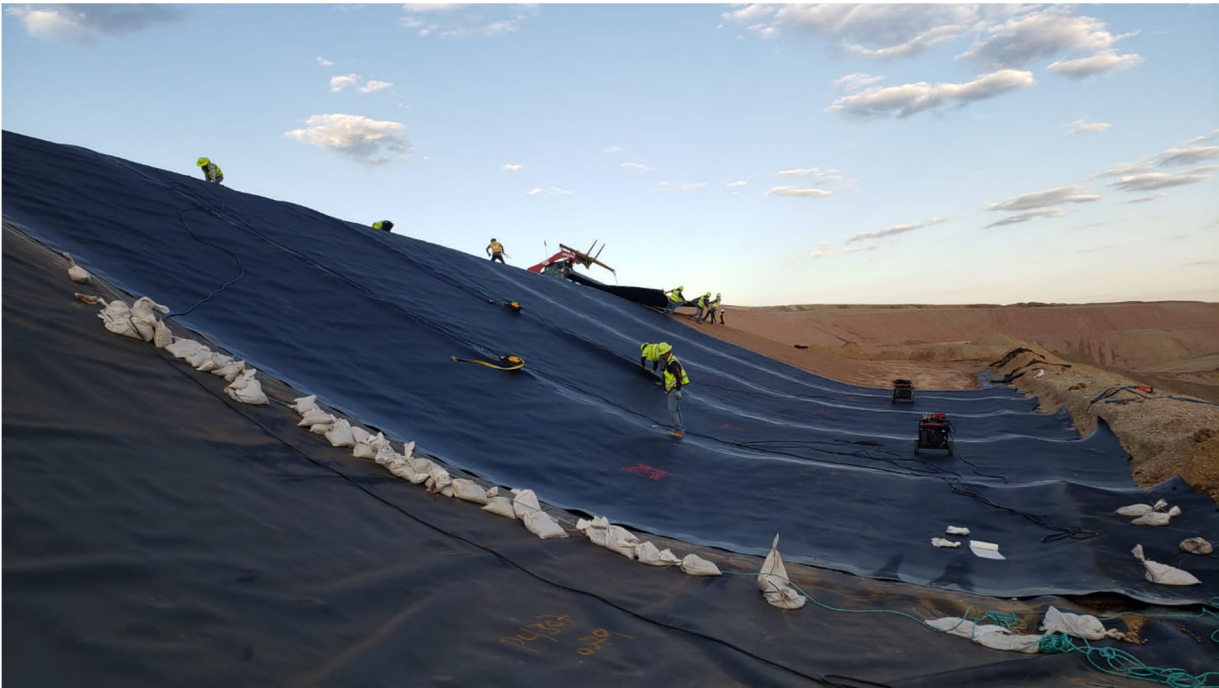
**July 5<sup>th</sup>, 2023 – Deployment of LLDPE over approved SLF on schist slopes**

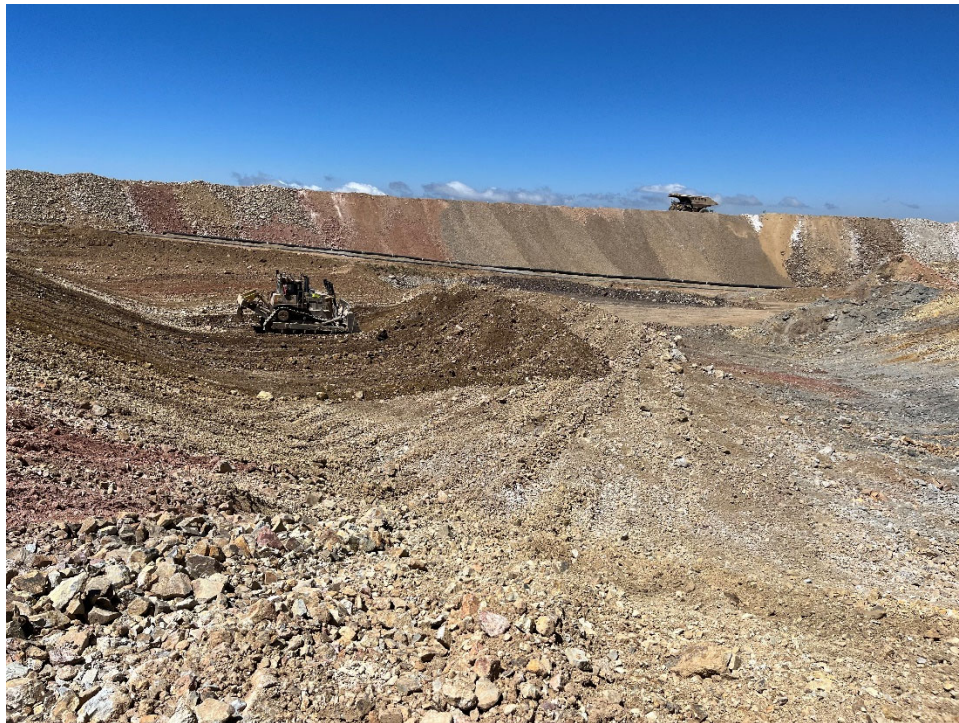
**July 6<sup>th</sup>, 2023 – Cutting of overburden material in topsoil triangle**

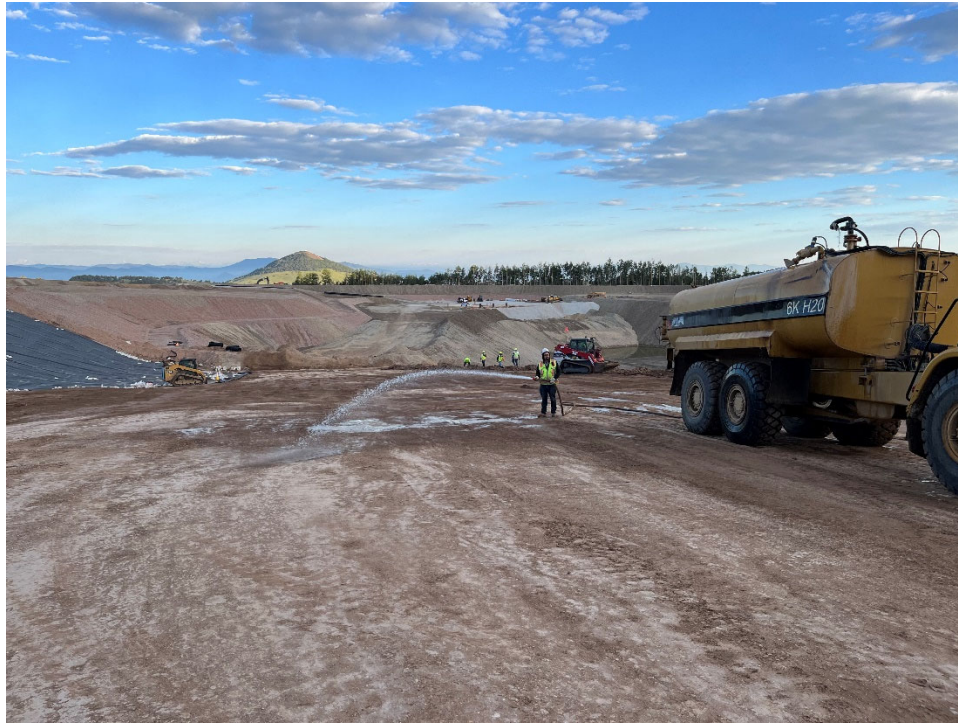
**July 7th, 2023 – Moisture conditioning of SLF surface ahead of LLDPE deployment**

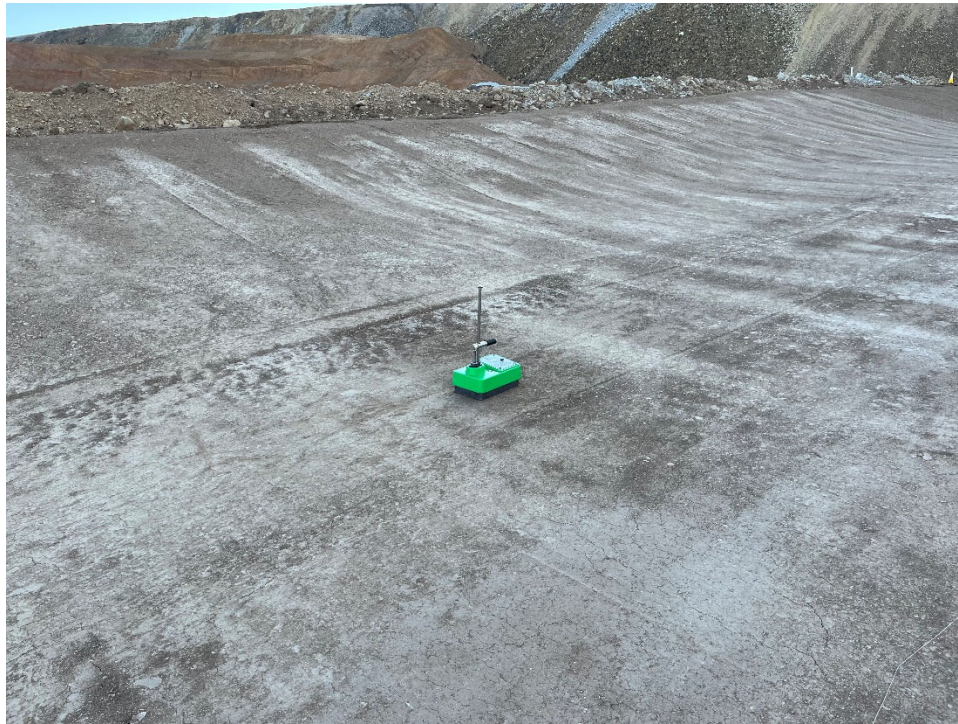
**July 12, 2023 – Density testing of SLF material in schist flats**

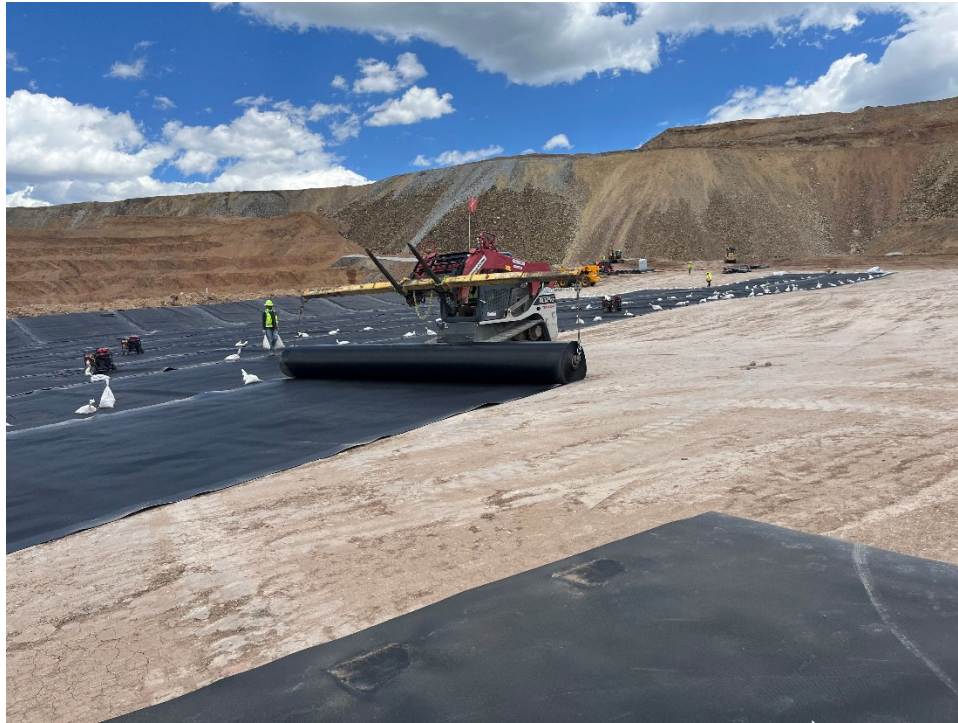
**July 12, 2023 – Deployment of LLDPE in schist flats**

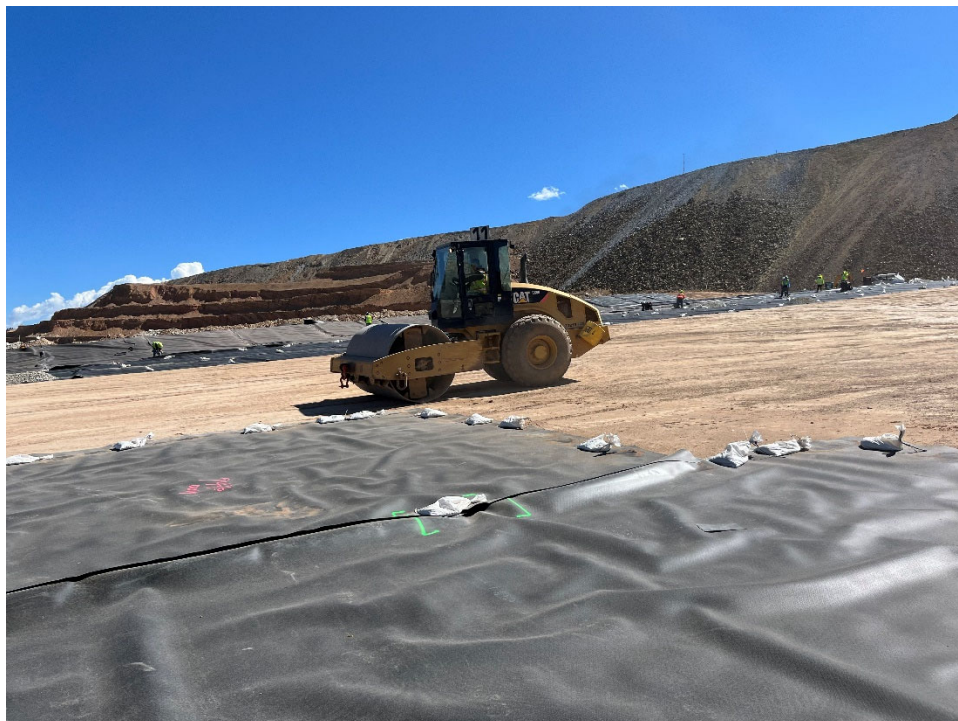
**July 13, 2023 – Finish rolling of SLF in front of deployment of LLDPE**

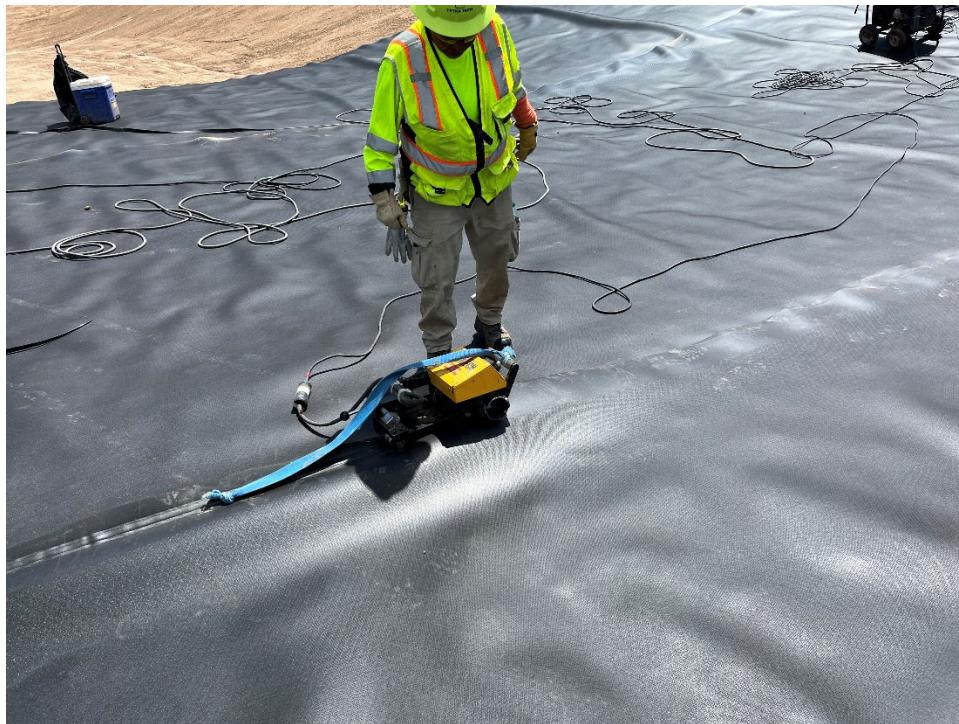
**July 17, 2023 – Fusion welding of LLDPE at bottom of turkey ridge HCBF**

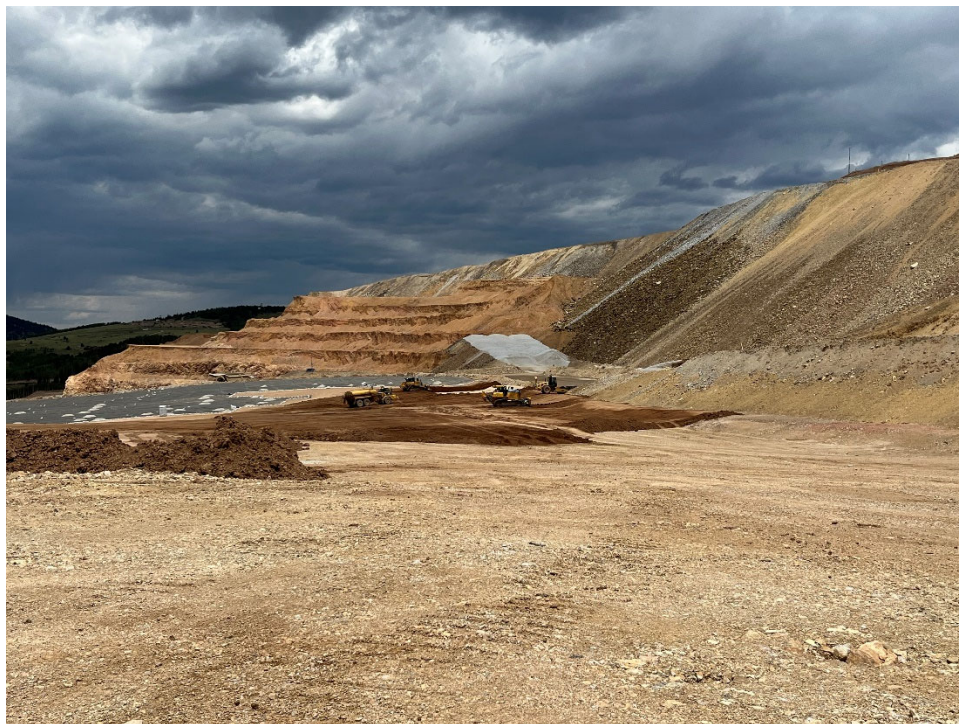
**July 18, 2023 – Placement of SLF on approved subgrade in the flat**

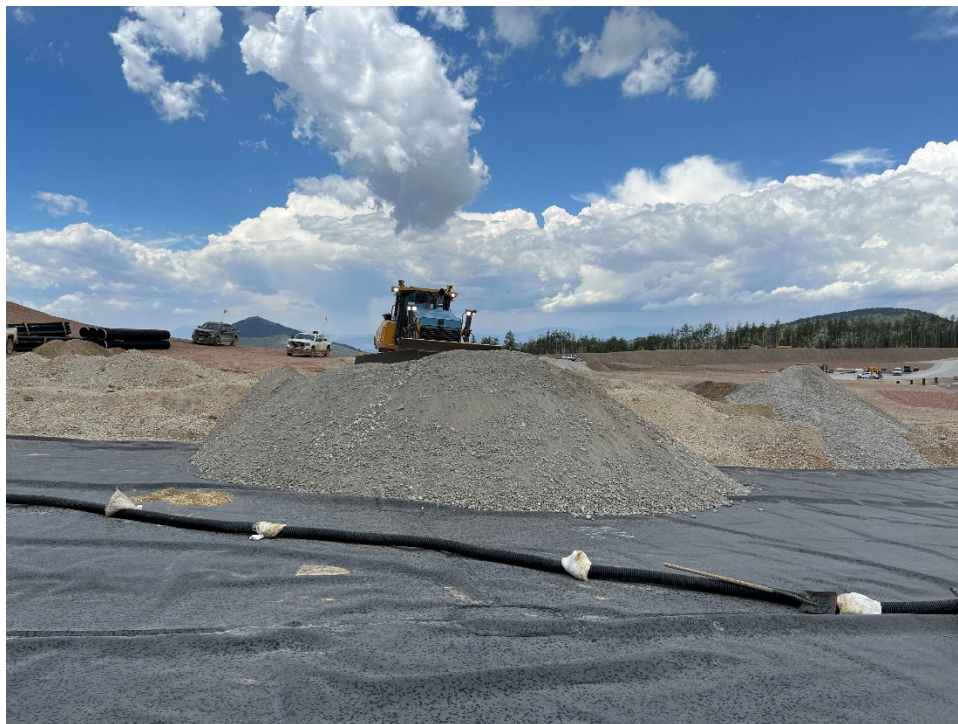
**July 19, 2023 – Finish rolling of SLF in front of LLDPE deployment**

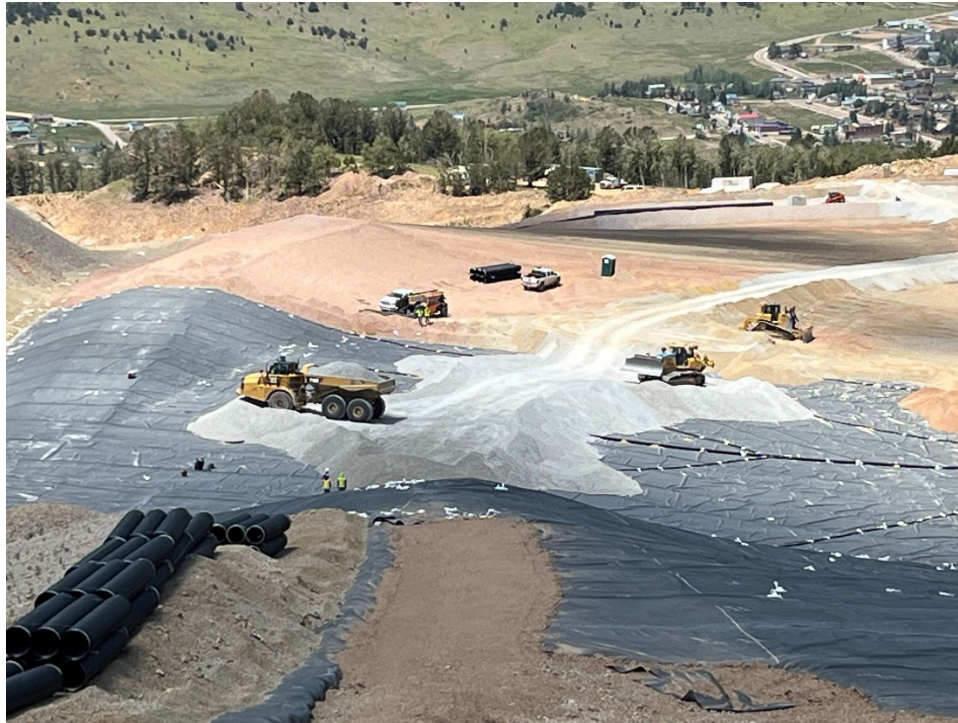
**July 20, 2023 – DCF placement startup over approved LLDPE across the honda**

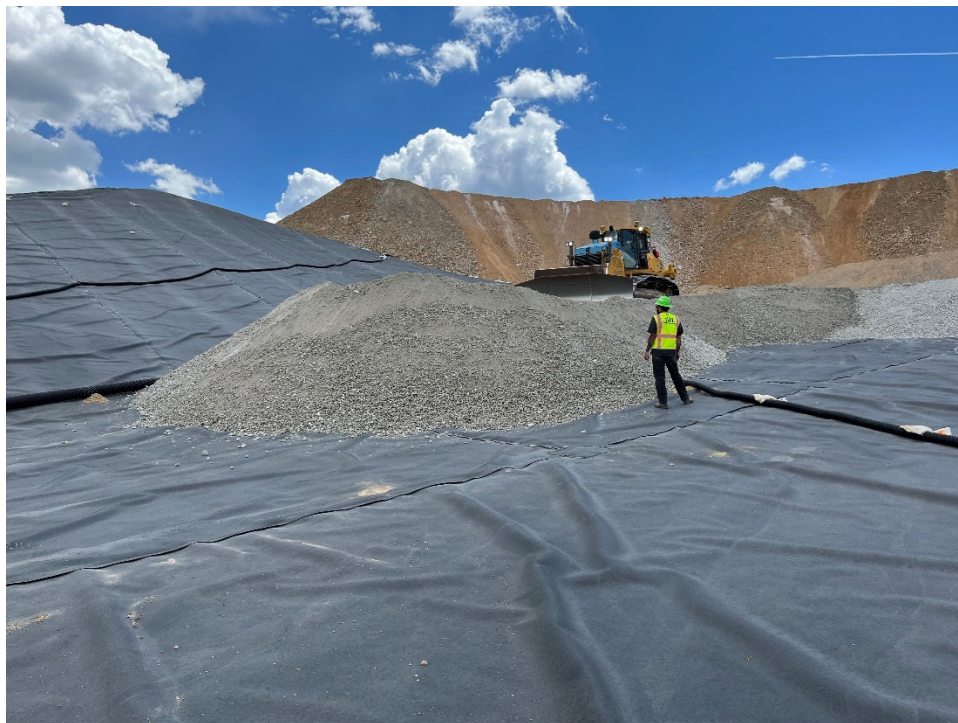
**July 25th, 2023 – Placement of DCF material on the backfill ramp**

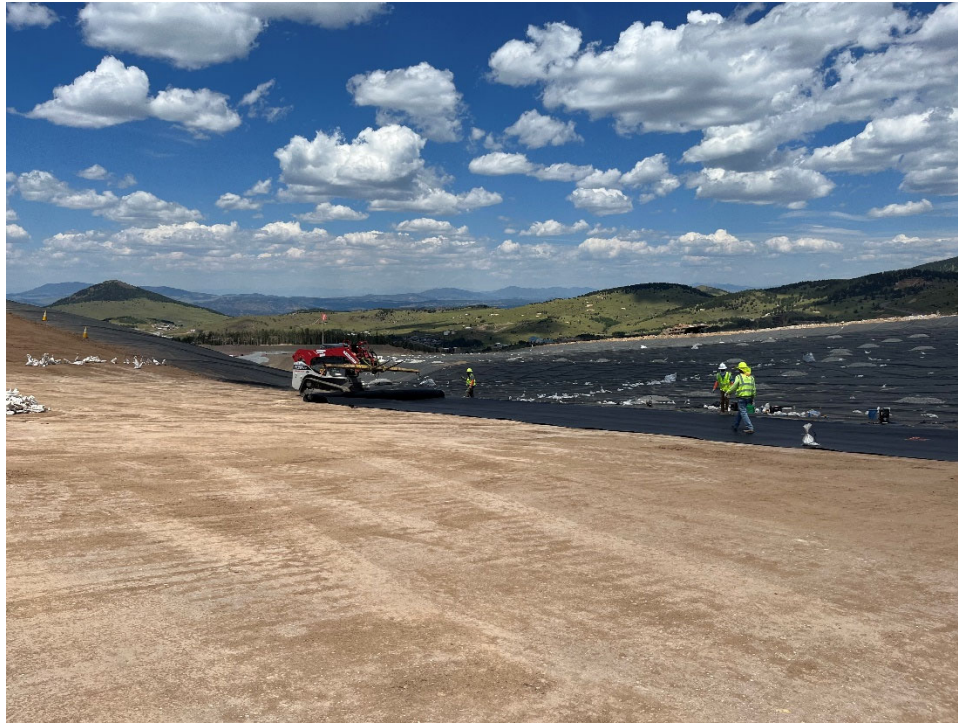
**July 25, 2023 – Deployment of LLDPE above the backfill ramp**

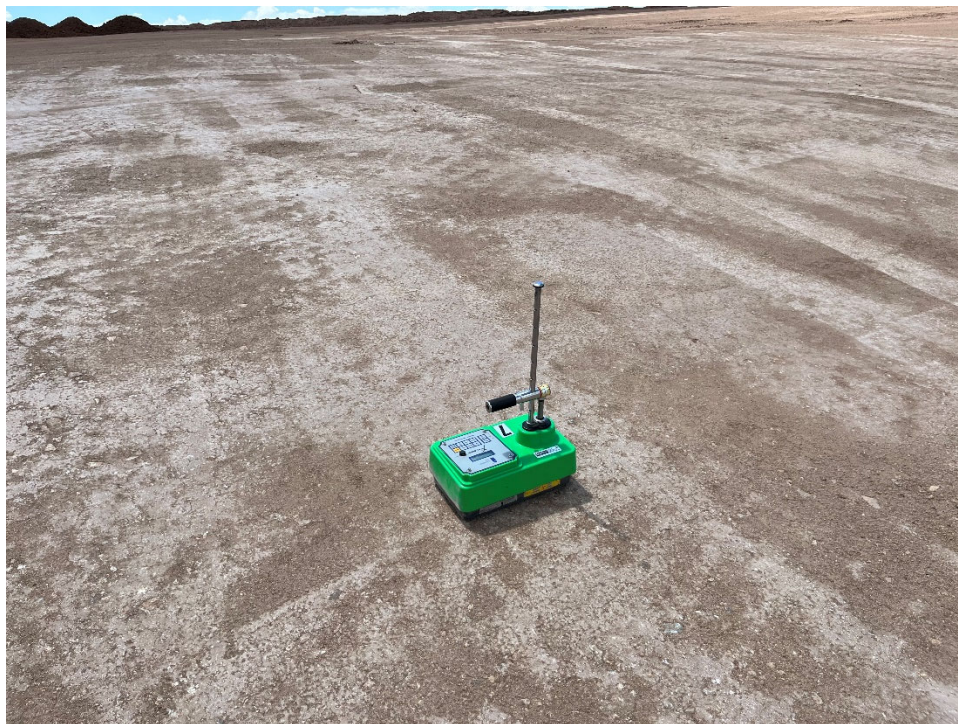
**July 25, 2023 – Density testing of SLF material above the backfill ramp**
