## **APPENDIX E – WEEKLY REPORTS**

## FIELD WEEKLY PROGRESS REPORT

**PROJECT:** VALLEY LEACH FACILITY 2 PHASE 3 2023 QUALITY ASSURANCE OVERSIGHT  
**SITE:** CRIPPLE CREEK & VICTOR GOLD MINE (COLORADO)  
**CONTRACTOR:** NEWMONT CC&V MINING OPERATIONS  
JHL CONSTRUCTORS  
KELLEY TRUCKING INC.  
**WEEK ENDING:** FRIDAY, APRIL 21, 2023

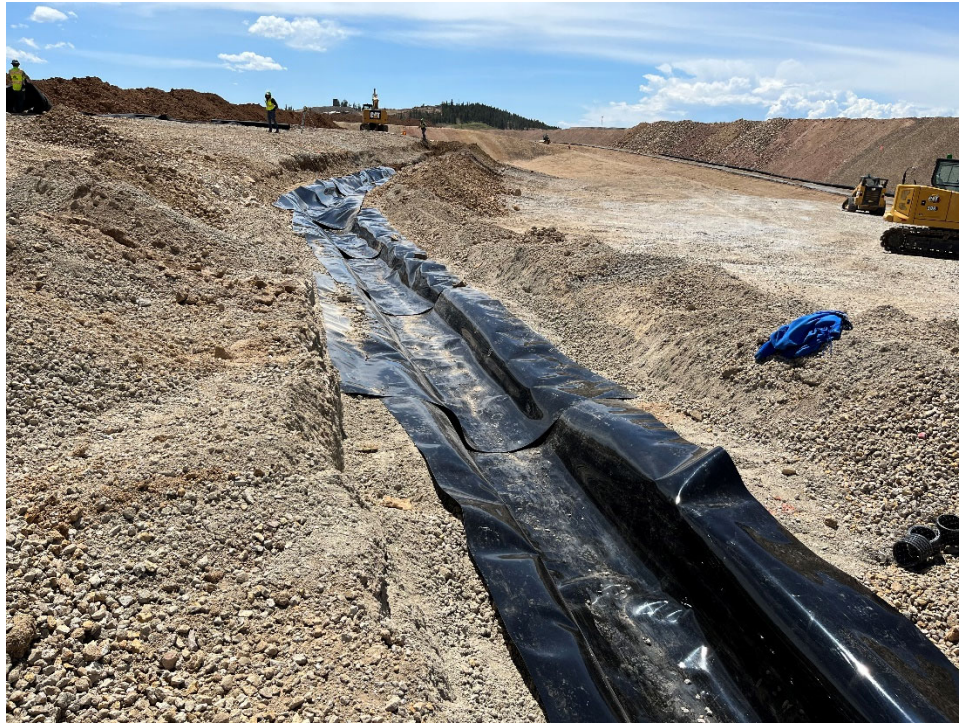
**July 27, 2023 – Construction of LDT2 with 40-mil HDPE above topsoil triangle**

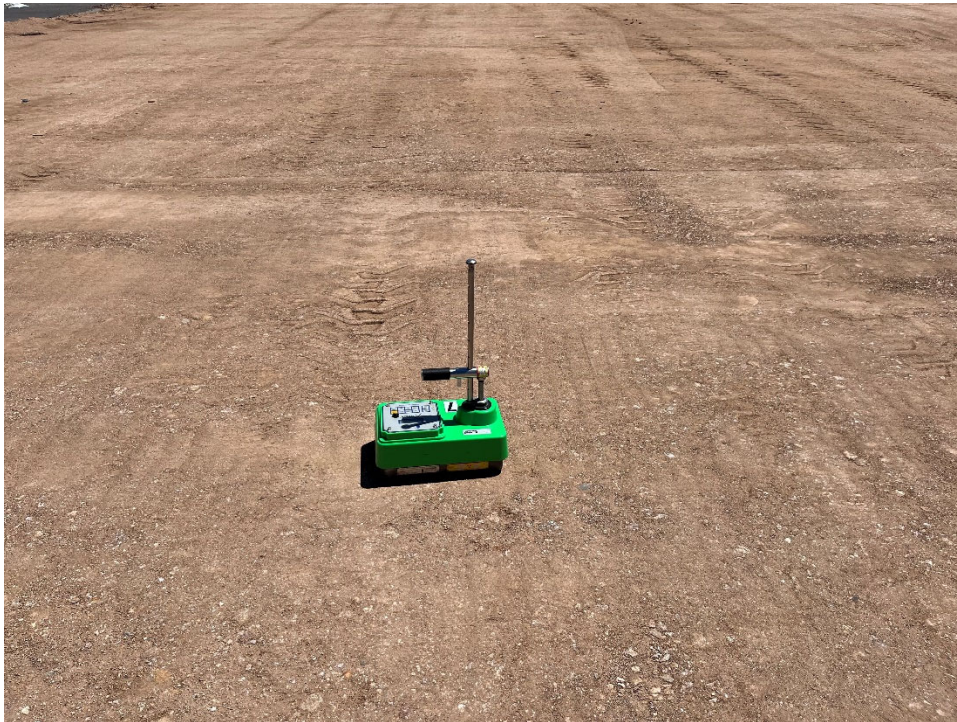
**July 31, 2023 – Density/Moisture testing of SLF**

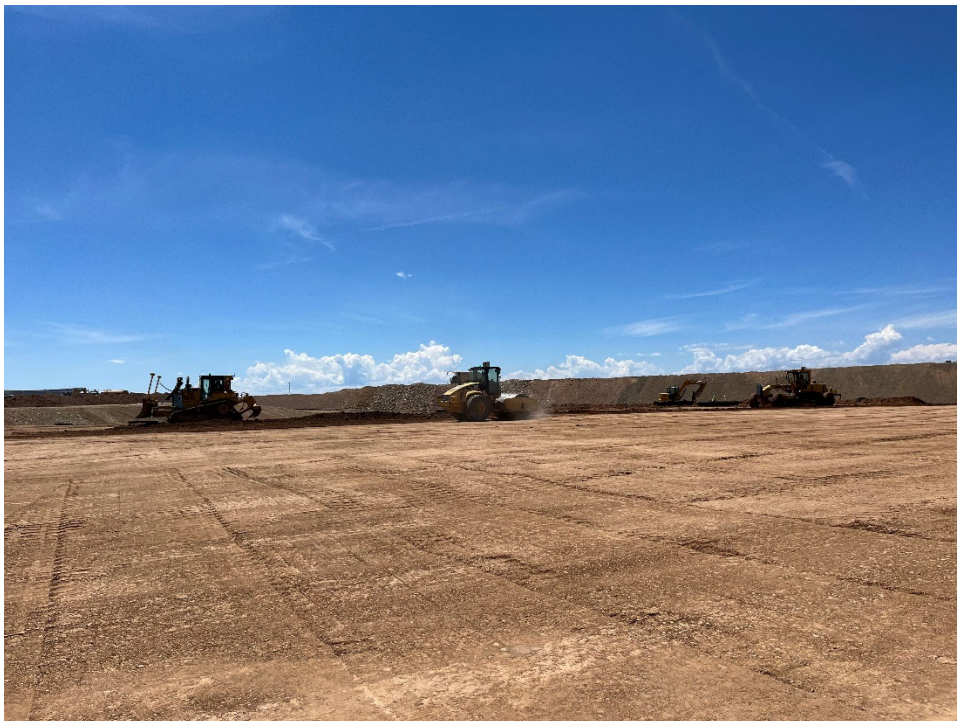
**July 31, 2023 – Placement, grading and compaction of SLF**

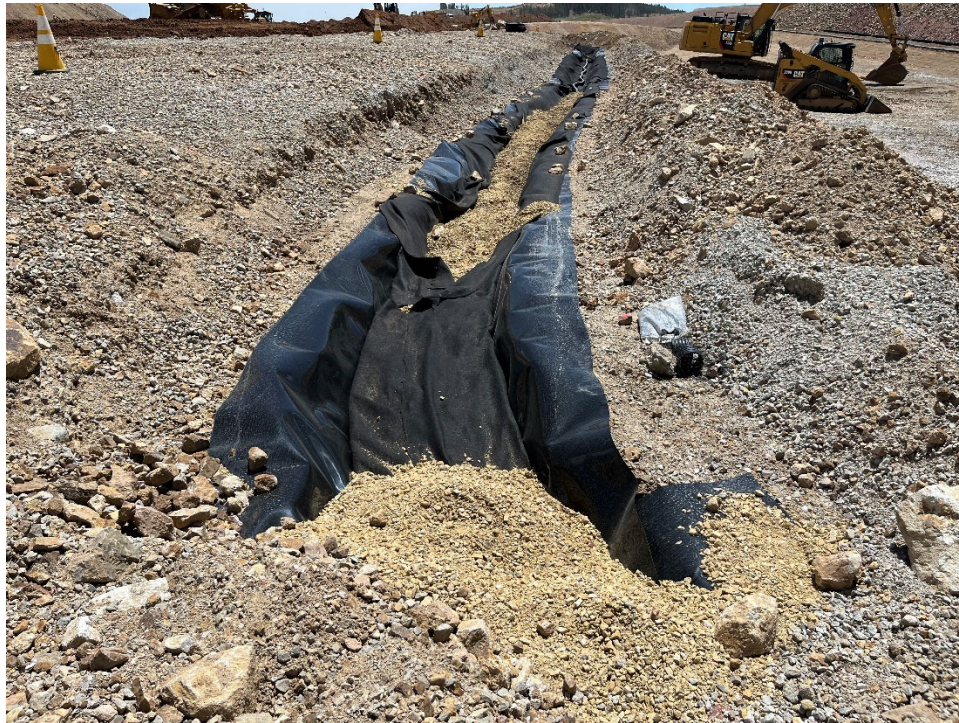
**July 31, 2023 – Construction of LDT2**

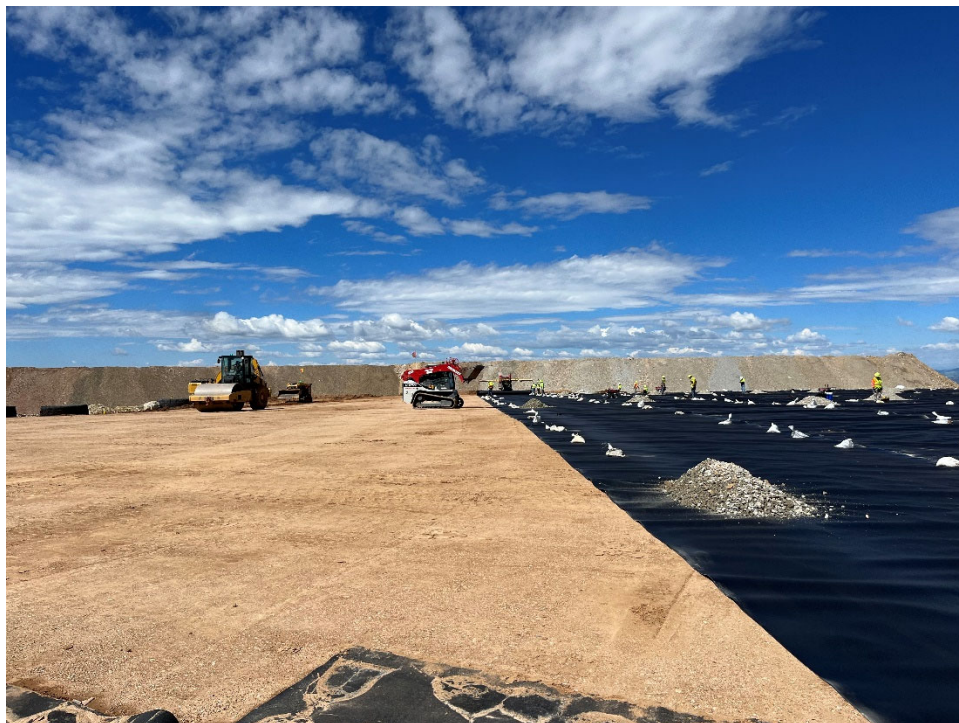
**August 2, 2023 – Deployment of geomembrane with DCF ballast placement**

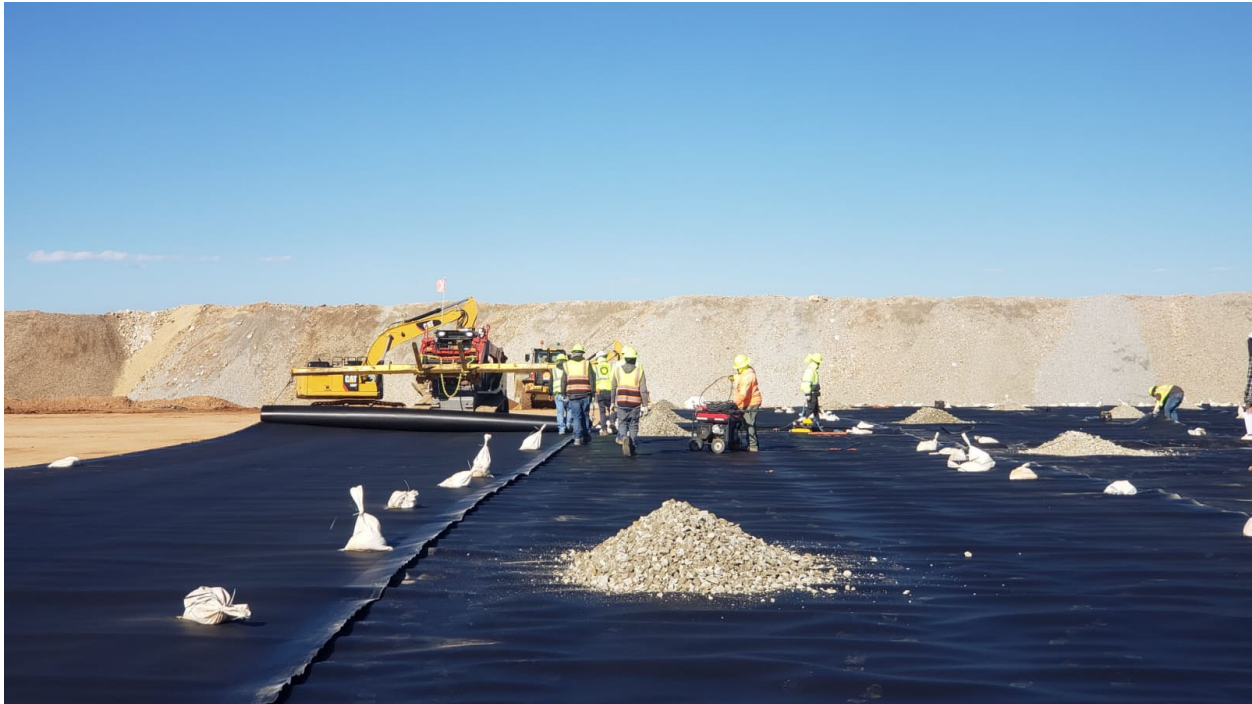
**August 3, 2023 – Deployment of geomembrane**

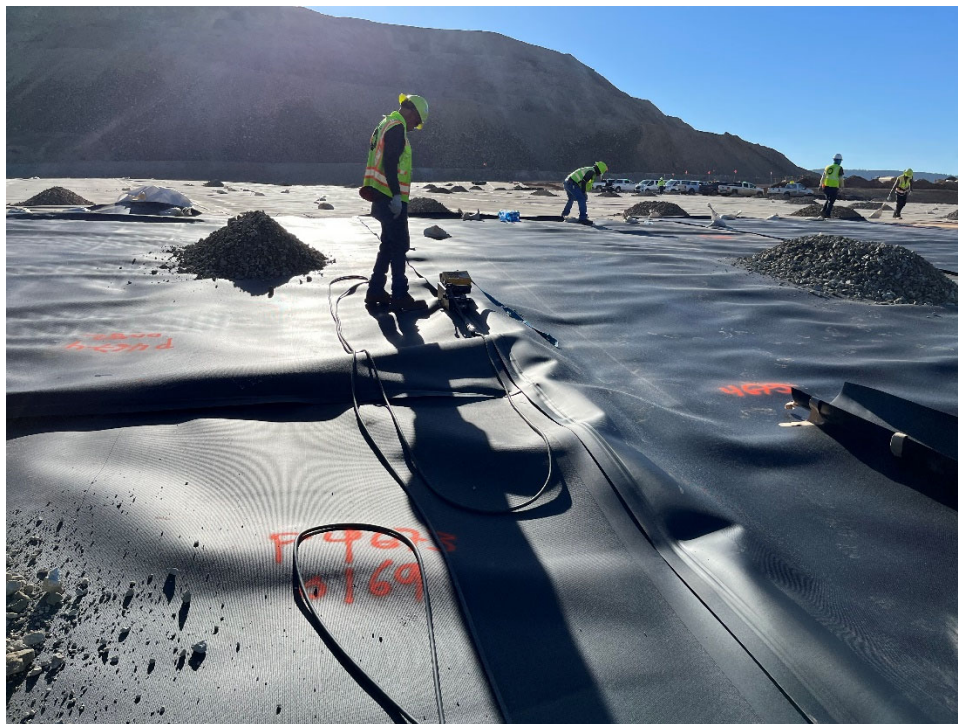
August 08, 2023 – Fusion welding of LLDPE

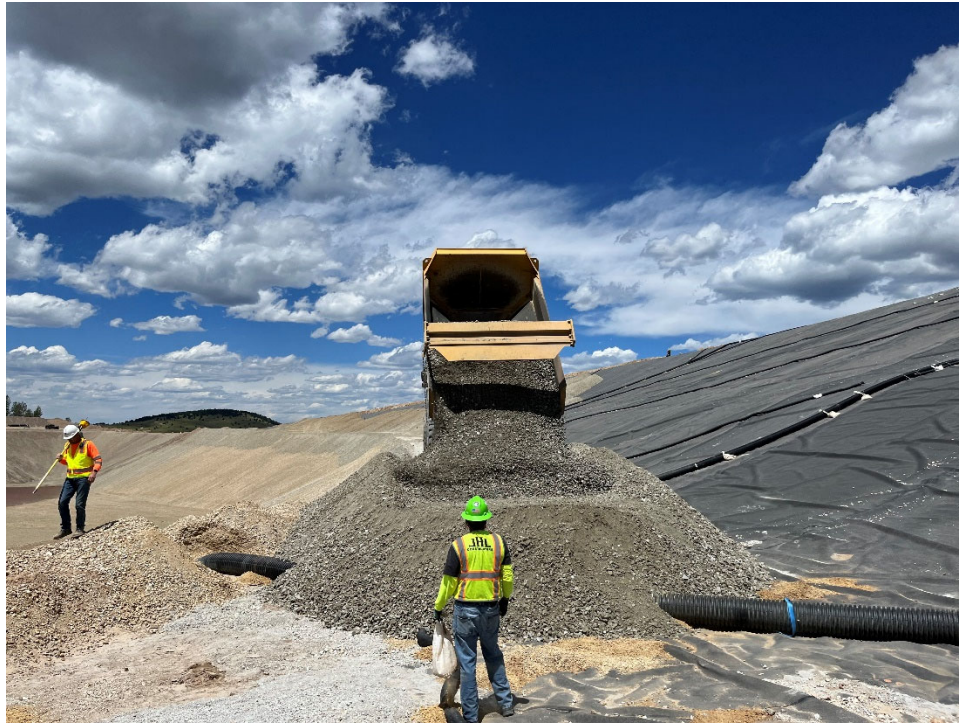
**August 08, 2023 – Placement of DCF on the 10,000' bench with survey support**

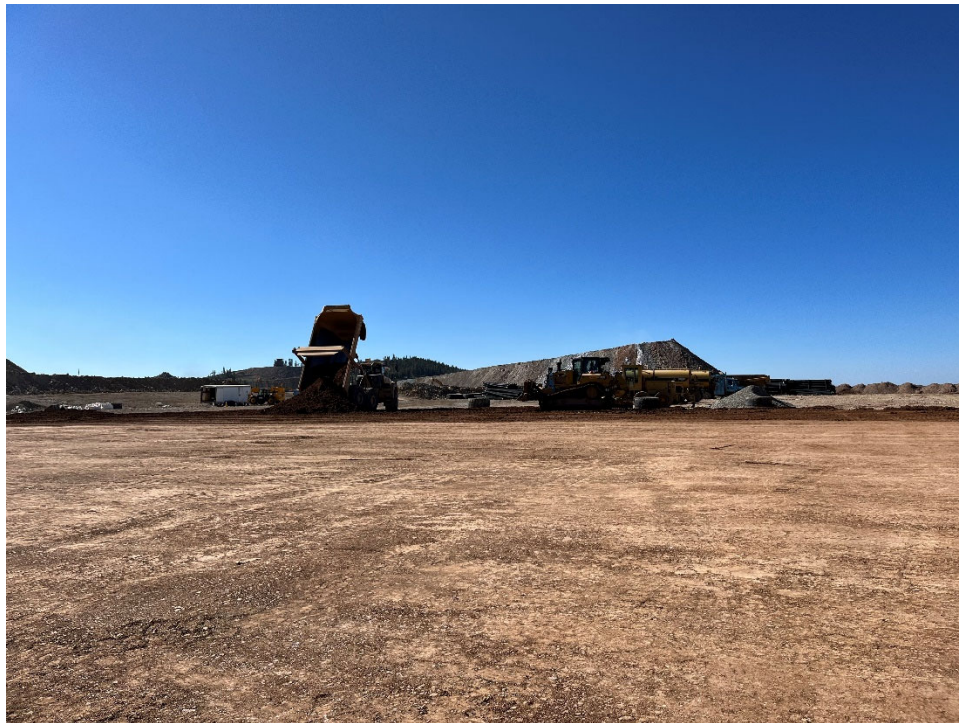
**August 9, 2023 – Placement of SLF on the flat area between haul road and channel**

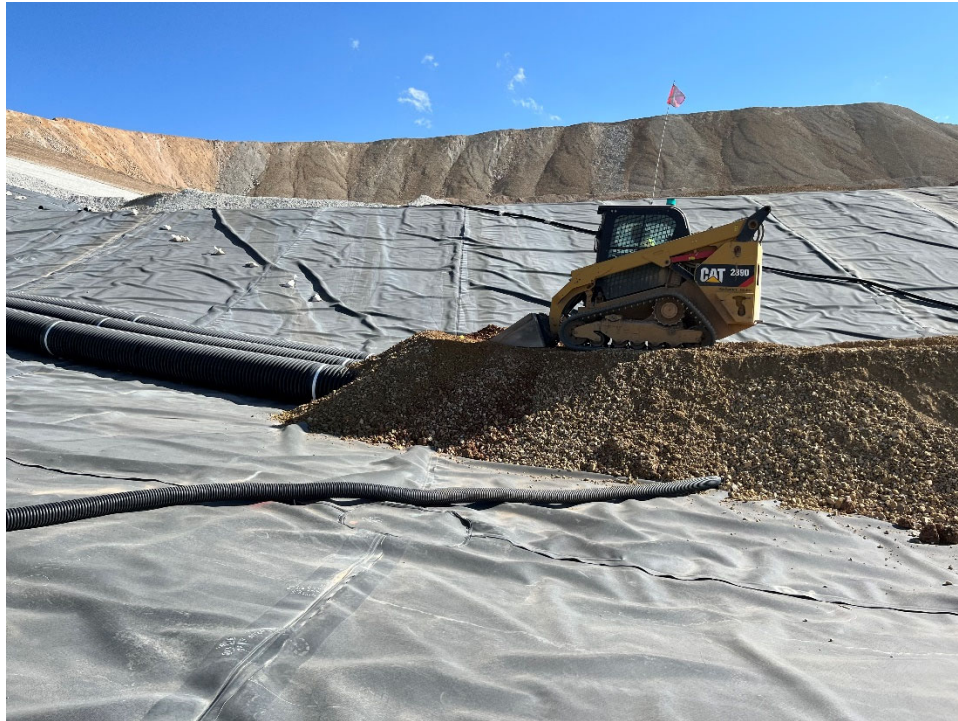
**August 9, 2023 – Placement of DCF to ballast 24" HVSC piping**

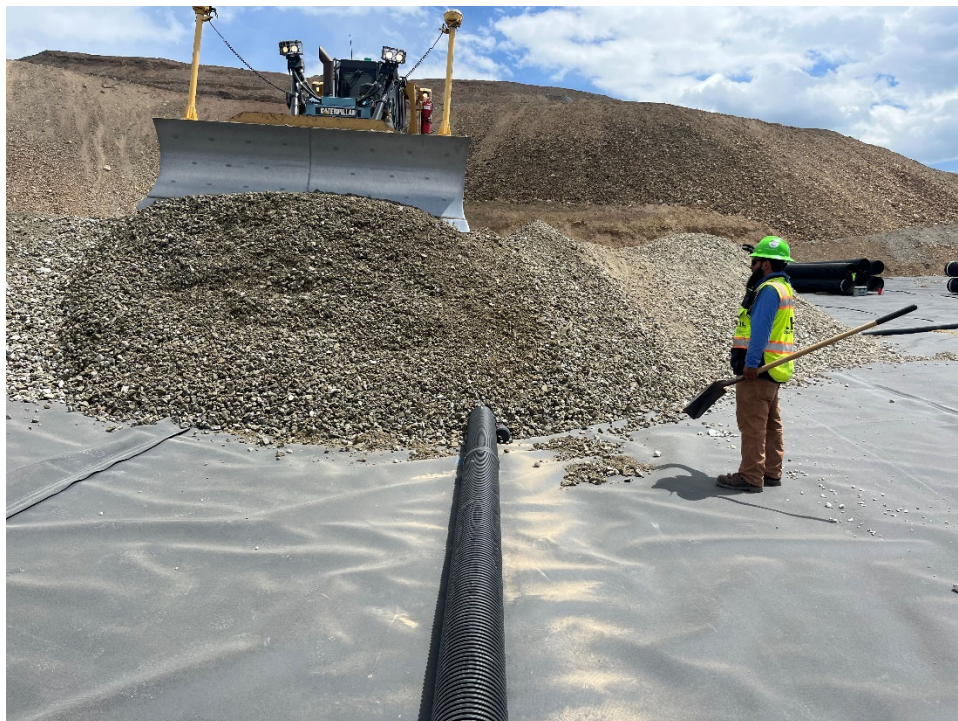
**August 10, 2023 – Placement of DCF on LLDPE on the backfill ramp**

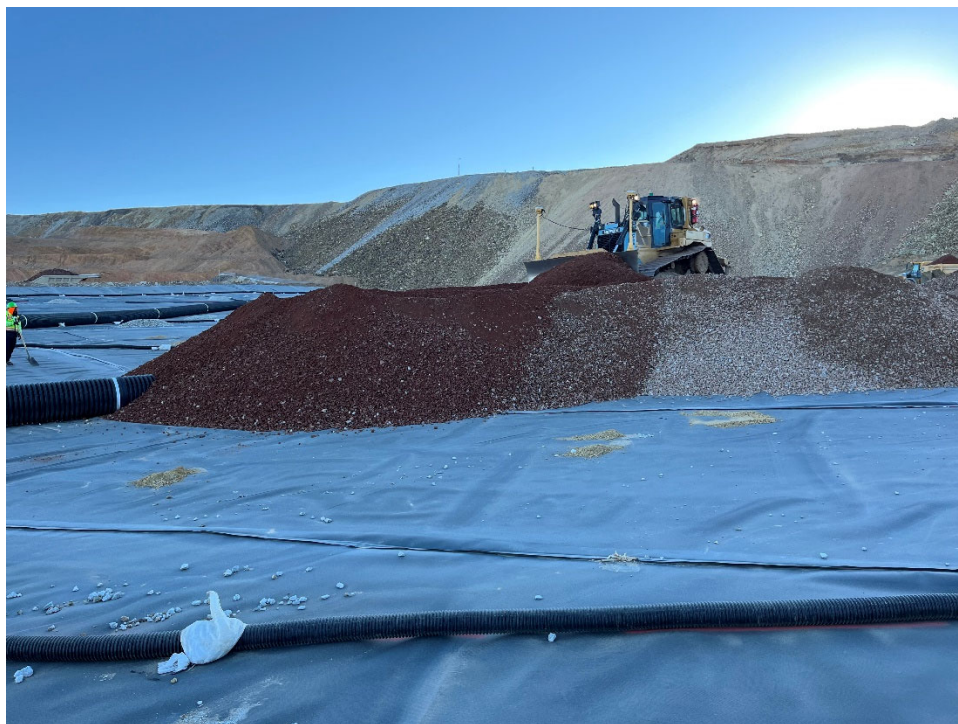
**August 16, 2023 – Placement of DCF on the backfill ramp**

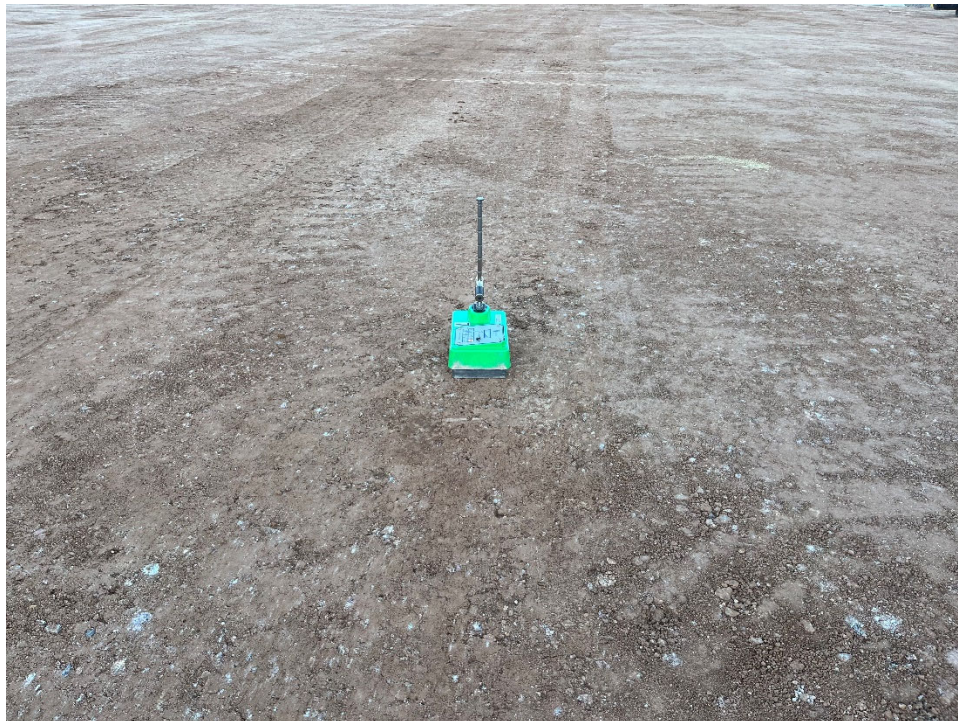
**August 22, 2023 – Density/Moisture testing by nuclear method**

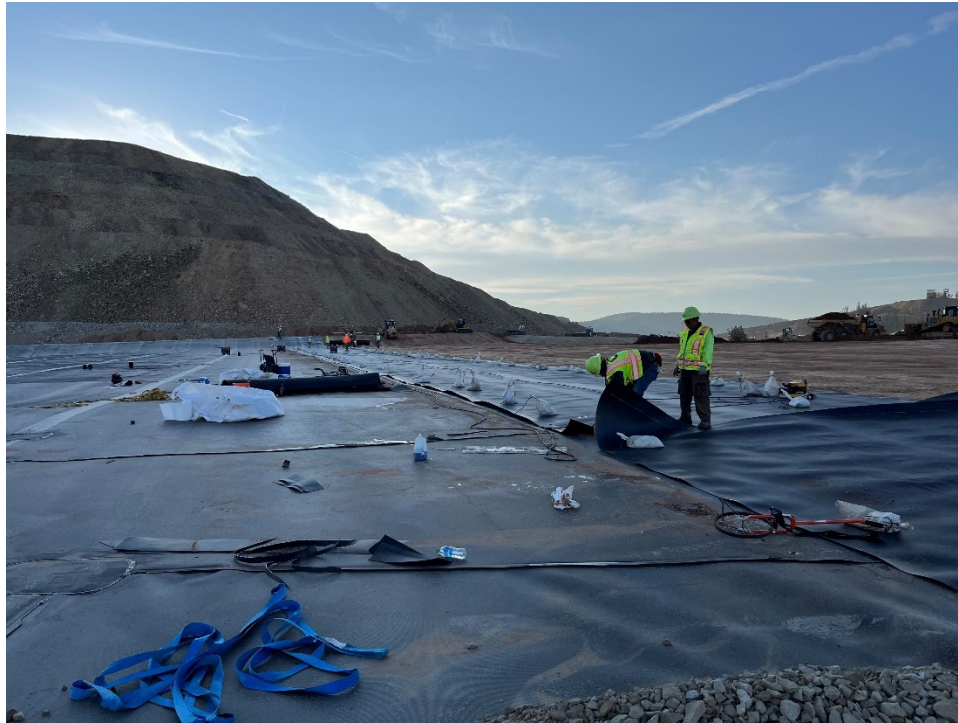
**August 22, 2023 – Deployment of LLDPE in the topsoil triangle**

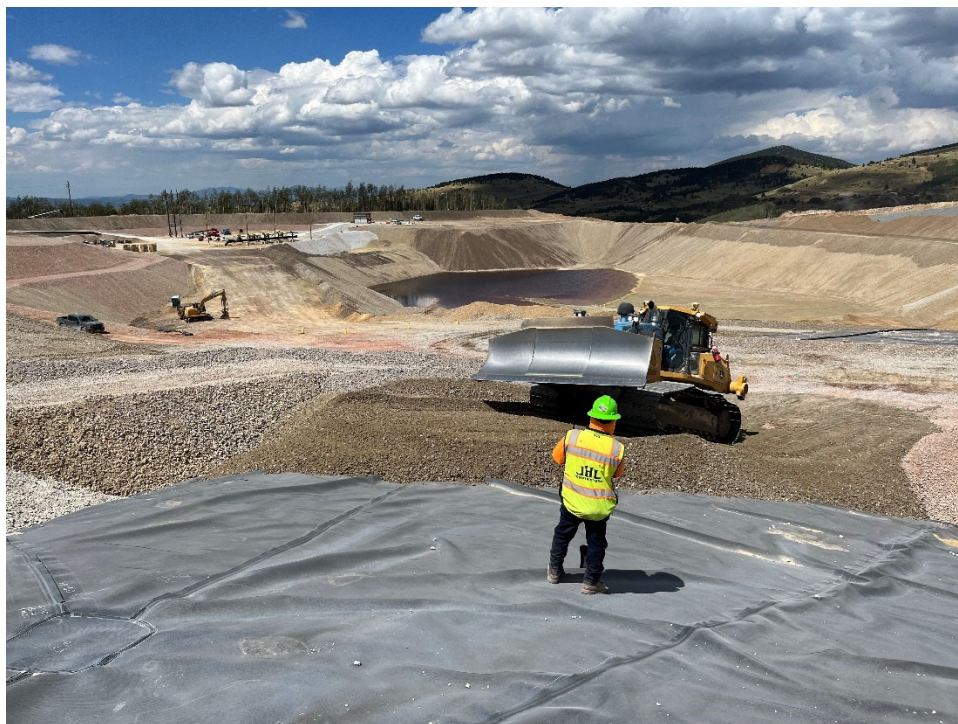
**August 24, 2023 – Placement of DCF above the backfill ramp**

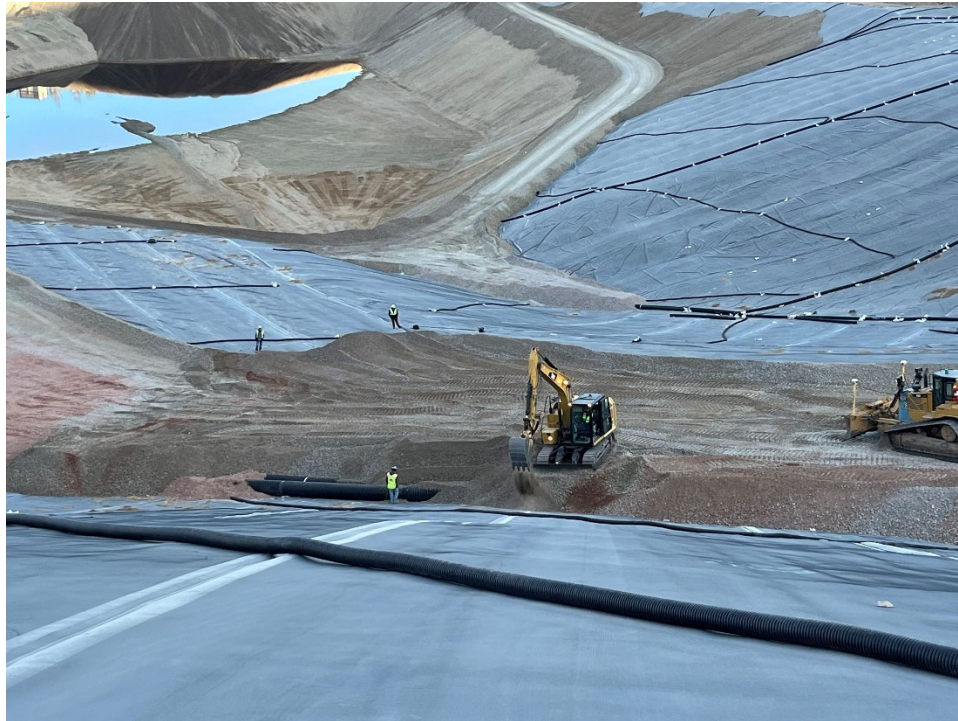
**August 25, 2023 – Ballasting of 24-inch CPeP pipe with DCF**

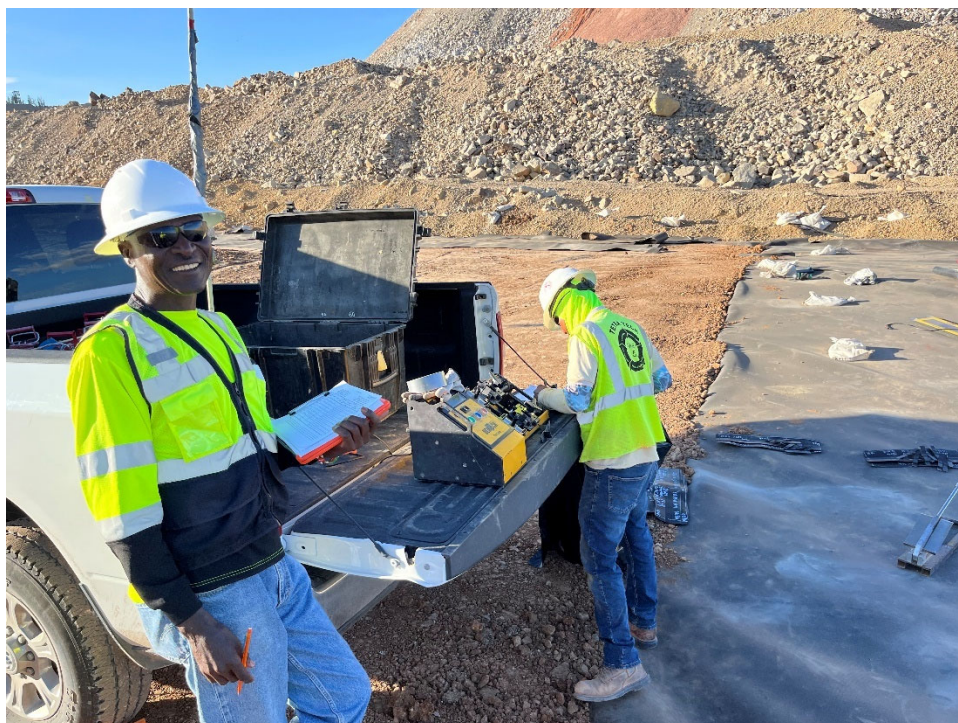
**August 25, 2023 – Testing and monitoring of Destructive Sample testing**

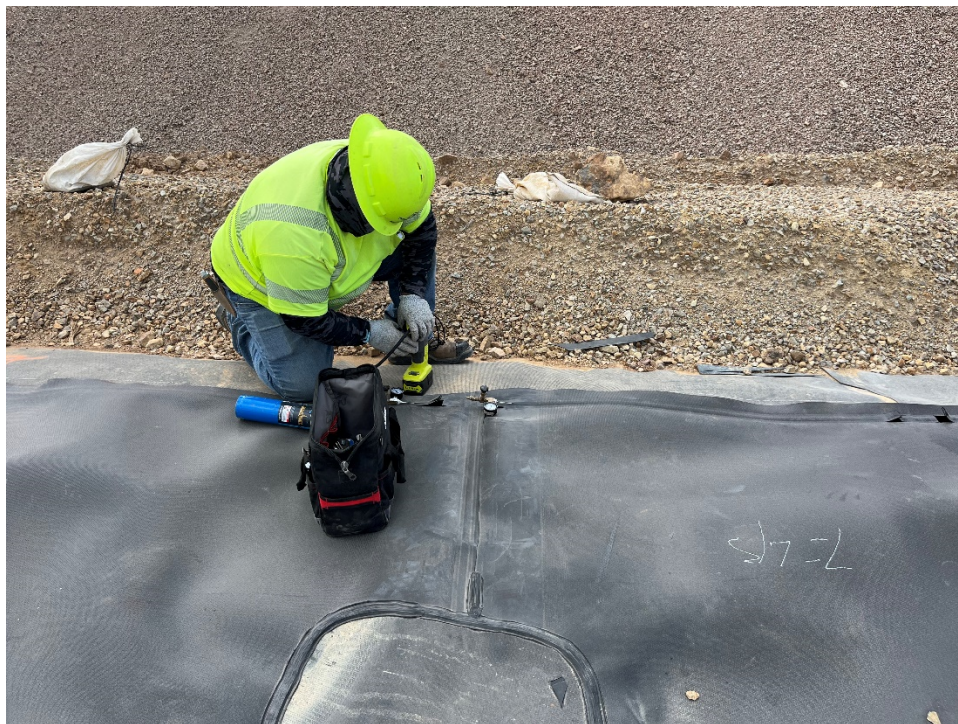
**August 28, 2023 – Pressure testing of fusion welded seams**

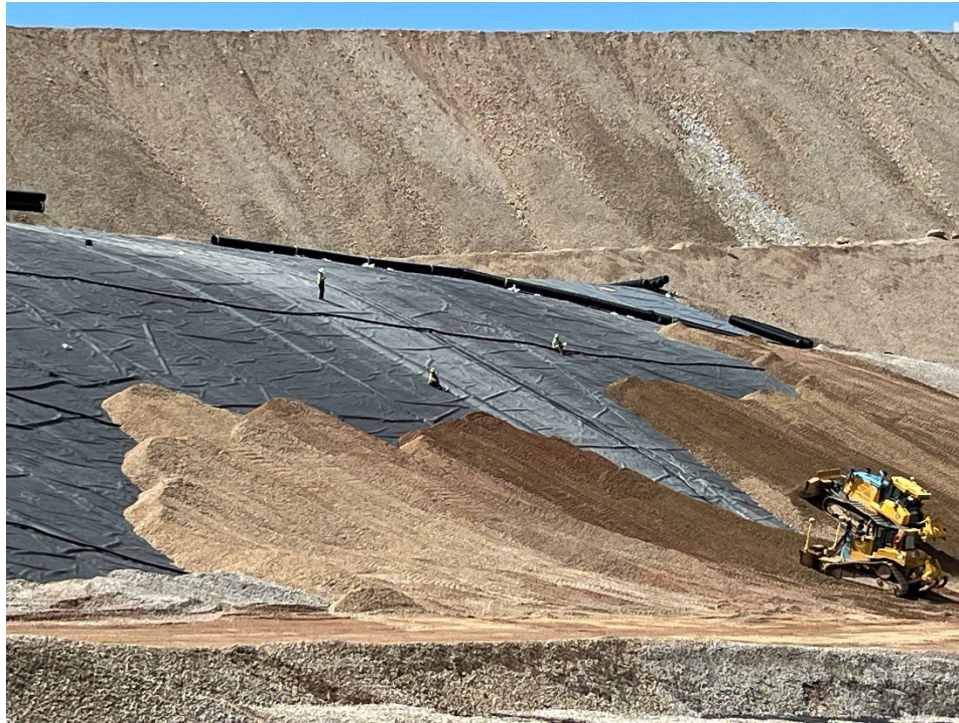
**August 29, 2023 – Placement of DCF above the backfill ramp**

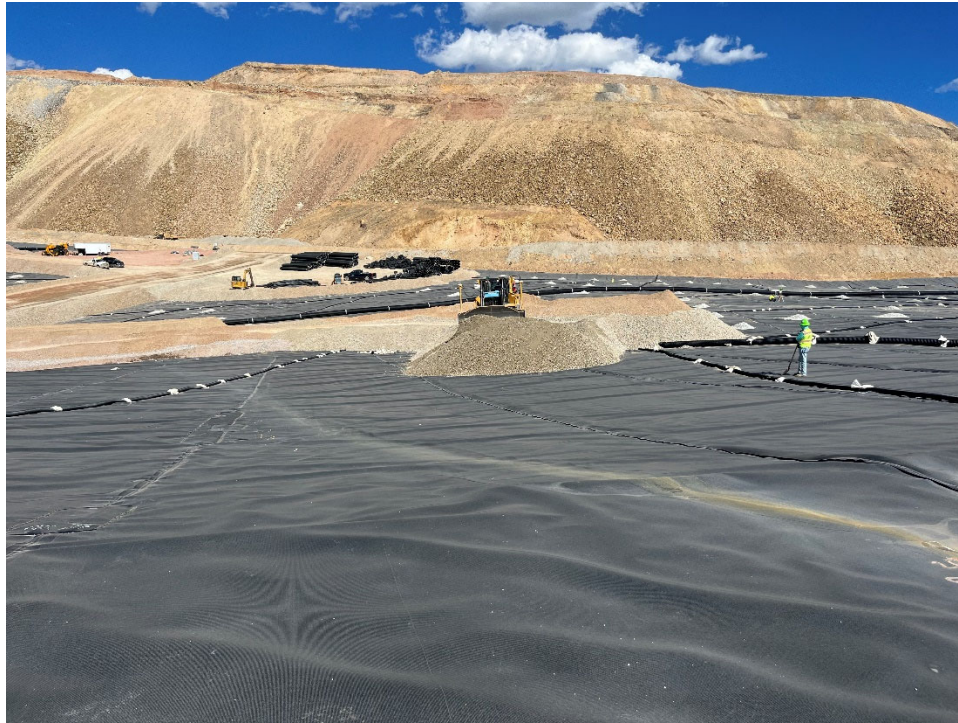
**August 31, 2023 – Placement of DCF above Turkey Ridge**

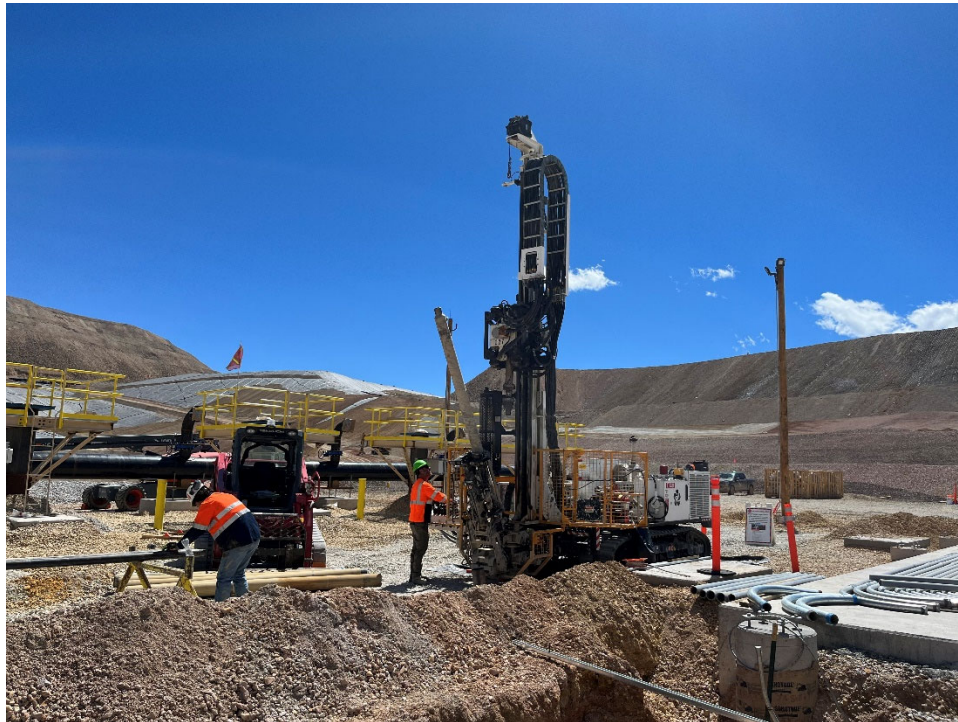
**September 4, 2023 – Construction of well by E-house**

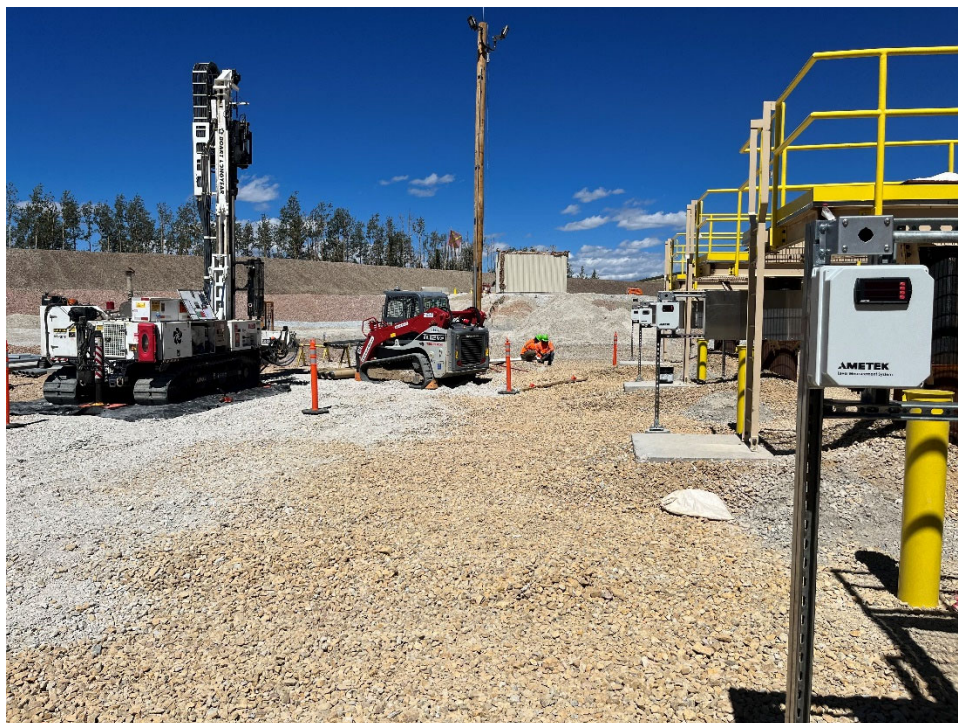
**September 4, 2023 – Construction of well by E-house and in place wells**

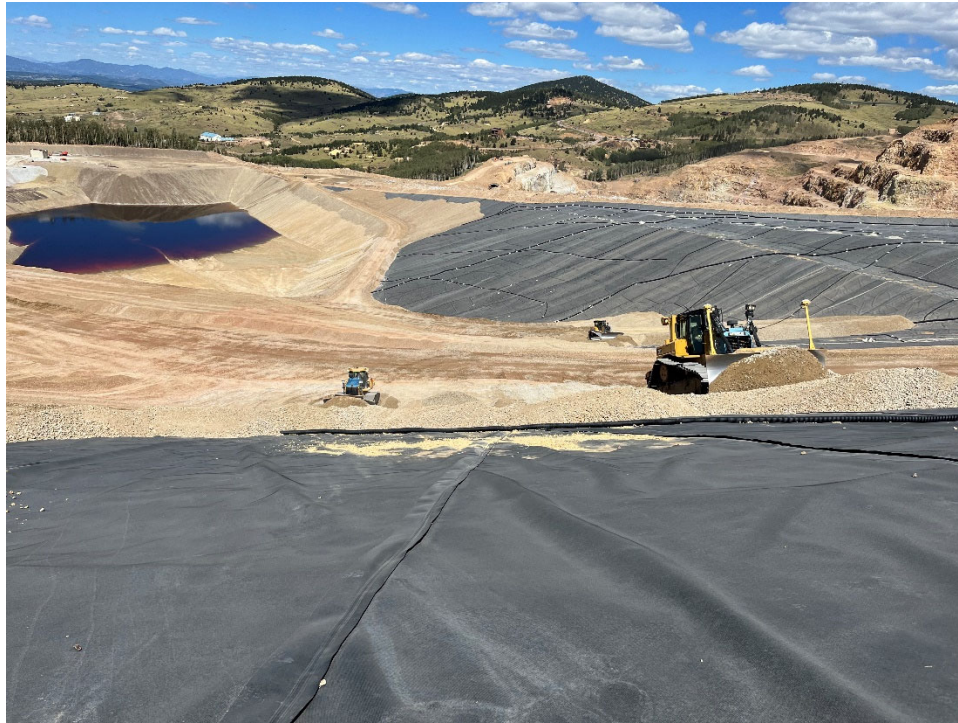
**September 5, 2023 – Placement of DCF above Turkey Ridge**

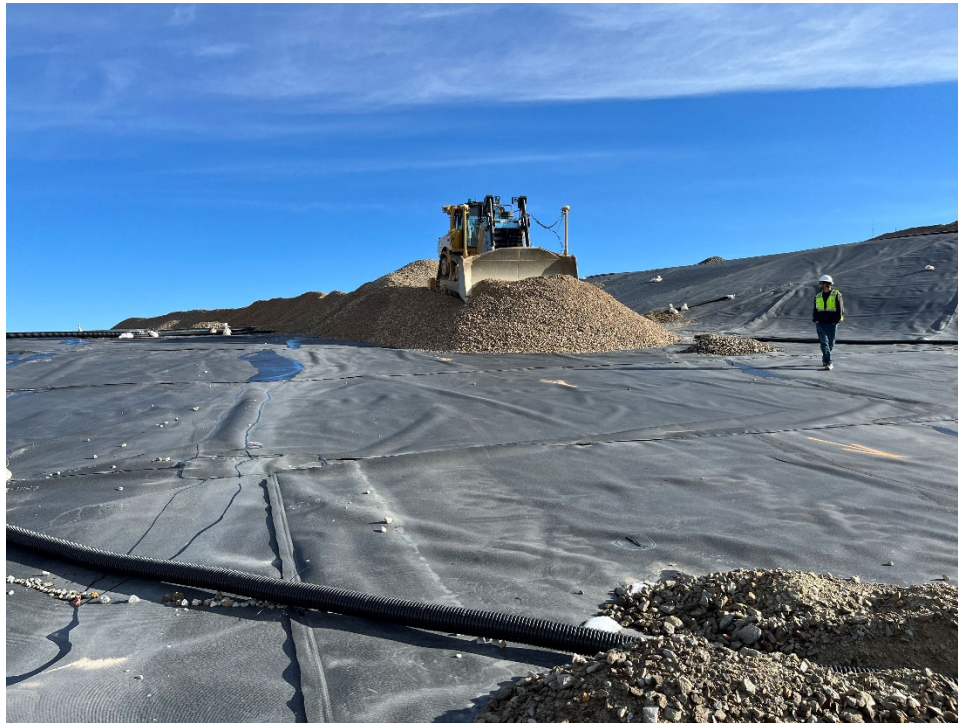
**September 12, 2023 – Placement of 4-foot minimum DCF road**

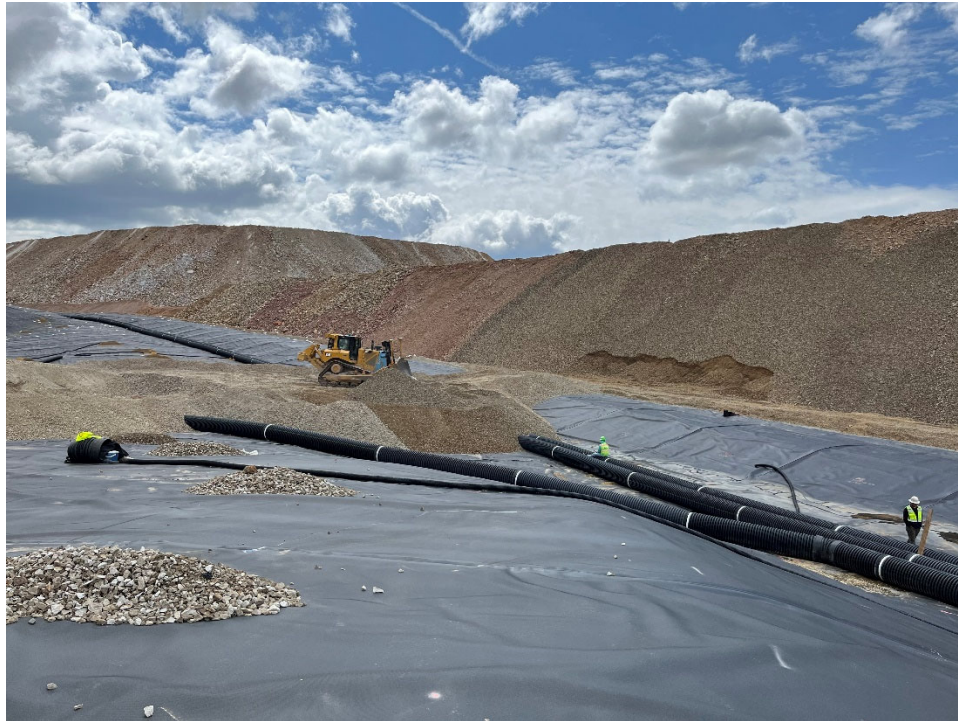
**September 13, 2023 – Placement of 6-foot minimum DCF road**

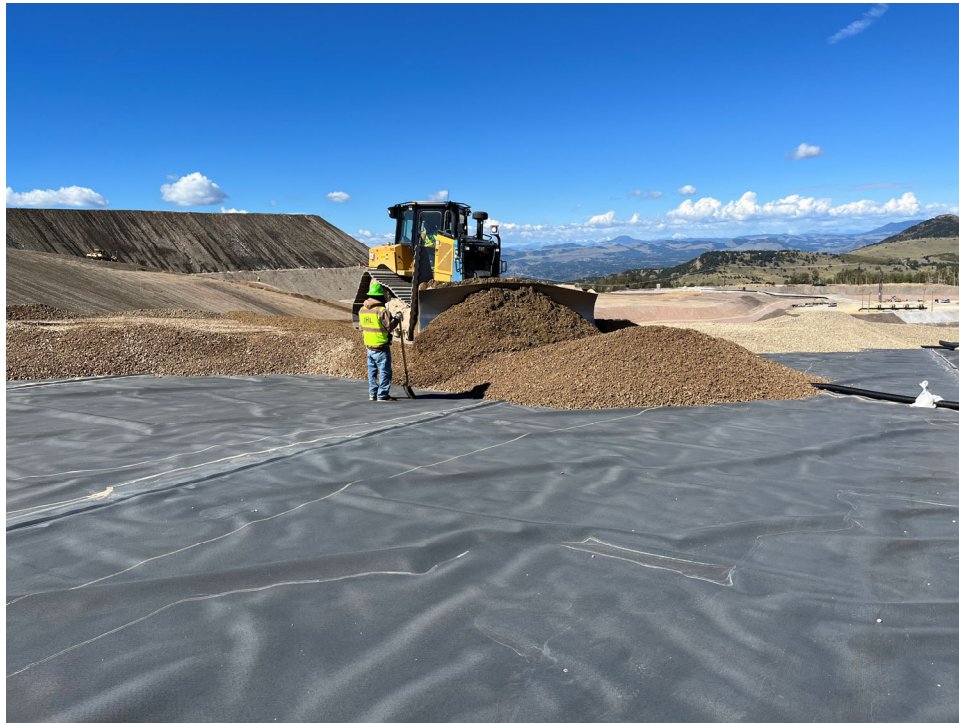
**September 19, 2023 – Placement of DCF**

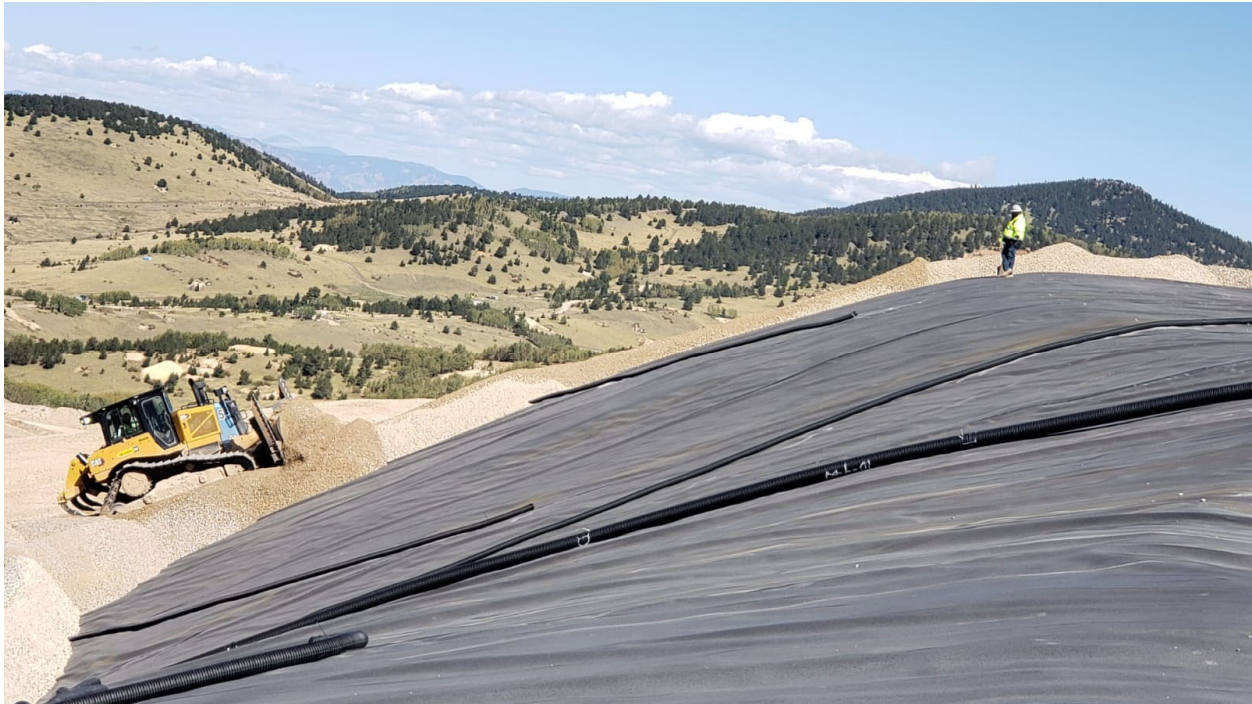
**September 20, 2023 – Placement of DCF**

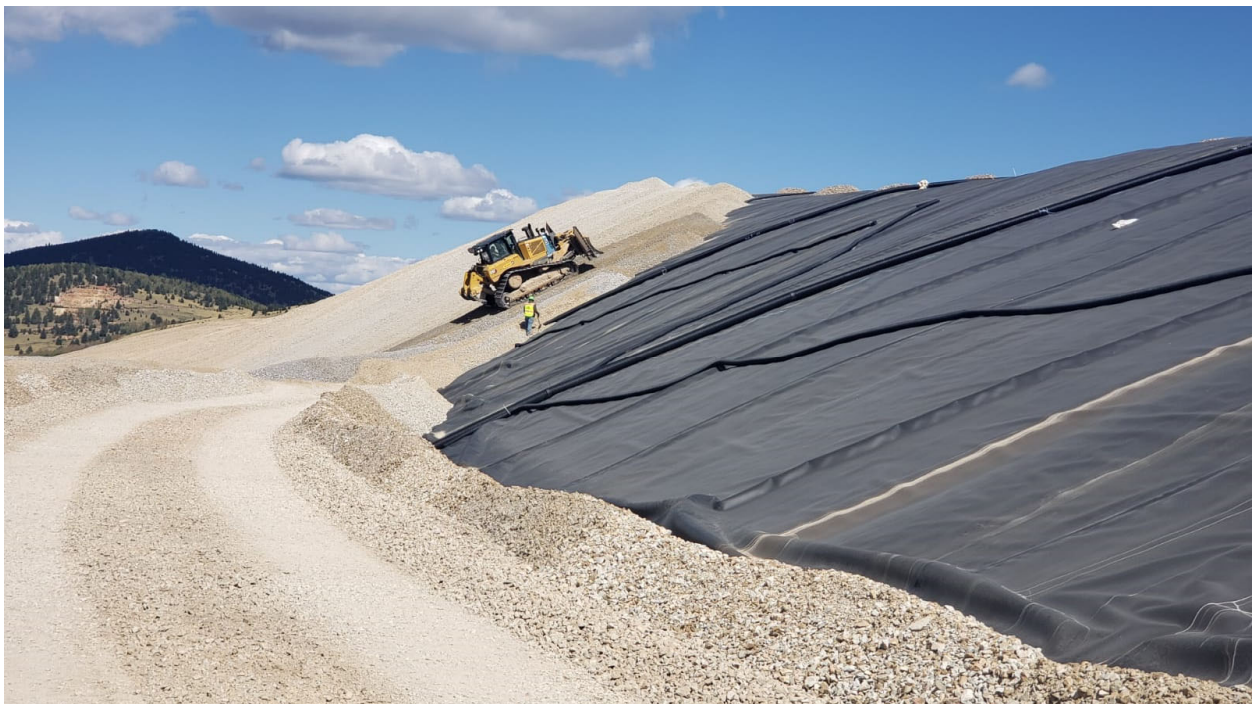
**September 21, 2023 – Placement of DCF**

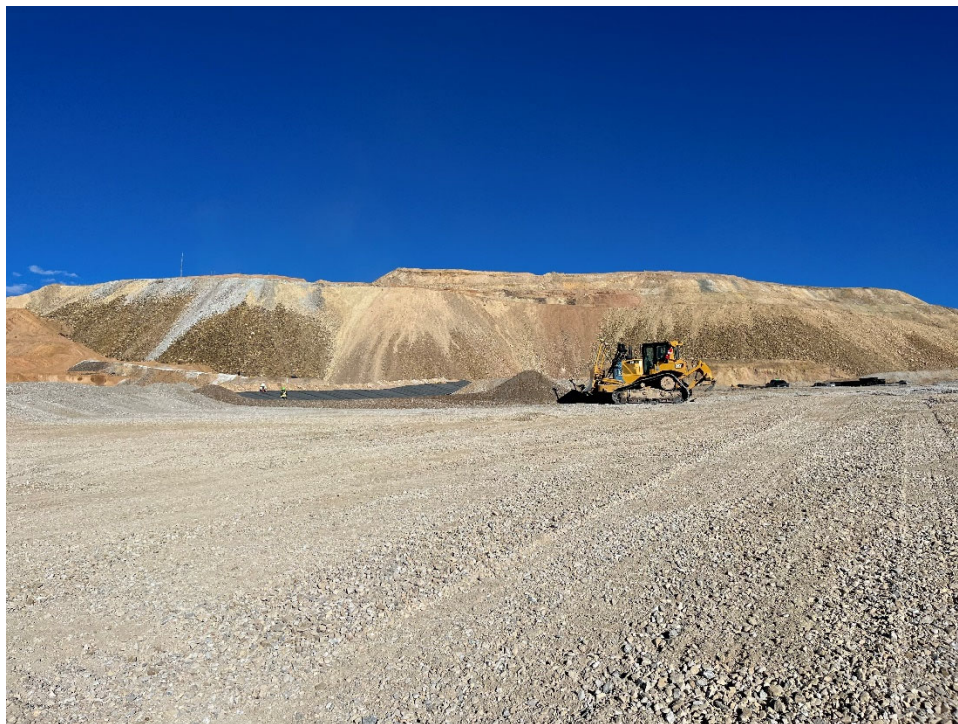
**September 25, 2023 – Placement of DCF**

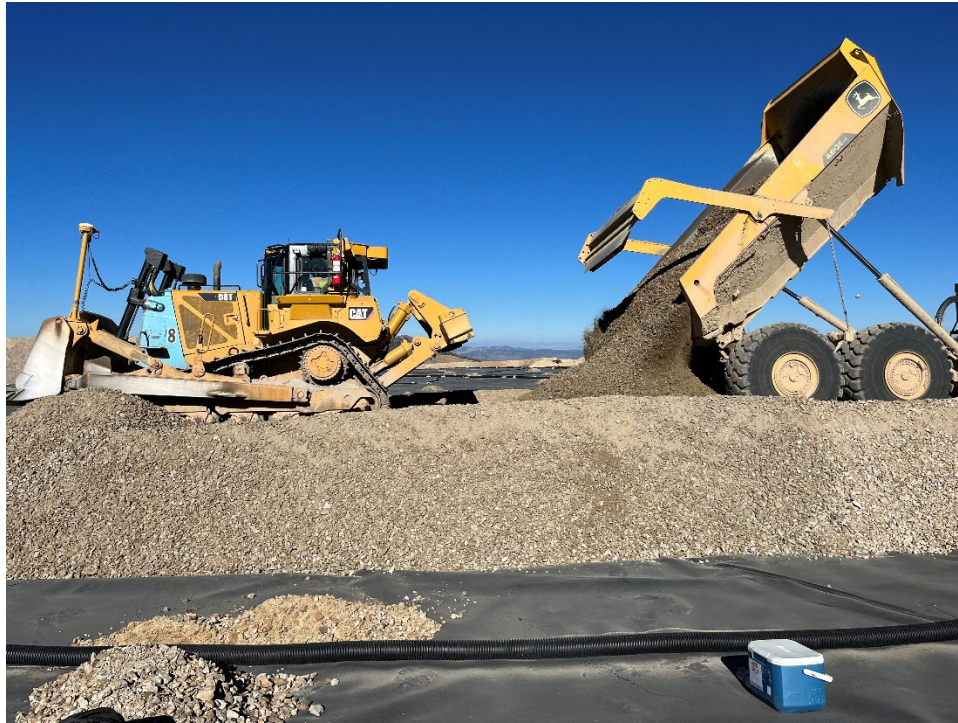
**September 26, 2023 – Placement of DCF on 4 foot minimum road**

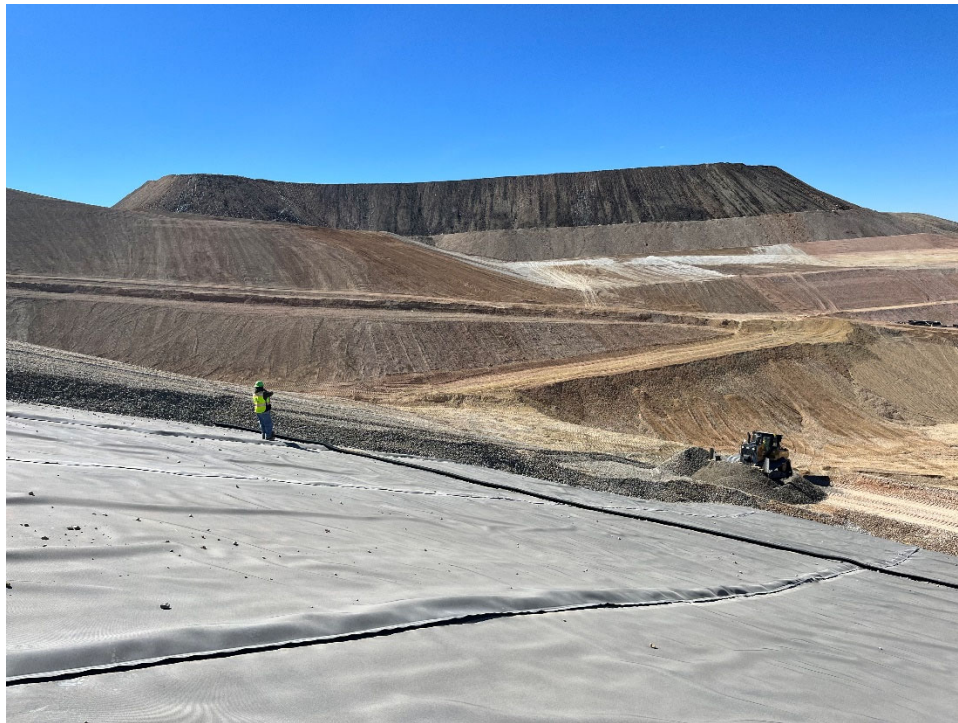
**September 29, 2023 – Placement of DCF**

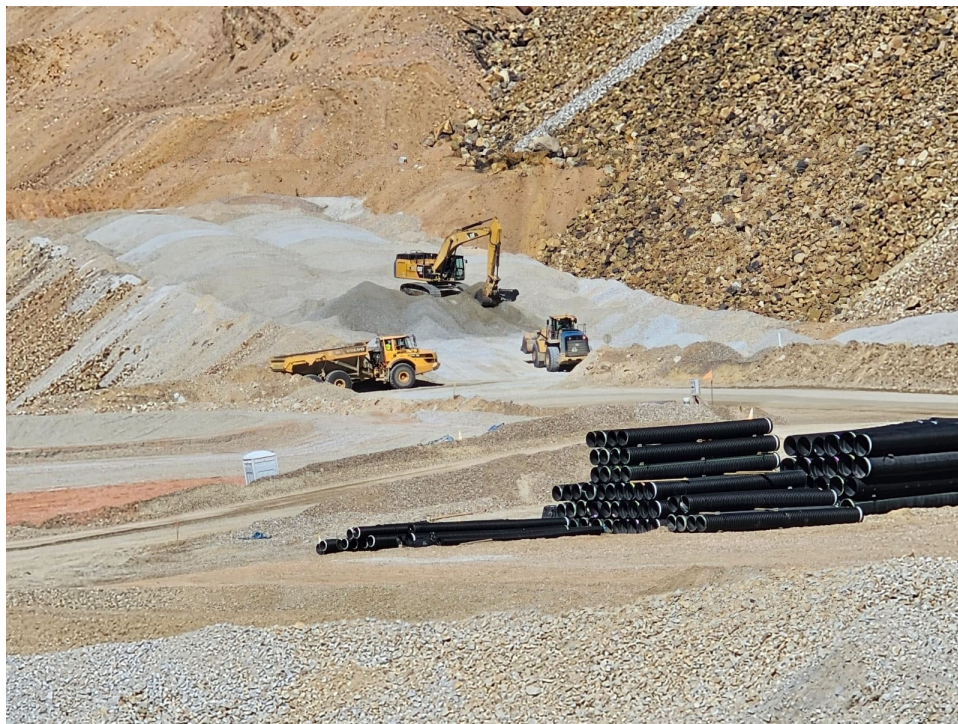
**October 3, 2023 – Loading of DCF at stockpile**
