## **APPENDIX E – WEEKLY REPORTS**

## FIELD WEEKLY PROGRESS REPORT

**PROJECT:** VALLEY LEACH FACILITY 2 PHASE 3 2023 QUALITY ASSURANCE OVERSIGHT  
**SITE:** CRIPPLE CREEK & VICTOR GOLD MINE (COLORADO)  
**CONTRACTOR:** NEWMONT CC&V MINING OPERATIONS  
JHL CONSTRUCTORS  
KELLEY TRUCKING INC.  
**WEEK ENDING:** FRIDAY, APRIL 21, 2023

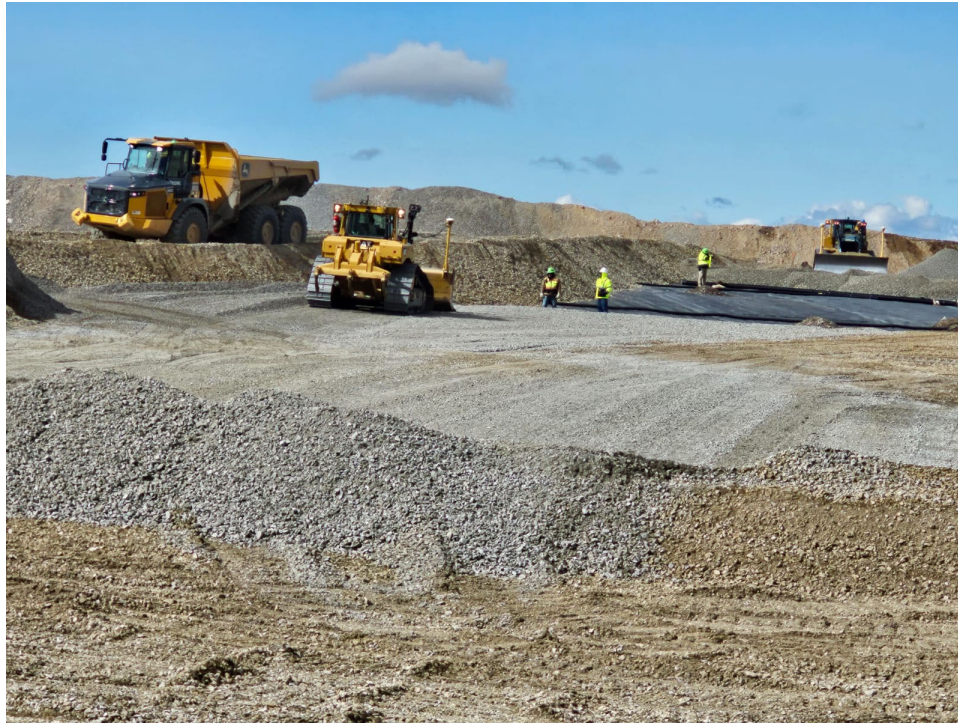
**October 4, 2023 – Placement of DCF**

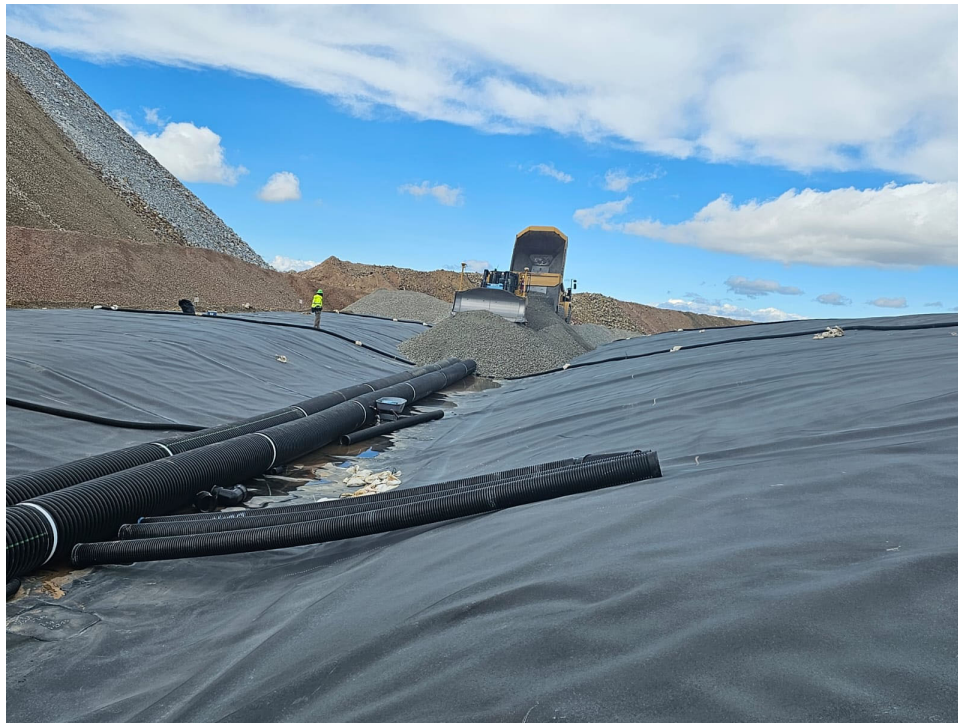
**October 4, 2023 – Placement of DCF on 6 foot minimum road**

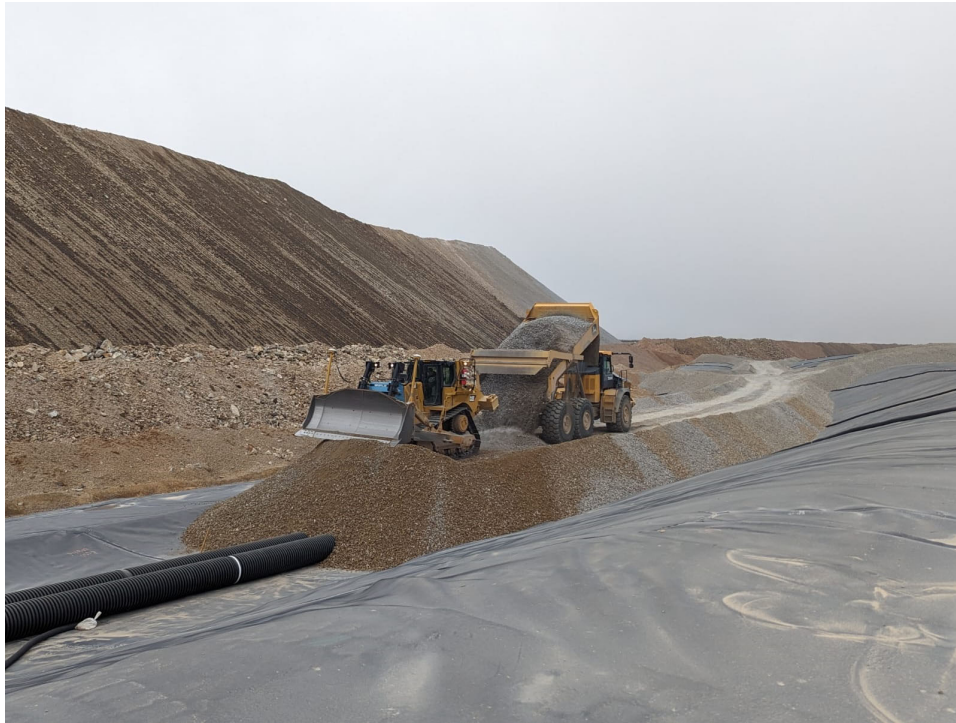
**October 6, 2023 – Placement of DCF on 6 foot minimum road**

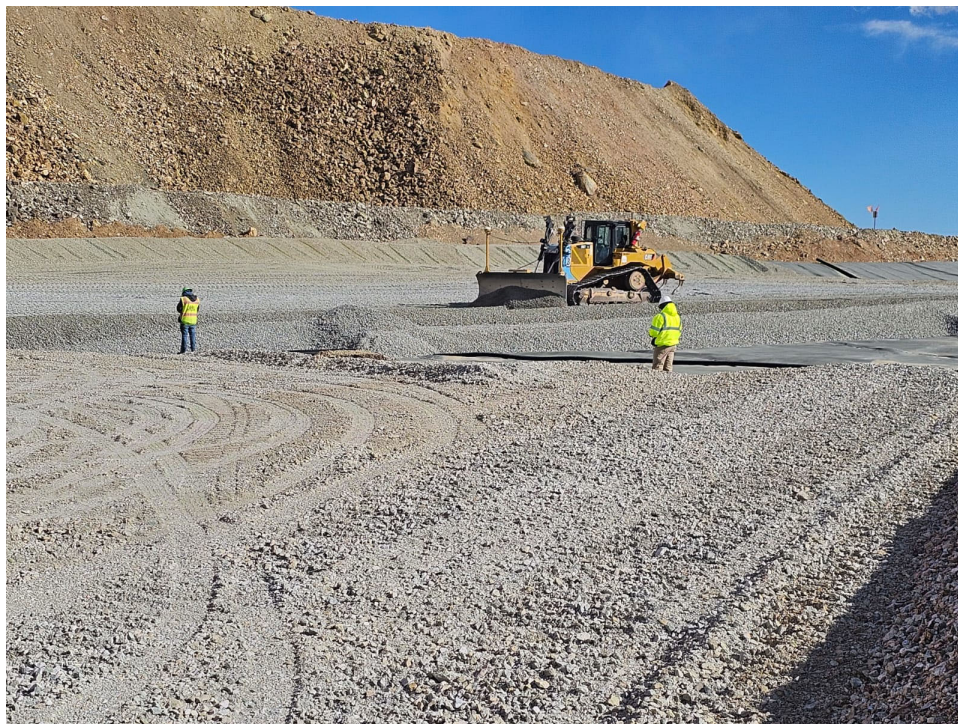
**October 9, 2023 – Placement of DCF 2 foot minimum thickness**

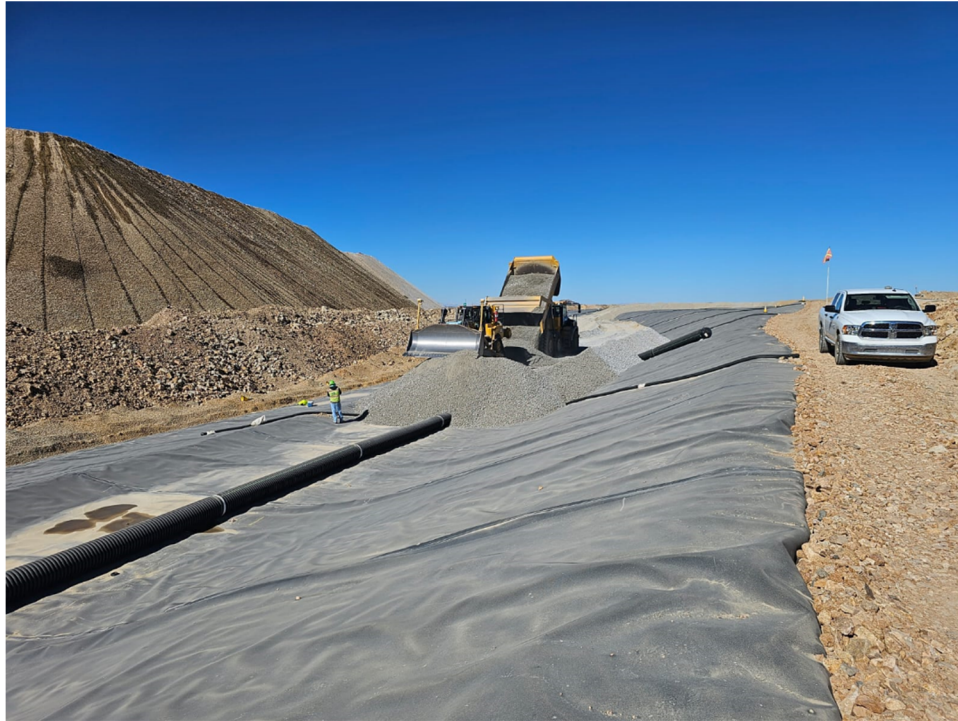
**October 9, 2023 – Placement of DCF 6 foot minimum road**

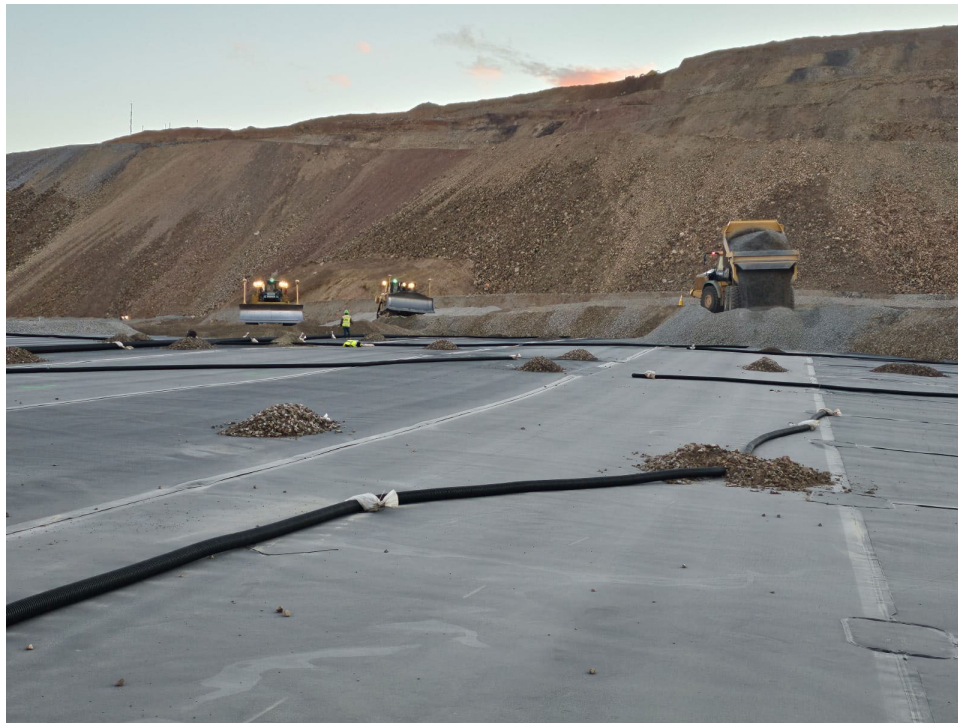
**October 11, 2023 – Placement of DCF over LVSC piping**

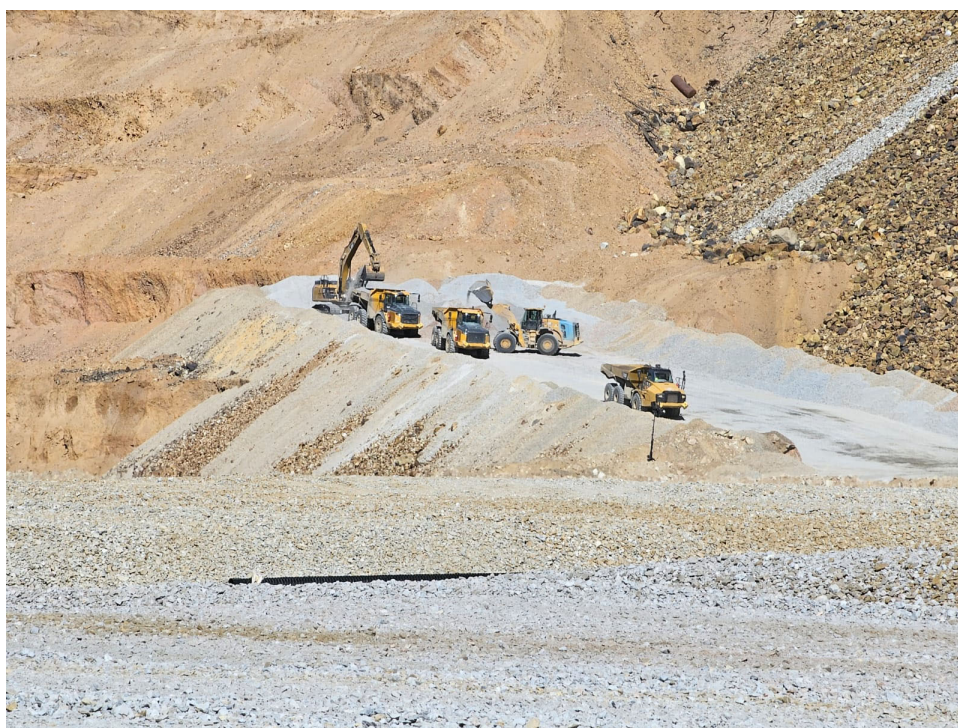
**October 16, 2023 – Loading of DCF material at stockpile**

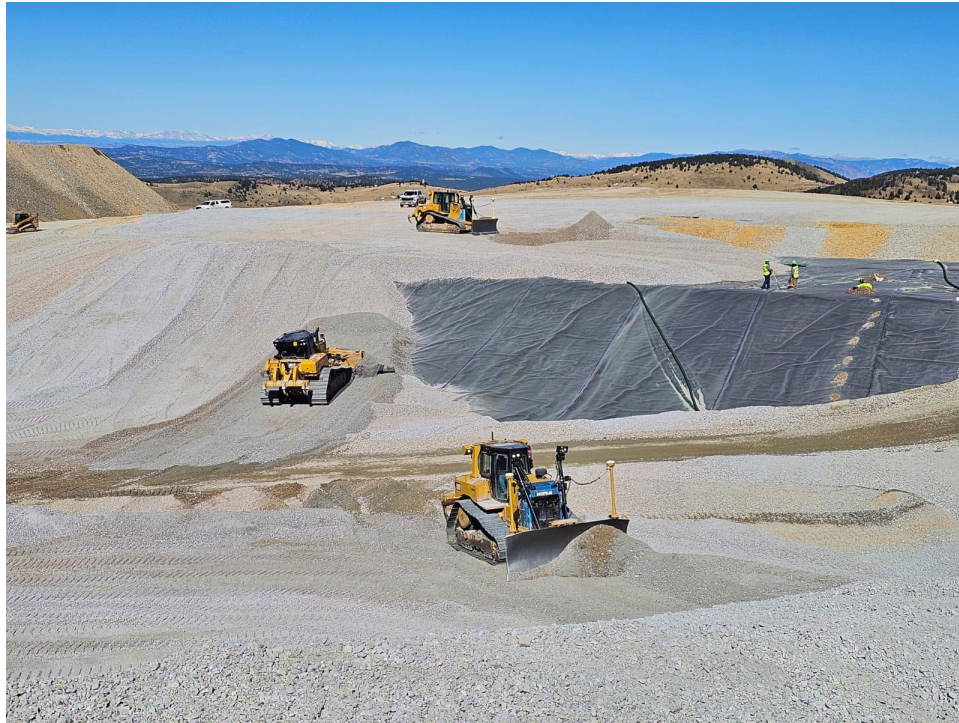
**October 16, 2023 – Placement of DCF**

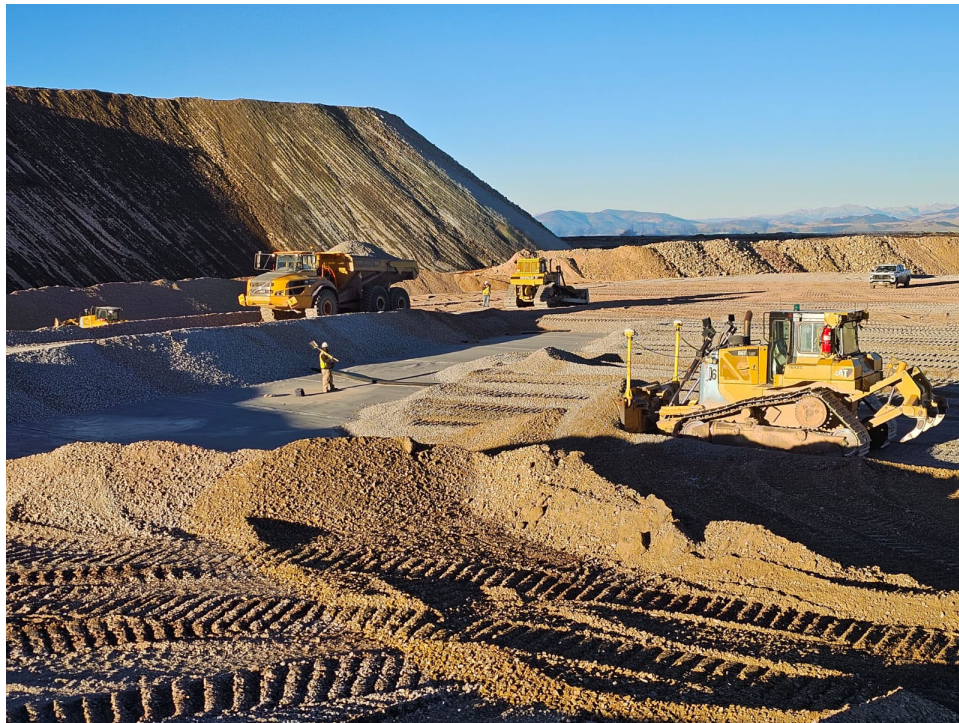
**October 20, 2023 – Placement of DCF**

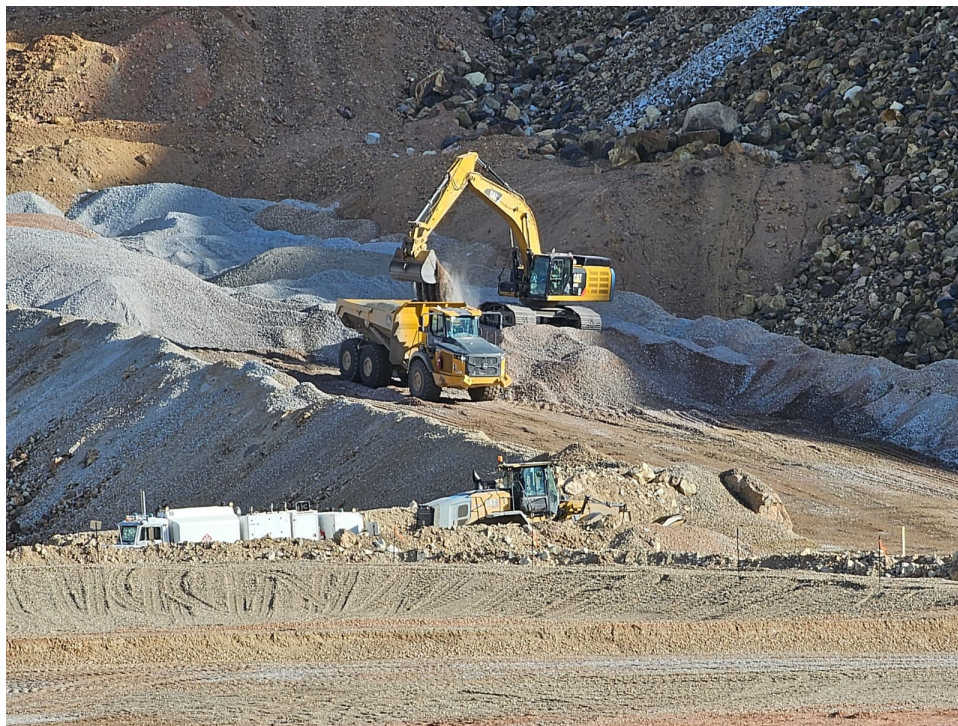
**October 23, 2023 – Loading of DCF material at stockpile**

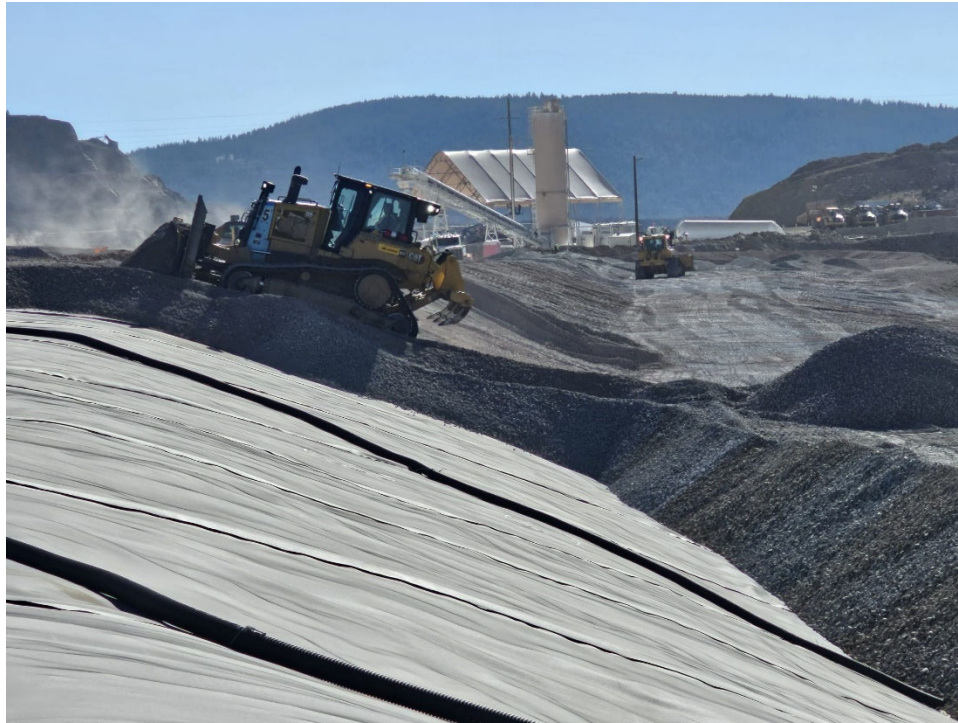
**October 23, 2023 – Placement of DCF**

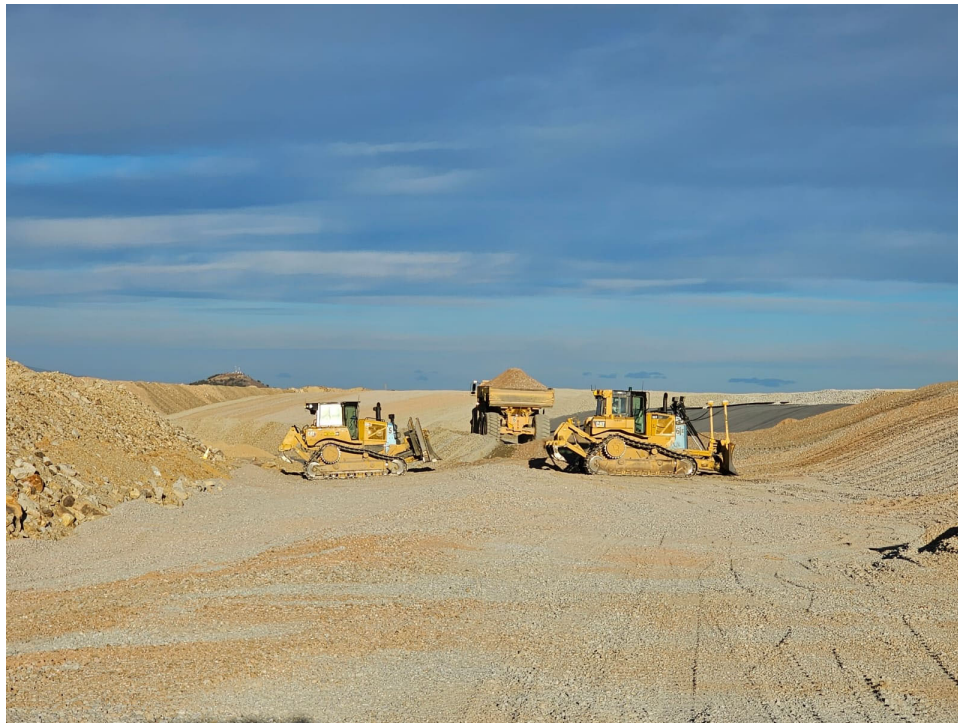
**October 24, 2023 – Placement of DCF**
