# PITCH RECLAMATION PROJECT COLORADO MINED LAND RECLAMATION BOARD 2023 ANNUAL RECLAMATION REPORT

**RECLAMATION PERMIT NUMBER M-1977-004**

April 2024

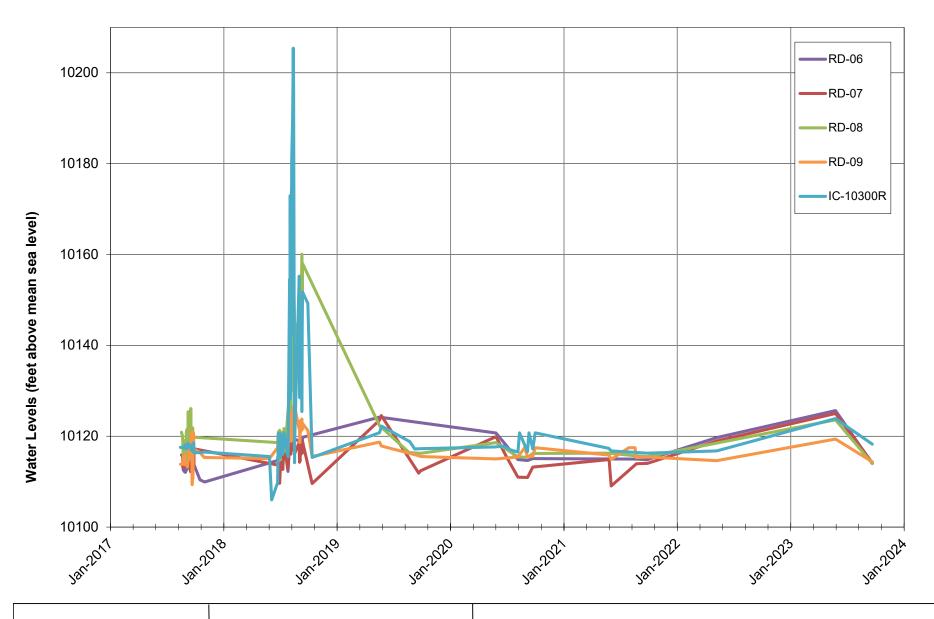
Figure 7: Historical Water Levels in Piezometers at the Toe of Indian Rock Dump

- Water levels in wells used for extraction during the phosphate injection pilot tests (RD-01, RD-03, and RD-05) fluctuated 2 to 5 feet (Figure 7). RD-02 and RD-04 are wells at the same ground surface elevation and fluctuated approximately 0 to 4 feet. Short-term water level variations between approximately 2015 and 2020 reflect changes during injection activities and appeared to have little influence on the overall subsurface water level. Variation in water level since injections stopped reflect seasonal water level fluctuations.

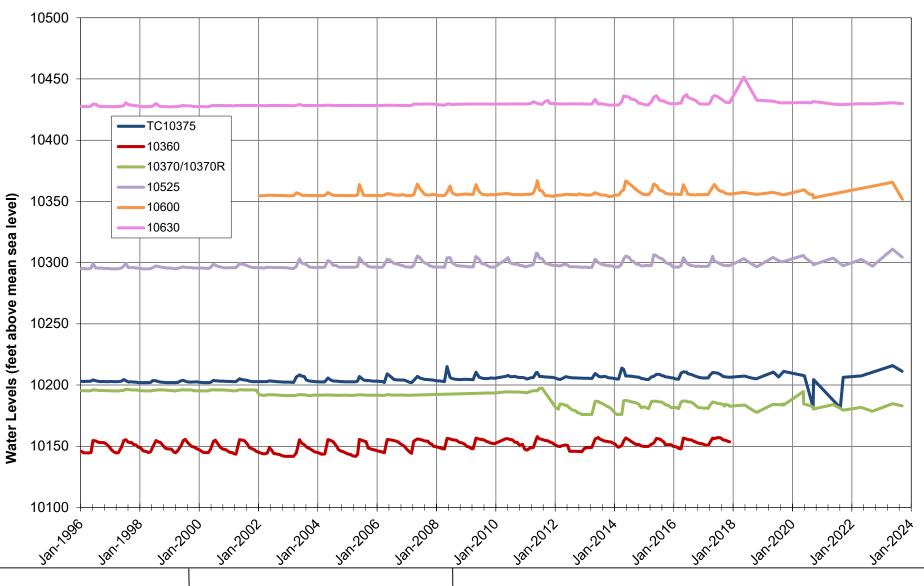
Figure 8: Historical Water Levels in Piezometers at the 10300 Level of Indian Rock Dump

- Wells RD-06, RD-07, RD-08, RD-09, and 10300R at the 10300 level were used for injection in 2017 and 2018. Water levels in these wells decreased roughly 3 to 13 feet from the spring snowmelt in the spring to low-flow conditions in the fall (Figure 8).

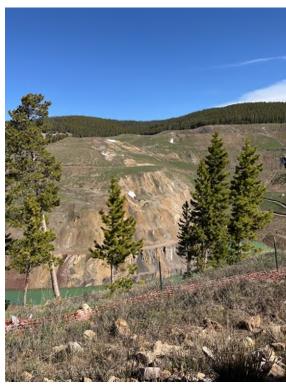
Photograph: 4

Description: IRD slope observation

Location: Underground Workings Injection System

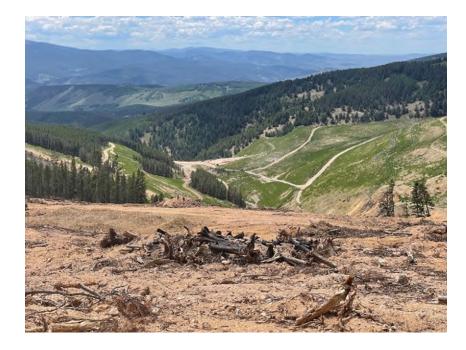
**Location: North Pit**

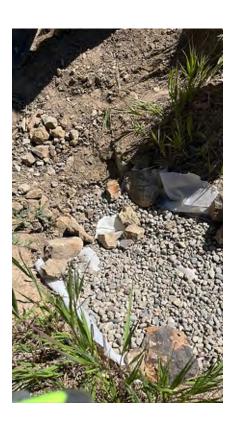
Photograph: 11

**Description: IRD Injection System**

**Location: PMD**

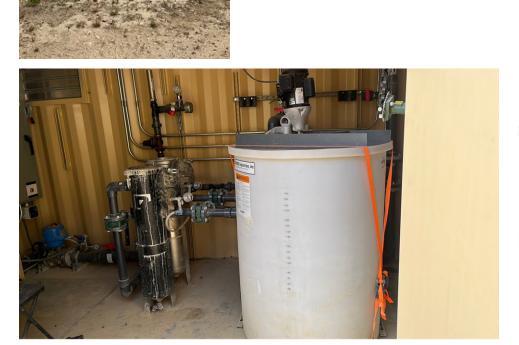
**Location: South Pit**

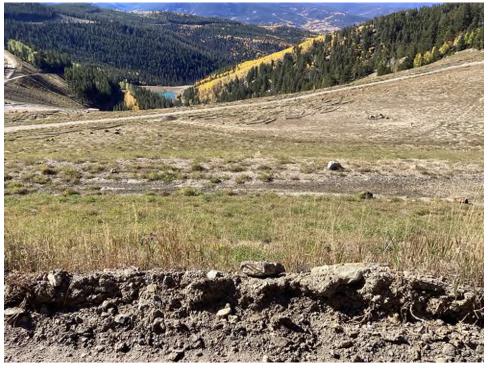
Photograph: 28

Description: Abandoned road showing signs of pooling

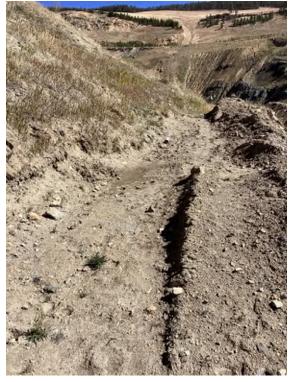
Photograph: 30

Description: Pooling area on the IRD

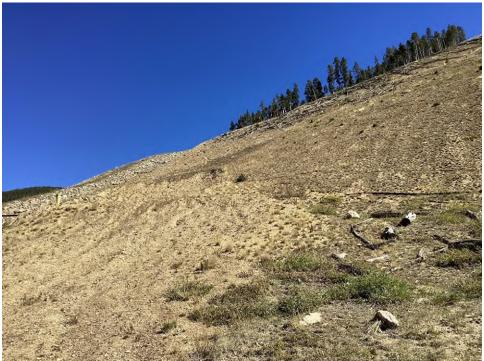
Photograph: 32

Description: Revegetation on slope behind P-11

**Location: South Pit**

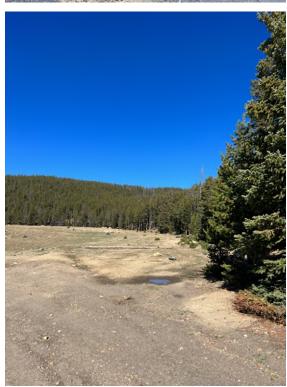
Photograph: 36

Description: Upper IRD pooling area

**Location: Upper IRD**

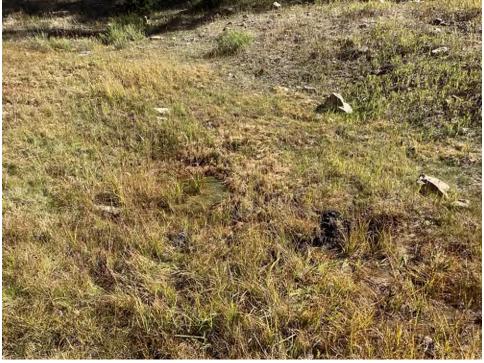
Photograph: 40

Description: IC-3 spring observation

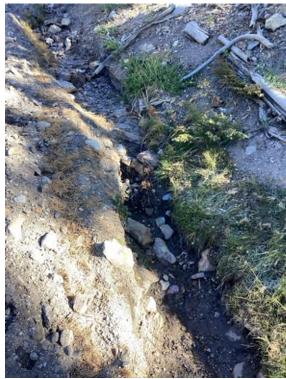
Photograph: 42

Description: New spring below IC-13

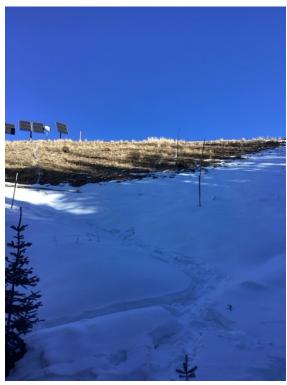
Photograph: 44

Description: Sediment Pond embankment

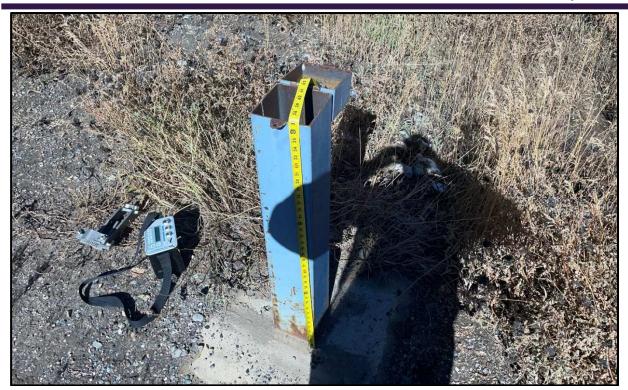
Photograph 1: Stickup Casing at IN-2

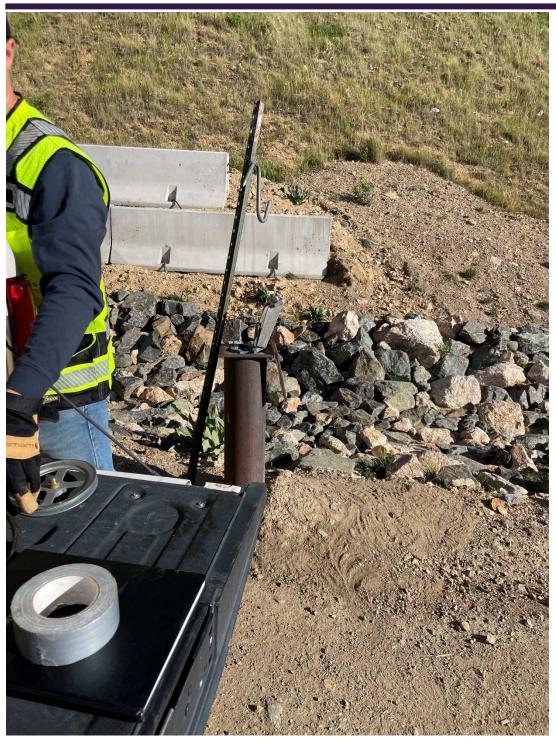
Photograph 2: Collecting readings at I98-1

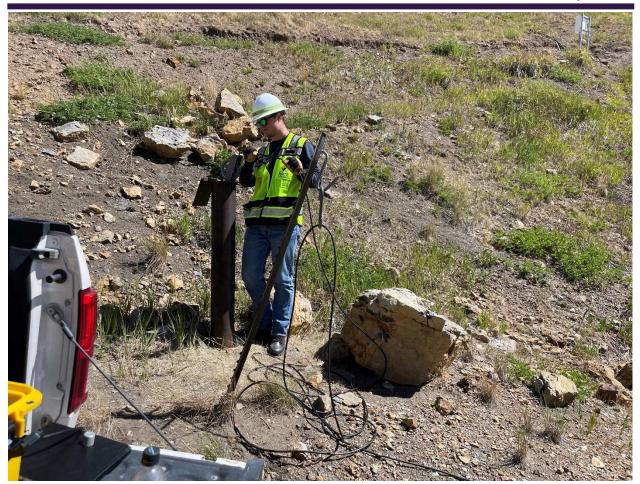
Photograph 3: Collecting readings at 198-2
