TECHNICAL MEMORANDUM

DATE: December 19, 2023

SUBJECT: Vermillion Creek Restoration at Diamond Peak Ranch - 2023 Adaptive Management
Phase 1 and 2

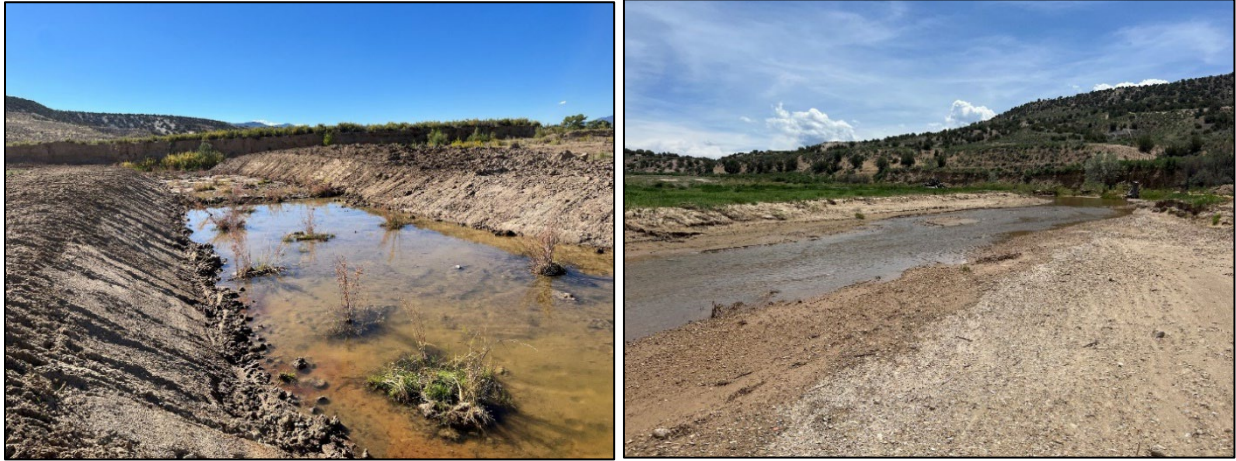
Figure 1. Post-construction channel (left photo) was SEM stage 2 (Channelization). Note the trapezoidal channel shape with no defined channel. SBS and transplants were installed to create disturbance including bank erosion to help push the channel further along the evolution trajectory. Post-flood channel (right photo) has widened and aggraded, moving towards SEM between Stage 5 and 6.

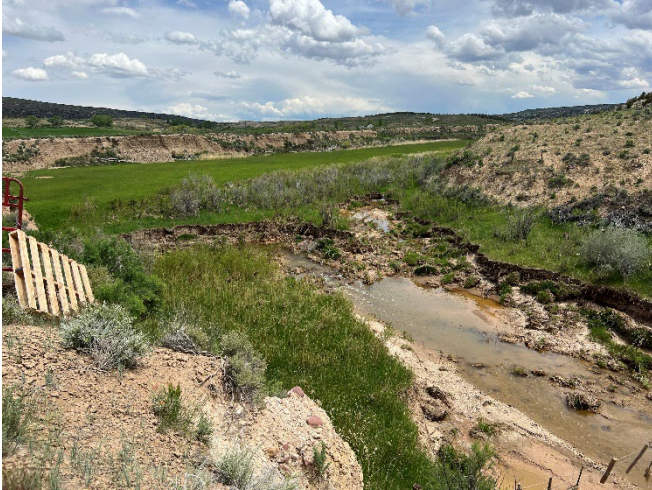
Photo 1: 5/25/2023 Reach 12 SEM score of 3.
Viewing the current location of the headcuts.

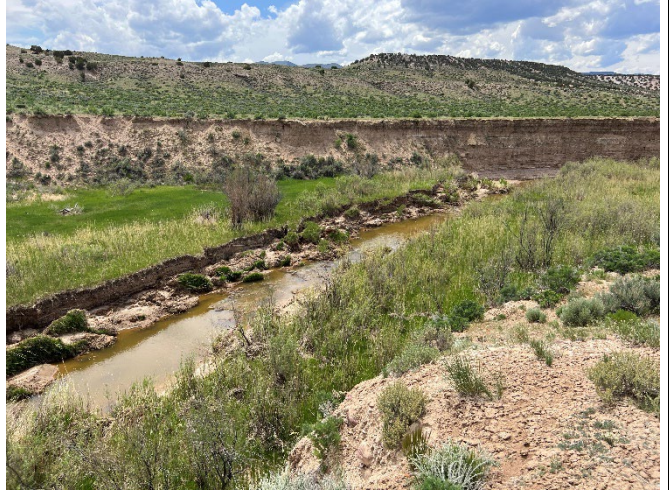
Photo 2: 5/25/2023 Reach 11 SEM score of 4

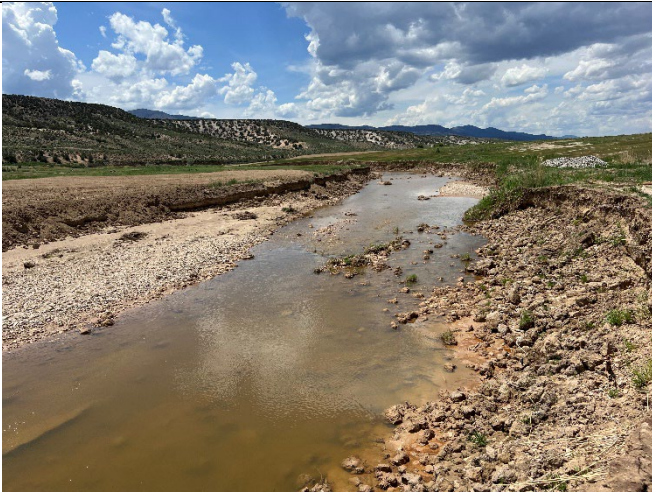
Photo 3: 5/25/2023 Reach 10 SEM score of 5

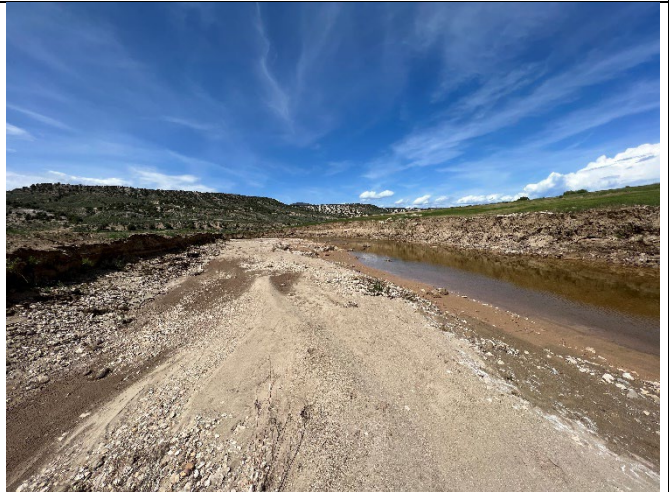
Photo 4: 5/25/2023 Reach 9 SEM score of 5.5

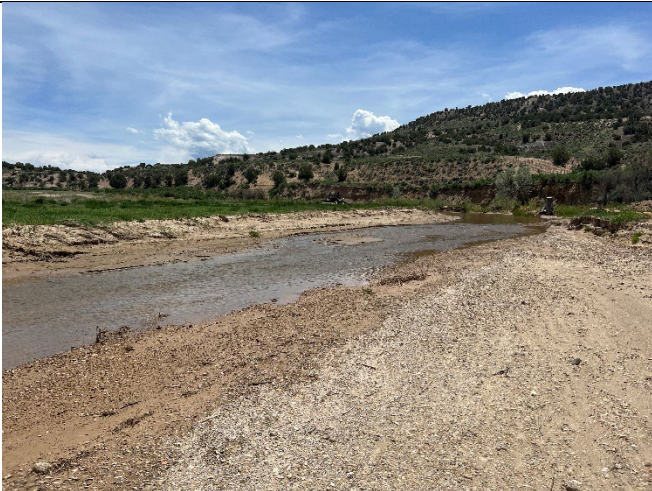
Photo 5: 5/25/2023 Reach 8 SEM score of 5

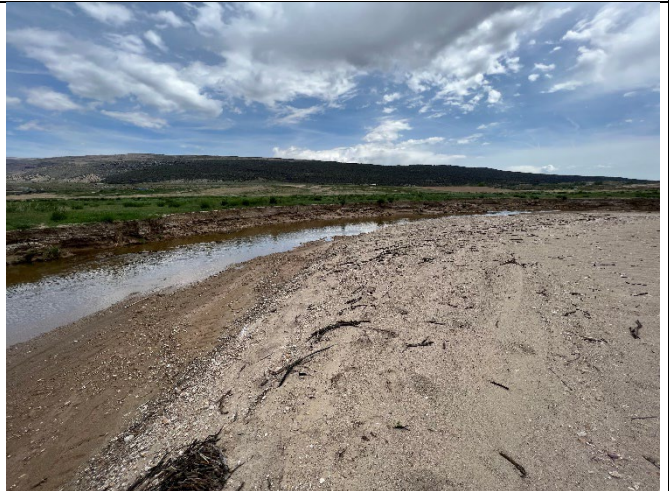
Photo 6: 5/25/2023 Reach 7 SEM score of 4.5

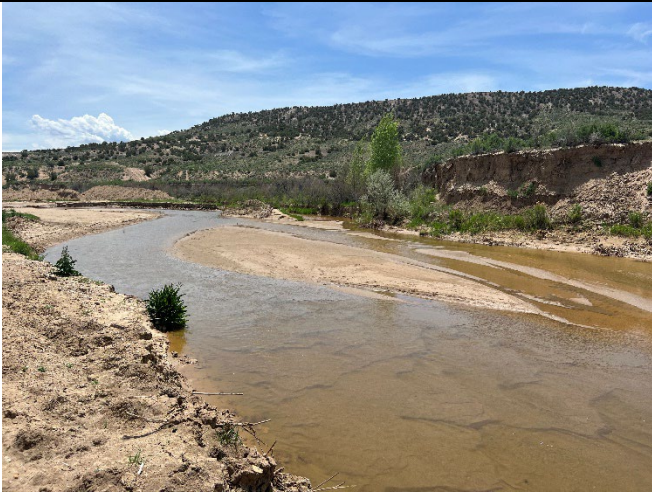
Photo 7: 5/25/2023 Reach 6 SEM score of 5.5

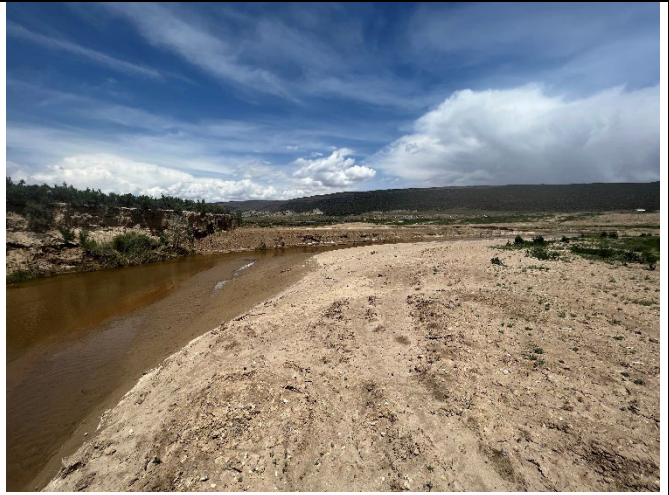
Photo 8: 5/25/2023 Reach 5 SEM score of 5

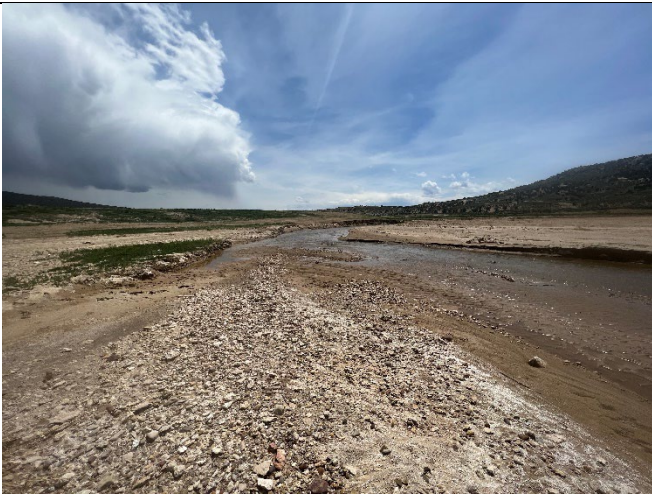
Photo 9: 5/25/2023 Reach 4 SEM score of 4.5

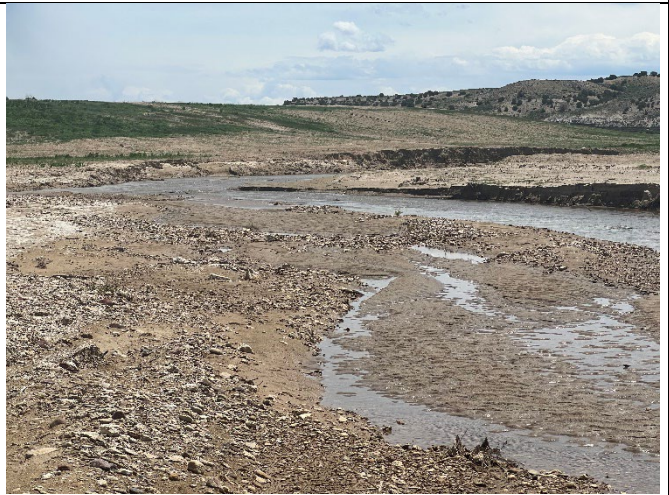
Photo 10: 5/25/2023 Reach 3 SEM score of 5.5

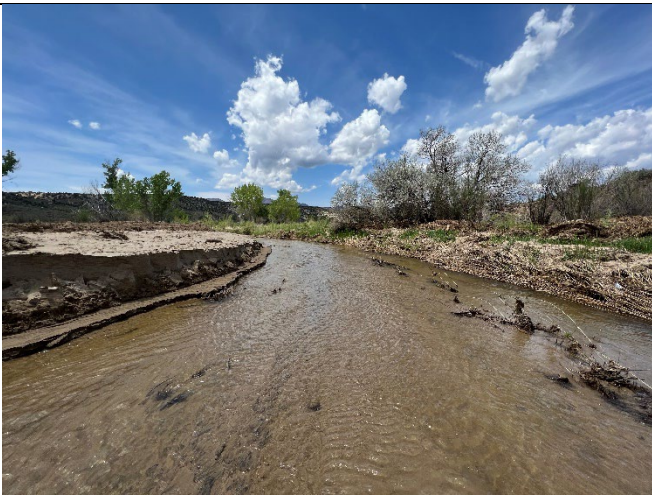
Photo 11: 5/25/2023 Reach 2 SEM score of 5

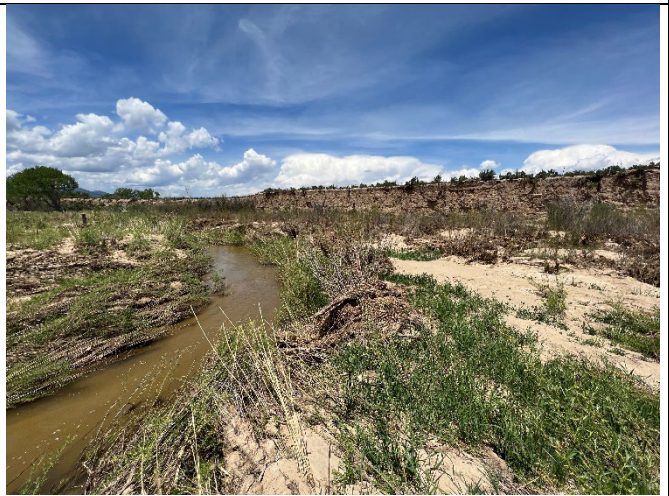
Photo 12: 5/25/2023 Reach 1 SEM score of 4

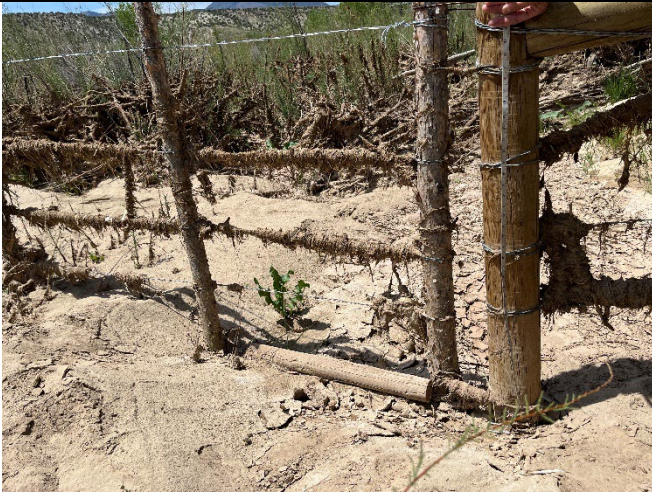
Photo 13: 5/25/23 Visual observations of debris flow near cross section STA 2+40

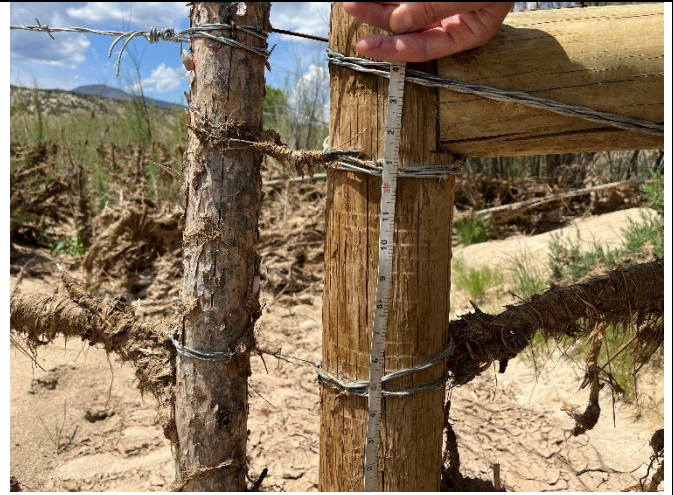
Photo 14: 5/25/23 Height of high flow debris measurement near cross section STA 2+40

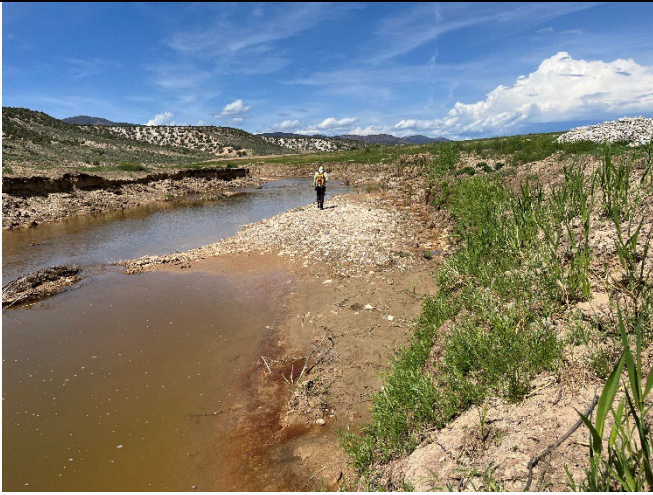
Photo 17: 5/25/2023 Revegetating bank

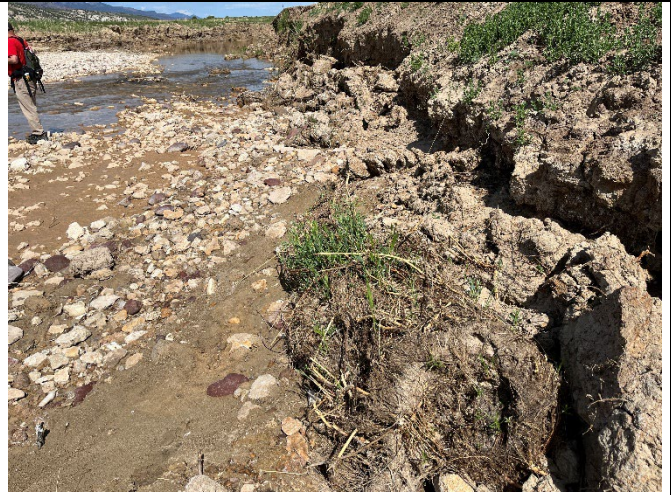
Photo 18: 5/25/2023 Volunteer vegetation along slumped toe.

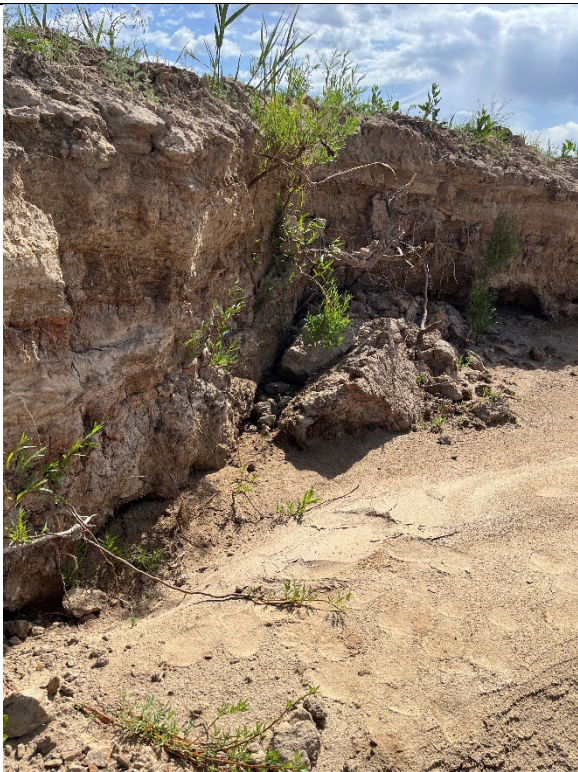
Photo 19: 5/25/2023 Willow recruitment along slumped toe and vertical banks.

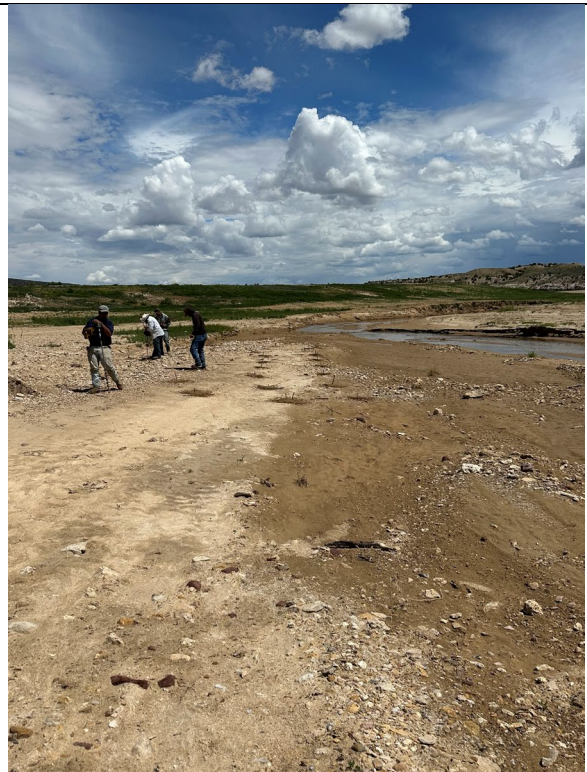
- 8600 willow cuttings were planted within the Vermillion Creek inset floodplain by June 10, 2023 (Photos 20, 22–24 in Appendix A). To ensure even distribution of the available plant materials throughout the floodplain, approximately 573 willow cuttings were planted

Photo 20: 6/7/2023 Willow staking in channel according to plan

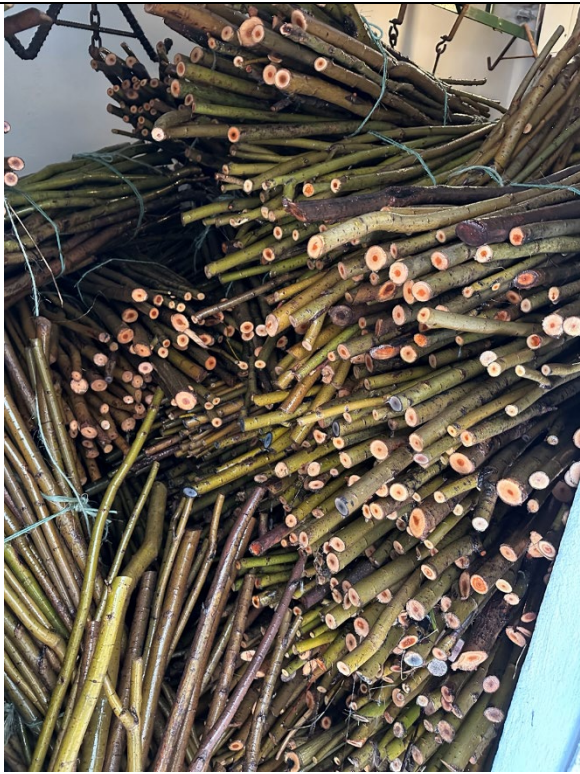
A total of 12,000 willow cuttings were harvested the week of April 23, 2023, processed, bundled, soaked, and placed in cold storage by May 8, 2023 (Photo 21 in Appendix A). These willow cuttings are in addition to the 2475 willow clumps planted in 2022. ECOS prepared a Willow Planting Layout Detail (modified Typical Main Channel Detail, Planset Sheet 27, Appendix F) to guide the distribution and planting operations, which was implemented as follows:

Photo 21: 5/6/2023 Willows in cold storage awaiting planting

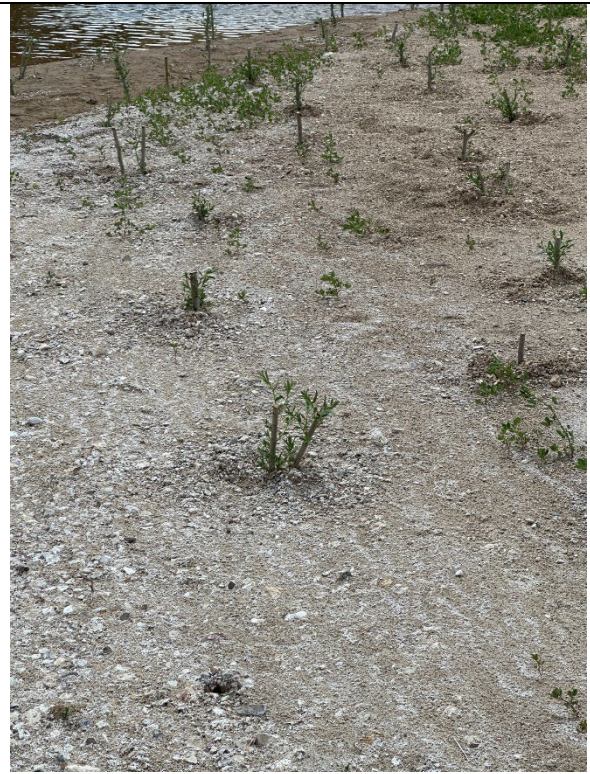
Photo 22: 6/29/2023 Willows stakes on inset floodplain resprouting

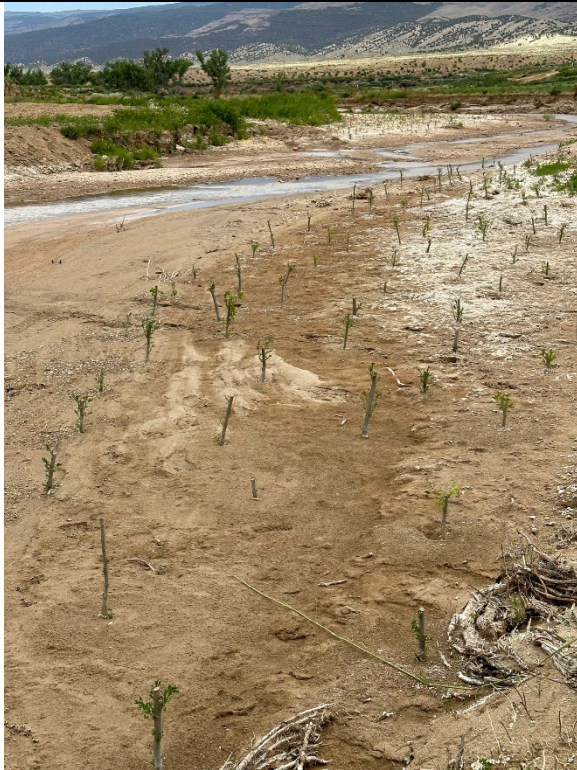
Photo 23: 6/29/2023 Willows stakes on inset floodplain resprouting.

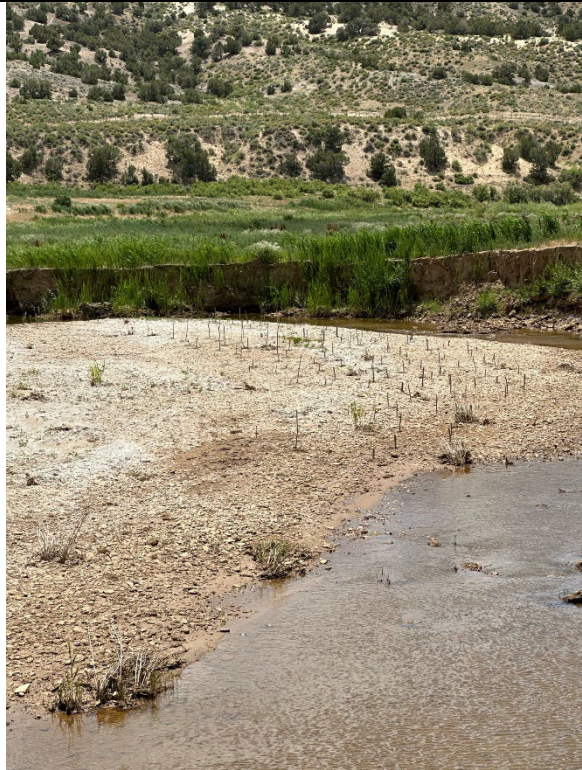
Photo 24: 6/29/2023 Willows stakes and SBS transplants on inset floodplain resprouting. Volunteer vegetation along slump toe.

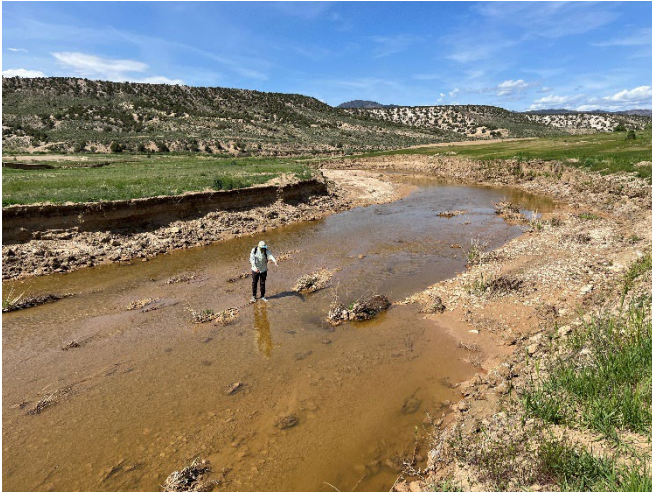
Photo 25: 5/25/23 Willow sprouting from SBS transplants in inset floodplain.

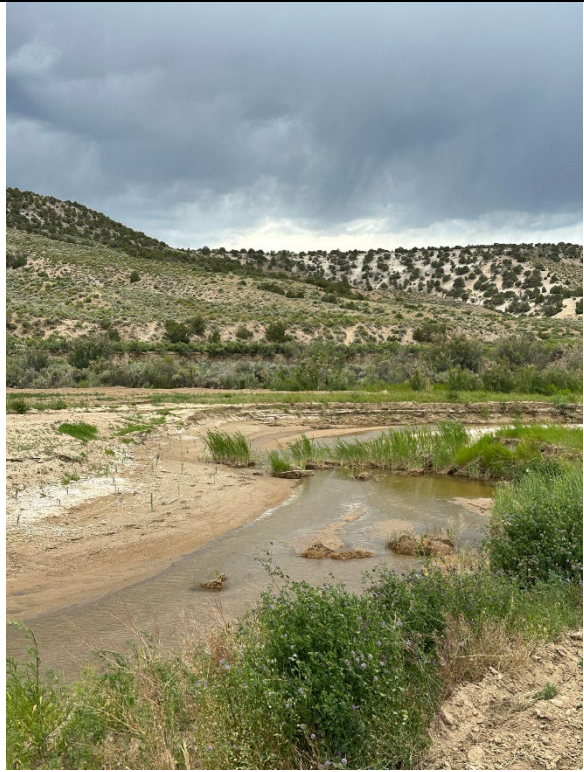
Photo 26: 6/29/23 SBS in channel with willow sprouting from SBS transplants.

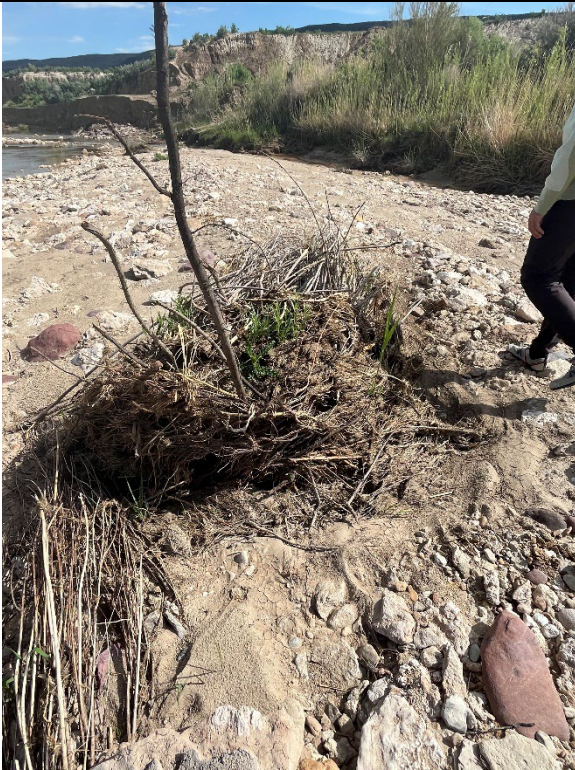
Photo 27: 5/25/2023 Willow sprouting from SBS transplants.

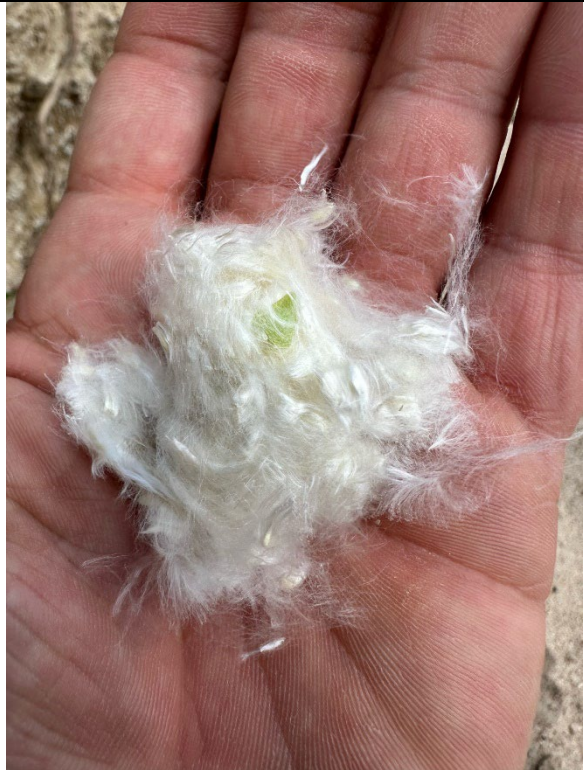
DPCC monitored cotton production, which took place around the last week in June 2023, then collected cotton and hand seeded it concurrently with the Riparian Seeding operations. (Photo 28 in Appendix A).

Photo 28: 6/29/2023 Cottonwood “cotton” collected from the downstream reach of the site.

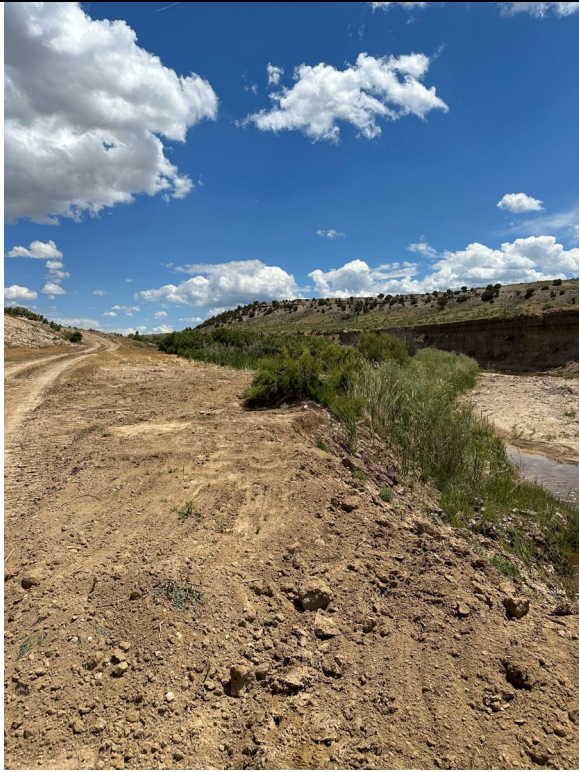
Photo 29: 6/17/2023 Concrete debris has been removed.

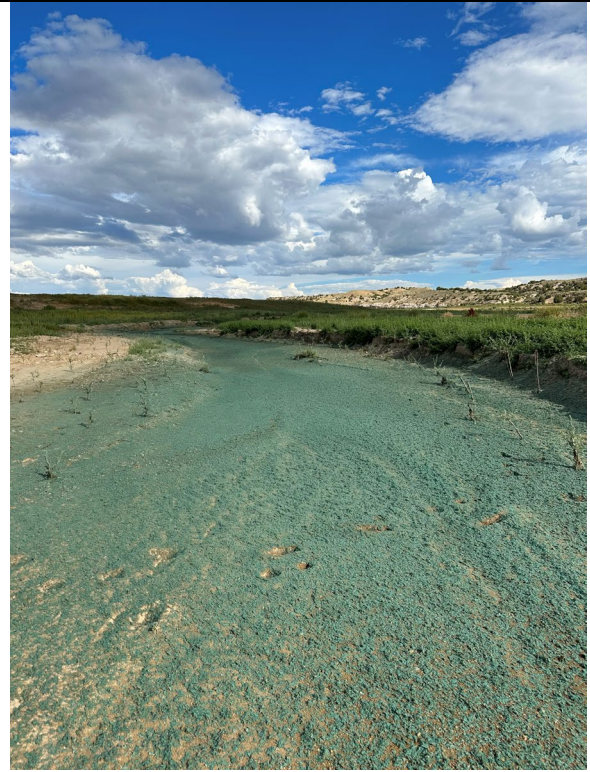
All Zone 2 Wetland Seeding areas within the bed of the inset Vermillion Creek inset floodplain and the Little Joe Wetland Complex were seeded with the specified Wetland Seed Mix at the rates indicated on the plans. Slumped toes at the base of vertical banks that were seeded with the Upland-Cover Crop Mix were also seeded with the Wetland Mix. The Wetland Seed was supplied by Granite Seed according to the seed schedules with no substitutions. Wetland seeding was completed by July 10, 2023, via a hydroseeder (Photo 30 in Appendix A).

Photo 30: 7/31/2023 Wetland seed applied to the inset floodplain

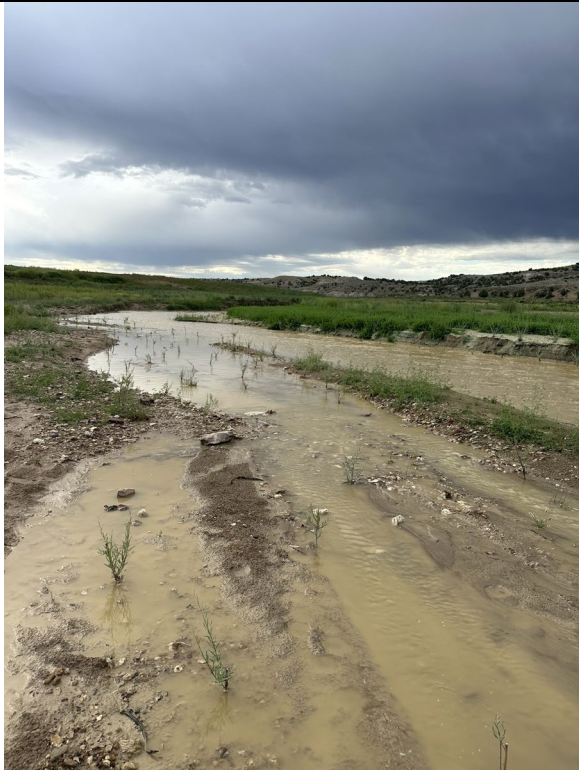
A flood pulse moved through the inset floodplain on August 3, 2023, several days after wetland seeding was performed (Photo 31 in Appendix A). During the August 29, 2023 monitoring inspection, hydromulch was observed to be generally still present, indicating that wetland seed was still in place. Approximately 20 pounds of the Wetland Mix has been reserved in cold storage to perform touch-up seeding in the Spring of 2024 for areas that may experience scour and wetland seed loss. Refer to the attached As-built Seeding and Planting Map for locations (Appendix G).

Photo 31: 8/3/2023 Three days after wetland seed was applied

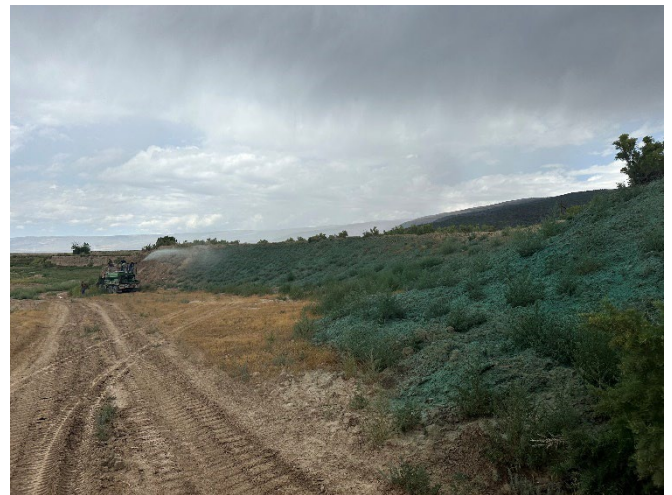
Photo 32: 8/7/2023 Upland seed applied to the bank at the entrance by stock yard.

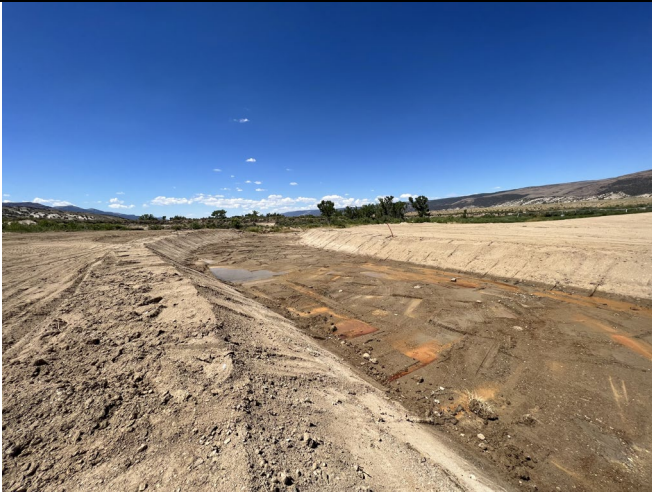
Photo 33: 8/17/2022 Completed channel excavation grading in lower reach.

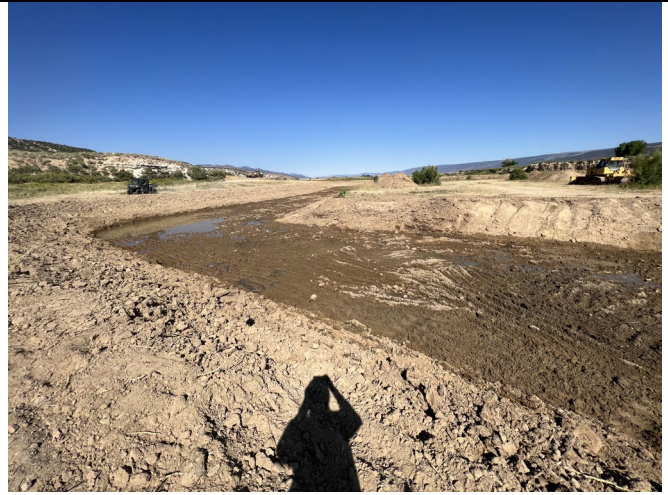
Photo 34: 8/18/2022 Completed channel excavation grading in upper reach.

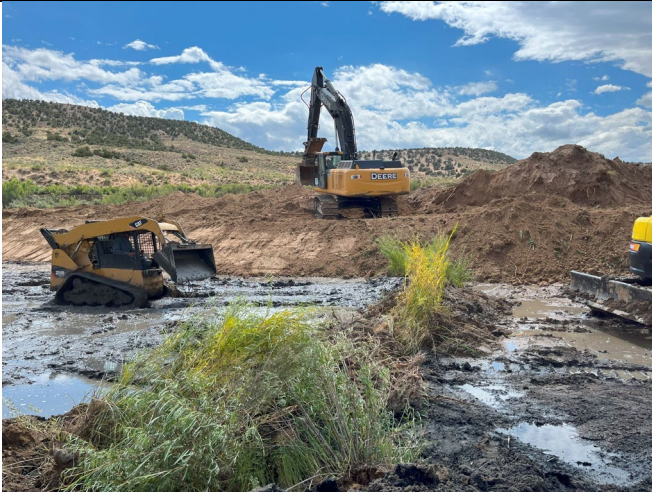
Photo 35: 8/2/2022 Completed SBS with direct transplants.

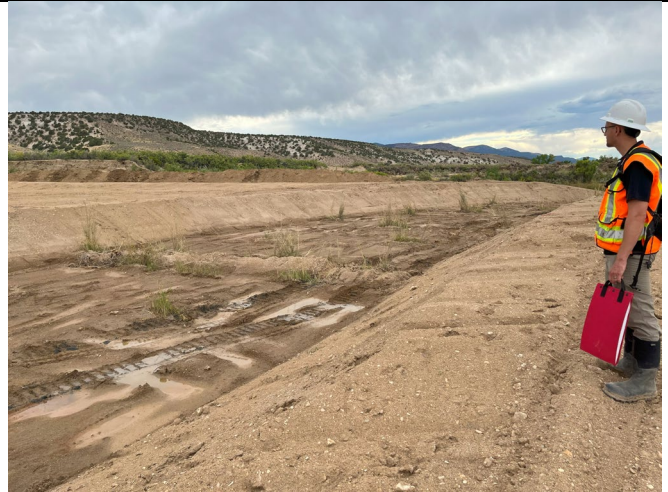
Photo 36: 8/25/2022 Completed SBS with direct transplants and willow transplants upstream and downstream of SBS.

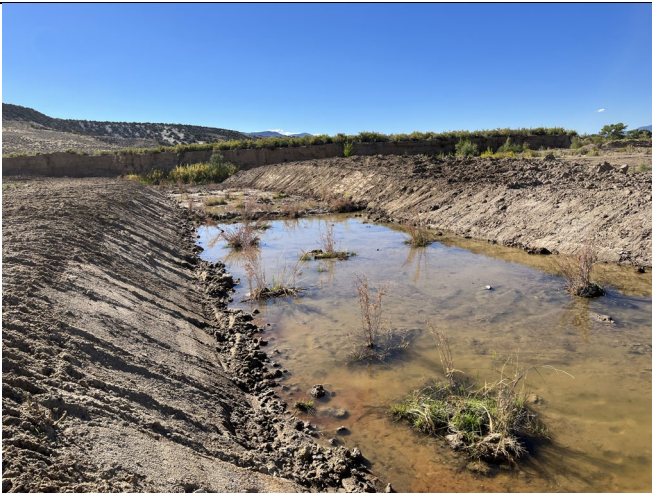
Photo 37: 8/25/2022 Willow transplants between installed SBS.

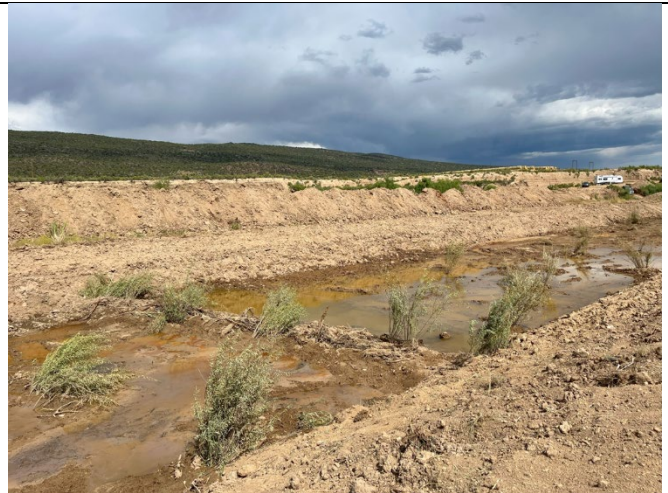
Photo 38: 8/25/2022 Completed SBS with direct transplants and willow transplants upstream and downstream of SBS.

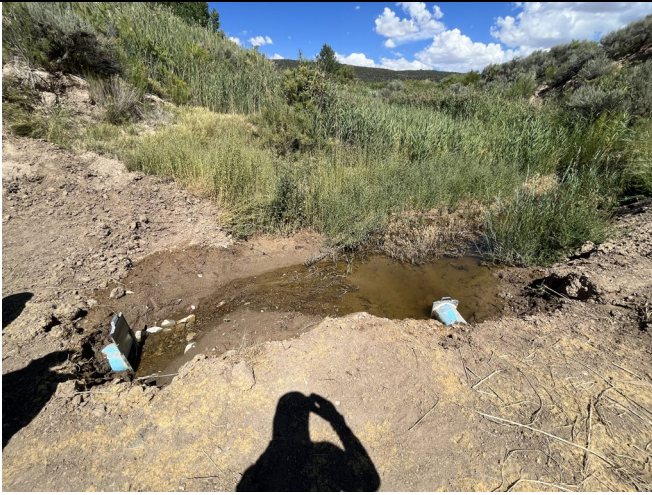
Photo 39: 8/17/2023 Little Joe Creek wetland complex water distribution.

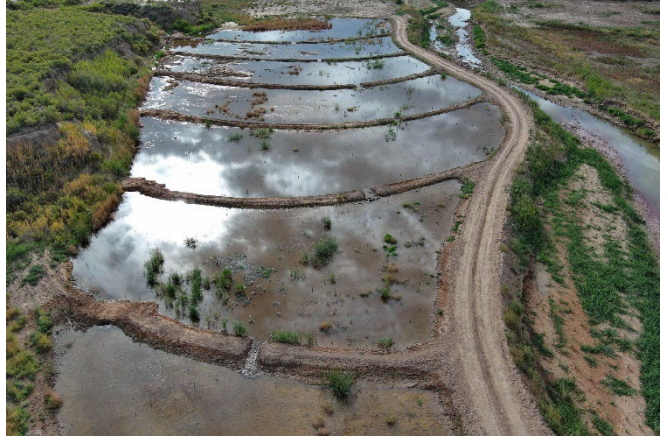
- 3000 willow cuttings were planted in the Little Joe Wetland Complex by August 26, 2023 (Photos 40–42 in Appendix A).
- 400 willow cuttings were planted along the bed and banks of the upstream head cut area by August 26, 2023, to supplement the existing willow present within the slumped banks

Photo 40: 9/18/2023 Little Joe Creek wetland complex complete with water flowing through.

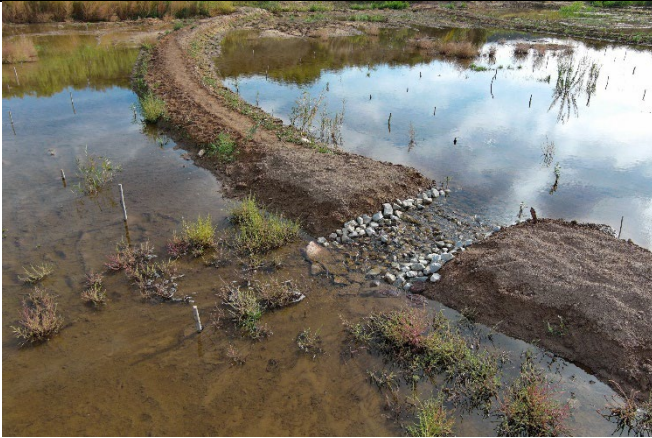
Photo 41: 9/18/2023 Little Joe Creek wetland complex connection between wetland cells.

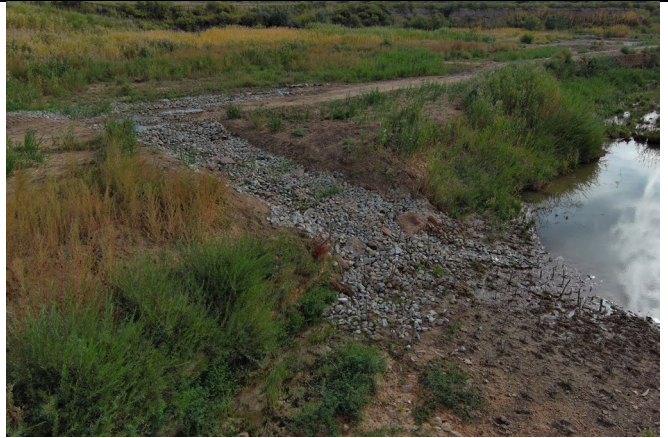
Photo 42: 9/18/2023 Little Joe Creek wetland complex connection to Vermillion Creek

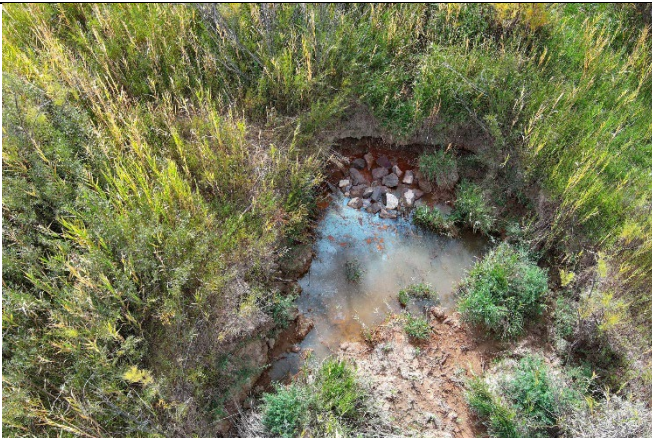
The occurrence of numerous large flow events prior to the implementation of the headcut treatment caused movement of the upstream headcut, as well as expansion in size and a split into two areas (referred to as northern and southern headcut) as it moved upstream. Implementation of modified headcut treatments (i.e., to address the two current headcuts) was completed as part of remaining Phase 1 construction activities in 2023. A rock ramp treatment was installed in the northern headcut where access for heavy equipment was feasible (Photo 44 in Appendix A). Heavy equipment could not access the southern headcut without causing additional harm to the ecosystem due to soft saturated wetland condition. The southern headcut treatment was therefore completed with hand tools and manual labor. Because the full rock ramp treatment could not be constructed via hand tools, large rocks and greasewood were “daisy-chained” for placement in the headcut (Photo 43 in Appendix A). The design team will continue to monitor the southern headcut and adaptively manage this area.

Photo 43: 9/18/2023 Headcut treatment completed in the southern headcut.

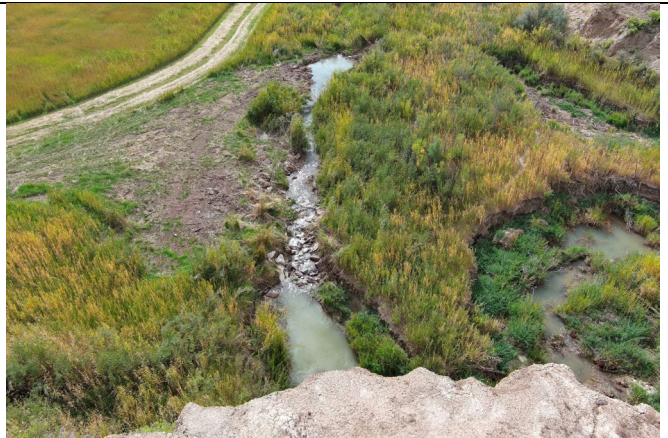
Photo 44: 9/18/2023 Headcut treatment in completed the northern headcut.

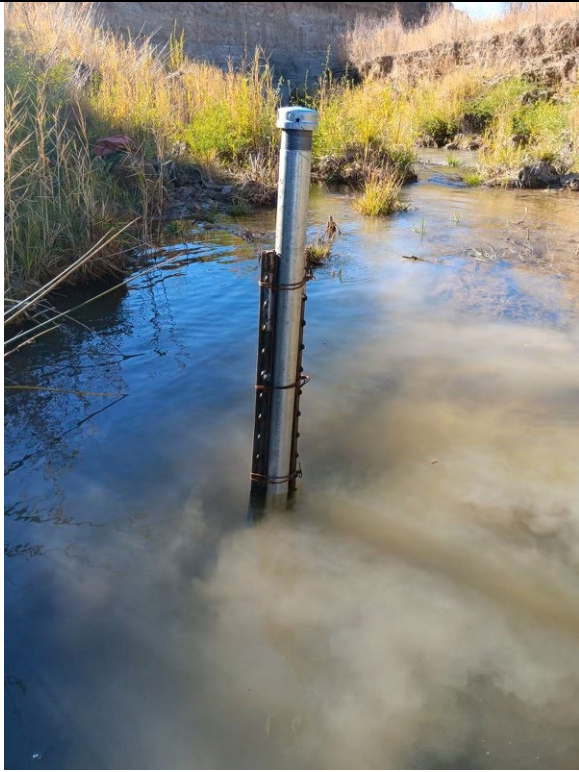
A USGS crest gage, Type A was purchased from Performance Results Plus, Inc. and installed in October 2023 as part of remaining Phase 1 construction activities (Photo 45 in Appendix A). Due to channel adjustments caused by the migration of the upstream headcut, the original location specified in the MAM Plan for the crest-stage gage was no longer suitable. The crest-stage gage was installed at the nearest suitable location to the original cross section as shown in Appendix H. Additionally, Mr. Raftopoulos will install a weather station with rain gage on the DPCC property to enable monitoring of precipitation events, which provides the trigger for timing of inspection of the crest-stage gage, starting in Spring 2024.

Photo 45: 10/17/2023 Staff gauge installed in the channel thalweg.

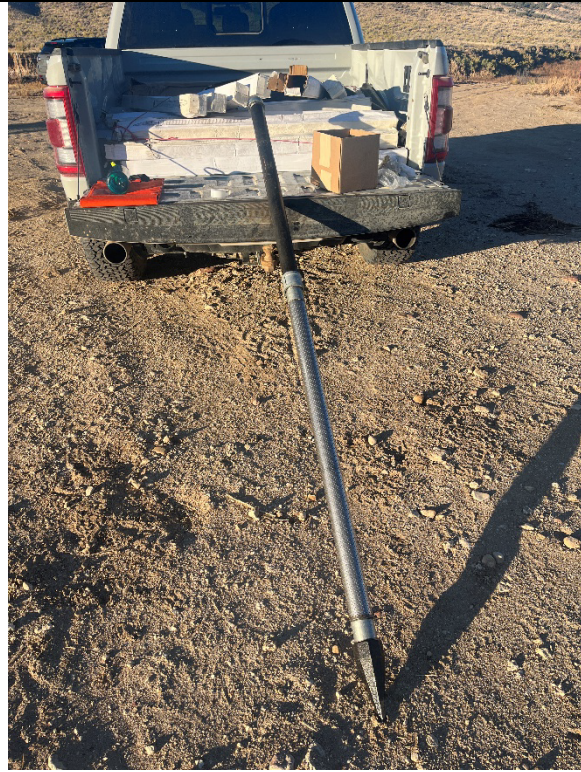
Photo 46: 10/17/2023 Assembled Drive Point Groundwater Well before installation.

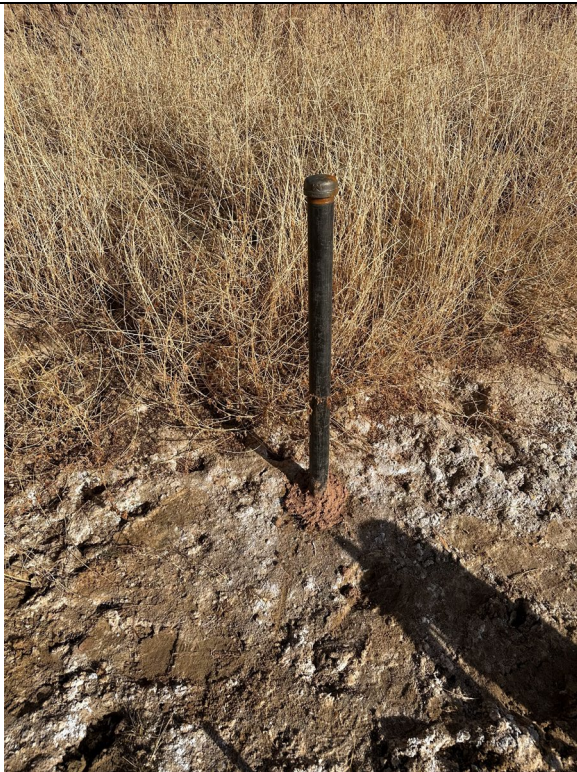
Additionally, a bentonite seal using bentonite chips was installed to seal the tops of the wells and to prevent surface water infiltration and sediment from entering the wells (Photo 47 in Appendix A). At this time, no protection against high runoff/debris flows has been installed. The design team will monitor the groundwater wells and install this protection as part of adaptive management activities, if conditions warrant. Installation of data loggers in the groundwater wells is planned to be completed before the start of the 2024 monitoring period (approximately May 17 to September 18).

Photo 47: 10/17/2023 Groundwater well installed at the toe of the channel.

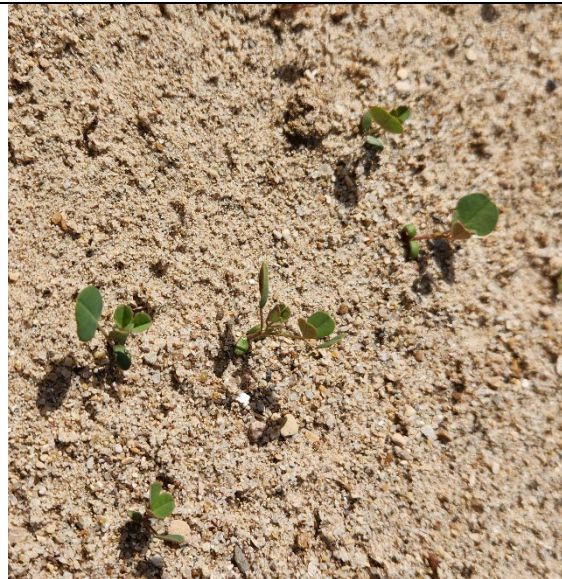
Either via seeding or natural recruitment, cottonwood seedlings and saplings (assumed to be Fremont cottonwood, *Populus fremontii*) were observed during the August 2023 site assessment throughout the inset floodplain at various stages of growth. (Photo 48–49 in Appendix A). Occurrence and density of cottonwood are greater in the downstream sections of the floodplain starting at approximately 50+00 with the highest density of seedlings downstream of Station 30+00. The higher density downstream is likely attributed to greater source of wind-blown cotton from nearby mature cottonwood in these areas, especially at the downstream-most end of the Project.

Photo 48: 5/25/2023 Cottonwood seedlings.

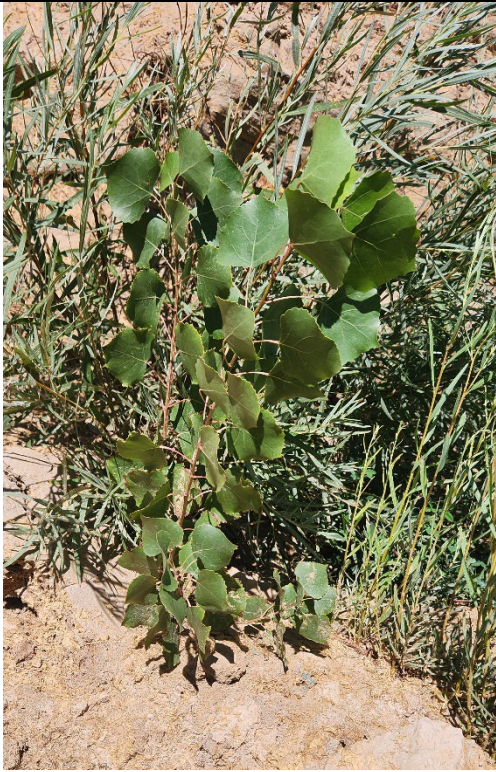
Photo 49: 8/28/2023 Cottonwood sapling

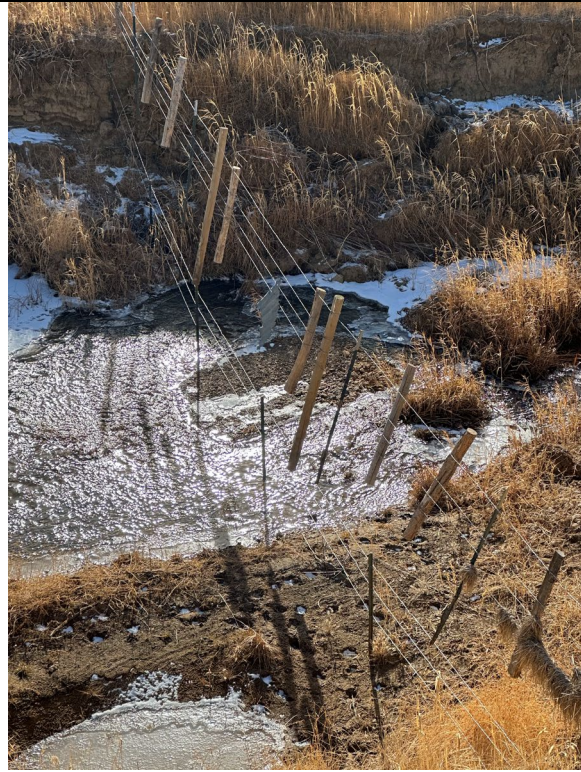
Photo 50: 12/17/2023 Fence extenders to preclude cows from entering site

- Fencing was added to preclude cows from entering the site from the upstream end of the project reach, near the headcut (Photo 50, Appendix A).
- Native coarse bed material was added to the upstream low water crossing to reduce potential barriers to fish passage (Photo 51, Appendix A).

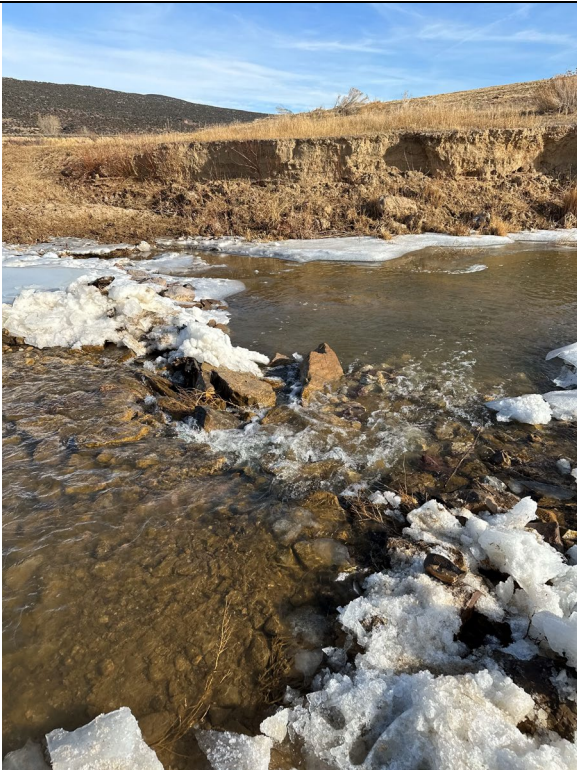
Photo 51: 12/17/2023 Added native cobble to upstream low water crossing to reduce fish passage barriers.

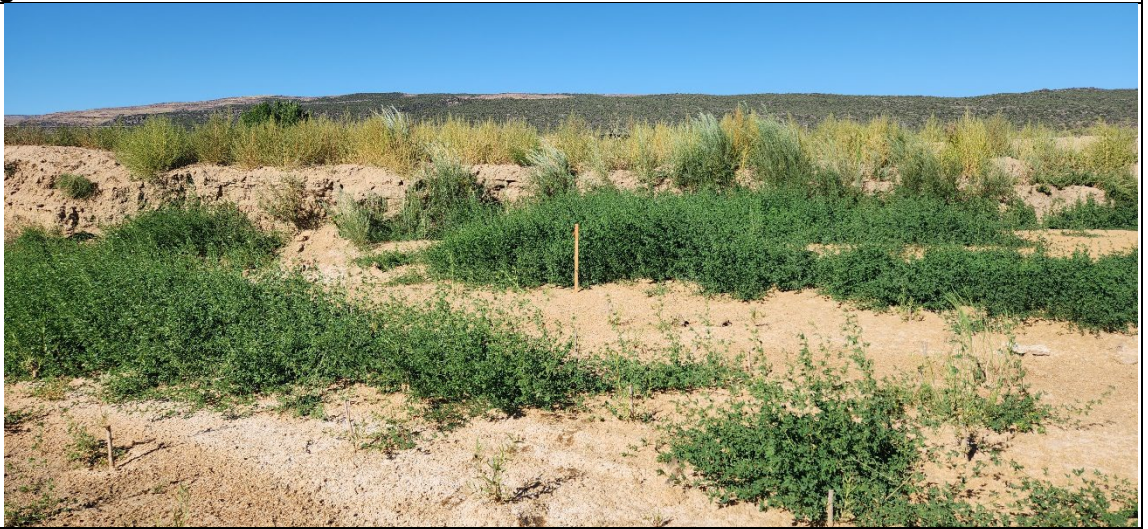
7. Description: View of inset floodplain and 25-foot buffer looking northeast.

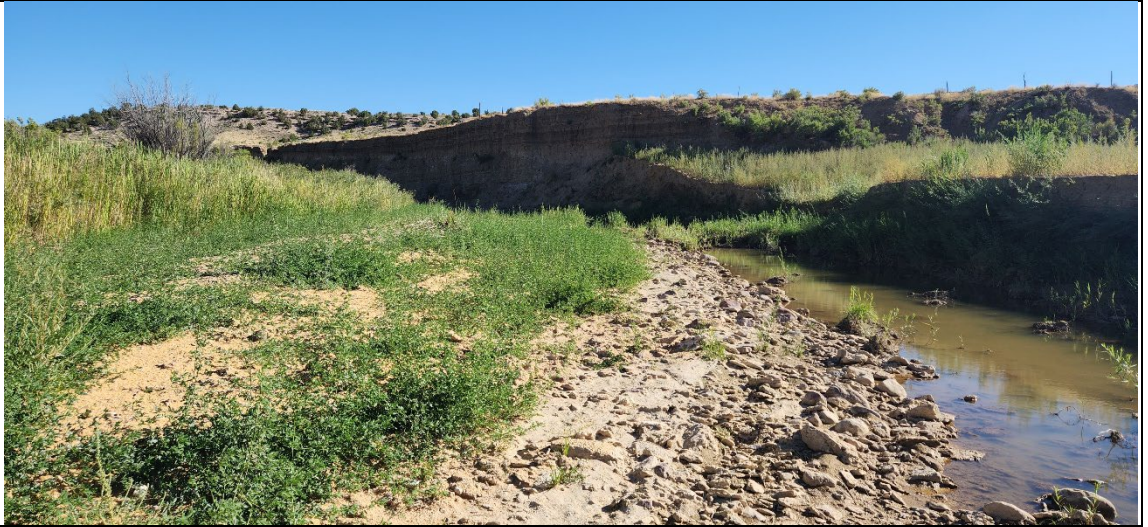
7. **Description:** View of inset floodplain and 25-foot buffer looking upstream.

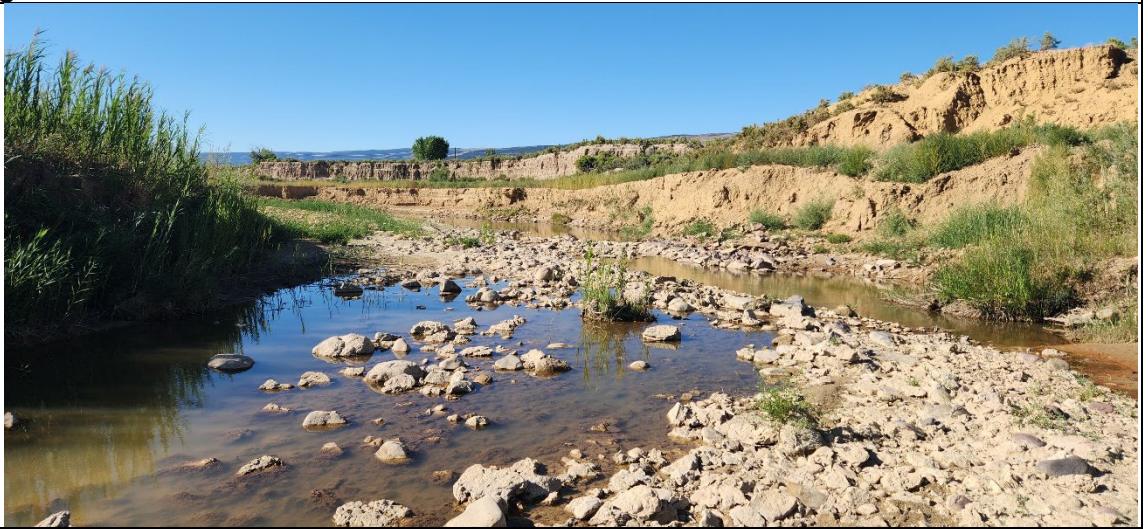
7. **Description:** View of inset floodplain and 25-foot buffer looking downstream.
