TECHNICAL MEMORANDUM

DATE: December 19, 2023

SUBJECT: Vermillion Creek Restoration at Diamond Peak Ranch - 2023 Adaptive Management
Phase 1 and 2

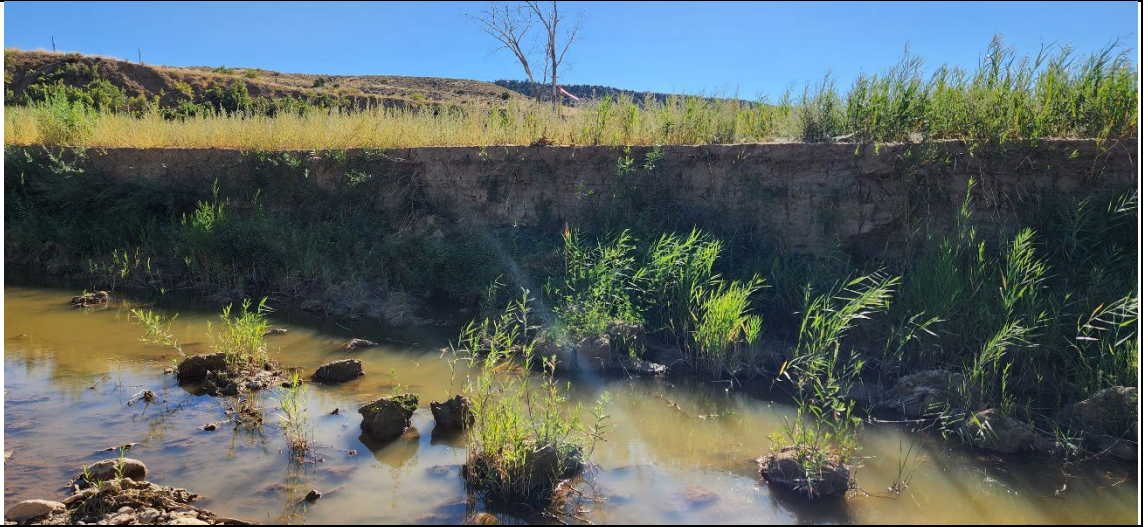
7. Description: View of inset floodplain and 25-foot buffer looking southwest.

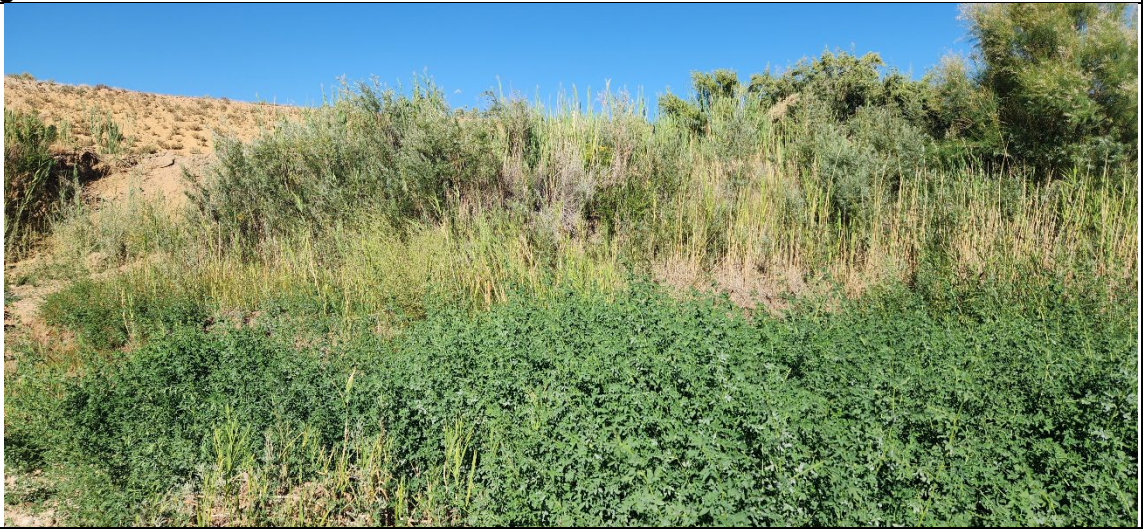
7. Description: View of inset floodplain and 25-foot buffer looking northeast.

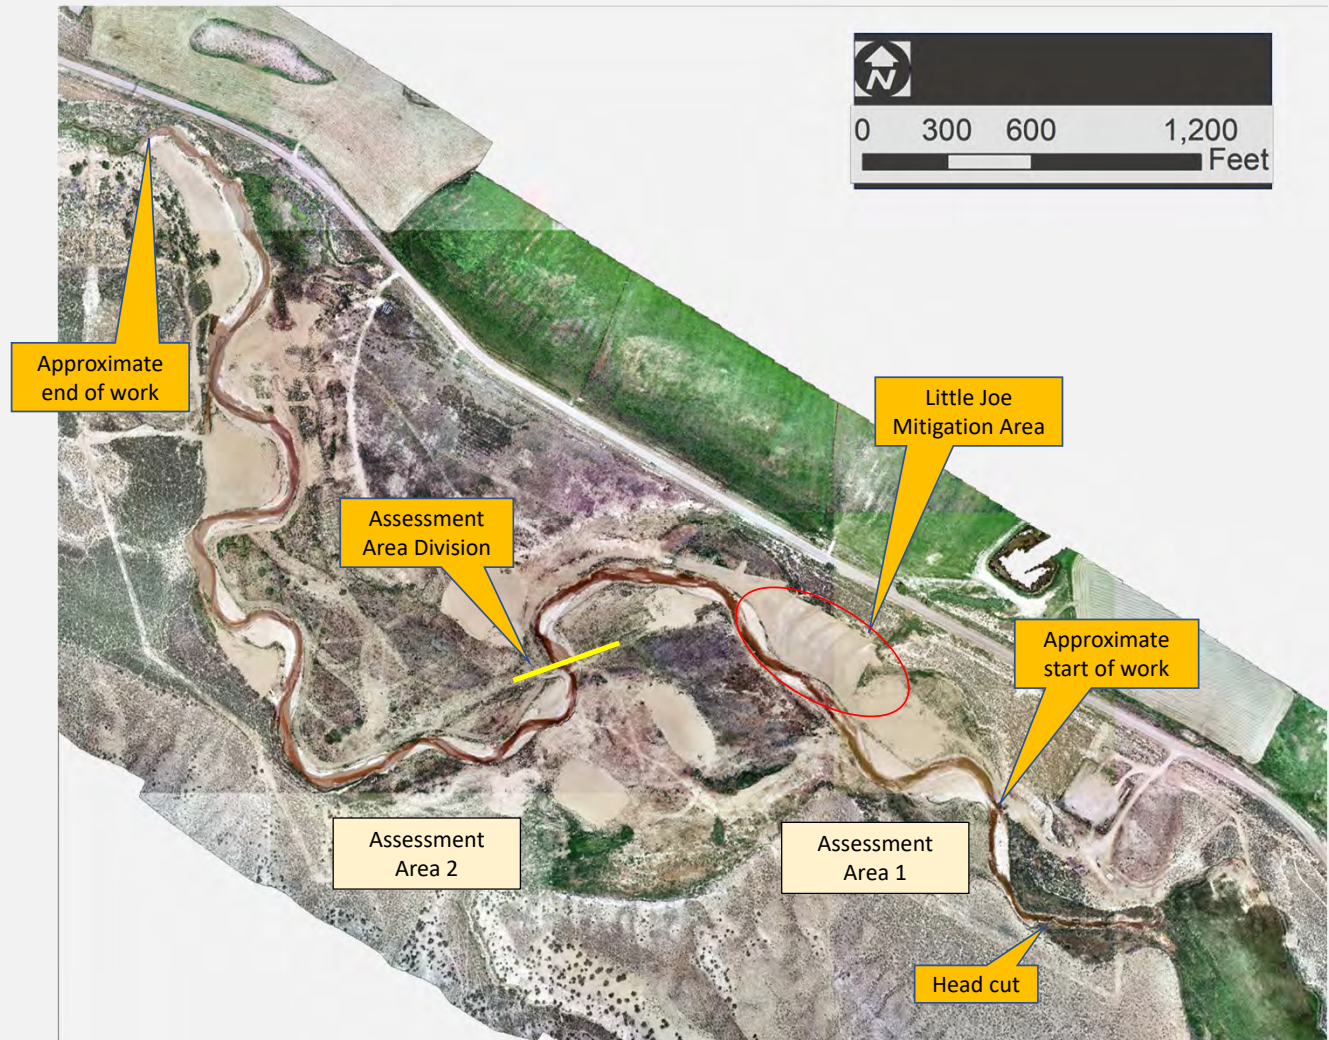
Figure 1 provides an overview of the major features of the mitigation areas. Vermillion Creek was divided into two assessment reaches for the FACWet. Little Joe was not evaluated using FACWet, because the regional references were focused exclusively on Vermillion Creek, as were the functionally-based performance standards included in the consent decree. Little Joe was evaluated with regard to its apparent ability to attain and/or support wetland conditions.

Figure 1. 2023 aerial photograph of the Vermillion Creek and Little Joe Mitigation areas, along with relevant features.

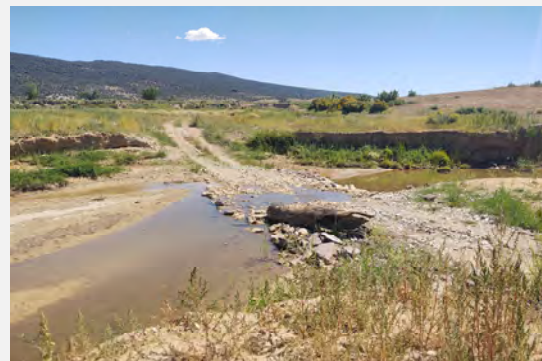
Fig. 4. View southeast of the low water crossing that divides the two assessment reaches.

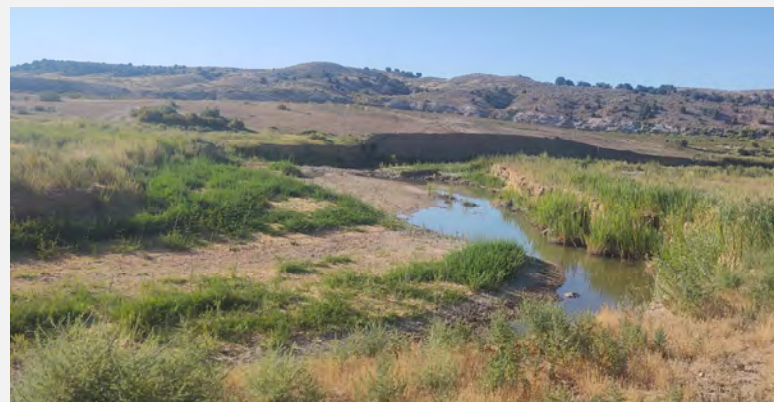
The October 2022 flow event advanced macro-geomorphic development of the restoration many years. A multistage floodplain configuration is common throughout the restoration, suggesting an ability to support diverse riverine wetland and riparian habitats (**Fig. 5**). The inset floodplain is also substantially larger than that which was actively excavated (approximately 9 acres), providing a larger than planned footprint of potential wetland and riparian habitat.

Fig. 5. View southwest showing the geomorphic template of the restoration.

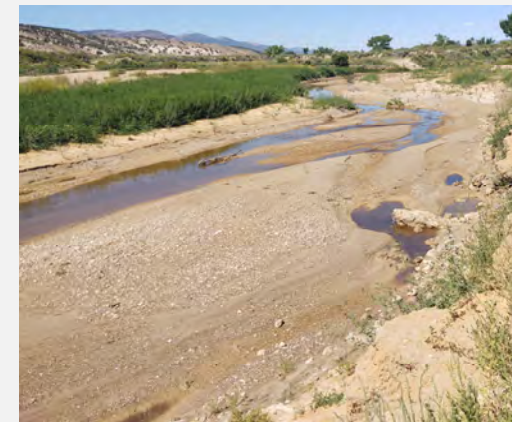
Mitigation functioning at this phase appears to parallel that of an arroyo (**Fig. 6**). Classically, arroyos are fine-grained systems, inset into uplands, that are periodically subjected to high energy flow events that essentially restart habitat succession. Vermillion Creek is somewhat atypical in having perennial rather than episodic flow, however. In arroyo habitat succession, if large events are infrequent, vegetation may move into the bottom and begin to exert control on low flows, splitting sheet flow into concentrated braids flowing between protected islands. When islands become stabilized with vegetation, channels with well defined bed and bank can form, being carved by the concentrated flows. The system may continue to develop along these lines until the next major event.

Fig. 6. The left panel is a photographic explanation of the character of an arroyo as found on the *World Atlas* webpage. The right panel is a photograph of the lower reach of the Vermillion Creek mitigation. There is a clear similarity in appearance.

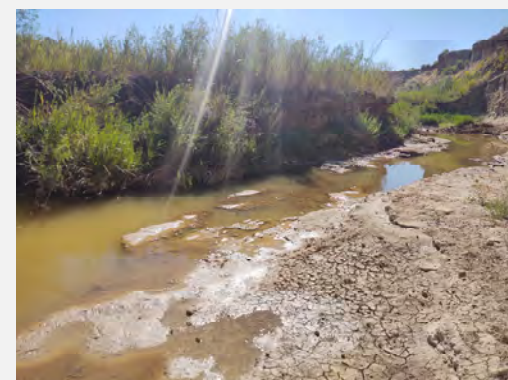
Fig. 15. An apparent bed rock sill in the head cut reach above the mitigation, is likely holding grade.

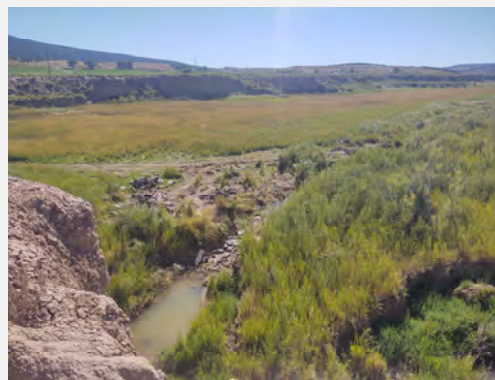
This study only assessed the head cut with regard to its potential affects on the mitigation. As of the time of this assessment, the head cut did not appear to be negatively impacting the mitigation, however, the affect of down cutting on adjacent wetlands should be monitored (**Fig. 17 and 18**). A loss of adjacent wetland habitat would impact the FACWet Buffer and Landscape Context variables. At the time of this assessment wetland vegetation exhibited no obvious signs of stress.

Fig. 18. A view down on to the surface of the bench shown in **Fig. 17**. The steep scarp in both pictures provides reference.

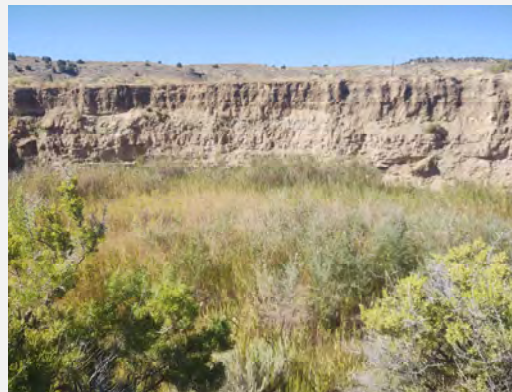
Fig. 17. View from inside the head cut. Based on the regional reference survey, bank heights in this area prior to October 2022 were four to five feet.

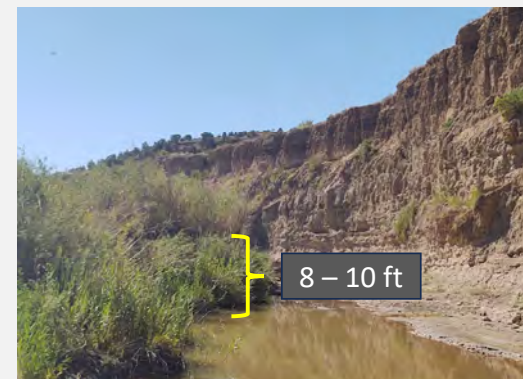
In the case of the Vermillion Creek mitigation, in the upper reach, the depth that the floodplain is inset does not impair the functioning of restored habitat within. It is unlikely that the creek will ever reattach to the historical floodplain placing it in the category of "relict". The inset floodplain will probably continue widening, creating more and more wetland and riparian habitat at the new, lower base level, thereby continuing the geomorphic succession illustrated in **Fig. 19**.

Fig. 19. View northwest showing the terrace scarp of the mitigation, in reference to a paleo terrace scarp associated with a long-abandoned floodplain.

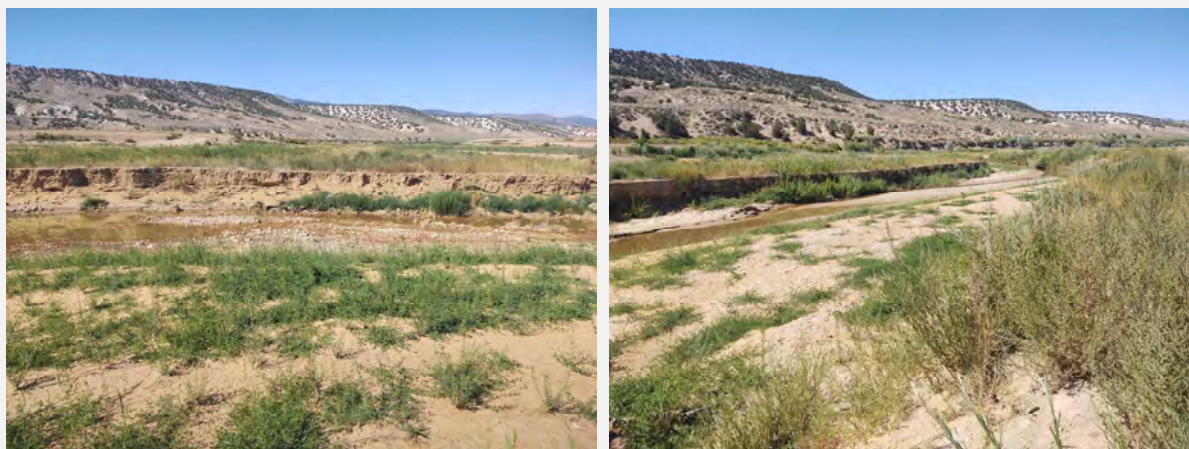
Vegetation at the time of this assessment was primarily volunteer herbaceous species and newly establishing willow slips (**Fig. 22**). The early growth of willow slips was often impressive. The herbaceous flora appeared overwhelmingly comprised of ruderal and weedy species. This is expected at early states of development. Additional seeding and willow and cottonwood planting were scheduled after the completion of this assessment.

Given these conditions the Vegetation Structure and Complexity variable was rated D-. This grade is expected to rise as mitigation matures.

Fig. 22. Vegetation establishment is at a rudimentary stage. The majority of vegetation coverage appears to be comprised of ruderal species.

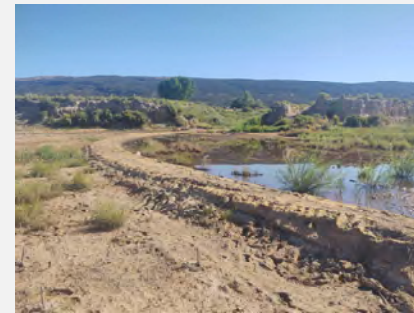
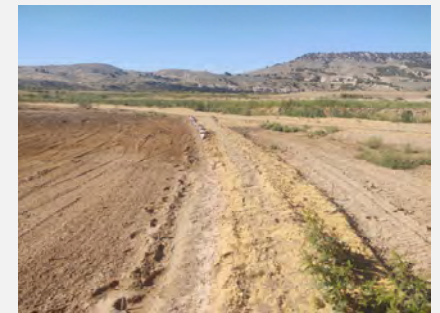
Fig. 24. Two photographs showing the berms partitioning wetland cells.

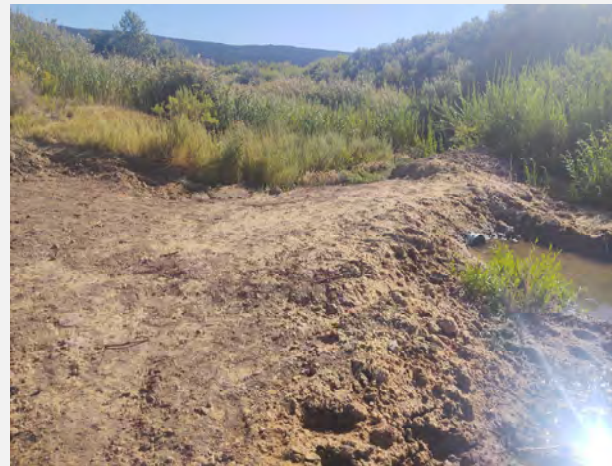
Fig. 26. Little Joe enters the wetland basin at the northeast corner.

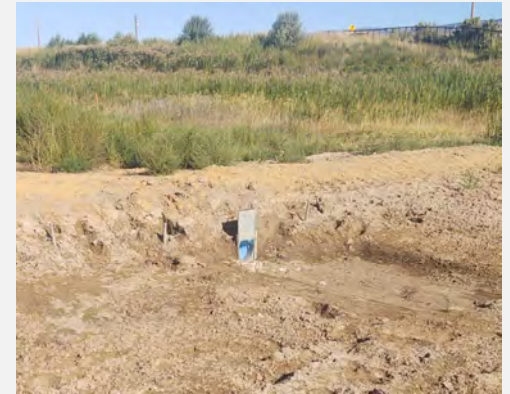
Fig. 27. The berms creating the wetland cells are pierced with a plastic pipe, fitted with a flow control gate that can be pulled up to increase flow volume.

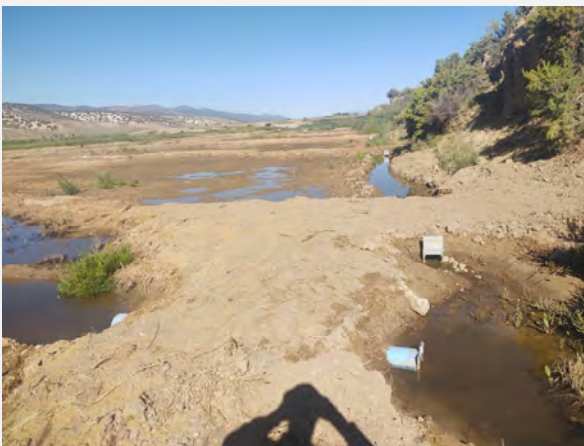
Fig. 28. View northwest looking down the peripheral supply channel, to the right in the picture. Another supply pipe goes left into the upper wetland cell.

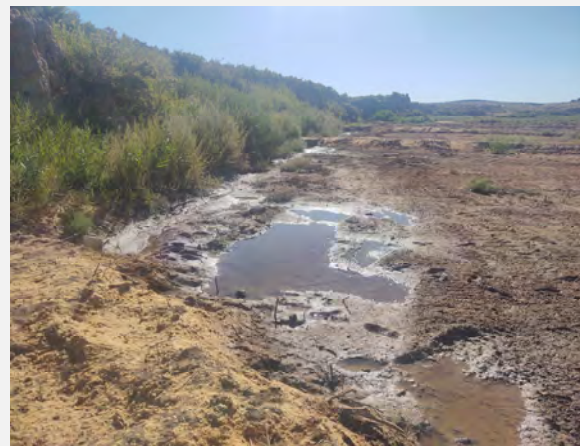
Fig. 29. View east-southeast of the peripheral supply channel from a dividing berm.
